[Docket No. 95-NM-277-AD; Amendment 39-9537; AD 96-06-01]

Airworthiness Directives; Boeing Model 757 Series Airplanes Equipped with Abex Spoiler Actuators

96-06-01 BOEING: Amendment 39-9537. Docket 95-NM-277-AD.

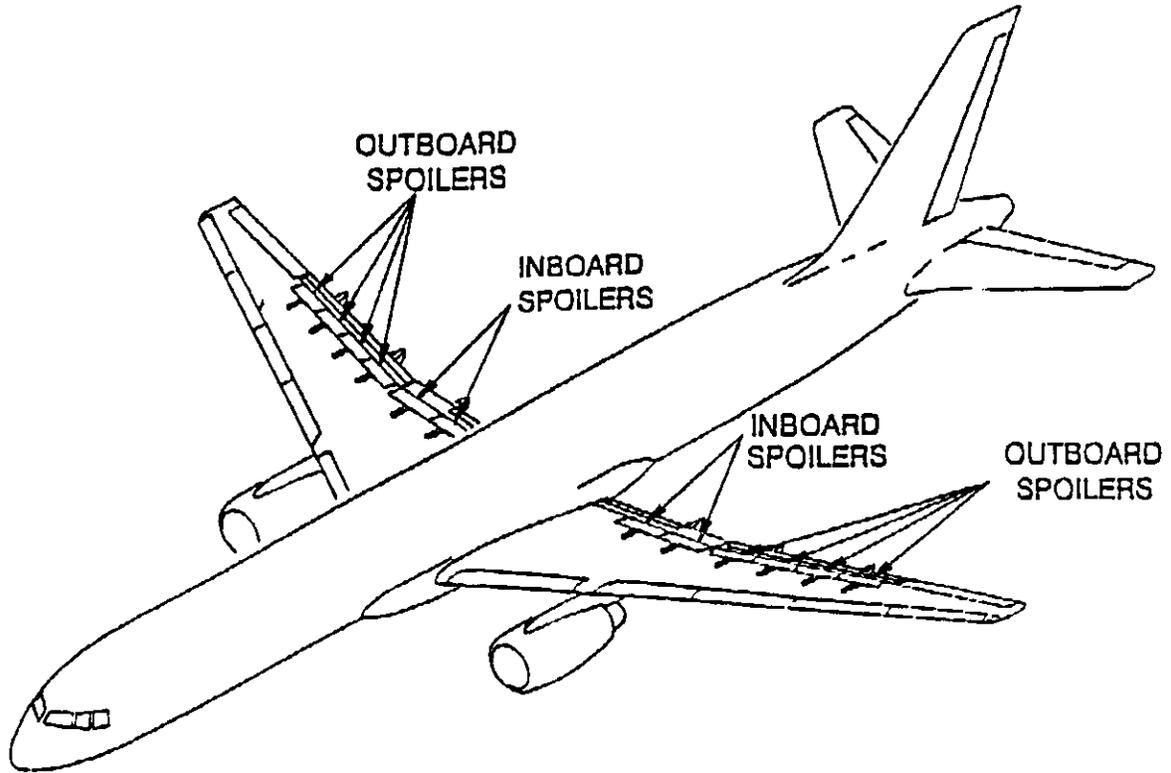
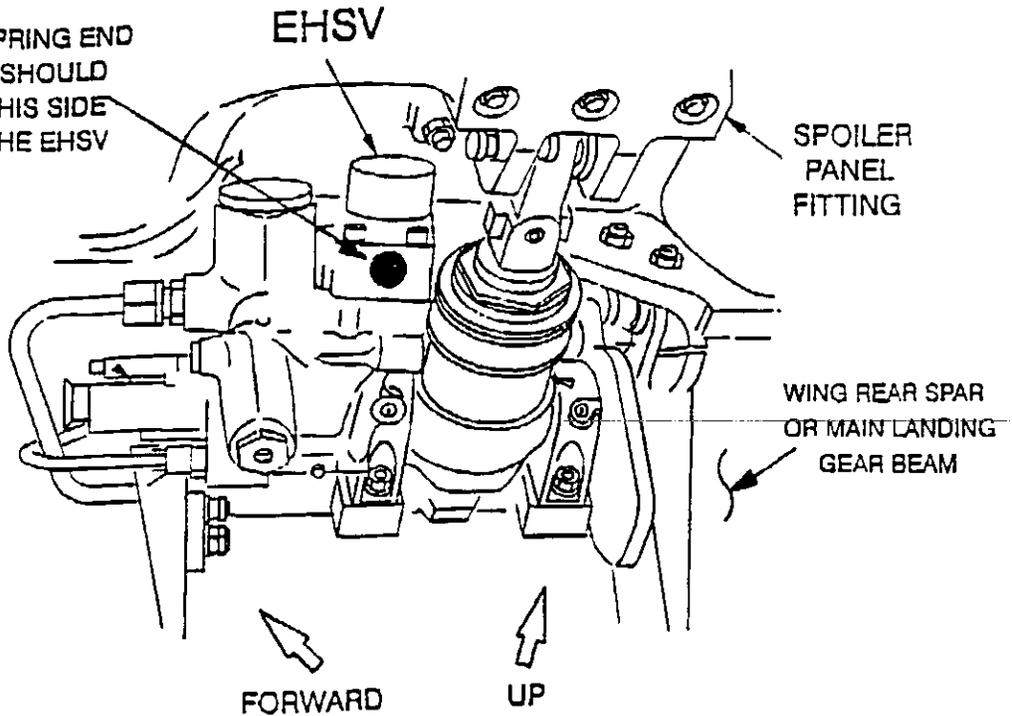
# Boeing Model 757 Actuator Installation

NOTE 2: To be correctly positioned, the second stage bias spring cap assembly should be on the upper or forward side of the EHSV assembly. Appendix 1 of this AD provides a visual representation of the correct positioning of the EHSV assembly.

SECOND STAGE SPRING END  
CAP PROTRUSION SHOULD  
NOT EXTEND ON THIS SIDE  
(UNDERSIDE) OF THE EHSV

- (a) Within 6 months after the effective date of this AD, perform the following procedure:
  - (1) While the airplane is on the ground, extend the flaps to 40 degrees and visually inspect the spoiler actuator EHSV assembly to determine the location of the second stage bias spring end cap assembly.
  - (2) If the second stage bias spring cap assembly is on the aft or lower side of the EHSV assembly, prior to further flight, replace the EHSV, having Abex part number 72196, with a serviceable unit in accordance with the airplane maintenance manual.
