STATE OF CALIFORNIA  
**DEPARTMENT OF TRANSPORTATION**  
ENGINEERING SERVICE CENTER,  
DIVISION OF MATERIALS ENGINEERING AND TESTING SERVICES

**COMPLIANCE CRASH TESTING OF K-RAIL USED IN  
SEMI-PERMANENT INSTALLATIONS**

1. REPORT NO. FHWA/CA/OR-99/07	2. GOVERNMENT ACCESSION NO.	3. RECIPIENT'S CATALOG NO.	
4. TITLE AND SUBTITLE COMPLIANCE CRASH TESTING OF K-RAIL USED IN SEMI-PERMANENT INSTALLATIONS		5. REPORT DATE October 1999

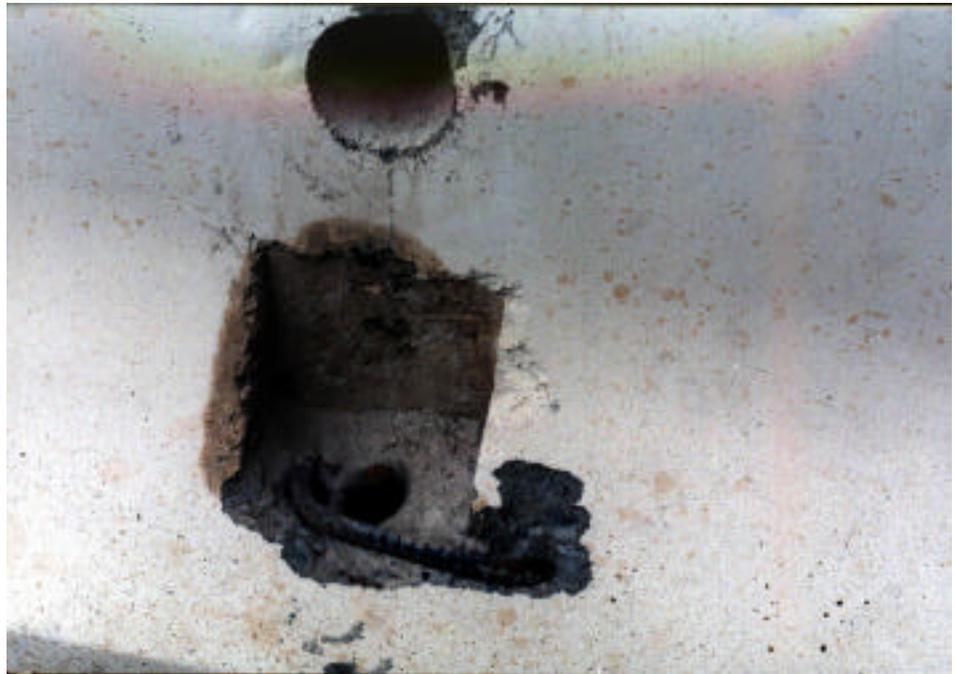
Figure 2-3 - Exposed  
Rebar

Because K-rail elements are very common in California, it was decided to order eight used rail elements. The elements were in good condition, except for the stake holes. The quality control of the K-rail elements is clearly a problem. All but two holes had to be cleared of concrete using various methods. Some holes were pounded out with a hammer and chisel. Others were drilled out with a roto-hammer using a 32-mm bit. During some of the stake-hole clearing, the concrete spalled away from the rail element, revealing mislocated reinforcing steel or even the absence of such steel (see Figure 2-3). One hole split completely, eliminating the possibility of getting positive anchoring from the stake.

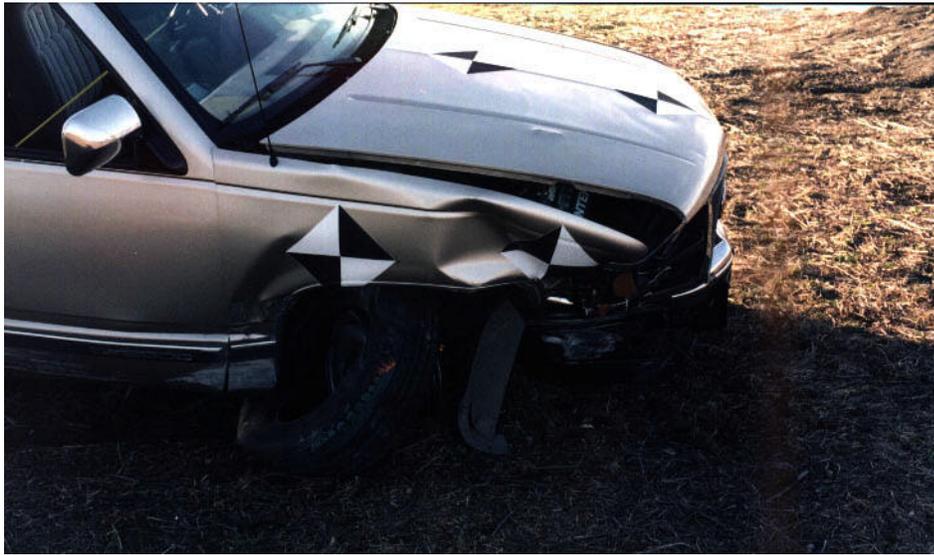
Figure 2-10 - Front Impact Side of Vehicle

Most of the damage to the vehicle was confined to right front corner. The right front tire was separated from the wheel. The right front fender and bumper were crushed (Figure 2-10). The tie-rod was broken, but the left front wheel could still be controlled by the steering wheel. There were scuff marks and scratches along the entire right side of the vehicle. The left rear wheel sustained minor damage, but the tire was still inflated.

The occupant compartment sustained some minor crumpling on the right side floorboard. The maximum deformation was 40 mm. The right door was jammed closed. The windshield was not cracked. Figure 2-16 presents a summary of the test results.

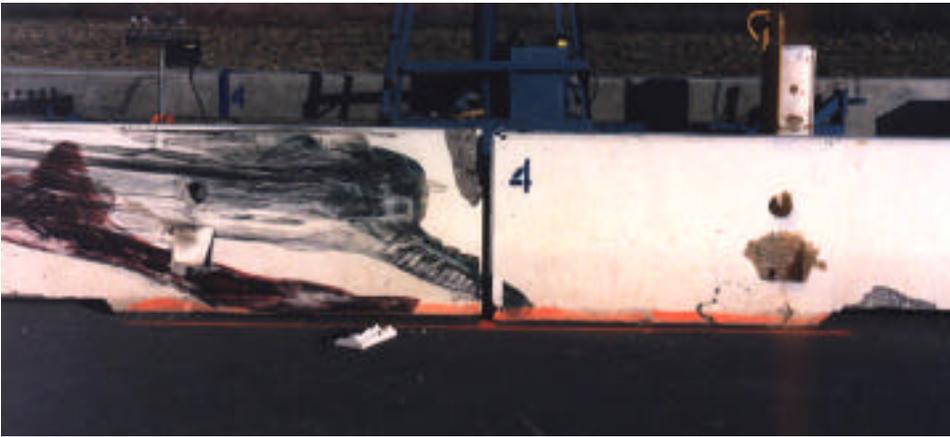
Figure 2-11 - Post Impact View of Barrier

Damage to the barrier was minimal (Figure 2-11 through Figure 2-15). The connecting pin-and-loop at joint 4-5 bent enough that it caused minor spalling and the pin had to be cut before the barrier could be moved. The maximum lateral displacement measured at the top of the barrier was 260 mm during impact. There was also some minor spalling of anchor stakes in segments 4 and 6.

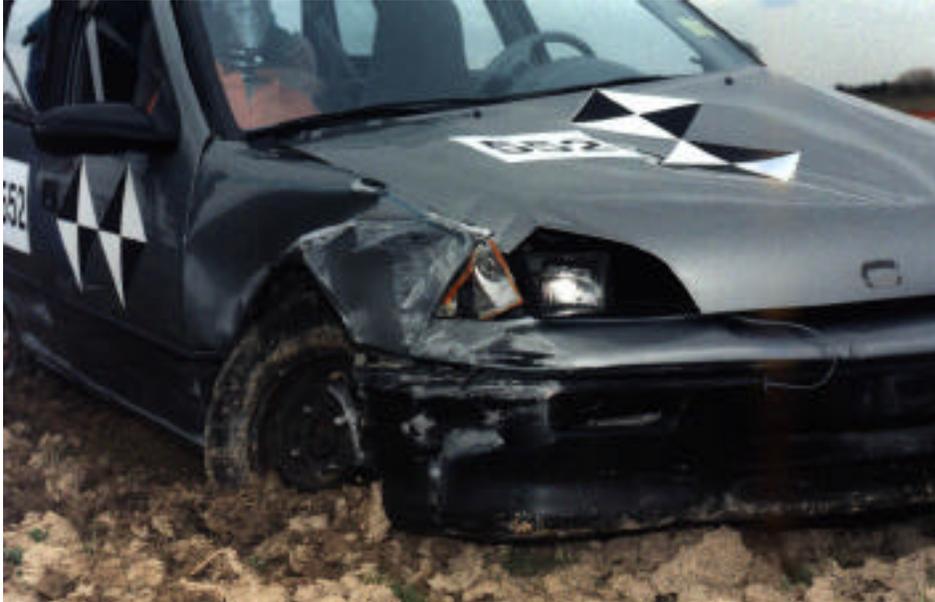
Figure 2-24 -Front View of Vehicle Impact Damage

As in Test 551, most of the damage to the vehicle was confined to the right front corner. The right 300 mm of the bumper was slightly pushed into the fender panel and the fender had considerable sheet metal damage. The parking light was broken. The right wheel assembly was pushed back and to the left, with the bottom of the wheel canted outward (see Figure 2-24 and Figure 2-25).

Other damage to the vehicle was minor. The hood had some minor crumpling. The right front door was scraped and jammed closed, but could be worked open by hand. The rest of the right side received scraping and minor crumpling. The windshield was unbroken.

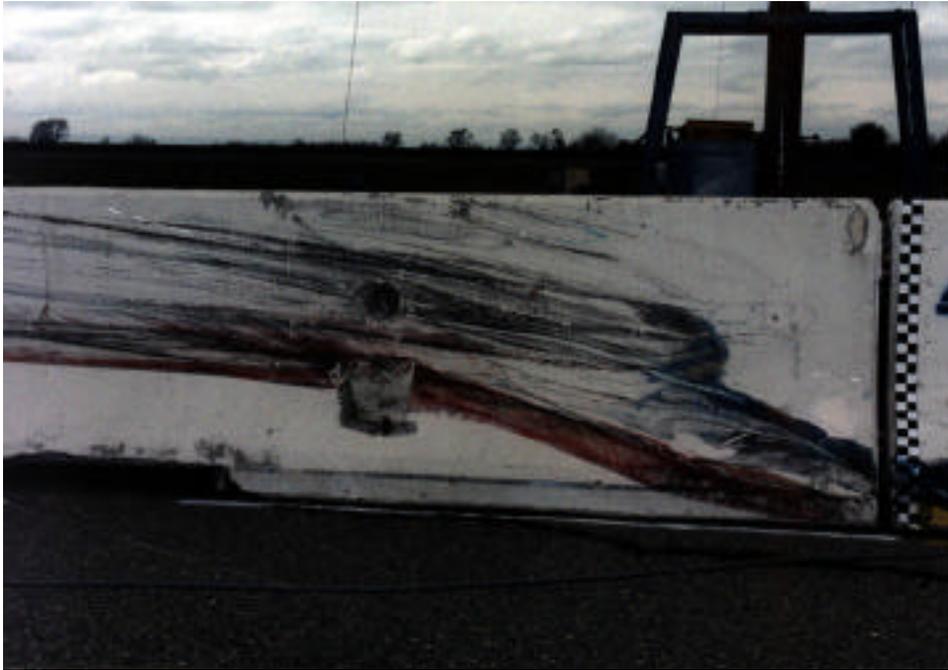
Figure 2-26 - Test  
552 Barrier  
Scuffing

Damage occurred only on the front of the barrier. Vehicle contact was limited to segments 4 and 5, where the barrier received superficial scuffing (see Figure 2-27). The K-rail cracked around several of the stake holes, but they all retained their integrity. The barrier rotated back approximately 30 mm during impact, but righted itself as the vehicle lost contact with the barrier.

Segment 4 had a permanent deformation of 25 mm, with the front edge of the barrier raised about 10 mm. The loop connections did not incur any damage.
