MARINE SAFETY CENTER

Damaged Stability Requirements for OSVs Regulated under Subchapter L

BULLETIN #04-97

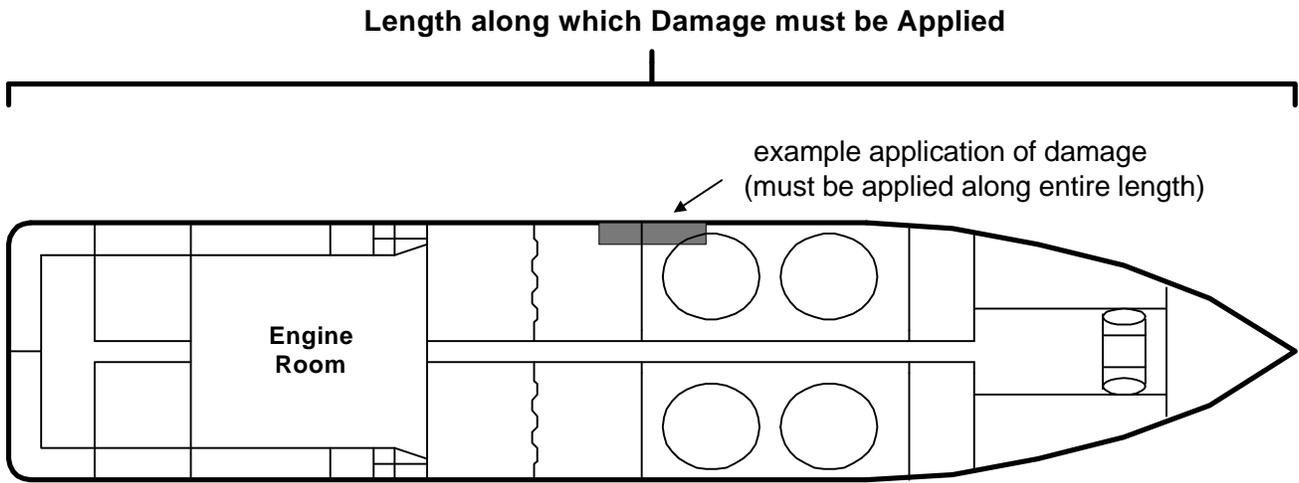
Figure 1: OSV Carrying More than 16 Offshore Workers

Applied Extent of Damage Damage is applied as stated in 46 CFR, Table 174.205(b). Transverse damage extends 30 inches inboard from the side of the vessel, applied at the deepest load waterline. Vertical damage extends from the baseline upward without limit, and the longitudinal extents are applied along the sides of the vessel, in increments dependent on the vessel's length. OSVs carrying more than 16 offshore workers are required to apply the damage along the entire sides of the vessel, while OSVs carrying 16 or fewer offshore workers are only required to apply the damage along the sides which lie between the forward and after watertight bulkheads of the main propulsion machinery space(s). See Figures 1 and 2.

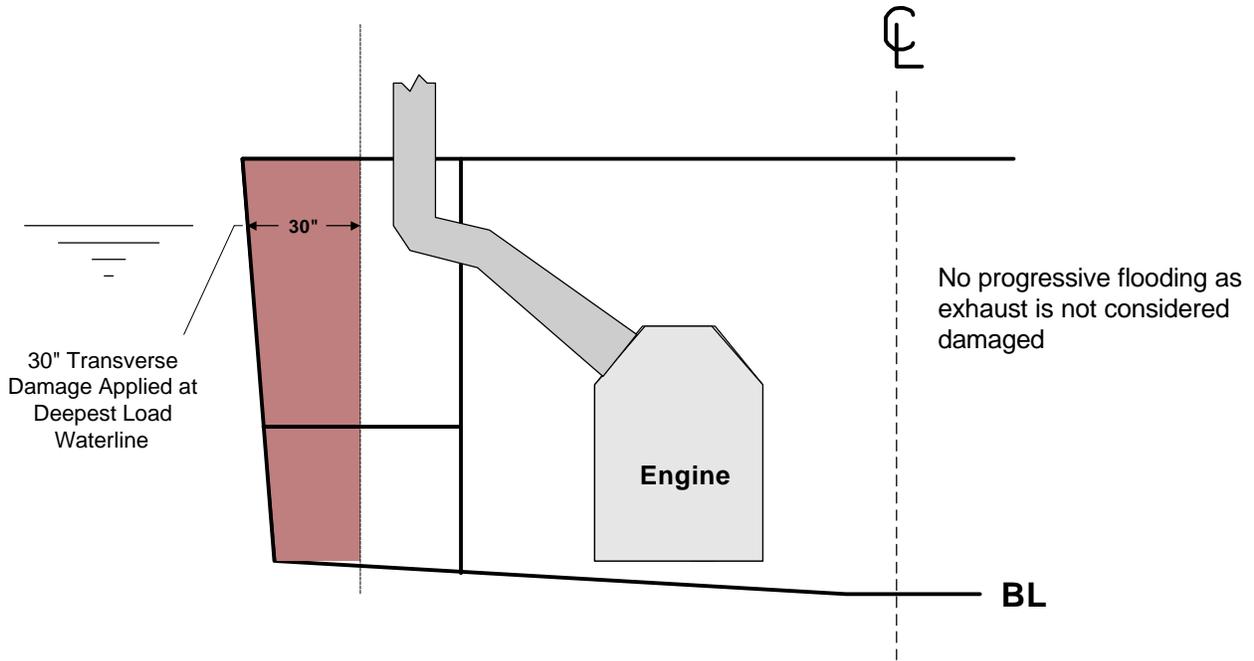
Figure 3: Undamaged Engine Exhaust Piping

Treatment of Damaged Engine Exhausts As with any piping, exhaust piping that passes within the boundaries of applied damage must be assumed to permit progressive flooding to all spaces with which that piping connects. See Title 46 CFR 174.205(e)(4). Essentially, the entire length of exhaust piping is considered damaged and any penetration of a watertight bulkhead must be assumed to allow progressive flooding. See Figures 3 and 4.

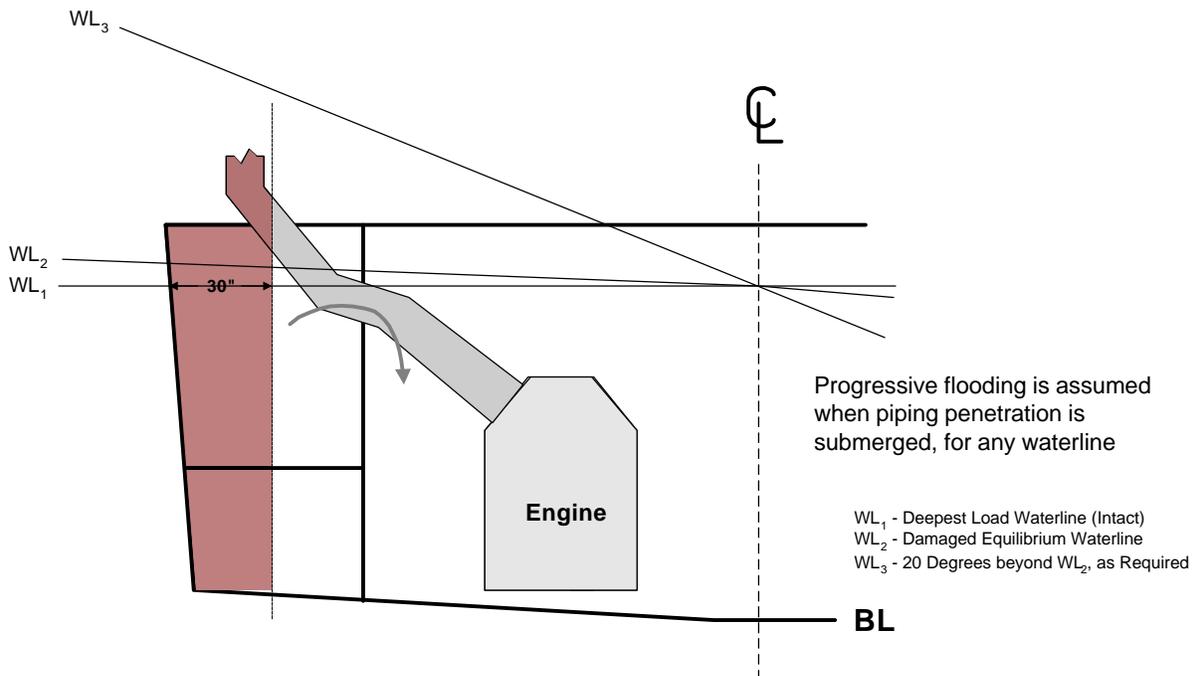
Figure 4: Damaged Engine Exhaust Piping

The range of stability requirements of 46 CFR 174.205(e)(3) must also be met through 20 degrees of additional heel beyond initial damaged equilibrium heel and trim. Progressive flooding through the damaged piping must also be considered throughout this additional heel. See Figures 4 and 5.
