UNITED STATES COAST GUARD

INVESTIGATION INTO THE CIRCUMSTANCES
SURROUNDING THE COLLISION BETWEEN THE
PASSENGER VESSEL
NOORDAM (NA)

FREIGHT VESSEL
MOUNT YMITOS (MT)

OFF SOUTHWEST PASS IN THE GULF OF MEXICO ON
NOVEMBER 6, 1993, WITH MINOR INJURIES, NO LOSS
OF LIFE AND NO POLLUTION

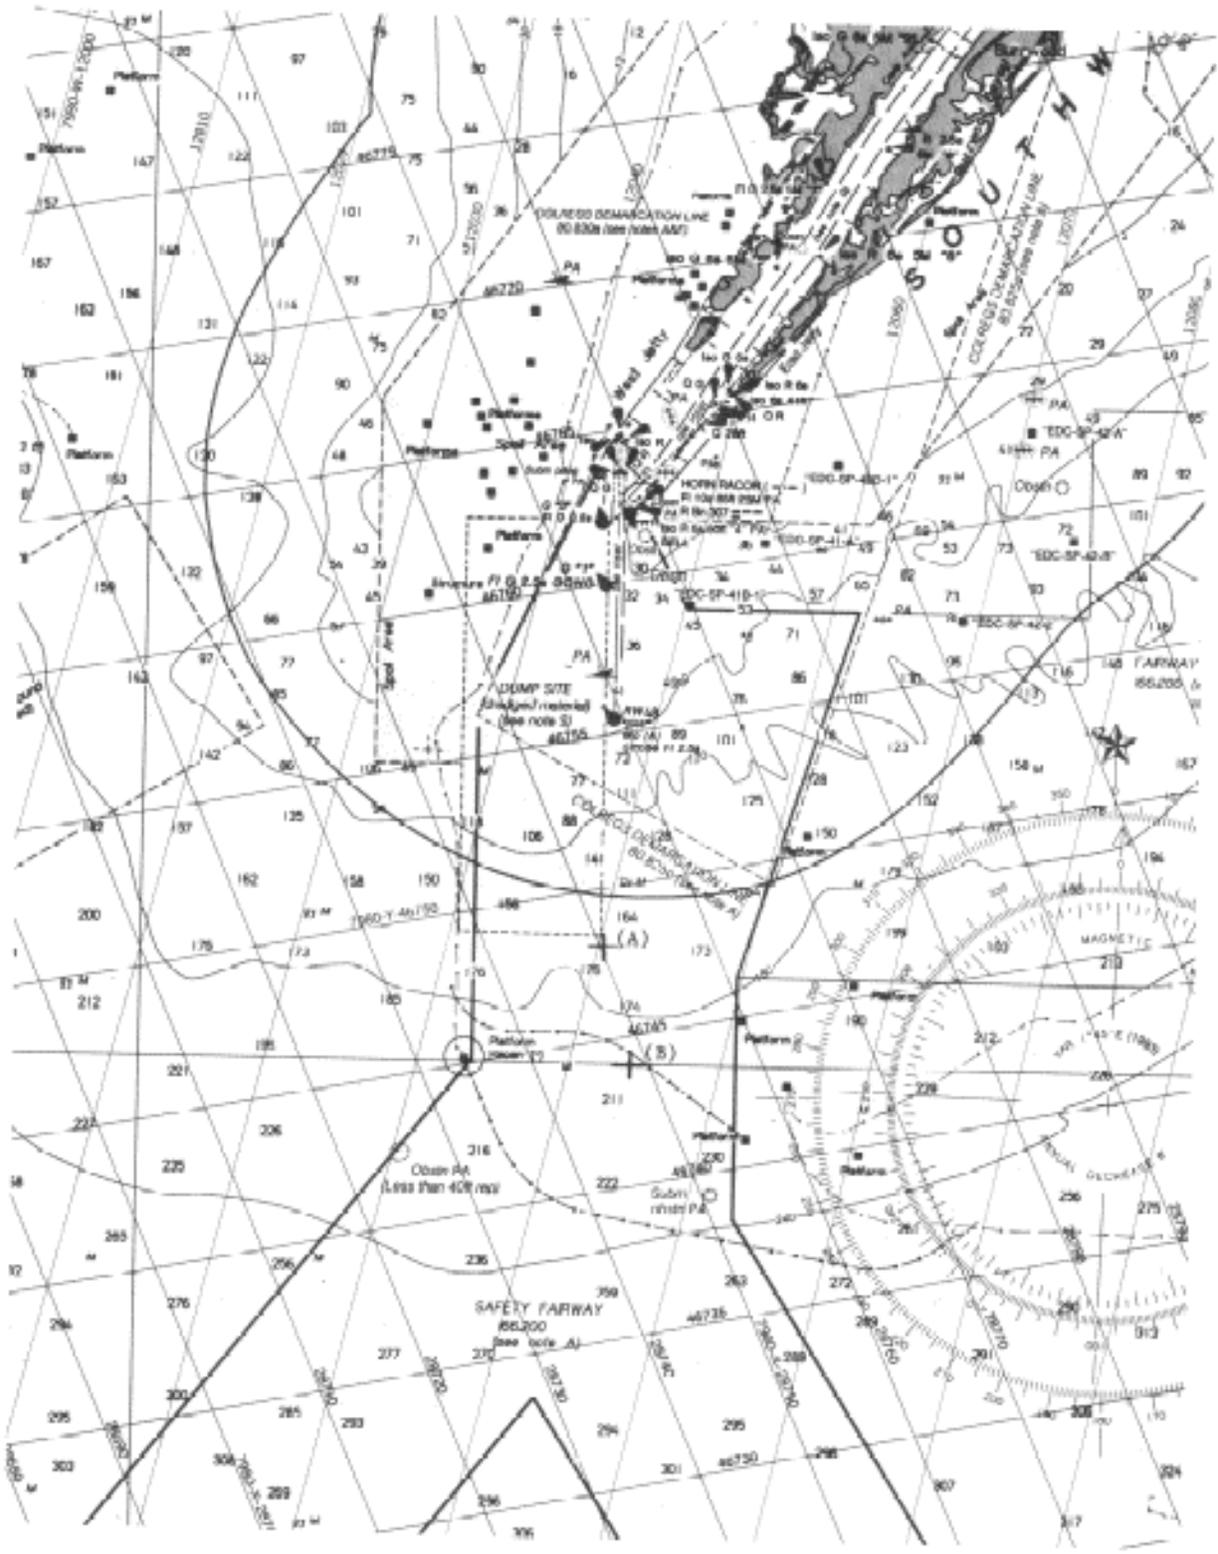
Approach to Southwest Pass - Gulf of Mexico
 (A) Position plotted by M/V MOUNT YMITOS at the point of collision
 (B) Position recorded by M/V NOORDAM's GPS at the point of collision

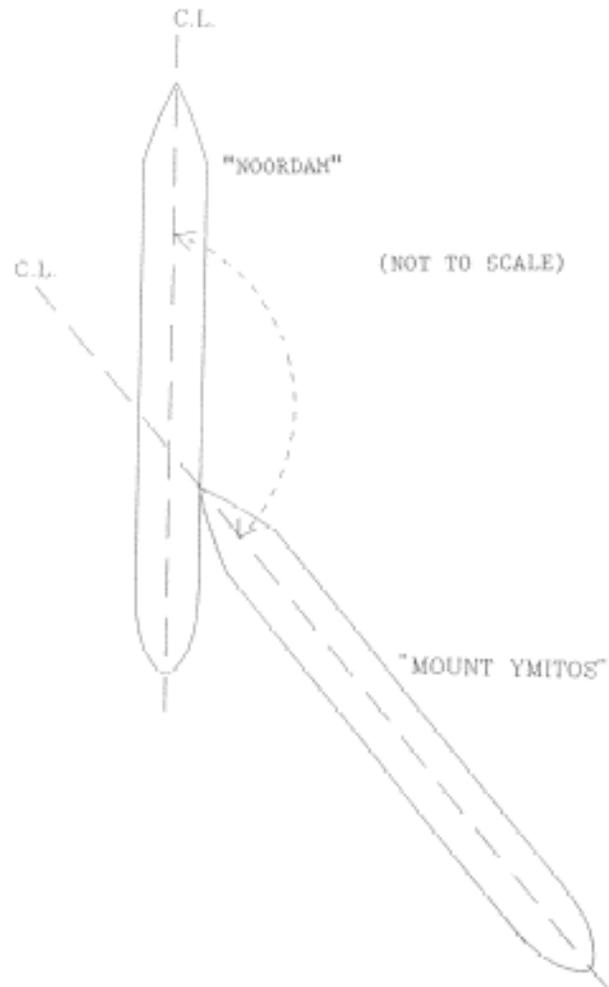
46. The collision took place at approximately 2042 with the MOUNT YMITOS' port bow impacting the NOORDAM in the starboard aft midships area. The NOORDAM was still swinging to port and making approximately 14 knots. The MOUNT YMITOS, having backed for about two minutes, was making approximately 3 knots. The NOORDAM was heading approximately 300 degrees when the collision occurred and the MOUNT YMITOS was heading approximately 230 degrees. The approximate angle of collision was 110 degrees measured from forward, and 70 degrees measured from aft.

Angle between the vessels at the time of collision

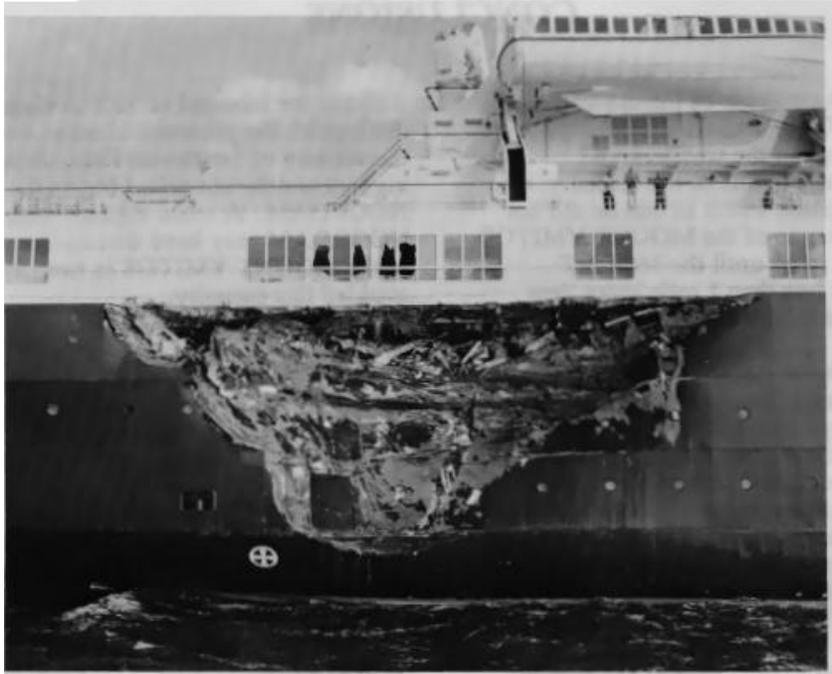
49. The NOORDAM sustained impact damage on its aft starboard side in way of frames 9-1/2 to 41-1/2 extending over four strakes. All of the damage was above the waterline. The MOUNT YMITOS suffered damage to its port bow and bulwarks well above the waterline.

Starboard quarter of the M/V NOORDAM

55. Permanent repairs were performed to the NOORDAM at Avondale Shipyard renewing the side shell plating and internals. Interior finish work was deferred for completion by a riding repair crew. The NOORDAM's propulsion train was not damaged by the collision; the starboard shaft was stopped immediately following the collision because a controllable pitch propeller (cpp) hydraulic line was severed in the area of collision damage.

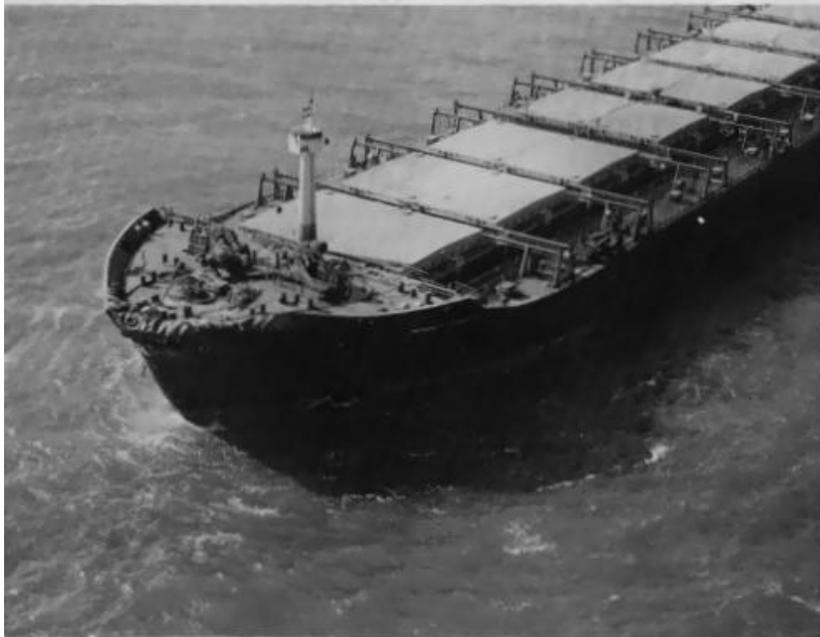
Damaged bow of the M/V MOUNT YMITOS

54. Temporary repairs were performed to the bow of the MOUNT YMITOS with the approval of Bureau Veritas in order to proceed with its cargo to Russia.
