**EPOXY COATED
REINFORCEMENT STUDY**

Final Report

STATE RESEARCH PROJECT #527

Oregon Department of Transportation
Research Group
200 Hawthorne SE, Suite B-240
Salem OR 97301-5192

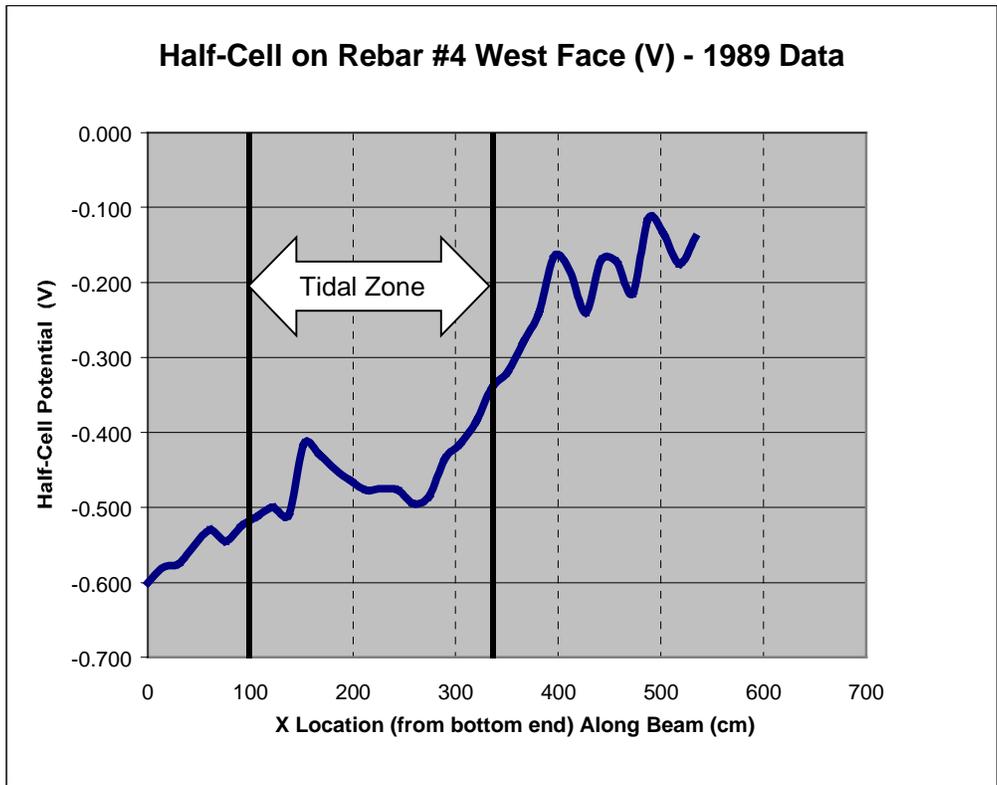
Figure 3.1: 1989 Half Cell Potential Profile for the Removed Test Beam

At the Laboratory, half-cell potential measurements were taken to develop a potential profile for the beam. Figure 3.1 provides the half-cell testing results. The tidal zone on the beam was estimated to be between 1.0 to 3.35 m, as measured from the bottom end of the beam.

As can be seen in Figure 3.1, the potential for corrosion within the tidal zone was more negative than the -0.35 V threshold, indicating a 90% probability that corrosion was occurring.

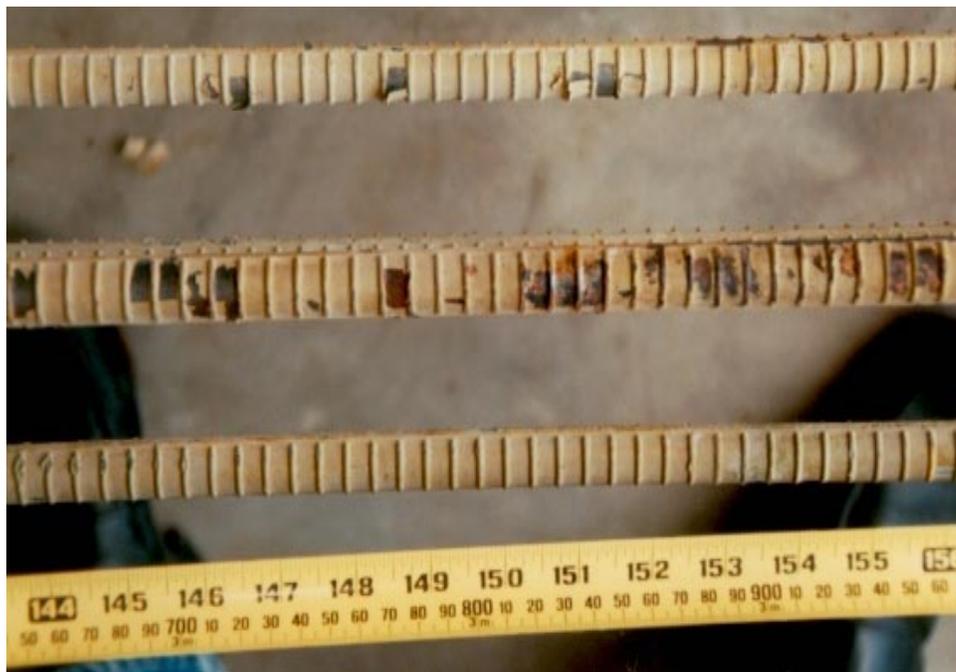
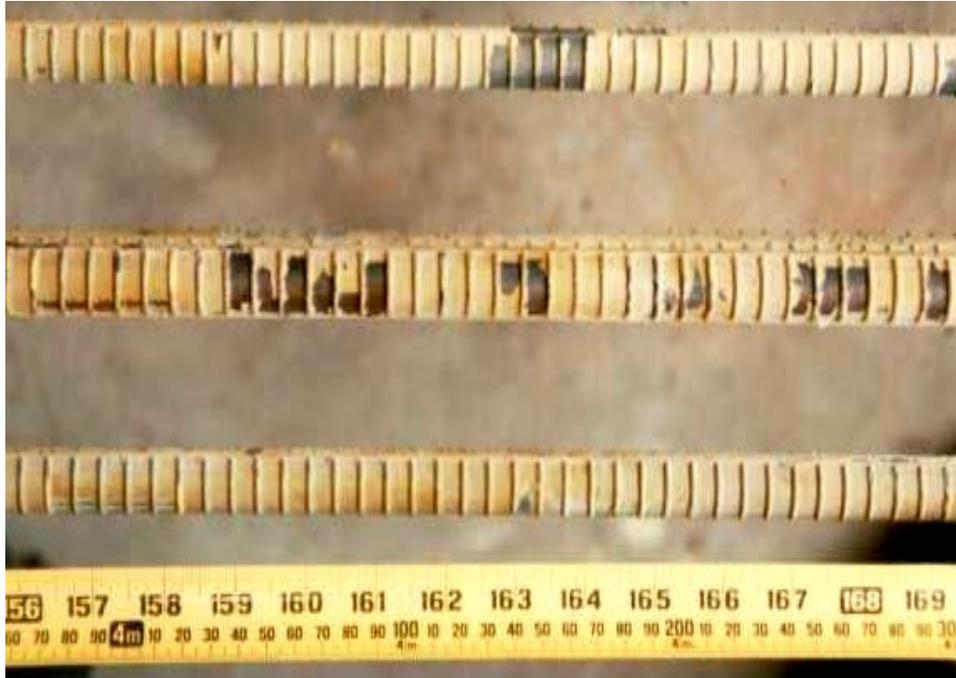
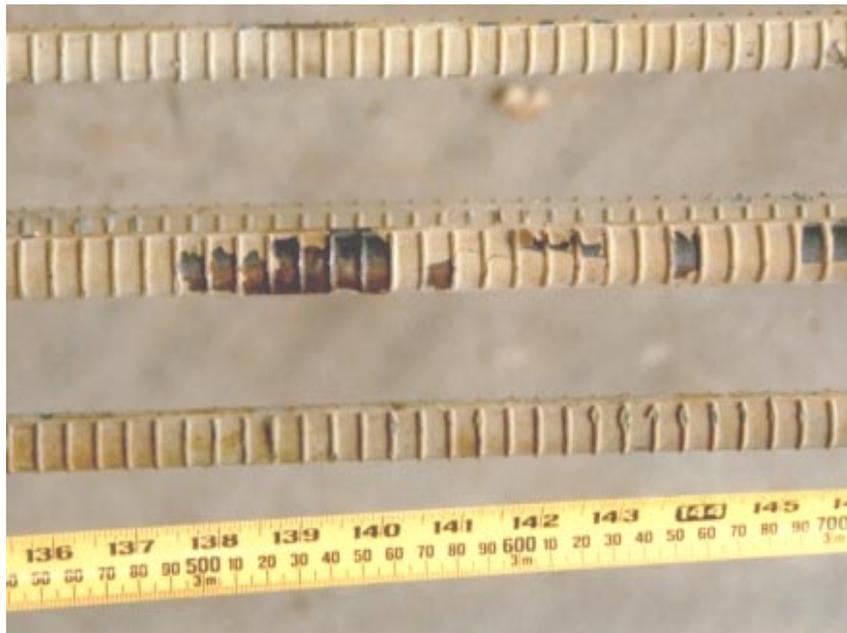
After the half-cell potential tests were completed, the concrete was removed and the epoxy coated reinforcement exposed for visual examination. Corrosion areas were observed on two of the longitudinal #5 bars as well as several #3 hoops. Figures 3.2 through 3.4 illustrate the corrosion on the longitudinal bars measured from the top end of the beam. The locations were within the beam's tidal zone, 3.0 to 4.4 m from top end of the beam (1.3 to 3.1 m from the bottom end).

Figure 3.2: Corrosion Along the Longitudinal Bar

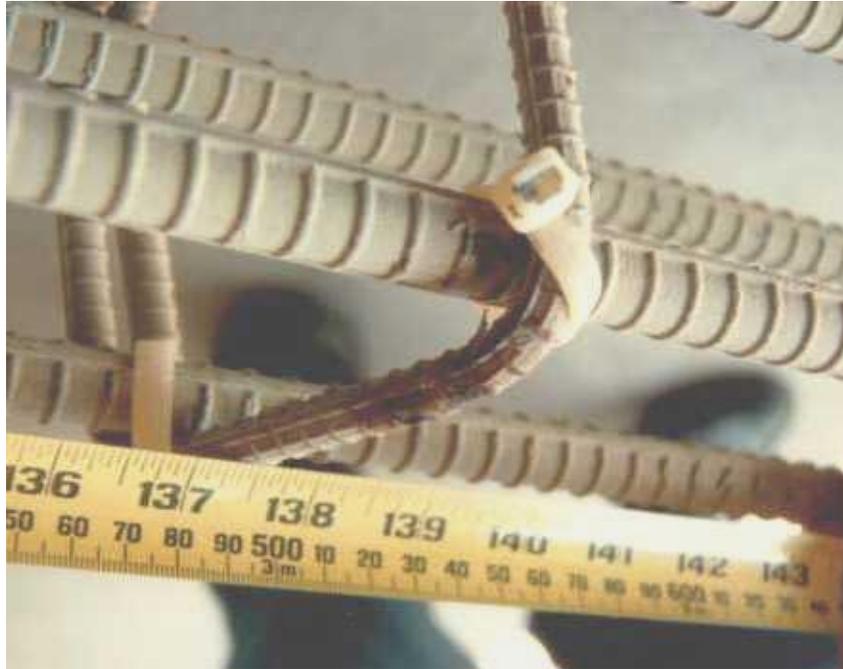
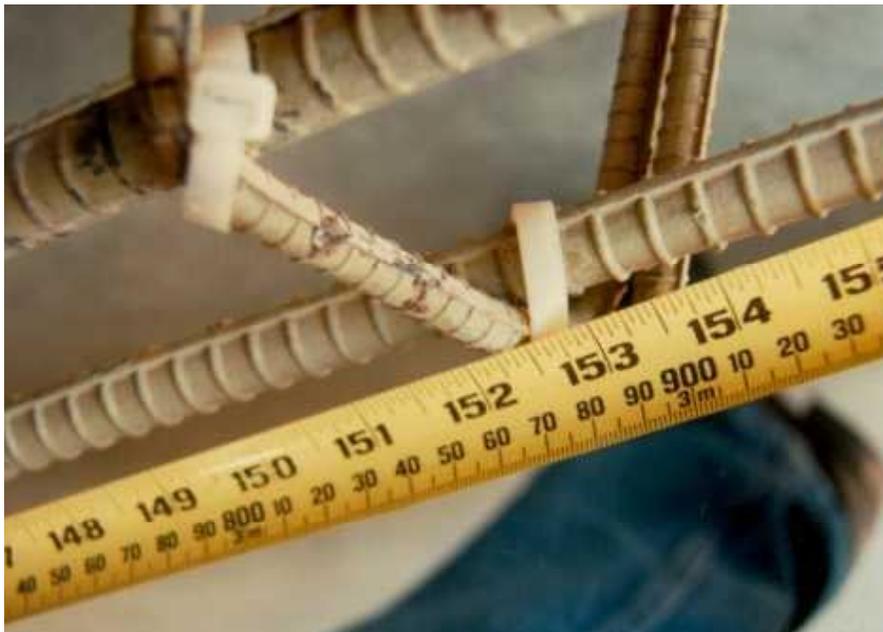
There was also corrosion noted on hoop reinforcement located between 3.5 and 4.0 m measured from the top end of the beam (2.1 to 2.6 m from bottom end). Figures 3.5 and 3.6 show corrosion, also occurring in the tidal zone.

Figure 3.5: Corrosion Along a #3 Hoop

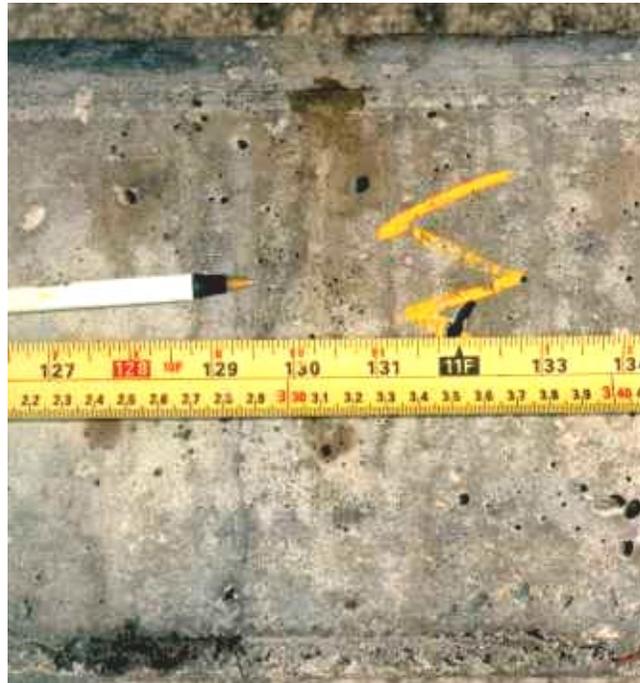
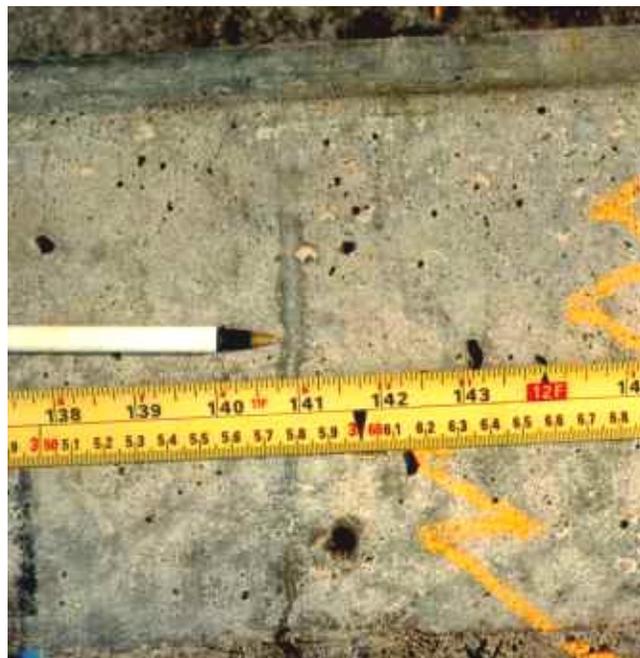
As seen in Figures 4.2 and 4.3, transverse cracking was noted on the beam, particularly in the upper half. The spacing of the cracks in this section occurred about every 200 to 250 mm, which mirrored the spacing of the hoop reinforcement. There are several possible factors that could have contributed to the cracking. These include:

- Reduced depth of cover of concrete at the hoop locations (50 to 64 mm);

- Expansion and contraction of the hoop reinforcement; and
- Corrosion of the hoop reinforcement with subsequent disruption and cracking of the concrete.

Figure 4.2: Transverse Cracking Propagated from the Reinforcing Hoop

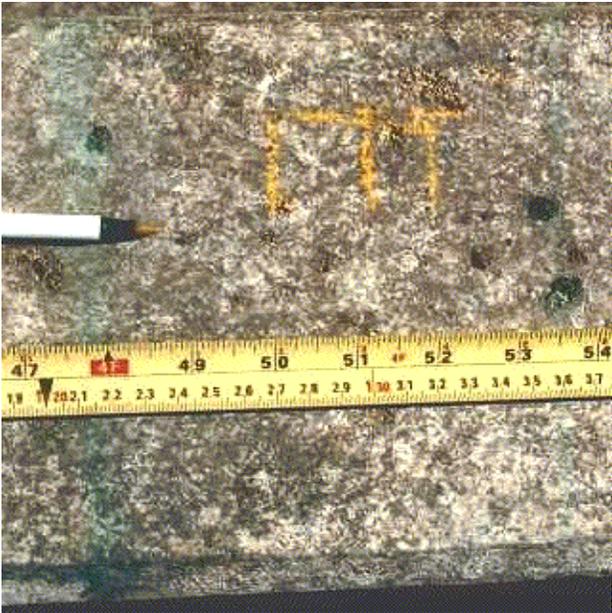
There was also some random cracking noted in the tidal and submerged zones of the beam (Figure 4.4). These were hairline type cracks with no apparent pattern. Cracks were hard to identify in these areas because of the surface discoloration caused by the barnacles.

Figure 4.4: Hairline Cracks Noted in the Submerged Zone

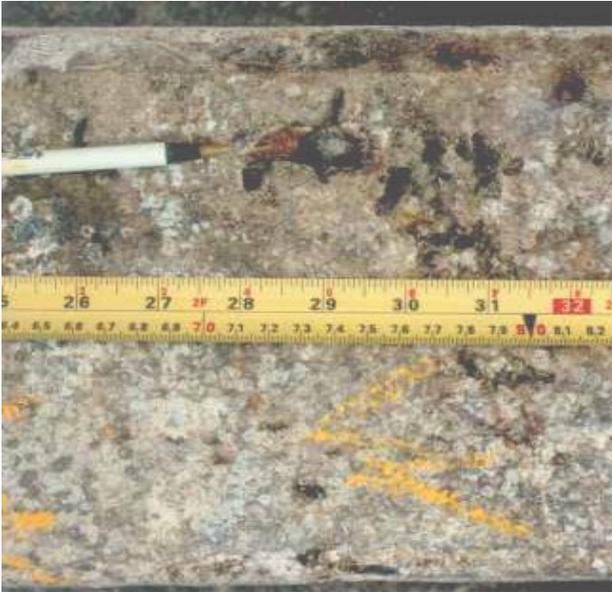
Of the four exposed faces of the beam, the west face had the most surface defects, especially in the submerged zone. Figure 4.5 shows some of the pockmarks that were found on this face of the beam.

Figure 4.5: West Face of the Beam with Pockmarked Areas

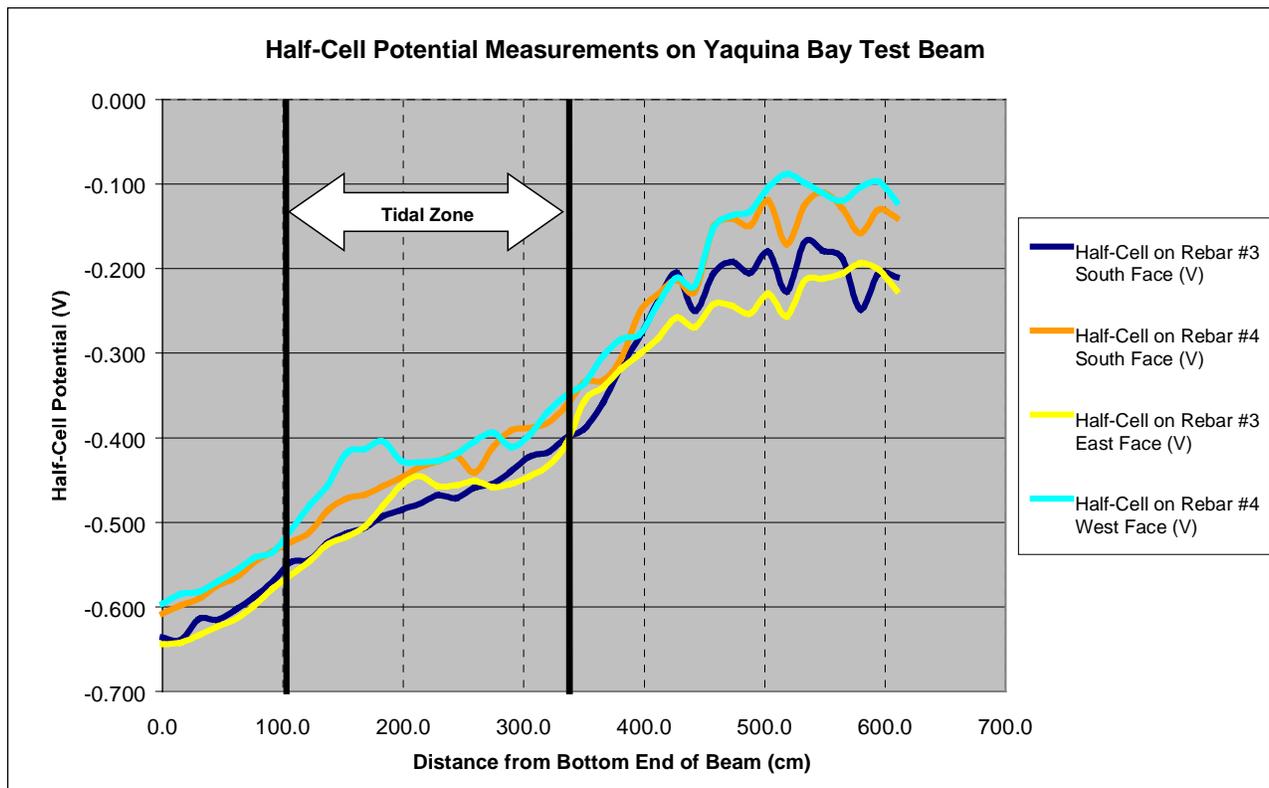
Figure 4.8: Half-Cell Potential Measurements Along Each Exposed Face of the Beam

Figure 4.8 shows there were no wide variations in the readings for each group. In the submerged zone (0 to 1.0 m), the potential levels are more negative than “-0.50 V”. The potential for corrosion is therefore much higher in this zone. However, because of the lack of available oxygen in the seawater, the corrosion process is very slow.

The numeric values of the half-cell potential measurements decreased as the distance along the beam increased. Within the dry zone, the readings were in the “-0.40 V to -0.35 V” range at the tidal zone/dry zone interface, but became more positive towards the top end of the beam. Based on the half-cell potential readings, the probability of corrosion occurring in the higher portions of the dry zone was low.

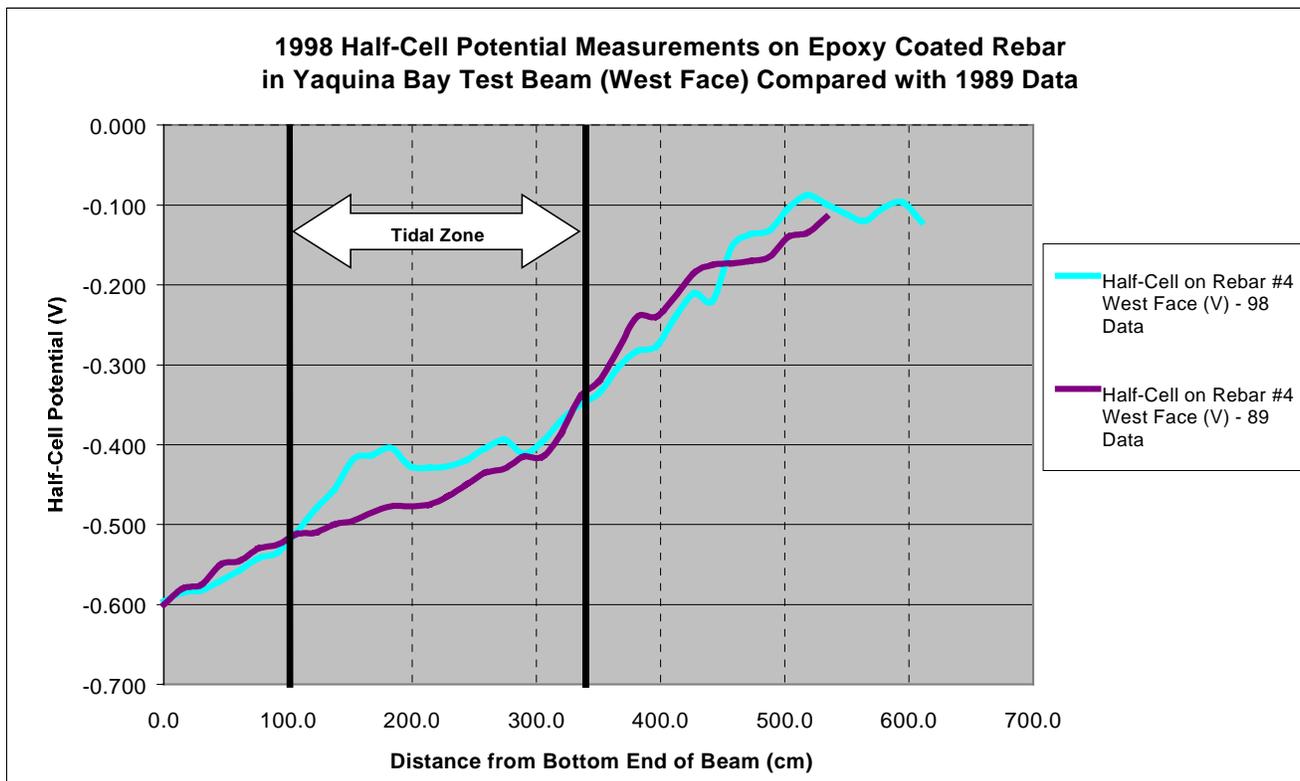
Figure 4.9: Comparisons of Half-Cell Potential Measurements for 1998 and 1989 Along the West Face for Bar #3

Figure 4.9 shows a comparison of the half-cell measurements taken from the 1989 test beam to the half-cell measurements taken in 1998. The two graphs are reasonably close and there appears to be little difference in the two sets of half-cell potential measurements.

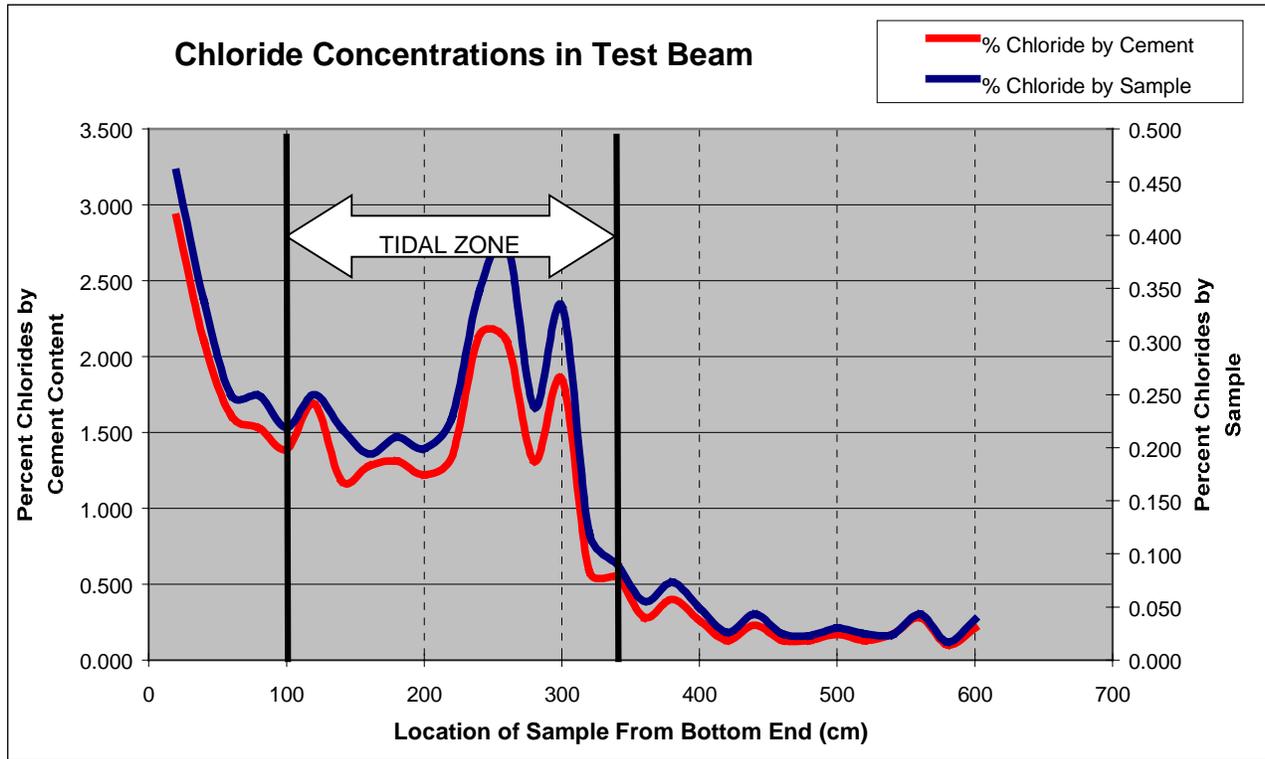
Figure 4.10: Chloride Concentrations Along the West Face From the Bottom End of the Beam

comprised of material taken from the beam's surface to a depth of 100 mm. Chloride concentration was then determined by testing for total chlorides in the sample and total chloride concentration by cement. The latter test was done to reduce errors occurring as a result of variable levels of aggregate in the powder sample. The results of the testing are shown in Figure 4.10.

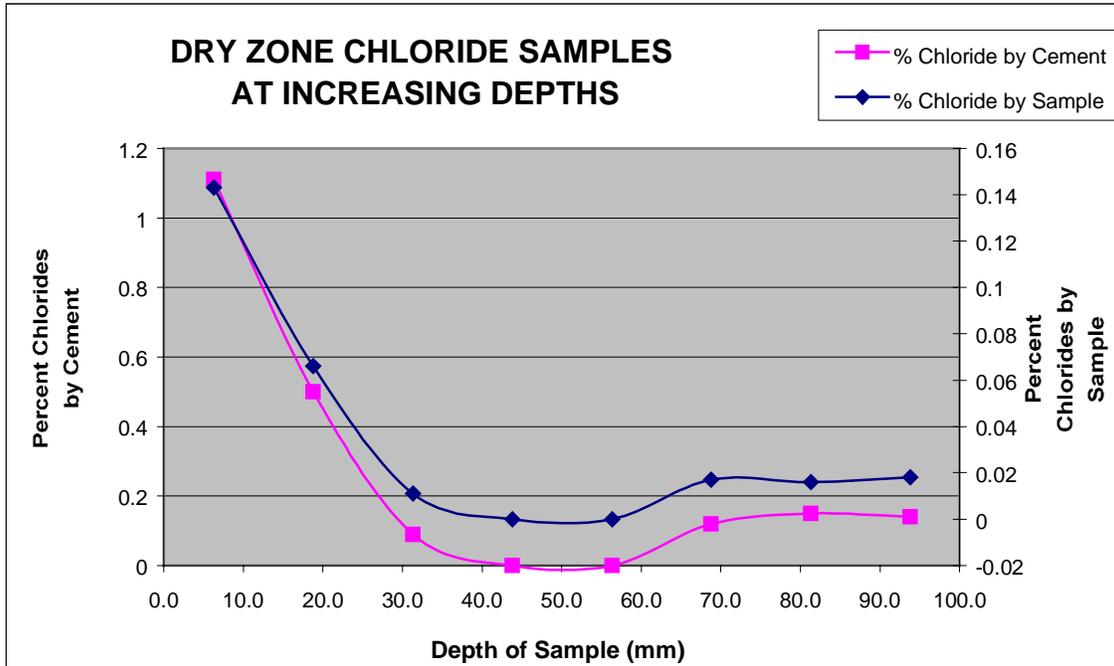
Figure 4.11: Chloride Testing on Samples Taken at Varying Depth Levels in the Dry Zone

In the dry zone (Figure 4.11), the graphs show that the chloride concentration decreases with increasing depth to a depth of 62.5 mm where the concentration is negligible. At greater depths, the chloride concentration increases slightly. There is no apparent explanation for this other than possible sampling or testing error at these low concentrations.

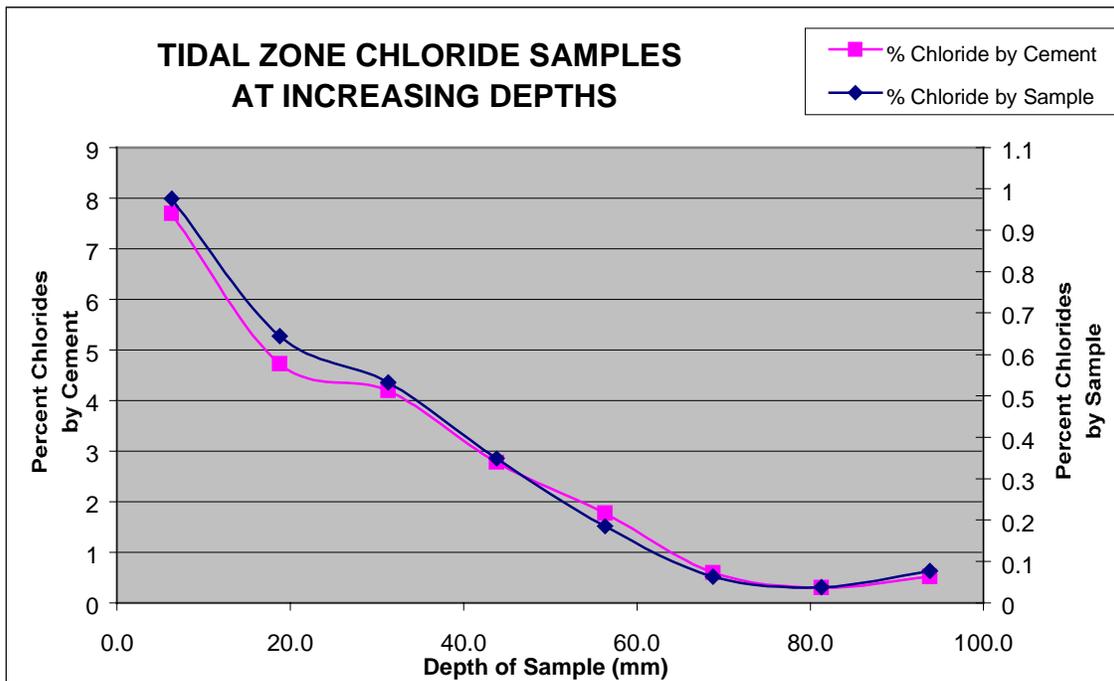
Figure 4.12: Chloride Testing on Samples Taken At Varying Depth Levels in the Tidal Zone

In the tidal zone (Figure 4.12), chloride concentration decreased as the depth where the sample was taken increased. At the interval, 87.5 to 100 mm however, the concentrations did appear to increase slightly, which again could be the result of sampling or testing error.

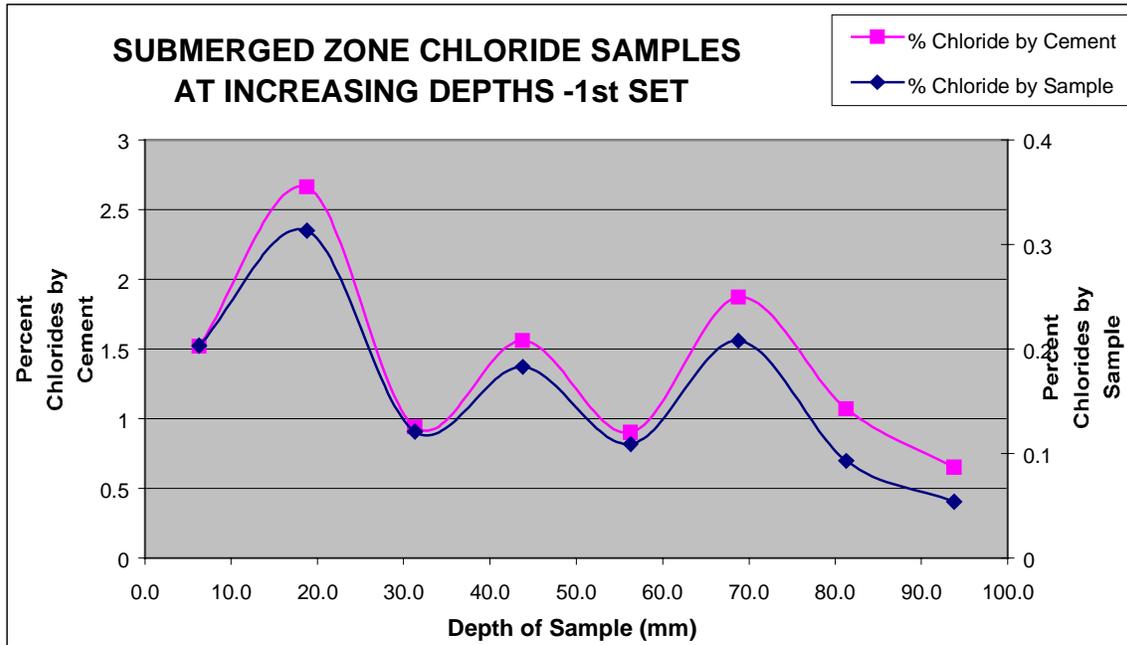
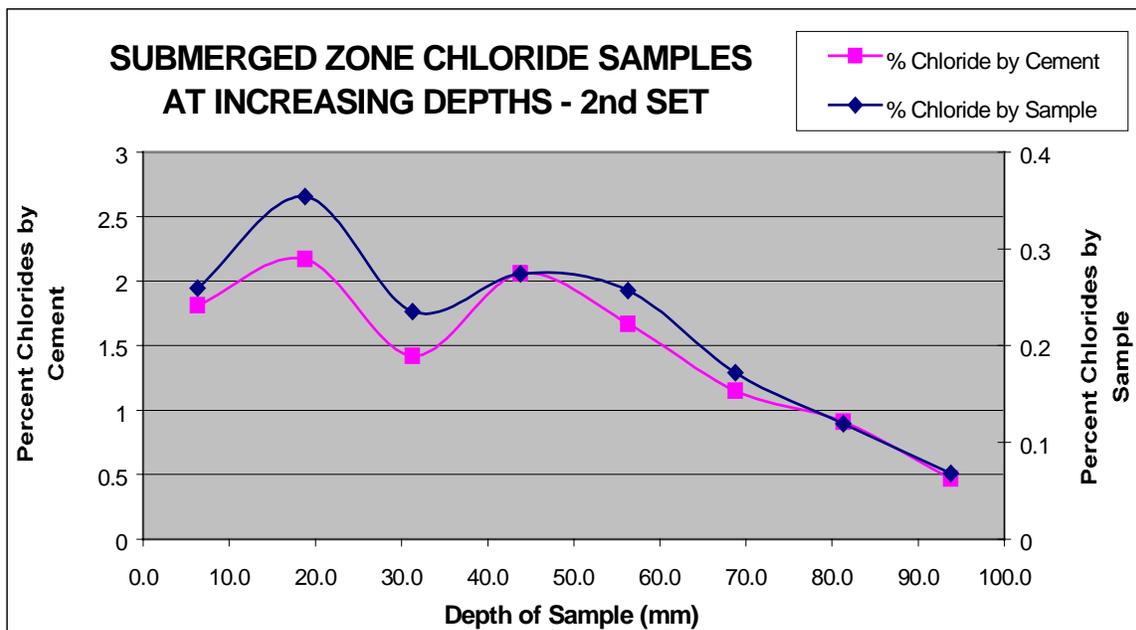
In the submerged zone (Figure 4.13), the concentrations did not follow the classical pattern recorded for sampling in the other two zones. As depth increased, chloride concentration also increased for three of the eight samples (12.5 to 25.0 mm, 37.5 to 50.0 mm, and 62.5 to 75.0 mm). As a result of this irregular pattern, a second group of chloride samples were taken for the submerged zone (Figure 4.14).

As seen in Figure 4.14, the chloride concentrations did increase at two of the same depth intervals (12.5 to 25.0 mm and 37.5 to 50.0 mm) as previously measured in the first set of samples for the dry zone. There is no apparent explanation for the irregular pattern in the two groups of dry zone samples.

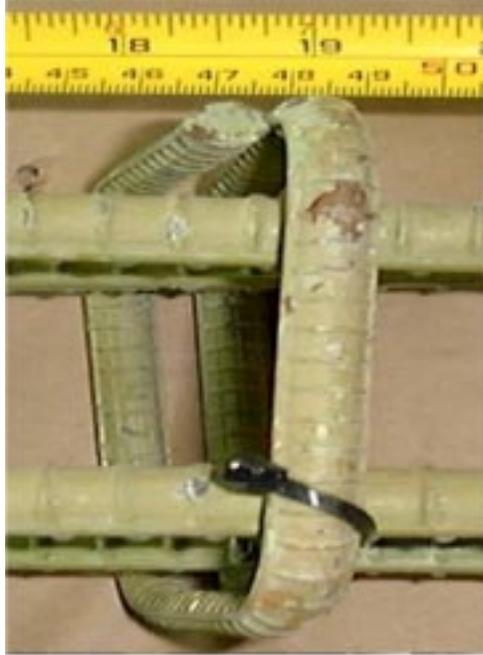
Corrosion was observed at approximately 200 mm and 950 mm from the bottom end along rebar #3 (Figure 4.15). The other bars appeared to have no visible signs of corrosion. Some corrosion was found on each of the hoops (Figure 4.16).

Figure 4.16: Observed Corrosion of Hoop in the Submerged Zone

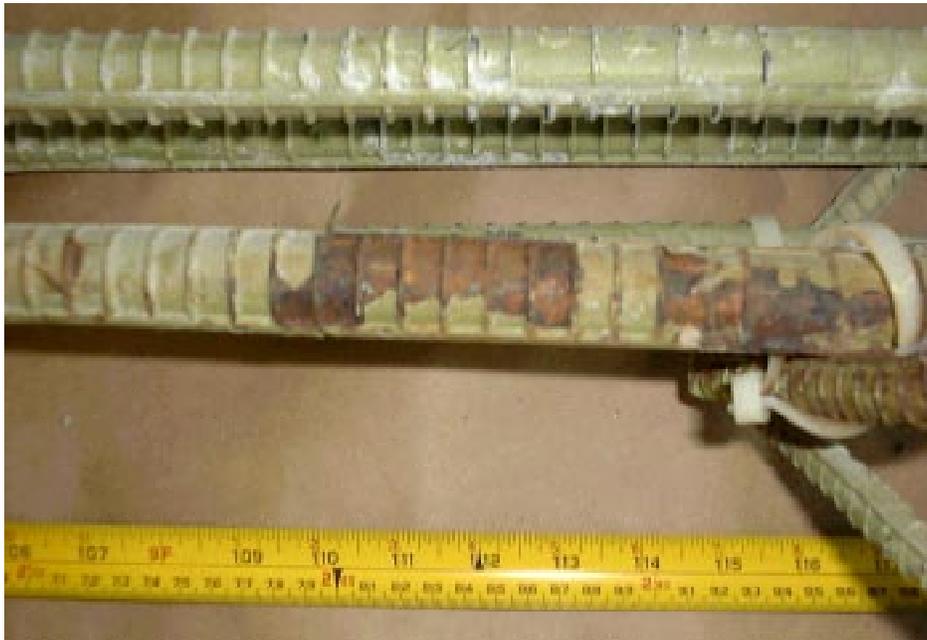
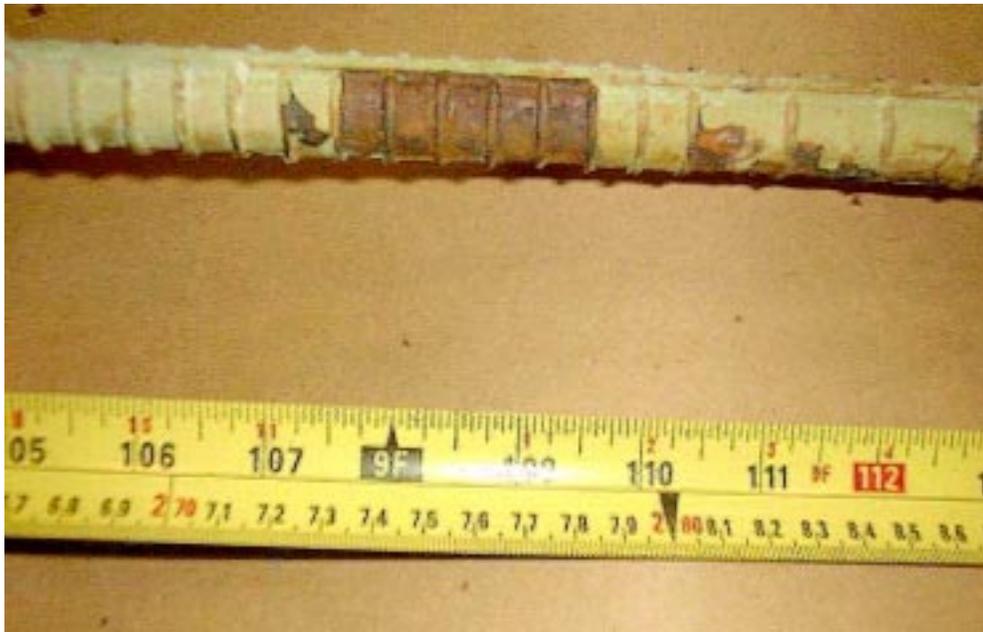
Corrosion was observed in many areas on the Scotchlite 213 epoxy coated reinforcement along rebar # 1 and the hoops. There was extensive corrosion between 2.6 and 3 m as measured from the bottom end of the beam along rebar #1. The other bars had no visible signs of corrosion. Figures 4.17 and 4.18 show two areas of corrosion along rebar #1.

Figure 4.17: Corrosion Along Rebar #1 (2.8 to 2.95 m from bottom end of beam)

Figure 4.18: Corrosion Along Rebar #1 (2.75 m from bottom end of the beam)

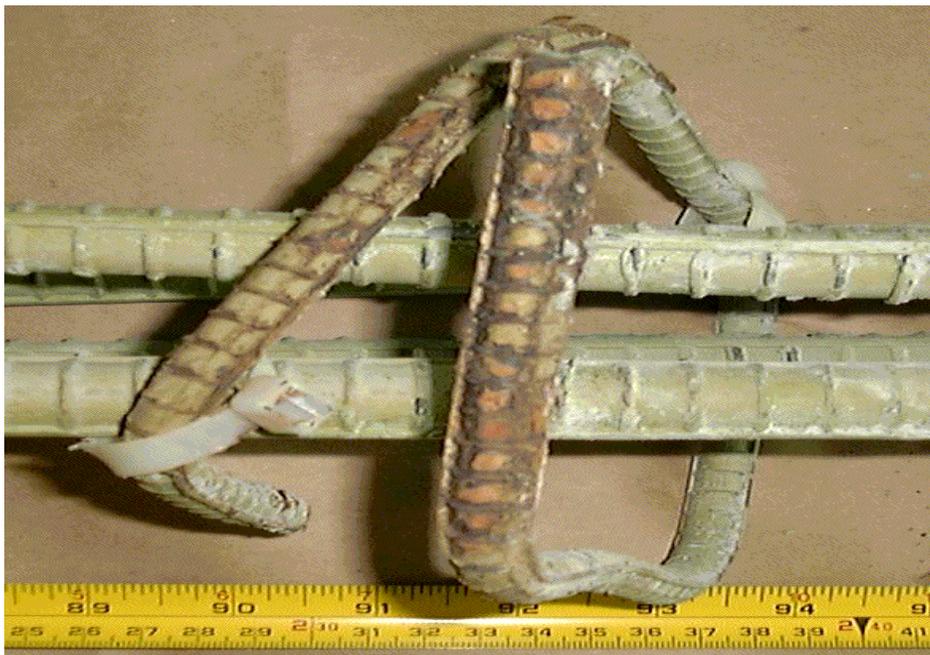
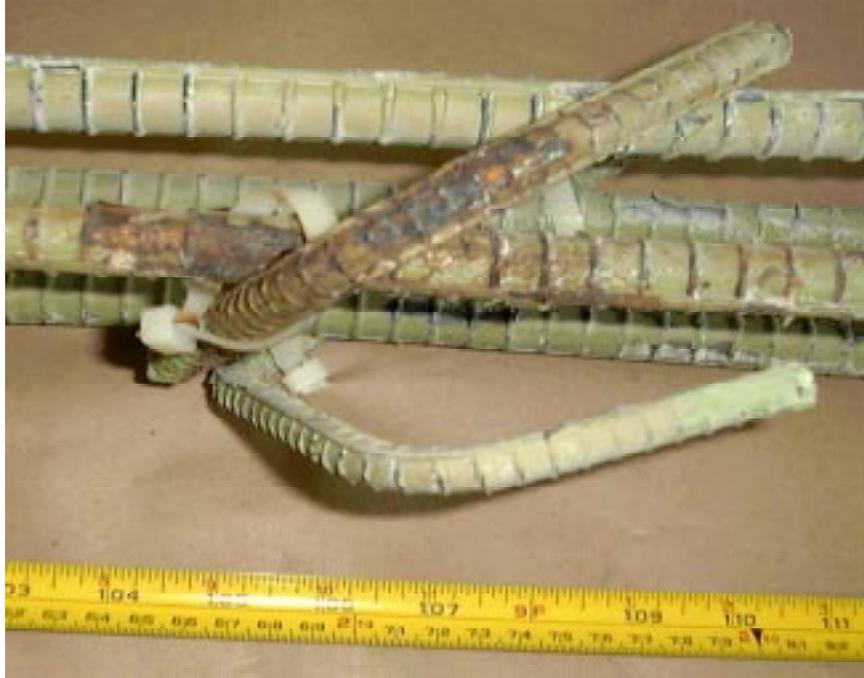
There was corrosion observed in all but one of the hoops in the tidal zone. The hoop that did not show signs of corrosion, was positioned in the beam at the high end of the tidal zone. Figures 4.19. and 4.20 illustrate the degree of corrosion appearing on the hoop reinforcement.

Figure 4.19: Hoop Corrosion in the Tidal Zone

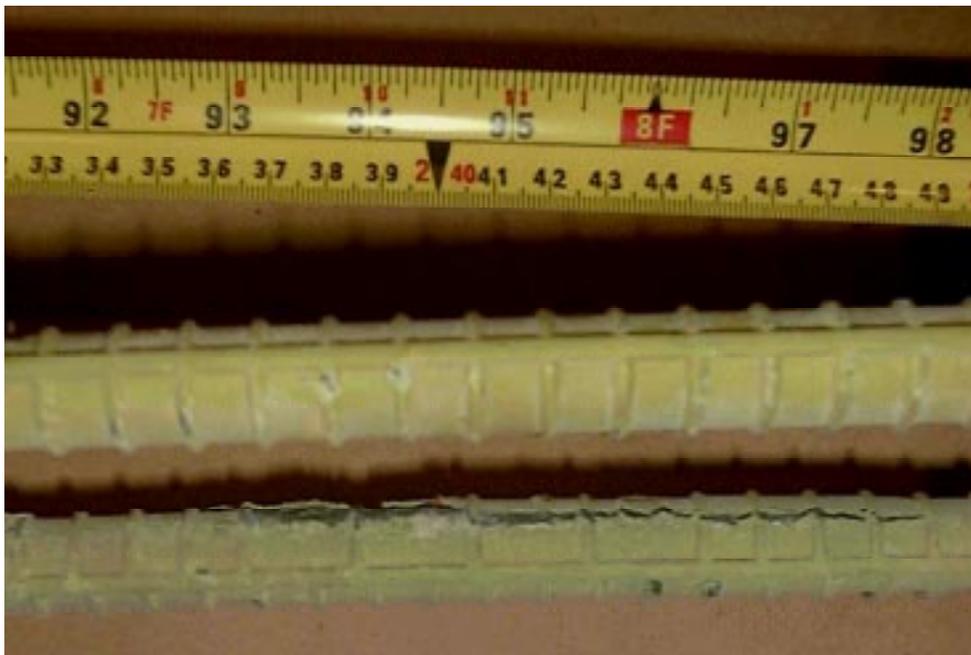
As noted earlier, there was significant adhesion loss of the coating within the tidal zone. An example of disbondment of the coating from the steel is shown in Figure 4.21.

Figure 4.21: Disbondment of the Epoxy Coating in the Tidal Zone

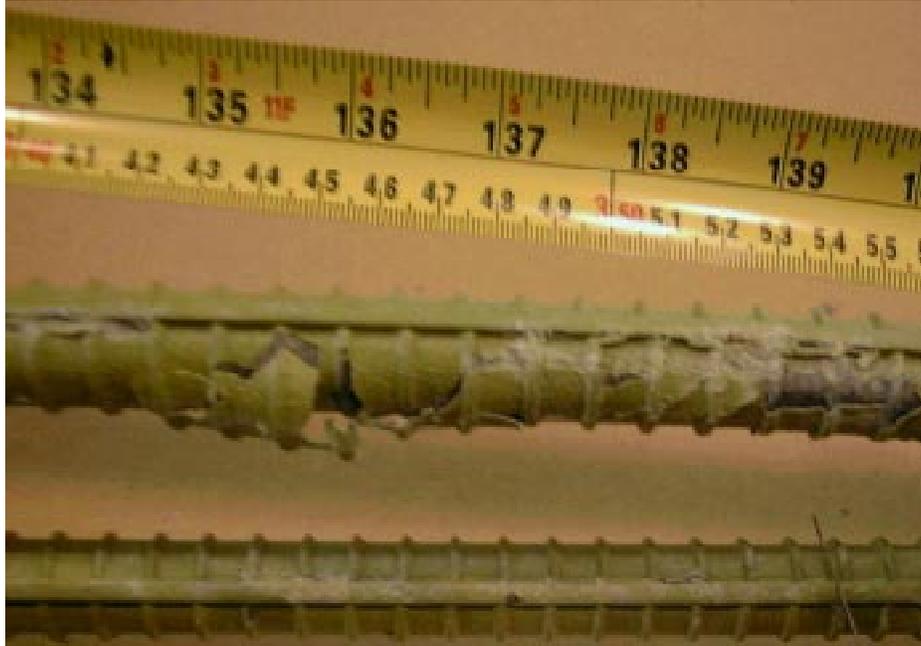
Within the dry zone, most of the Scotchlite 213 epoxy coated reinforcement appeared to be in good condition. Visible corrosion was not apparent in this area. There was some disbondment of coating closer to the tidal zone boundary (Figure 4.22).

Figure 4.22: Disbondment of the Coating at the Tidal and Dry Zone Interface
