# Investigation of Concrete from I-20 Near Monroe, Louisiana

Miscellaneous Paper SL-98-1  
January 1998

**Final report**

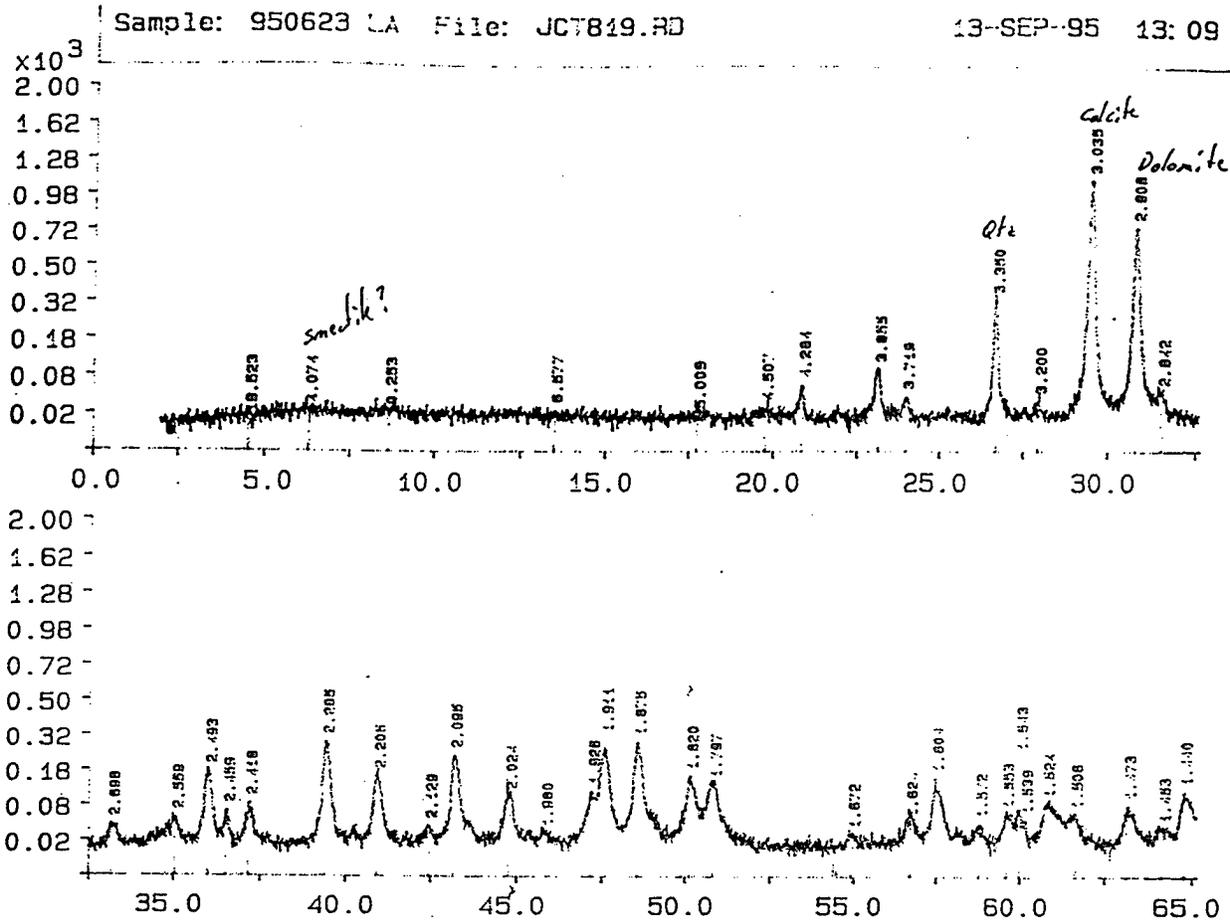
- a. 950623 - This core was cut along its entire length to expose the interior concrete. A near-surface vertical crack was associated with subsurface dark-gray coarse-aggregate particles with prominent reaction rims. These particles showed some interior cracks. X-ray diffraction examination of one particle indicated that the particle was composed of a fine-grained dolomitic limestone containing some quartz and clay, as shown in Figure 16. Some interior, randomly oriented incipient cracks were also observed associated with dark-gray coarse-aggregate particles with reaction rims, as illustrated in Figure A1, Appendix A. These cracks were located in the lower portion of the core.

Figure 16. X-ray diffraction pattern of reactive coarse-aggregate particle from core 950623

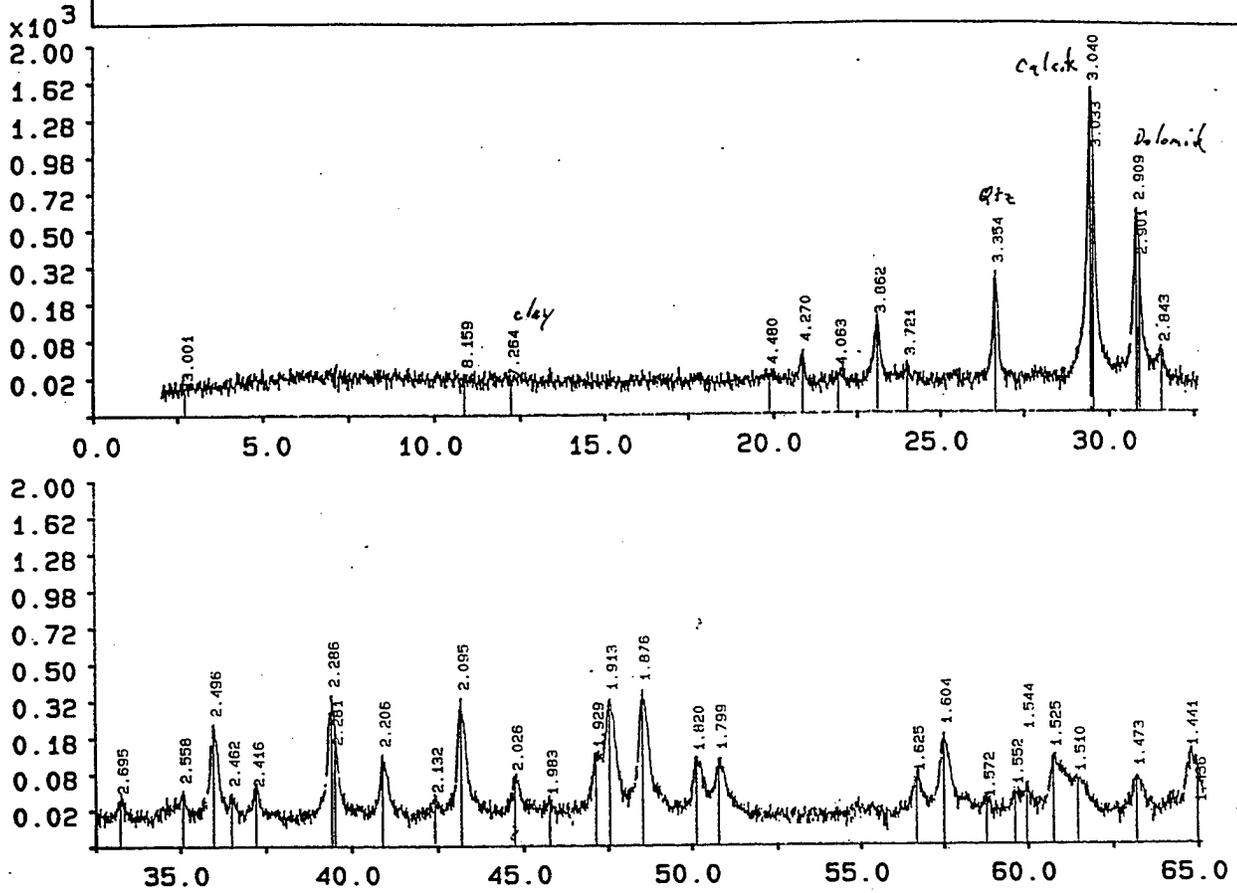
dark-gray fine-grained limestone coarse-aggregate particles in the concrete. Some of the pieces were large coarse-aggregate particles and some were small. Cracks were always associated with the larger pieces of aggregate of this nature and were less common with smaller pieces. Many of these pieces of aggregate showed open cracks in the interior of the particle. The X-ray diffraction pattern showed the coarse-aggregate particles to consist of a dolomitic limestone containing some quartz and clay (Figure 17).

Figure 17. X-ray diffraction pattern of reactive coarse-aggregate particle from core 950628

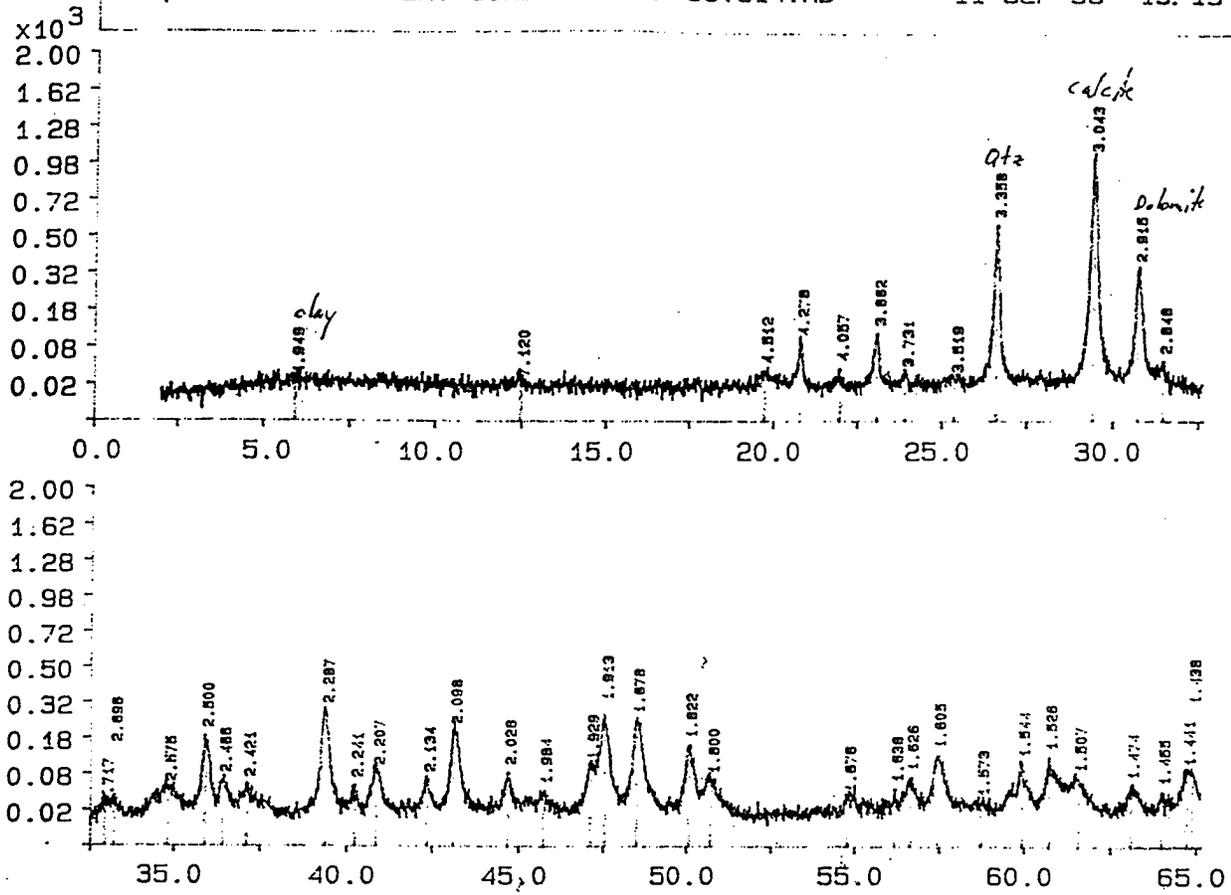
- f.* 950620 - The core was cracked throughout its length. The cracks were randomly oriented. There were numerous dark-gray limestone coarse-aggregate particles with dark reaction rims. The rims exhibited radial cracks that extended into the paste. Aggregate particles with these rims were dolomitic limestone containing quartz and clay. X-ray diffraction patterns are presented in Figures 18 and 19. Figure A6, Appendix A, shows the appearance of these aggregate particles.

Figure 18. X-ray diffraction pattern of reactive coarse-aggregate particle #A from core 950620

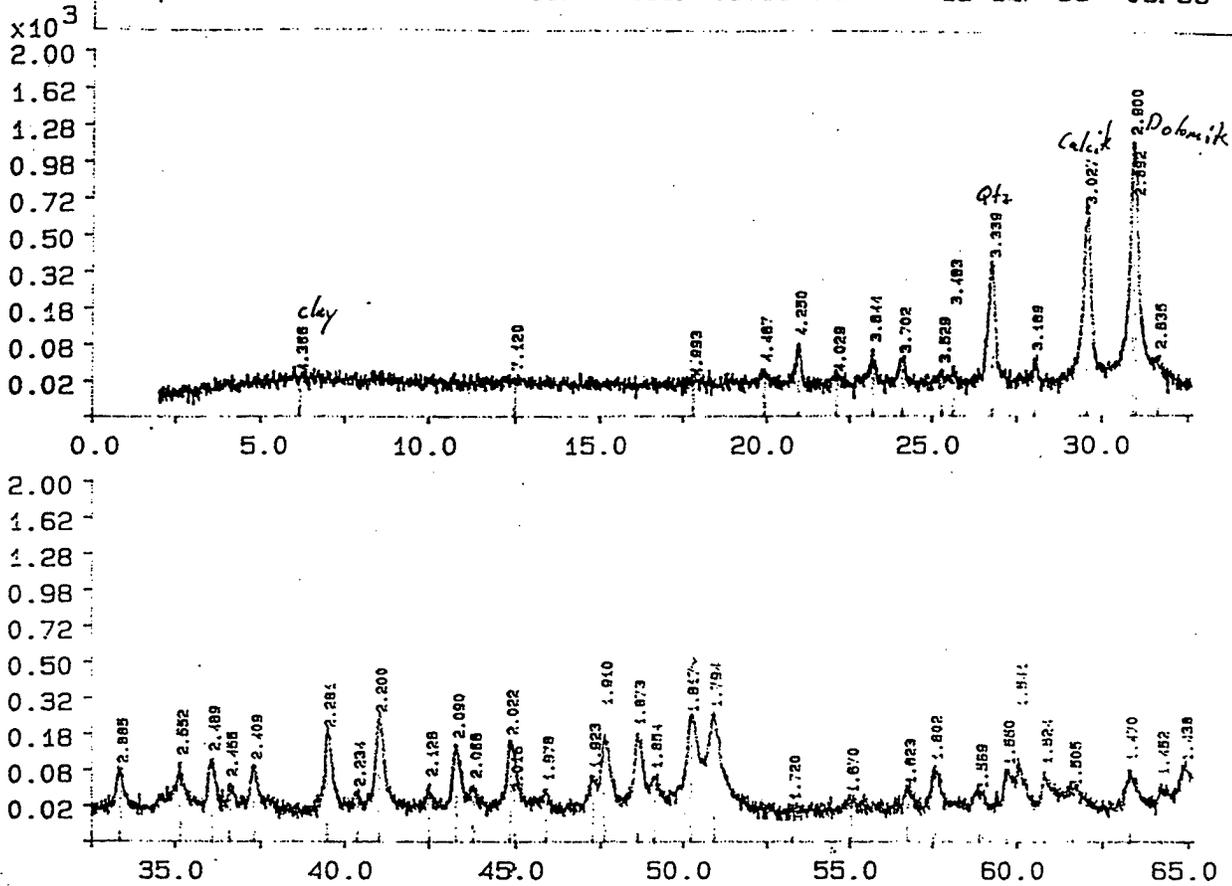
Figure 19. X-ray diffraction pattern of reactive coarse-aggregate particle #B from core 950620.

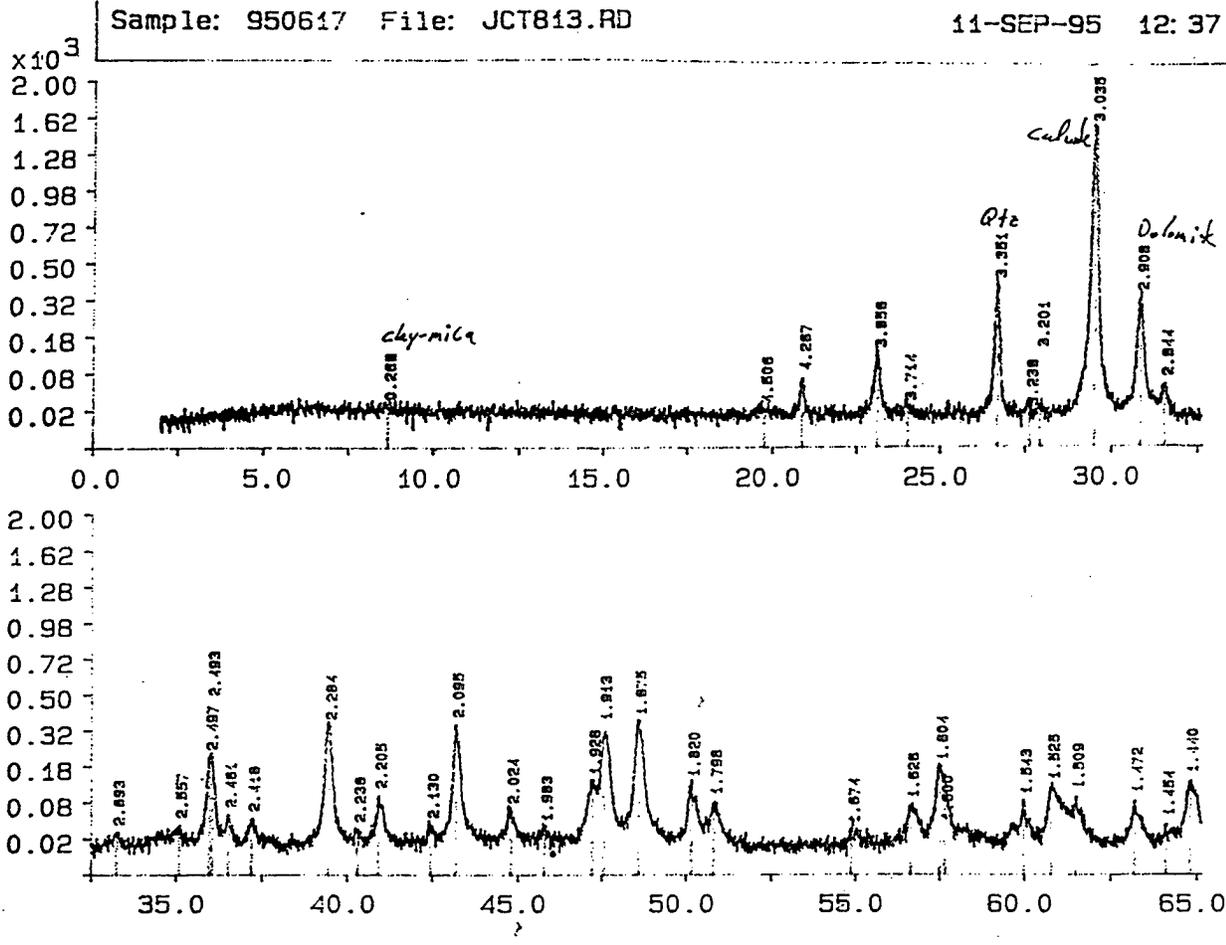
- h.* 950617 - This sample consisted of rubble. The core had broken into fragments during the coring process. One large piece was impregnated using an epoxy resin and then cut open for examination. The concrete was highly fractured (Figure A8, Appendix A). There were numerous dark-gray limestone coarse-aggregate particles. Cracks were mostly associated with the larger coarse-aggregate particles. The associated dark-gray coarse-aggregate particles were dolomitic limestone containing some quartz as well as illite (clay-mica). An X-ray diffraction chart showing the relative abundance of the calcite and dolomite is presented in Figure 20.

Figure 20. X-ray diffraction pattern of reactive coarse-aggregate particle from core 950617

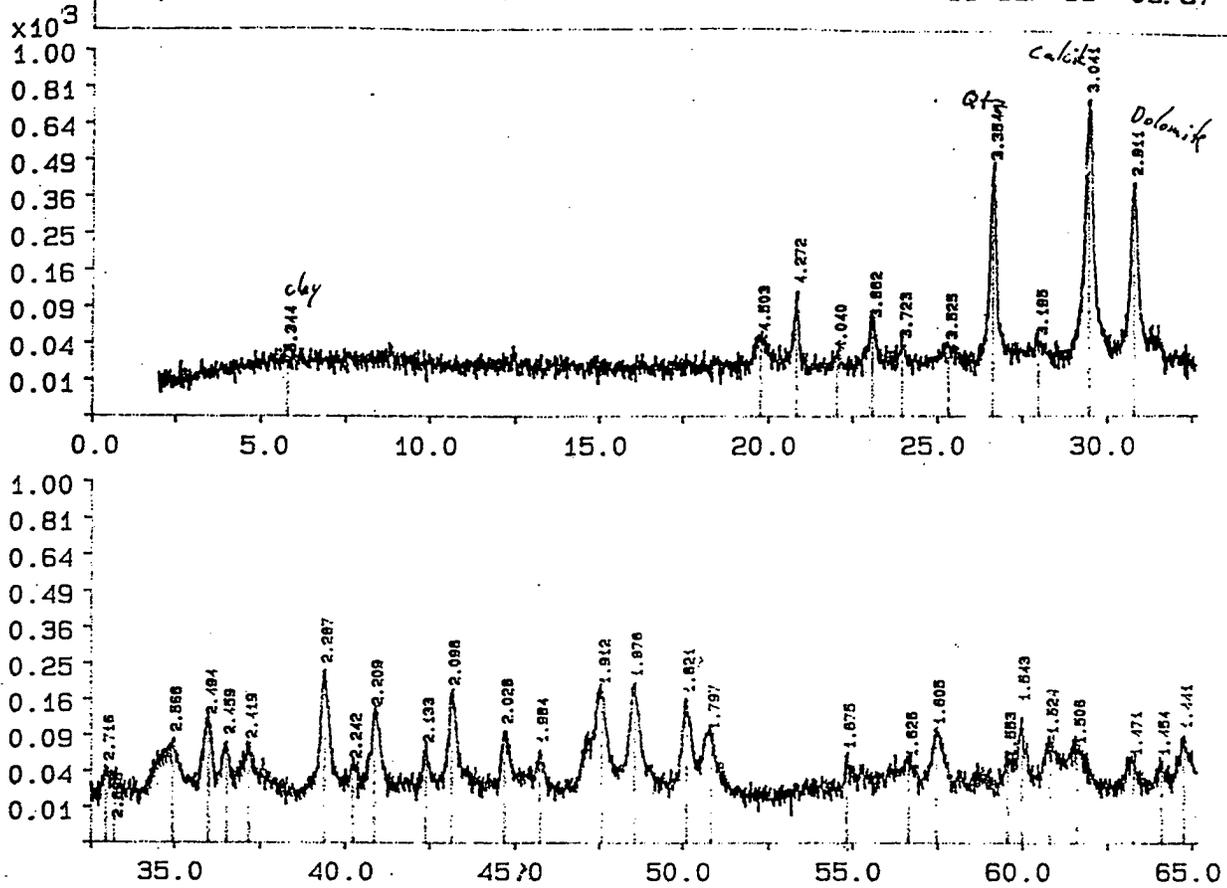
- j.* 950616 - The surface cracking was light. However, the interior concrete showed an extensive crack system. A vertical crack extended several inches into the interior concrete going through coarse-aggregate particles as well as around them. The vertical cracks intersected horizontal and diagonal cracks (Figures A9a and A9b, Appendix A). The majority of the cracks were associated with cracked dark-gray fine-grained limestone coarse-aggregate particles. Two particles examined by X-ray diffraction were dolomitic limestone with acid-insoluble materials consisting of quartz and clays. Figures 21 and 22 illustrate the relative abundance of the carbonate phases.

Figure 21. X-ray diffraction pattern of reactive coarse-aggregate particle #A from core 950616

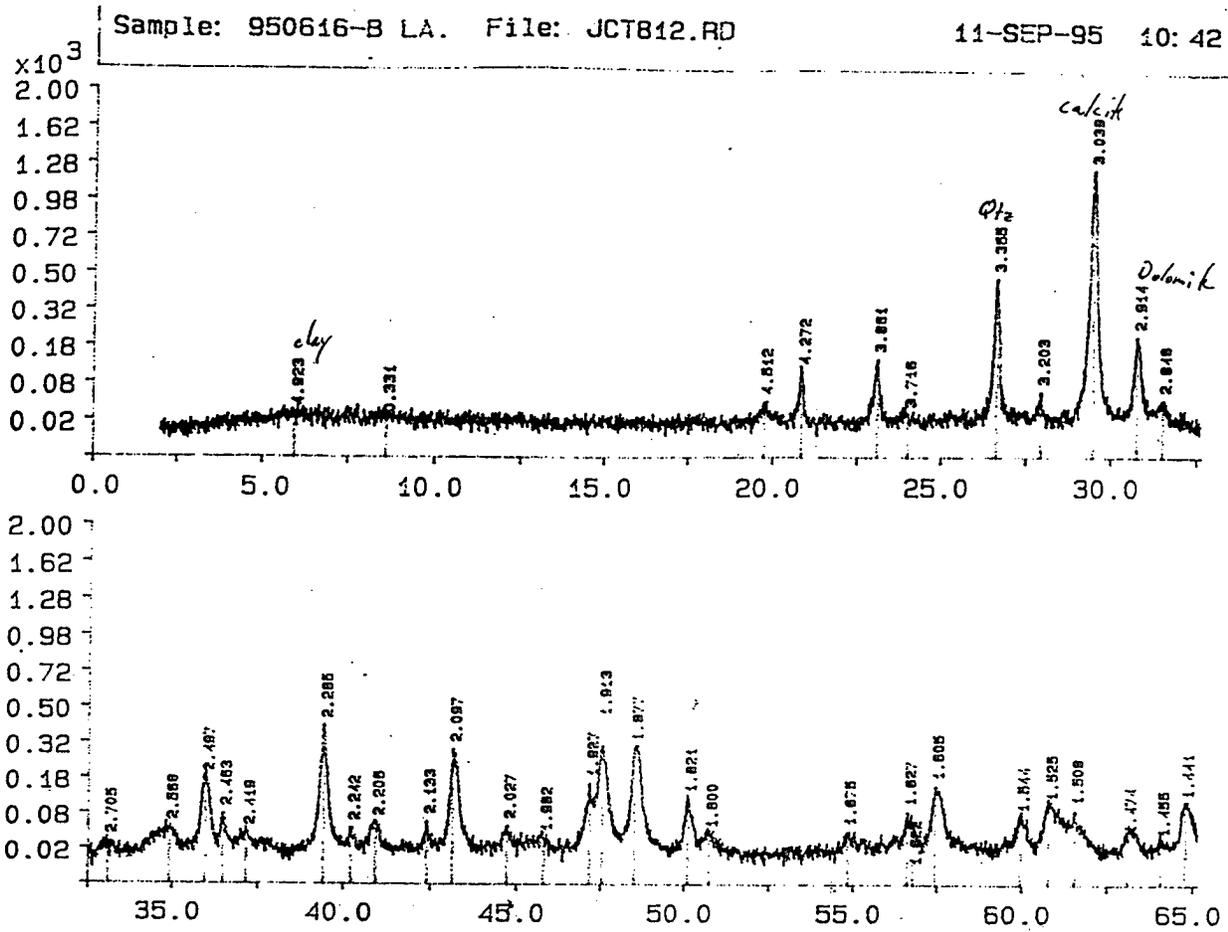
Figure 22. X-ray diffraction pattern of reactive coarse-aggregate particle #B from core 950616

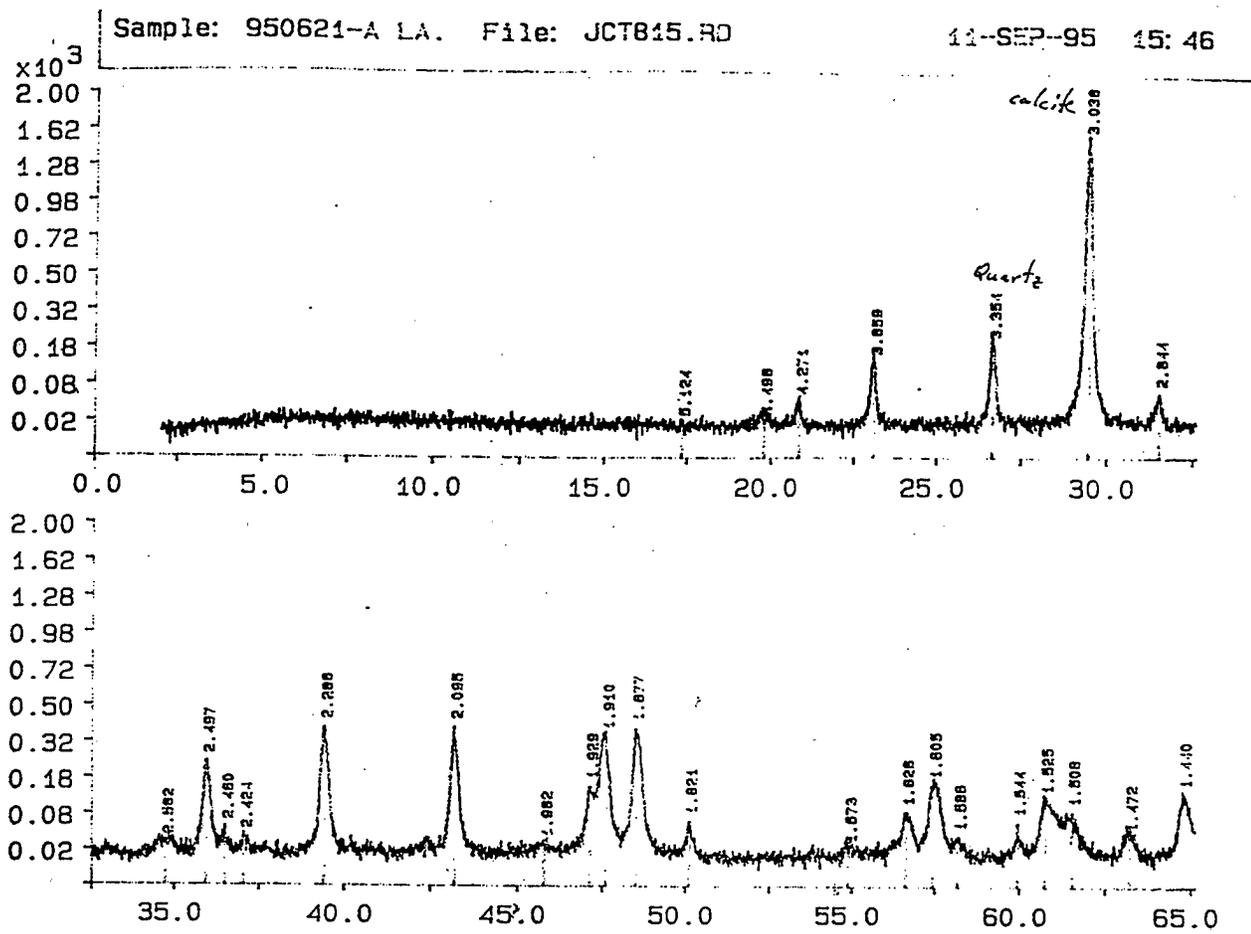
Figure 23. X-ray diffraction pattern of non-expansive reactive coarse-aggregate particle #A from core 950621

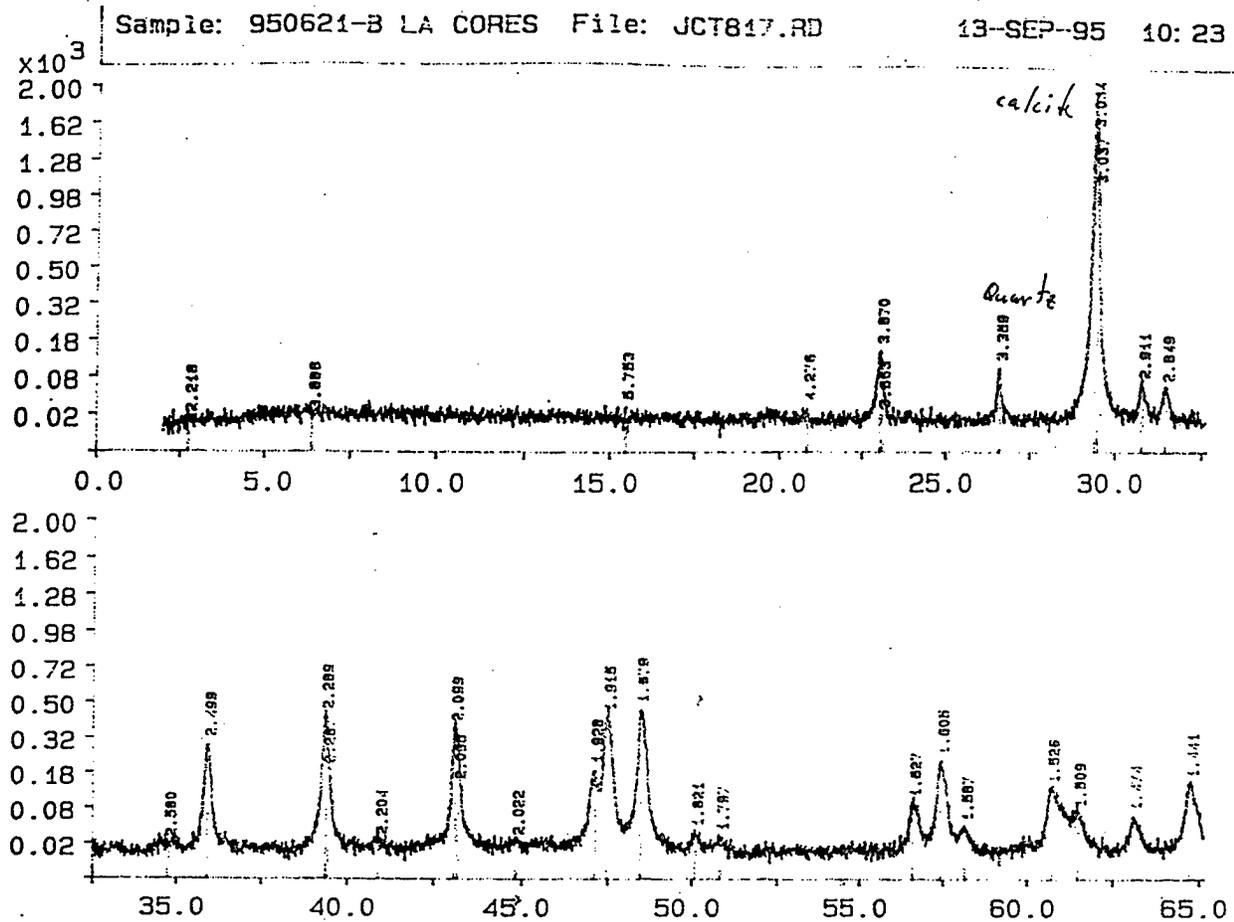
- m.* 950621 - This concrete had some hairline cracks at the surface. One crack penetrated into the interior concrete approximately 1 in. (25.4 mm) and terminated in the paste. The upper portion of the concrete consisted of lighter colored limestone coarse-aggregate particles. The lower portion of the core contained numerous dark-limestone coarse-aggregate particles with dark reaction rims. Some cracks associated with these limestone aggregate particles are shown in Figure A12, Appendix A. The X-ray diffraction pattern of aggregate particle #A, a dark-gray particle with a prominent dark reaction rim, showed it to be pure limestone, as shown in Figure 23. Light-colored brownish limestone with a reaction rim (particle #B) was pure limestone, as identified in Figure 24. The dark-gray particle

Figure 24. X-ray diffraction pattern of non-expansive reactive coarse-aggregate particle #B from core 950621

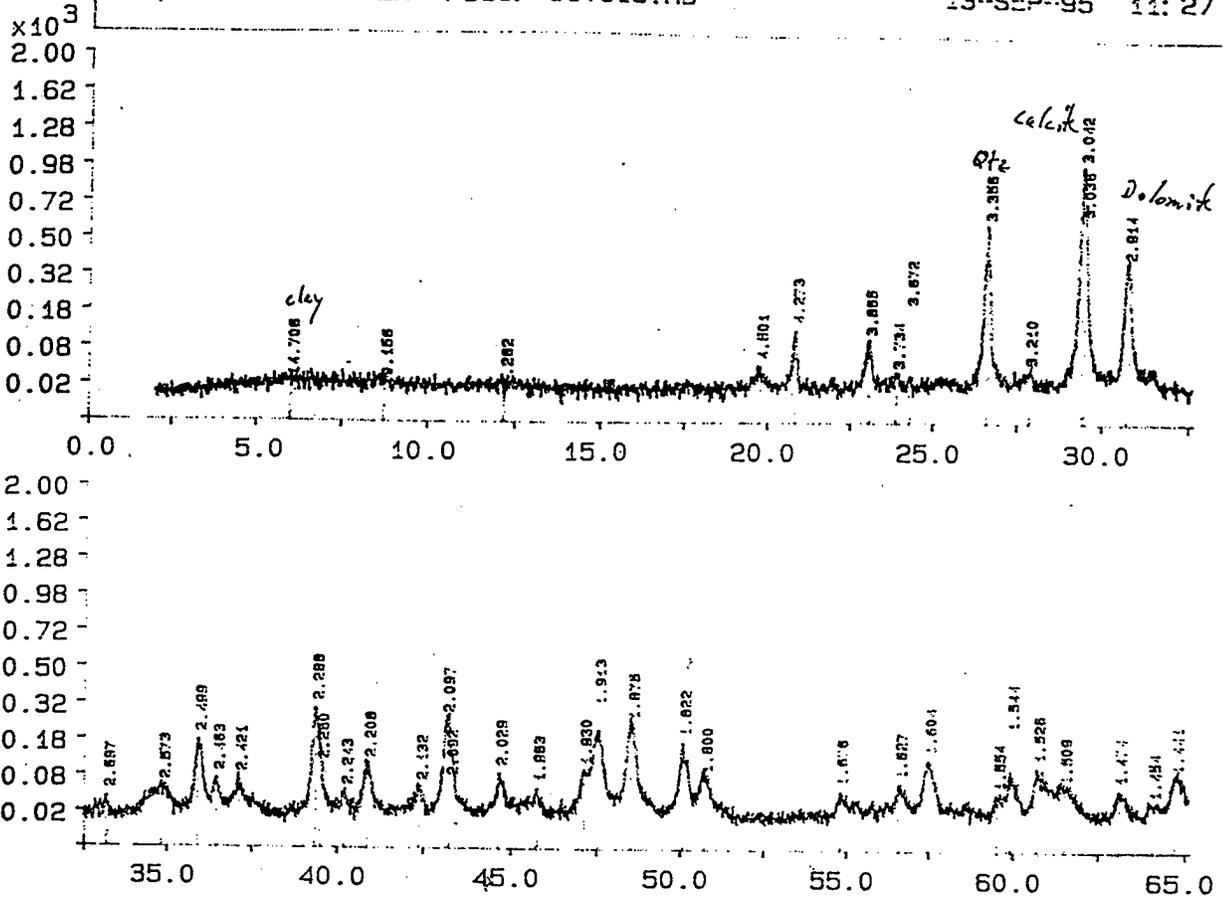
with a prominent reaction rim (Figure A12, Appendix A) (particle #C) was a fine-grained dolomitic limestone also containing insoluble material including clays and quartz (Figure 25). A thin section of a near-surface dark-gray fine-grained impure limestone coarse-aggregate particle showed a rim on this aggregate and micro cracks in the rim propagating into the paste. Etching of coarse-aggregate particle using dilute hydrochloric acid showed no relief in the rim area; i.e., the rim was neither more nor less acid soluble than the unaltered rock.

Figure 25. X-ray diffraction pattern of expansive reactive coarse-aggregate particle #C from core 950621

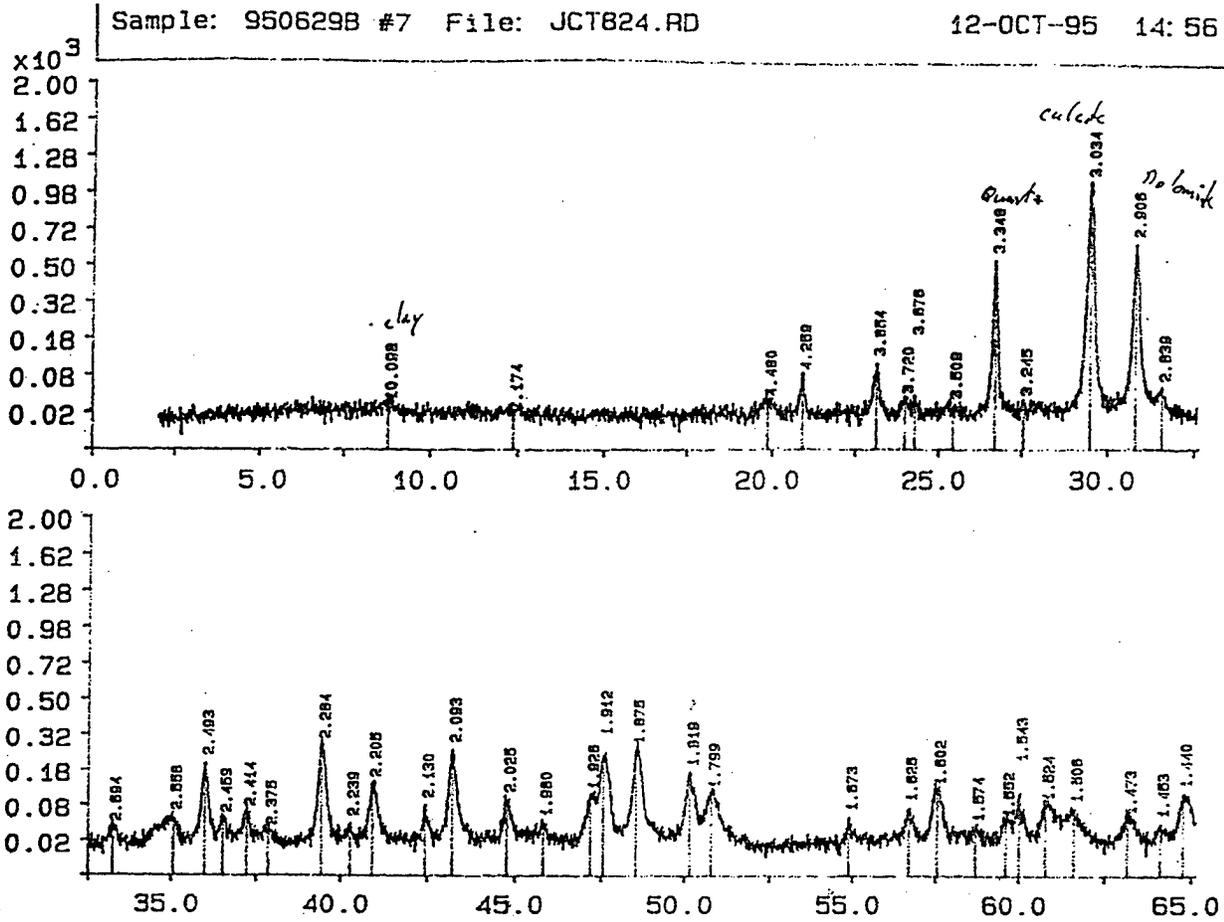
Figure 26. X-ray diffraction pattern of highly reactive coarse-aggregate particle #B from limestone sample 950629 after treatment in sodium hydroxide

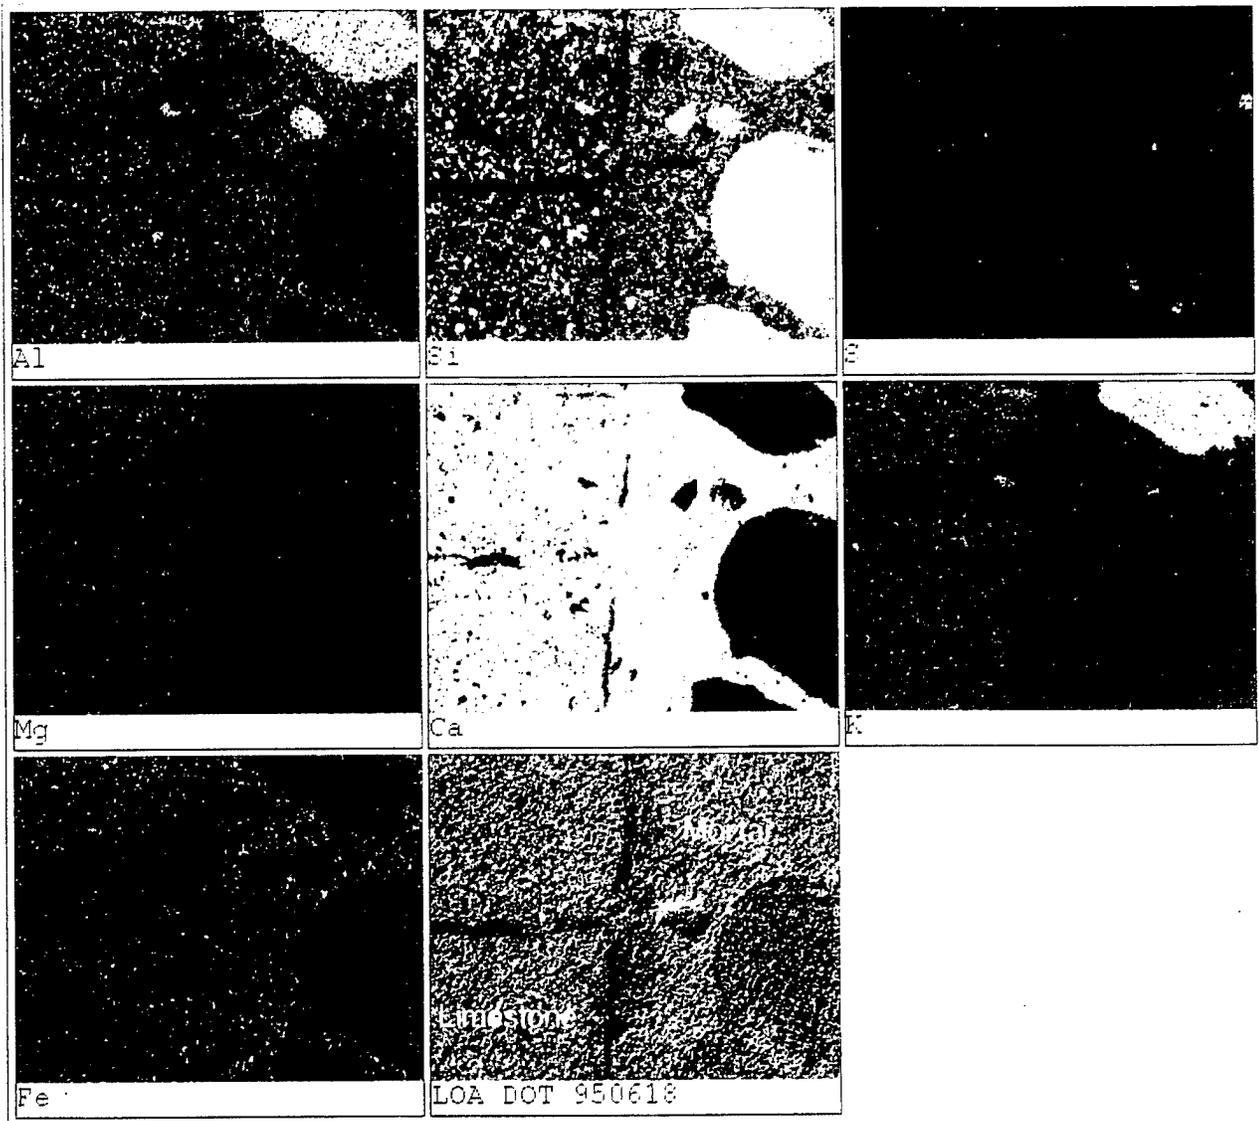
- l.* 950618 - This concrete was heavily cracked. Vertical, horizontal, and diagonal cracks were abundant throughout the length of core. The cracking was associated with a large dark-gray limestone coarse-aggregate particle (Figure A11, Appendix A). Fractures were observed in the central portion of the aggregate particle as well as in the rim area of the particle. A specimen of this aggregate particle was cored along the paste-to-aggregate interface and prepared for examination as a ground section. The specimen was impregnated using an epoxy resin to reinforce the sample and minimize possible additional cracking in the preparation process. The specimen showed the propagation of cracks through the interface zone. The cracks were not confined to the interface zone of the aggregate particle as they propagated into the interior of the aggregate particle. The interior portion of the aggregate particle was also cracked. High-resolution elemental analysis using the scanning electron microscope (SEM) and energy dispersive X-ray (EDX) showed no migration of elements in this particular aggregate particle, as illustrated in Figure 27.

Figure 27. High-resolution X-ray elemental map of reactive coarse aggregate interface with paste. No migration of elements is observed

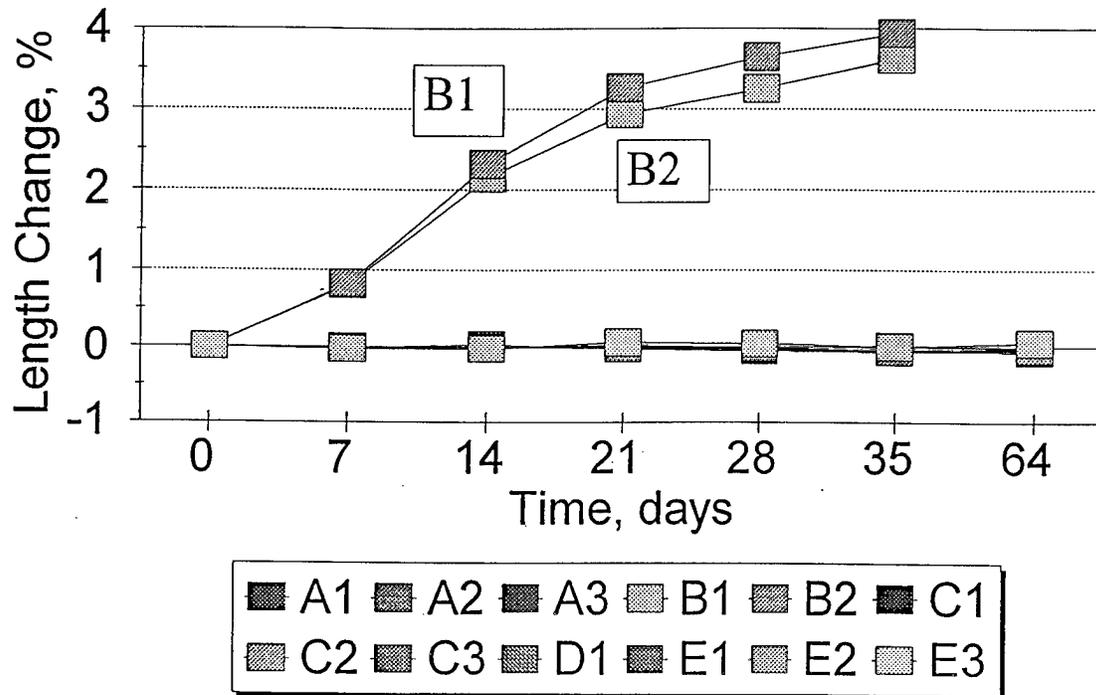
Figure 28. Rock cylinder test shows two specimens (B1 and B2) from sample 950629 expanding quickly while others did not expand. Cores were taken from five particles (A, B, C, D, and E) representing varieties of rock

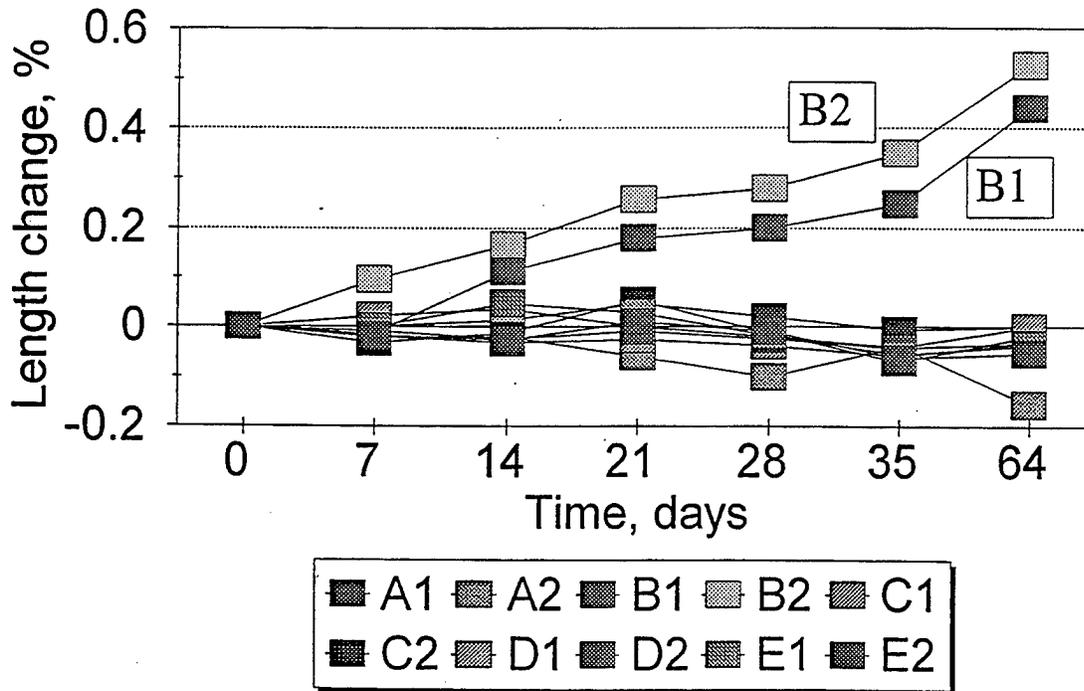
Figure 29. Rock cylinder test shows two specimens (B1 and B2) from sample 950630 expanding while others did not expand. Cores were taken from five particles (A, B, C, D, and E) representing varieties of rock

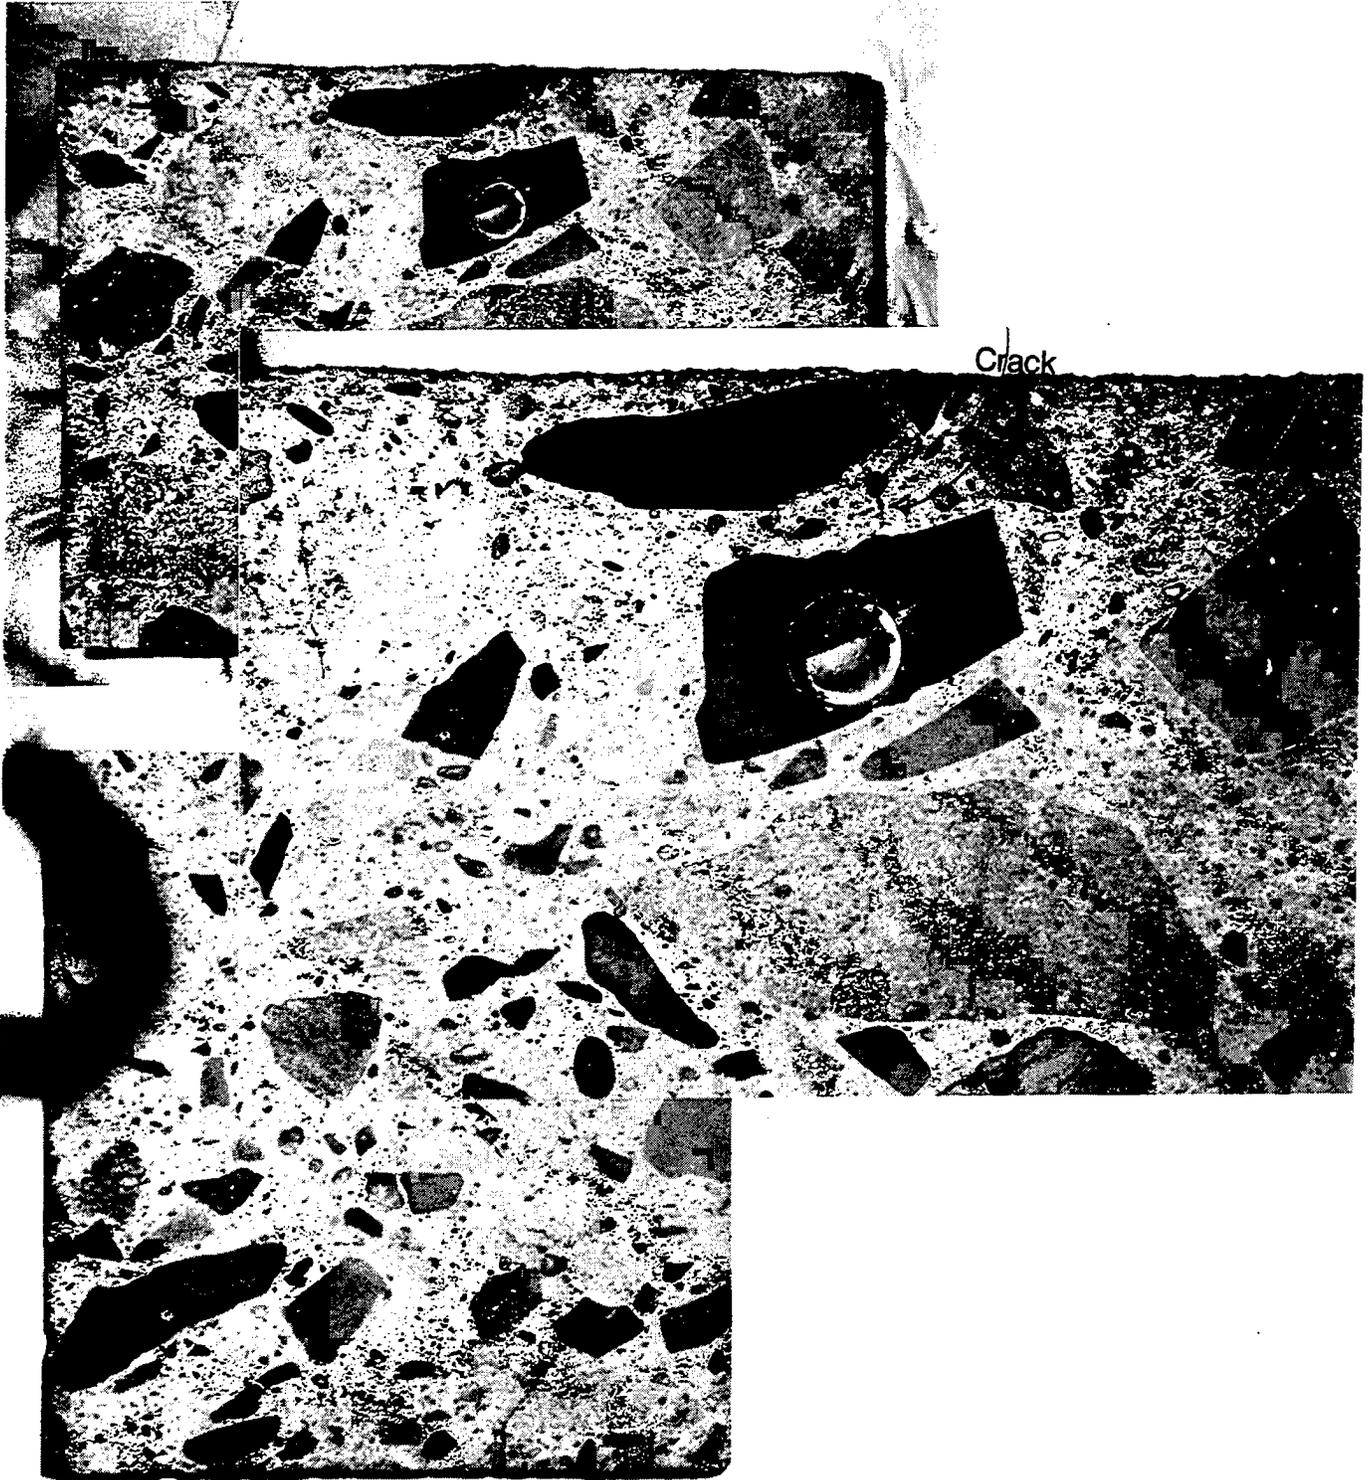
Figure A1. Sample 950623 shows reactive particles 1 and 2 near top surface associated with cracks. The top and bottom samples are 6 in. (152 mm) left to right

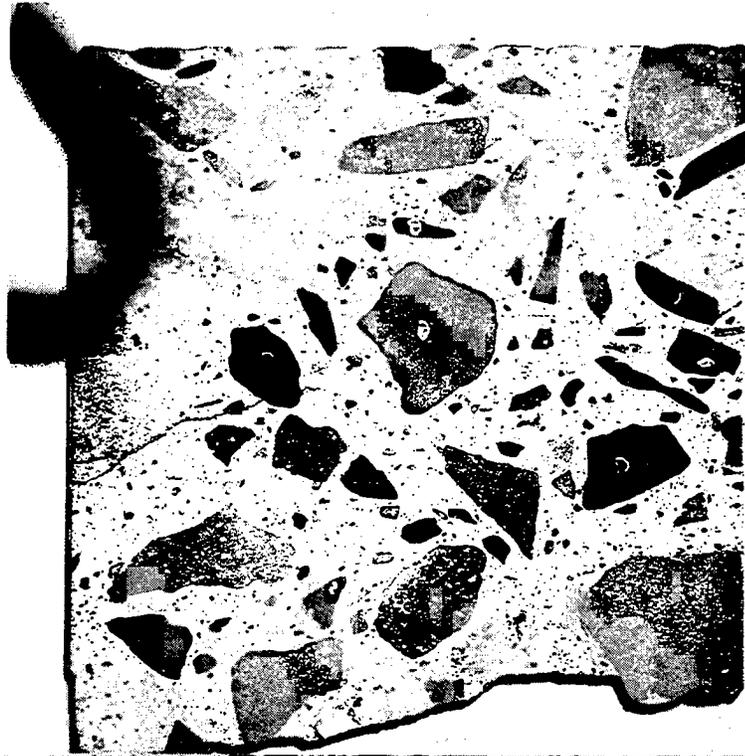
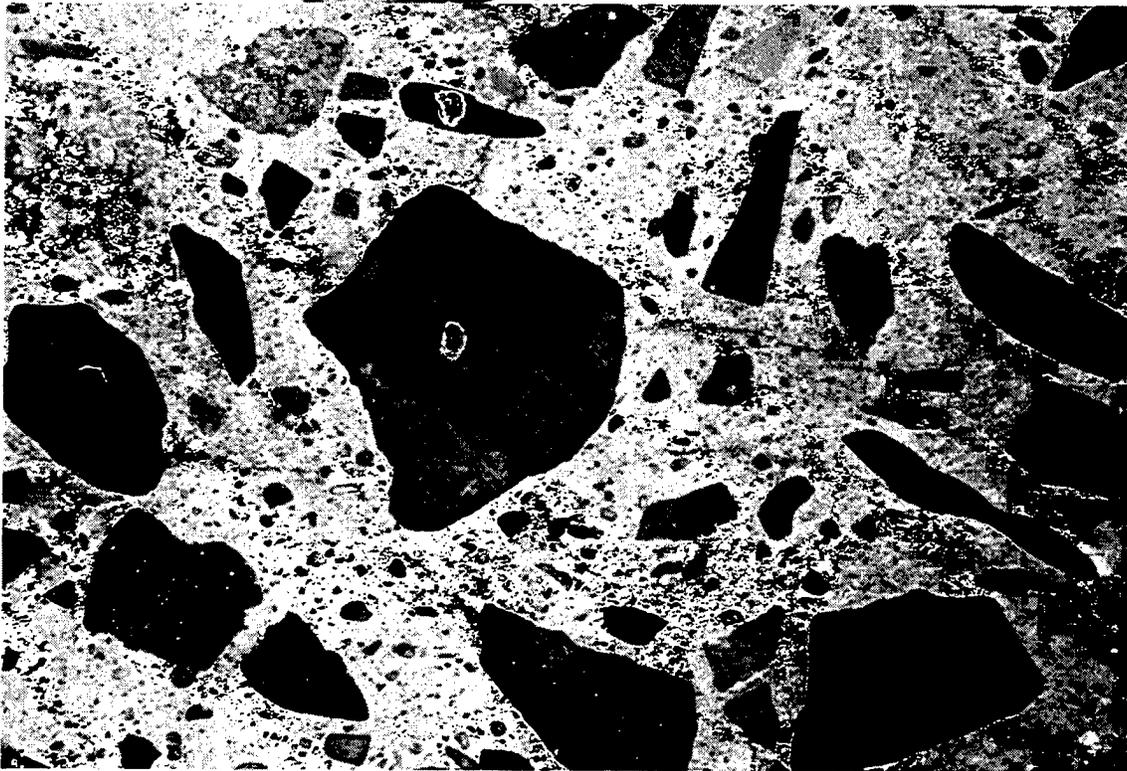
- b. 950625 - Vertical cracks from the surface intersected dark-gray coarse-aggregate particles as well as horizontal intermittent fractures, as shown in Figure A2, Appendix A. All fractures could be traced to dark-gray coarse-aggregate particles with dark reaction rims either partially or entirely rimming the particle. No cracking was associated with similar smaller dark coarse-aggregate particles. Cracks in some particles were continuous into the paste while other cracks in the aggregate particles showed no such continuation. The paste was hard and intact.

Figure A2. Sample 950623 shows a random crack pattern with cracks propagating from central reactive coarse aggregate. Other reactive aggregate particles are also present. Top sample is 6 in. (152 mm) left to right

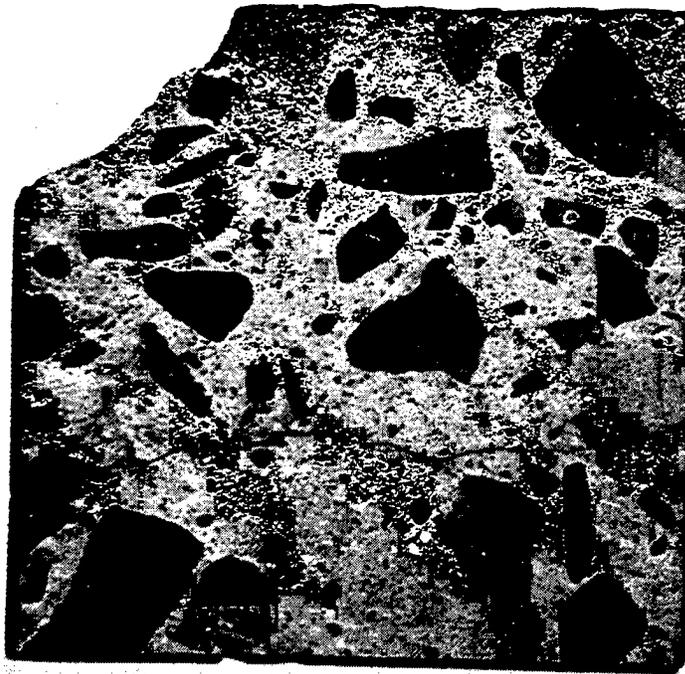
- c. 950626 - This concrete sustained localized damage. A single horizontal crack and some hairline fracturing were observed on a cut section on one side of the slab (Figure A3a, Appendix A). On the reverse side, heavy fracturing of the concrete associated with dark-gray coarse-aggregate particles was observed. Minor cracking at the bottom of the core associated with cracked dark-gray coarse aggregate is illustrated in Figure A3a, Appendix A. Examination of a thin section containing coarse-aggregate particles showed a linear opening along oriented features. The cracks contained no observed reaction products.

Figure A3a. Sample 950626 shows some interior cracking in the concrete and a few small reactive particles with reaction rims. The sample is 6 in. (152 mm) left to right

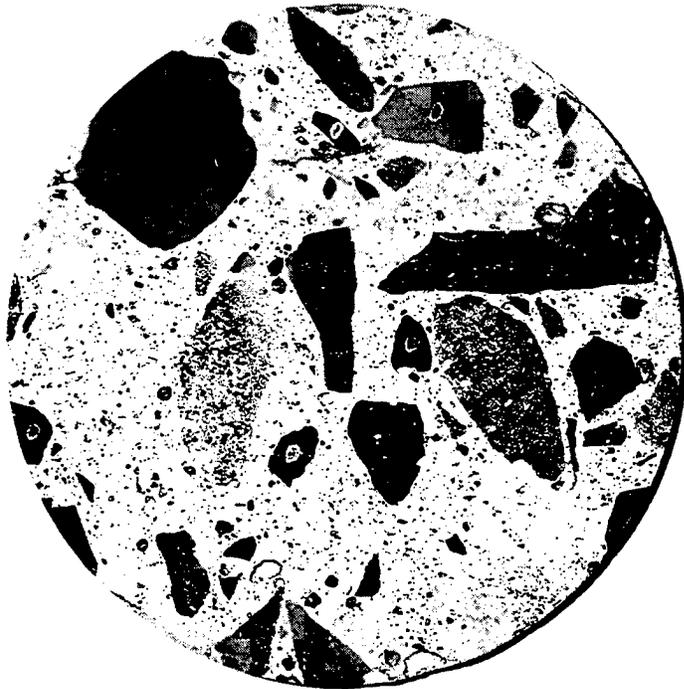
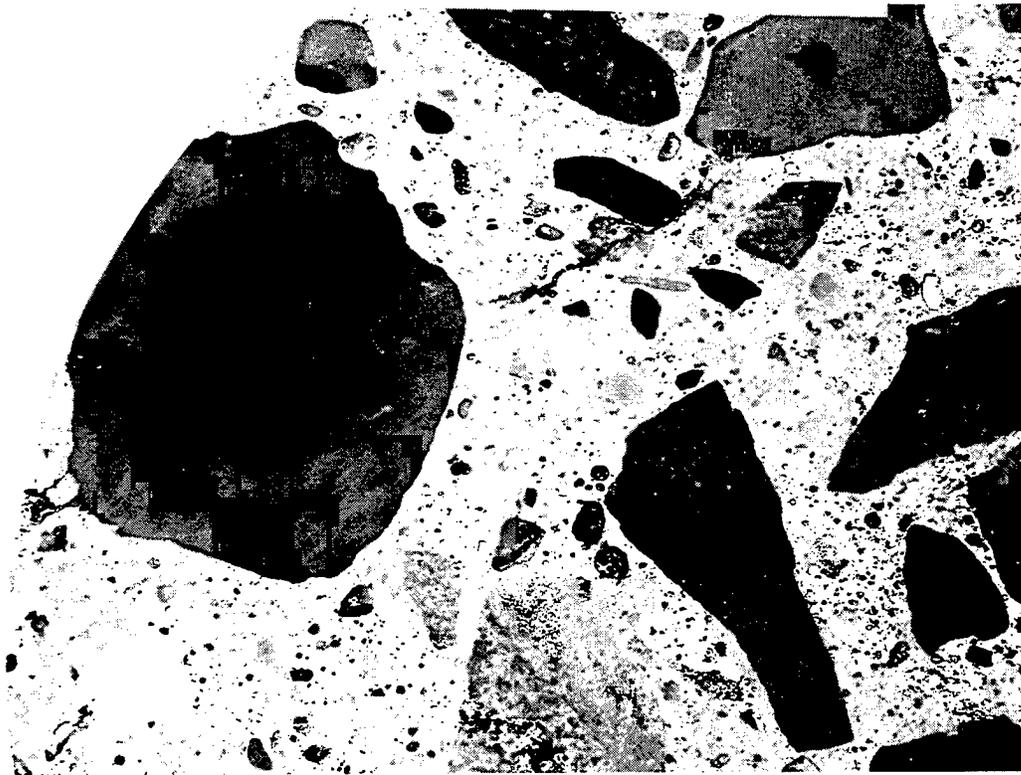
Figure A3b. Sample 950626 shows reactive aggregate particles at bottom of core. The sample is 6 in. (152 mm) left to right
