# Investigation of Concrete from I-20 Near Monroe, Louisiana

Miscellaneous Paper SL-98-1  
January 1998

**Final report**

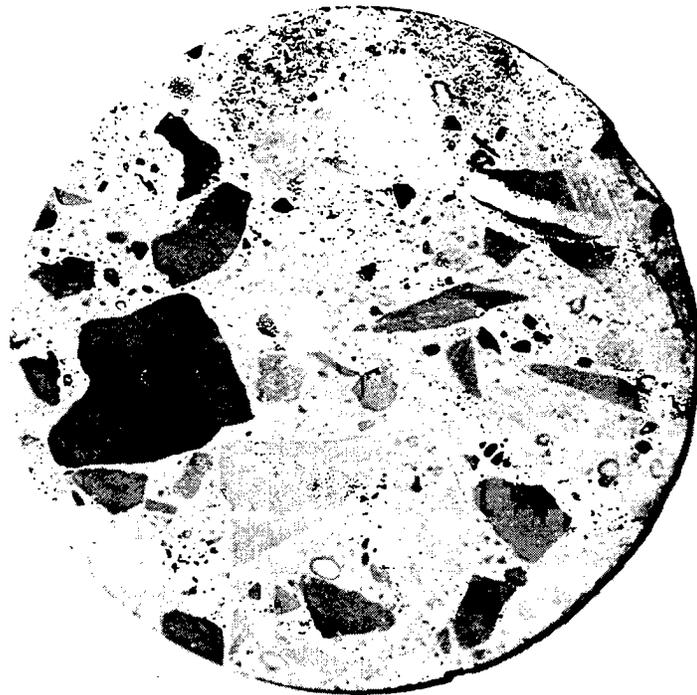
Figure A4. Sample 950627 shows no cracks. The sample is 6 in. (152 mm) left to right

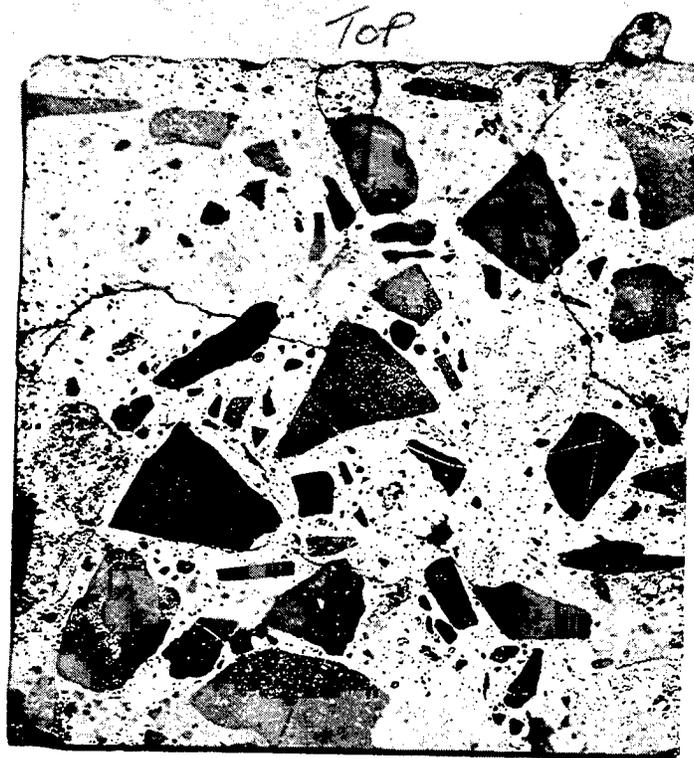
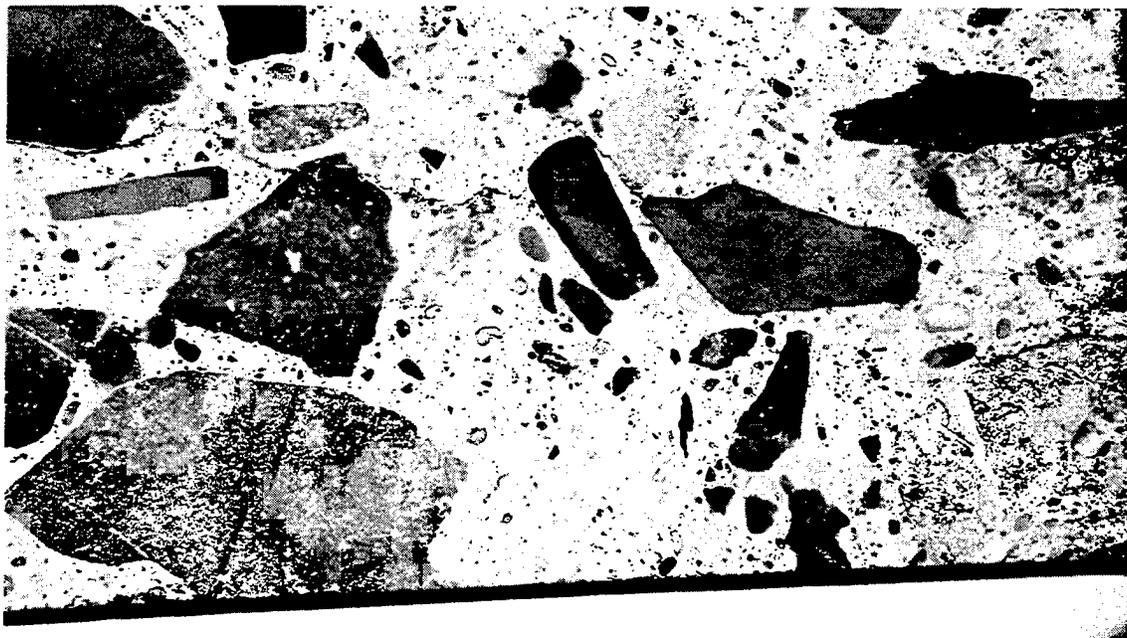
- e. 950628 - The concrete contained numerous cracks throughout the length of the core. The cracks were vertical, horizontal, and diagonal going through, as well as around, coarse-aggregate particles, as shown in Figures A5a and A5b, Appendix A. There were numerous

Figure A5a. Sample 950628 shows severe cracking in near surface concrete. Epoxy resin fills the cracks. Top sample is 6 in. (152 mm) left to right

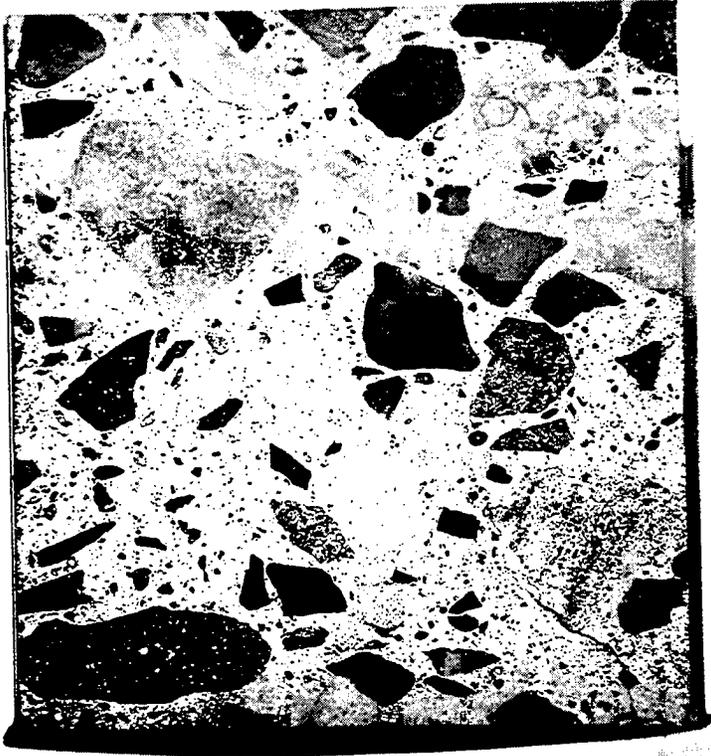
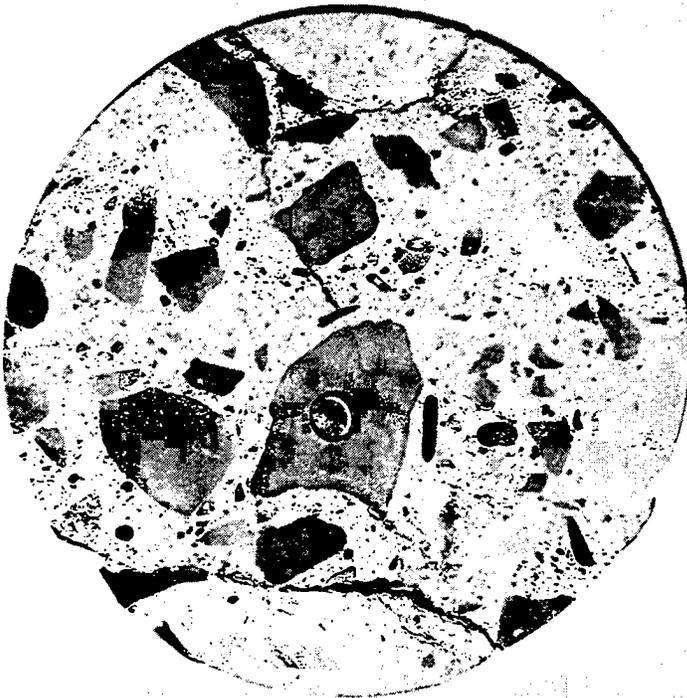
Figure A5b. Sample 950628 shows cracking is continuous throughout the entire length of core. Both samples are 6 in. (152 mm) left to right

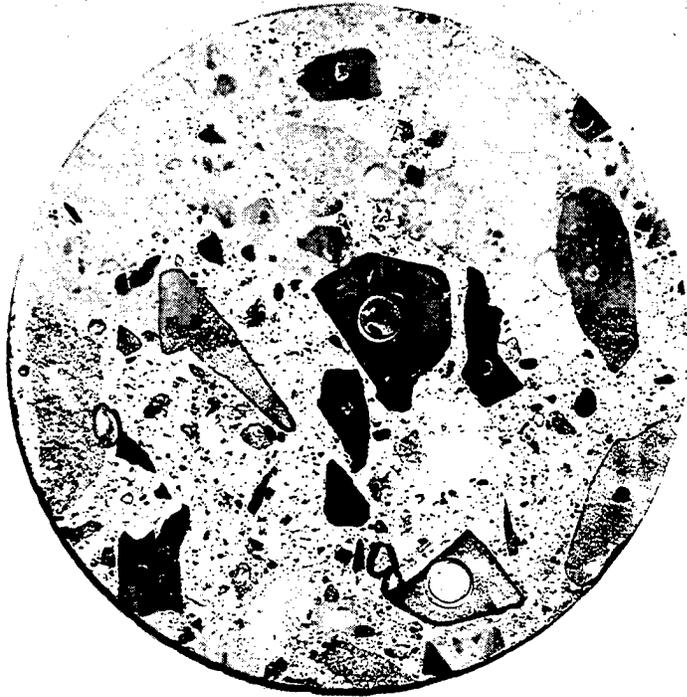
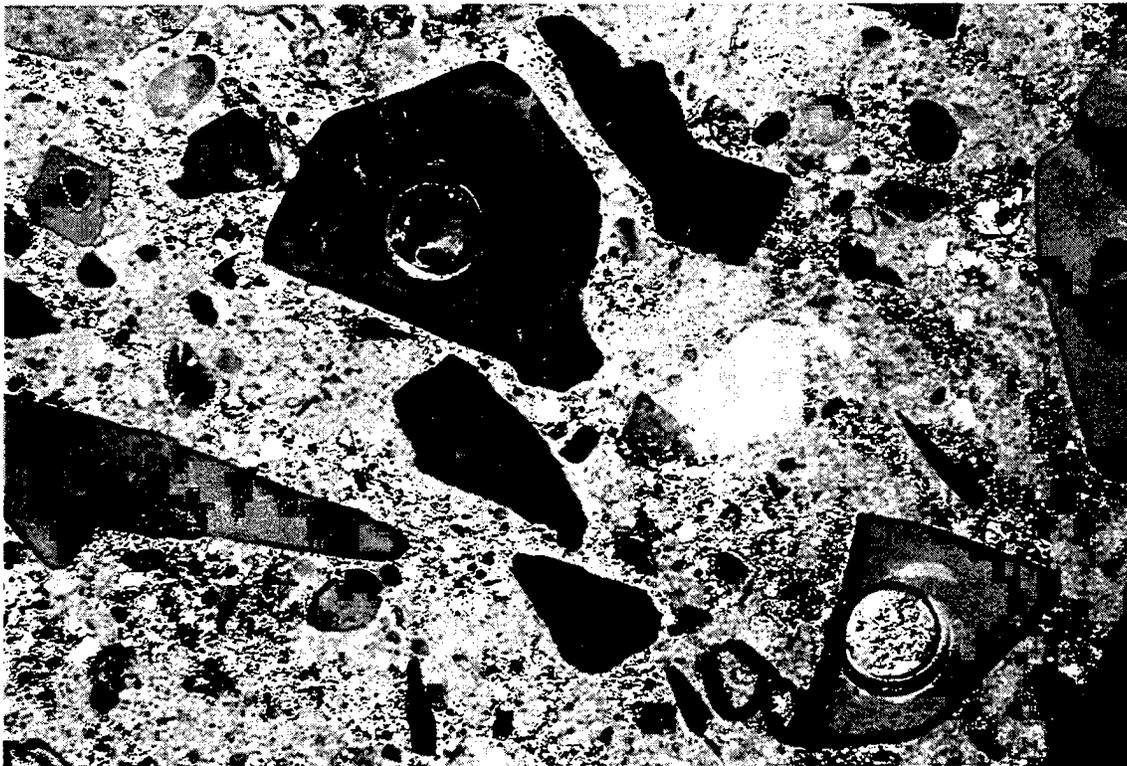
- f.* 950620 - The core was cracked throughout its length. The cracks were randomly oriented. There were numerous dark-gray limestone coarse-aggregate particles with dark reaction rims. The rims exhibited radial cracks that extended into the paste. Aggregate particles with these rims were dolomitic limestone containing quartz and clay. X-ray diffraction patterns are presented in Figures 18 and 19. Figure A6, Appendix A, shows the appearance of these aggregate particles.

Figure A6. Sample 950620 shows aggregate reaction at the base of the core. Cracks are visible along the reaction rim. Top sample is 6 in. (152 mm) left to right

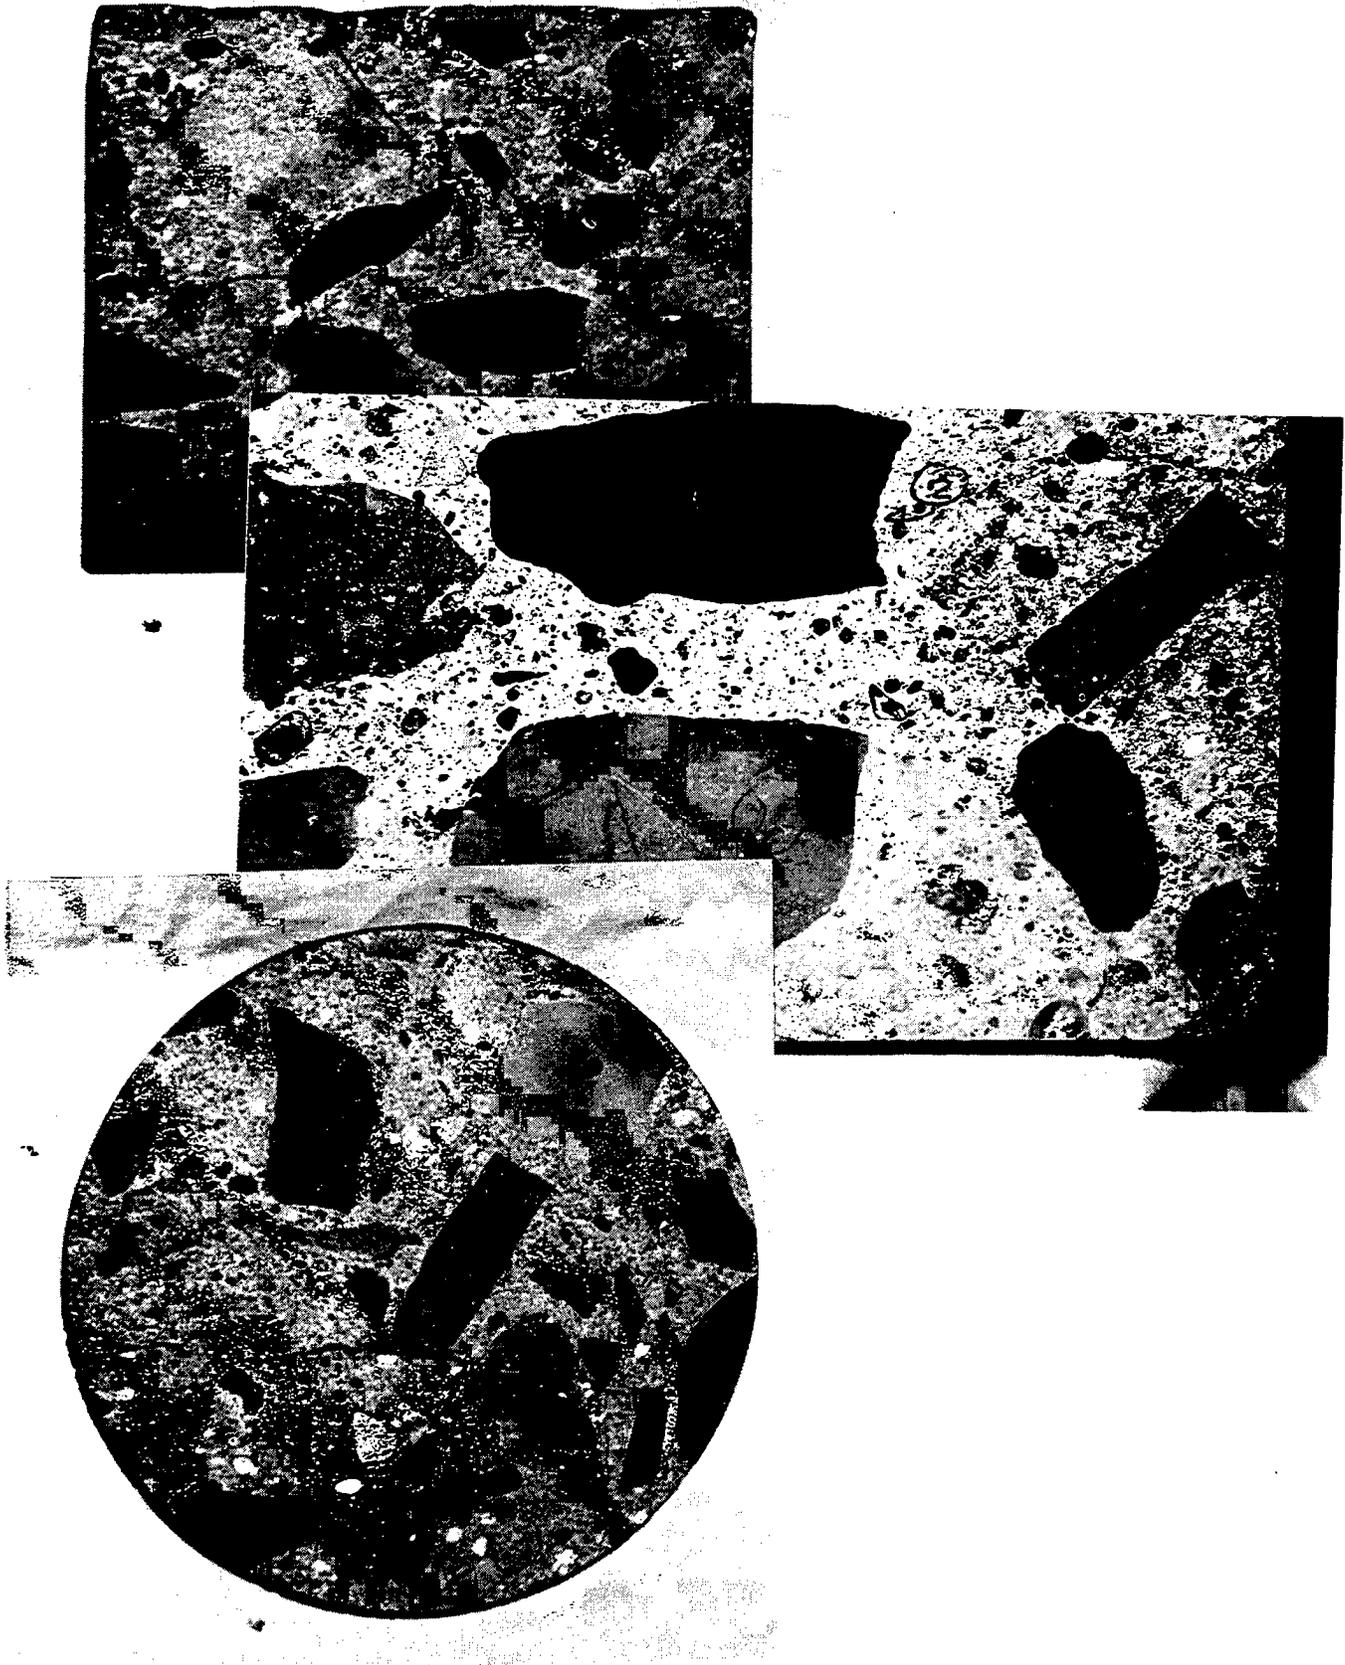
- g.* 950619 - The core was cracked throughout its length. Cracking in the near-surface concrete was more severe as vertical, horizontal, and diagonal cracks were common and associated with dark-gray limestone coarse-aggregate particles (Figure A7, Appendix A). Thin sections of two coarse-aggregate particles were prepared. Particle #A was a light-colored fine-grained limestone consisting of a fine-grained matrix and rhombohedral dolomite crystals. No cracks associated with this particle were observed. Particle #B was a dark-gray fine-grained limestone with a rim around it and was associated with cracking. No difference could be observed between the material in the rim and the interior of the particle. Fine quartz grains were embedded in a calcite matrix.

Figure A7. Sample 950619 shows random crack pattern with cracks propagating from two central reactive coarse-aggregate particles and cracking in bottom end of sample. Top and bottom samples are 6 in. (152 mm) left to right

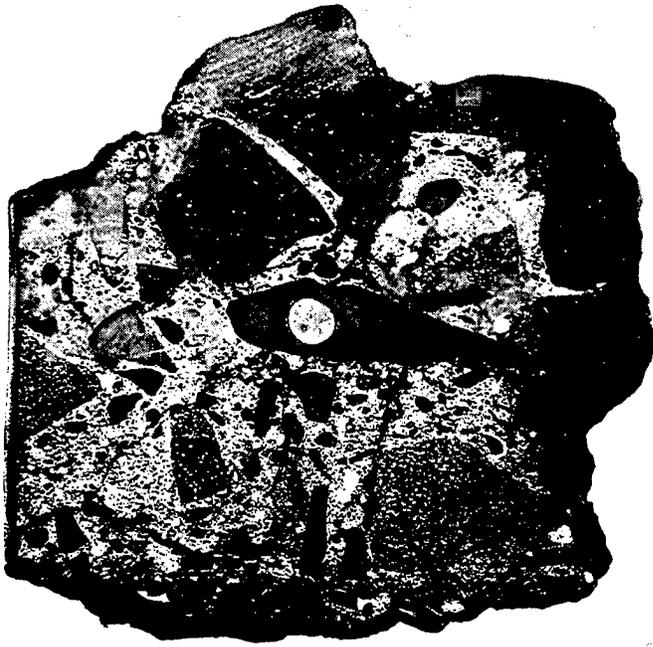
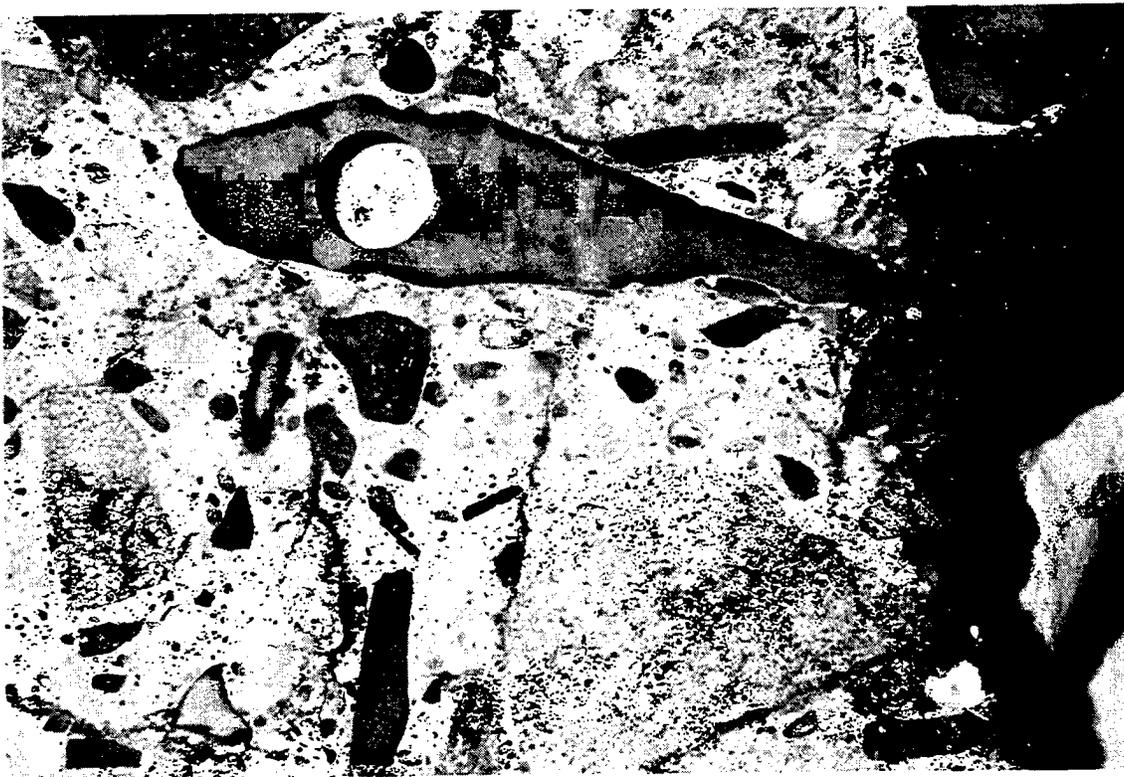
- h.* 950617 - This sample consisted of rubble. The core had broken into fragments during the coring process. One large piece was impregnated using an epoxy resin and then cut open for examination. The concrete was highly fractured (Figure A8, Appendix A). There were numerous dark-gray limestone coarse-aggregate particles. Cracks were mostly associated with the larger coarse-aggregate particles. The associated dark-gray coarse-aggregate particles were dolomitic limestone containing some quartz as well as illite (clay-mica). An X-ray diffraction chart showing the relative abundance of the calcite and dolomite is presented in Figure 20.

Figure A8. Sample 950617 shows a reactive aggregate particle and cracking of rim zone. Diameter core boring is 11 mm

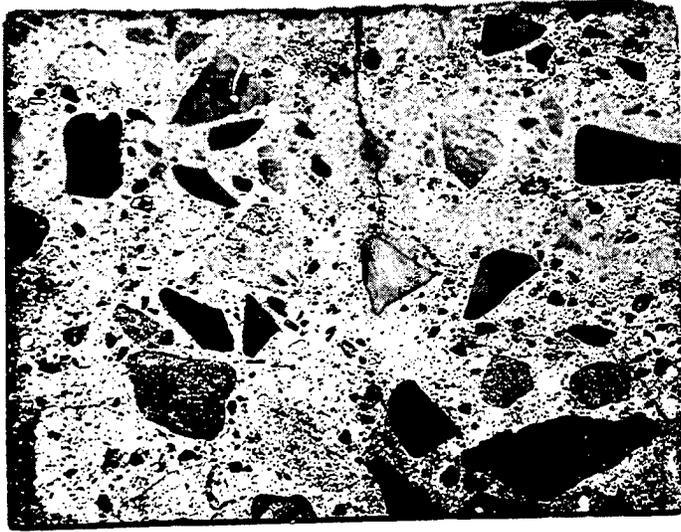
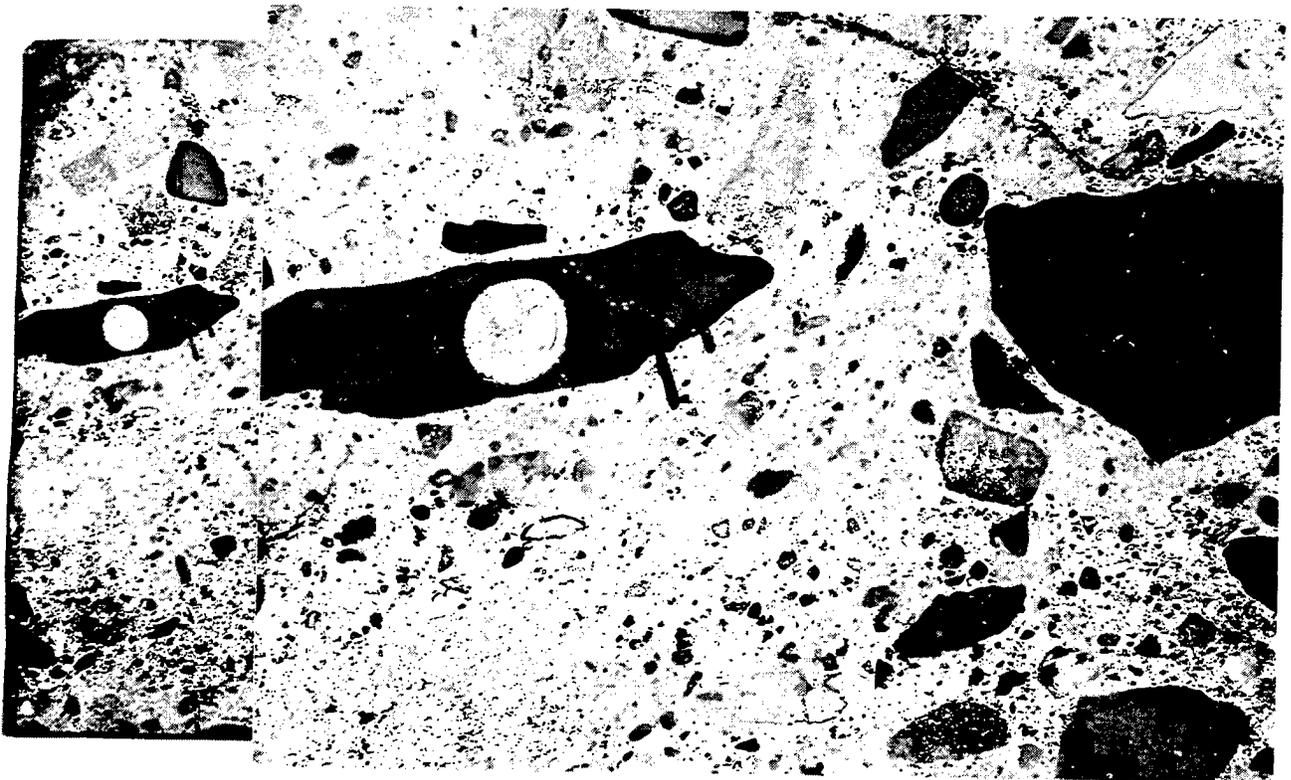
- j.* 950616 - The surface cracking was light. However, the interior concrete showed an extensive crack system. A vertical crack extended several inches into the interior concrete going through coarse-aggregate particles as well as around them. The vertical cracks intersected horizontal and diagonal cracks (Figures A9a and A9b, Appendix A). The majority of the cracks were associated with cracked dark-gray fine-grained limestone coarse-aggregate particles. Two particles examined by X-ray diffraction were dolomitic limestone with acid-insoluble materials consisting of quartz and clays. Figures 21 and 22 illustrate the relative abundance of the carbonate phases.

Figure A9a. Sample 950616 shows a central vertical near-surface crack and some incipient cracks associated with aggregate particle A. Samples on left are 6 in. (152 mm) left to right

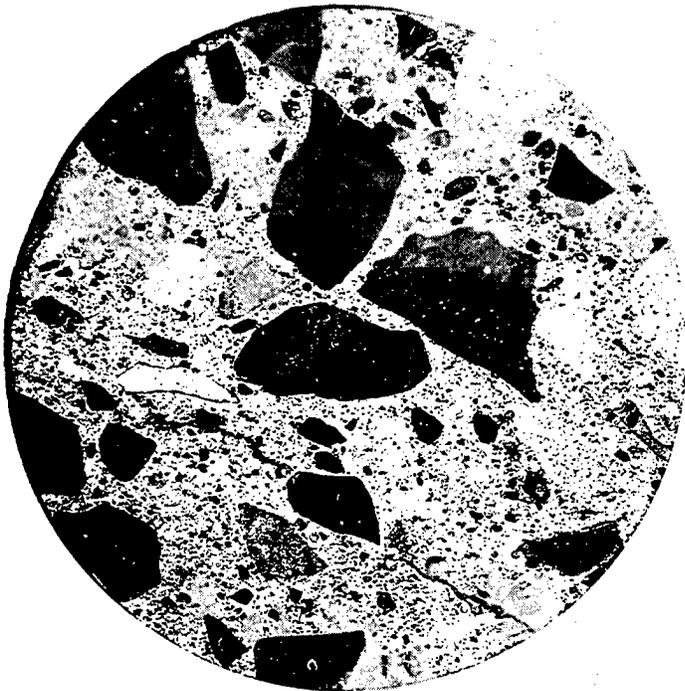
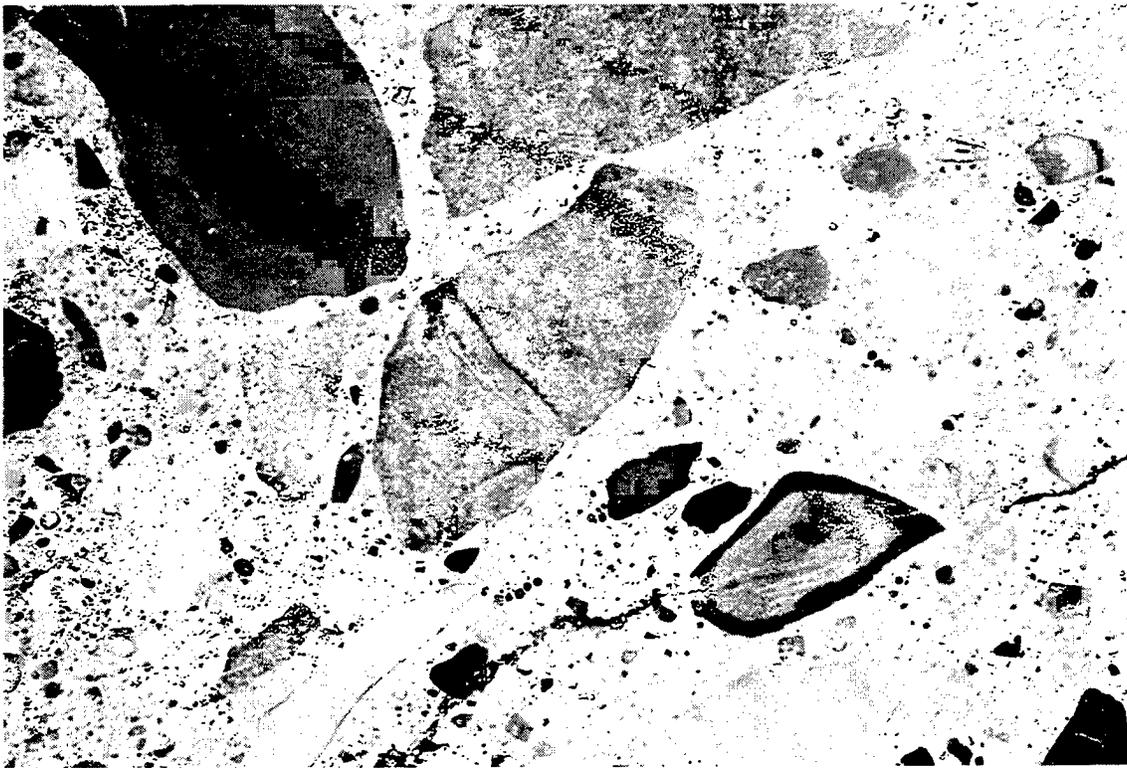
Figure A9b. Sample 950616 shows bottom of core and crack associated with reactive aggregate particle. Top sample is 6 in. (152 mm) left to right

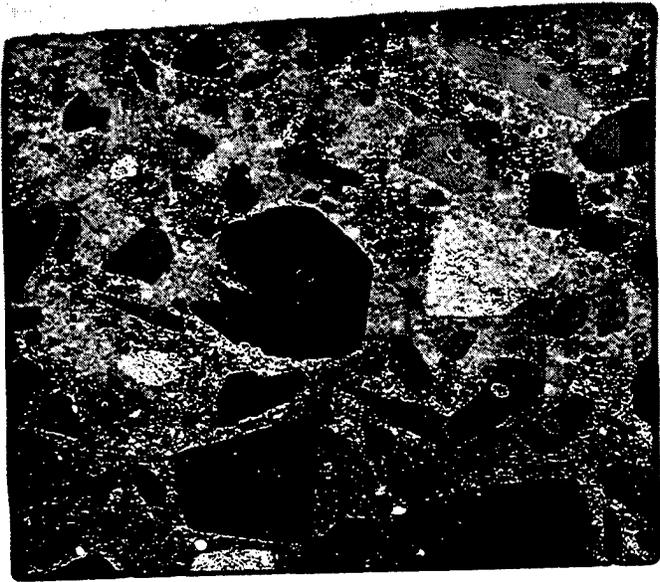
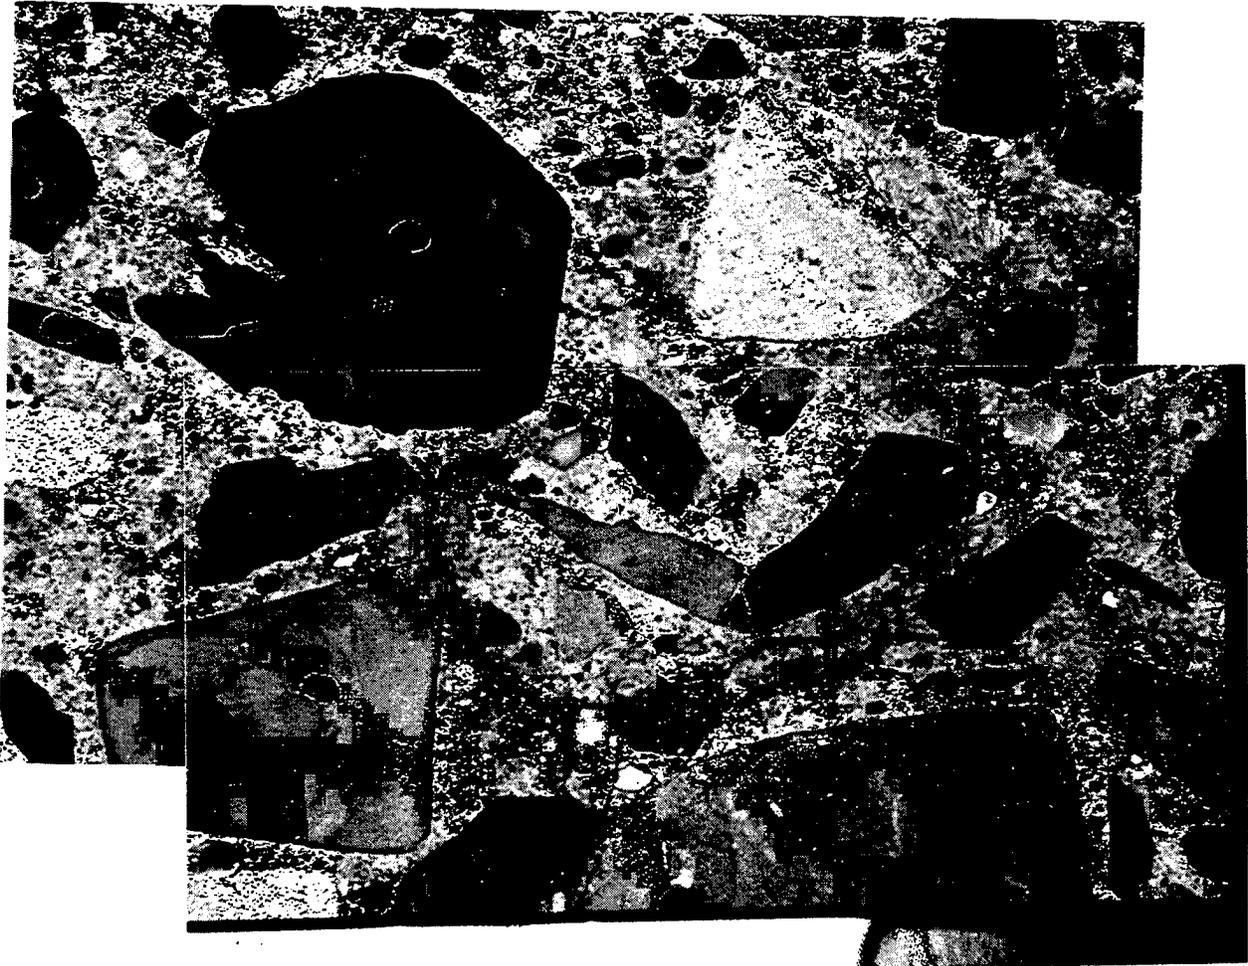
- l.* 950618 - This concrete was heavily cracked. Vertical, horizontal, and diagonal cracks were abundant throughout the length of core. The cracking was associated with a large dark-gray limestone coarse-aggregate particle (Figure A11, Appendix A). Fractures were observed in the central portion of the aggregate particle as well as in the rim area of the particle. A specimen of this aggregate particle was cored along the paste-to-aggregate interface and prepared for examination as a ground section. The specimen was impregnated using an epoxy resin to reinforce the sample and minimize possible additional cracking in the preparation process. The specimen showed the propagation of cracks through the interface zone. The cracks were not confined to the interface zone of the aggregate particle as they propagated into the interior of the aggregate particle. The interior portion of the aggregate particle was also cracked. High-resolution elemental analysis using the scanning electron microscope (SEM) and energy dispersive X-ray (EDX) showed no migration of elements in this particular aggregate particle, as illustrated in Figure 27.

Figure A11. Sample 950618 shows random crack pattern with cracks propagating from central reactive coarse-aggregate particle. Other reactive particles are also evident. Top sample is 6 in. (152 mm) left to right

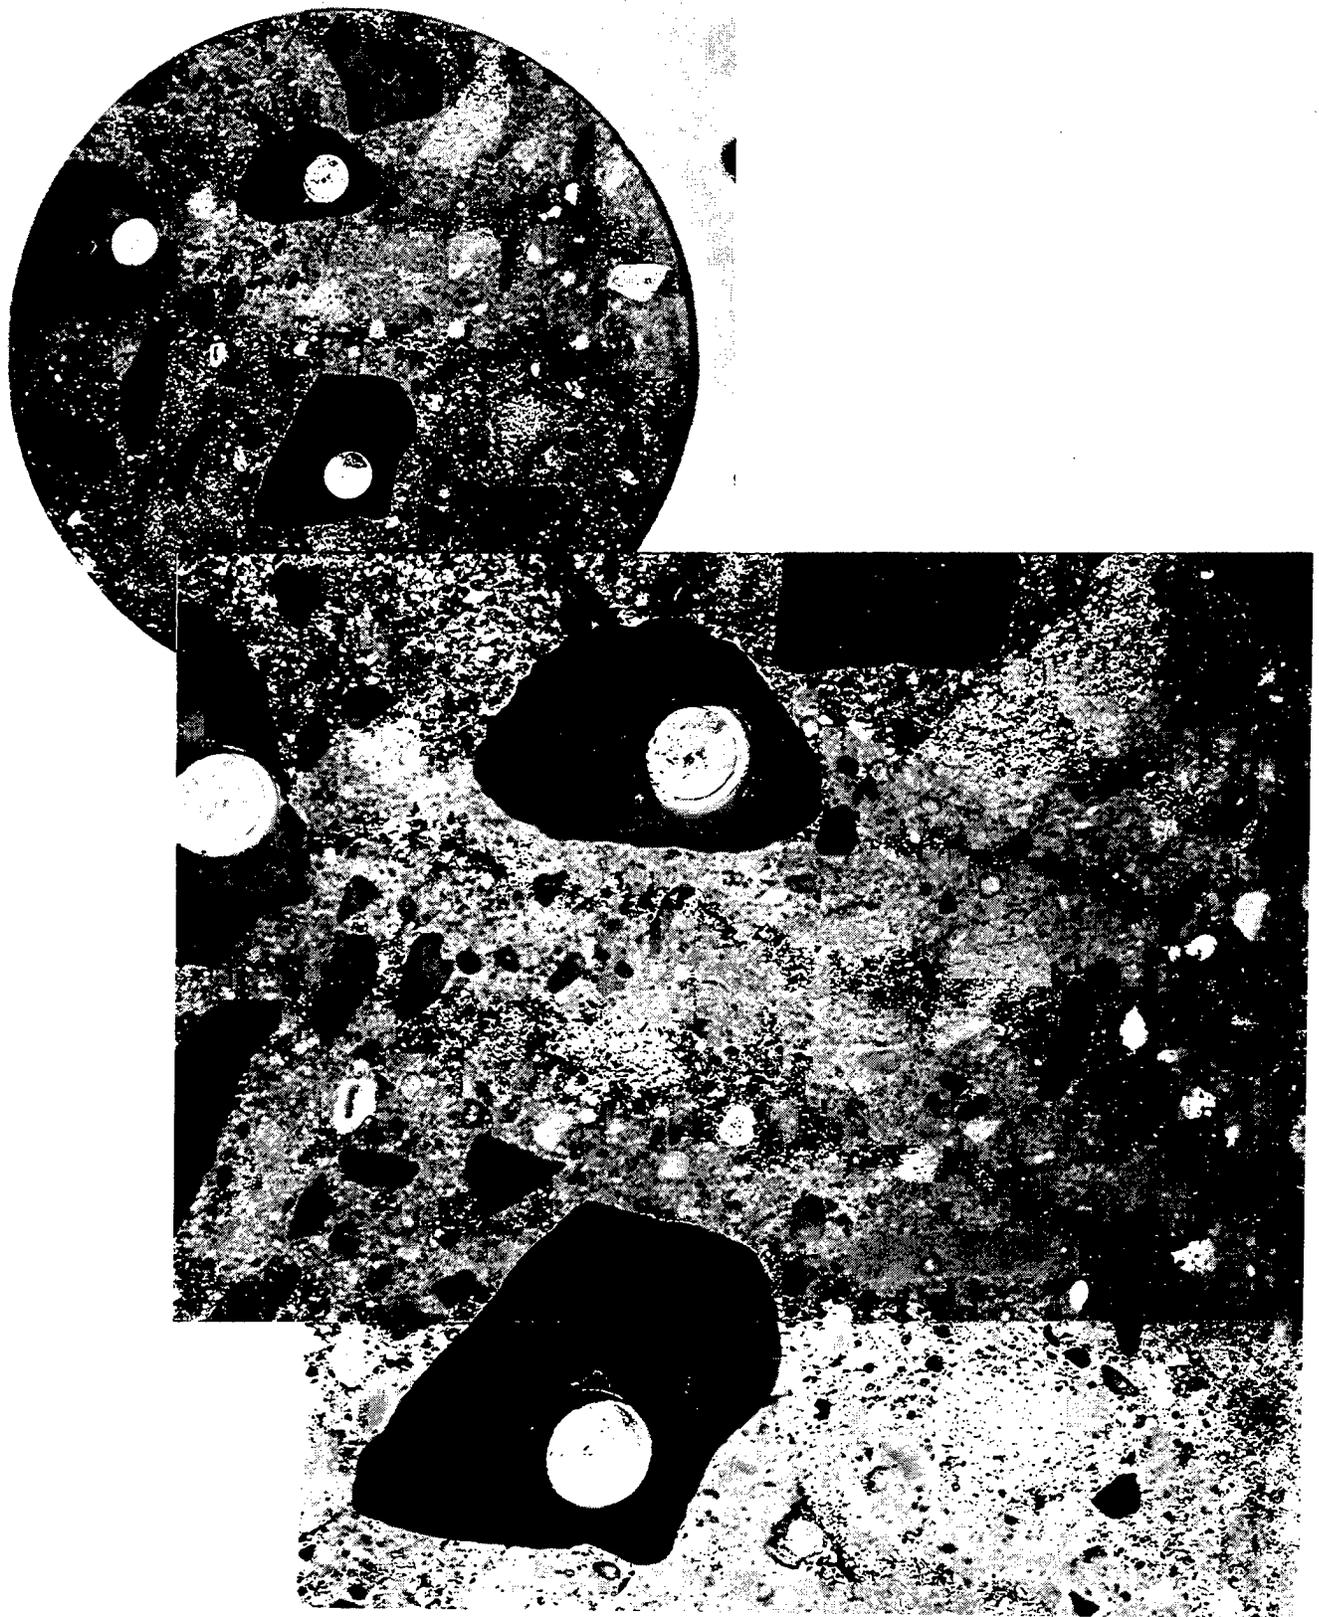
- m.* 950621 - This concrete had some hairline cracks at the surface. One crack penetrated into the interior concrete approximately 1 in. (25.4 mm) and terminated in the paste. The upper portion of the concrete consisted of lighter colored limestone coarse-aggregate particles. The lower portion of the core contained numerous dark-limestone coarse-aggregate particles with dark reaction rims. Some cracks associated with these limestone aggregate particles are shown in Figure A12, Appendix A. The X-ray diffraction pattern of aggregate particle #A, a dark-gray particle with a prominent dark reaction rim, showed it to be pure limestone, as shown in Figure 23. Light-colored brownish limestone with a reaction rim (particle #B) was pure limestone, as identified in Figure 24. The dark-gray particle

with a prominent reaction rim (Figure A12, Appendix A) (particle #C) was a fine-grained dolomitic limestone also containing insoluble material including clays and quartz (Figure 25). A thin section of a near-surface dark-gray fine-grained impure limestone coarse-aggregate particle showed a rim on this aggregate and micro cracks in the rim propagating into the paste. Etching of coarse-aggregate particle using dilute hydrochloric acid showed no relief in the rim area; i.e., the rim was neither more nor less acid soluble than the unaltered rock.

Figure A12. Sample 960621 shows aggregate particles A, B, and C. A is non-expansive, B is non-expansive, and C is expansive. Top sample is 6 in. (152 mm) left to right

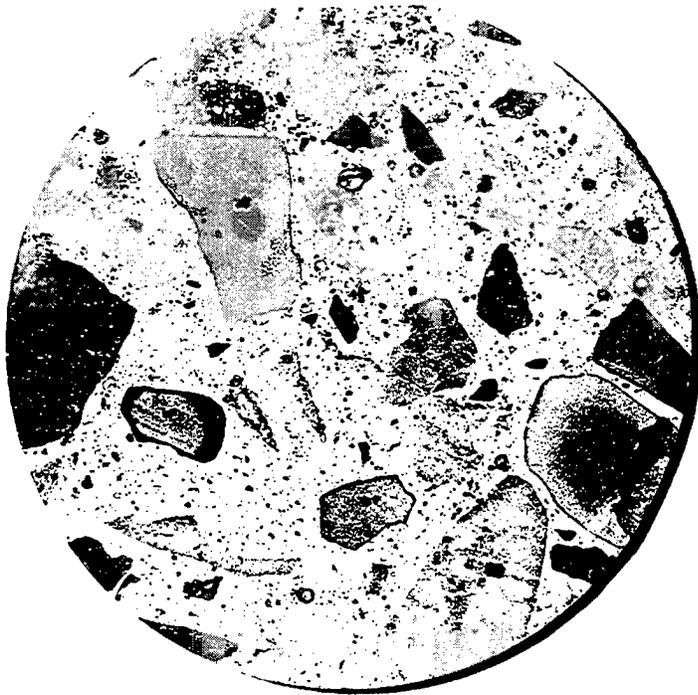
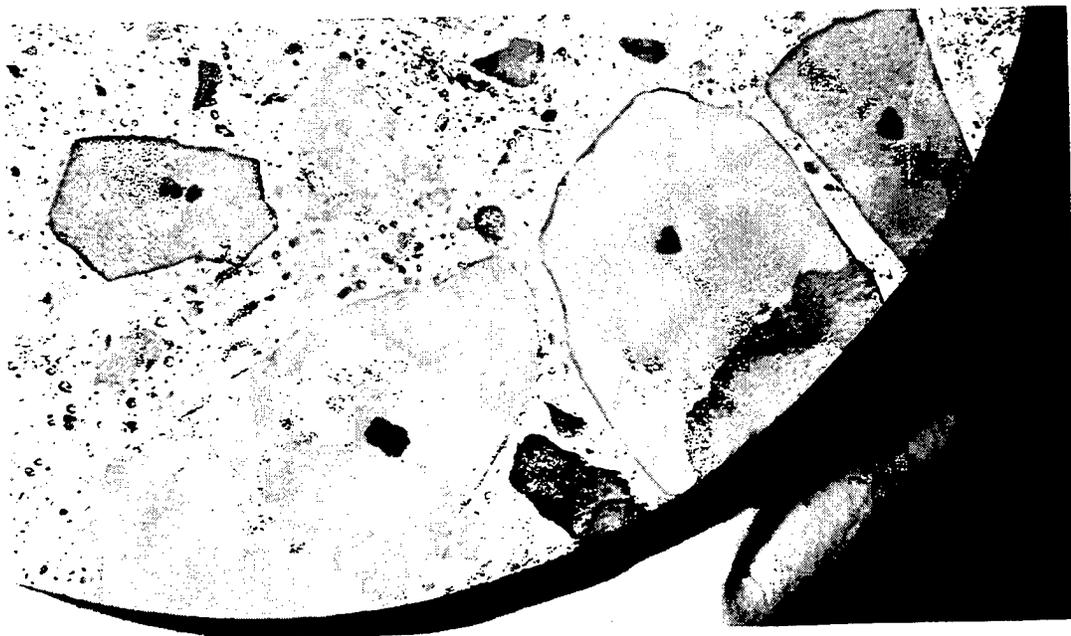
Figure A13. Sample 950615 shows some non-expansive reactive aggregate particles. Top sample is 6 in. (152 mm) left to right
