CRASH TEST OF TYPE III BARRICADES

FINAL REPORT

FEBRUARY 2000

By M. El-Gindy, A. Scanlon, and R. Tallon

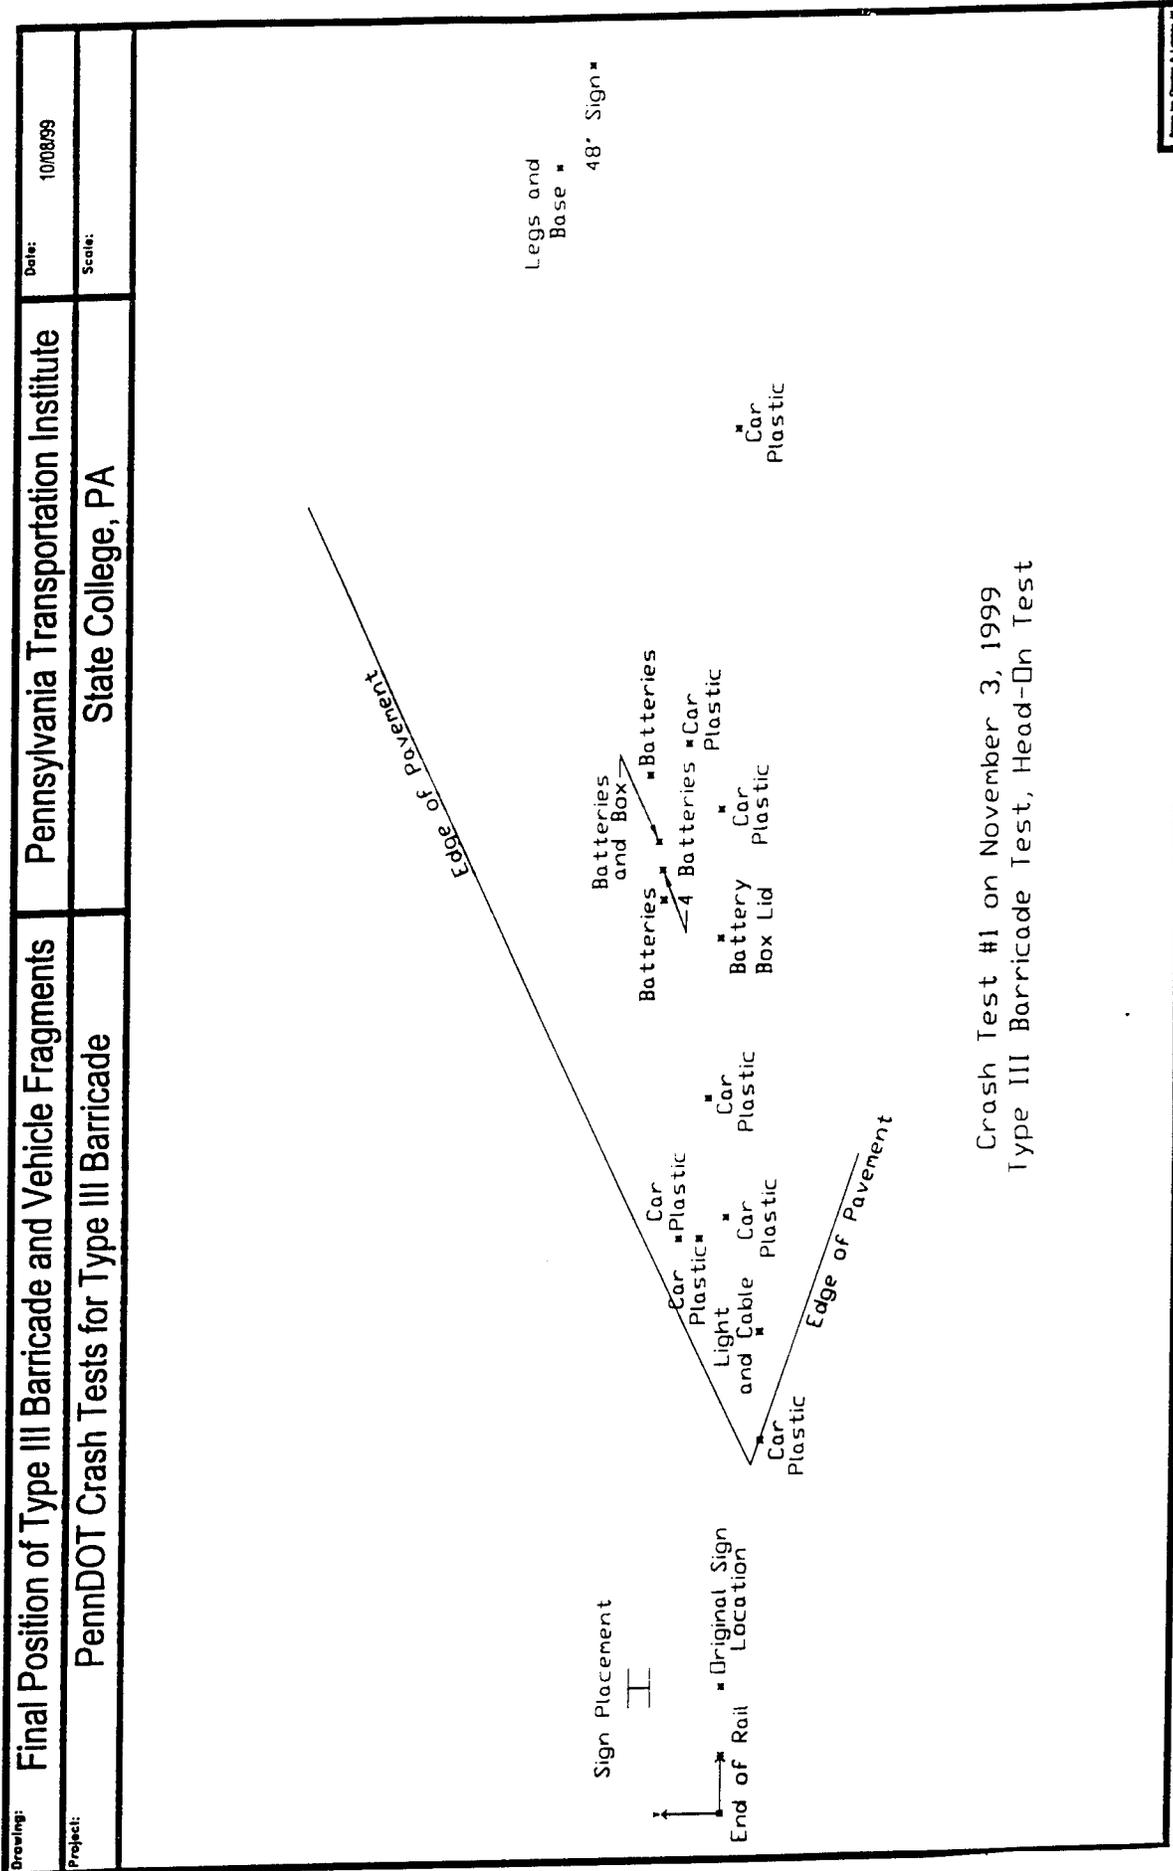
Figure 9. Crash Test #1: Type 3 barricade head-on test (November 3, 1999).

In both the head-on test and the edge-impact test, the Type III barricade was essentially destroyed with debris coming to rest at the locations shown in *Figures 9 and 10*. The final condition of each test article after the test can be seen in *Figures 11 and 12*.

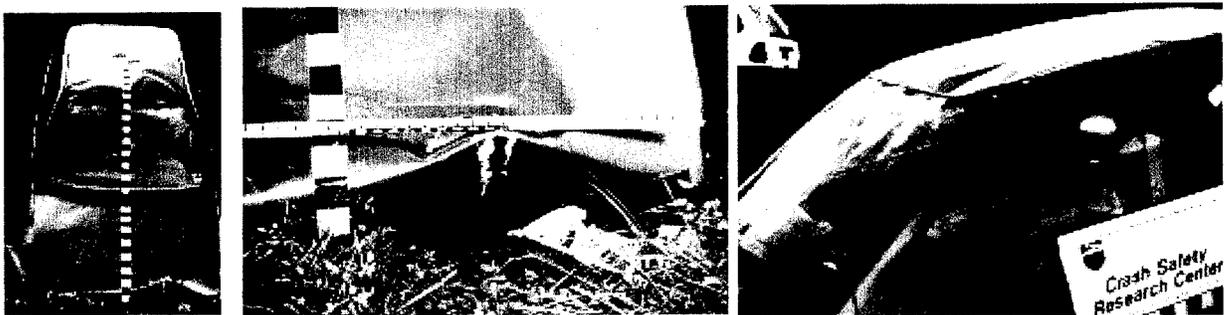
Figure 13. Damage to the test vehicle as a result of the head-on test.

During the head-on collision (crash test #1), the barricade rotated toward the vehicle upon impact, with the upper sign impacting the roof of the vehicle causing a small dent that is consistent with contact by the bolt used to mount the warning light on the top of the barricade. As shown in *Figure 13*, some damage occurred to the windshield of the car but there was no penetration of the passenger compartment and good visibility was maintained through the windshield. The impact of the vertical post caused a dent in the front of the hood of the vehicle.

Upon impact, the barricade rotated toward the vehicle with the upper sign impacting the roof of the vehicle. There is a small dent on the roof of the vehicle to the left of center that is consistent with contact by the bolt, which was used to mount the warning light on the top of the barricade.

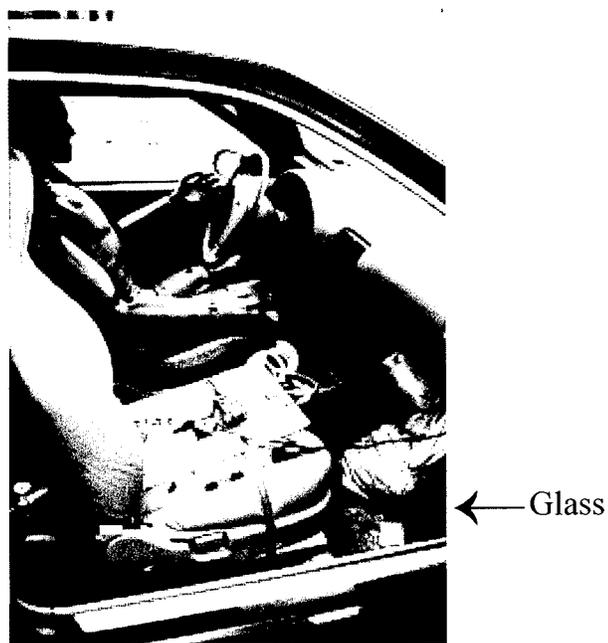
Figure 15. Pieces of glass inside the passenger compartment after the edge-impact test.

The impact with the test article did not result in damage that would cause risk to the passengers in the vehicle in either of the tests. There was no penetration of test article debris into the passenger compartment. The windshield was damaged; however, it was not breached and provided adequate visibility after impact. In the head-on collision (test #1), the plastic rails rested on the windshield for a short period of time before sliding off to the side. Small pieces of glass were found inside the passenger compartment after the edge-impact test (test #2); however, this was not considered a significant risk to occupants.
