RESEARCH PROJECT NO. 86-001

**Geogrid Mesh For Reflective Crack Control In
Bituminous Concrete Overlays**

**FINAL REPORT
JULY 2000**

SITE A
SR 0073, Gilbertsville, Montgomery County
Engineering District 6-0

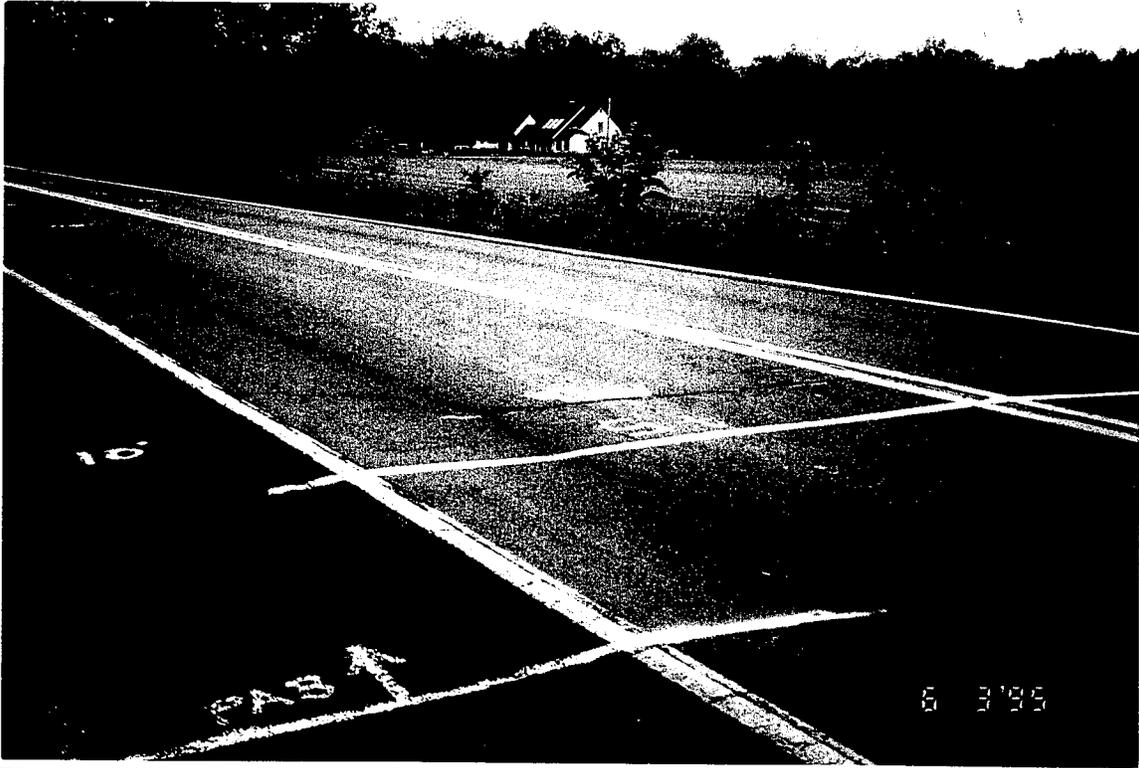
Photograph - 1, Segment 0070/0990, 9 foot crack edgeline toward centerline

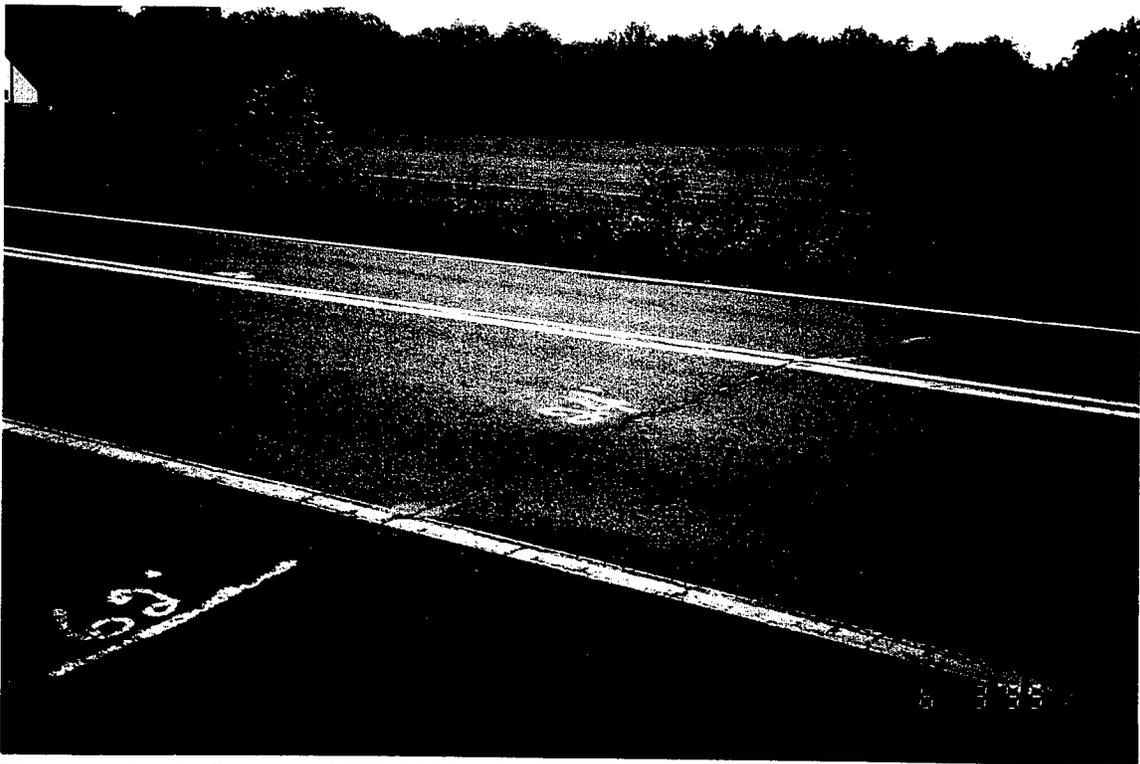
Photograph - 2, Segment 0070/0938, edgeline to edgeline 24 foot crack

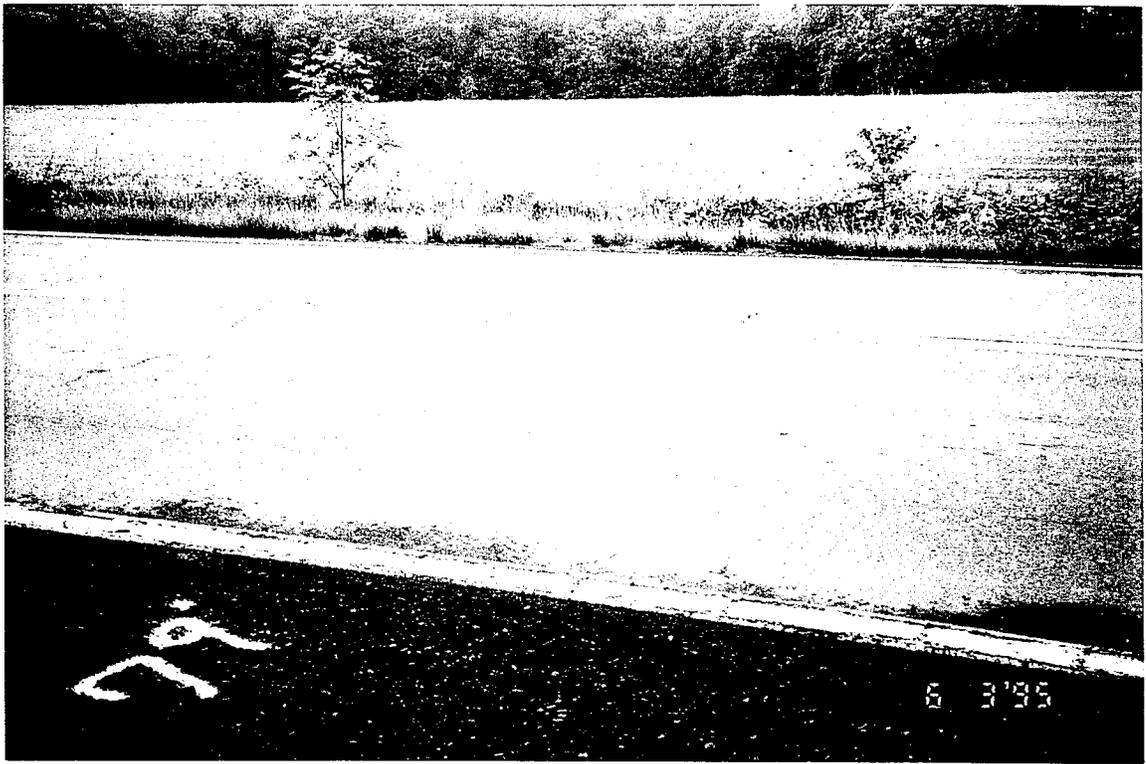
Photograph - 3, Segment 0070/0921, 2 foot crack 12 feet from the edgeline

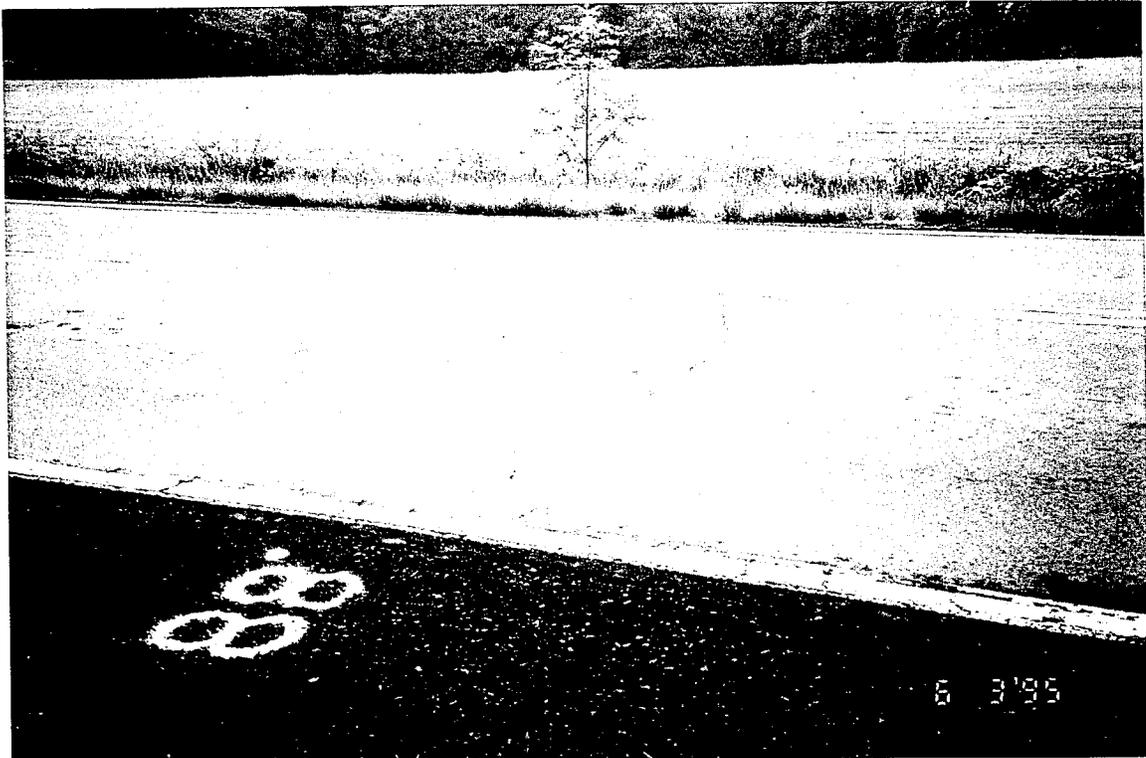
Photograph - 4, Section, 0070/0912, 12 feet long, from the edgeline to the double yellow line.

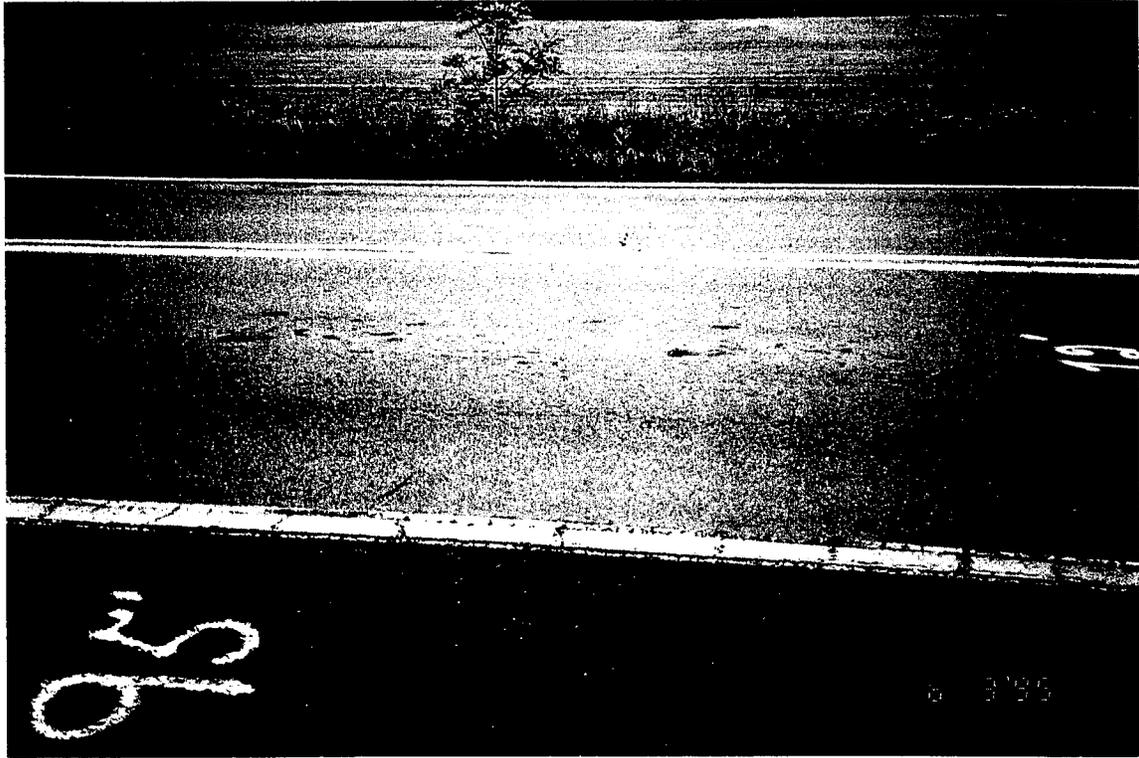
Photograph - 5, Segment 0070/0905, 10 foot crack from the double yellow line to 2 feet from the edgeline.

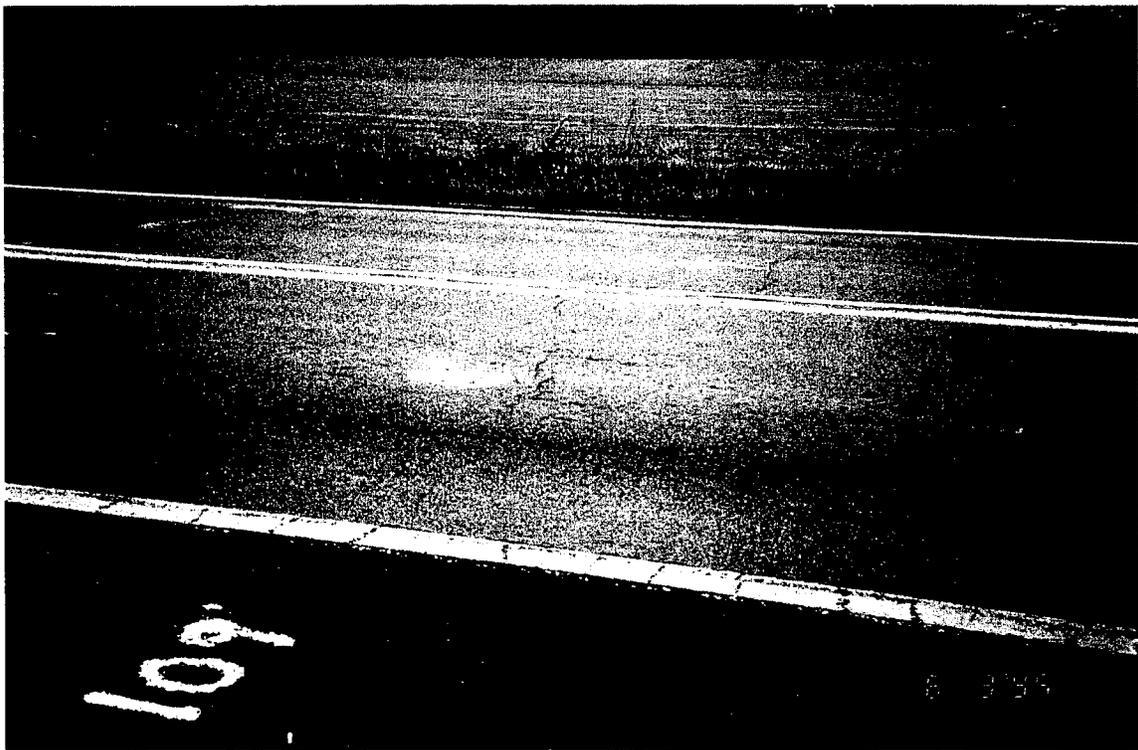
Photograph - 6, Segment 0070/0891, 15 foot crack, starting 3 feet from the eastbound edgeline.

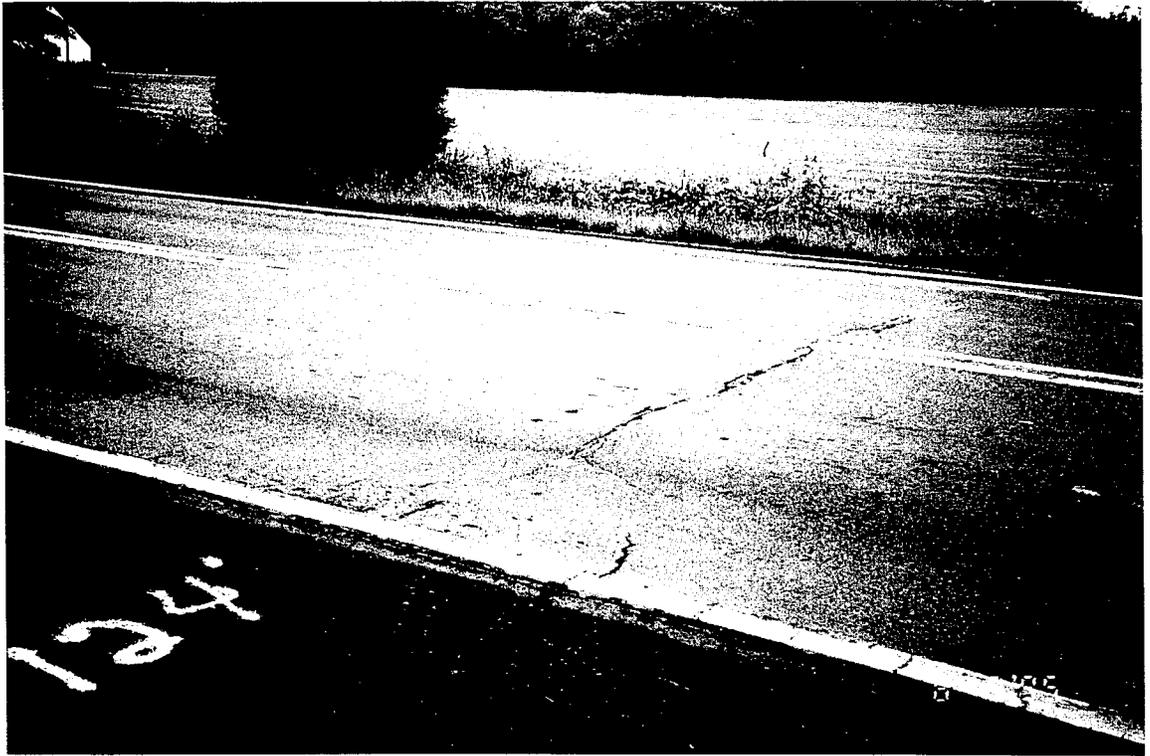
Photograph - 7, Segment 0070/0876, 20-foot crack, that starts 2 feet from the east bound edgeline.

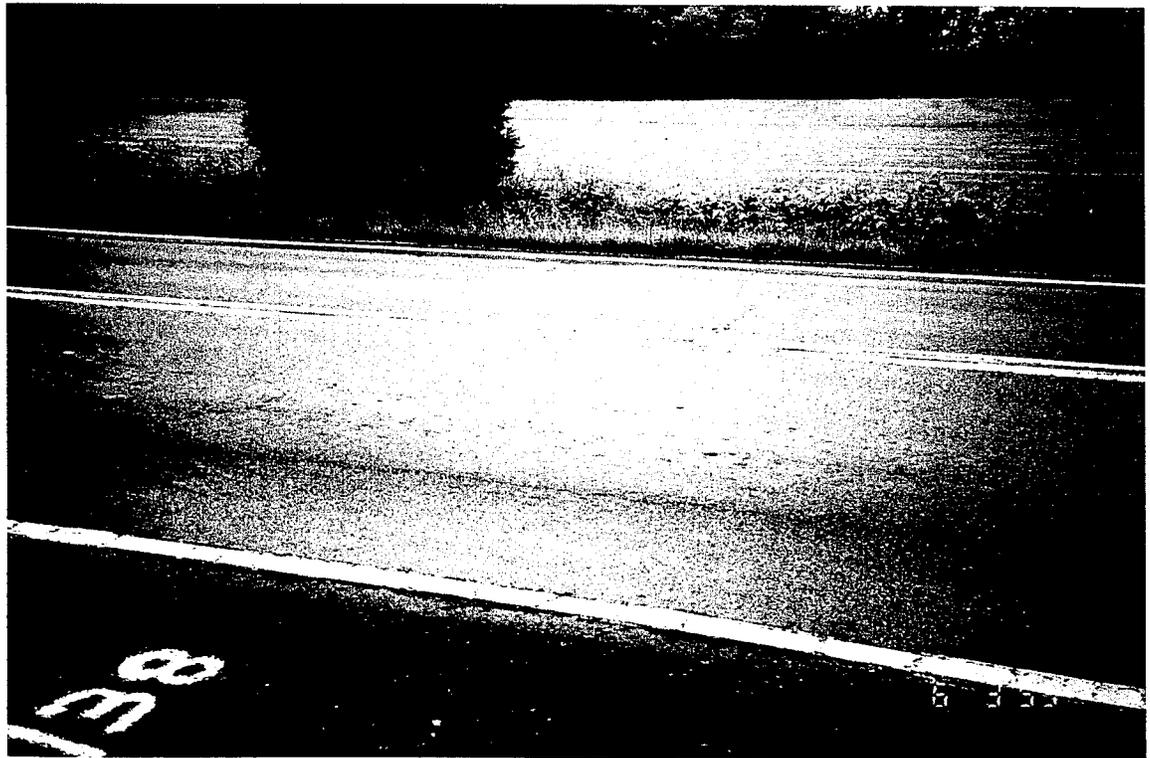
Photograph - 8, Segment 0070/0862, 10 foot crack, 12 feet from the east bound edgeline.

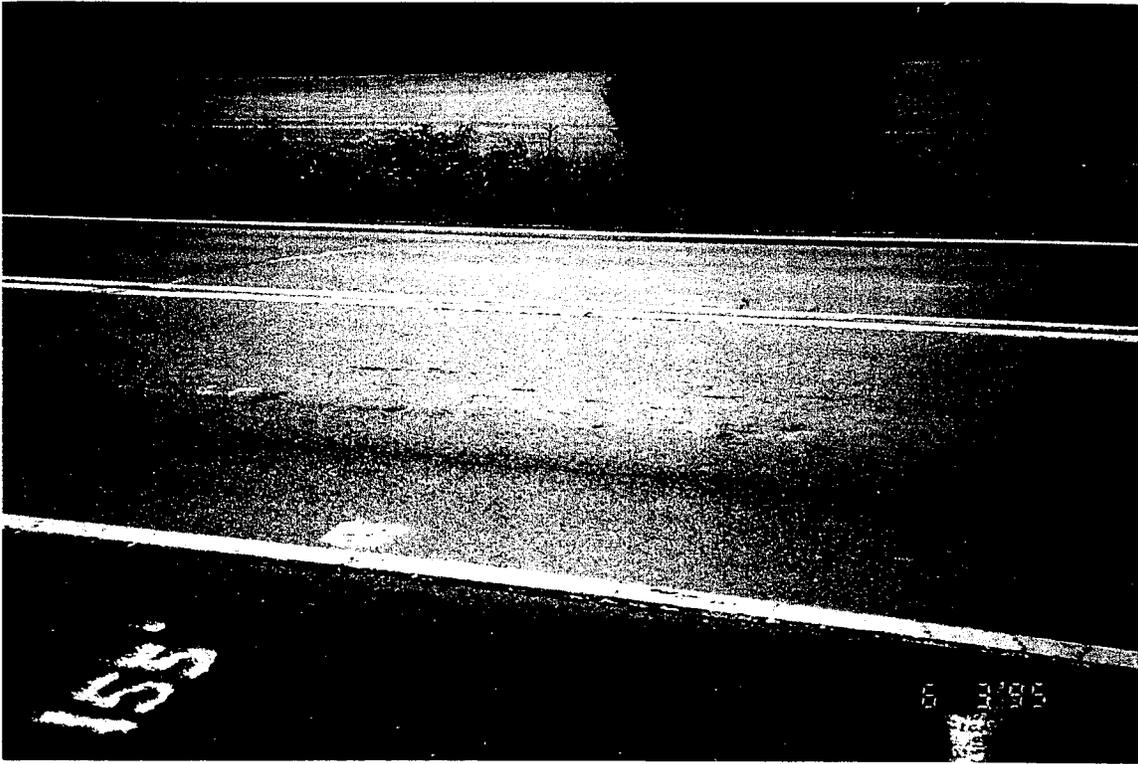
Photograph - 9, Segment 0070/0845, 1 foot crack, 12 feet from the east bound edgeline.

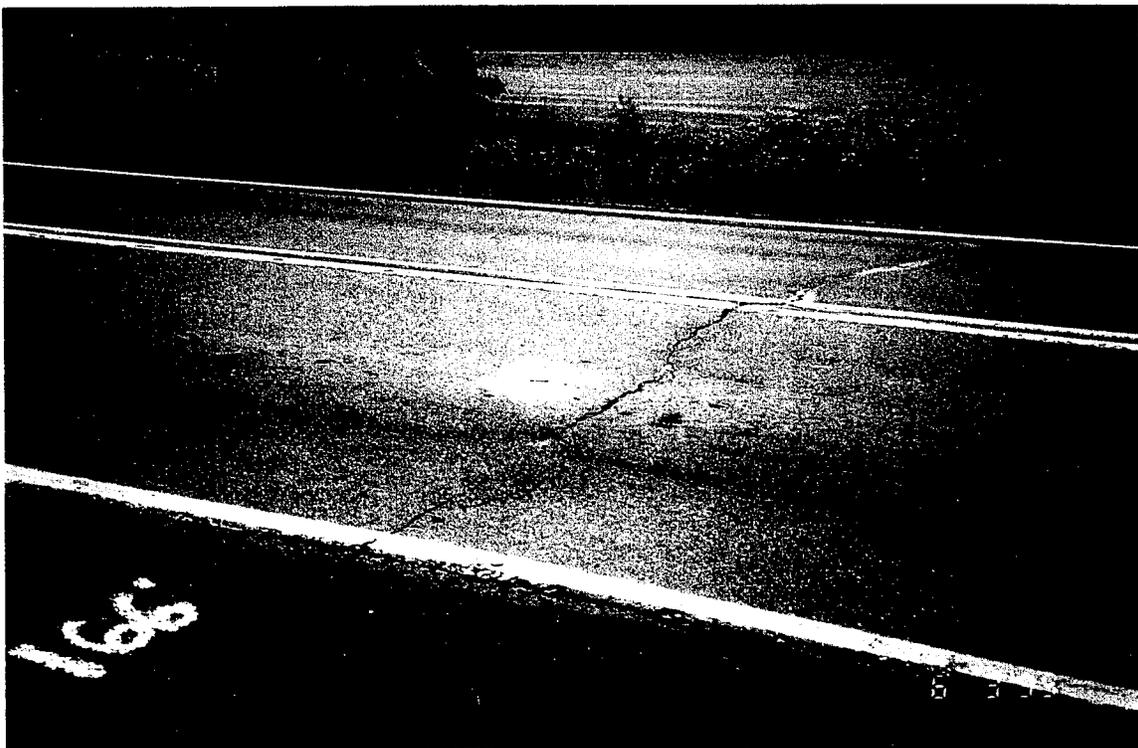
Photograph - 10, Segment 0070/0834, 22-foot crack, starting at the east bound edgeline.

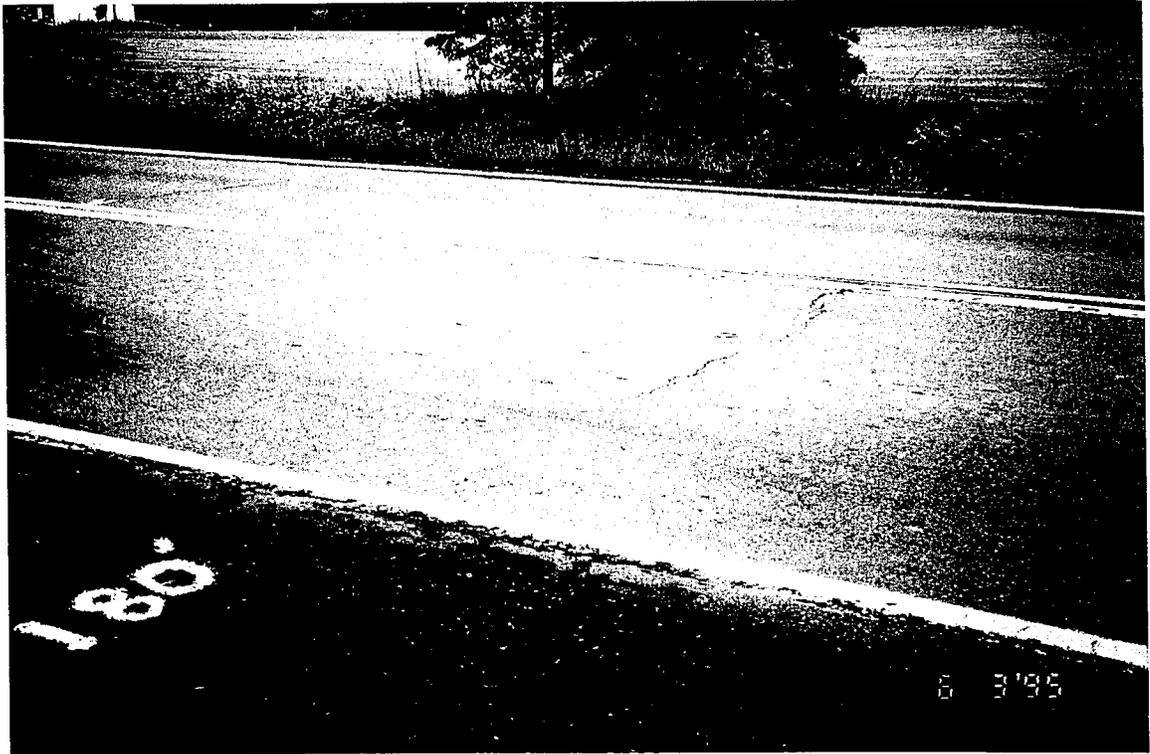
Photograph - 11, Segment 0070/0820, 8-foot crack, starting 4 feet from the east bound edgeline.

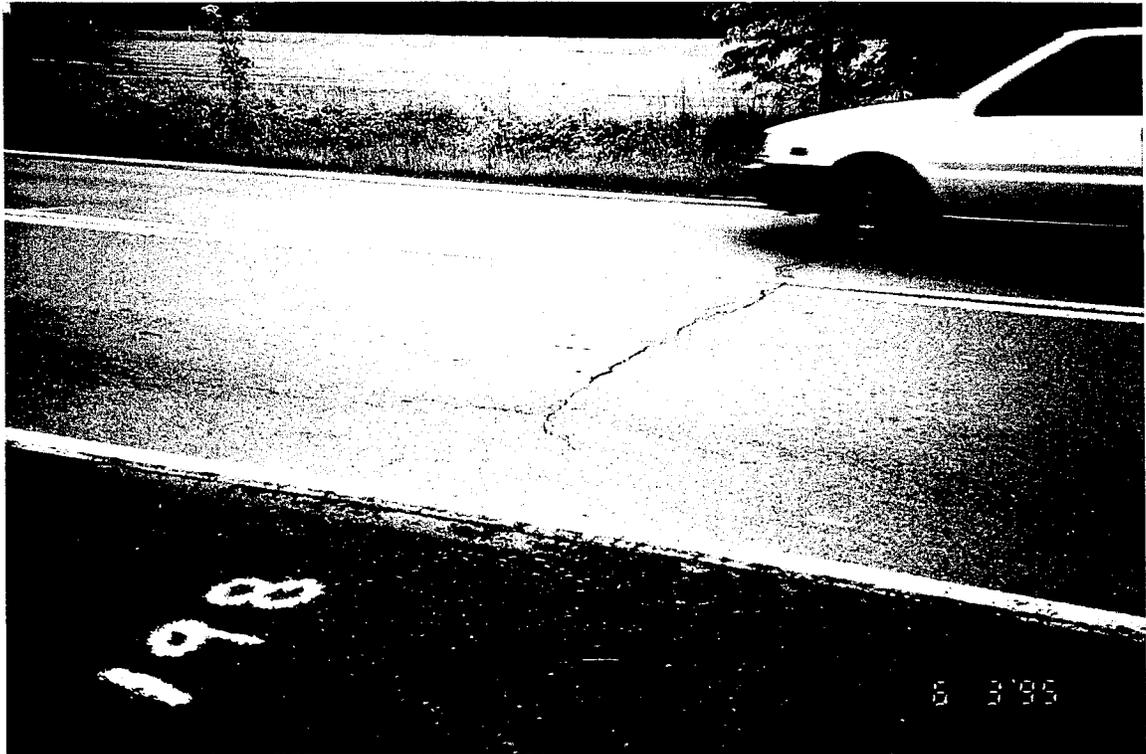
Photograph - 12, Segment 0070/0802, 18-foot crack, 3 feet from the east bound edgeline.

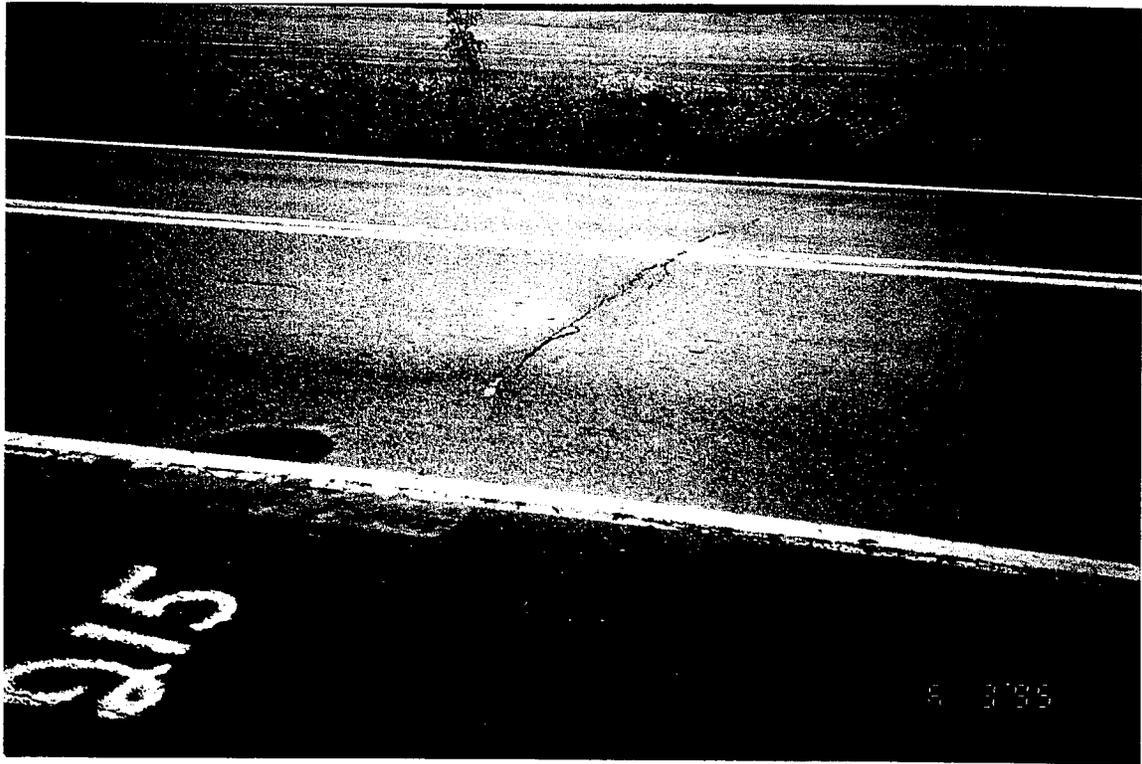
Photograph - 13, Segment 0070/0785, 18-foot crack, 3 feet from the east bound edgeline.

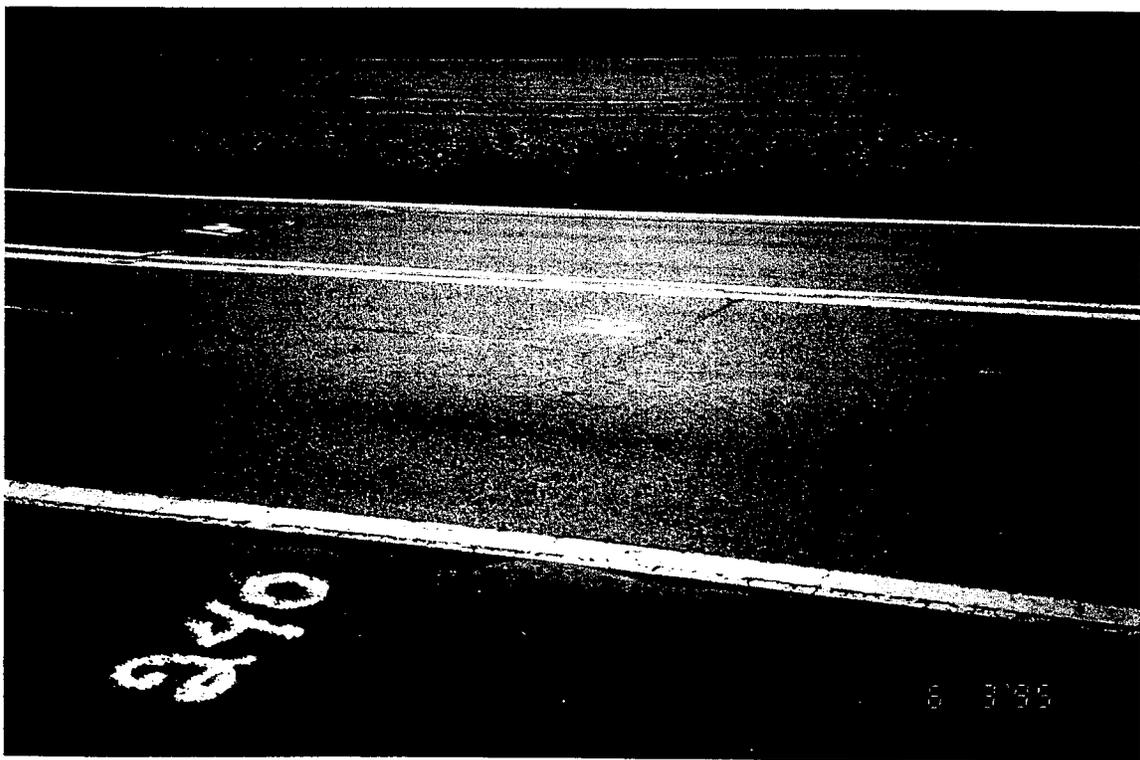
Photograph - 14, Segment 0070/0760, 10-foot crack, 4 feet from the east bound edgeline

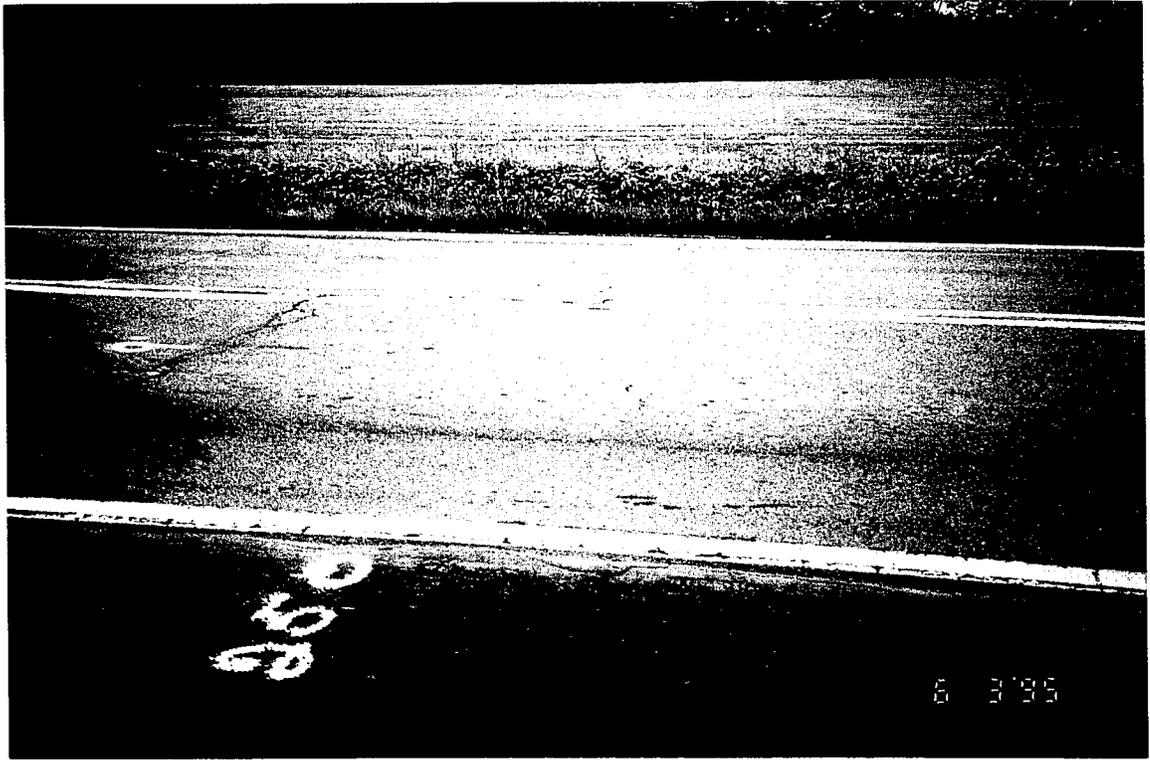
Photograph - 15, Segment 0070/0750, 12-foot crack, 12 feet from the east bound edgeline

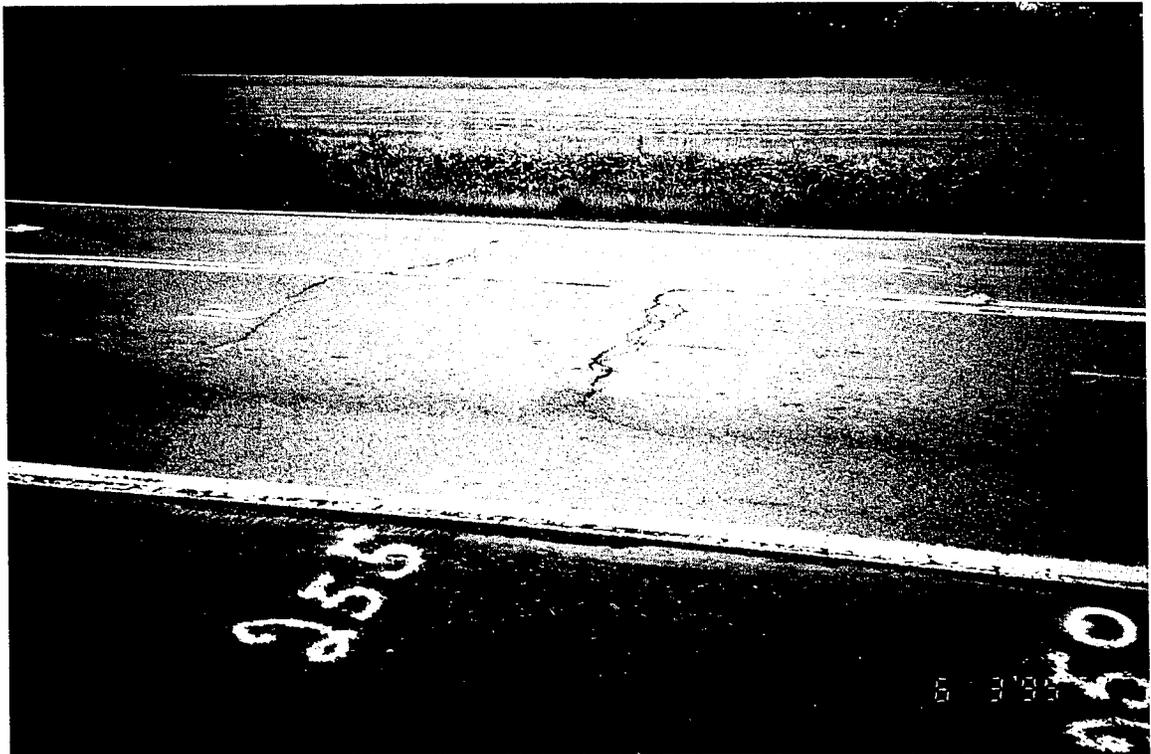
Photograph - 16, Segment 0070/0745, 9-foot crack, 3 feet from the east bound edgeline.

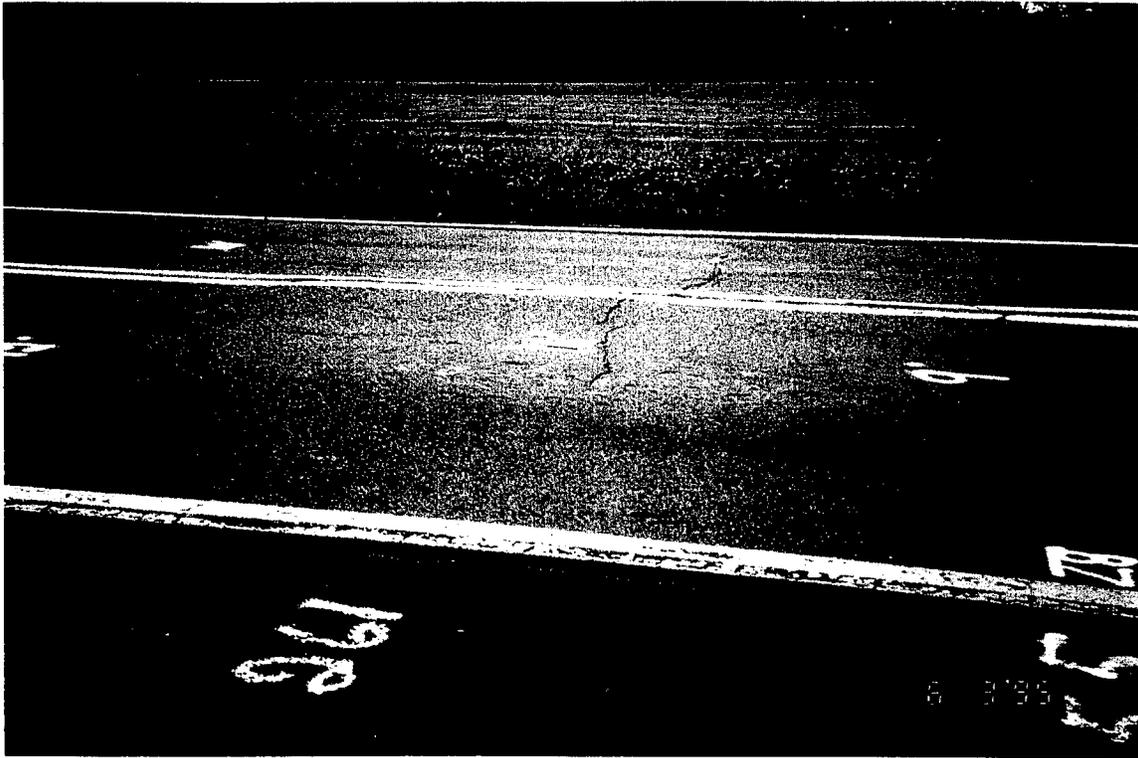
Photograph - 17, Segment 0070/0739, 16-foot crack, 5 feet from the east bound edgeline.

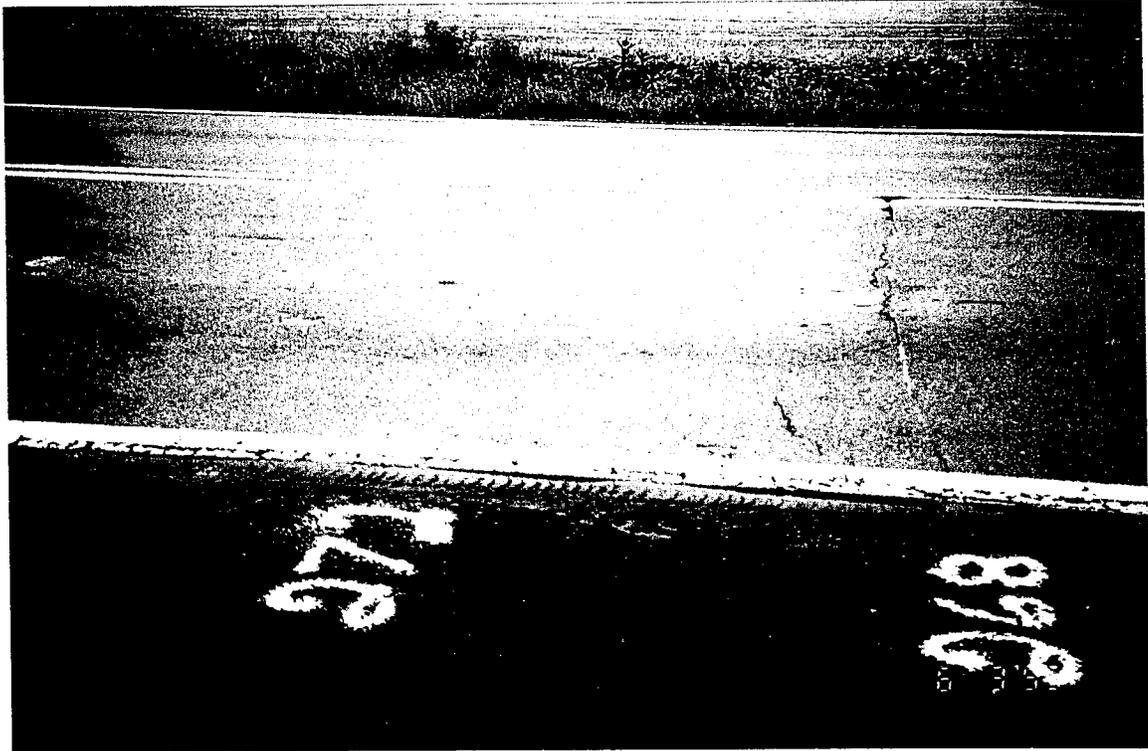
Photograph - 19, Segment 0070/0728, 10-foot crack, 12 feet from the east bound edgeline.

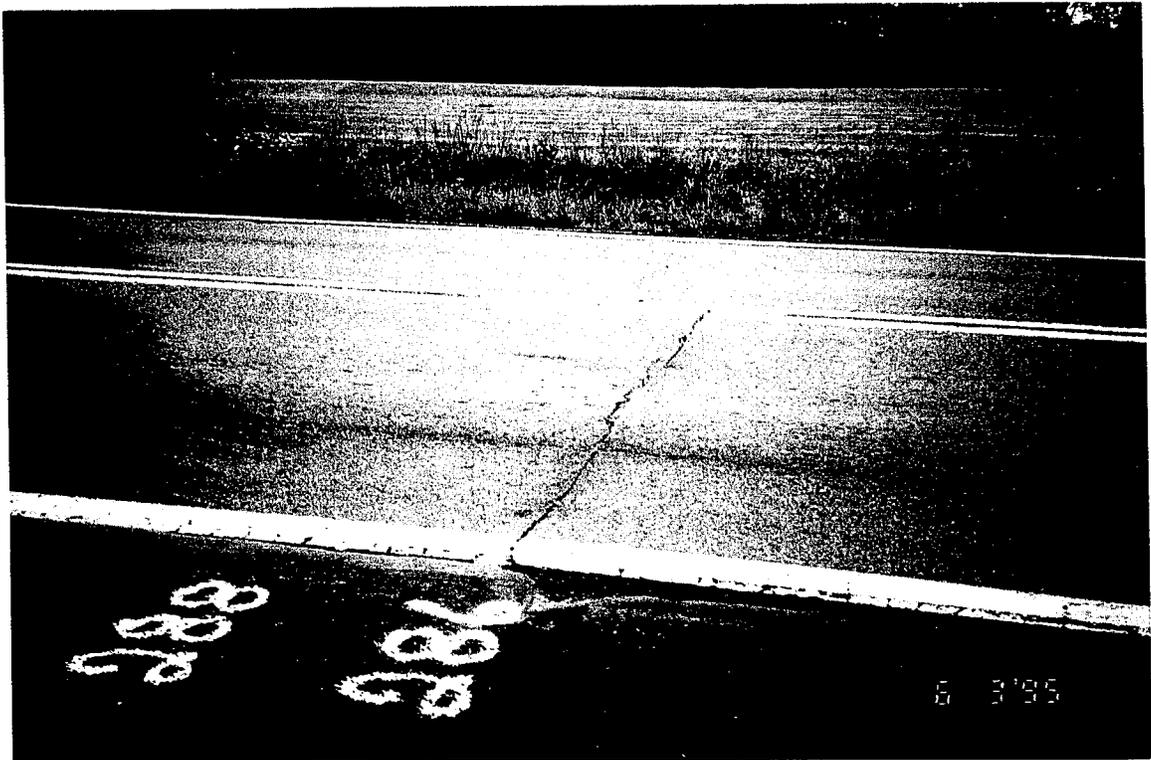
Photograph - 20, Segment 0070/0714, 12-foot crack, starting at the east bound edgeline.
Segment 0070/0712, 10-foot crack, 12 feet from the east bound edgeline.

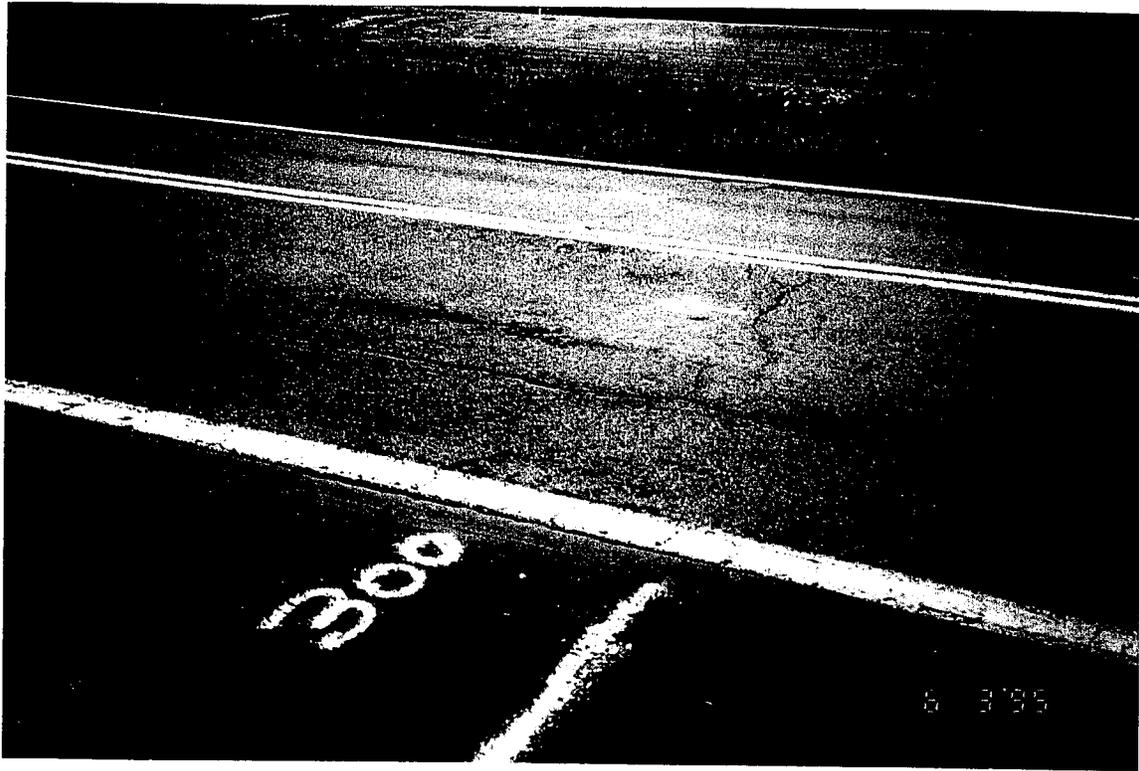
Photograph - 21, Segment 0070/0700, 9-foot crack, 8 feet from the east bound edgeline.

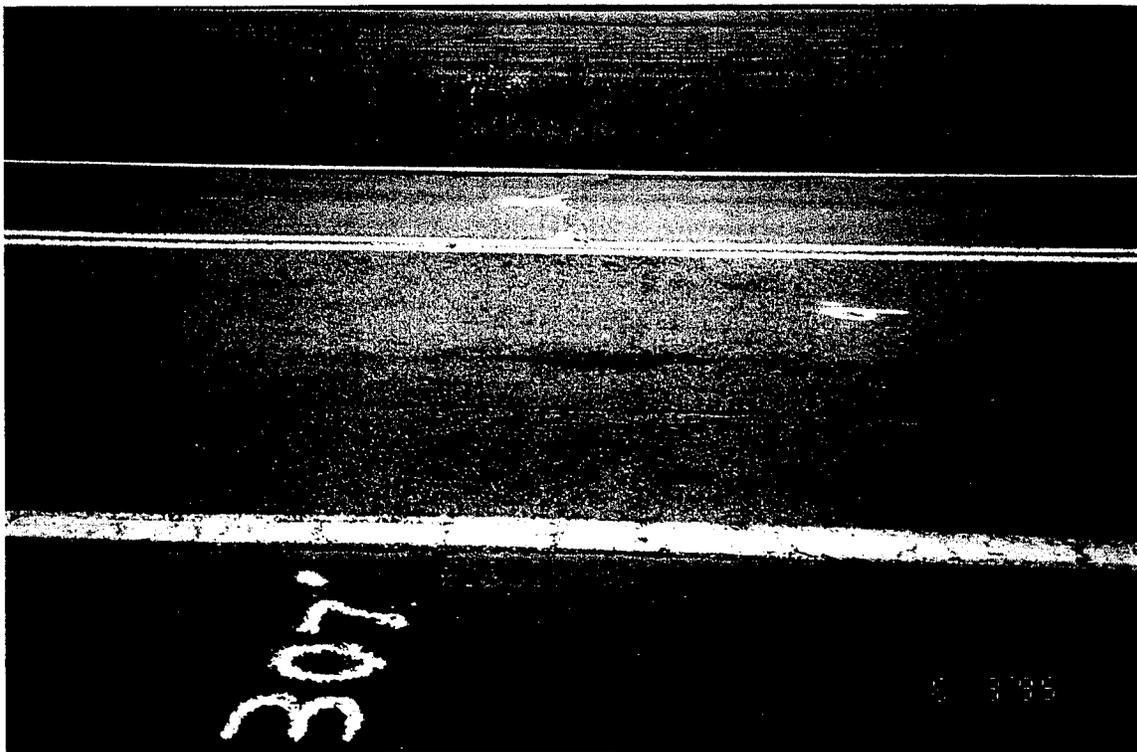
Photograph - 22, Segment 0070/0693, 12-foot crack, from the double yellow line toward the edgeline.

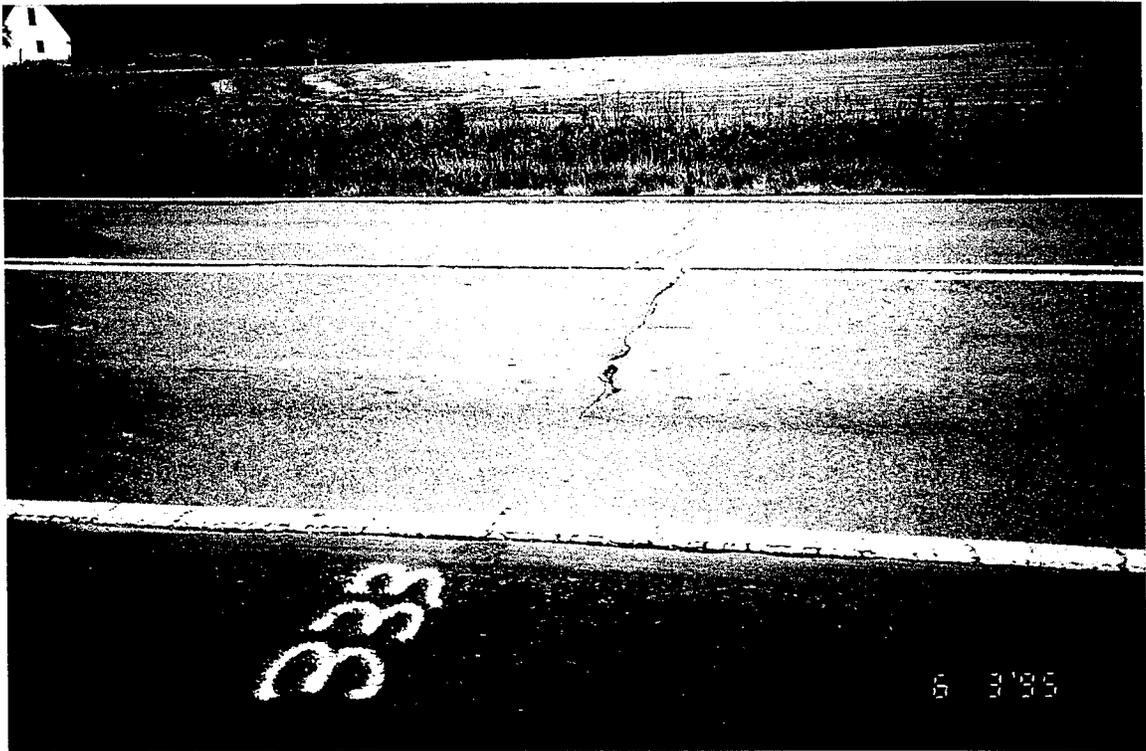
Photograph - 23, Segment 0070/0667, 21-foot crack, 3 feet from the east bound edgeline.

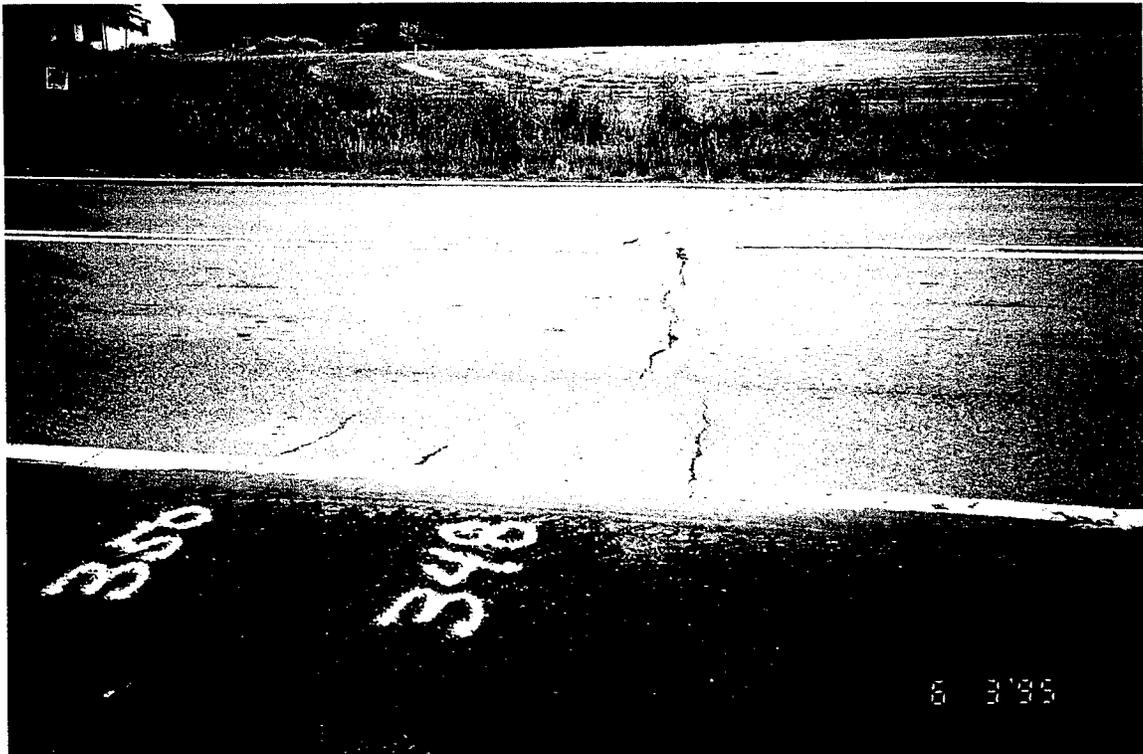
Photograph - 24, Segment 0070/0652, 22-foot crack, starting at the east bound edgeline.
Segment 0070/0652, 2-foot crack, starting at the eastbound edgeline.

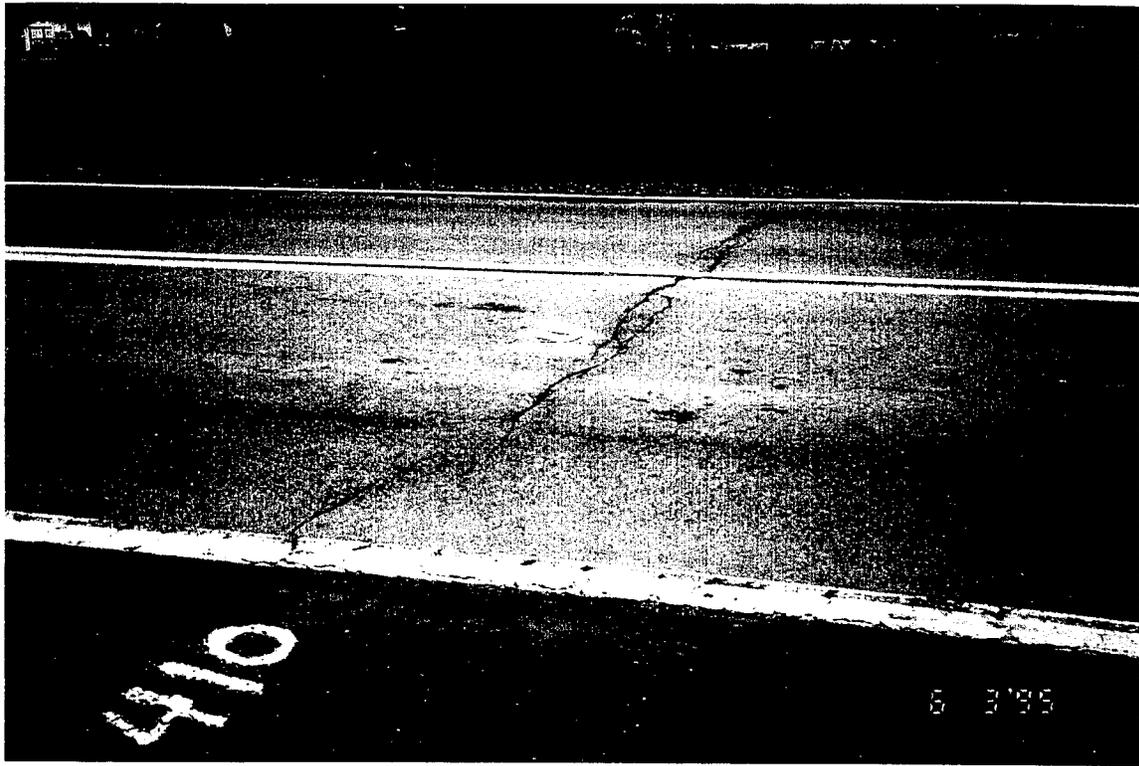
Photograph - 25, Segment 0070/0590, 24-foot crack, edgeline to edgeline.

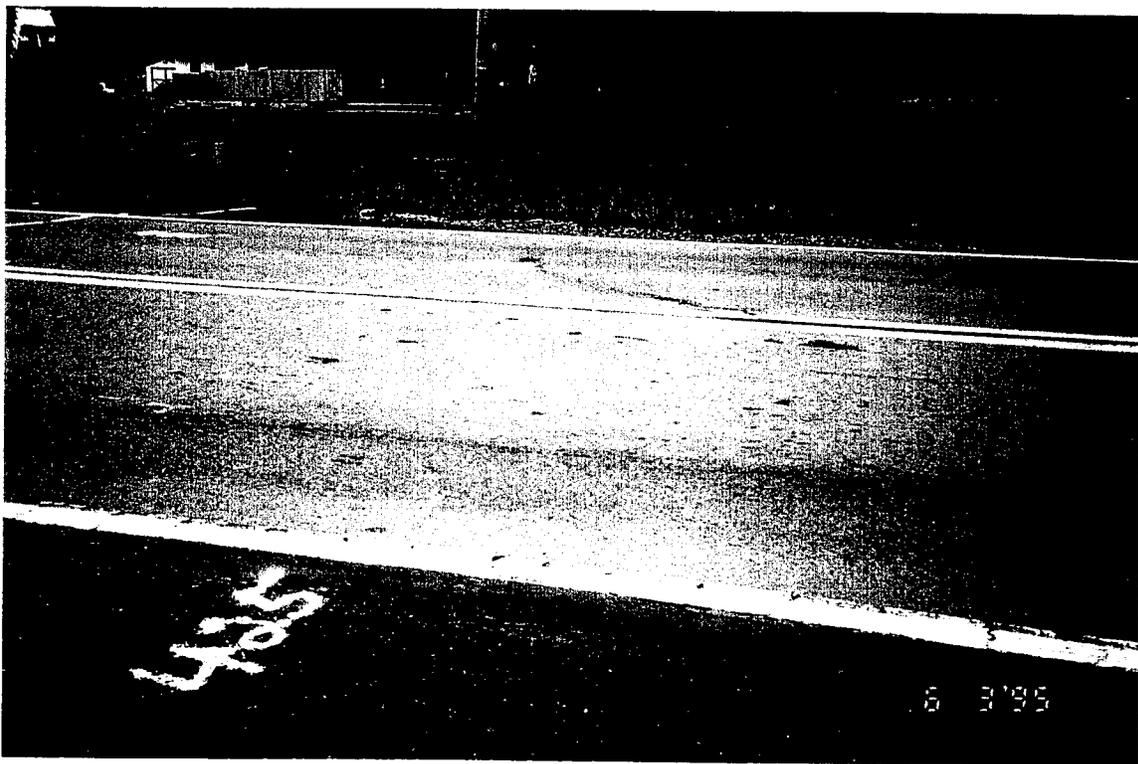
Photograph - 26, Segment 0070/0575, 12-foot crack, 12 feet from the east bound edgeline.

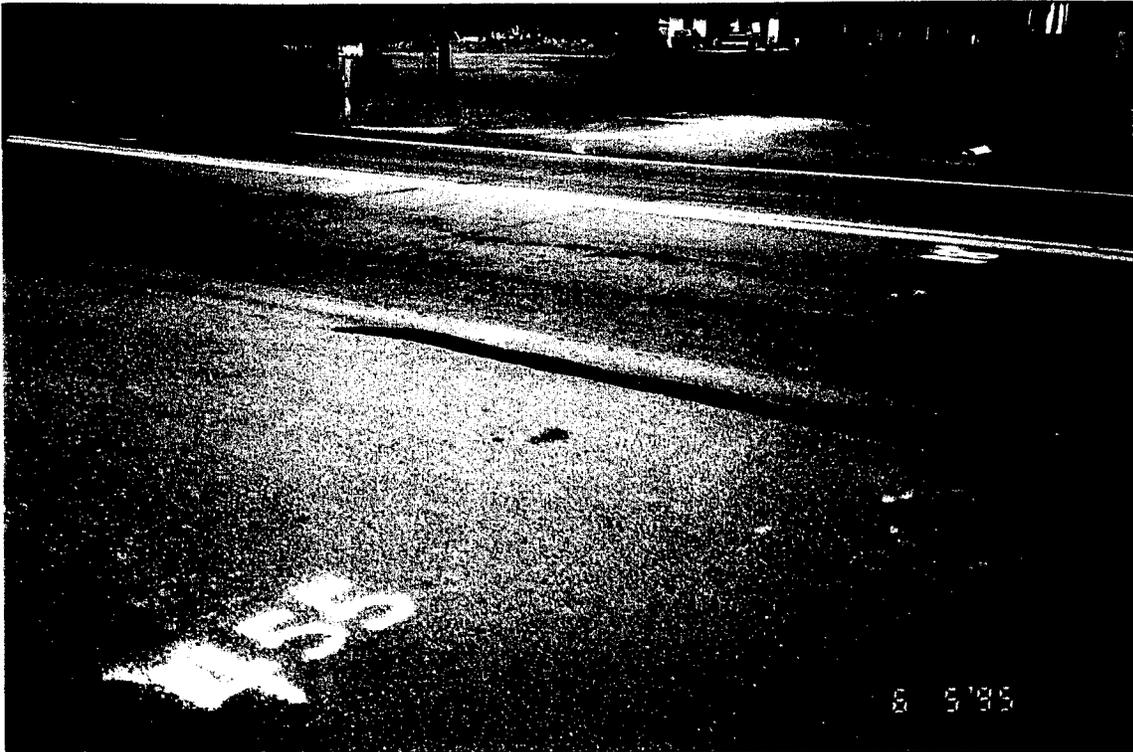
Photograph - 28, Segment 0070/0545, 18-foot crack, 4 feet from the east bound edgeline.
