RESEARCH PROJECT NO. 86-001

**Geogrid Mesh For Reflective Crack Control In
Bituminous Concrete Overlays**

**FINAL REPORT
JULY 2000**

SITE A
SR 0073, Gilbertsville, Montgomery County
Engineering District 6-0

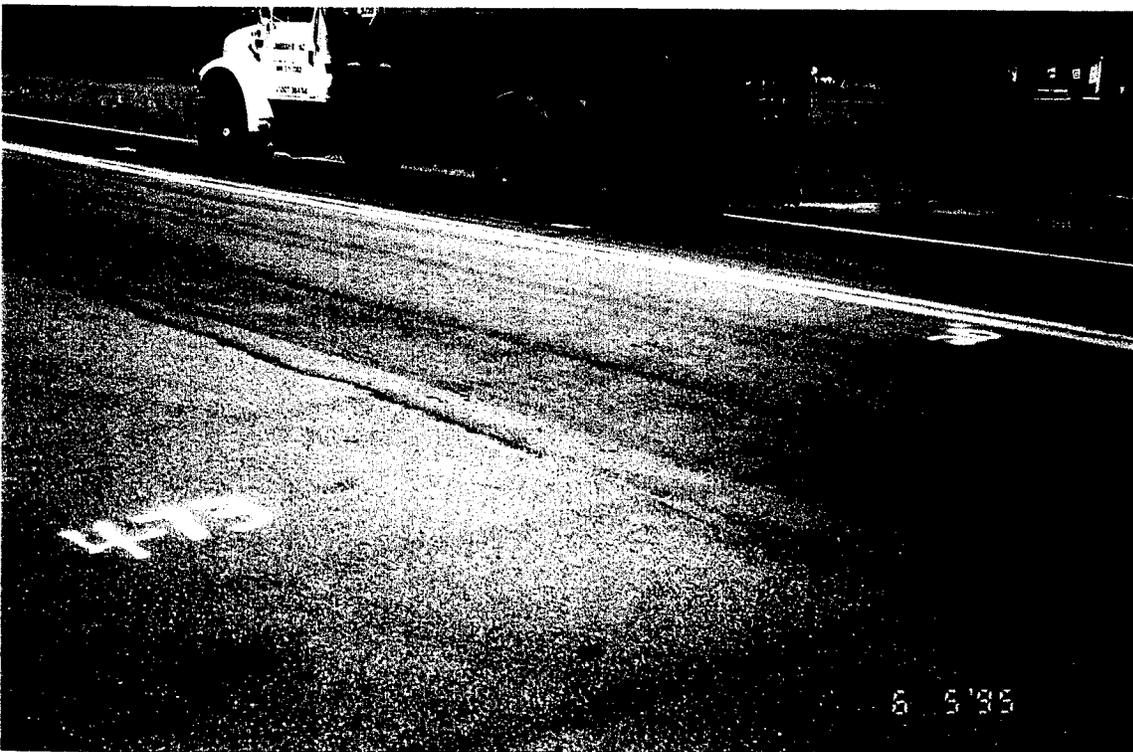
Photograph - 29, Segment 0070/0527, 20-foot crack, 4 feet from the east bound edgeline.

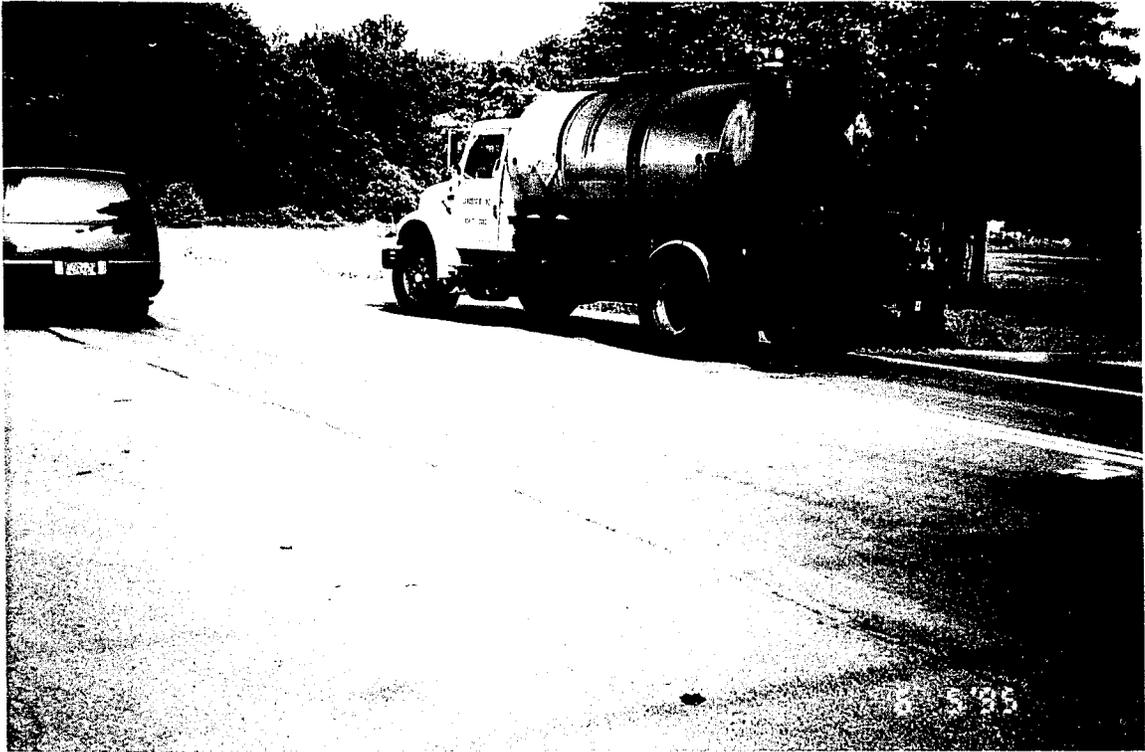
Photograph - 30, Segment 0070/0543, 10-foot crack, 12 feet from the east bound edgeline.

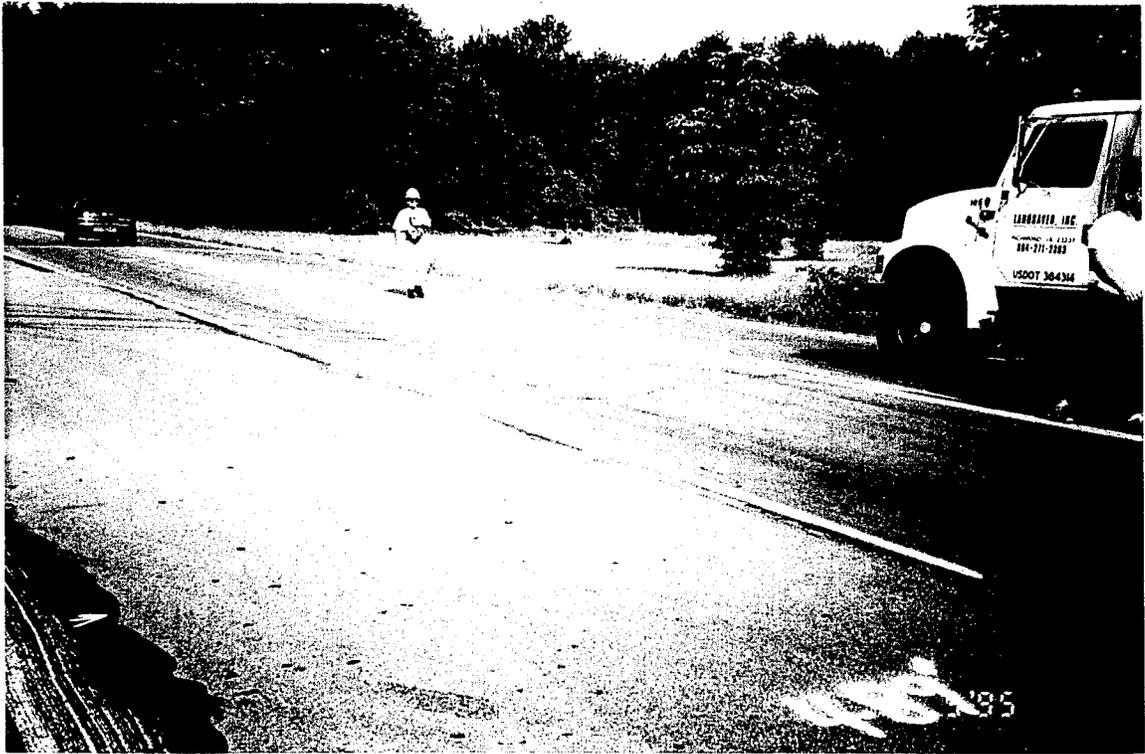
Photograph - 31, Segment 0070/0522, 8-foot crack 3 feet from the east bound edgeline.

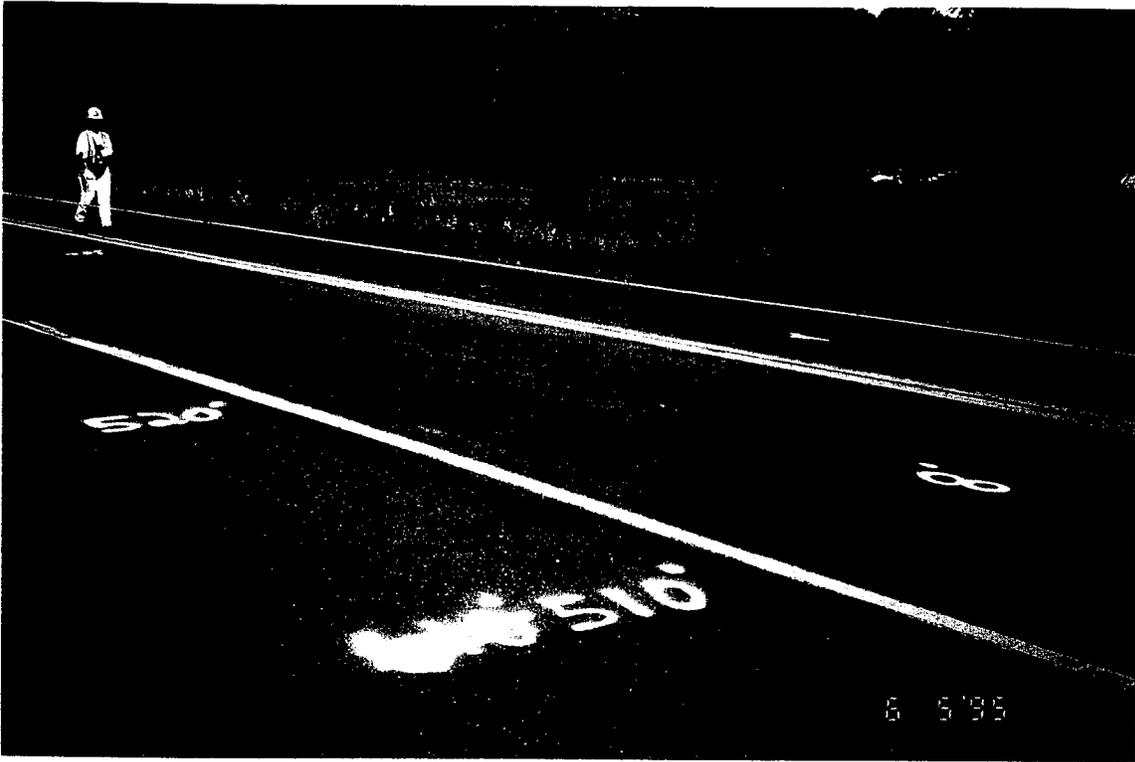
Photograph - 32, Segment 0070/0522, 8-foot crack, 3 feet from the east bound edgeline.

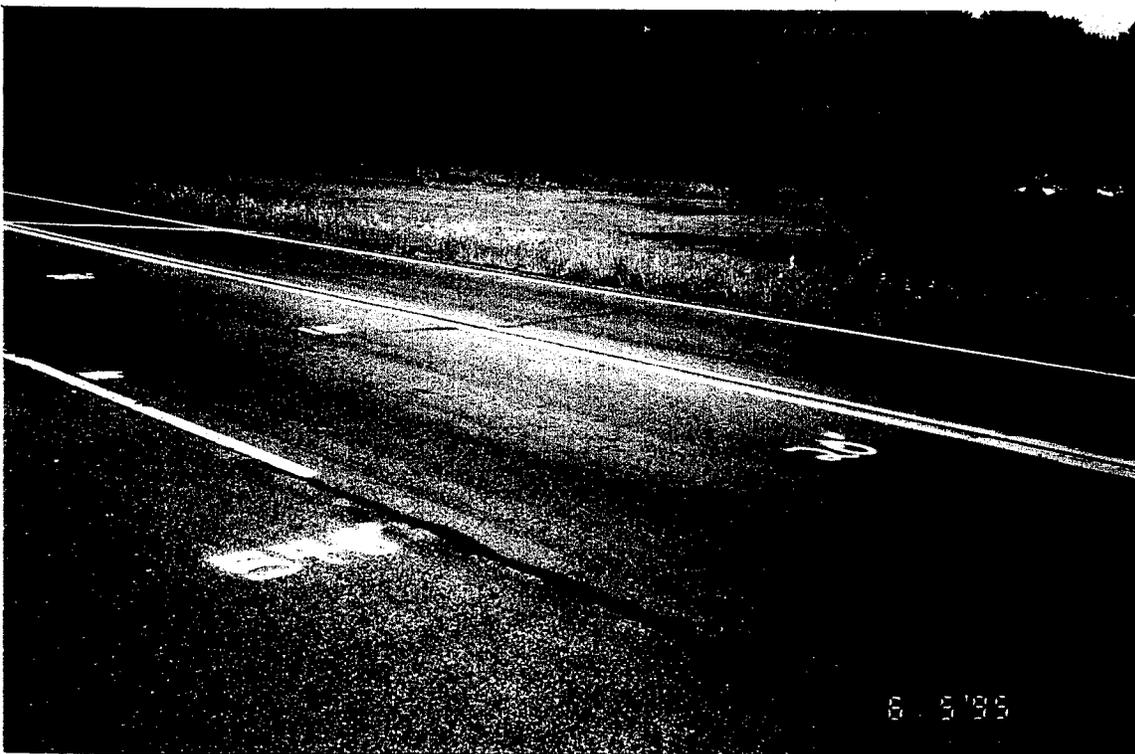
Photograph - 33, Segment 0070/0484, 20 foot crack, 4 feet from the east bound edgeline.

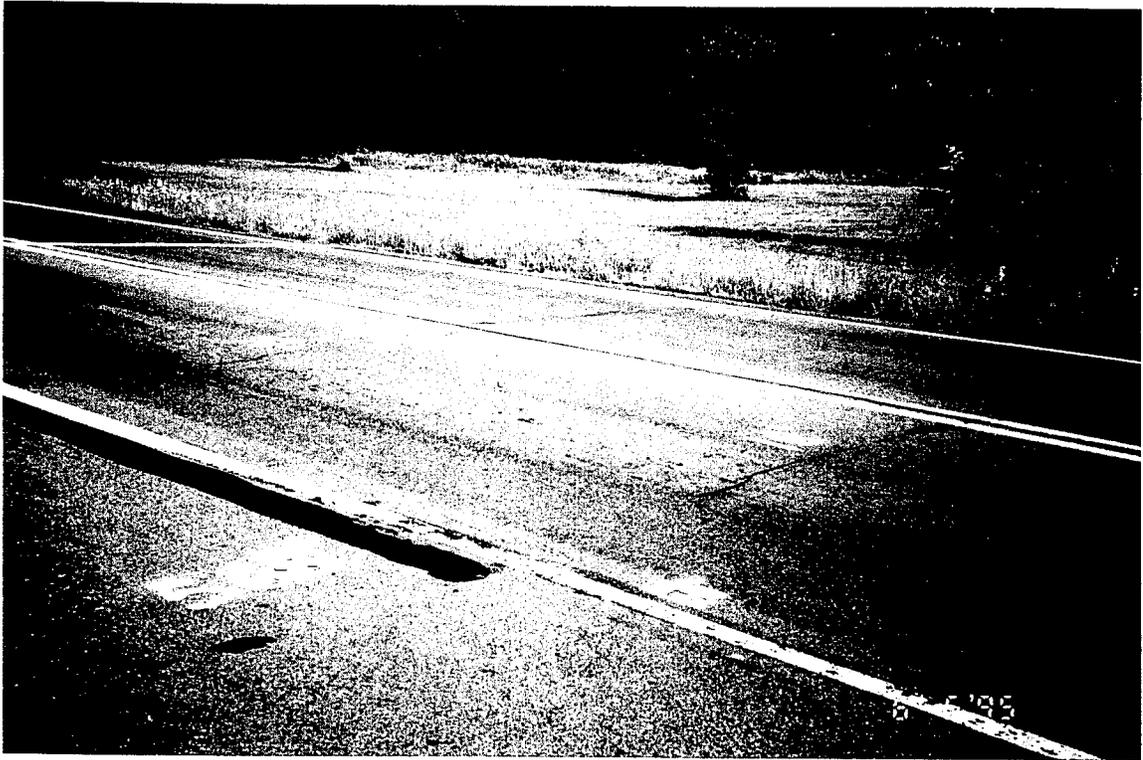
Photograph - 34, Segment 0070/0467, 18-foot crack, 4 feet from the east bound edgeline.

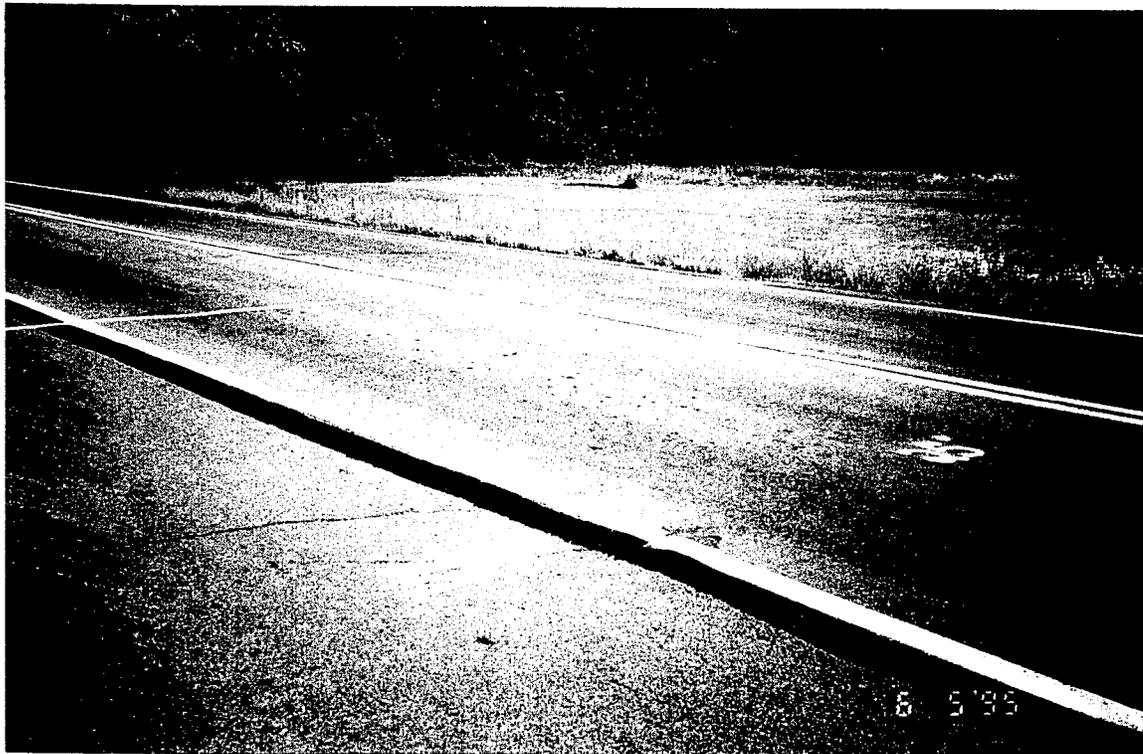
Photograph - 35, Segment 0070/0454, 25-foot crack, edgeline to edgeline.

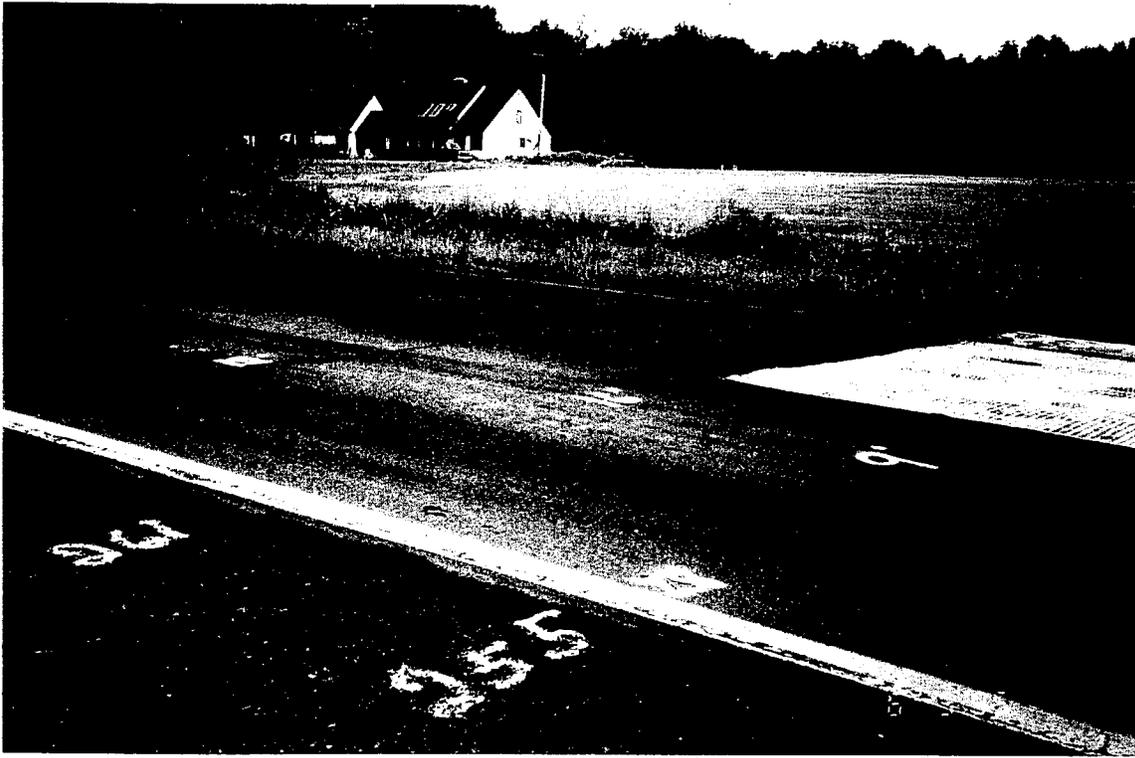
Photograph - 40, Note the amount of Bit-U-Tex overlap onto the Petromat.

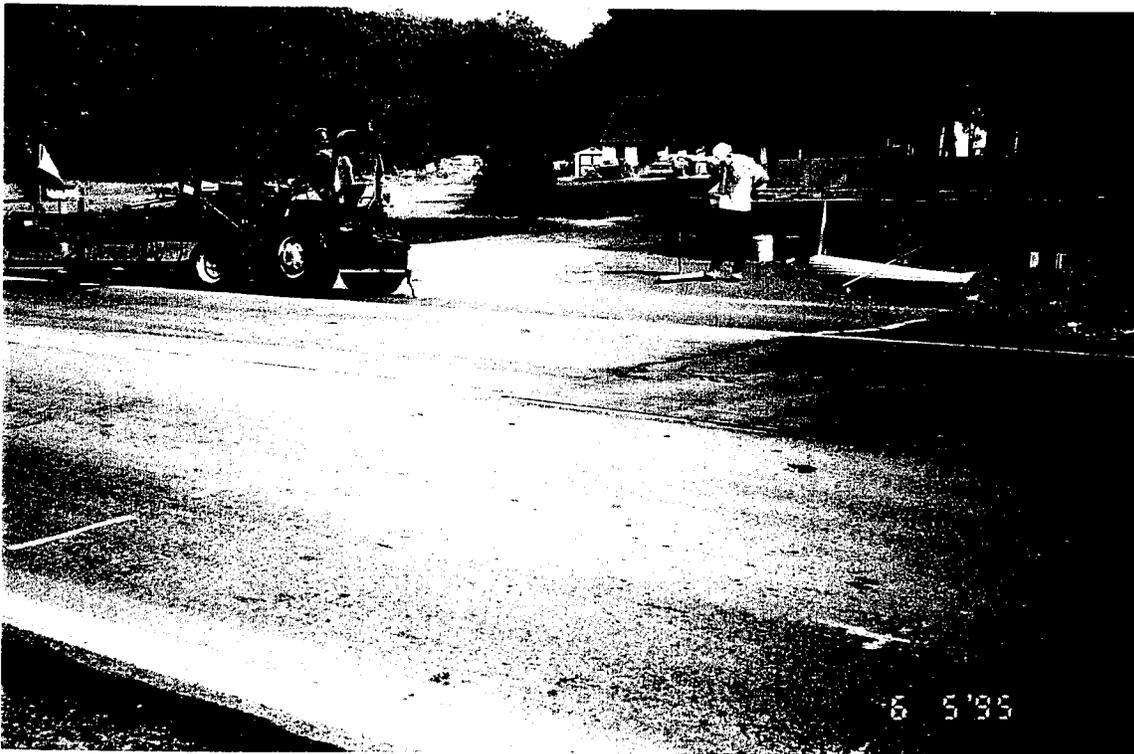
The Petromat test section was installed adjacent to the Bit-U-Tex without incident but was being picked up by the tires on triaxle dump trucks as the trucks were unloading ID-2 into the hopper on the paver (see photograph 41). The paver even picked up the Petromat at each of the overlapped seams during placement of the ID-2 bituminous wearing course. The fabric was being pulled off the AC-20 tack coat by the rubber-tired equipment. The high air temperature did not allow the AC-20 to harden sufficiently prior to placing the bituminous wearing. The first phase of construction on the test sections was done during the cool of the morning. This allowed the AC-20 to cool and become tacky enough to hold down the fabric. The afternoon phase of operations did not have the optimum field temperature to allow the material to be placed without experiencing some problems.

Photograph - 41, Petromat sticking to the dump truck tires.

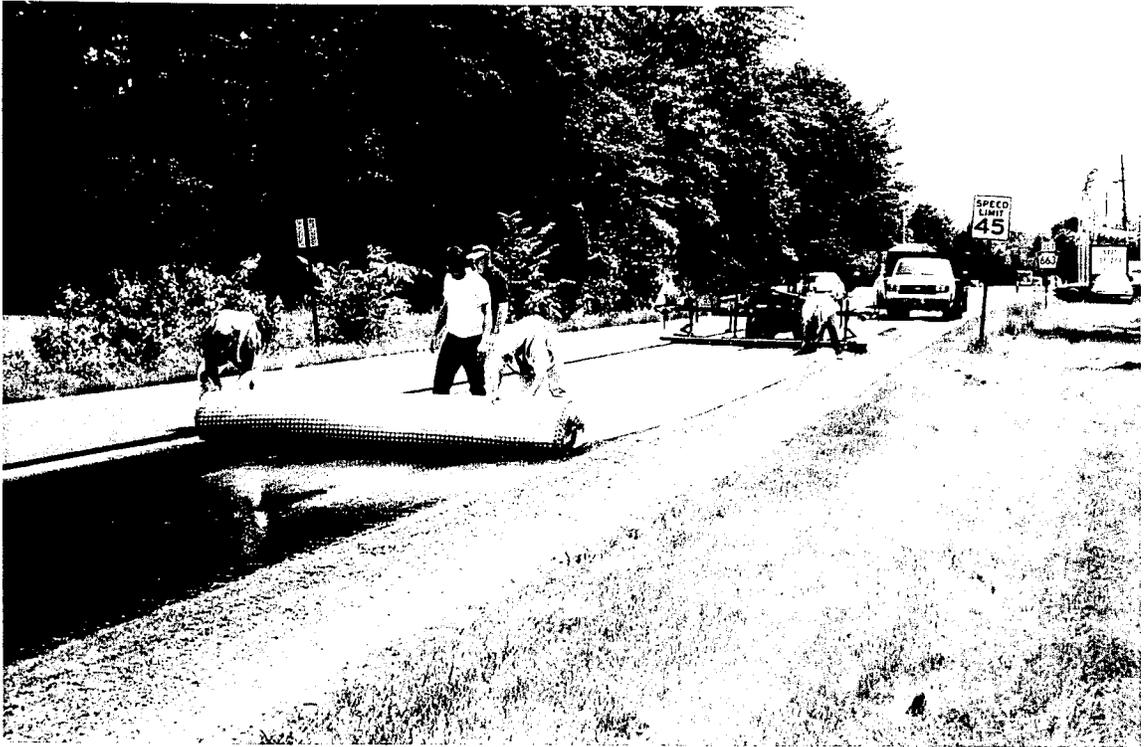
The Bit-U-Tex and Petromat test sections were installed in two phases. The west bound lane materials were placed, then paved over with a 1½ inch thick layer of bituminous ID-2 wearing and compacted to the specified density. There were no problems evident during this phase of construction. The second phase of construction in the eastbound lane, however, experienced some problems. The core tube in the roll of Bit-U-Tex disintegrated during placement of the west bound lane. This resulted in the remainder of the roll being placed manually and unevenly in some areas (see photographs 42 and 47).

Photograph - 42, Contractor had to place second pass by hand with grid facing down.

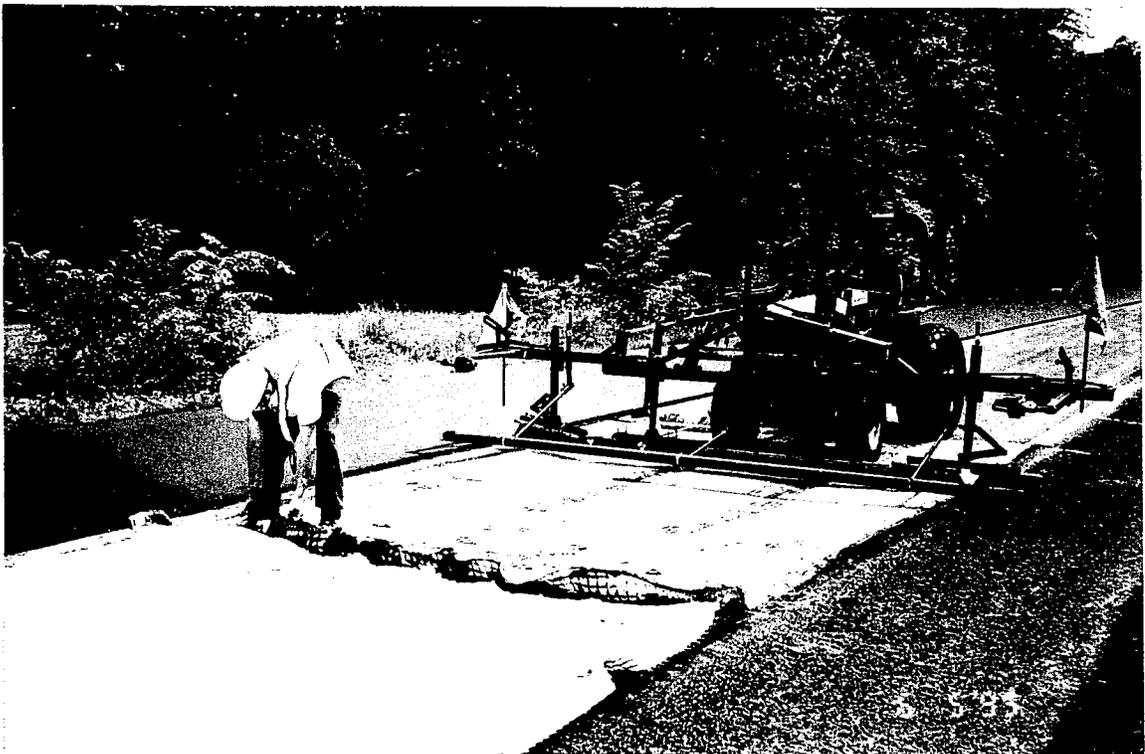
Photograph - 43, Note the grid is falling down and there are wrinkles in the fabric.

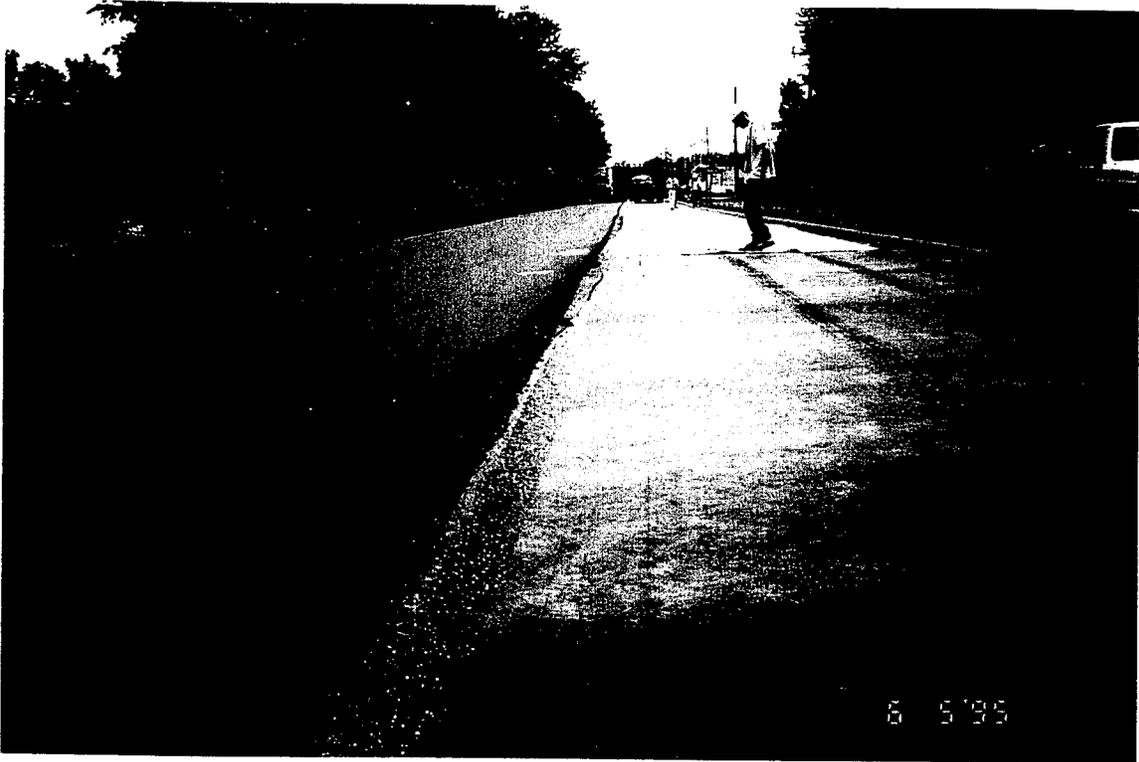
Photograph - 44, Note that there is no overlap from east bound to westbound and AC-20 is showing

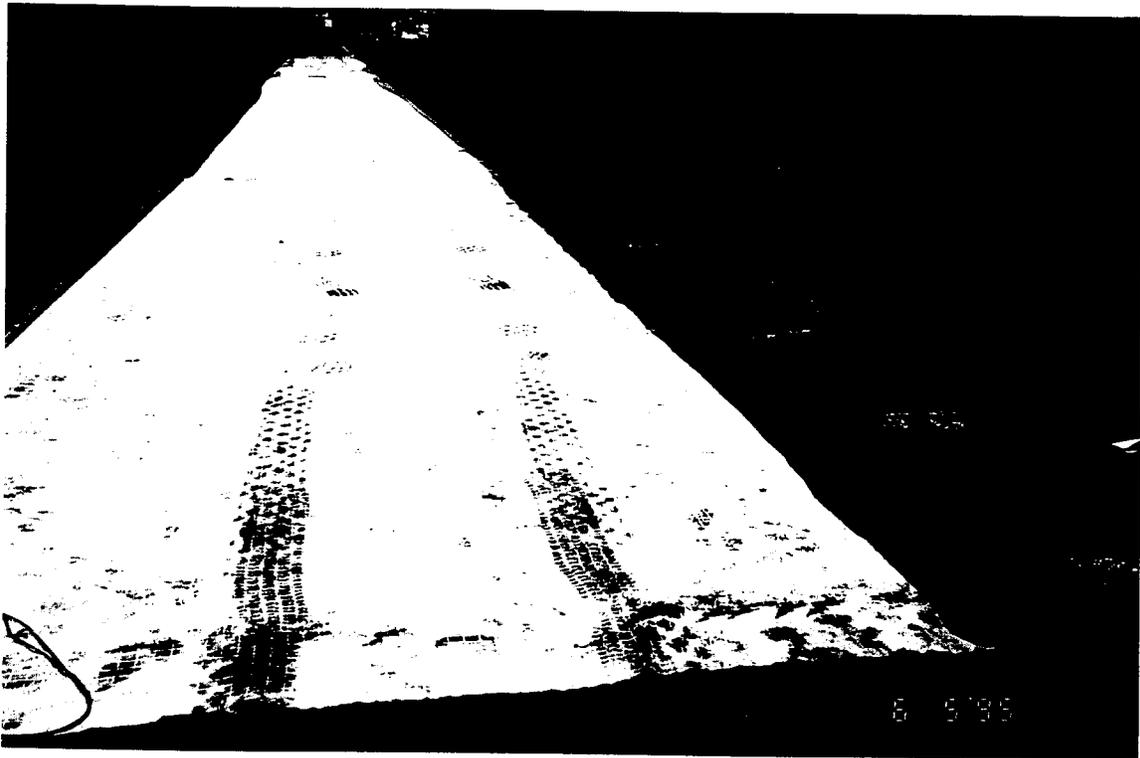
Photograph - 45, Note the grid is face down, does not overlap, and area's are patched with Petromat.

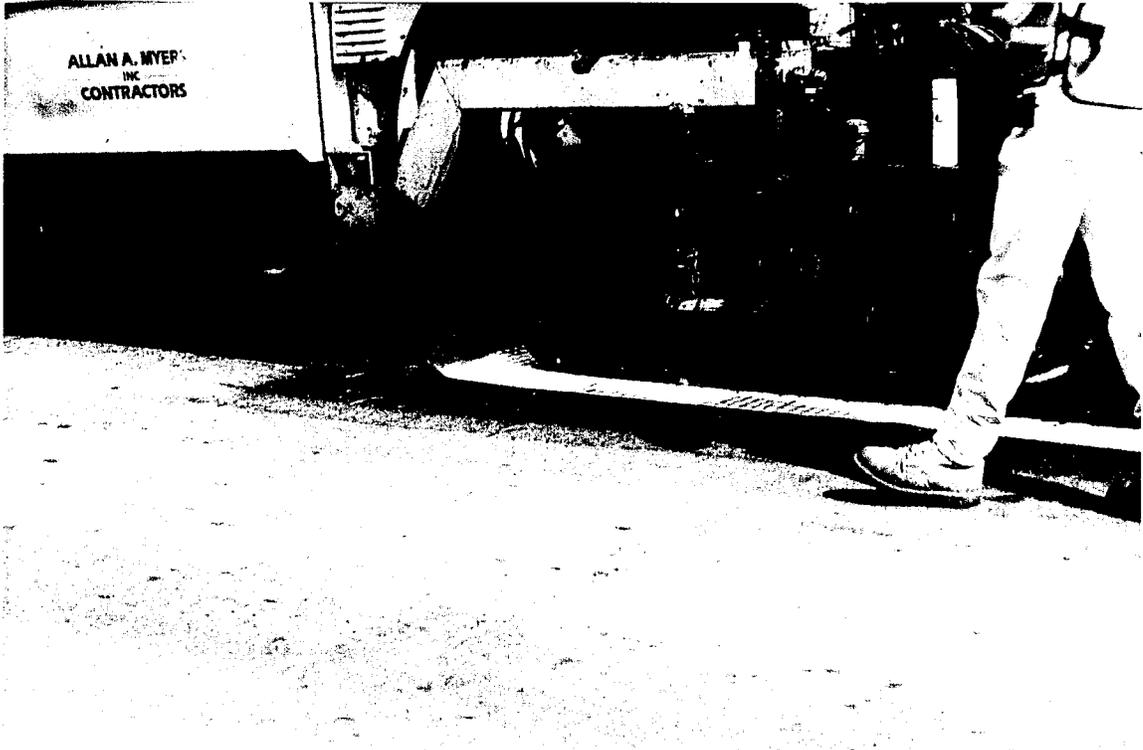
Photograph - 46, Note there is no overlap with Petromat and Bit-U-Tex.

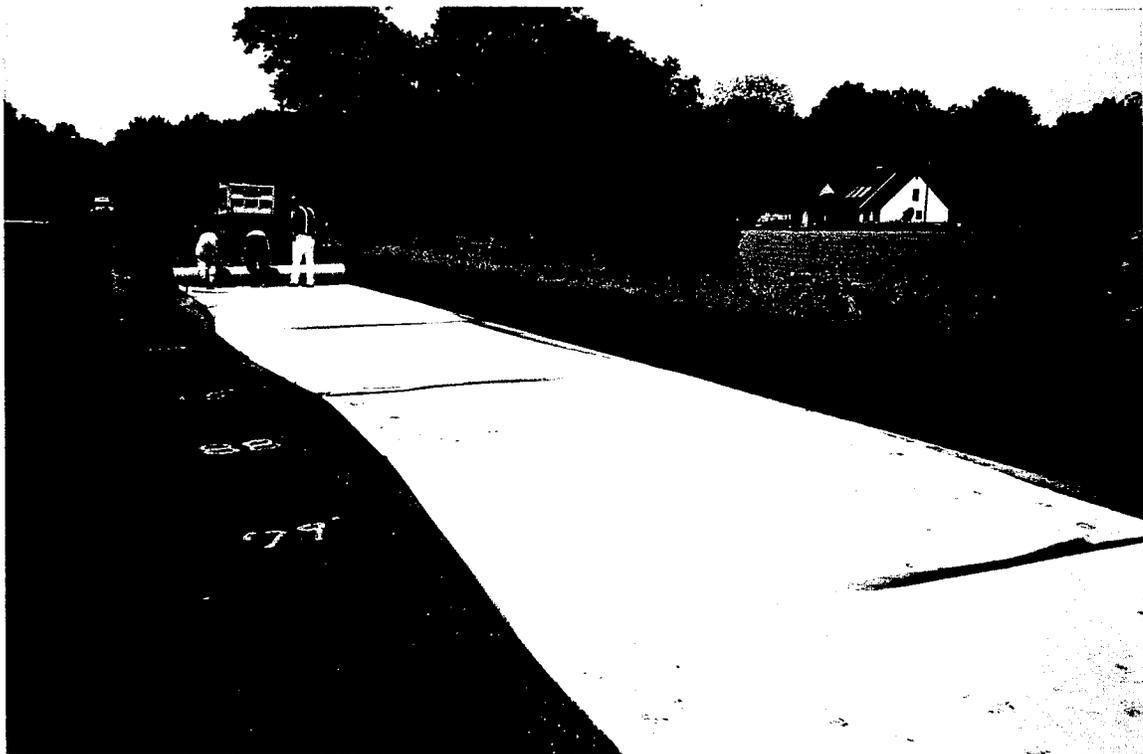
Photograph - 47, 2nd pass Bit-U-Tex, grid is facing down, uneven, and has wrinkles.

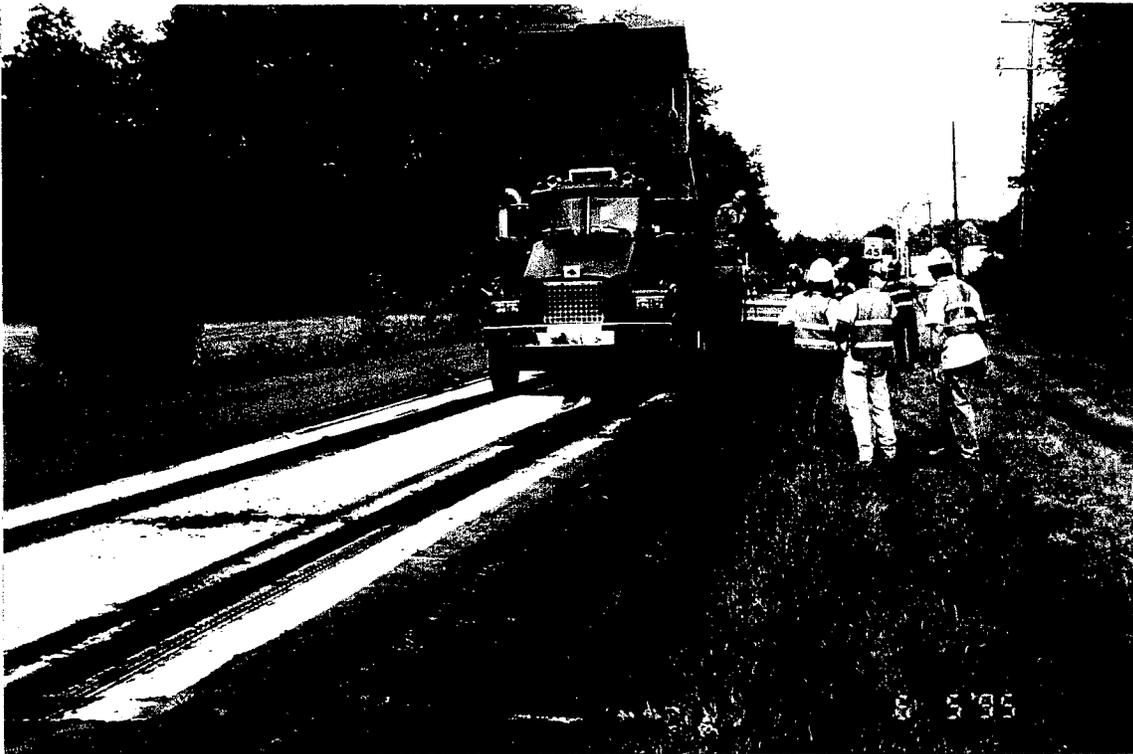
Photograph - 48, Note the patching with Petromat in the Bit-U-Tex test area.

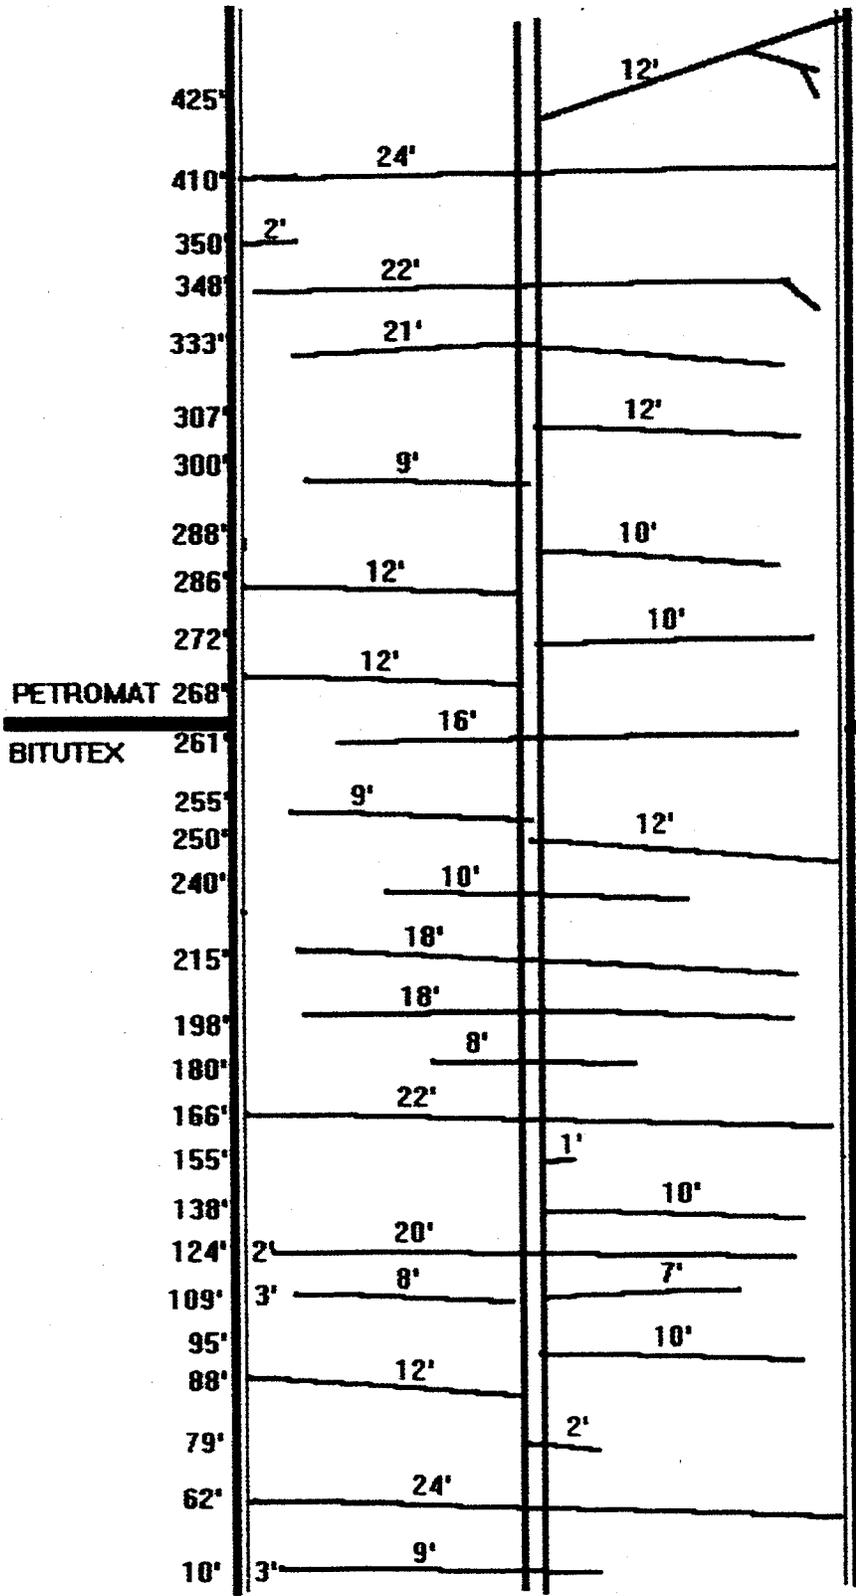
Figure 1. Site A - Crack Mapping

NOTE : There are vertical cracks
 600' long located 3' in
 from both edgelines and
 down the middle of the
 double yellow.

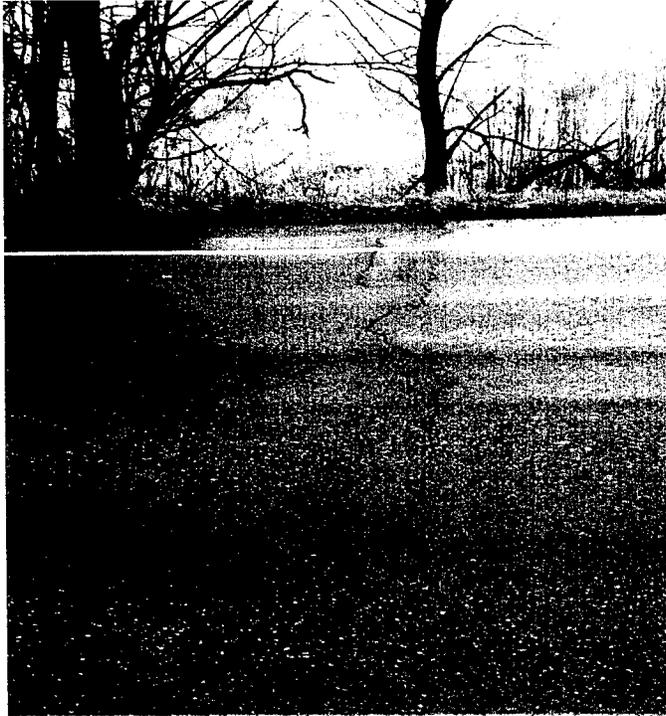
Photograph – 101, Test Section 3,
Reflective cracking after two years

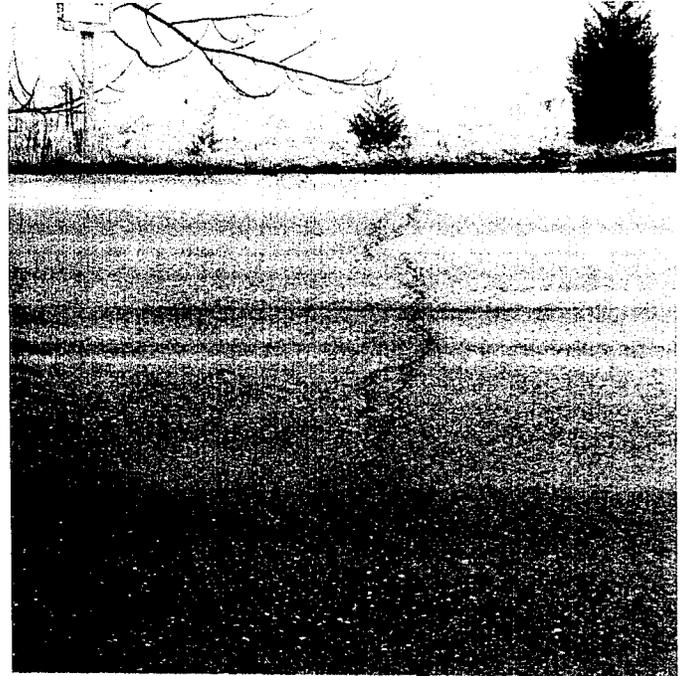
Photograph – 102, Test Section 4,
Reflective cracking after two years

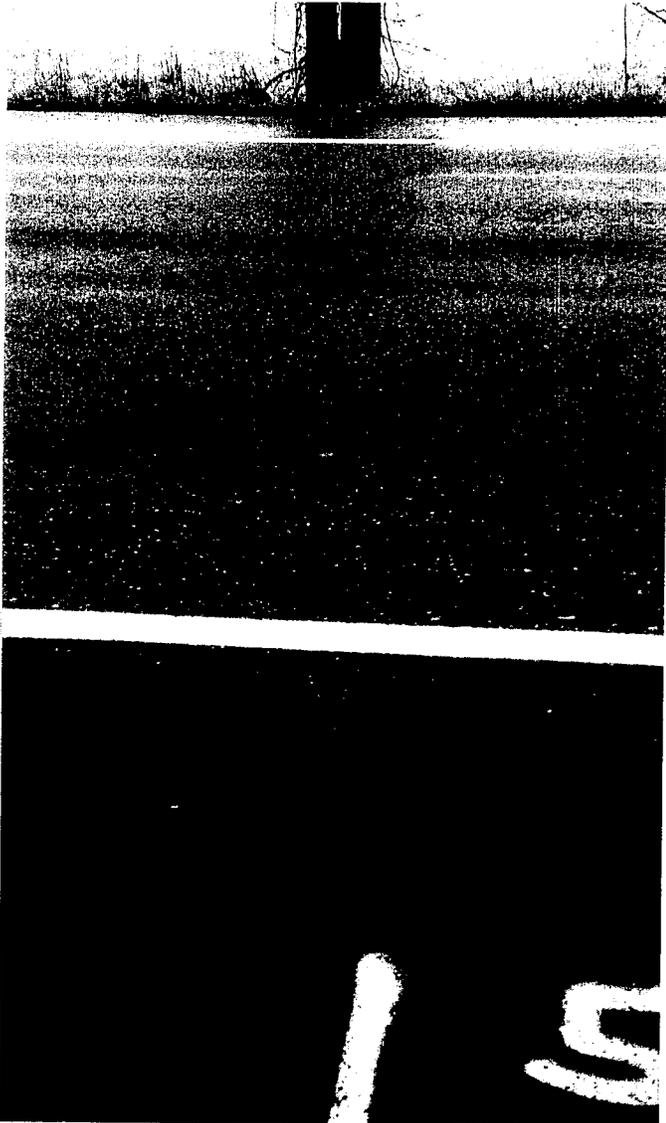
Photograph – 103, Test Section 5
Reflective cracking after two years

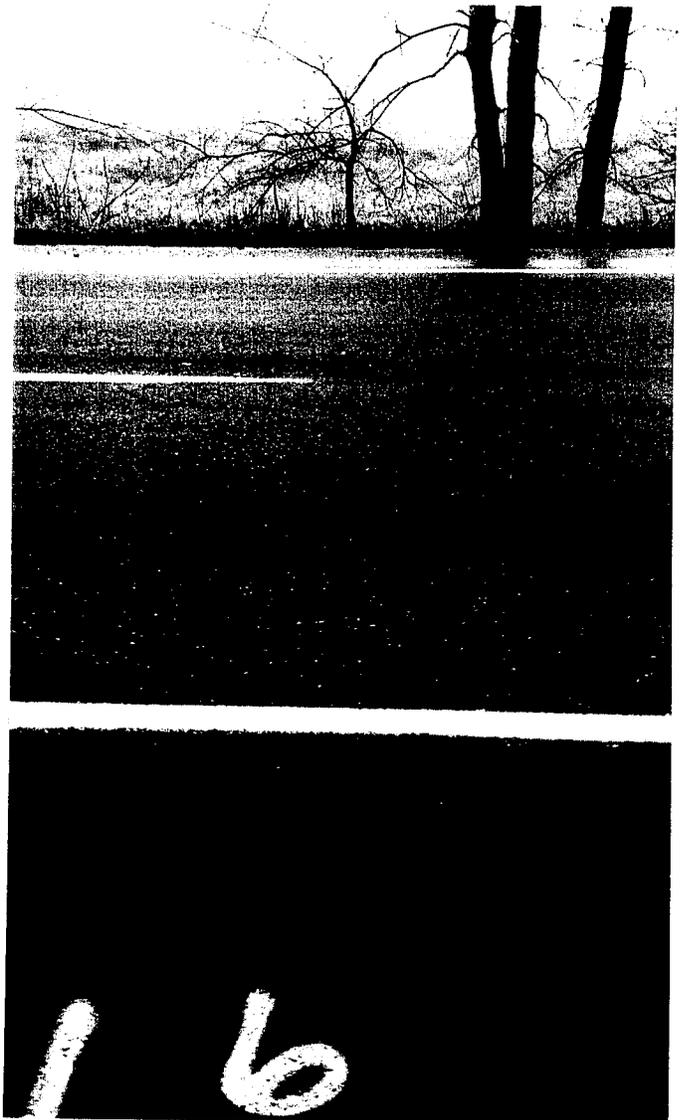
Photograph – 104, Test Section 6
Reflective cracking after two years

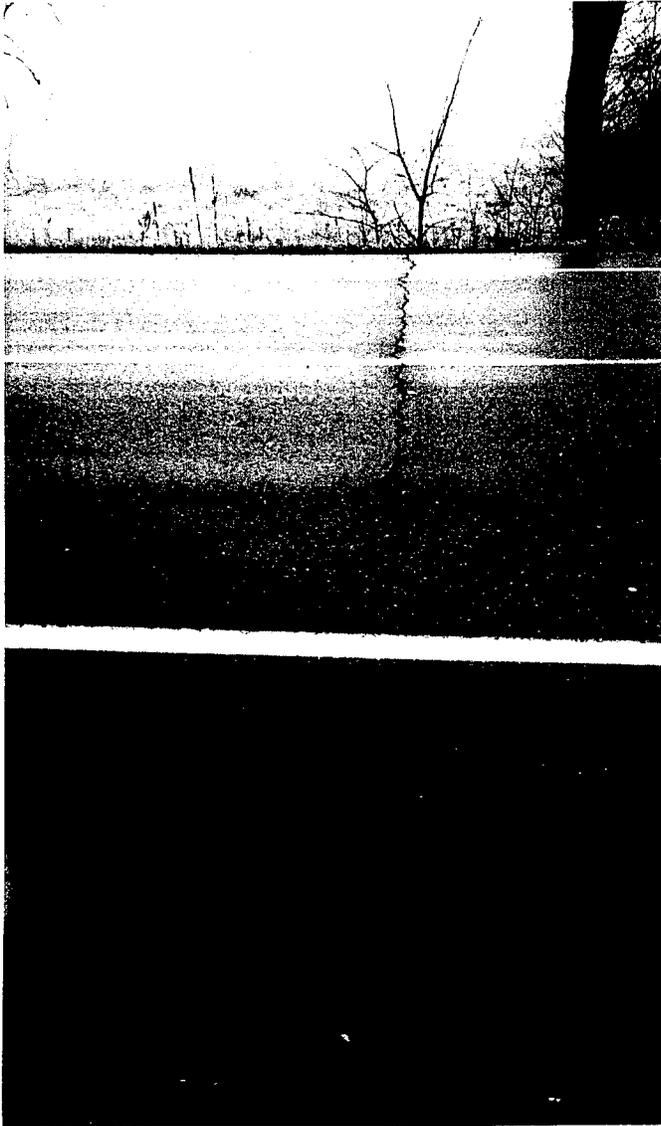
Photograph – 105, Control Section 1
Reflective cracking after two years

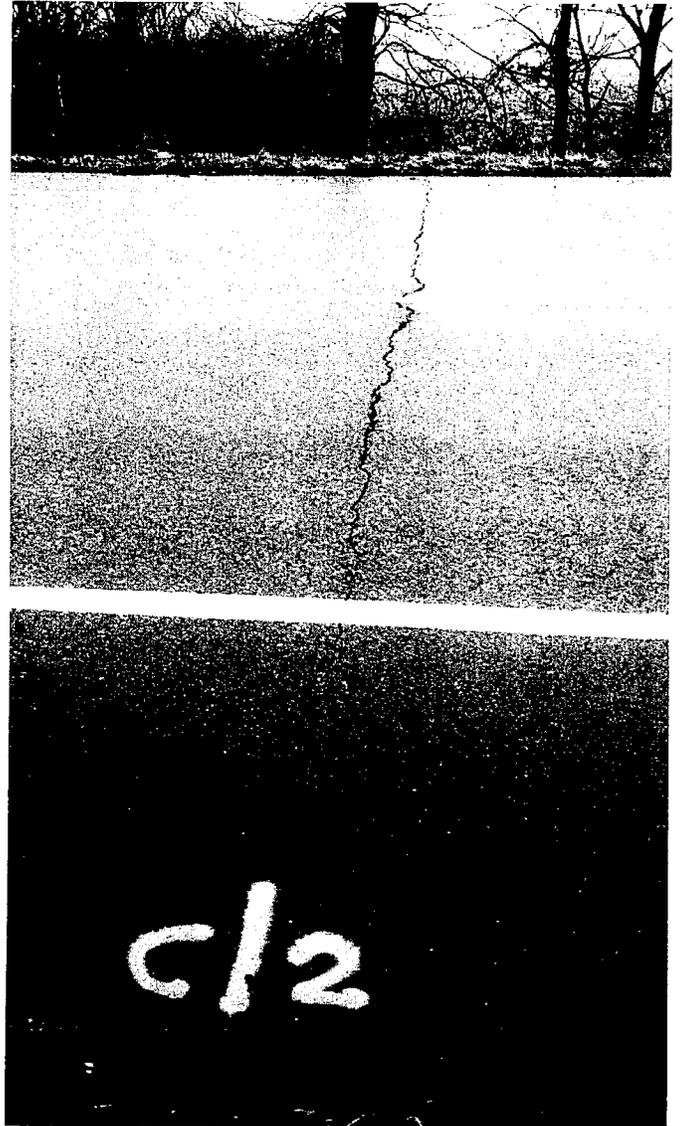
Photograph – 106, Control Section 2
Reflective cracking after two years

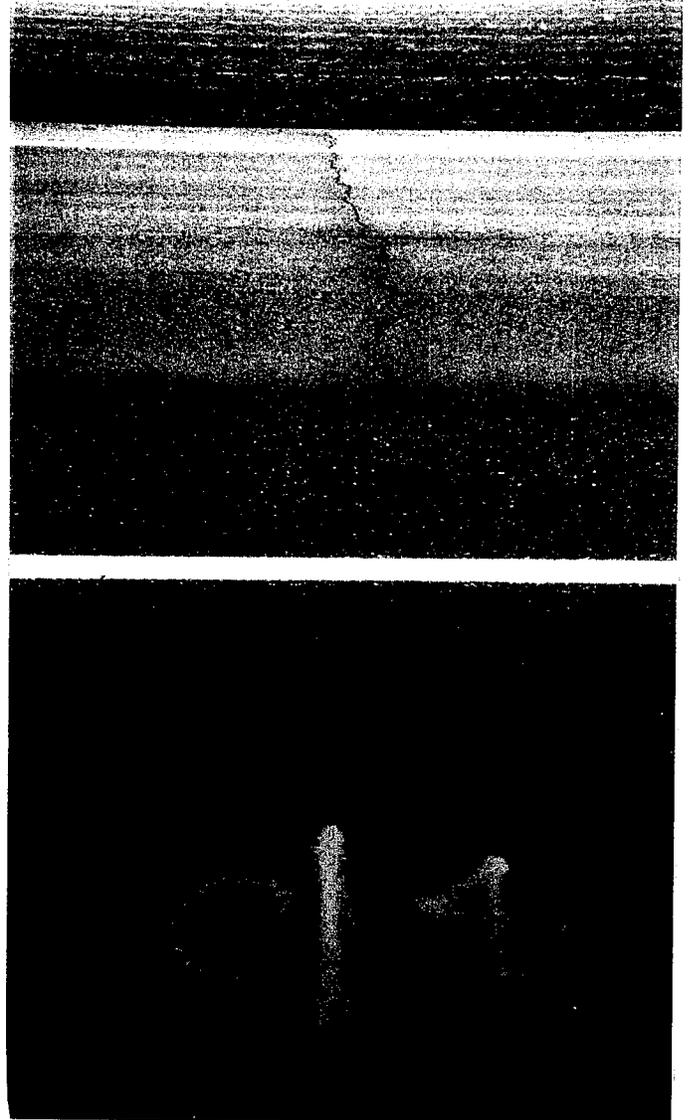
Photograph – 108, Control Section 4
Reflective cracking after two years

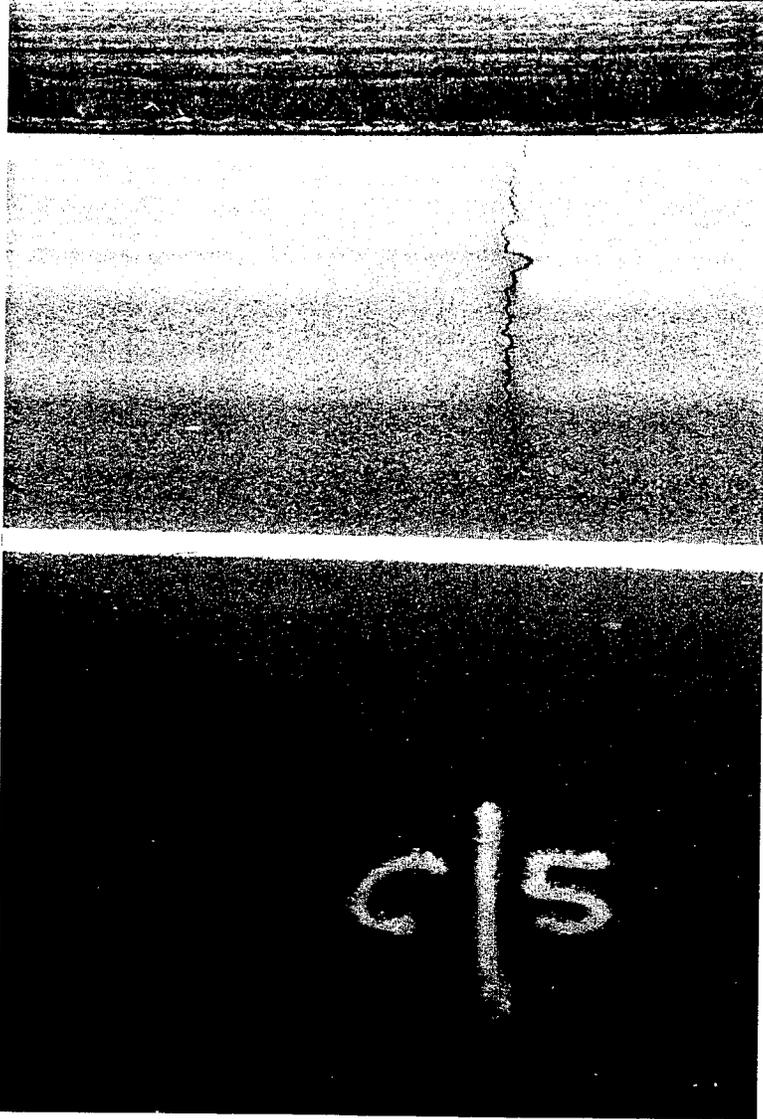
**Photograph – 109, Control Section 5
Reflective cracking after two years**
