Research Report
KTC-00-8

LONG-TERM MONITORING OF EXPERIMENTAL FEATURES, SUBTASK 2
Alexandria-Ashland Highway (KY 9) Pavement Performance
Monitoring

June 2000

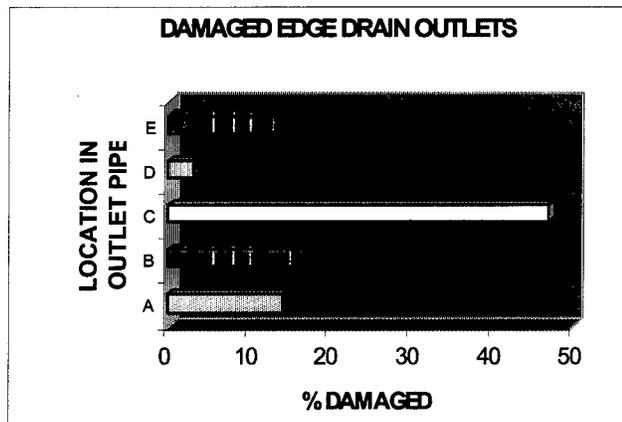
Of the 64 outlet pipes that were inspected, approximately 90 percent of the outlets were significantly damaged. Figure 7 indicates the frequency of damage occurring in each of the outlet pipe sections and shows that the outlet pipe was damaged most often at Section C. Damage to Section C is not typical to previous inspections of edge drains. Generally, Section A and B have higher rates of failure than Section C.

Figure 7. Damaged Outlet Pipe Sections.

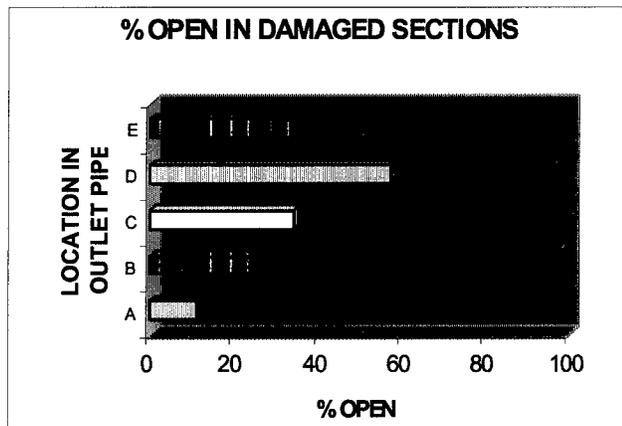
In Figure 8, the average percent of open area in the damaged outlet pipe sections is shown graphically. Figure 8 also shows that the closer the damaged outlet pipe section was to the headwall the less percent open the pipe became because of a higher degree of damage to the pipe in this area. A contributing factor to this damage is that the outlet pipe tends to be buried with less cover as the pipe approaches the headwall from the mainline which results in less protection for the pipe.

Figure 8. Average Open Area in Each Section.

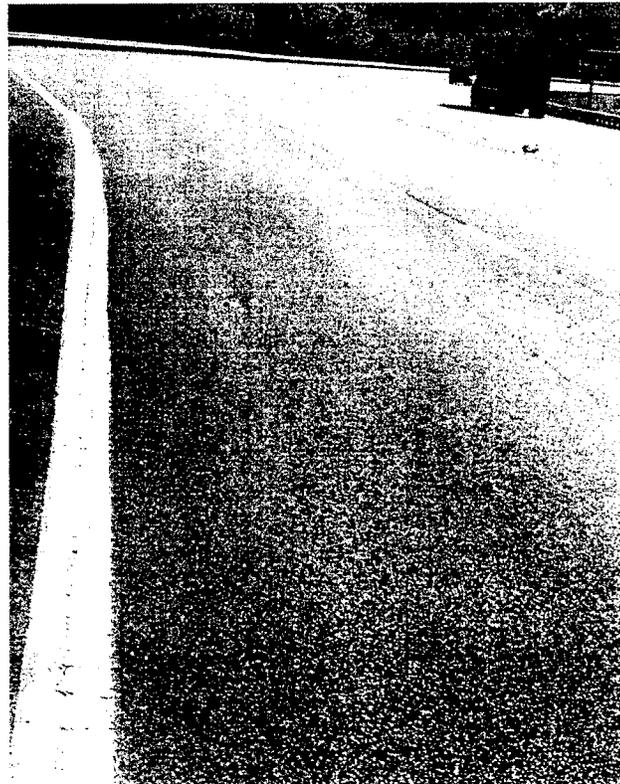
Longitudinal and transverse cracks were observed throughout the section.

Figure 14. Section C2 (Transverse and Longitudinal Cracks).

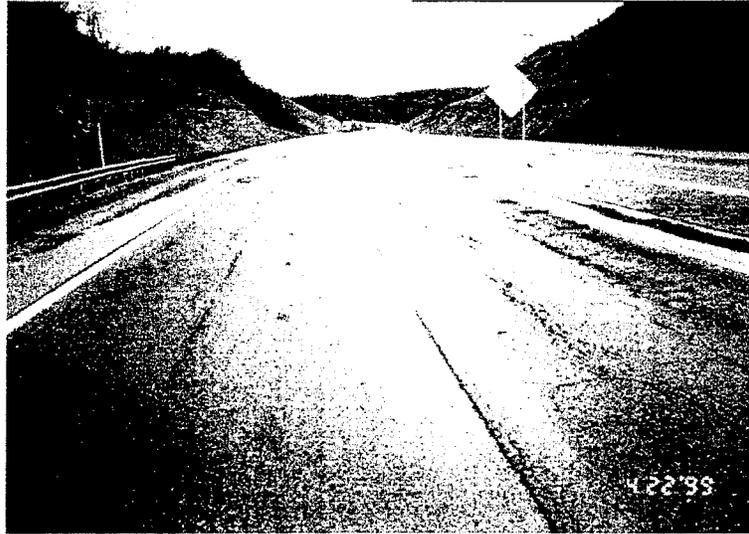
Longitudinal and transverse cracks were observed throughout the section. Fatigue failures, raveling, and alligator cracking were also observed.

Figure 15. Section C3 (Longitudinal Cracks, Transverse Cracks, Alligator Cracks, Fatigue Failures, and Raveling).

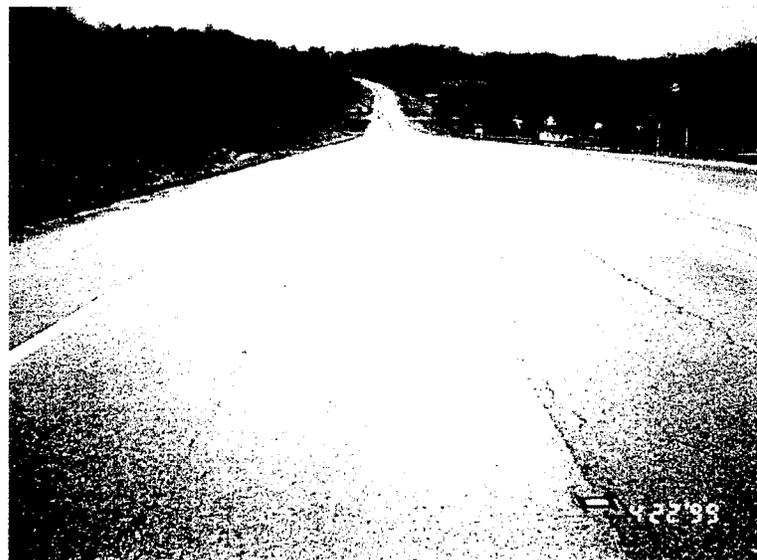
Longitudinal cracking was observed between the wheel paths, likely resulting from fatigue.

Figure 16. Sections B1 & B2 (Longitudinal Cracks, Fatigue Failures between Wheel Path).

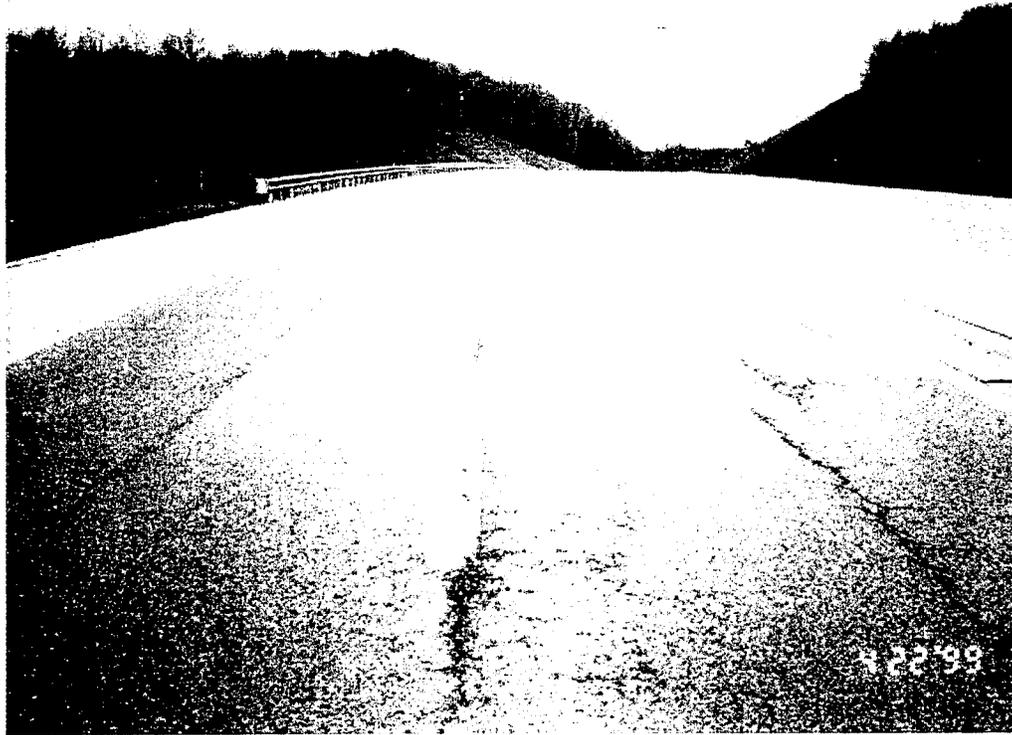
Longitudinal cracking was observed in and between the wheel paths.

Figure 17. Sections B3 & B4 (Longitudinal Cracks at Center Line and in Wheel Paths).

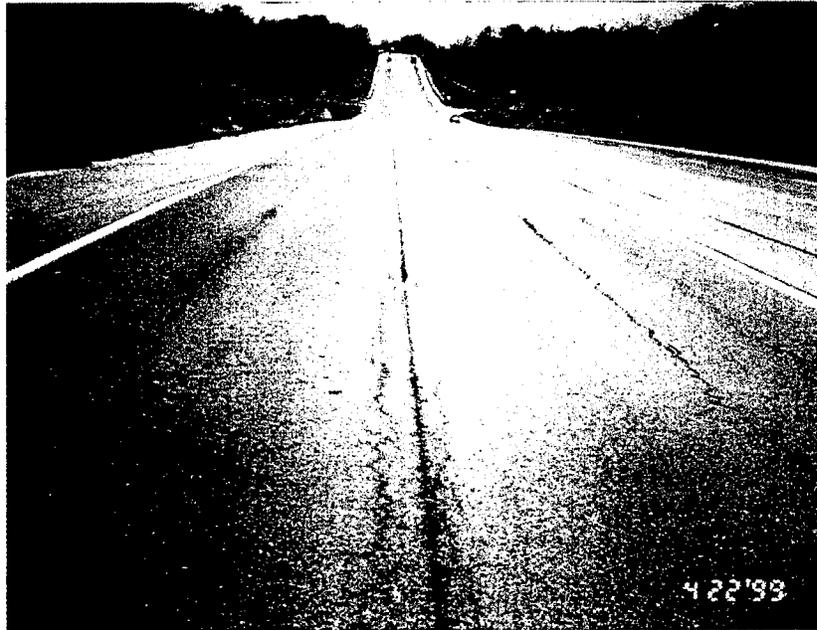
Longitudinal cracking had occurred in the wheel path and between the wheel paths. Some alligator cracking, block cracking, and environmental cracking were also noted.

Figure 18. Section 6A (Longitudinal Cracks in and Between Wheel Paths, Some Alligator and Environmental Cracks).

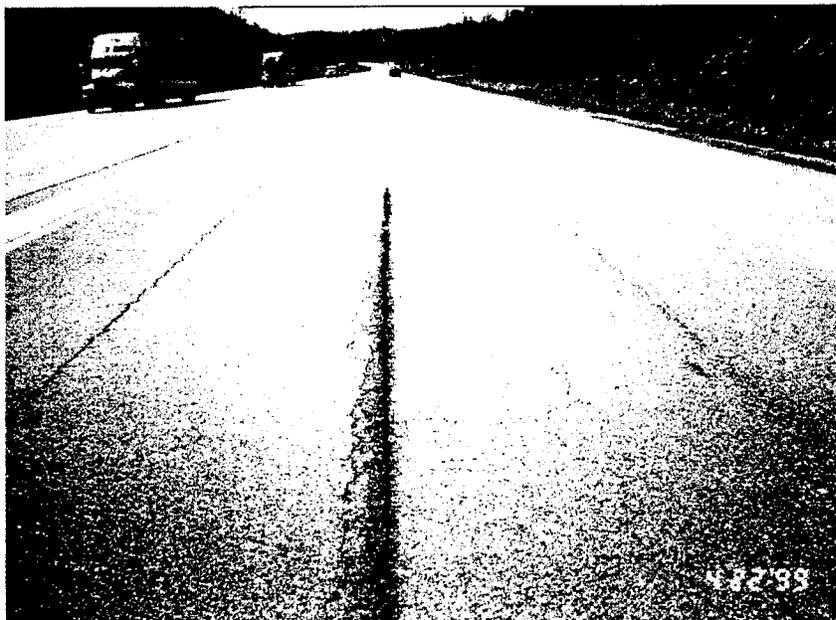
Figure 21. Section 6 (Longitudinal Cracks and Water at Centerline).

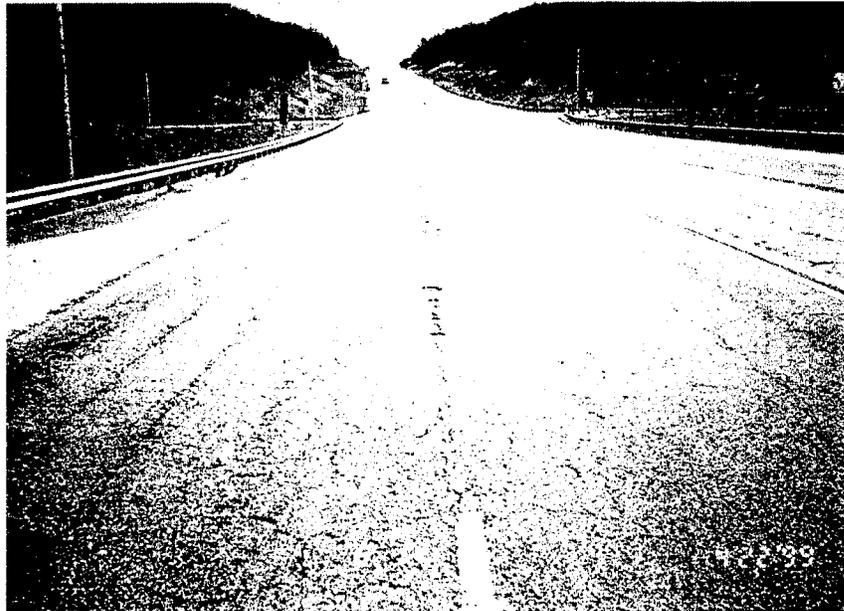
Environmental cracking and raveling were observed throughout the section. The centerline joint was badly raveled. Significant aggregate loss was also observed. Only a slight amount of fatigue cracking had occurred.

Figure 22. Section 7 (Environmental Cracks Throughout, Center Joint Raveled).

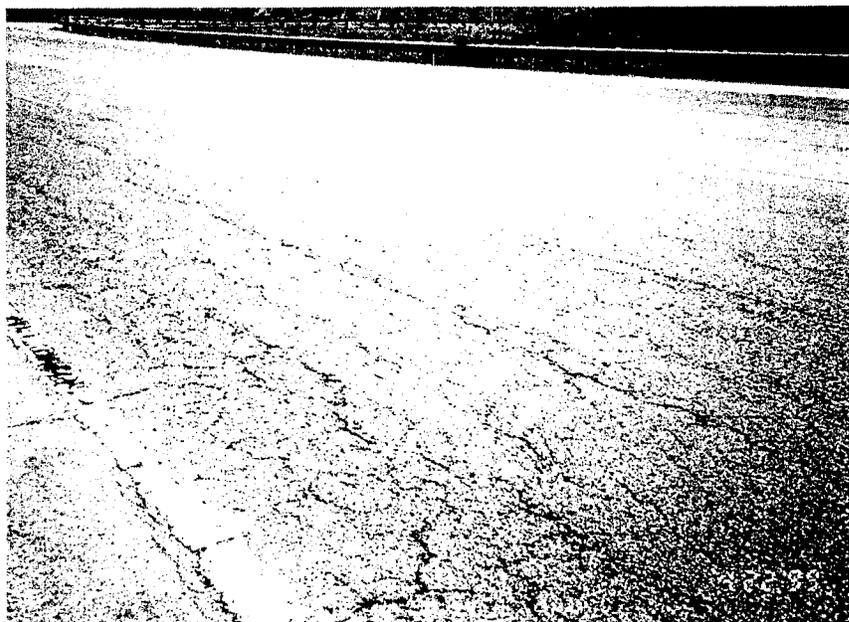
Figure 23. Section 7 (Environmental Cracks).

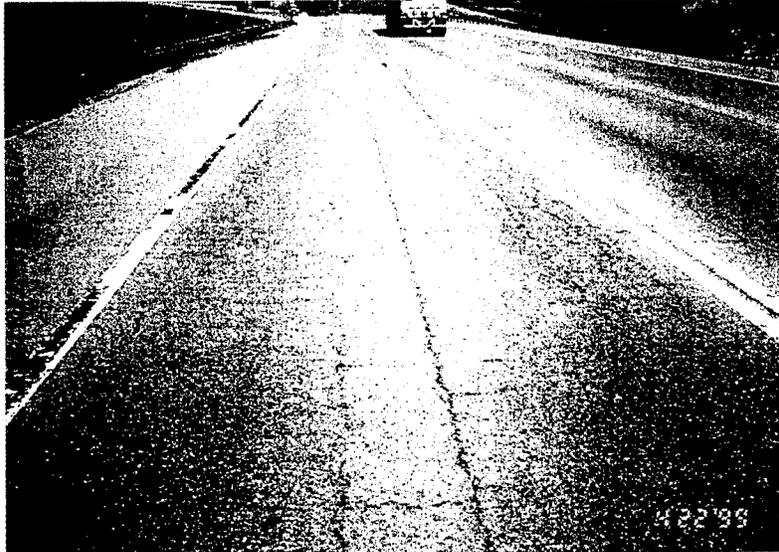
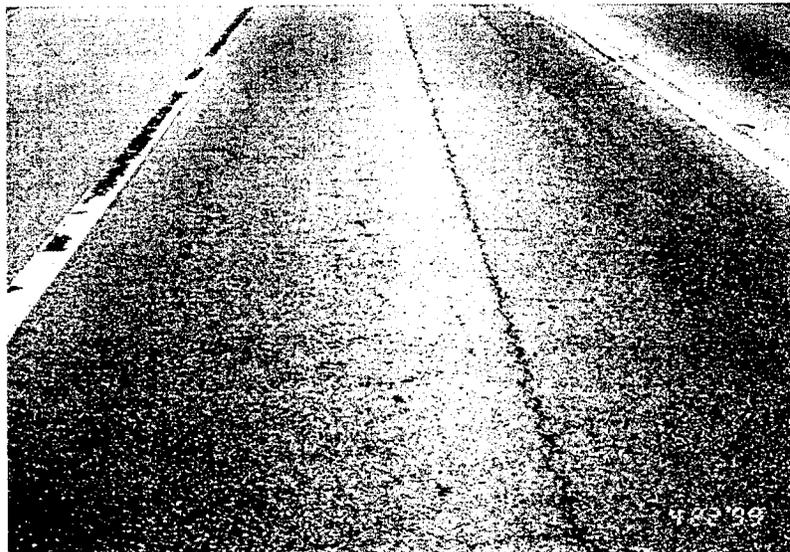
Environmental cracks were noted throughout the section. Longitudinal cracking had occurred in and between the wheel path. These appear to be the result of fatigue. Raveling, aggregate loss, and alligator cracking were observed throughout. Water was observed at the centerline of a steep grade.

Figure 26. Sections 9 & 10 (Longitudinal Cracks, Environmental Cracks, Alligator Cracks in Wheel Path, Raveling).

Figure 27. Sections 9 & 10 (Longitudinal Cracks, Environmental Cracks, Alligator Cracks in Wheel Path, Raveling).

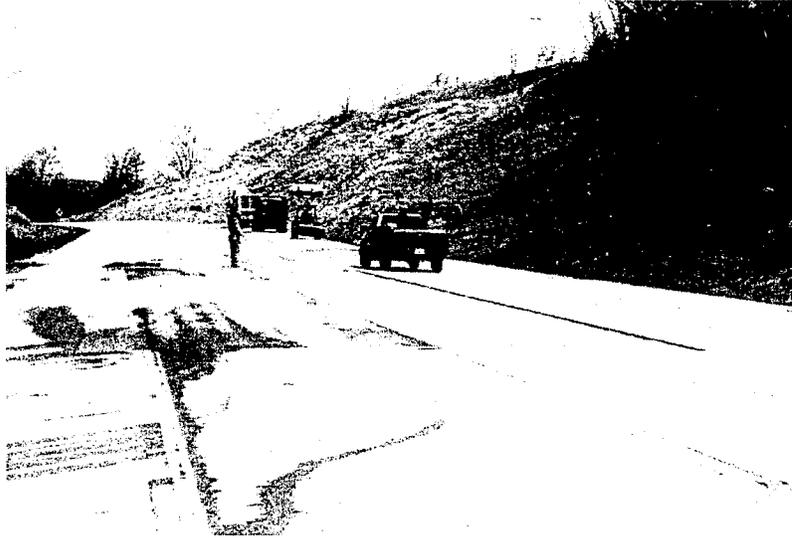
Some environmental cracking was observed in the section. However, cracking was not as bad as previous sections. Longitudinal cracking was observed in some areas of the section. At milepost 11.2, the pavement had been milled.

Figure 28. Section 11. Milled Area at Milepost 11.2 (Some Environmental and Longitudinal Cracks Between Wheel Paths).

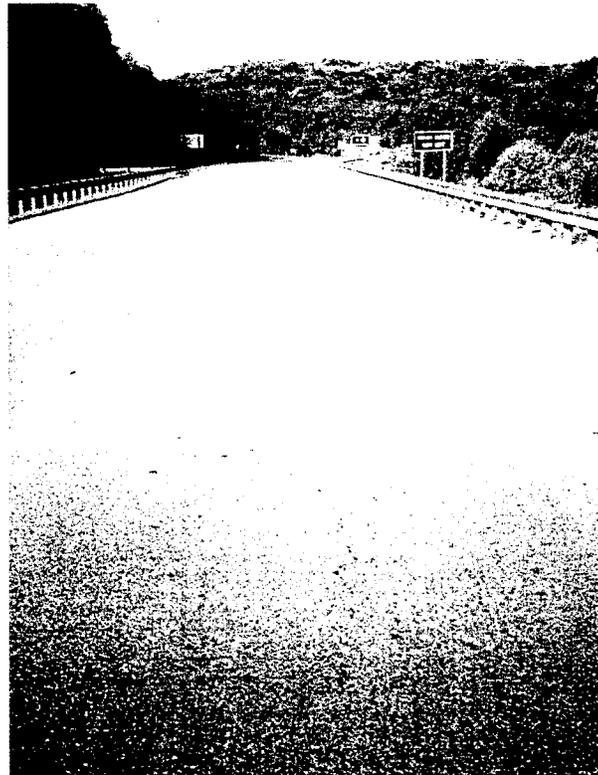
Figure 29. Section 11 (Longitudinal Cracking).

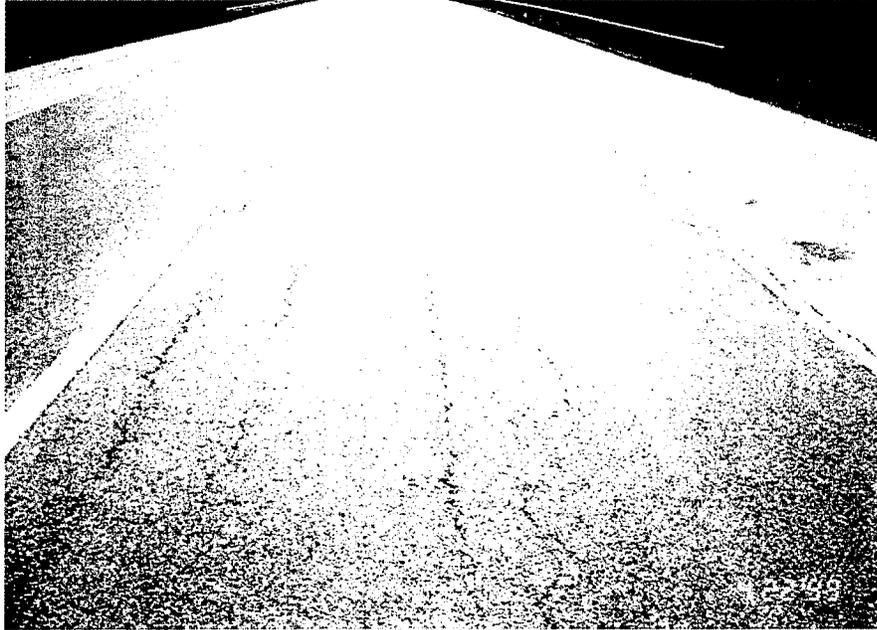
Longitudinal cracking was observed in the wheel path and some at the centerline. Longitudinal cracks were not throughout the entire section, only in certain areas. Environmental cracking was noted in some areas.

Figure 30. Section 12 (Longitudinal Cracks Between Wheel Paths and Some Environmental Cracks).

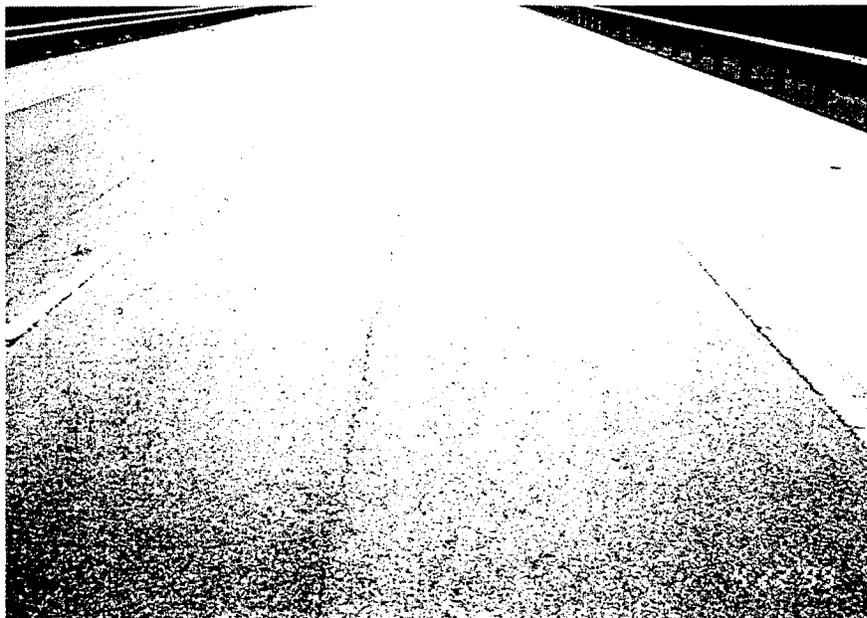
Figure 31. Section 12 (Longitudinal Crack at Center of Lane).

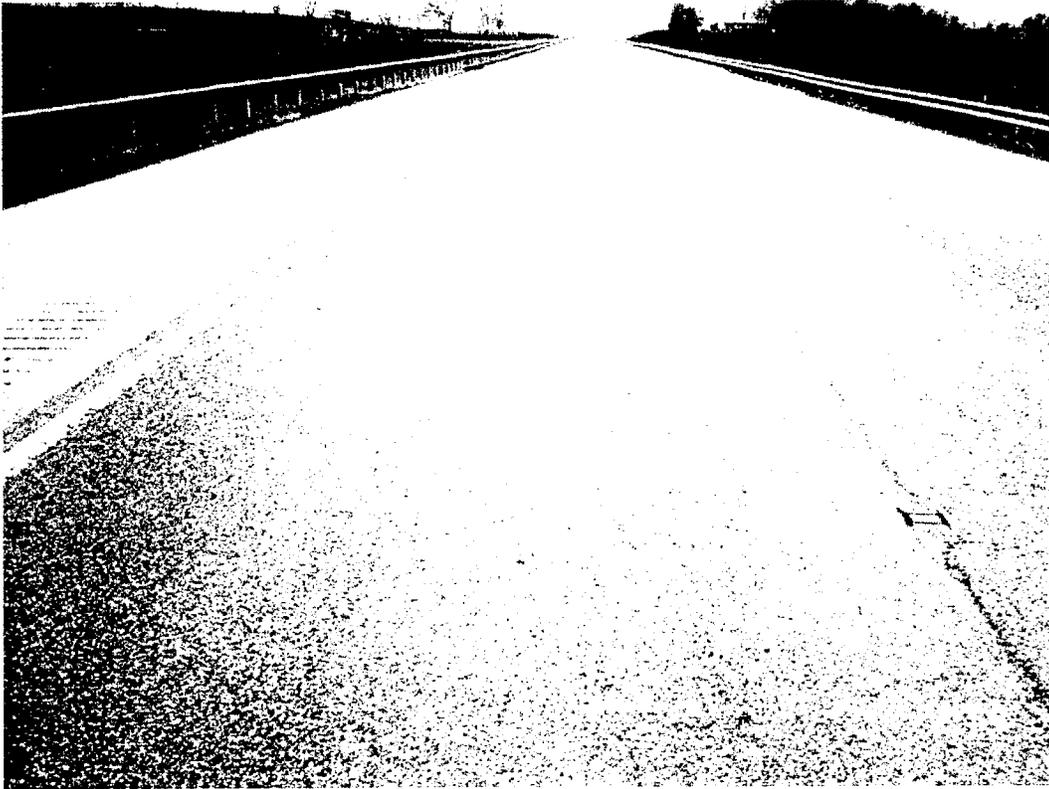
A considerable amount of raveling had occurred in Sections 15 & 16. Longitudinal cracks were observed between the wheel paths. Some environmental cracking was noted in the sections. The area between Maysville and KY 11 had been overlaid in 1998.

Figure 34. Sections 15 & 16 (Significant Raveling, Longitudinal Cracking, Some Environmental Cracks).

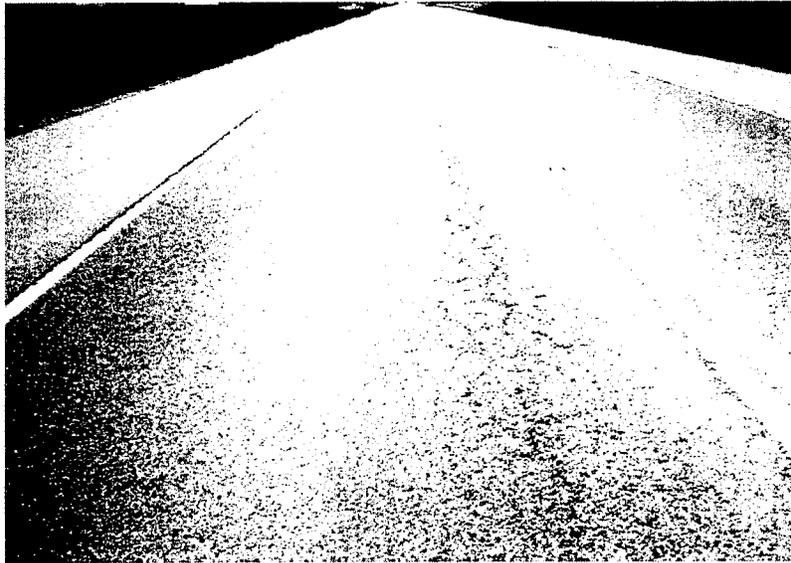
A considerable amount of fatigue cracking was observed in the wheel paths. Raveling was also observed in the wheel path. Several large patches were observed throughout the section.

Figure 37. Section 19 (Considerable Fatigue Cracks, Raveling in Wheel Path, Several Patched Areas).

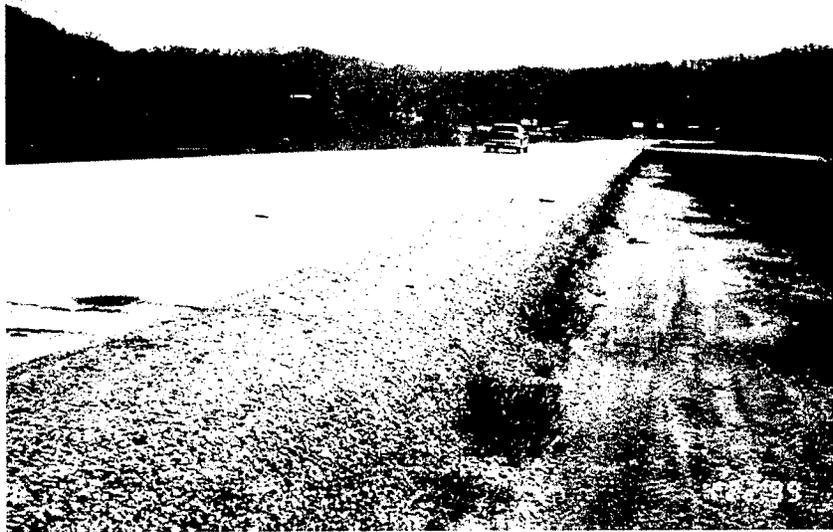
Figure 39. Section 21A (Edge of Drainage Blanket).

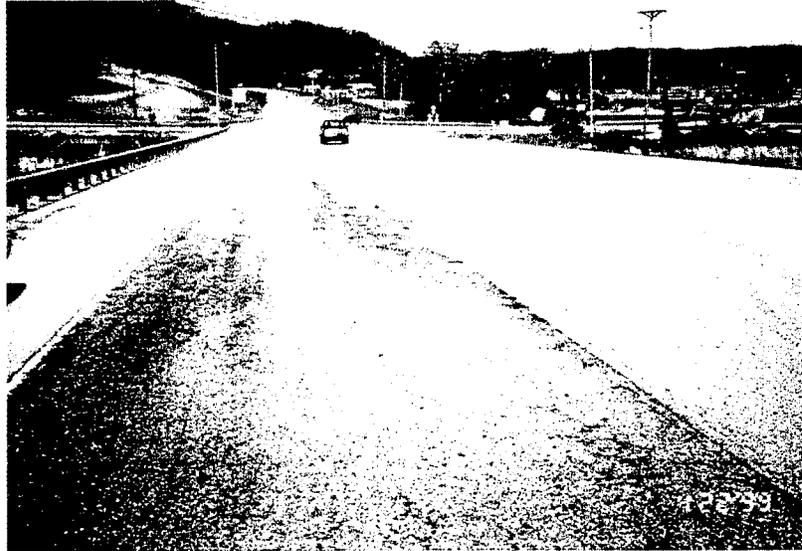
Both sections had considerable raveling and environmental cracking near the beginning of the sections. Bad raveling and potholes were observed throughout. Most problems were located on steep grades. A long patch was observed in one area of the sections that was on a steep grade.

Figure 41. Sections 21B & 22 (Bad Raveling and Environmental Cracking).

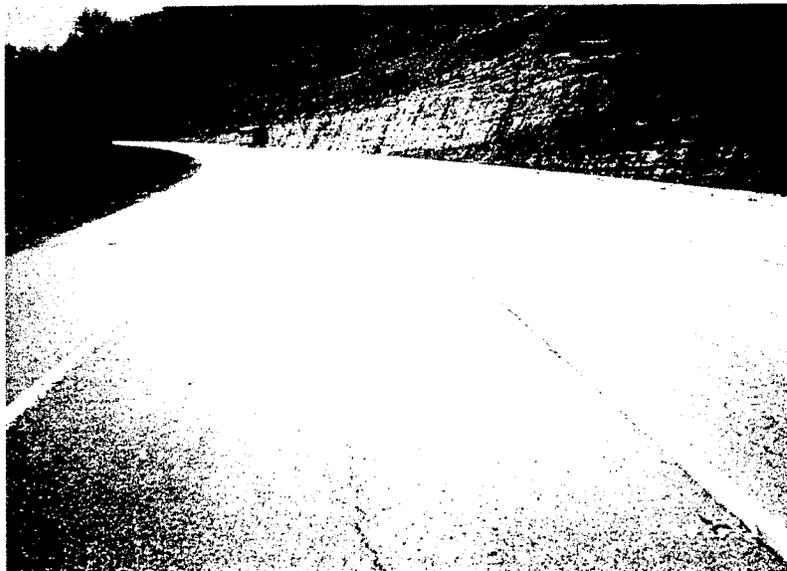
Isolated fatigue cracking in and between the wheel paths was observed in isolated areas.

Figure 42. Section 23 (Isolated Fatigue Cracking).

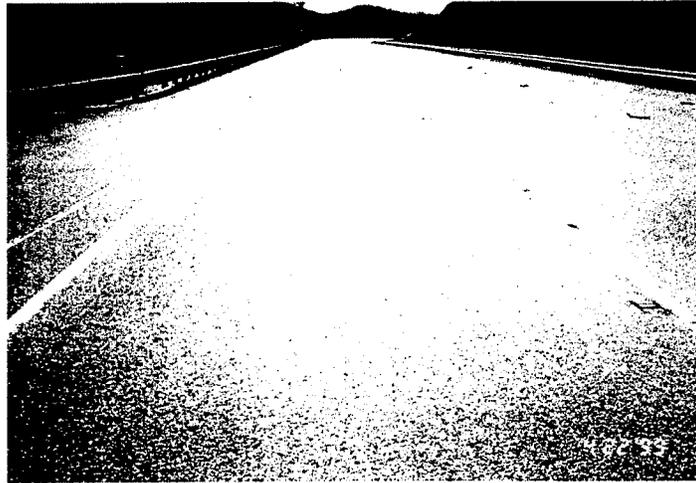
The section appeared to be in better condition than most of the other sections. Isolated fatigue cracking was observed in areas.

Figure 43. Section 24 (Isolated Fatigue Cracks in Areas).

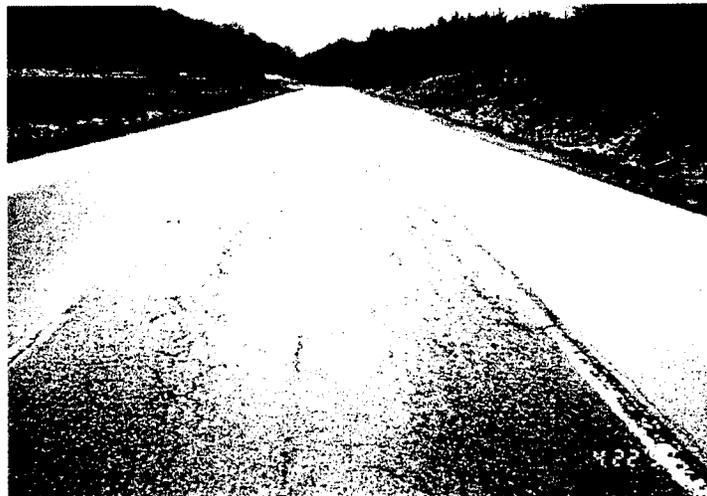
The section had fatigue cracking, raveling, and environmental cracking throughout most of the section.

Figure 44. Section 25 (Raveling, Environmental and Fatigue Cracking).

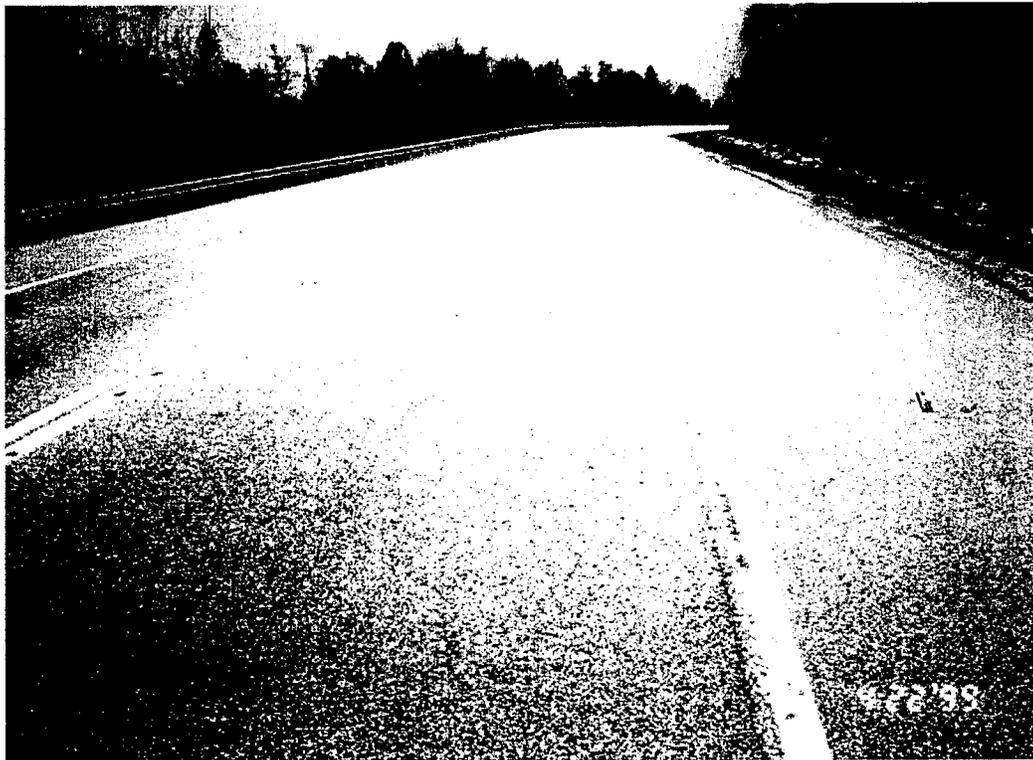
The section had some isolated cracking in the wheel paths. Overall, the section appeared to be in good condition.

Figure 45. Section 26 (Some Isolated Cracking in Wheel Path).
