**Materials-Related Forensic Analysis and
Special Testing,
Pennsylvania Department of Transportation**

“Metallurgical Investigation of Reinforcing Steel”

**Final Report
December 2000**

During the construction of a bridge deck on SR 0228, Section 241 in District 10-0, epoxy-coated reinforcing steel was found to break during field bending by mandrel and arm strength. The steel was traced to product produced by Co Steel (New Jersey). Due to schedule considerations the fabricator replaced all the steel on the site from the same "heat" number. Steel from another manufacturer, SMI (North Carolina) was also shipped to the District 10-0 jobsite. Initially, both sources were investigated.

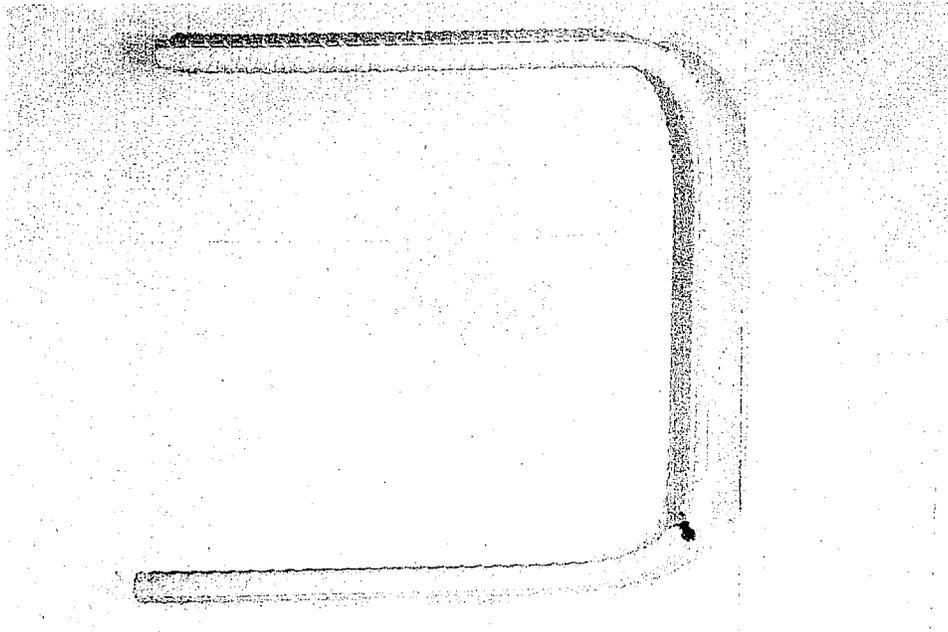
An overall view of the the failed epoxy coated #5 reinforcing bar received for examination is shown in Figure 1. Enlarged views of the fracture area in the bend region of the bar and fracture surfaces are shown in Figures 2 and 3, respectively. As received, the crack surfaces were largely covered with a light layer of corrosion product suggesting that a crack may have existed in the bar for a period of time before complete fracture. The reddish-brown color was consistent with corrosion product formed by exposure of the crack surfaces to the weather. The bright fracture area near the inside radius of the bar delineates the uncracked cross-section prior to the final break and represents about 10% of the bar cross-section.

Figure 1 - Fractured #5 Bar Stirrup Removed From Bridge Deck Under Construction
on SR 0228, Section 241 (District 10-0).
(8/00/17-2)

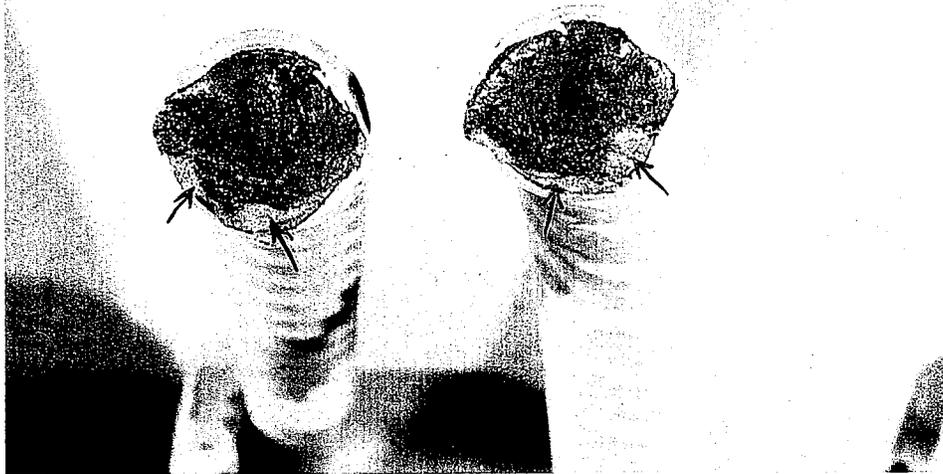
Figure 3 - Corrosion Covered Crack Surfaces (Arrows Show Final Break Region).
(8/00/17-6)

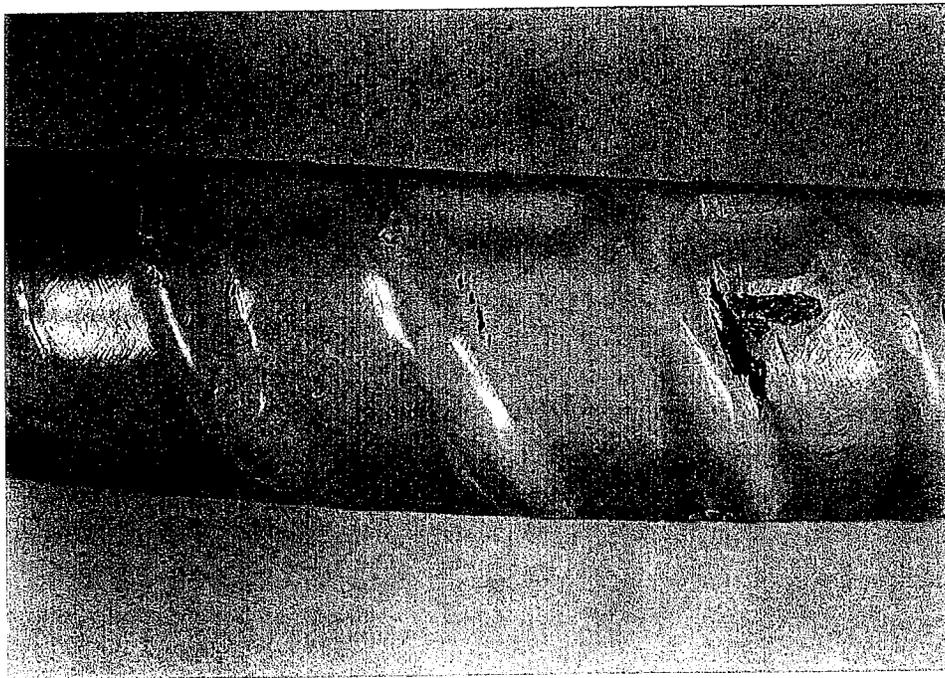
Indications of small surface cracks were also evident in the outer radius of the other bend in the stirrup (see Figure 4). These were all located in the toe area of the bar deformations similar to the location of the fracture in the failed bend (see Figure 3). A longitudinal cross-section through these surface cracks verified the existence of fine cracks penetrating the reinforcing bar at these locations as shown in Figure 5. These cracks are also seen to form at the toe of the bar deformation. The depth of the cracks were about 0.015-0.025 in.

Figure 4 - Small Surface Cracks at Deformations on the Outer Radius
of the Unfractured Bend of the Stirrup.
(9/00/5-2)

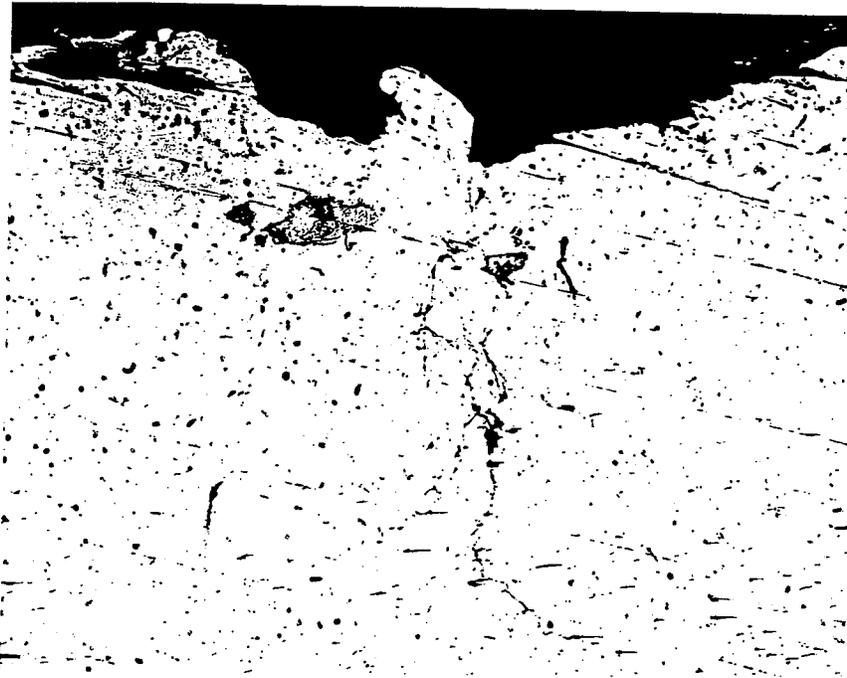
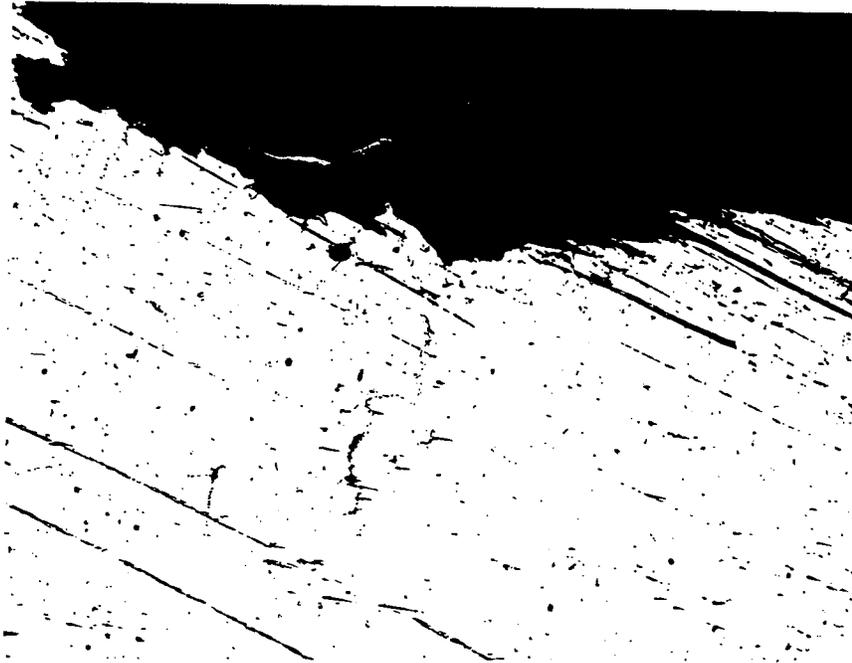
Figure 5 - Cross-sectional View of the Surface Cracks in the Bend Region of the Stirrup Along the Toe of the Bar Deformations (see Figure 4).

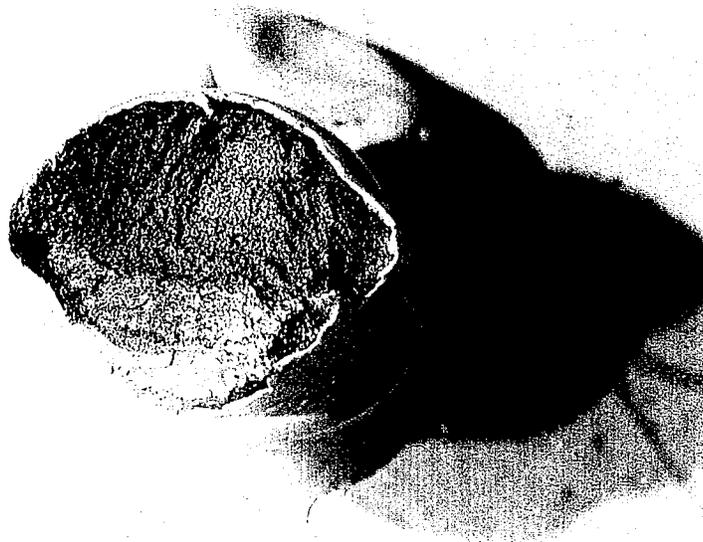
The corrosion product on one crack surface was removed by a brief ultrasonic cleaning in Alconox detergent prior to microscopic examination with the scanning electron microscope (SEM). The appearance of the crack surface after removing the corrosion product is shown in Figure 6. A low magnification (4.8X) view of the crack surface as imaged by the SEM is shown in Figure 7. Higher magnification views of the areas marked "a" and "b" representing the area originally covered with corrosion and the bright final fracture region, respectively, are shown in Figure 8. The region originally covered with corrosion product showed dimple fracture associated with ductile fracture over the entire region. No indication of a material defect or different fracture mechanism was observed at the toe of the bar deformation where the crack presumably initiated. In contrast, the final break region (region "b") showed cleavage fracture over the entire area, not uncommon in low toughness materials containing large initial cracks.

Figure 6 - Appearance of the Crack Surface After Removing Corrosion Product.
(8/00/17-12)

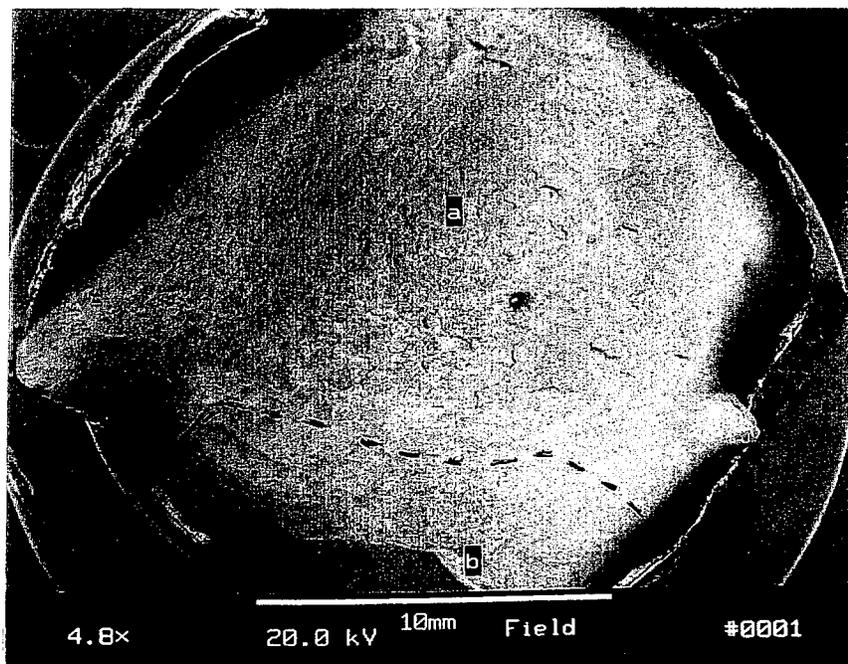
Figure 7 - SEM View of the Crack Surface. [Mag. 4.8X]
(Dashed Line Delineates Original Crack and Final Break Regions)

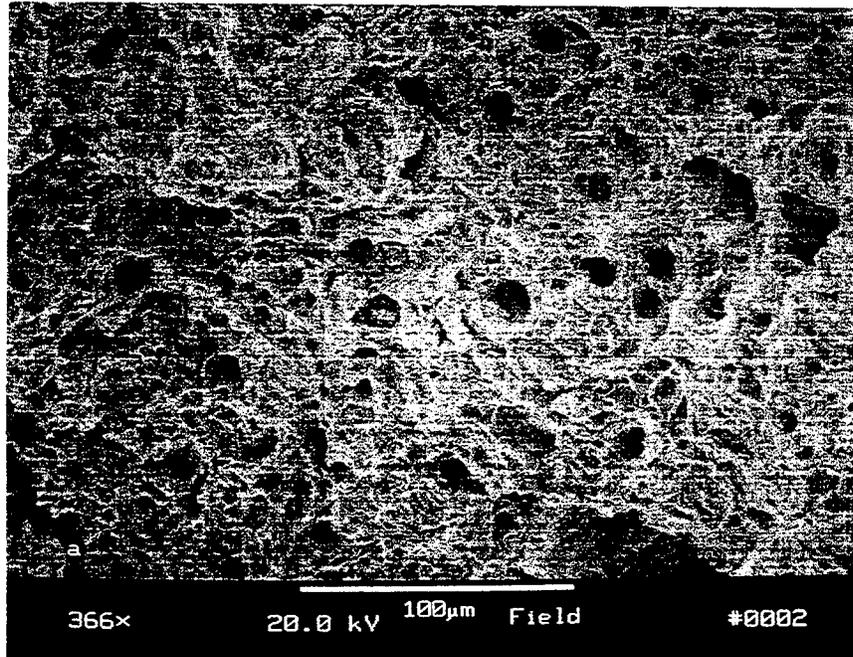
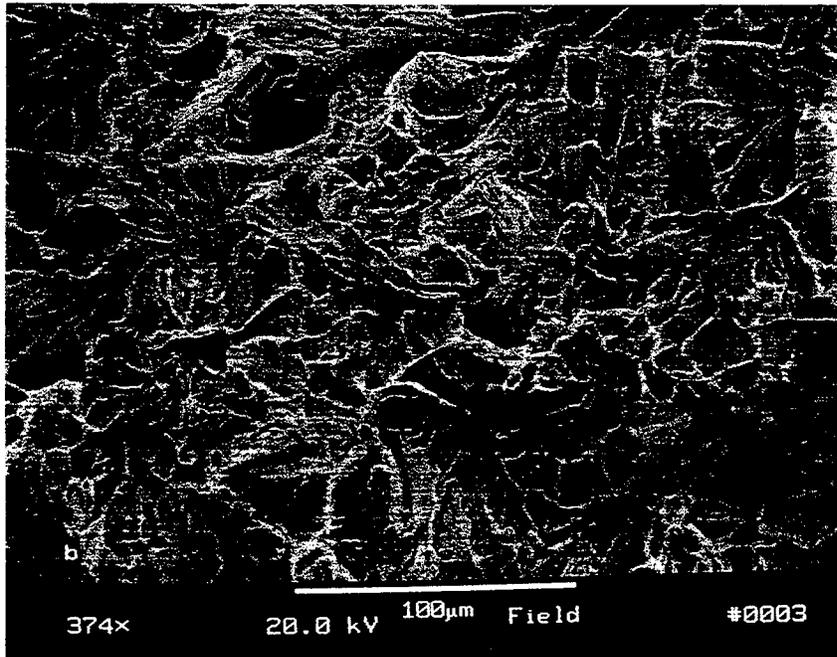
Figure 8 - Higher Magnification SEM Micrographs of the Crack Surface Obtained in the Original Crack Region (Area "a" in Figure 7) Showing Dimple Fracture (Top) and in the Final Break Region (Area "b" in Figure 7) Showing Cleavage Fracture (Bottom).
[Mag. 366X & 374X]

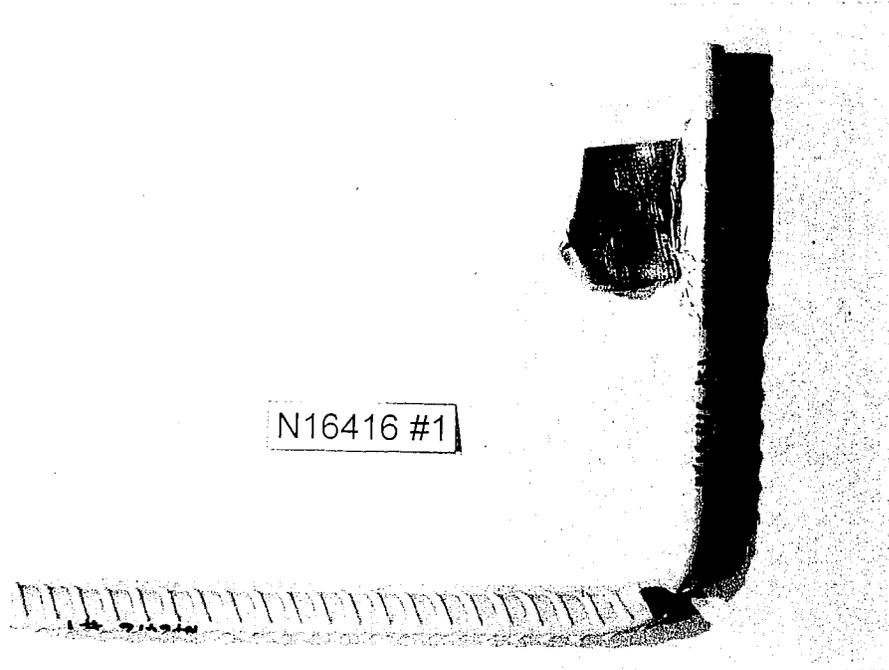
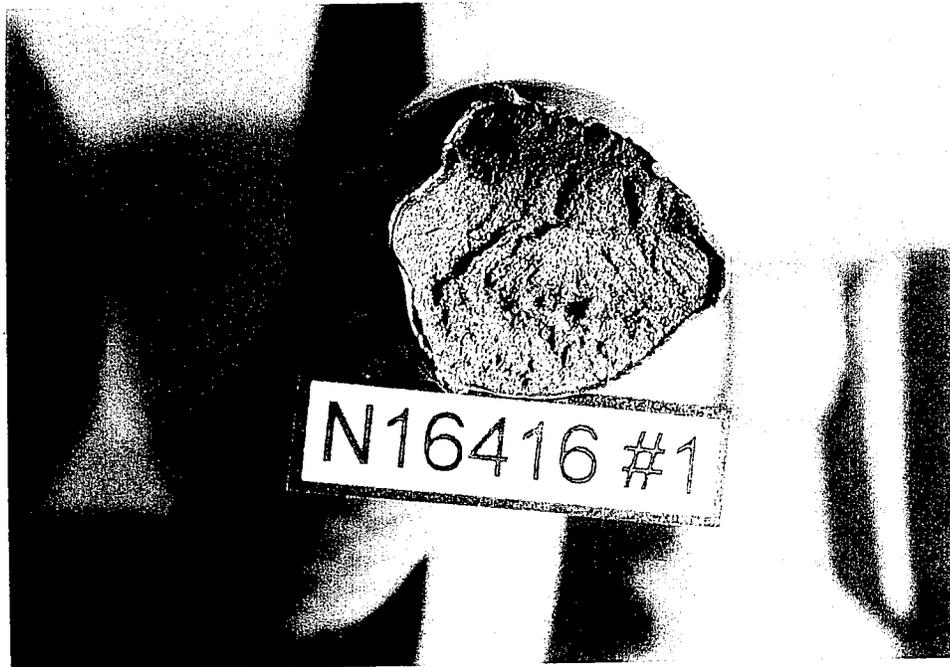
Initial bend tests performed by PennDOT Material Testing Division on #5 reinforcing bar from the same heat as the failed stirrup (Co-Steel Heat No. N16416) resulted in one failed specimen in three tests. Reinforcing bar from a different manufacturer (SMI Heat No. 27778) also used in the affected bridge deck was also tested and also resulted in one premature fracture in three tests. Both fractures were examined fractographically for comparison to the fracture in the failed stirrup. The two fractured test specimens and corresponding fracture surface appearance are shown in Figures 10 and 11. In both cases the bar failed after bending approximately 90 degrees. Test #1 from Heat No. N16416 developed a thumbnail tear prior to fracturing brittlely. The fracture initiated at the toe of a bar deformation as also observed in the failed stirrup. Test #3 from Heat No. 27778 developed a similar thumbnail tear before fracturing brittlely, however, the tear formed in a smooth area between bar deformations. SEM examination of the crack surfaces verified the fracture mechanisms in both cases and did not reveal a material defect at the crack origin in either bar.

Figure 10 - Failed #5 Bar Bend Test Specimen (Co-Steel Heat No. N16416).
(8/00/19-2 & 8/00/19-8)

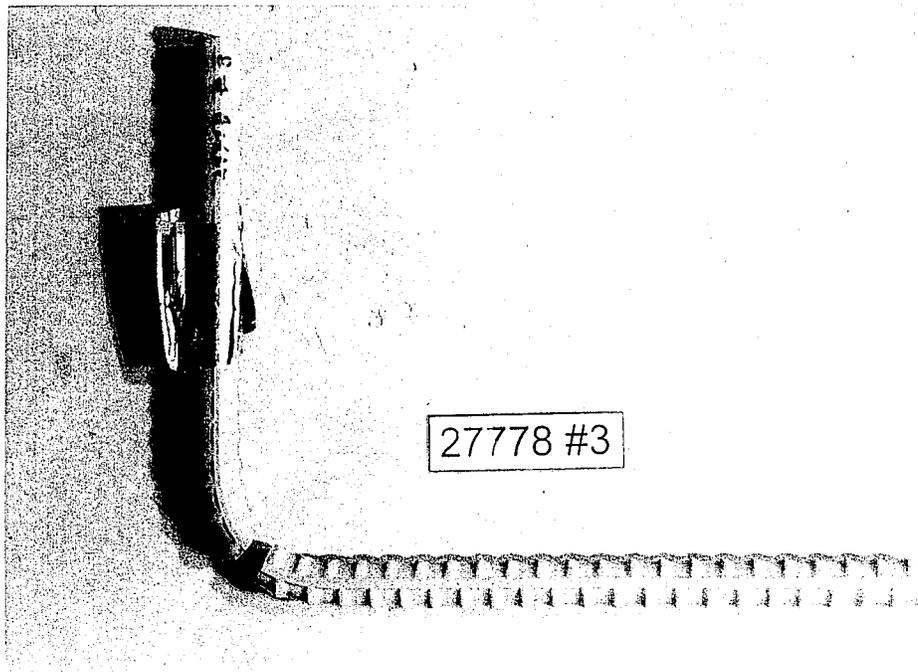
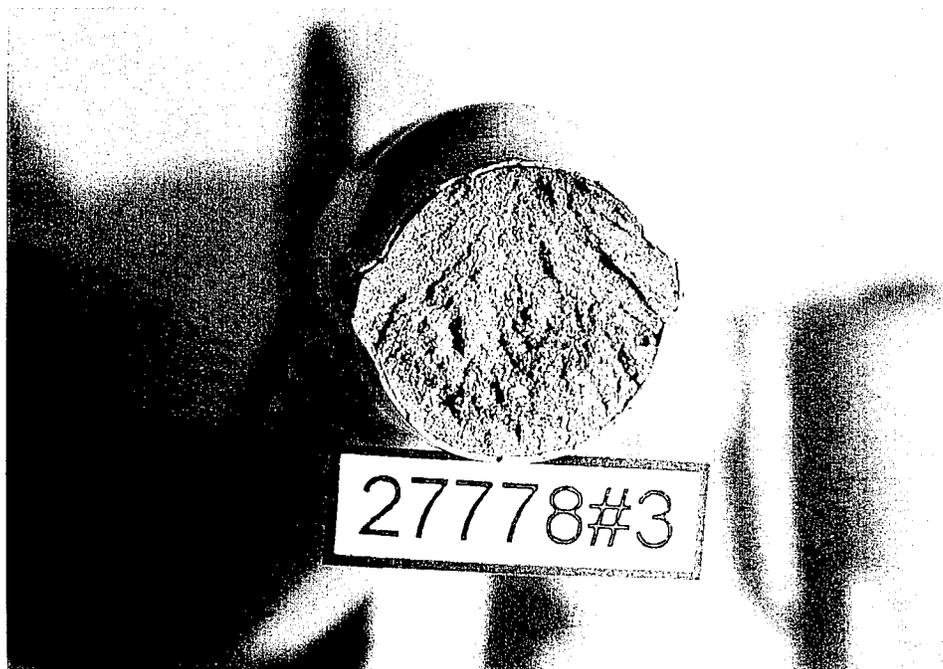
Figure 11 - Failed #5 Bar Bend Test Specimen (SMI Heat No. 27778).
(8/00/19-4 & 8/00/19-6)

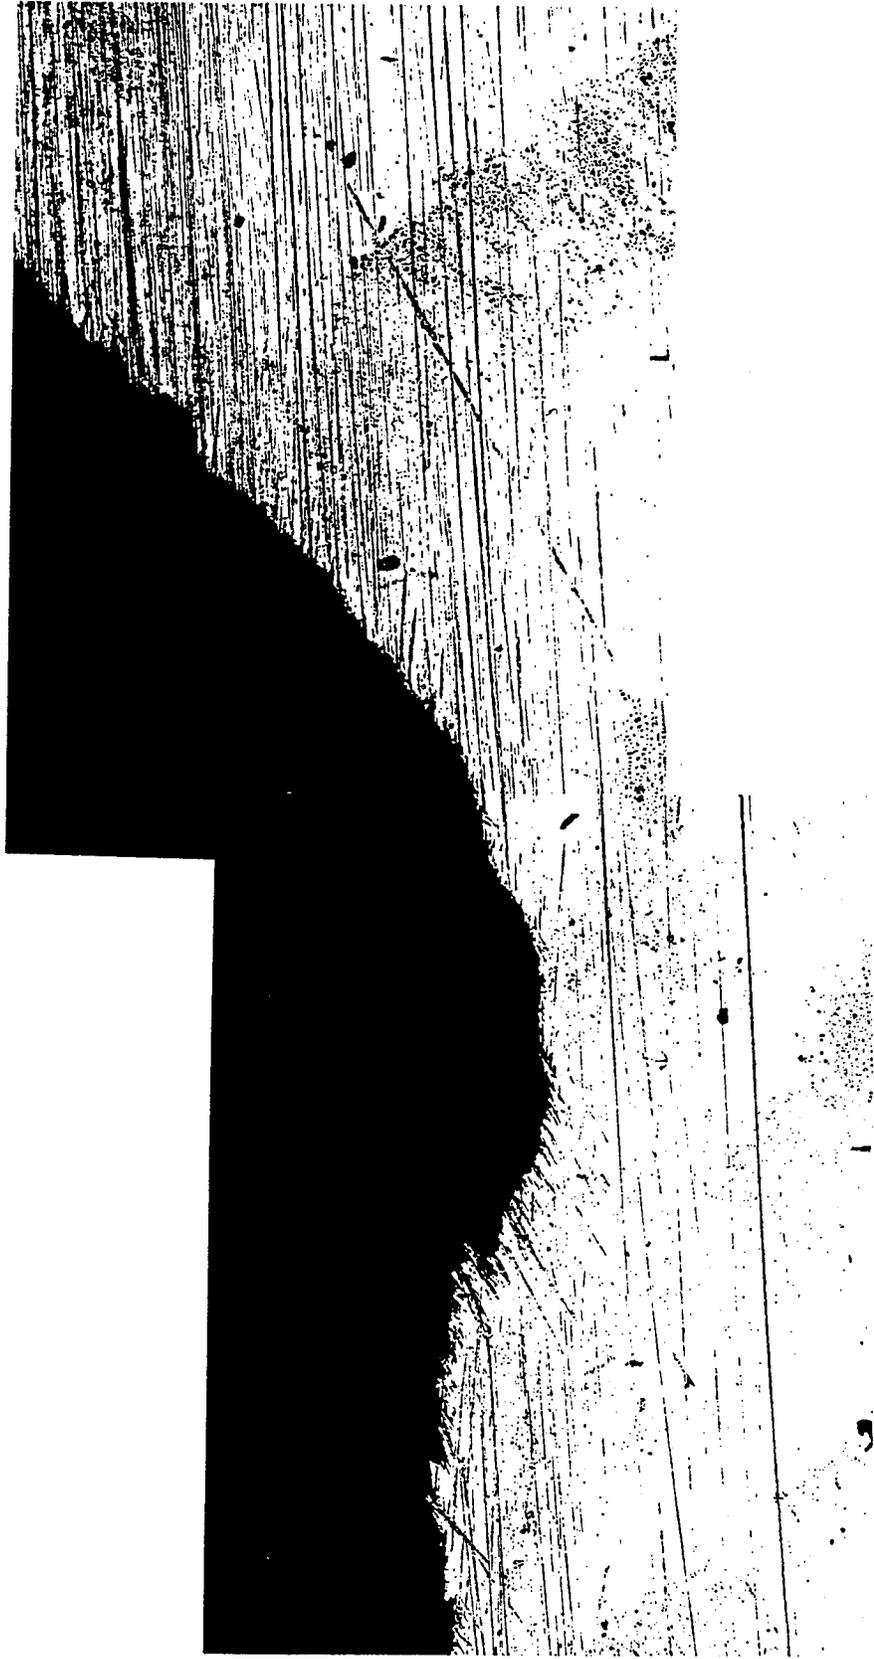
Figure 13 shows a typical bar deformation toe profile obtained from the failed stirrup. The toe of the deformation is seen to be scalloped and rises steeply to the crest of the deformation. A typical deformation profile observed in the SMI Heat 27778 bar is shown in Figure 14 for comparison. In this case the bar deformation rises gradually without any scalloping at the toe. A similar scalloped toe profile was observed in other bar samples from Co-Steel Heat No. 16416 (see Figure 15). The toe profile observed in bars from this heat are clearly more unfavorable as strain concentrators and may be the cause for the cracks observed in the bend area of the failed stirrup and high incidence of bend test failures in bars from this particular heat.

The observed irregular toe profiles are believed to be caused by wear of the rolls which introduce the bar deformation over their life. It is interesting that the scalloped toe profile was observed on only one side of the reinforcing bar. The toe profile in the opposing set of deformations appeared smoother similar to the SMI bar deformations (see Figure 16). This suggests that one roll may become worn sooner than the other. This may also help explain the statistical nature of the bend test results in Heat N16416 where some tests pass and some fail since the set of deformations exposed to tension in the bend test would be random.

Figure 13 - Typical Toe Profile of Bar Deformation in Failed #5 Bar Stirrup Showing Scalloped Toe Condition.
(Co-Steel Heat No. N16416) [Mag. 100X]

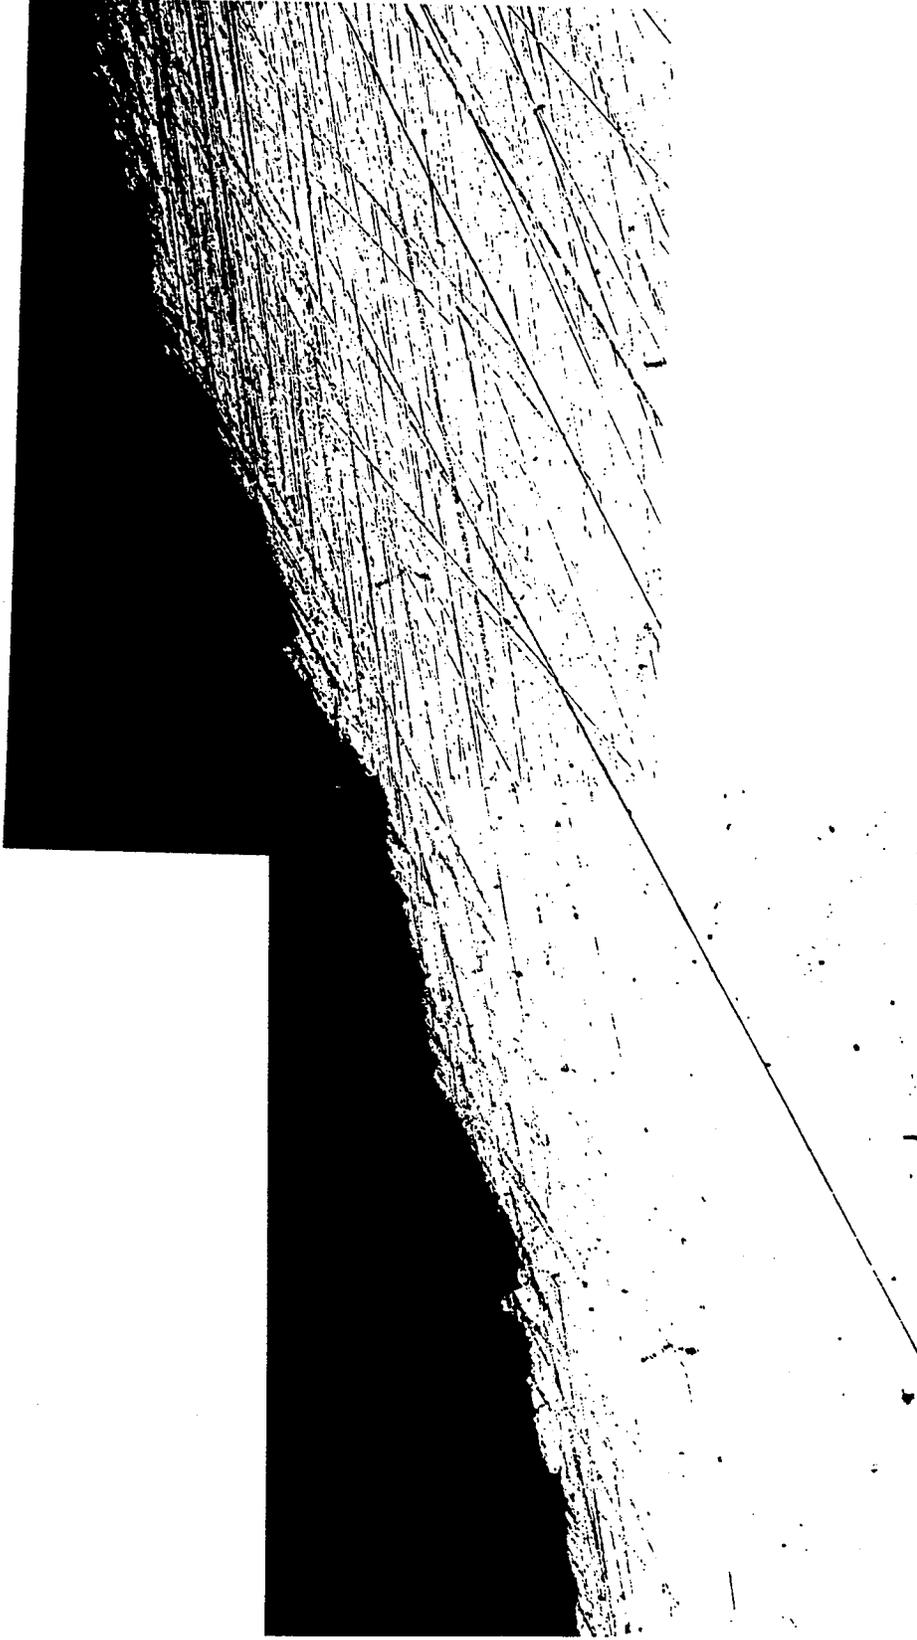
Figure 14 - Typical Toe Profile of Bar Deformation Showing Gradual Sloping Toe Condition.
(SMI Heat No. 27778) [Mag. 100X]

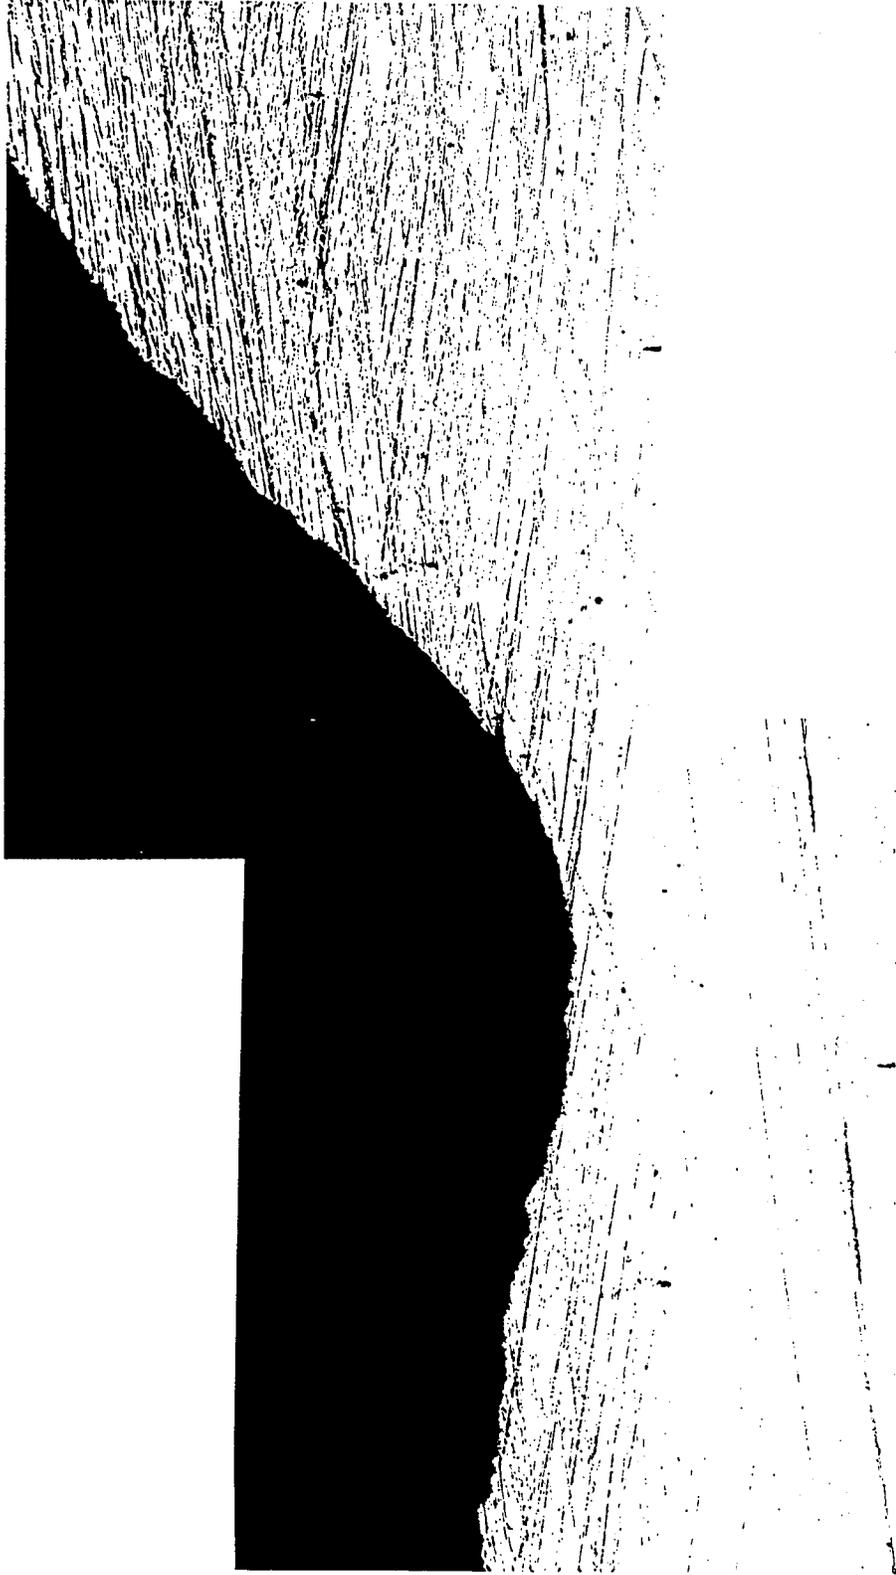
Figure 15 - Typical Toe Profile of Bar Deformation in Bar Showing Scalloped Toe Condition.
(Co-Steel Heat No. N16416) [Mag. 100X]

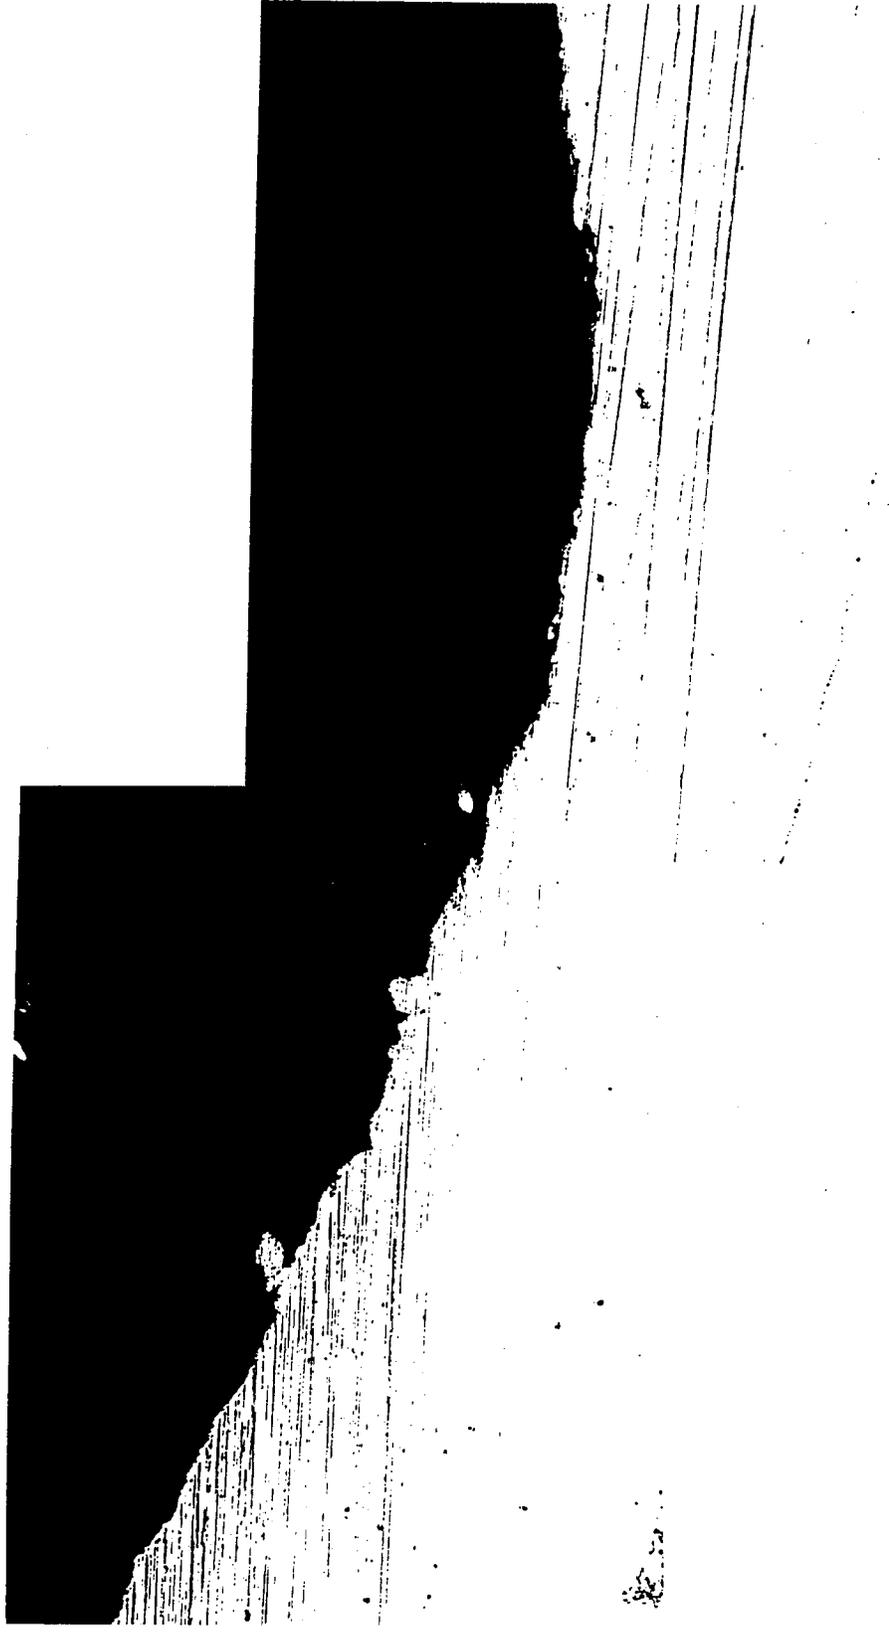
Figure 16 - Typical Toe Profile of Opposite Bar Deformation Without Scalloped Toe Condition (see Figure 15).
(Co-Steel Heat No. 16416) [Mag. 100X]

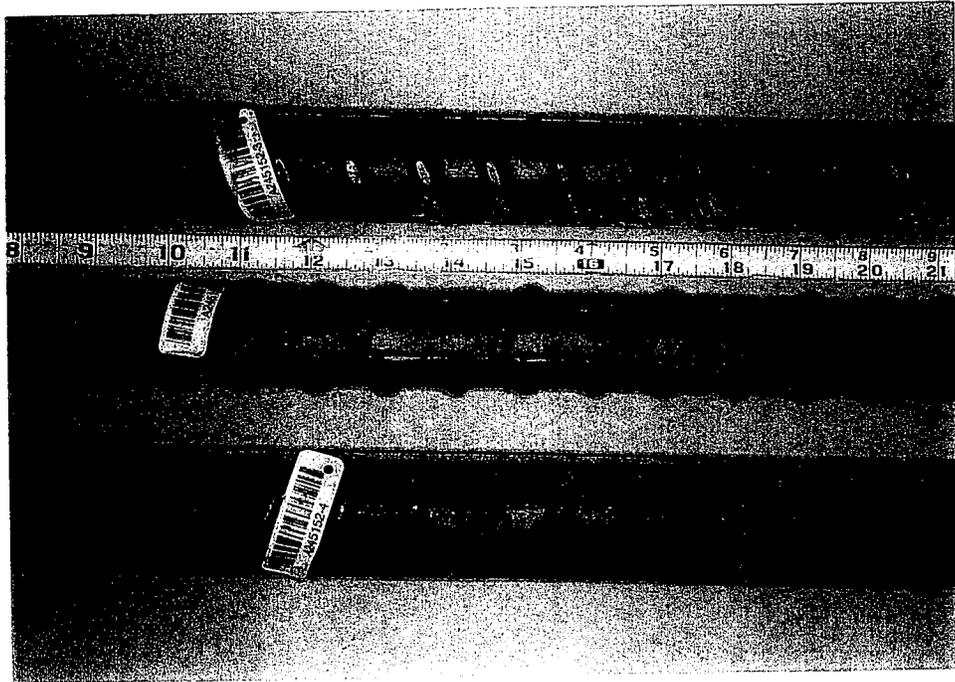
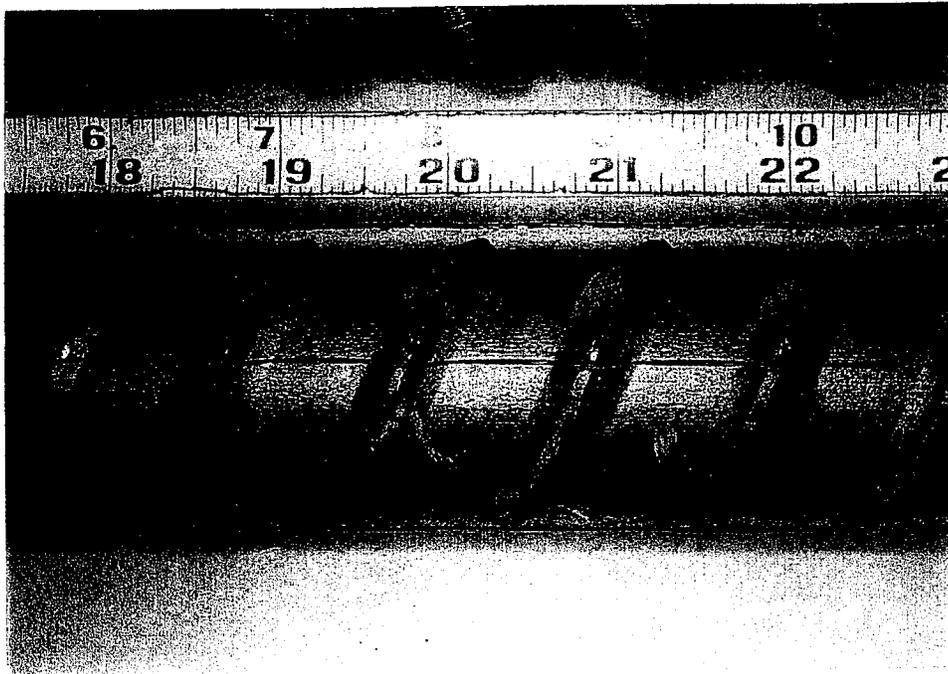
Six #11 bar samples approximately four feet in length containing longitudinal crack-like defects were provided for evaluation. The heat number of the bars was indicated to be N15361. Visually, the severity of the defects varied ranging from long continuous splits extending the full length of the sample (see Figure 1) to intermittent fine cracks (see Figure 2).

Figure 1 - #11 Bar Samples Showing Continuous Longitudinal Crack-Like Defects.
(9/00/5-6 & 9/00/5-8)

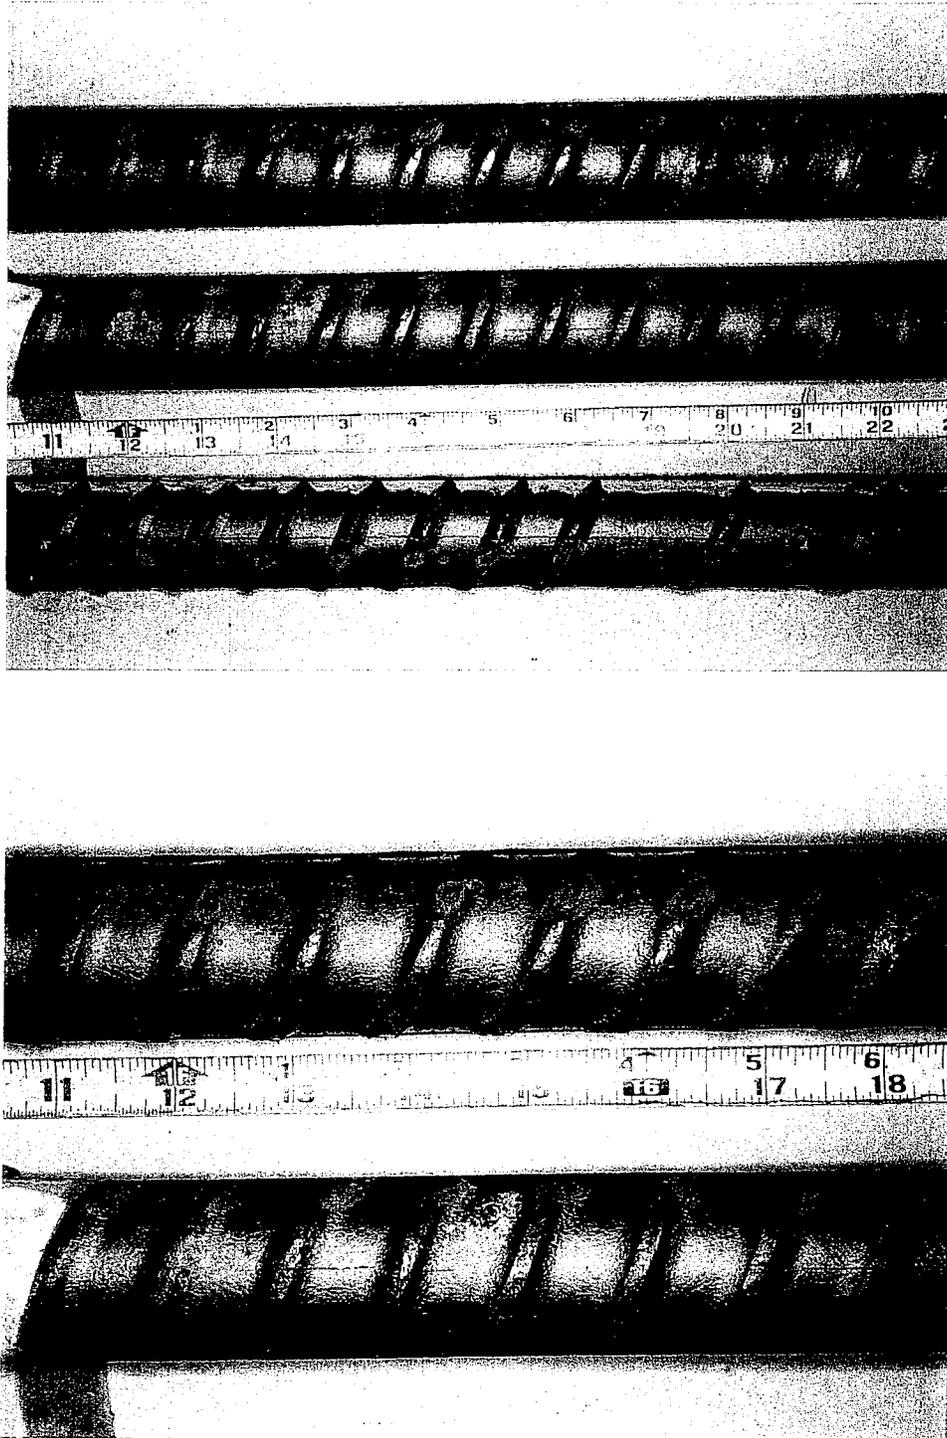
Figure 2 - #11 Bar Samples Showing Fine Intermittent Longitudinal Crack-Like Defects.
(9/00/5-10 & 9/00/5-12)

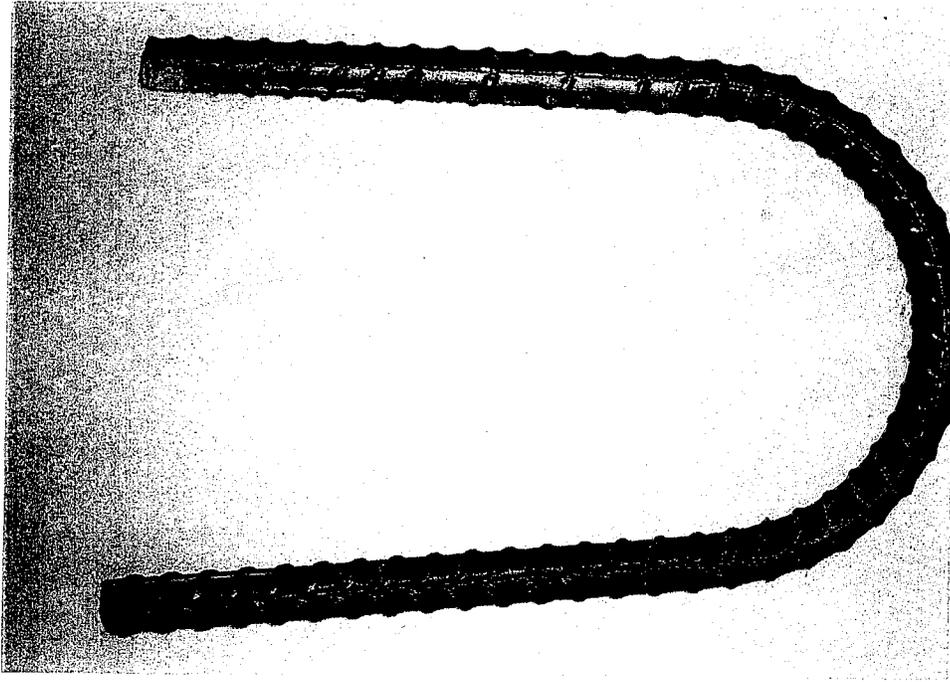
Figure 3 - #11 Bar Bend Test Specimen.
(9/00/12-6)

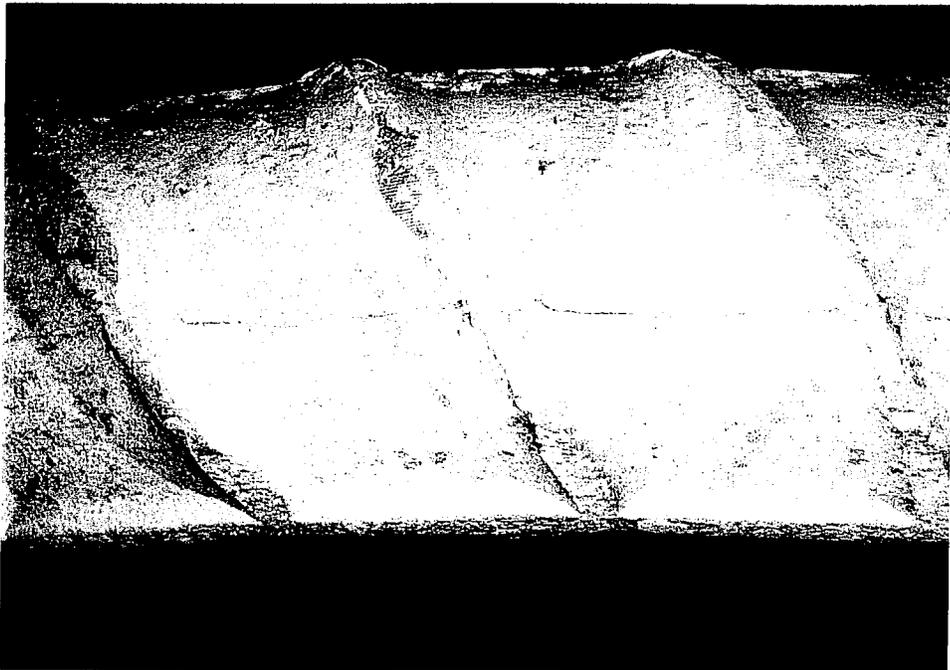
Both the tensile and bend test results indicated that the bars satisfied the mechanical property requirements of ASTM A615 Gr. 60. The longitudinal crack-like defects did not appear to adversely affect the straining behavior of the bars in tension or bending. Figure 3 shows a typical bend test specimen after bending. An enlarged view of the outer radius area containing a longitudinal defect is shown in Figure 4 where it can be seen that the crack-like defect has not extended or opened.

Figure 4 - Enlarged View of Bend Region Showing Original Longitudinal Defect.
(9/00/12-9)

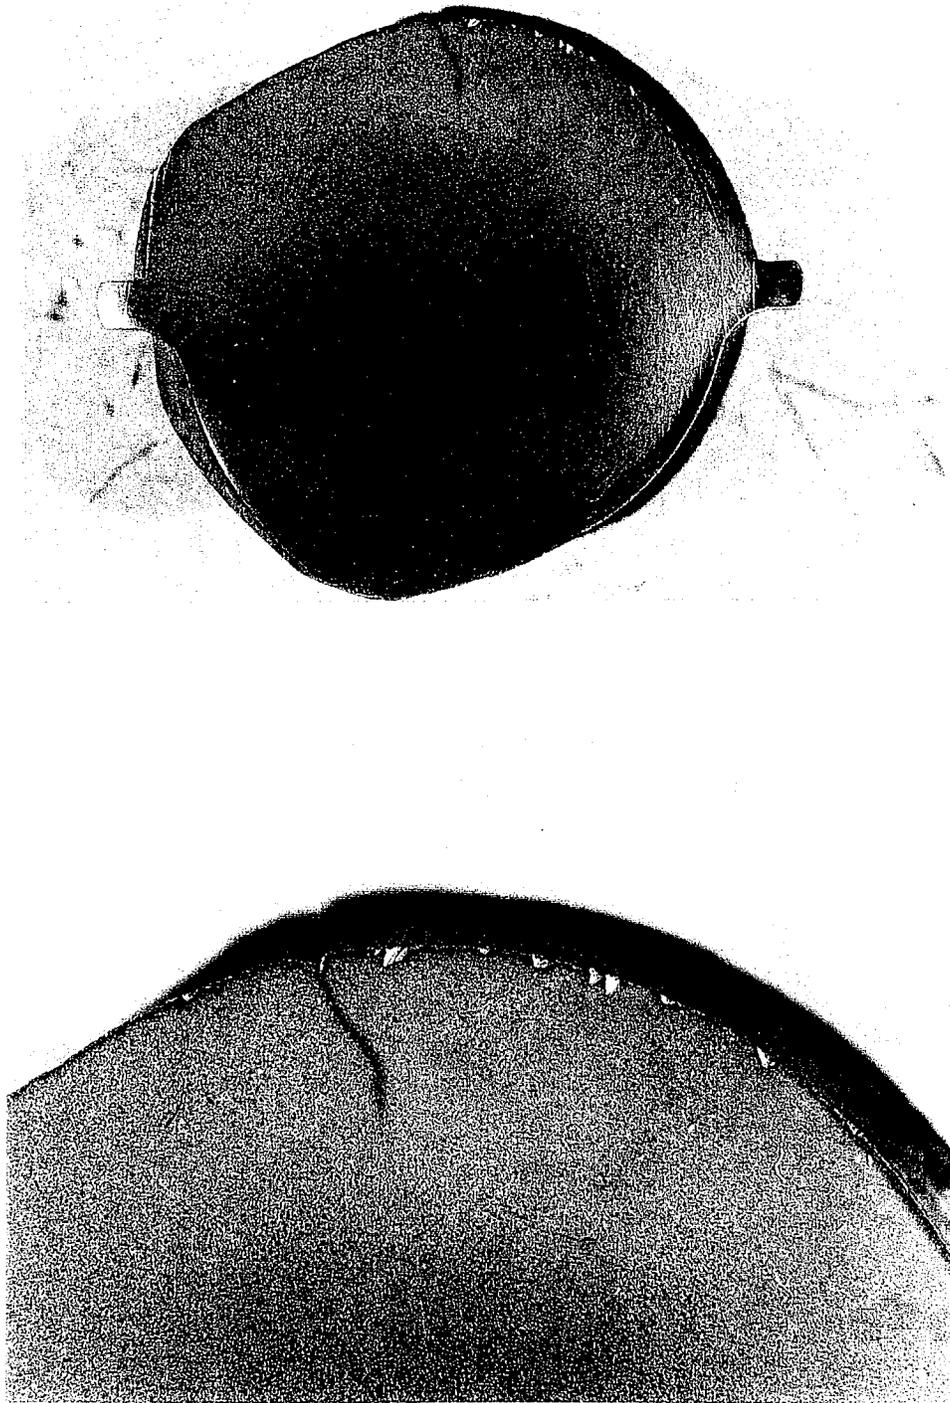
Figure 5 shows an etched cross-section through a longitudinal defect. An enlarged view of the defect is shown in the lower photograph. The depth of the defect is approximately 1/8 in. and is relatively planar and longitudinal. Figure 6 shows a higher magnification view of the crack (100X). The material adjacent to the crack is largely ferrite (white etching) in comparison to the general pearlitic (dark etching) microstructure of the material. This decarburized area in which the defect resides suggests that the defect existed prior to hot-rolling of the bar and was likely associated with a surface defect in the original continuously cast billet. Closer examination of the crack region showed a clustering of non-metallic inclusions along the crack path also consistent with this conclusion. Apparently the defect in the billet was not detected prior to hot-rolling into bars and subsequently remained through the rolling process.

3. Metallographic examination of the defect condition provided evidence that the origin of the defects was a surface defect in the original cast billet which was not detected during manufacturing and was subsequently rolled into the reinforcing bar.

Figure 5 - Cross-Sectional View of a #11 Bar Longitudinal Defect.
(9/00/12-2 & 9/00/12-5)
