**Materials-Related Forensic Analysis and
Special Testing,
Pennsylvania Department of Transportation**

“Metallurgical Investigation of Reinforcing Steel”

**Final Report
December 2000**

During the construction of a bridge deck on SR 0228, Section 241 in District 10-0, epoxy-coated reinforcing steel was found to break during field bending by mandrel and arm strength. The steel was traced to product produced by Co Steel (New Jersey). Due to schedule considerations the fabricator replaced all the steel on the site from the same "heat" number. Steel from another manufacturer, SMI (North Carolina) was also shipped to the District 10-0 jobsite. Initially, both sources were investigated.

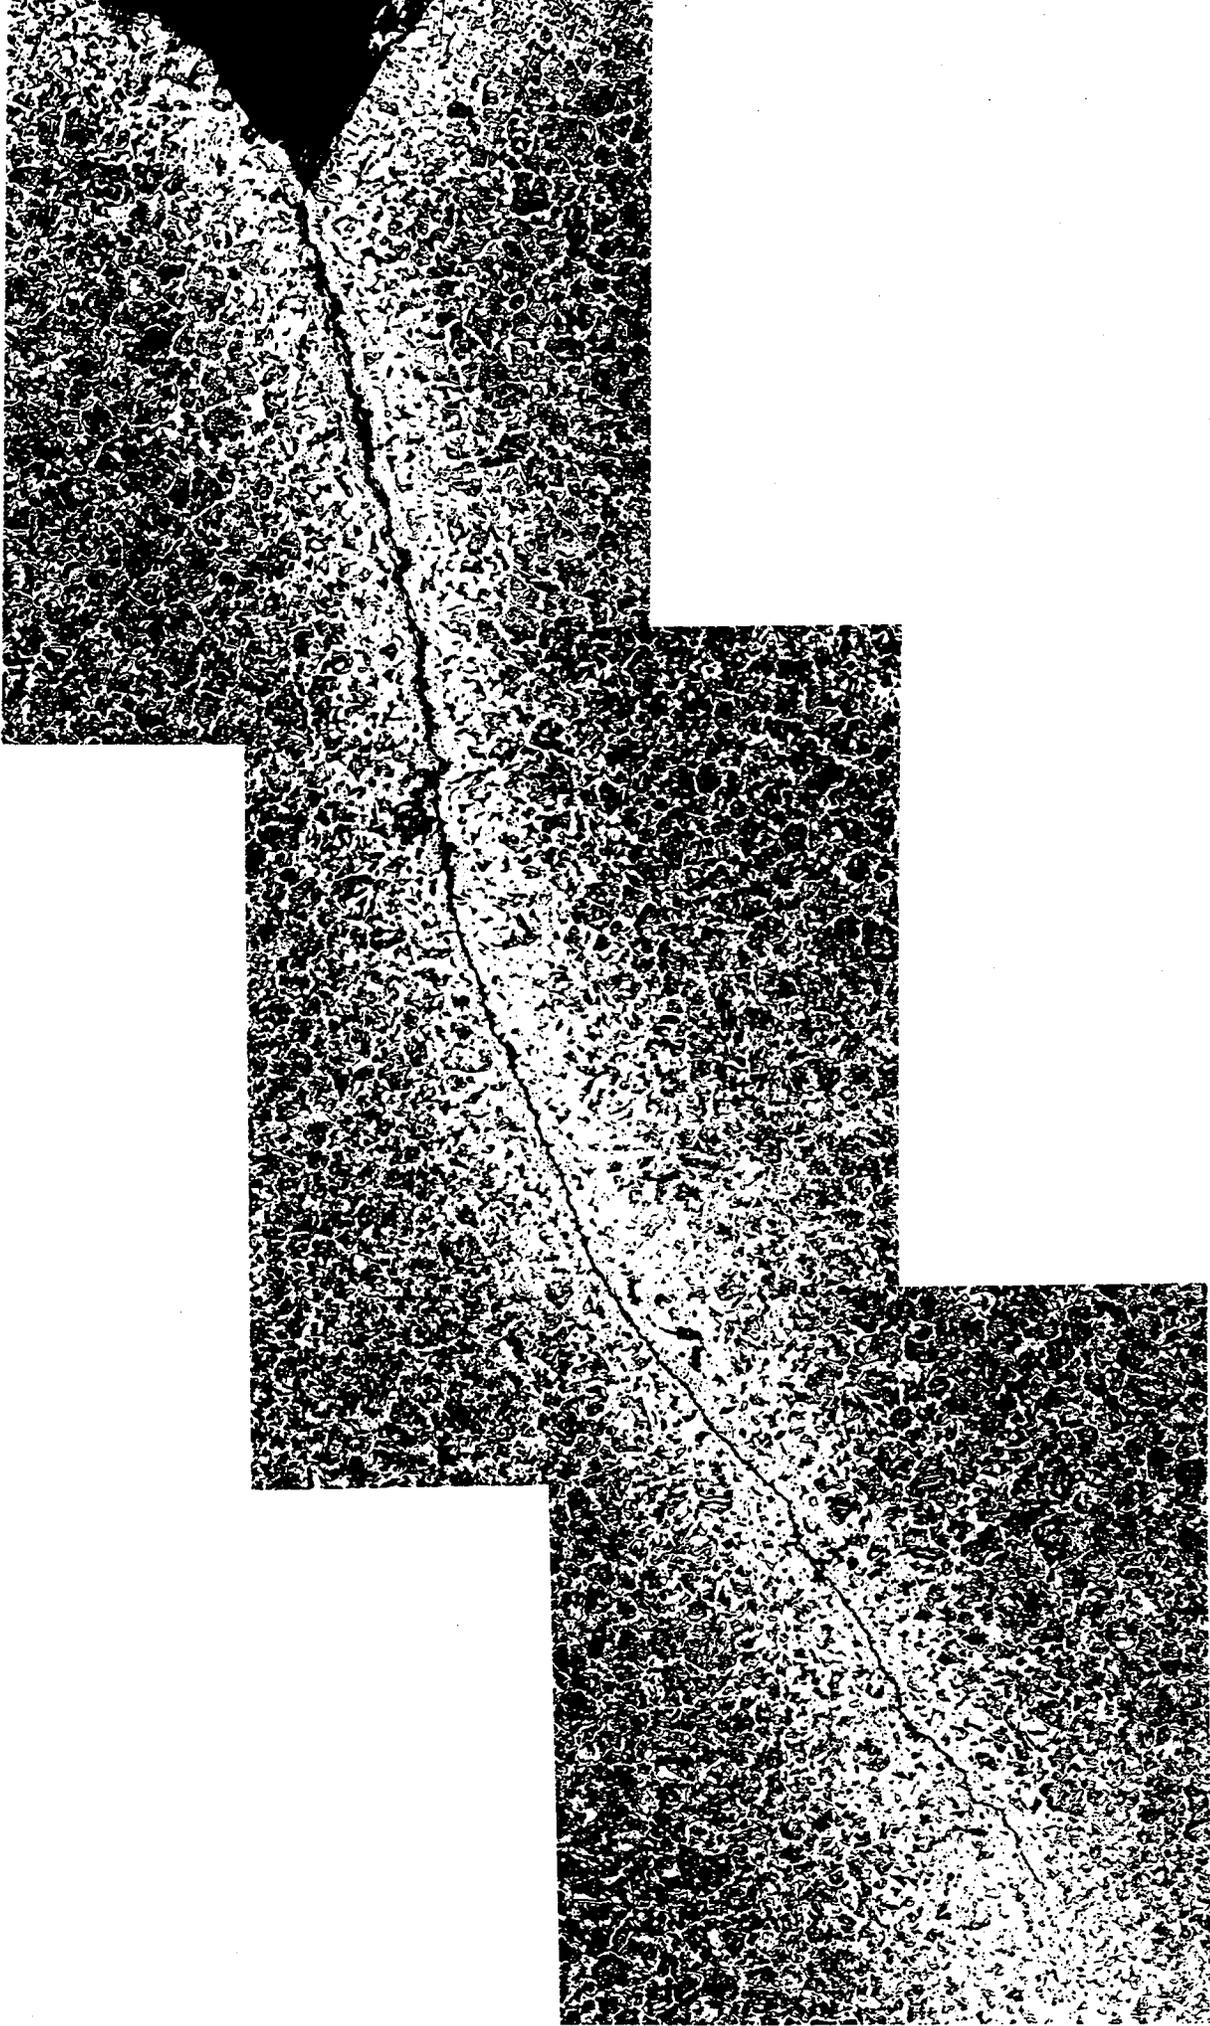
Figure 5 shows an etched cross-section through a longitudinal defect. An enlarged view of the defect is shown in the lower photograph. The depth of the defect is approximately 1/8 in. and is relatively planar and longitudinal. Figure 6 shows a higher magnification view of the crack (100X). The material adjacent to the crack is largely ferrite (white etching) in comparison to the general pearlitic (dark etching) microstructure of the material. This decarburized area in which the defect resides suggests that the defect existed prior to hot-rolling of the bar and was likely associated with a surface defect in the original continuously cast billet. Closer examination of the crack region showed a clustering of non-metallic inclusions along the crack path also consistent with this conclusion. Apparently the defect in the billet was not detected prior to hot-rolling into bars and subsequently remained through the rolling process.

Figure 6 - Etched View of a Longitudinal Defect. Note Decarburized Region Adjacent to Crack-Like Defect. [Mag. 100X]
