Crash Test Between a 6-KG/M U-Channel Sign Support and a 1997 Geo Metro: FOIL Test Number 99F007

PUBLICATION NO. FHWA-RD-01-049

MARCH 2001

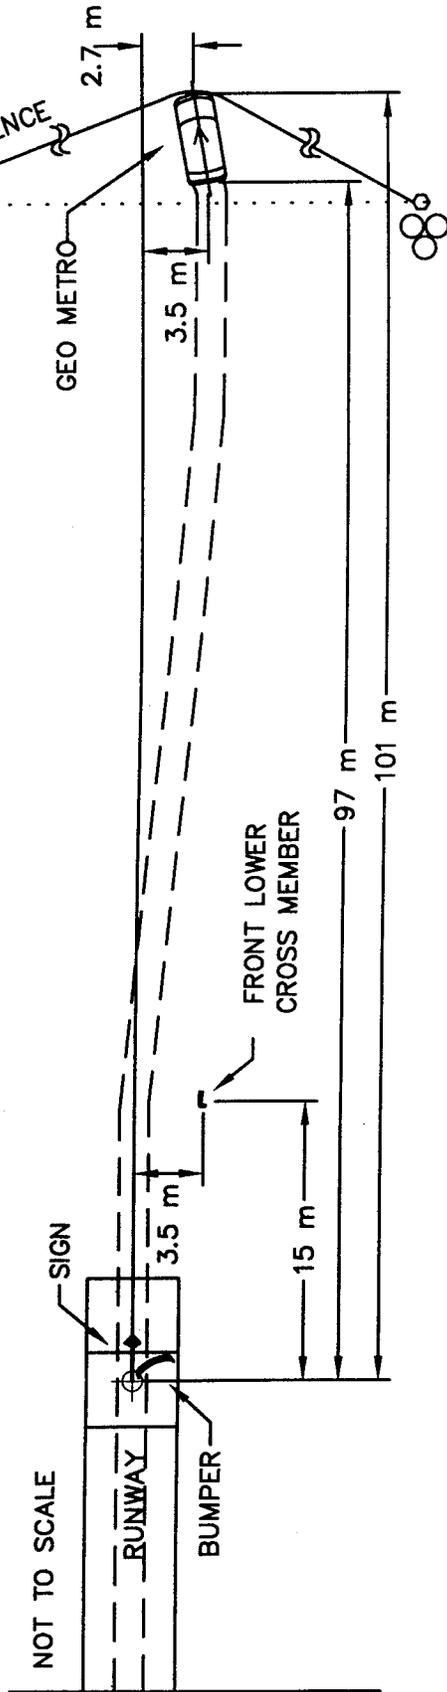
Figure 4. Summary of results, test 99F007.

The results summarized in figure 4 indicate that the 6-kg/m small sign support embedded in strong soil did not meet the safety performance criteria outlined in *NCHRP Report 350* (test designation 3-61). The sign support did not fracture as anticipated and the longitudinal OIV (5.2 m/s) was higher than the allowable limit (5.0 m/s). Table 6 summarizes the safety performance of the small sign support.

Occupant Risk:	Observed	Design/Limit
Longitudinal:		
Occupant delta V at 0.6 m.....	5.2 m/s	3/5 m/s
Ridedown acceleration.....	1.1 g's	15/20 g's
Lateral:		
Occupant Delta V at 0.3 m.....	no contact	NA
Ridedown acceleration.....	no contact	NA
Peak 50 ms acceleration:		
Longitudinal.....		7.1 g's
Lateral.....		0.9 g's
Vehicle Damage:		
Traffic Accident Data (TAD).....		12-FC-4
Vehicle Damage Index (VDI).....		12FCEN3
Static crush.....		305 mm
Post fracture.....	460 mm vertical tear in web	
Exit speed.....		73.9 km/h
Exit angle.....		0.0°
