EXPERIMENTAL INSTALLATION OF LARGE DIAMETER (48 in.) HIGH DENSITY POLYETHELENE CULVERT PIPE (HDPE)

CONSTRUCTION REPORT

CONSTRUCTION REPORT
Report # PE-09-00

Joe Wilson
Wisconsin Department of Transportation
Technology Advancement Specialist

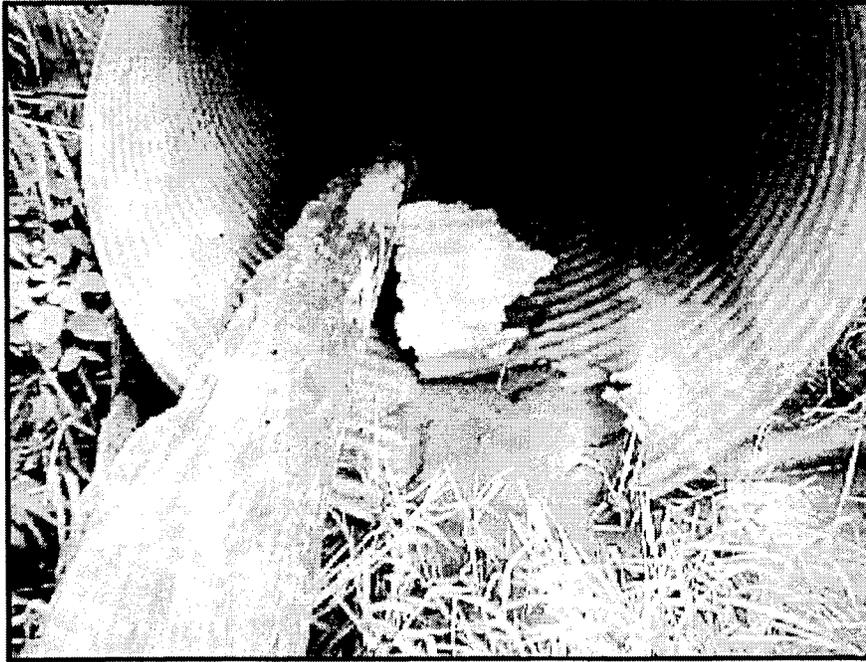
Upon removal of the existing 54 in. corrugated metal pipe (Prints 1-7, Appendix C), it was observed that the bottom of the pipe was deteriorated and corroded, probably due to standing acidic water in the bottom of the pipe. It was estimated that the pipe was approximately 25 years old.

Print 1. View of the inlet of the old metal corrugated culvert pipe. Notice the deterioration of the pipe on the bottom due to the acidic water.

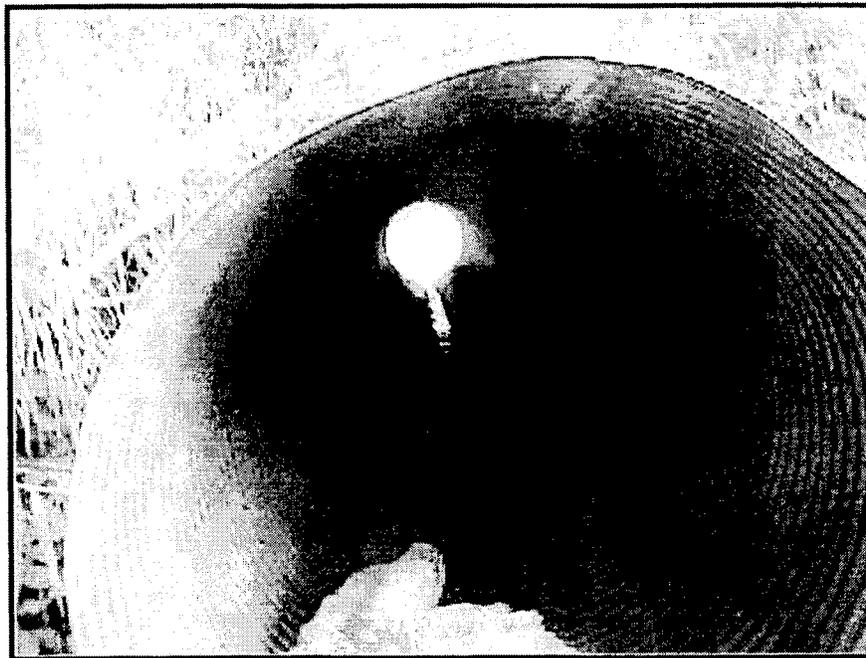
Print 2. Another view looking at the old pipe from the inlet end.

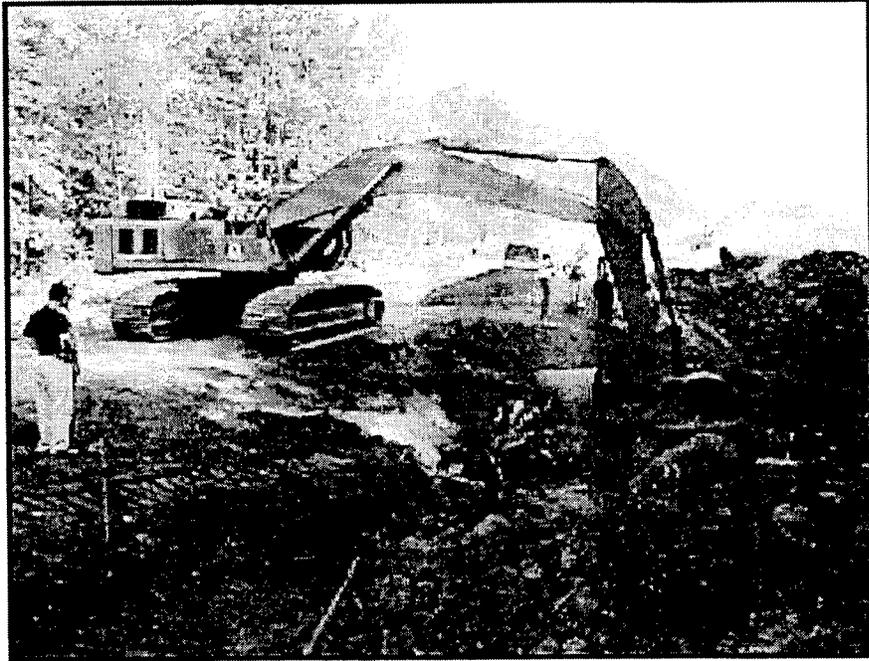
Print 3. View of the old pipe prior to removal.

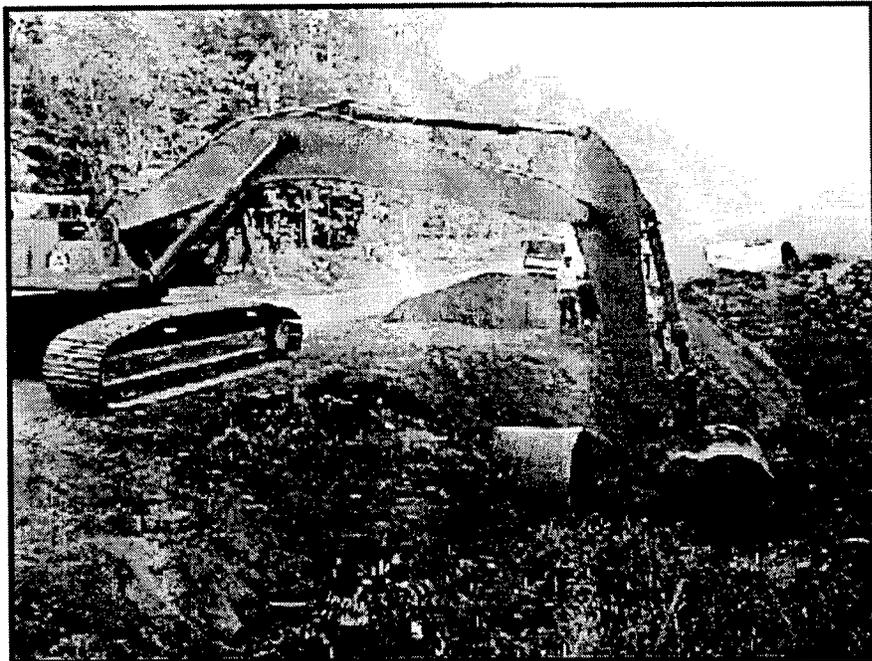
Print 4. A closer view of the same image above.

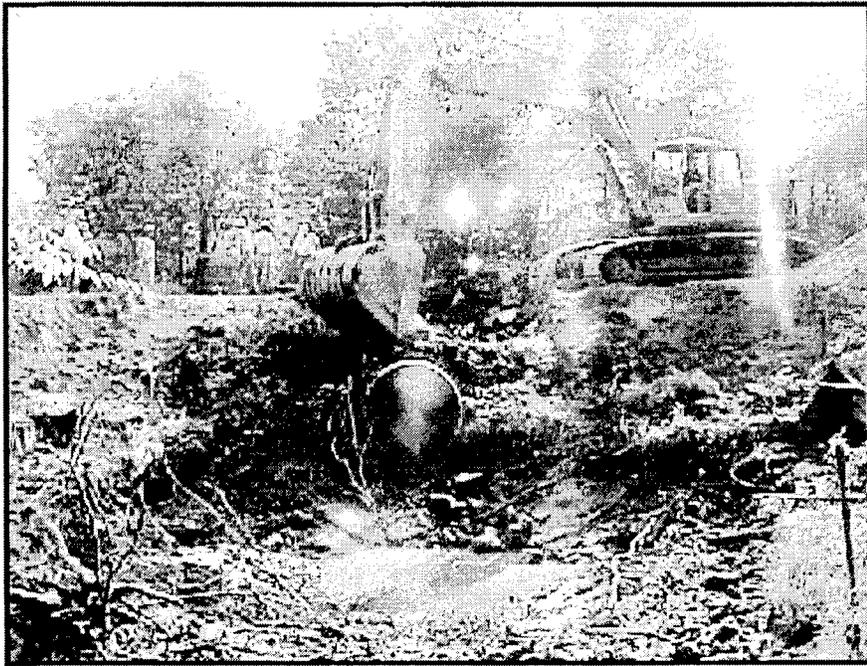
Print 5. View of the old pipe being dug out looking from the outlet side.

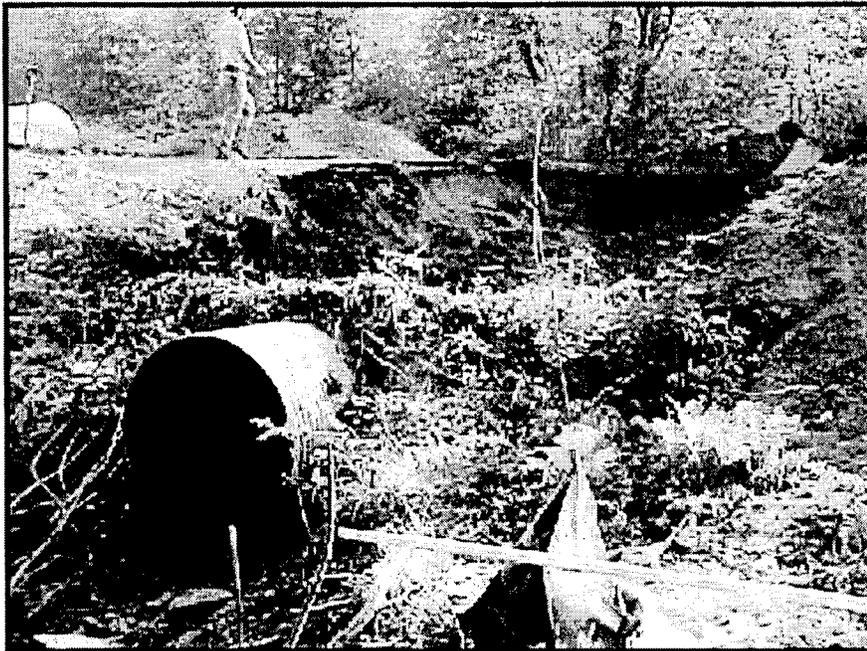
Print 6. View of the old pipe looking from the inlet side.

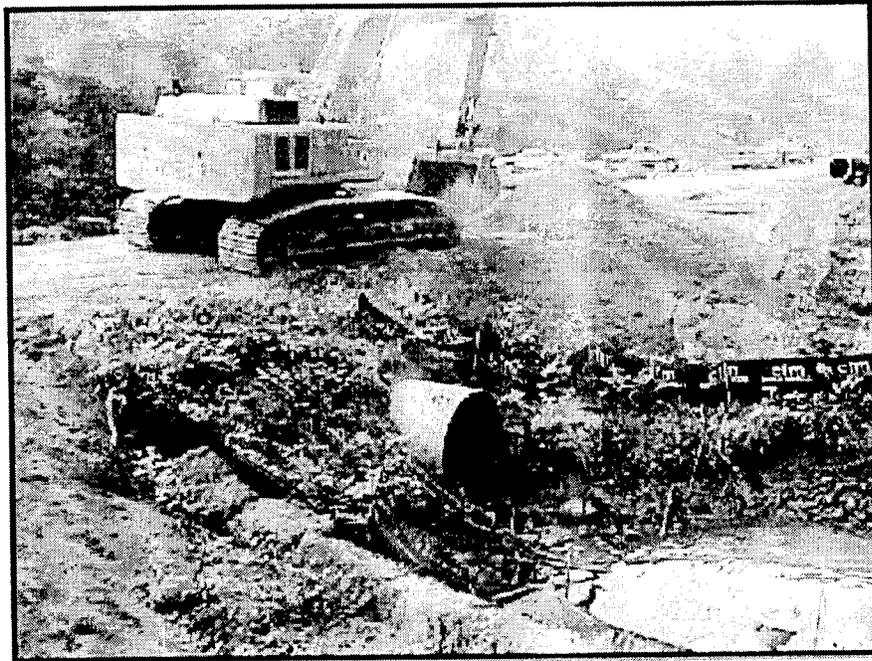
Print 7. View of the outlet and scour hole of the old pipe. Most of the water was pumped out of the scour hole prior to the removal operation.

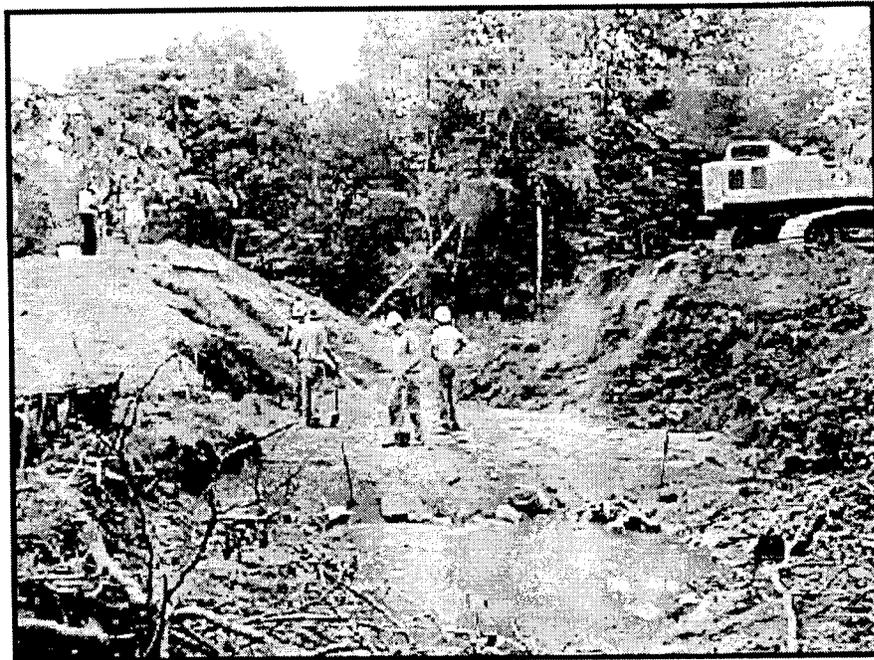
Print 8. View of the trench and preparation of the bedding material looking from the outlet end.

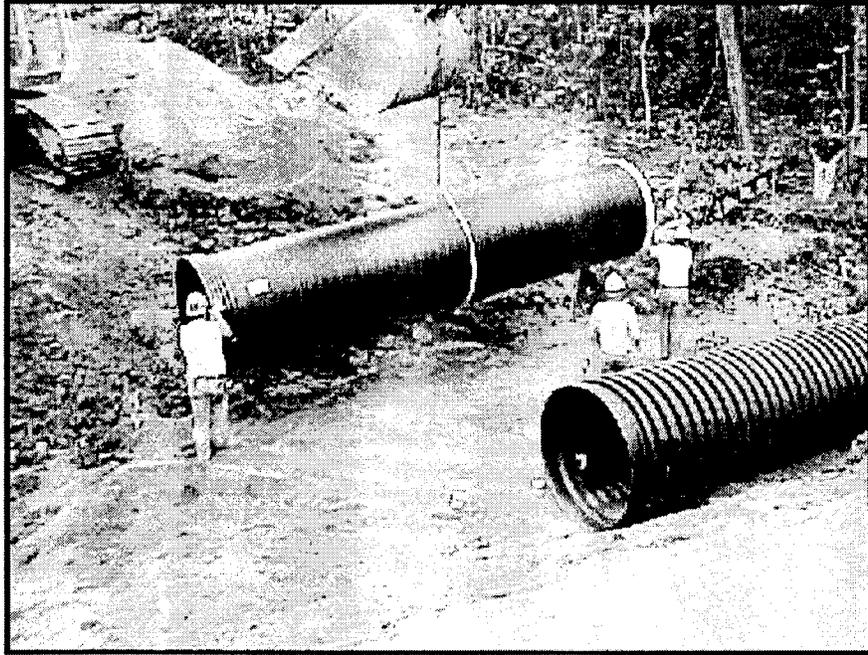
Print 9. Placing the ADS pipe on the bedding material, Hancor pipe is on the right. Notice the ADS pipe has a smooth exterior with no corrugation.

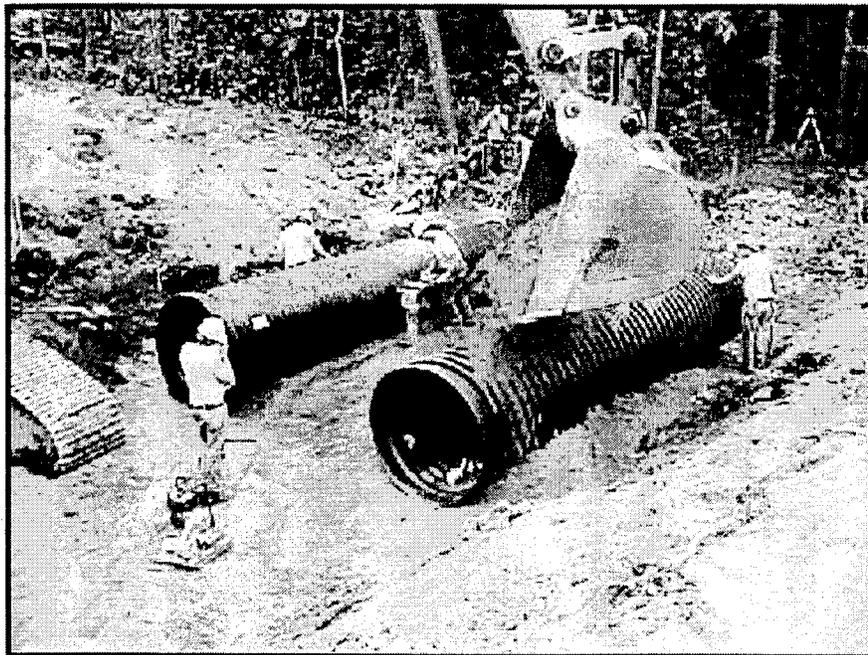
Print 10. Showing the backfilling and compaction of the first two pipe sections.

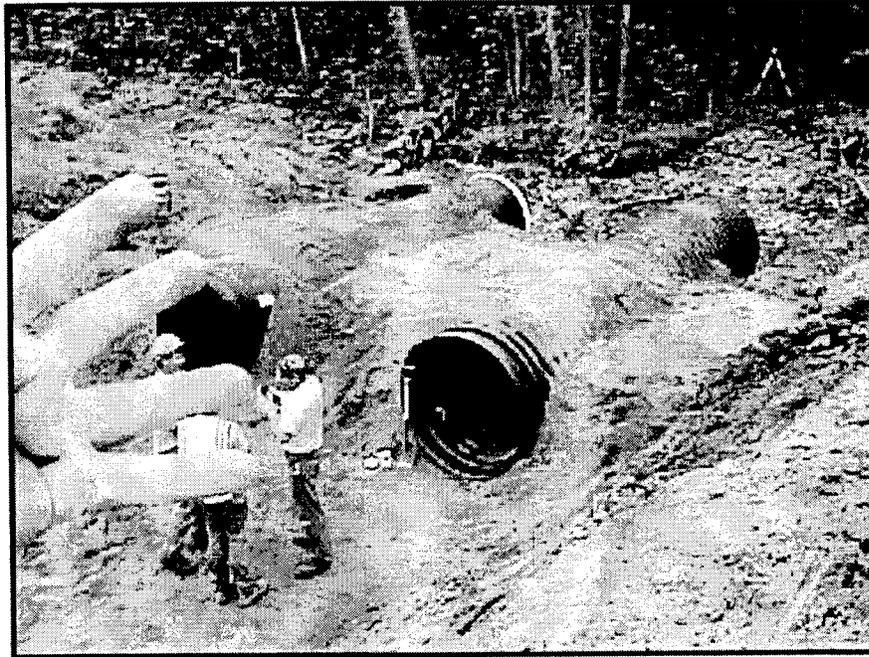
Print 11. The first two pipe sections after 4 compacted lifts.

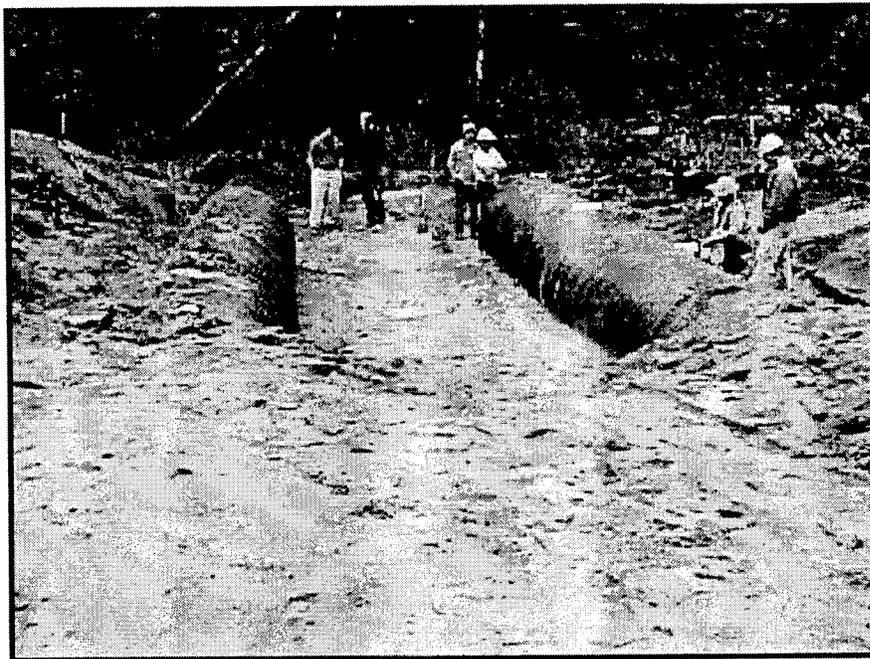
Print 12. Another view of the pipes during the backfill and compaction operation.

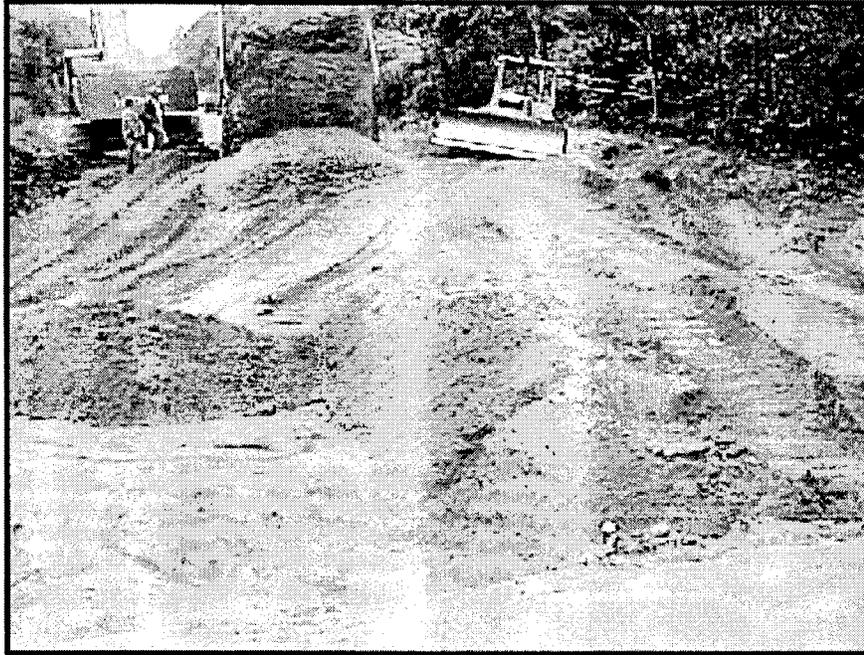
Print 13. The final lifts are being spread and prepared.

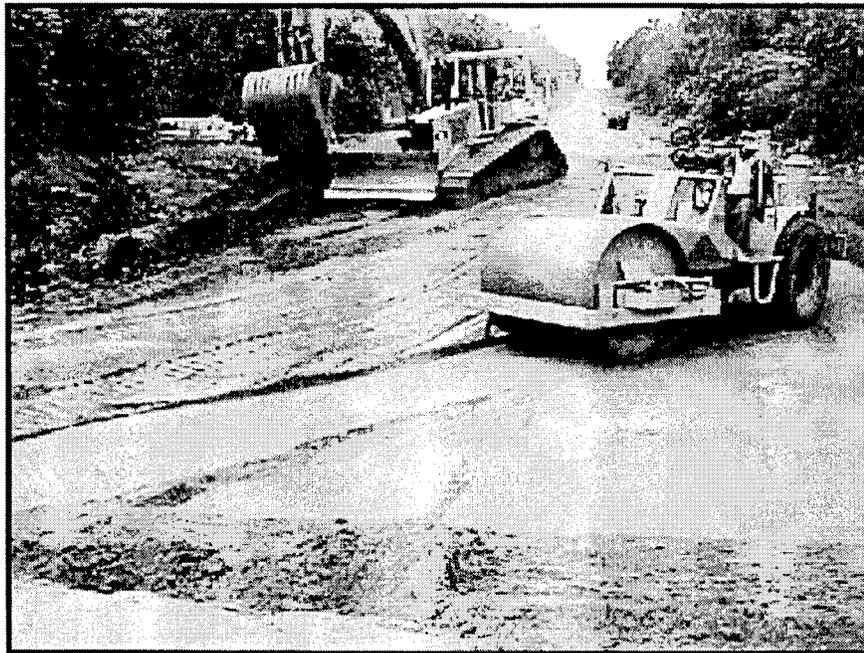
Print 14. Vibratory steel wheeled roller compacting the final lifts.

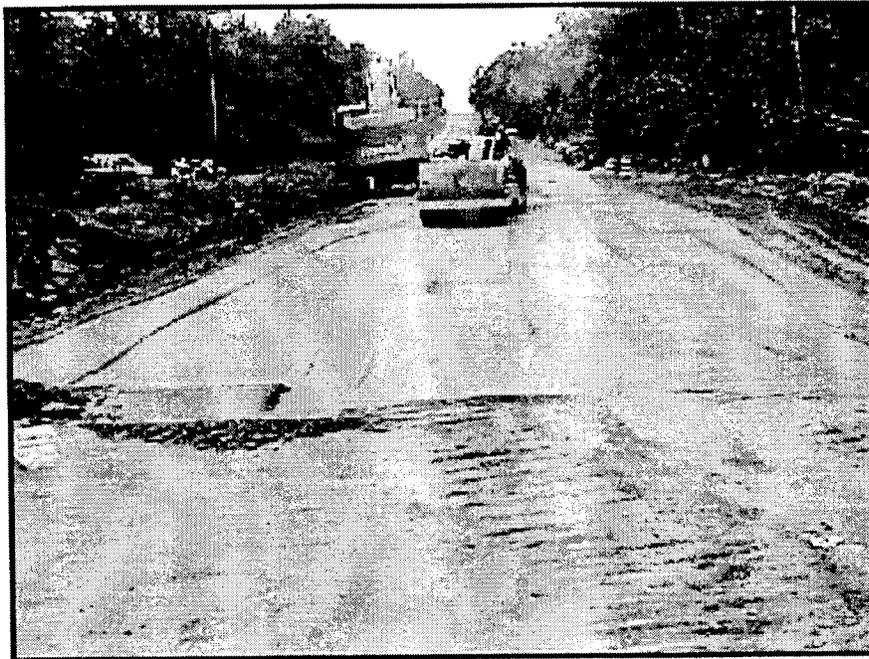
Print 15. The final lift being compacted.

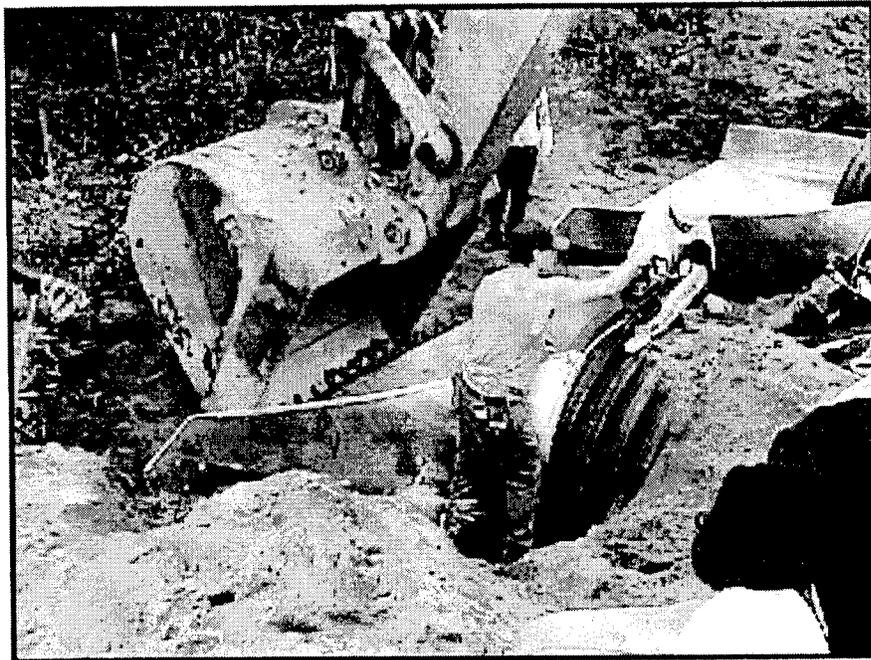
Print 16. Placement of the end wall aprons, the bucket being used to “snug” up the apron.

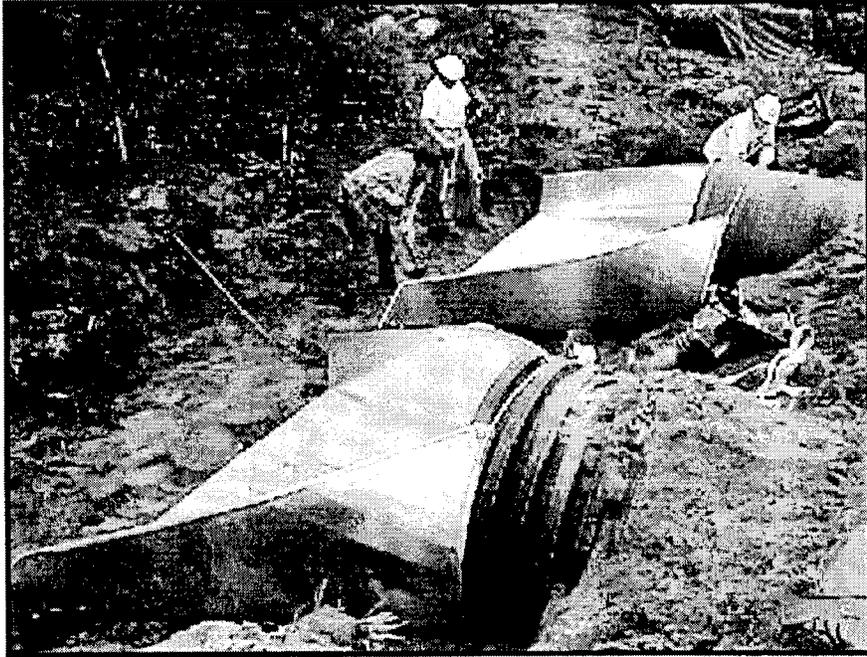
Print 17. Another view of the end wall aprons. Notice the lip or groove on the Hancor pipe in the foreground providing sound attachment of the end wall apron to the culvert pipe.

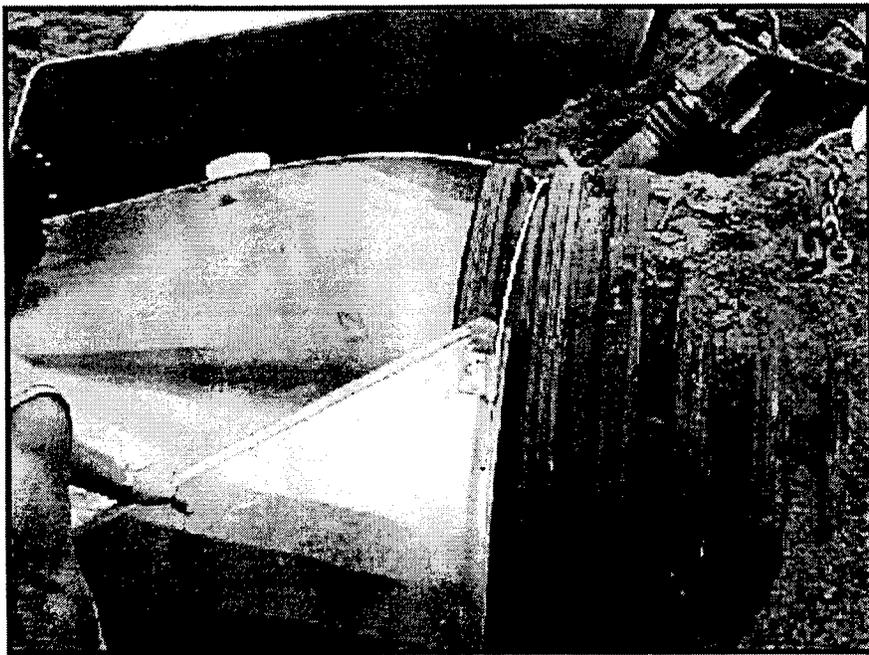
Print 18. A close up view of the end wall apron attachment to the Hancor pipe.

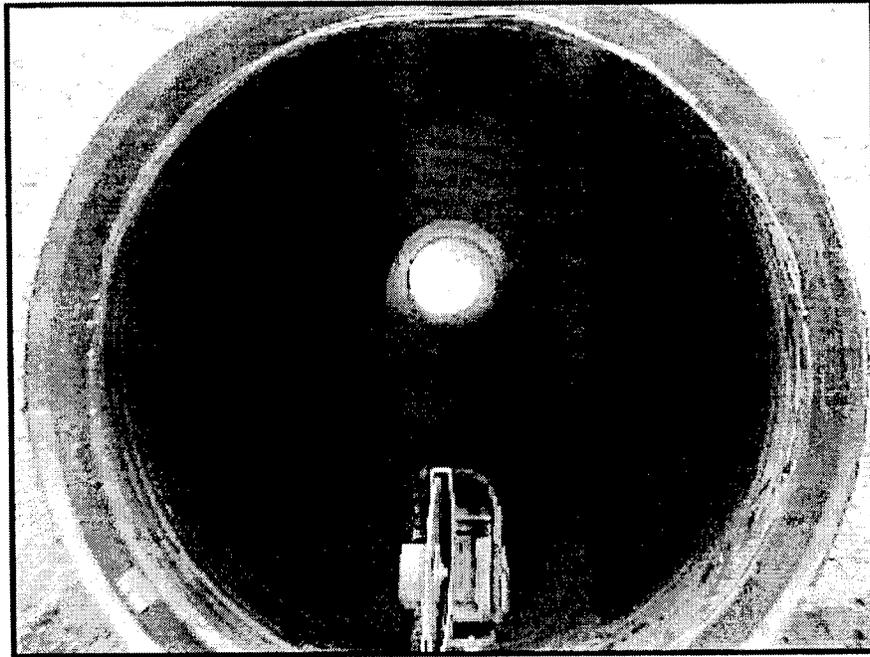
Print 19. View of the ADS pipe after installation showing no noticeable deformation from the installation.

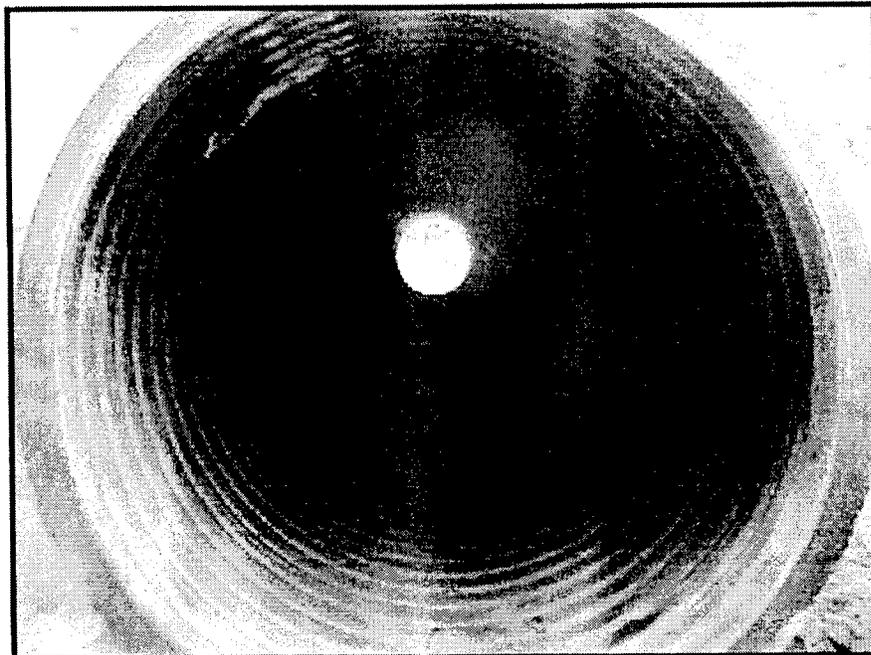
Print 20. View of the Hancor pipe after installation showing no noticeable deformation from the installation.
