REPORT FHWA/NY/SR-01/137

# Load Testing of An FRP Bridge Deck On A Truss Bridge

# **LOAD TESTING OF AN FRP BRIDGE DECK ON A TRUSS BRIDGE**

Special Report 137  
July 2001

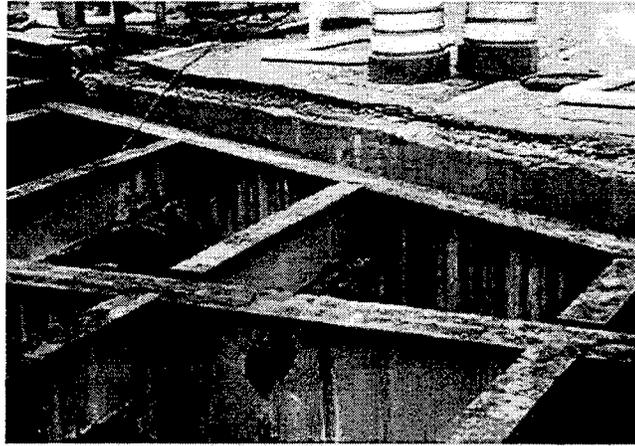
**Figure 2. Corrosion of steel superstructure at the south abutment.**

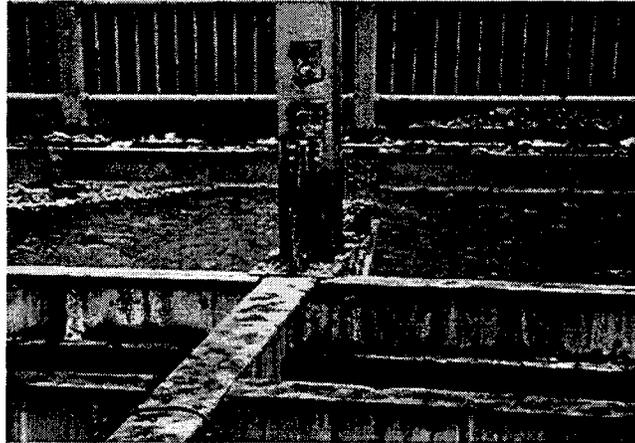
**Figure 3. Corrosion at the floor-beam to truss connection.**

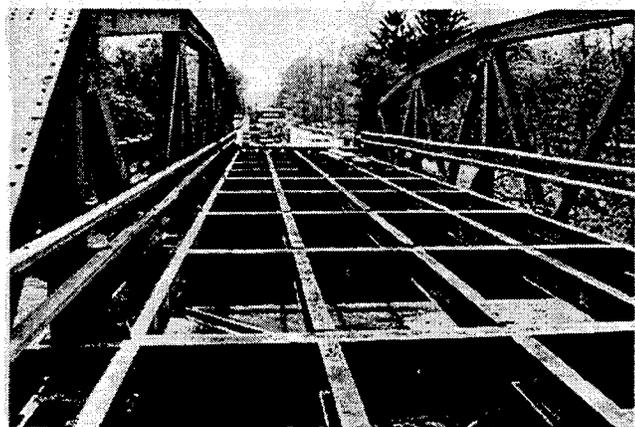
**Figure 4. Corrosion of floor-beams.**

rating of the deck was 3, on a scale of 1 to 7 used in New York State (see Table 2), indicating serious deterioration. The steel trusses were found to be in relatively good condition even though the superstructure was built in 1940. The minor deterioration was attributed to leakage of water laden with de-icing salts. The load posting had a negative impact on local commerce and restoring the bridge to full service was imperative. Exploration of rehabilitation alternatives began in 1998.

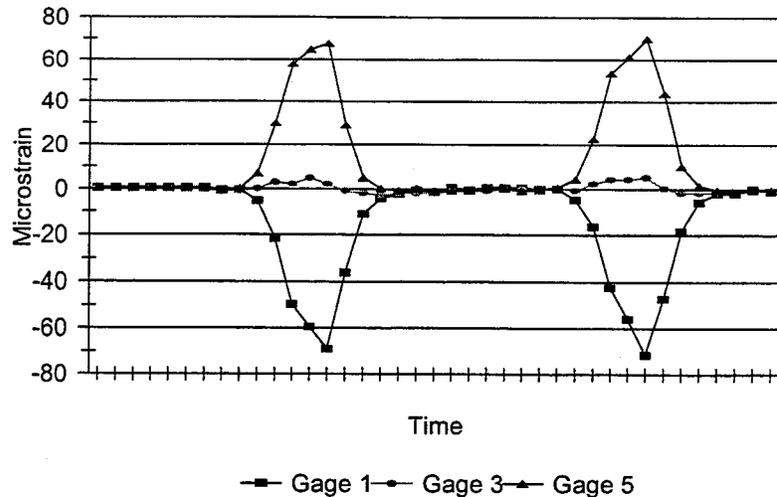
Strain gages 0, 1, 2, 3, 4, and 5 were mounted on a steel floor-beam supporting the FRP deck (see Figure 9) to determine neutral axis of the deck-floor-beam system. Gages 0 and 1 were mounted to the upper flange, gages 2 and 3 were mounted on the web at mid-height of the girder (at the neutral axis of the floor-beam), and gages 4 and 5 were mounted to the lower flange. If there is no composite action between the floor-beam and the deck, neutral axis of the deck-floor-beam system should coincide with the neutral axis of the floor-beam. In this situation, Gages 2 and 3 should read no flexural strains; and top flange gages (0 and 1) and bottom flange gages (4 and 5) should read strains of same magnitude with opposite signs (positive for tension, and negative for compression). Data collected from Gages 1, 3, and 5 during Load Cases 1 and 2 are shown in Table 4. The results show that the strains in bottom and top flanges are almost the same except for the sign (as expected) and represent a mirror image, with negligible strain at the center of the girder. The data indicates that the neutral axis of the girder is unchanged with the addition of the FRP deck and no composite action exists between the deck and the floor-beams. Redundant Gages 0, 2, and 4 confirmed this observation. The same behavior can be seen in the data collected during the passage of a truck rolling at 5 km/hr across the bridge (see Figure 15).

Figure 15. Gages on steel floor-beam during the 5km/hr rolling tests.

This validates the deck design, which assumed no composite action between the deck and the floor-beams, and the effectiveness of the connection system used to fasten the FRP deck to the floor-beams.

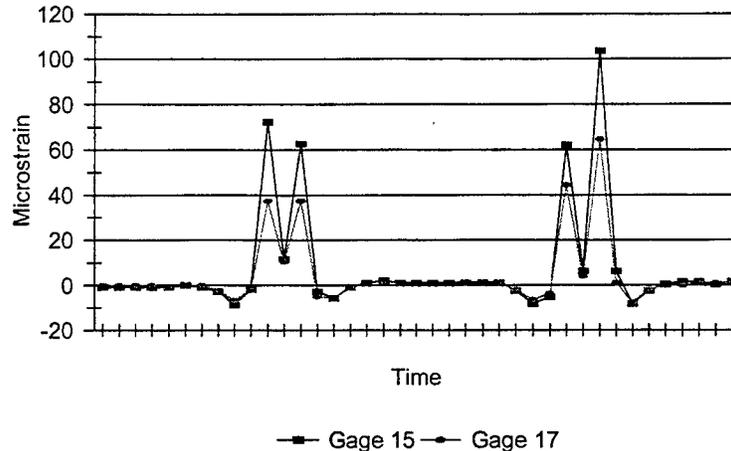
The deck panels were connected to each other with epoxy resin on the vertical faces as well as top and bottom FRP cover plates. There is no other mechanical shear-key mechanism. Hence to study the effectiveness of the joints, strain gages were installed on both sides of the longitudinal joint and loaded trucks were positioned in both lanes of the structure (Load Case 1 - see Figure 12), one truck at a time. The data from this load case is shown in Table 5. If the joint is transferring the loads effectively, strains recorded by the gages on either side of the longitudinal joints should be equal. With one truck located on deck panels on each side of the joint, (the case of Trucks A+B), both the gages read similar strains as expected since the trucks have near equal weights. When the load is only on one side of the joint, the readings changed noticeably. The data shows that the joint is transferring approximately 65 to 70% of the load. The same trend can be observed using the data obtained from semi-static load testing (see Figure 16). These results indicate that the longitudinal joint is transmitting loads from one deck segment to the other, but the load is not completely carried across the joint. Since the deck joints were new at the time of the testing, it is recommended that testing be repeated after a few years to determine if in-service loads and environmental conditions have degraded the joint effectiveness.

Figure 16. Gages both sides of the longitudinal joint during the 5km/hr rolling tests.
