Bonded Concrete Overlay Performance In Illinois

**FINAL REPORT
PHYSICAL RESEARCH REPORT NO. 143
JUNE 2002**

Illinois Department of Transportation

BONDED CONCRETE OVERLAY PERFORMANCE
IN ILLINOIS

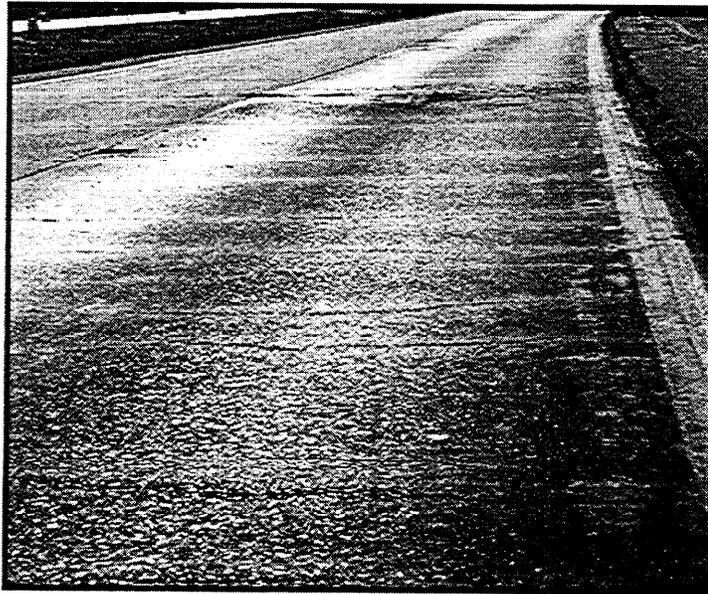
Figure 3
Interstate 80 Before Rehabilitation

The existing 8-inch CRC pavement on Interstate 80 was constructed in 1965. The shoulders were 12-inch bituminous concrete and there were no underdrains placed during original construction. The existing pavement displayed a frequent amount of medium severity, transverse cracking and a significant amount of centerline distress prior to the rehabilitation. Figure 3 illustrates a representative area of the Interstate 80 pavement before rehabilitation. Prior to placing the bonded concrete overlay, the existing pavement was patched with full-depth and partial depth patches. In addition, any bituminous patch material found on the surface was removed.

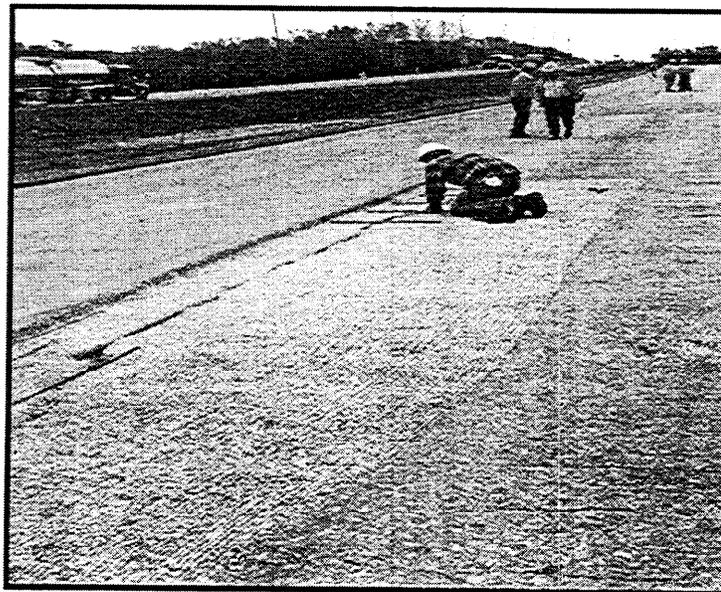
Figure 4
Partial-Depth Patch Reinforcement

One partial-depth patch was required in the eastbound direction and eight were required in the westbound direction. These patches were placed over severe longitudinal cracks. The existing surface was milled down to a depth of 2.5 inches by 36 inches wide. The crack was reinforced with #5 tie bars placed at 90 degree angles to the crack on 30-inch centers. These concrete patches were placed monolithically with the concrete overlay. Figure 4 illustrates the placement of the reinforcement bars within a partial depth patch area. The combined area of these patches was 0.28 percent of the total project roadway area.

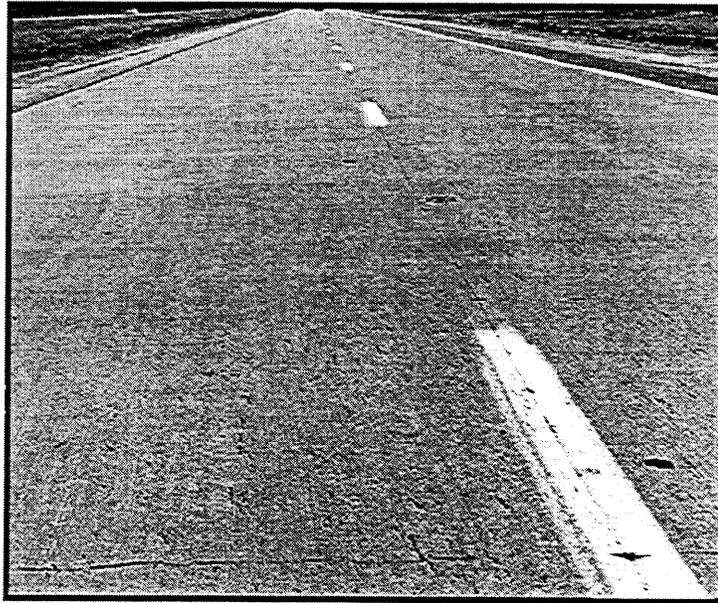
Figure 5
Interstate 88 Before Rehabilitation

prior to the overlay. Figure 5 is a typical view of this section prior to the overlay. Full-depth and partial-depth patches were placed in the existing pavement before the overlay was constructed.

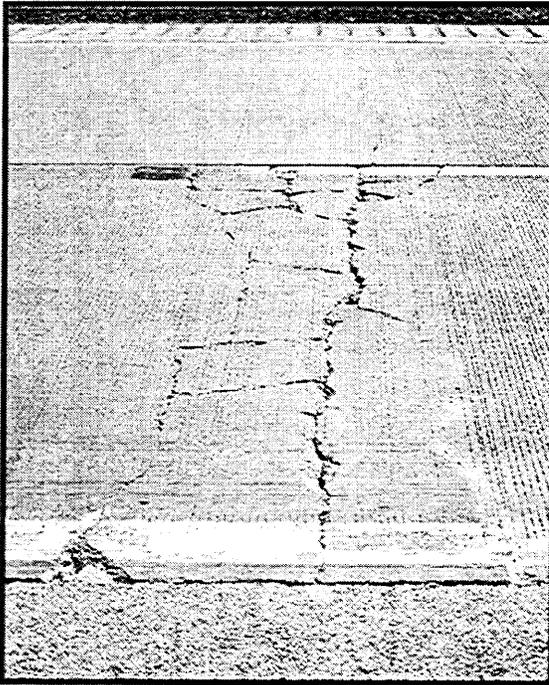
Figure 11
Interstate 80 High Severity Crack

The post-construction distress surveys of the Interstate 80 project indicated that the eastbound lanes have deteriorated more rapidly than the westbound lanes. A large number of working, low severity, transverse cracks were found in the eastbound lanes within two years after construction. The three year survey indicated that many of these cracks had propagated into medium and high severity cracks. Examples of this type of

distress may be found in Figures 11 and 12. Eventually, these cracks developed into areas of edge-of-pavement punch-outs and centerline spalling. An example of this may be found in Figure 13. The eastbound lanes continue to deteriorate at an increasing rate.

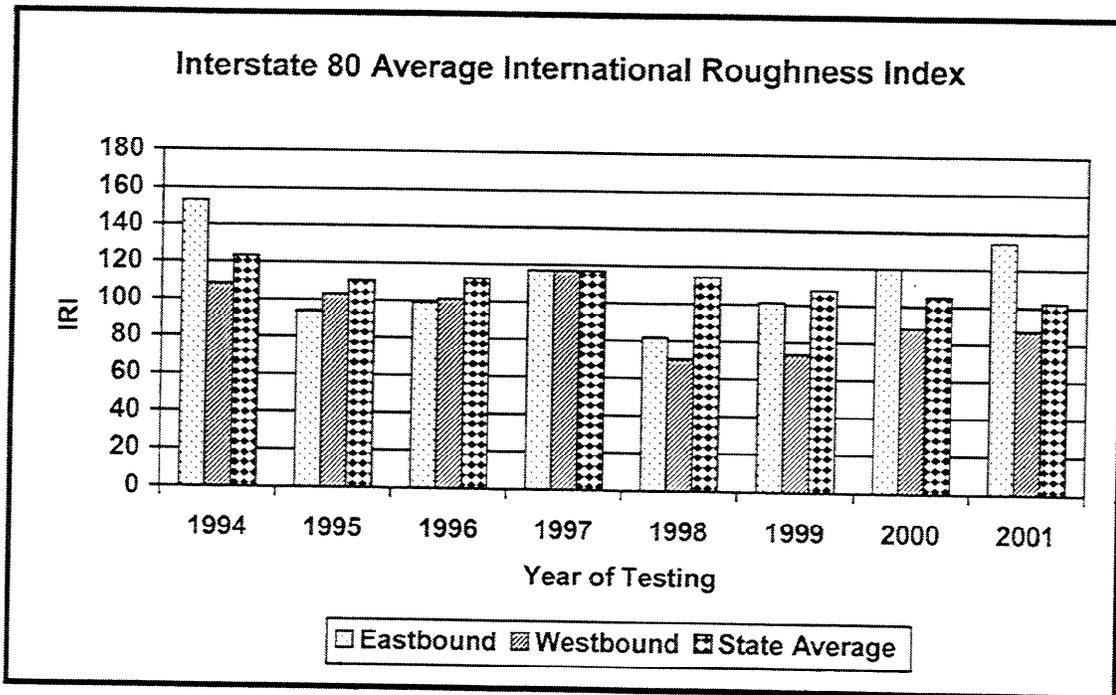
Figure 14
Interstate 80 Average International Roughness Index

The data for the Interstate 80 project indicate that the BCO dramatically improved the pavement smoothness in the eastbound direction, while only slightly improving the westbound direction. By 1997, both directions were rougher and comparable to the level of the statewide average. The patching completed in 1998 improved the pavement smoothness in both directions. The patching and maintenance that has been completed since 1998 has had little effect on the IRI in either direction. The IRI values for the eastbound lanes are increasing rapidly (from 82 to 134 over the last four years), while the westbound lanes have only increased from 70 to 87 over the same four years.

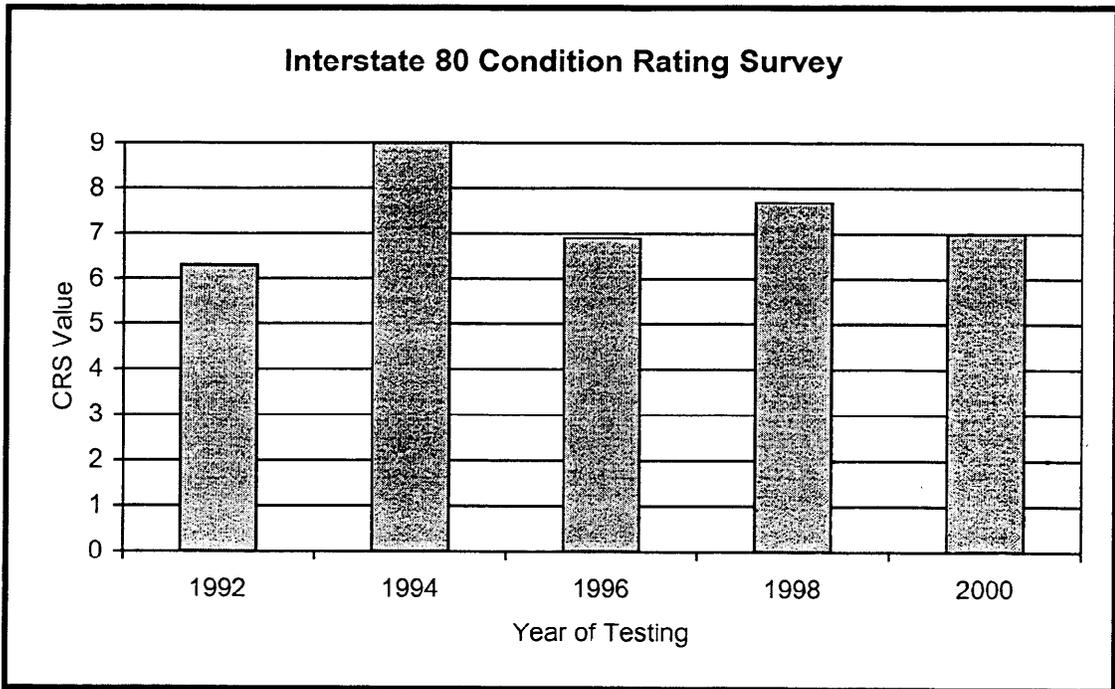
Figure 16
Interstate 80 Condition Rating Survey

The pre-overlay CRS value for Interstate 80 had fallen to a 6.3 value. This is still within the “good” category; however, a section of interstate that falls below a rating of 6.5 typically is scheduled for rehabilitation. Due to the construction of the overlay in 1994 and 1995, the 1994 CRS value was set at 9.0. The CRS value quickly fell back into the “good” category with a 6.9 by 1996 and only improved to a 7.7 with the patching contract in 1998. In spite of the patching contract in 2000, the CRS value was determined to be 7.0.

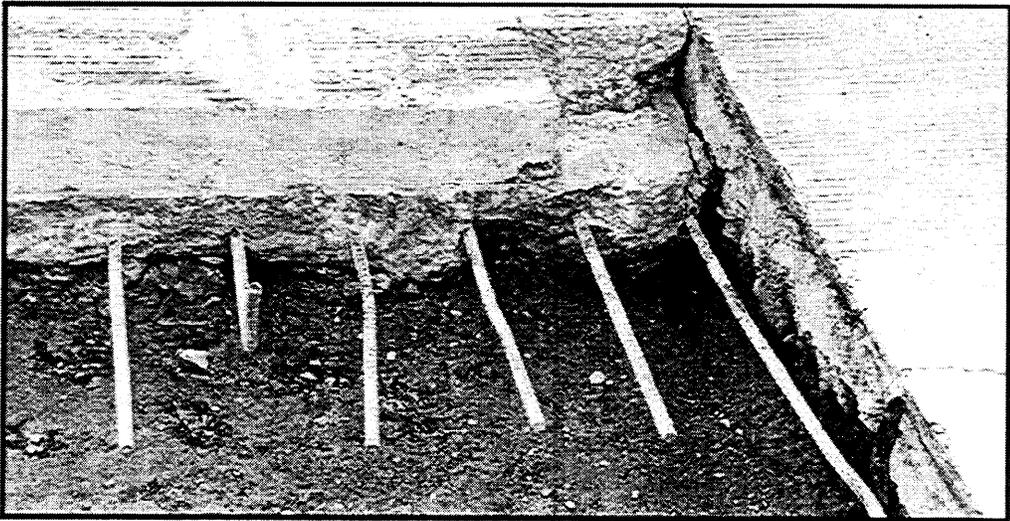
Figure 18
Full-Depth CRC Patch

The decision to use a full-depth or partial-depth patch was based on a visual survey and sounding of the pavement around a crack. Working cracks that developed into edge-of-pavement punchouts were rehabilitated with a full-depth patch. All moderate to severe transverse cracks were rehabilitated with a partial-depth patch. The size of the partial-depth patches was determined by sounding the pavement around the crack to determine the area of delamination. In some cases, a partial-depth patch was converted to a full-depth patch once the original pavement was exposed and the condition was rated.

A full-depth patch included replacement of the CRC pavement and the overlay as one monolithic patch. The CRC reinforcement was replaced in the original pavement; however, there was no reinforcement added to the concrete overlay. Partial-depth patches included replacement of the overlay only. The existing overlay was removed in these areas, and the original surface was cleaned and sand blasted for texture. Figures 18 and 19 illustrate a full-depth and partial-depth patch, respectively.
