**Engineering and Organizational Issues Related to  
The World Trade Center Terrorist Attack**

**Reconnaissance and Preliminary  
Assessment of a Damaged Building  
Near Ground Zero**

**Volume 2:  
Reconnaissance and Preliminary Assessment of a  
Damaged Building Near Ground Zero**

April 2002

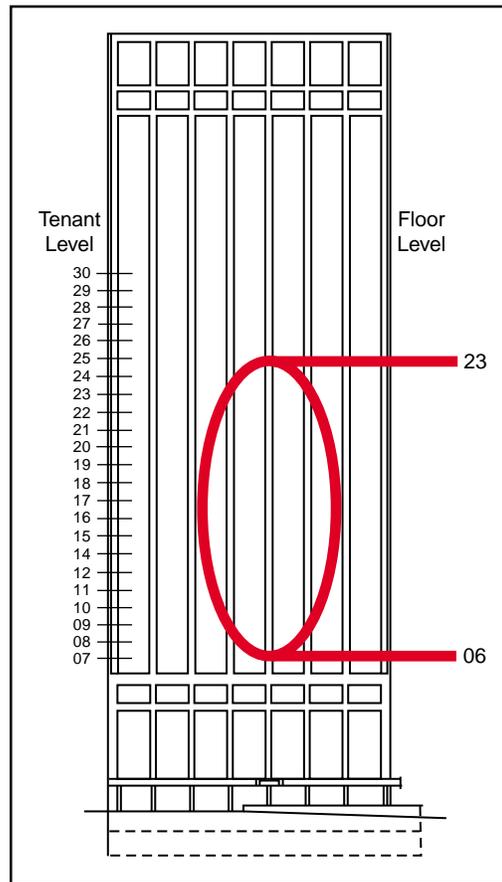
Figure 1.3. Sketch of northern façade showing the zone of damage

The façade of the building is composed of windows and a lightweight cladding system. An artist's rendering of the northern façade is presented in Figure 1.3. This façade was badly damaged by falling debris in the zone described by the elliptical line in the figure. Tenant Levels are identified in the figure to facilitate the description of damage to the building presented in Section 2.

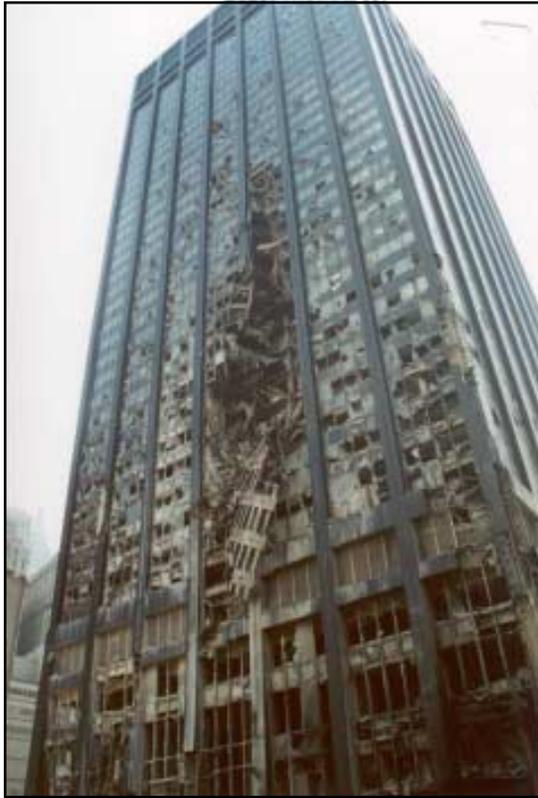
a. View of northern facade

Figure 2.1 presents four photographs of the building taken on September 21, 2001. The view in a. is of the northern façade showing the large gash in the exterior wall caused by falling debris that was ejected from WTC 2 as it collapsed. One large piece of the façade of WTC 2 can be seen in this figure at approximately the 9th floor level. It is highly likely that this three-story high piece of debris caused much of the damage that is evident above TL 7. Clearly seen in this figure is the loss of a column on Line D (see Figure 1.2) between TL 7 and TL 25 (see Figure 1.3).

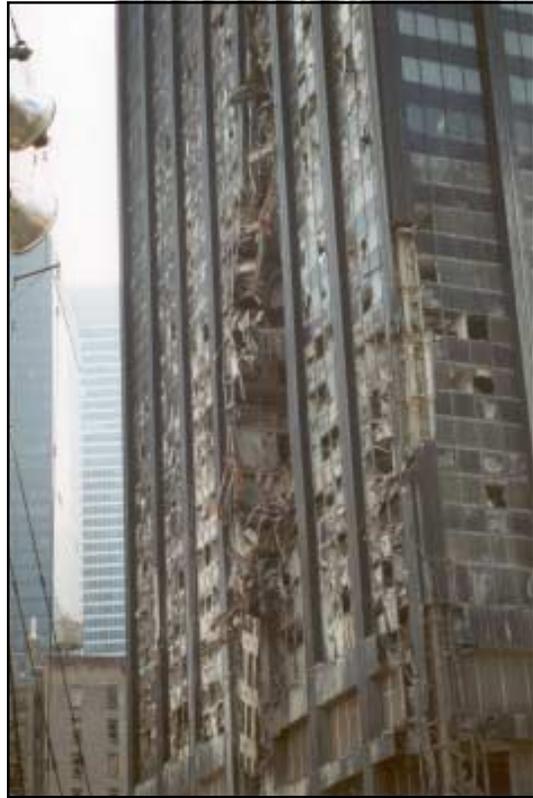
b. View of northern and western facades

Part b. of Figure 2.1 shows damage to the northern and western faces of the building. Windows were broken on both of these faces of the building but the damage on the western face was confined to a one-bay width between Lines 7 and 8. The cladding to corner column A8 was lost between the ground and TL 5 and between TL 9 and 12.

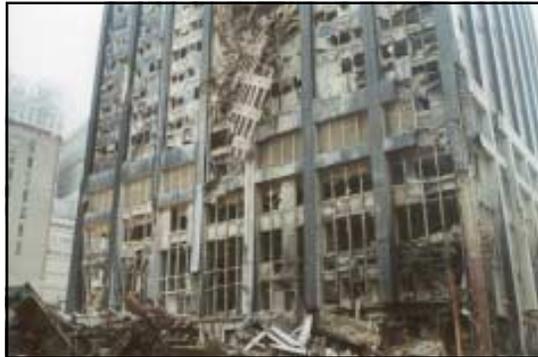
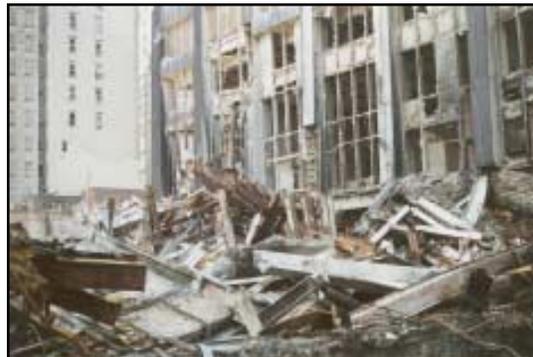
*Figure 2.1. Damage to the 130 Liberty Plaza building from the exterior*

Parts c. and d. of Figure 2.1 show damage to the lower levels of the building on its north face. Burning debris ignited small fires in the lower levels of the building but these fires appeared to have been confined to the perimeter of the building. Most of the windows in the lower levels, especially below the mechanical plant room at the 5th floor level, were broken but it is not known how many of these windows were broken on purpose by the rescue teams to eliminate falling glazing hazards to the rescue workers operating to the immediate south of WTC 2. Part d. of the figure shows the debris pile to the immediate north of the building, 10 days after the terrorist attacks. Much of the debris was from WTC 2.

c. View of lower 10 stories of northern facade

d. Damage to the northern façade at the entry level

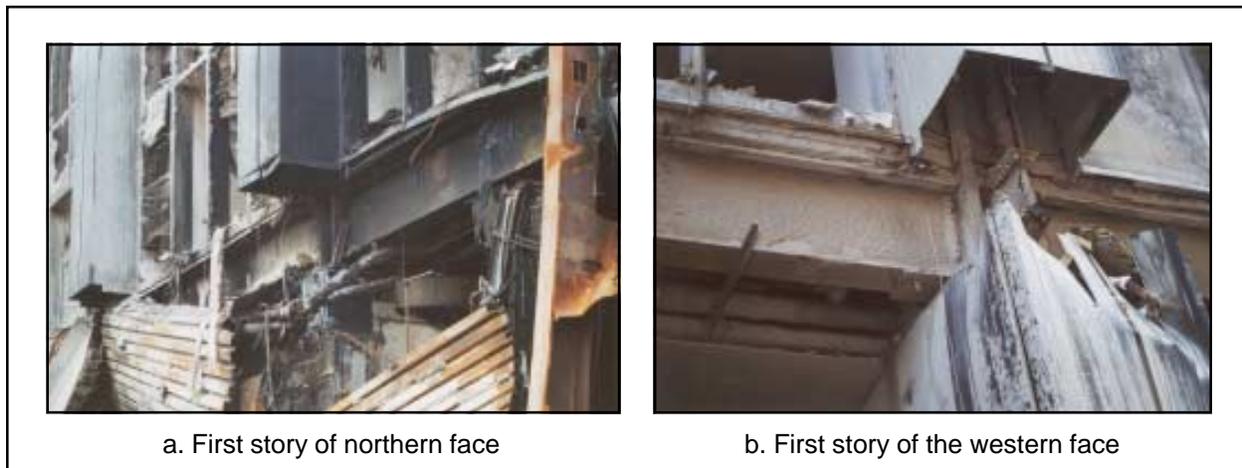
*Figure 2.2. Exposed steel moment framing in the first story of the building*

Figure 2.2 presents information on the moment-resisting connections used in the building. Part a. of the figure shows fire damage to the lower framing, a cover-plated moment connection of the beam to the column, and the connections used to join the steel floor beams to the perimeter girders. No spray-on fireproofing is evident on the side or bottom of the perimeter beam although it may have been knocked off by the impact of falling debris. Façade construction

details can be clearly seen in this figure. Part b. shows a typical beam-column moment connection on the western face of the building. Cover-plates are clearly visible in this connection and damaged (or incomplete) fireproofing can be seen on the exterior face (web) of the perimeter beam.

However, it must be noted that the cover-plated moment-resisting connections employed in the construction of the building likely have limited plastic rotation capacity as demonstrated by a series of tests conducted following the 1995 Northridge earthquake (Kim et al., 2000). Therefore, the results of the simple plastic analyses must be interpreted with care.

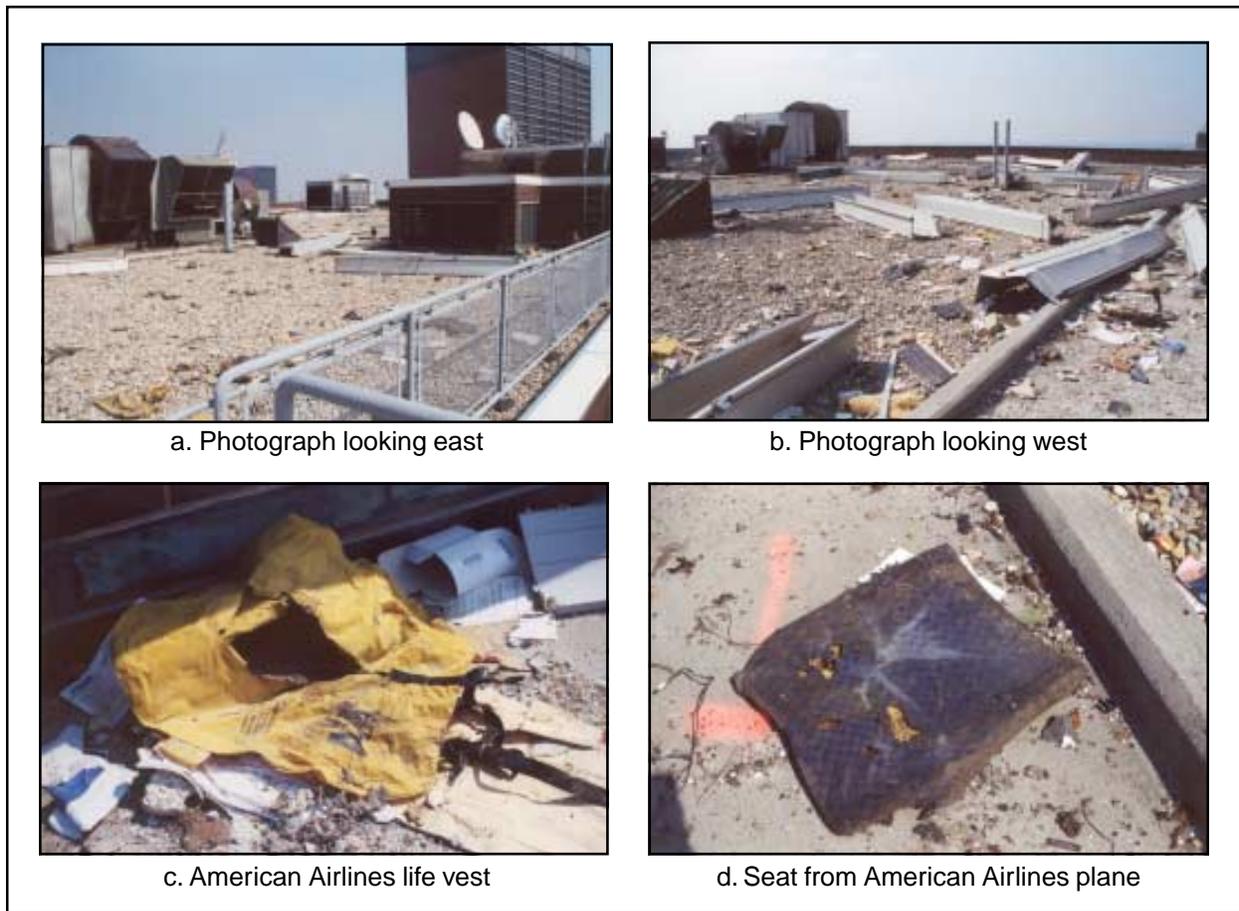
*Figure 2.3. Debris at the roof level of 130 Liberty Plaza*

Figure 2.3 presents photographs taken at the roof level of the building. Part a. of the figure is the view looking east across the roof. Silver U-shaped aluminum panels from WTC 2 can be seen in the figure together with life vests from American Airlines (AA) Flight 11 that struck the north face of WTC 1 (approximately 120 meters from 130 Liberty Plaza). Part b. of the figure is a view looking west across the roof. Aluminum panels and AA life vests are also

visible in this figure. Parts c. and d. are close-up photographs of an AA life vest and a seat from AA Flight 11.

No structural damage was observed at the roof level of the building and there was no evidence that the roof floor slab had been punctured by falling debris from WTC 2. This observation was confirmed by the walk-through of the plant-room spaces immediately below the roof. Apart from broken glass in the stairwells from the roof-level skylights, the structure and mechanical plant in the 38th story were undamaged by the collapse of WTC 2.

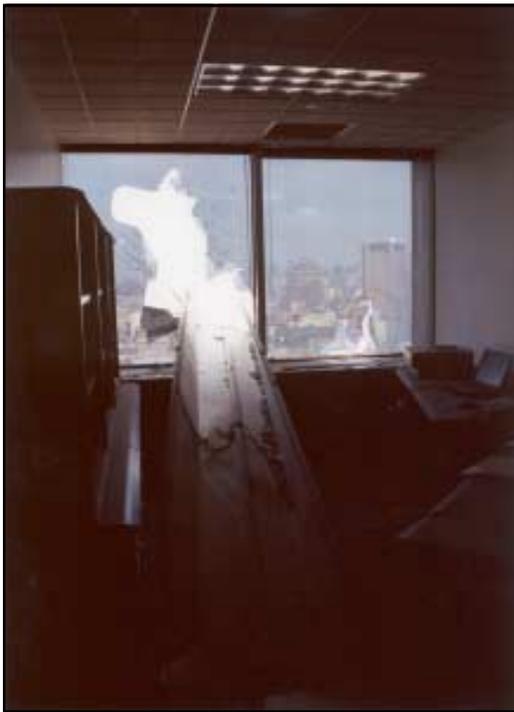
*Figure 2.4. Office space damage above Tenant Level 29*

Damage to the building above TL 29 was modest (relative to the damage below TL 25) and was limited to broken glass (caused by debris ejected from WTC 2 as it collapsed). Figure 2.4 shows typical nonstructural damage above TL 29. Part a. shows damage caused by a section of fascia that was ejected from WTC 2 and which penetrated through a window on the northern face of the building. Part b. shows debris in a corner office at Grid A8. The angle section lying atop the

a. Penetration of WTC 2 fascia piece

b. Typical damage in office space

overturned chair in this figure penetrated through the north-facing window of the building. (The hard hat and flashlight in the photograph belonged to the photographer.)

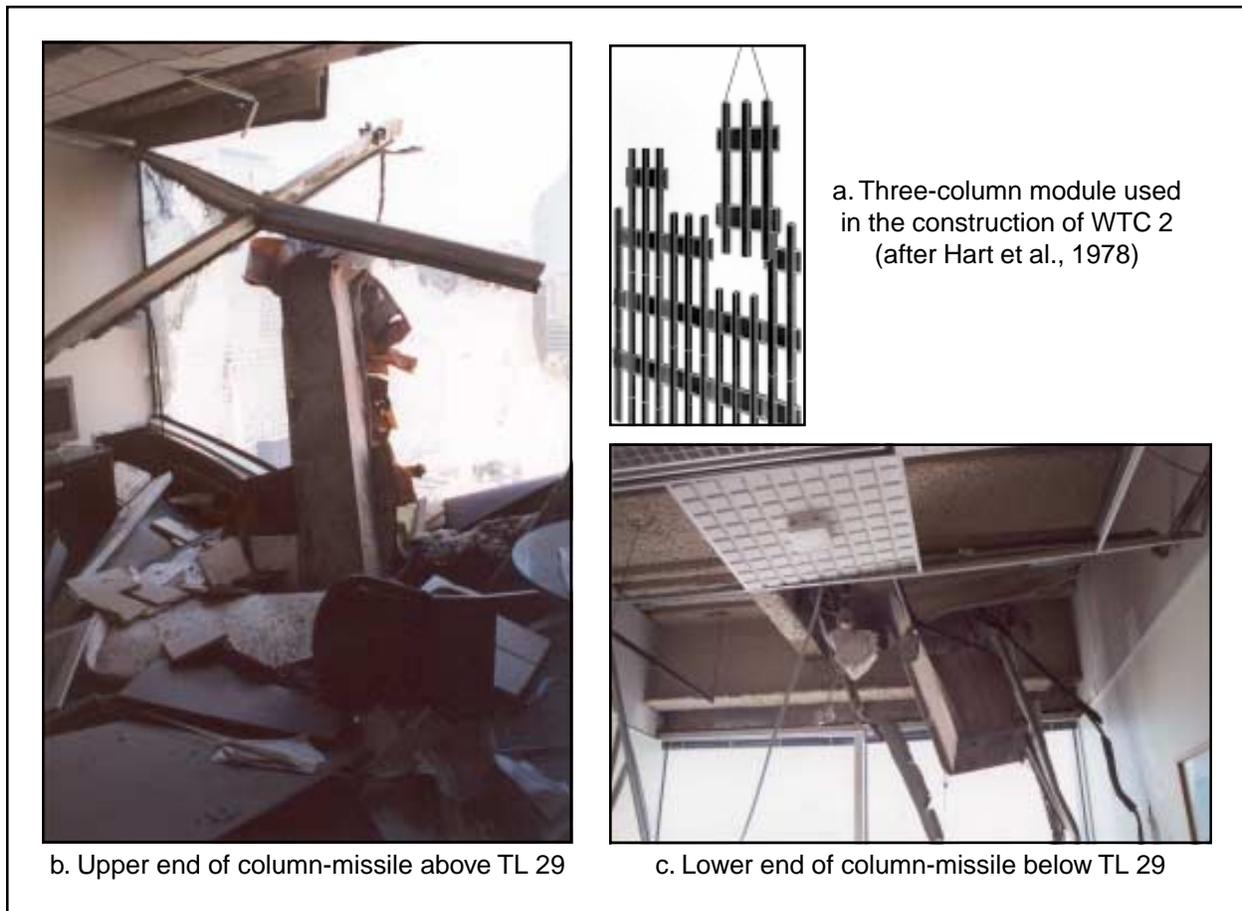
*Figure 2.5. Damage due to column-missile ejected from WTC 2*

The first major structural damage was observed at TL 29 and was due to the impact of one single-story tall structural steel column from WTC 2. (Note that, as described in Bruneau et al., 2002, this column was one of three in a typical spandrel module, so the two steel beams linking the three columns were destroyed before the single column hit the 130 Liberty Plaza building.) Figure 2.5a is a sketch of a typical three-column module. Figure 2.5b shows the upper end of the column above TL 29. Figure 2.5c shows the underside of the column and the damage it caused to the ceiling system. It is noteworthy that one unreinforced slab on the metal deck arrested the fall of this substantial steel member.

There was little evidence of damage to or distress in the building frame in the stories immediately above the zone of structural damage. There was no sign of excessive deflection in the framing above TL 25 as evinced by the total lack of deflection-induced damage in brittle components such as glazing and plasterboard partitions.

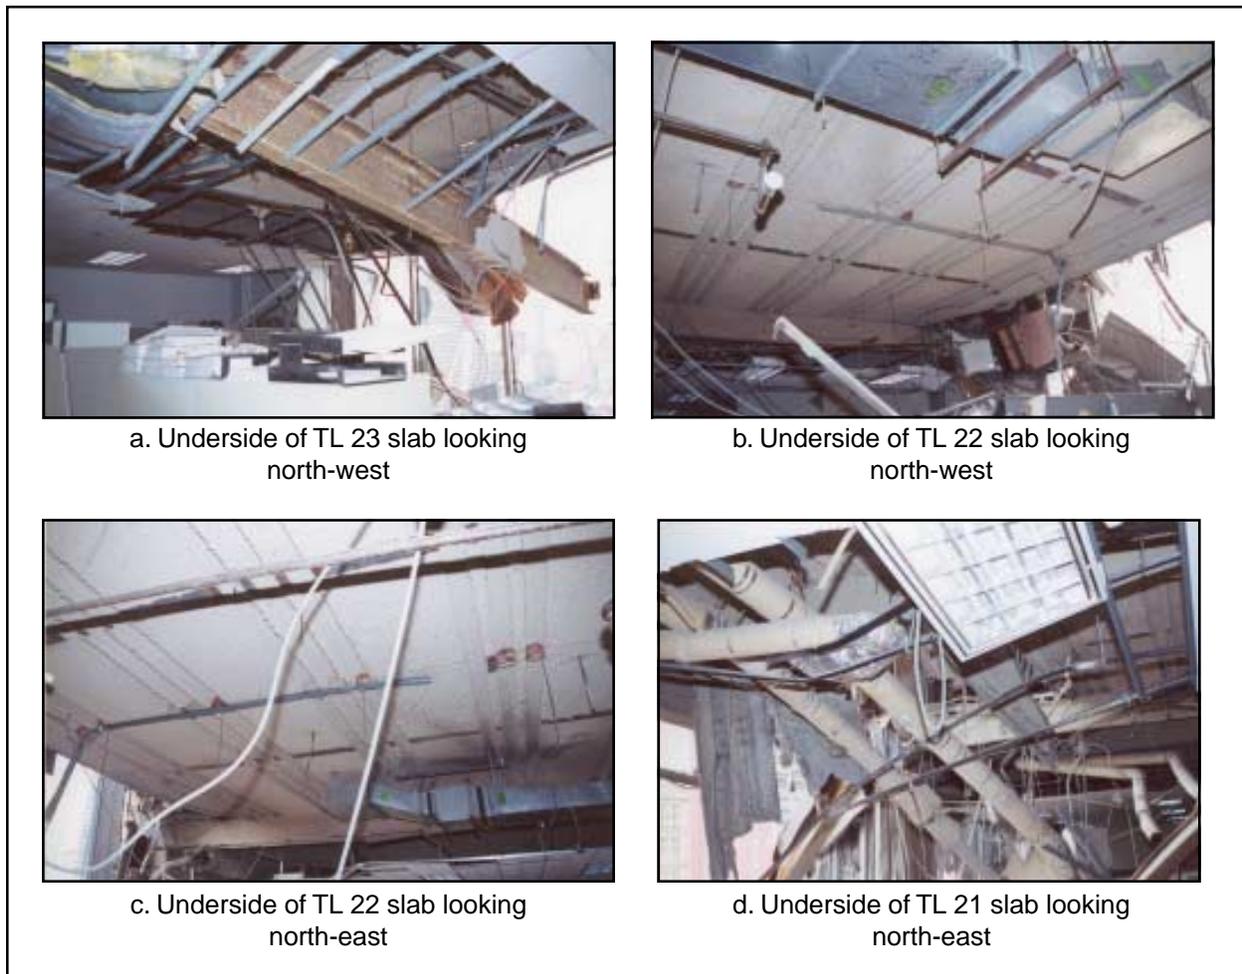
*Figure 2.6. Interior damage at TLs 22 and 21*

The degree of damage to the structural framing increased substantially below TL 26. Figure 2.6a shows a north-south spanning floor beam at the underside of TL 23 that has lost its support on Line 8 due to the failure (loss) of the spandrel beam between Lines D and E. Note the clean separation of the metal deck from the beam (made possible by the lack of studs joining the beam to the slab). Part b. shows the underside of the floor slab at TL 22. At this level, both north-south spanning floor beams were lost; the locations of these beams are marked by dark stripes on the underside of the metal decking. Of importance to the integrity of the floor system is the fact that the TL 22 slab at this location was able to span three times the distance assumed in design, namely, 26 feet, albeit with large deflections in the slab system. Part c. shows a view of the slab of part b. looking north-east. Part d. is a view looking north-east of the underside of the slab at TL 21: a photograph taken from approximately the same location as Figure 2.6c but one floor lower in the building. Fracture of the metal deck floor system at the line of the girder spanning north-south on Line E can be seen in part d. of the figure together with gross distortion of two steel floor beams spanning north-south to the (lost) spandrel.

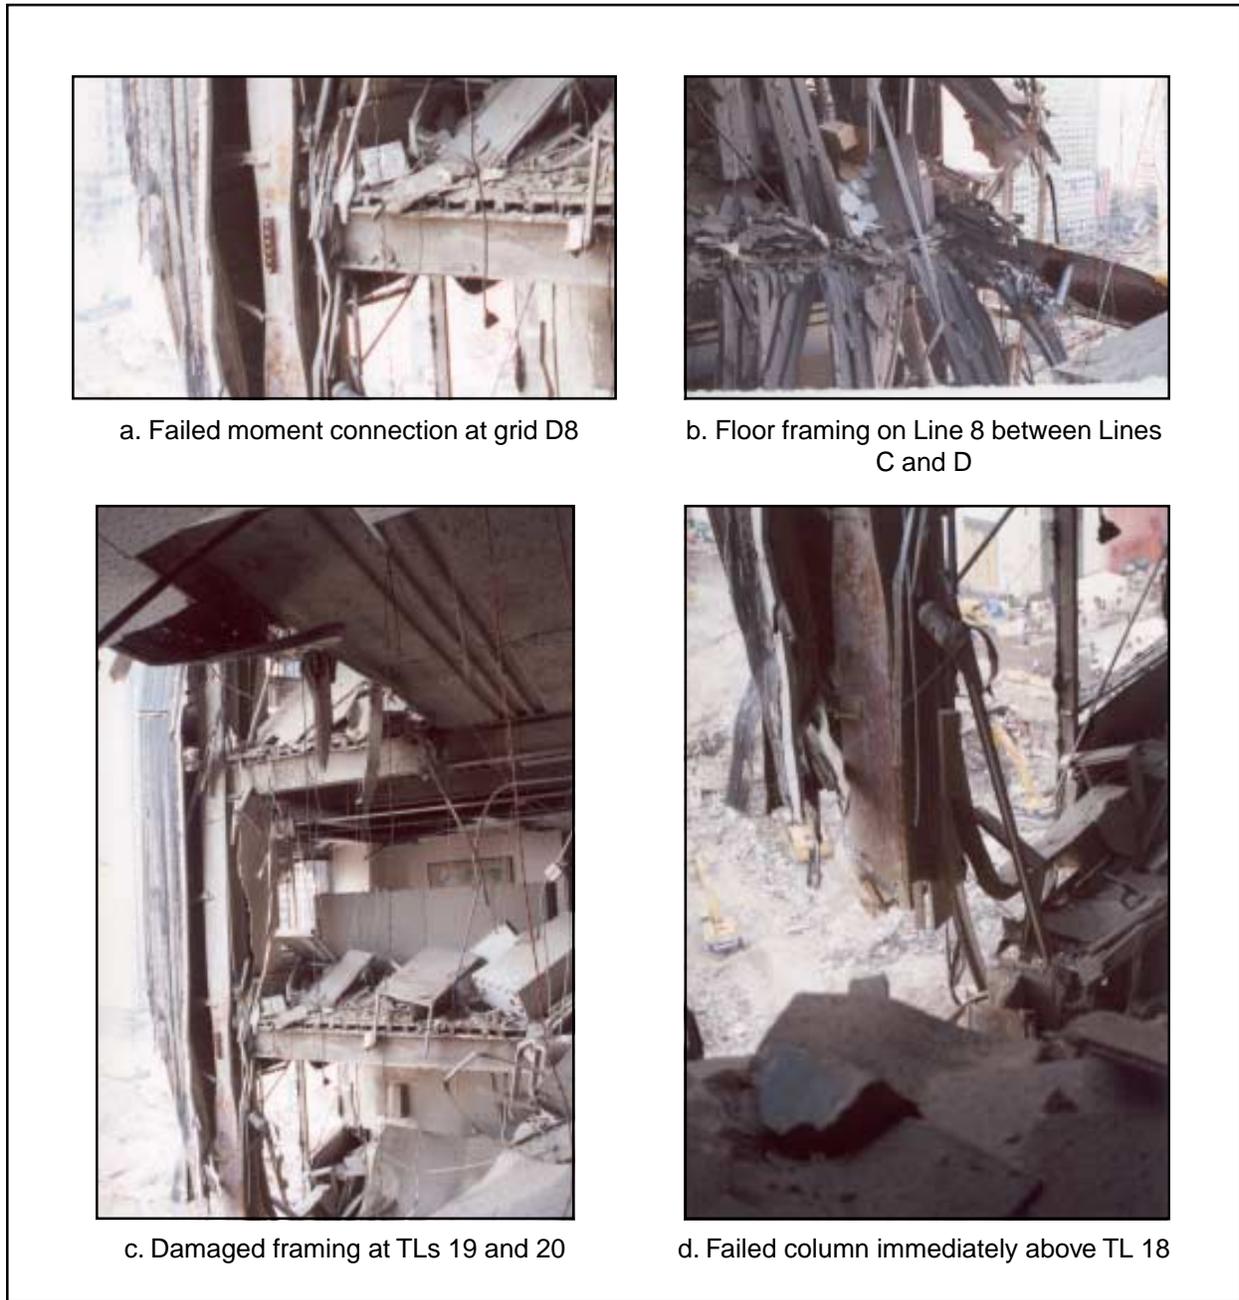
*Figure 2.7. Interior damage photographs from TL 19*

Figure 2.7 presents photographs taken from TL 19 in the building. Figure 2.7a shows the remnants of a moment-resisting connection at grid D8; the fractured flange connections and the welded web tab are clearly visible. Part b. is a photograph taken from the same location as the photograph of part a. but looking towards the north-south spanning girder on Line C. The World Financial Center and Winter Garden can be seen in the background of this photograph. Figure 2-7c is a view of two stories of framing along Line D. Note the distortion in the column flanges at the level of the beam-to-column connection and that the metal decking fractured cleanly along a butt (noncontinuous) joint atop the girder on Line D. Large deflections in the floor framing are not seen in this figure. Part d. shows the fractured column on Line D at approximately three feet above TL 18; immediately below the bottom of the framing shown in part c. of the figure. The debris pile at the base of WTC 2 can be seen in the lower portion of part d.

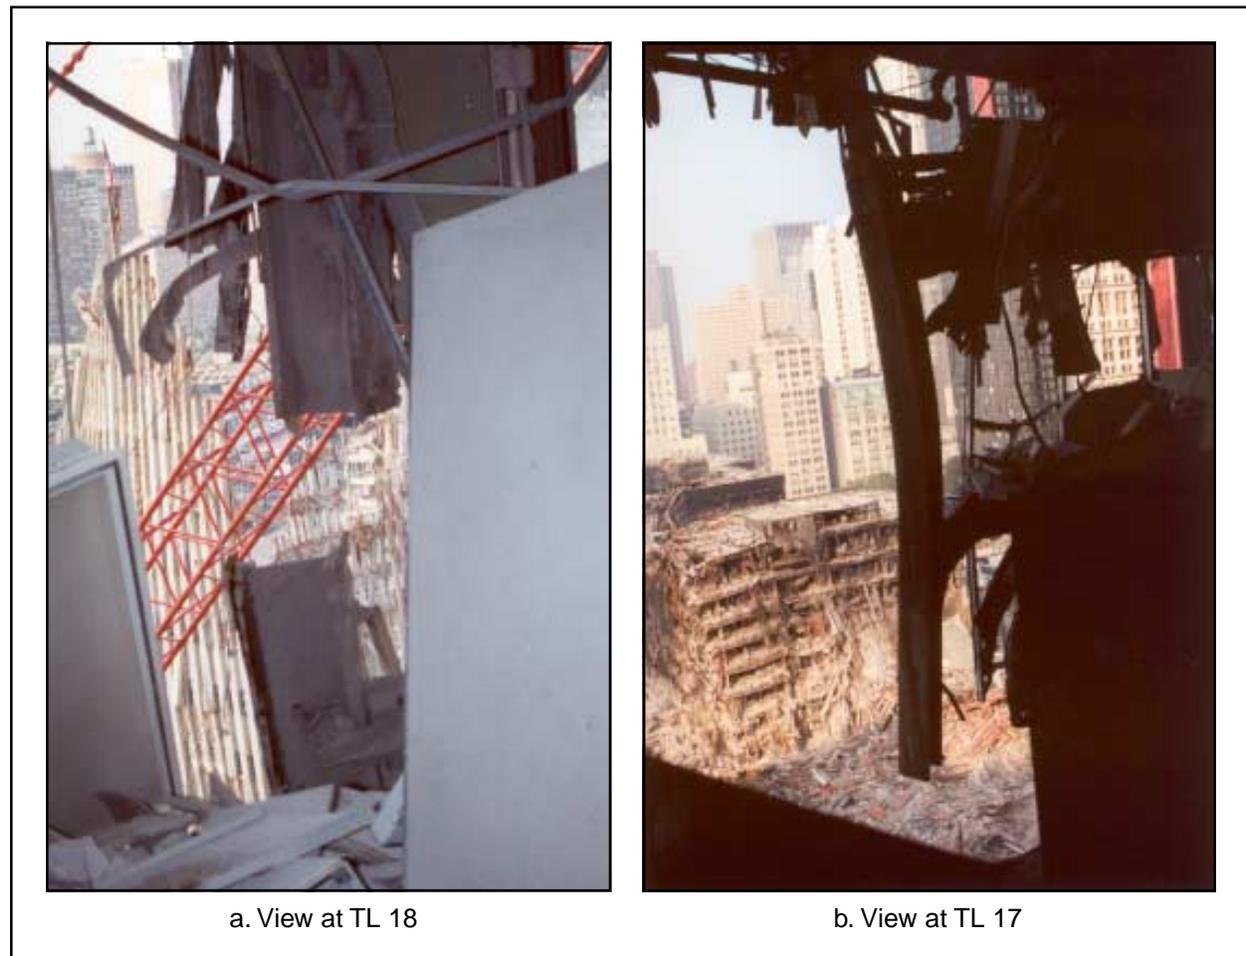
*Figure 2.8. Fractured column on Line D from TLs 18 and 17*

Figures 2.8a and 2.8b show the fractured column on Line D taken from TJs 18 and 17, respectively. The façade of WTC 2 can be seen in the background of part a. and World Trade Center 4 can be seen in the background of part b.

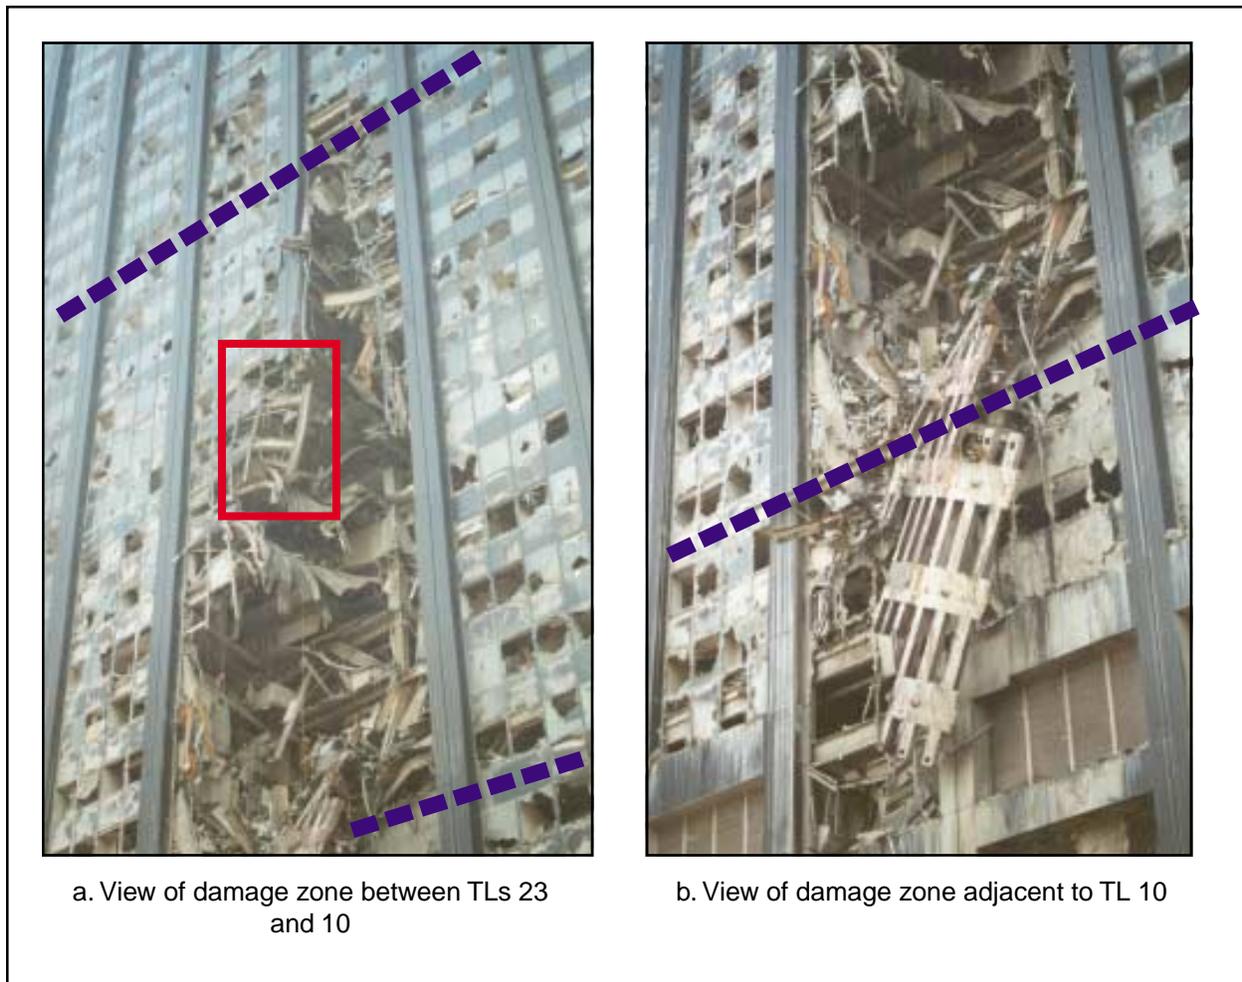
*Figure 2.9. Damage to the northern face of the building between TLs 23 and 10*

Figure 2.9 presents two photographs taken from outside the building looking toward the damage zone. The box superimposed on Figure 2.9a shows the column of Figure 2.8. The fracture evident in Figure 2.8a is located at the top of the box. The distorted but intact 2-story section of column seen in Figure 2.8b is located in the center of the box. In Figure 2.9a, the upper dashed line is at TL 25 and the lower dashed line is at TL 7. The dashed line in Figure 2.9b corresponds to the lower dashed line of Figure 2.9a. The large piece of debris that likely caused most of the damage above TL 10 is seen in Figure 2.9b precariously attached to the façade of the building.

damage zone. As seen in Figures 2.9a and 2.9b, the zone of extreme damage expanded below TL 16 to the 2-bay by 2-bay zone bounded by Lines C and E and 6 and 8.

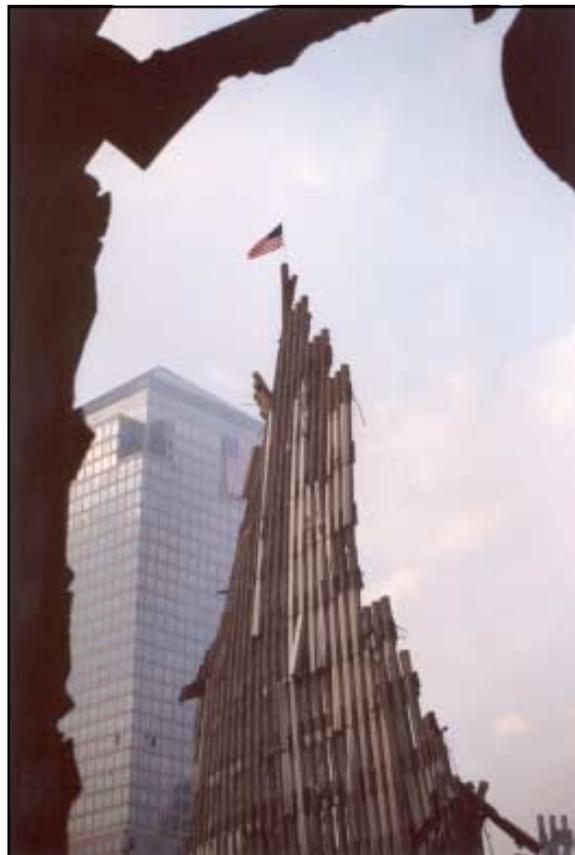
*Figure 2.11. View of the WTC 2 façade looking north-west from the foyer of the building*

Structural damage below the mechanical plant rooms that were located below TL 9 was modest and no photographs were taken at the levels between TL 9 and the entryway to the building. Figure 2.11 is a photograph taken inside the building looking north towards a standing section of the WTC 2 façade.
