# Mechanical Texturing Of Three Bridge Decks

MECHANICAL TEXTURING OF THREE BRIDGE DECKS

Final Report on Research Project 12-6  
Conducted in Cooperation with  
The U.S. Department of Transportation  
Federal Highway Administration

Special Report 101  
December 1991

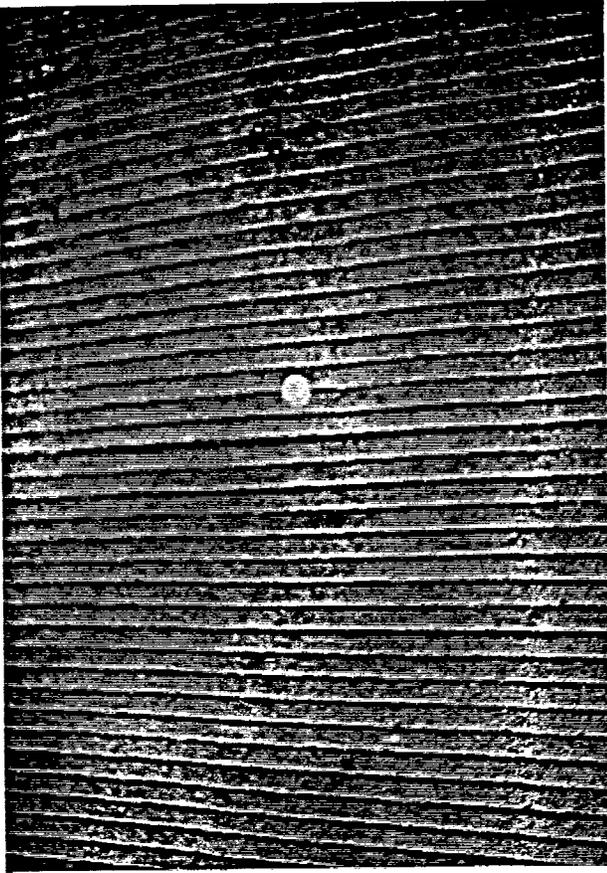
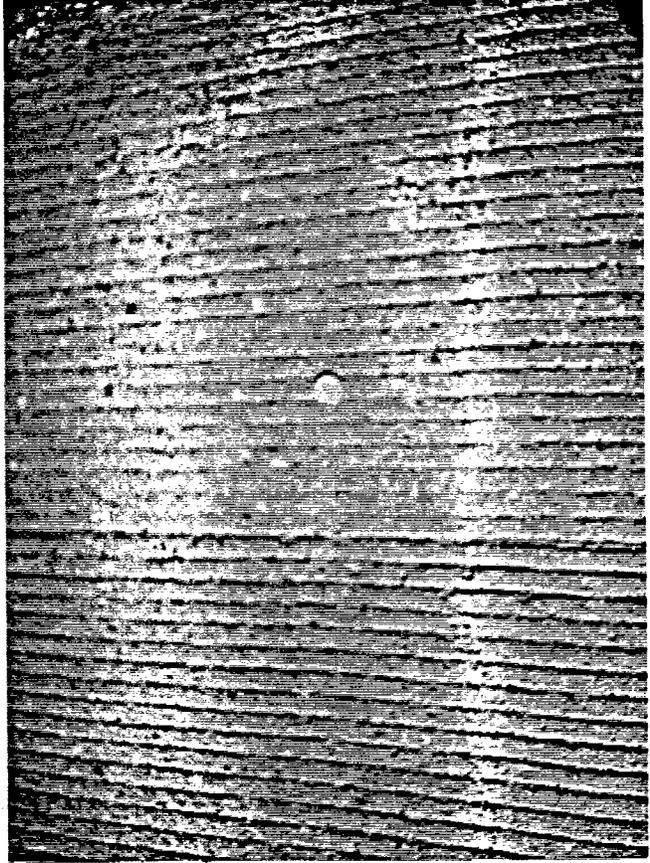
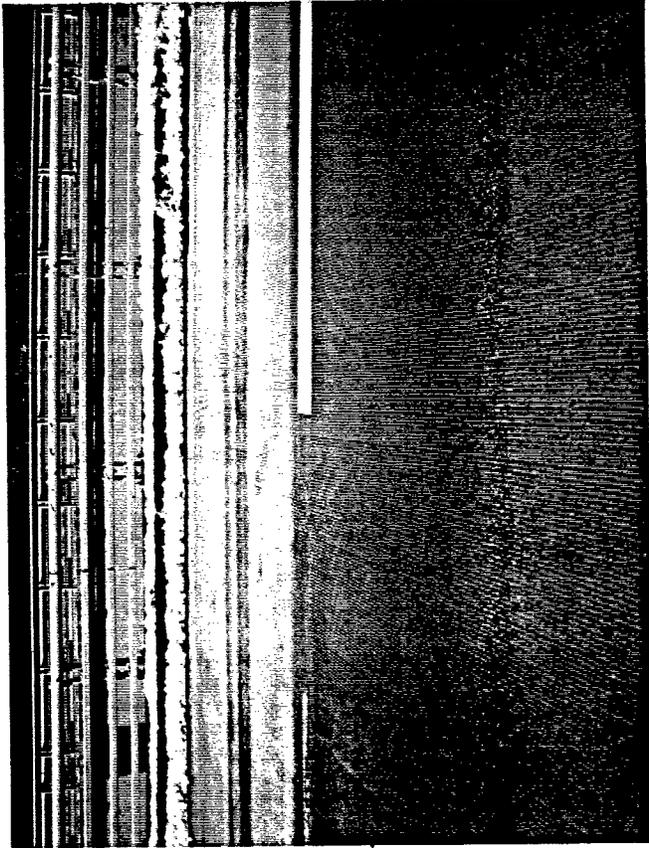
This was built with HDLS concrete in October 1980, and surveyed after 10 years in service as shown in Figures 2 through 4. Sawcut texturing appears more durable than tine texturing, and spalling and popouts seem not to have posed a problem.

Figure 2. View of the Riverbank deck, perpendicular to the centerline, with transverse tine texturing in the foreground (below). Texture at the driving-lane centerline (upper right) shows less wear than in the wheelpath (lower right).

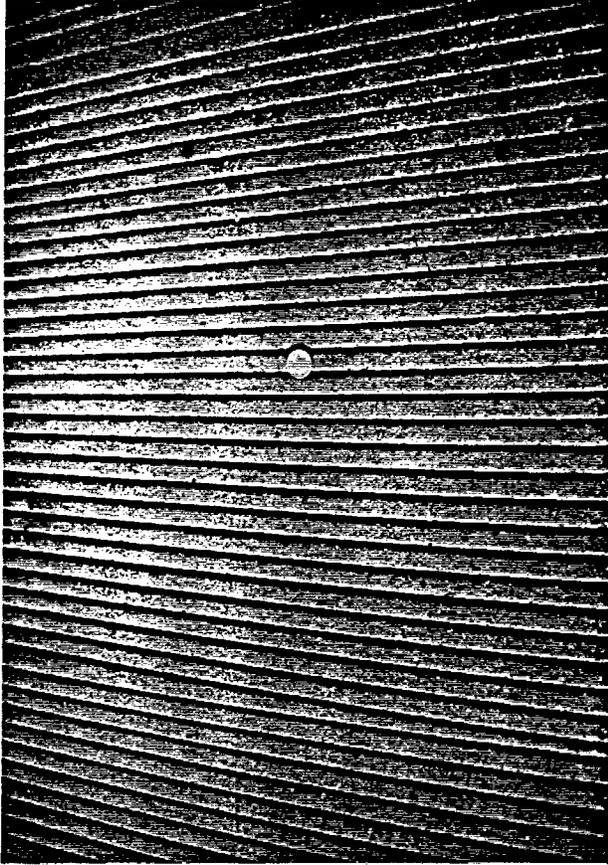
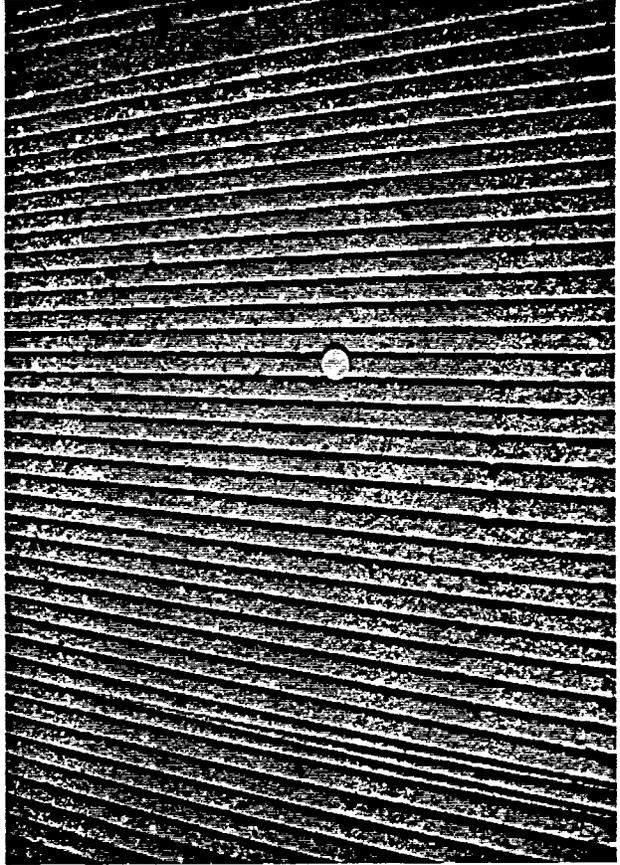
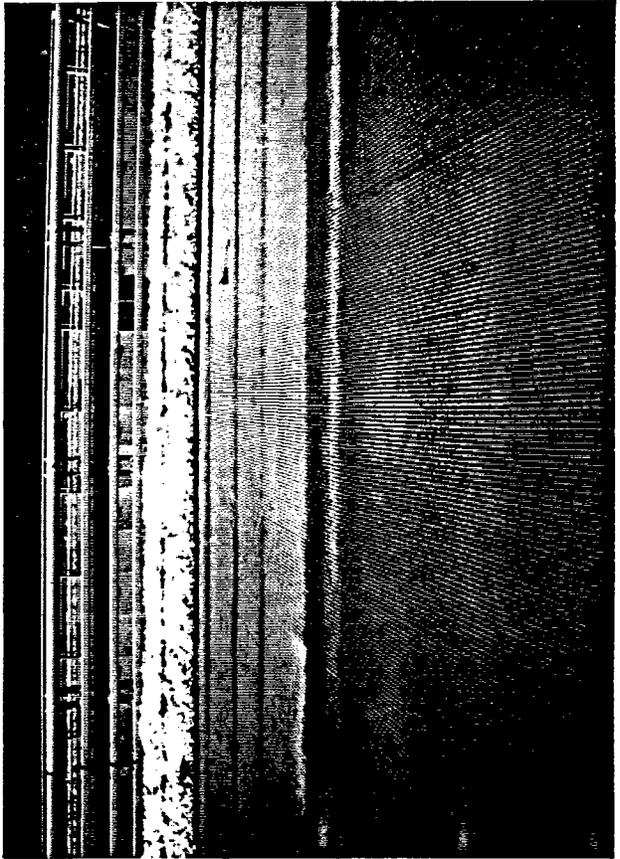
Figure 3. View of transverse sawcuts at Riverbank (below), with only slight wear evident at the driving-lane centerline (upper right) and wheelpath (lower right).

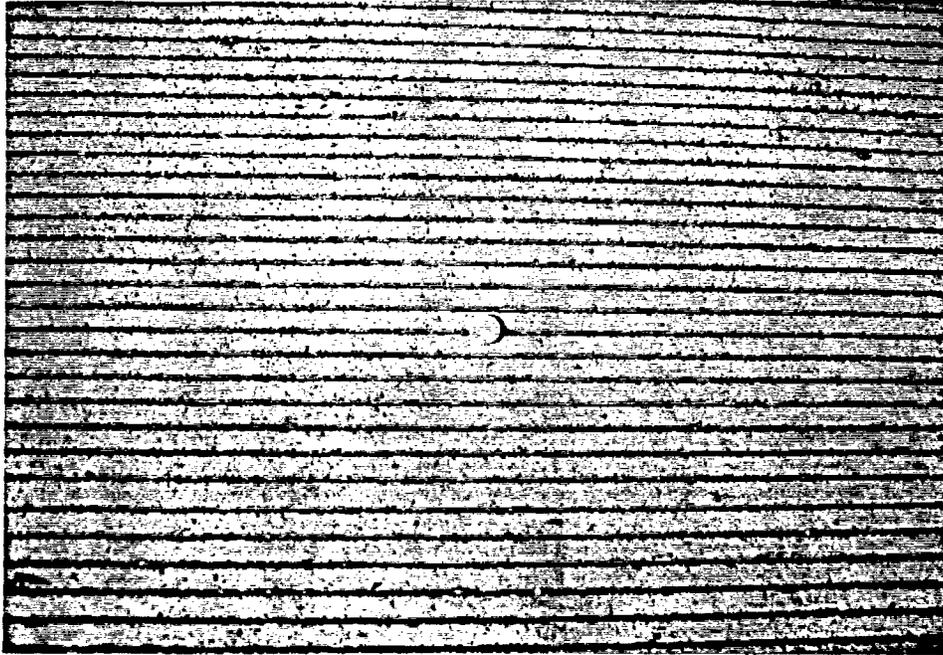
Figure 4. Wear of longitudinal sawcuts at Riverbank, at the driving lane centerline (above) and in a wheelpath (below).

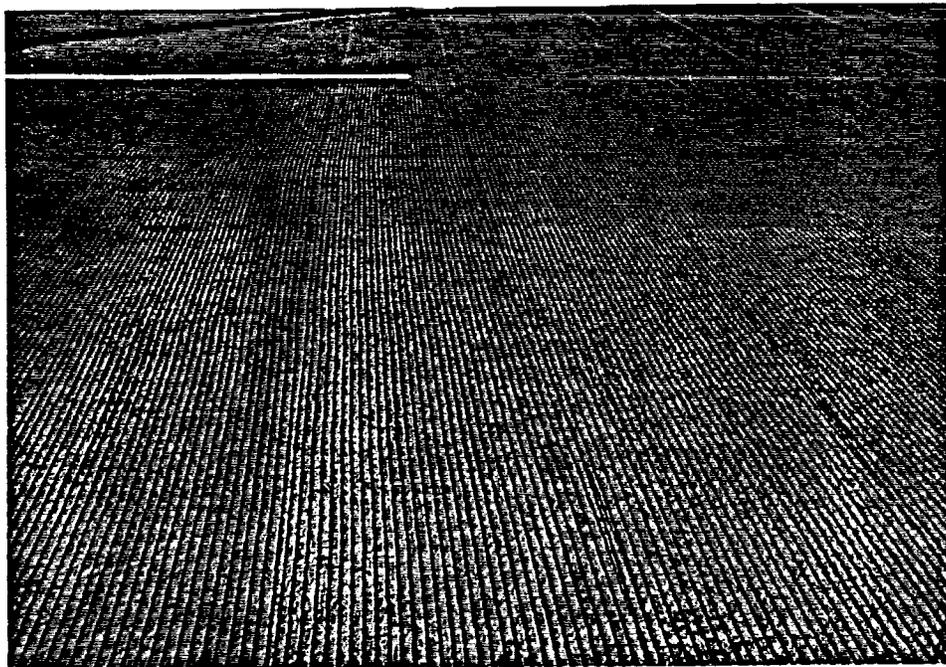
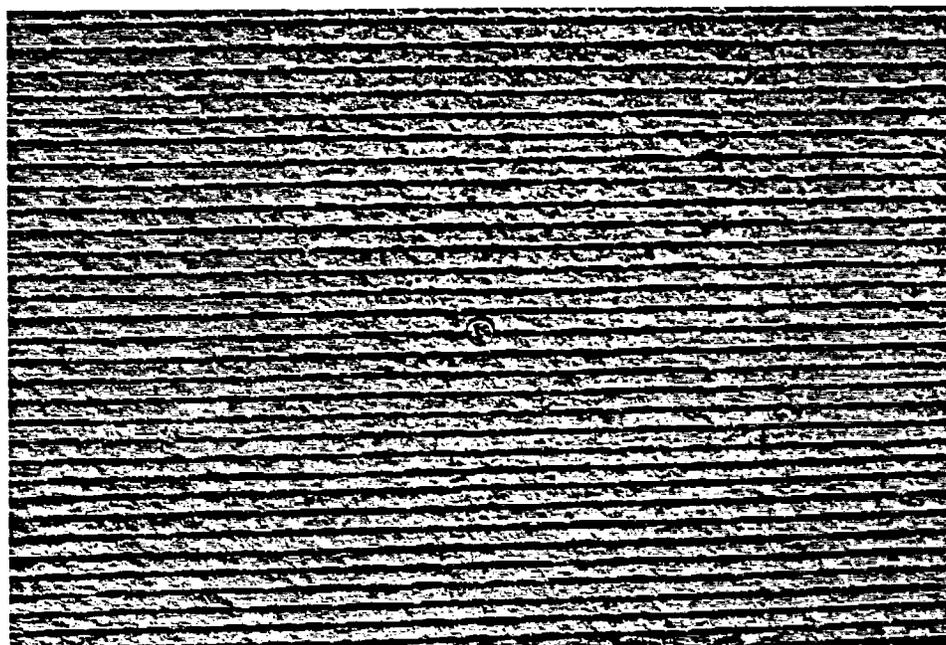
This was built with Class E concrete in October 1980, and surveyed after 10 years in service as shown in Figures 5 through 8. Overall, centerline sawcut grooves are in better condition than those formed by tine texturing. Spalling and popouts were not a major problem, but the tine-textured surface showed greater wear.

Figure 5. General view (above) and detail (below) of transverse tine texturing on the eastbound Port Crane bridge.

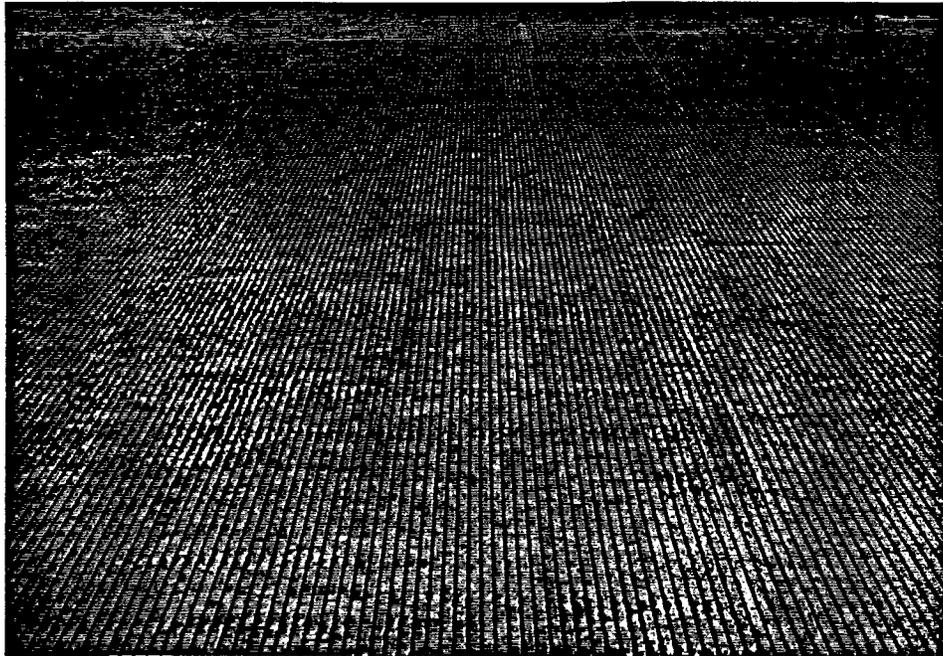
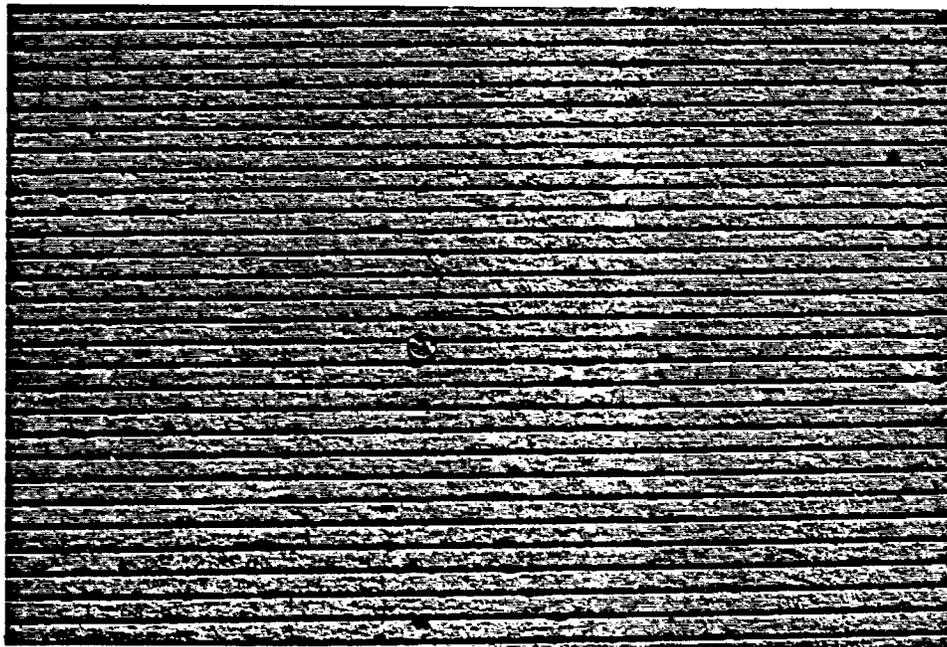
Figure 6. General view (above) and detail (below) of transverse sawcutting on the eastbound Port Crane bridge.

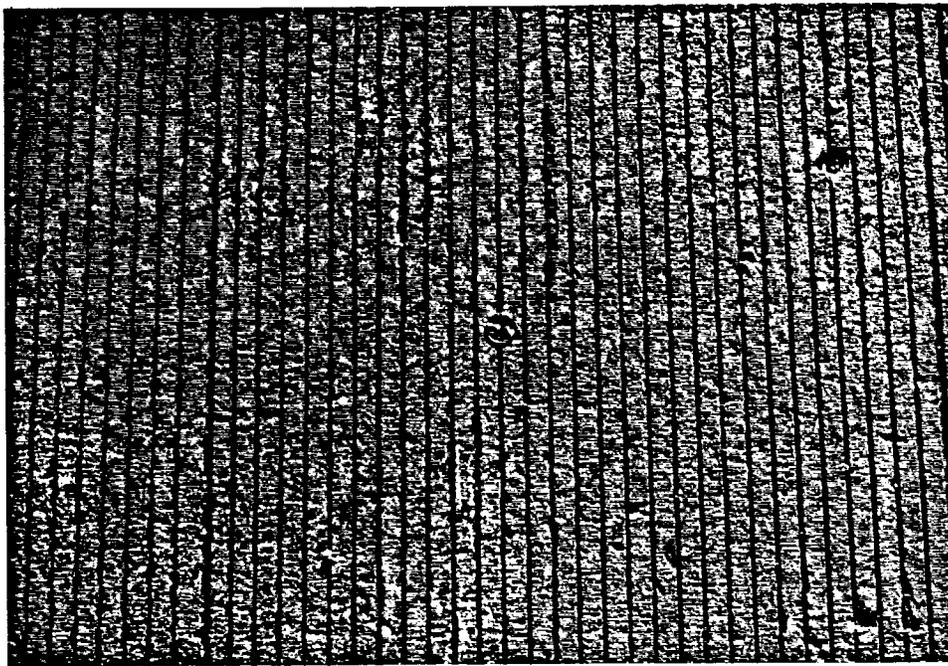
Figure 7. General view (above) and detail (below) of longitudinal sawcutting on the eastbound Port Crane bridge.

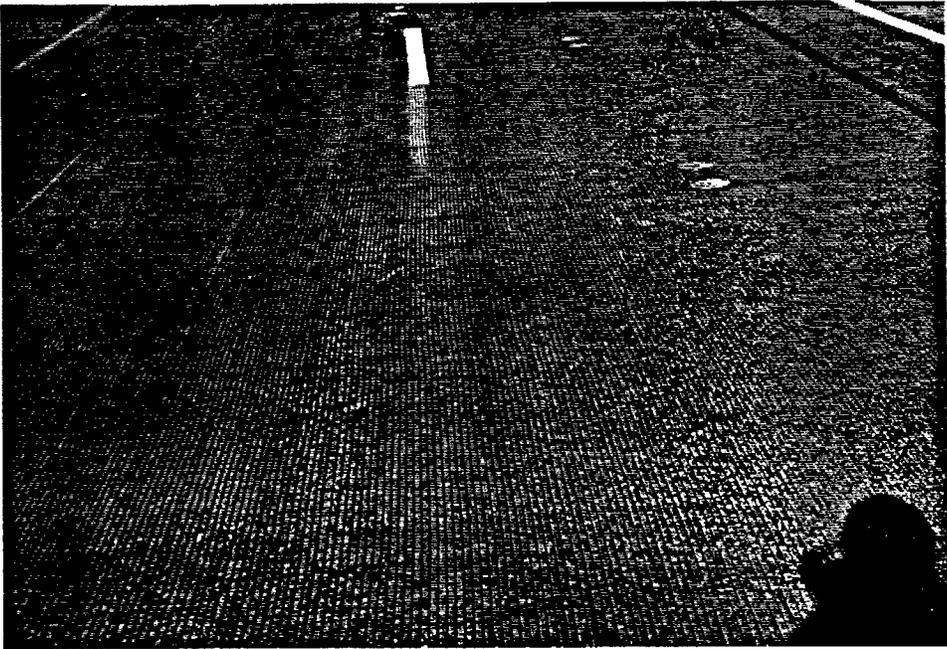
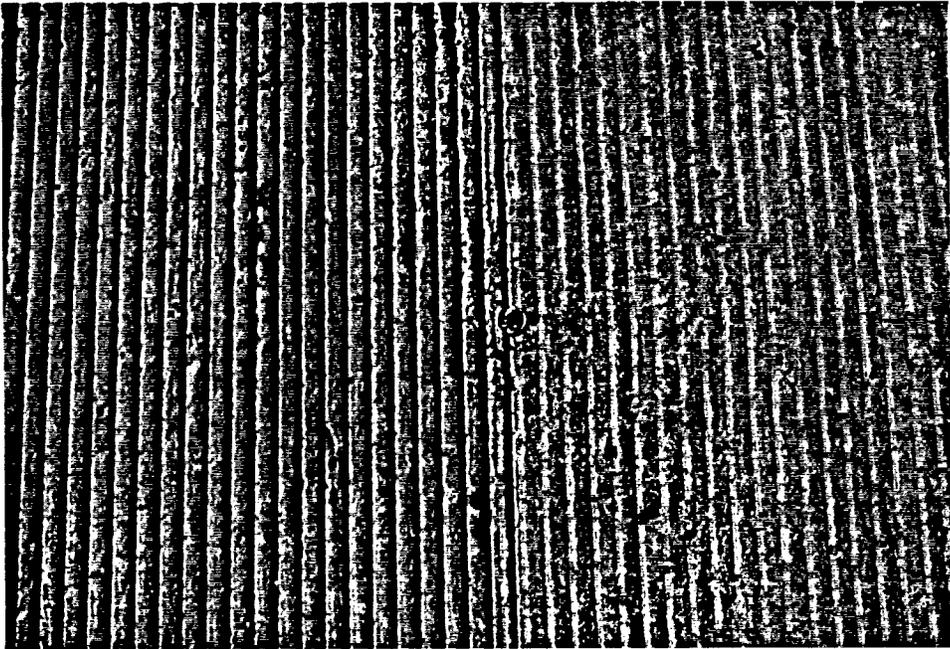
Figure 8. Longitudinal sawcutting on the westbound Port Crane bridge (above), with detail of juncture of sawcut grooves (below left) and tined grooves (below right).

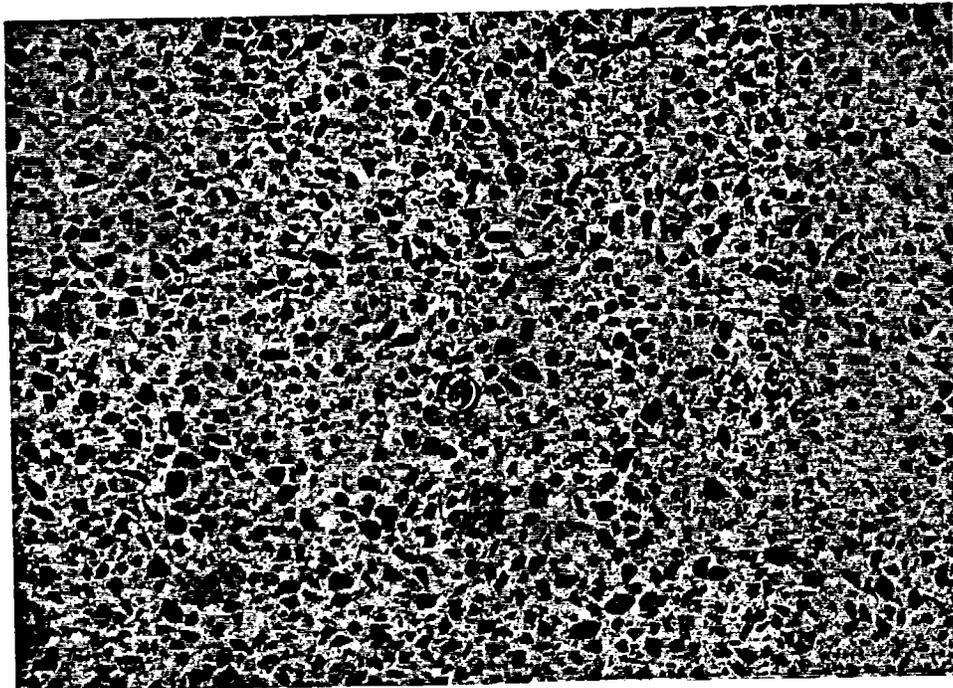
This was built with HDLS concrete in August 1981, and surveyed after 9 years in service, as shown in Figures 9 and 10. Diamond-ground texturing had worn away in the wheelpaths, and tine texturing although still visible was also worn.

Figure 9. Diamond-ground texture on the Binghamton deck driving lane is shown near the shoulder (above) and worn away in a wheelpath (bottom).
