# **EVALUATION OF A MODIFIED STEEL POST W-BEAM GUARDRAIL SYSTEM**

Report 3963-S  
Research Study Number 7-3963  
Research Study Title: Guardrail Testing to NCHRP Report 350 Criteria

Sponsored by the  
Texas Department of Transportation

November 1997

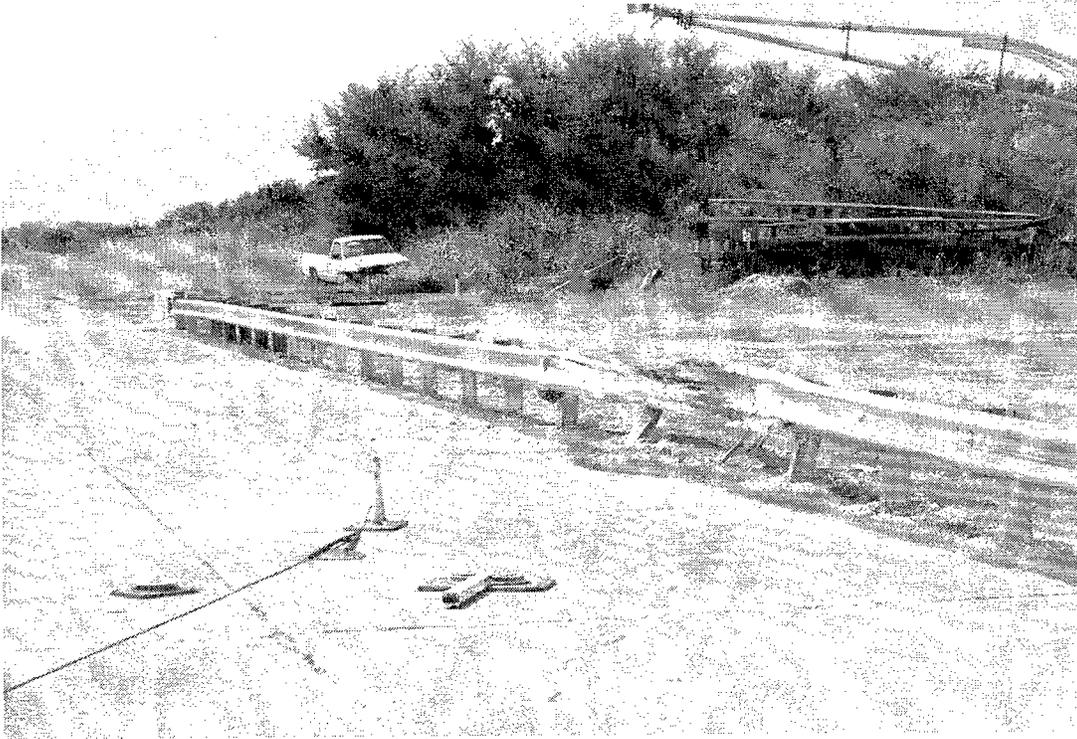
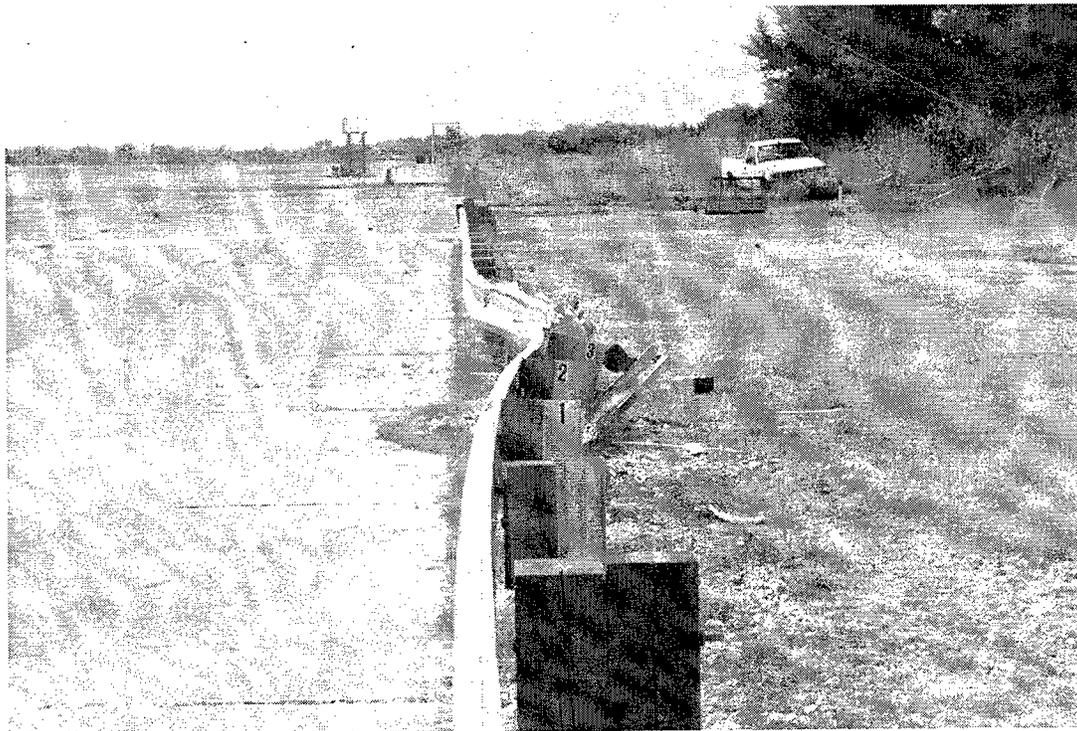
**Figure 8. After impact trajectory for test 439637-1.**

While airborne, the vehicle lost contact with the guardrail at 0.535 s, traveling at a speed of 62.35 km/h and an exit angle of 9.67 degrees. As it was exiting the system, the right rear tire briefly contacted the top of the rail. The left rear tire recontacted the ground at 1.079 s, followed shortly thereafter by the left front tire, the right front tire and, lastly, the right rear tire. The brakes on the vehicle were applied 3.05 s after impact and the vehicle subsequently came to rest 70.2 m down from the impact point and 7.3 m behind the guardrail. Sequential photographs of the test period are shown in Appendix B.

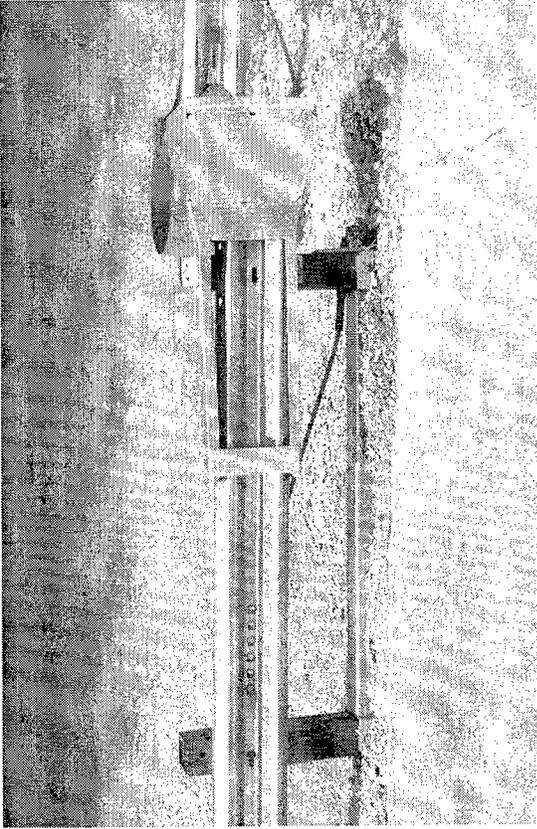
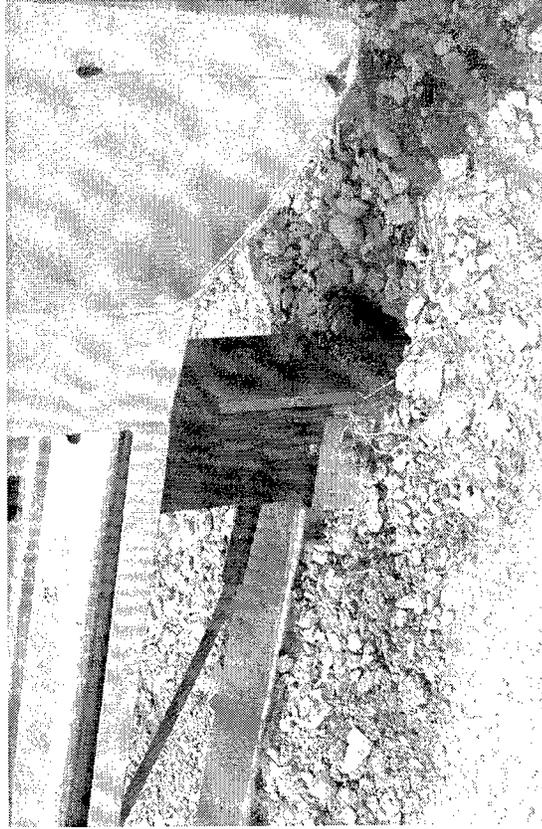
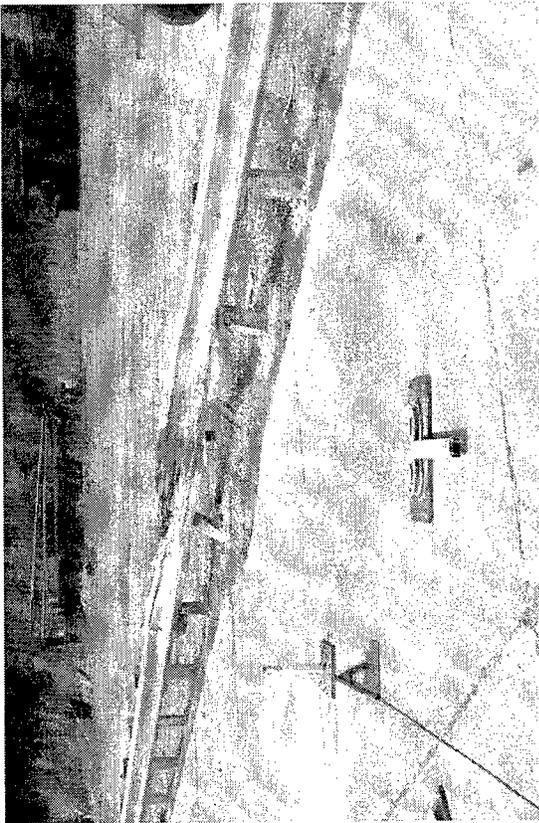
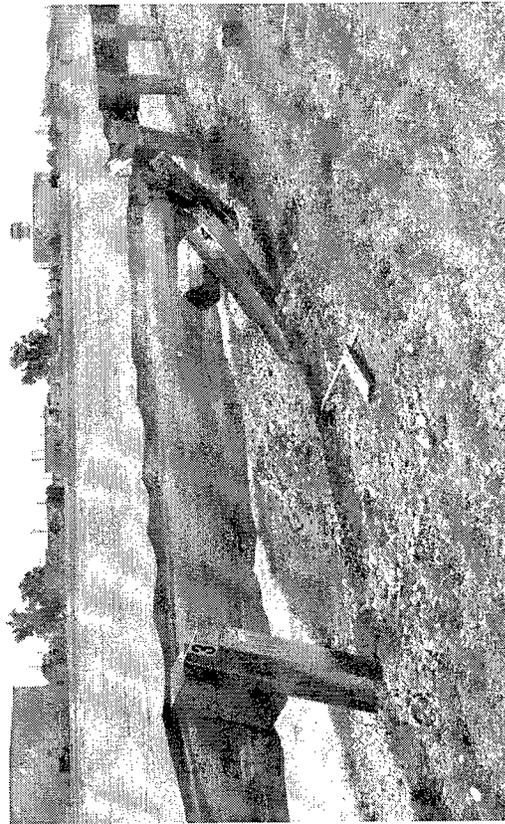
**Figure 9. Installation after test 439637-1.**

Damage to the guardrail is shown in Figures 8 and 9. Posts 10 through 16 were displaced laterally with maximum movement at the ground line measured to be 380 mm at post 13. Post 12 was separated from the guardrail but the rail remained attached to post 13, which was at a splice. The length of contact of the vehicle with the guardrail was 5.2 m.

Maximum dynamic deflection of the rail was 0.75 m and the maximum permanent deformation was 0.45 m.

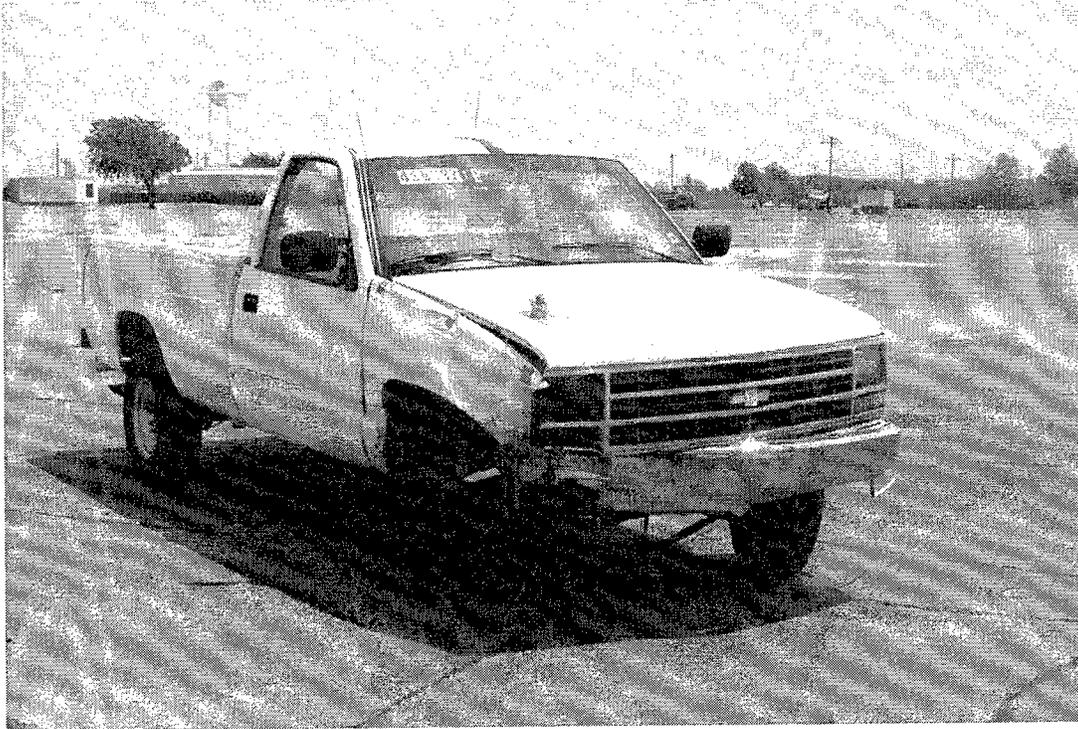
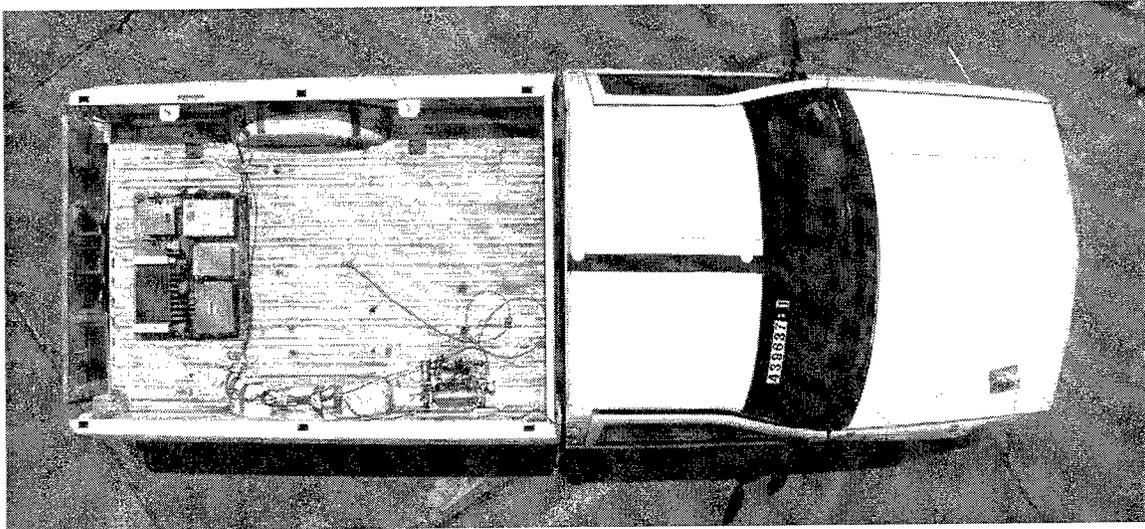
**Figure 10. Vehicle after test 439637-1.**

The vehicle sustained damage to the upper and lower A-arms, stabilizer bar, right front frame, and right front tie rods. Also damaged were the fan, radiator, the right side grill, right front quarter panel, and right front tire and rim. Maximum crush to the exterior of the vehicle at bumper height was 435 mm. Maximum deformation into the occupant compartment was 23 mm in the left floorpan area. Photographs of the vehicle damage are shown in Figure 10. Additional information on vehicle damage such as exterior crush measurements and occupant compartment deformation measurements are shown in Appendix C.
