**TEN YEAR PERFORMANCE OF  
ASPHALT ADDITIVE TEST  
SECTIONS  
LAVA BUTTE – FREMONT  
HIGHWAY JUNCTION SECTION  
THE DALLES - CALIFORNIA HIGHWAY  
(US#97)  
DESCHUTES COUNTY, OREGON  
FHWA Test and Evaluation Project #3**

September 1998

1. Report No. FHWA-OR-RD-99-08		3. Recipient's Catalog No.	
4. Title and Subtitle TEN YEAR PERFORMANCE OF ASPHALT ADDITIVE TEST SECTIONS: LAVA BUTTE ROAD - FREMONT HIGHWAY JUNCTION SECTION		5. Report Date September 1998

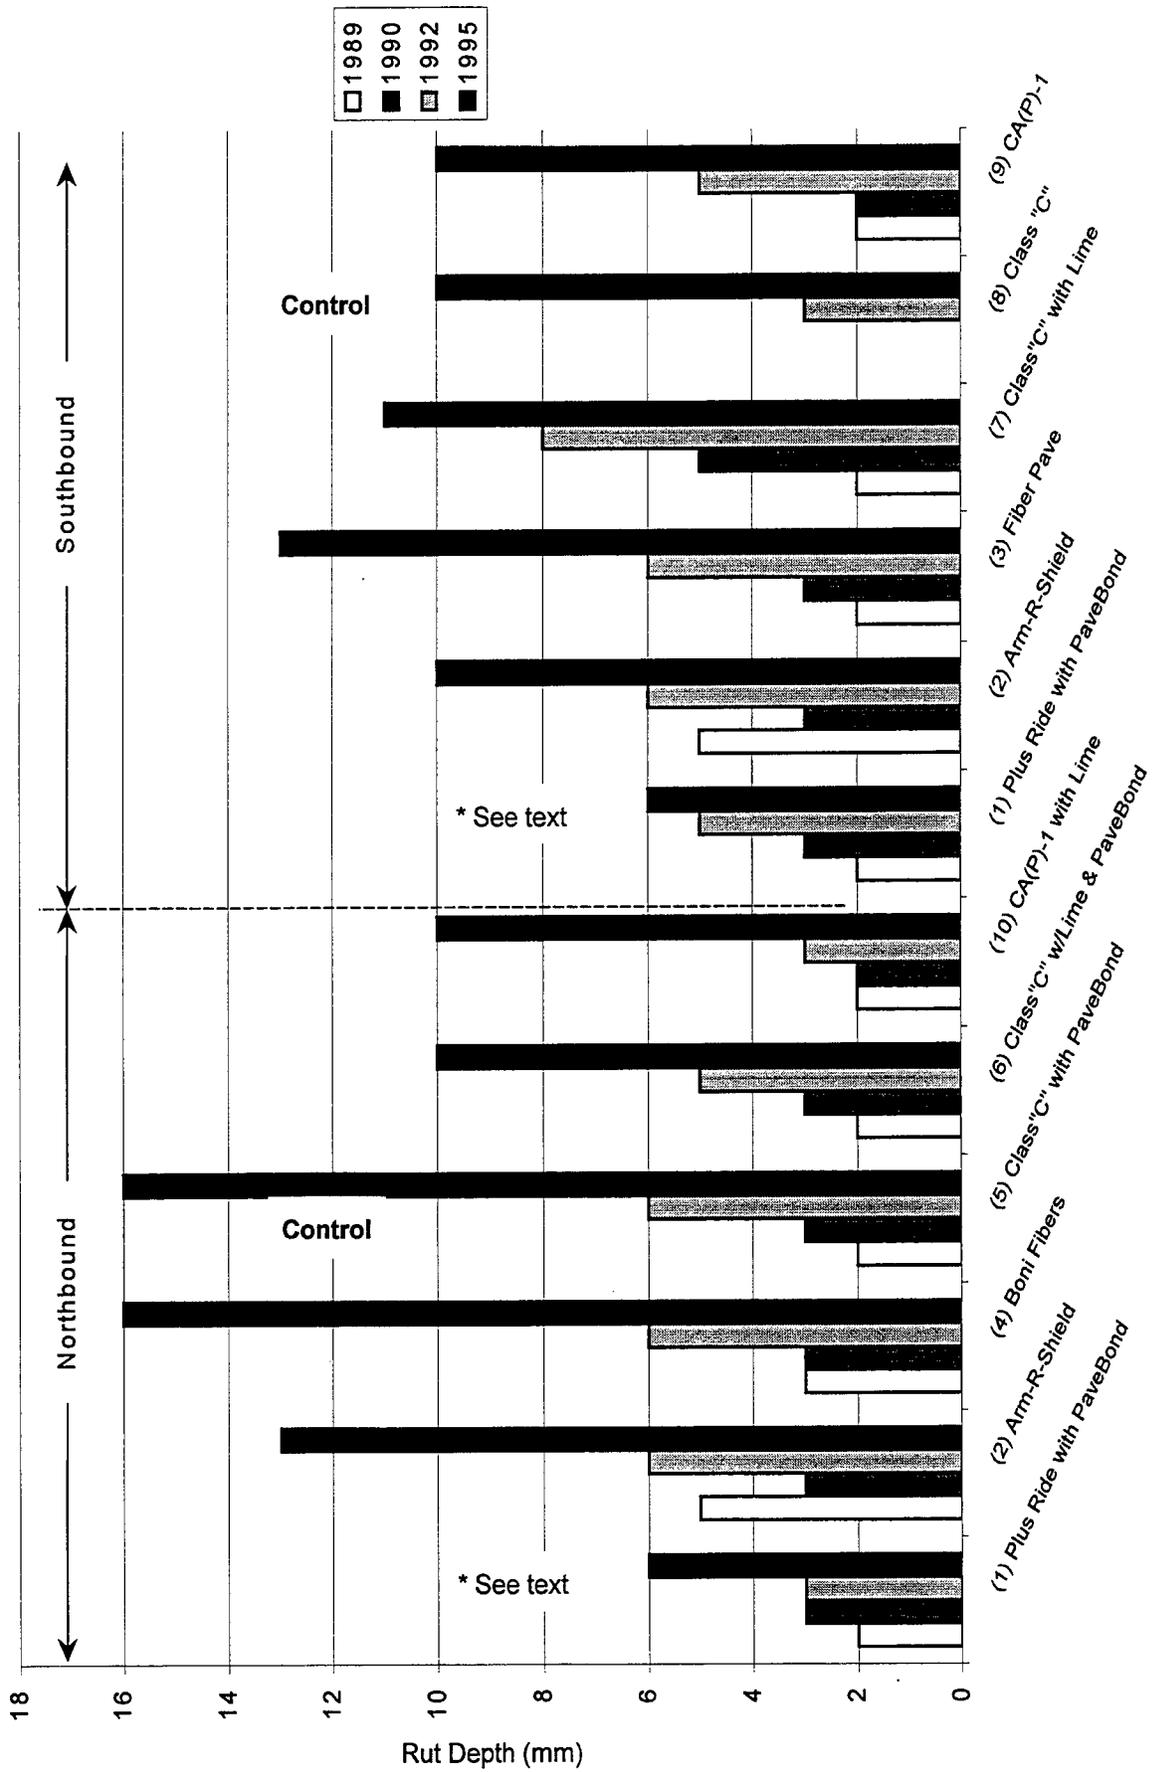
Figure 2.1: Average Rut Depths 1989-1995

With the exception of the Plus Ride section, the rutting resistance on all sections was the same as, or slightly better than, the control sections. The Plus Ride rut depth in 1995 was less than the other sections, but this was due to the reduction in traffic caused by the construction of slow moving vehicle lanes in 1990. Since the Plus Ride rut depths were similar to the control sections

in 1989 and 1990, it is assumed that the overall rutting resistance of Plus Ride is similar to the control section (see Figure 2.1).

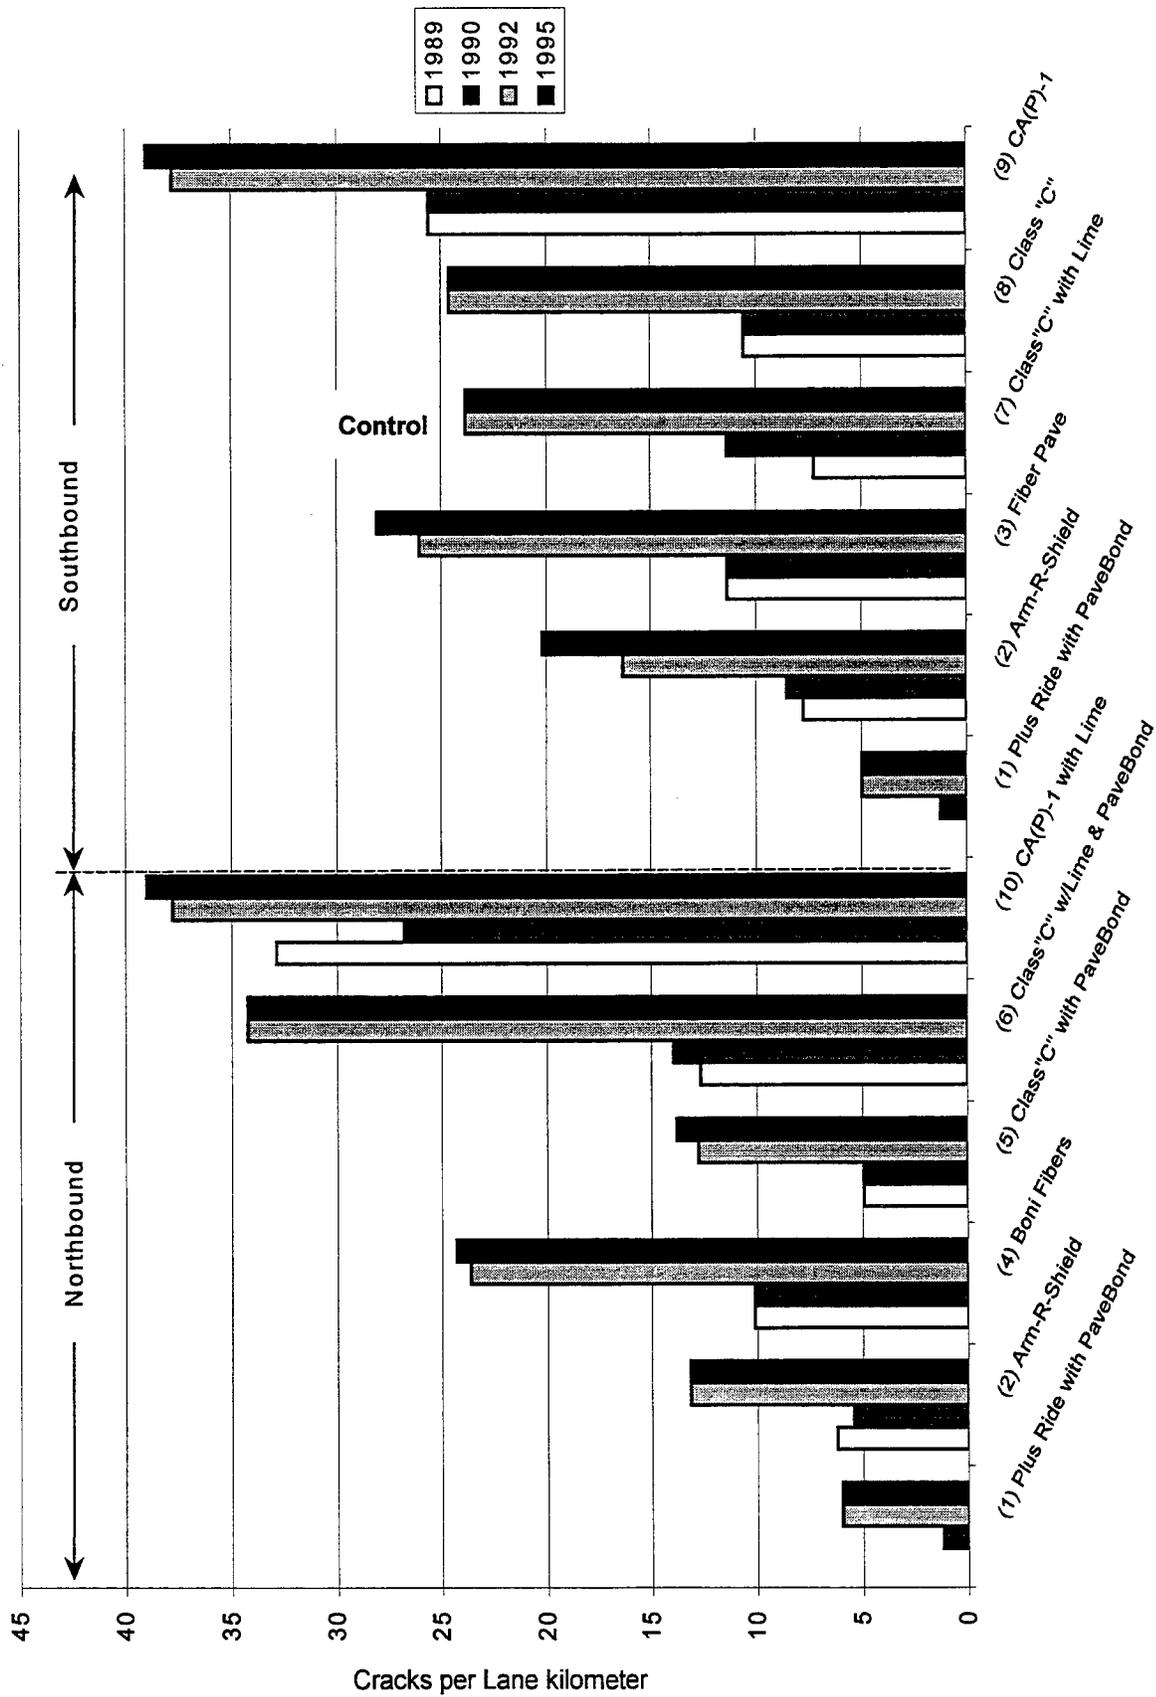
Figure 2.3: Transverse Cracking

The test and control section's transverse crack counts ranged from 5 to 39 cracks per lane kilometer. Consequently, all of the sections had much less transverse cracking than the 93 large transverse cracks per lane kilometer on the road before the overlay.

Plus Ride had the least amount of transverse cracking, followed by Class "C" with Pave Bond and Arm-R-Shield. CA(P)-1 had the most cracking. The low number of cracks in the Plus Ride and Arm-R-Shield sections was expected, as these sections contain rubber which is usually resistant to thermal cracking. The lack of transverse cracking in the Class "C" with Pave Bond mix is puzzling, as this section is alongside the Class "C" with Lime section which has about twice as much transverse cracking. It was initially thought that the Pave Bond improved transverse crack resistance. However, this may not be true. The Class "C" with Pave Bond and Lime section had more transverse cracking than the Class "C" section that is alongside it.

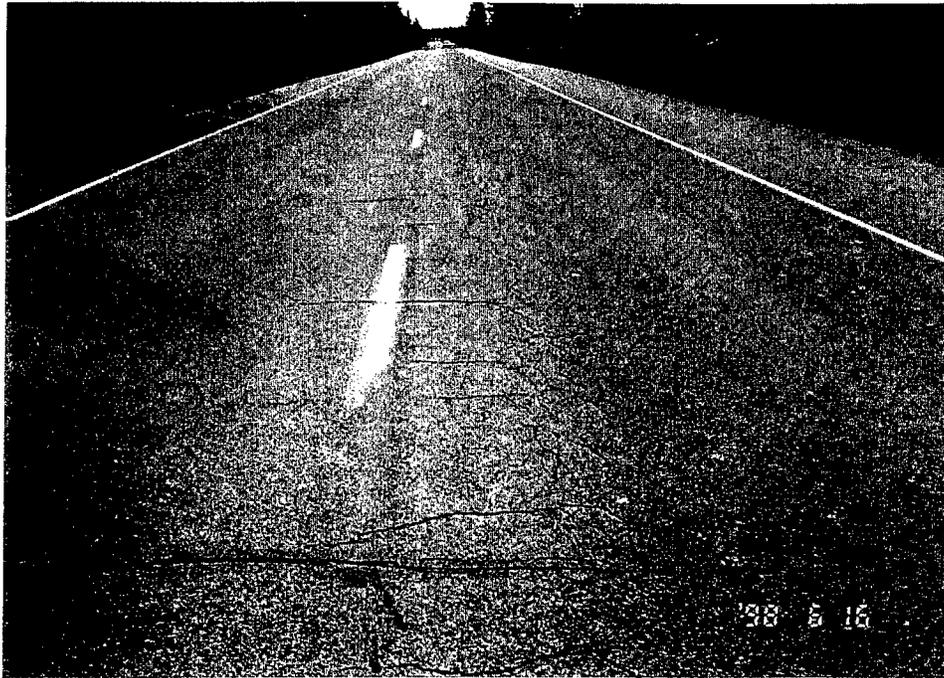
Transverse cracks approximately 0.3 to 0.6 m long were found near the centerline of many sections. An example of this cracking is shown in Figure 2.4. These cracks were counted as block cracking rather than transverse cracks. The remainder of the cracks may be reflective cracks, cracks in the old roadway reflecting up through the overlay. The presence of this block cracking near the centerline is accounted for in Table 2.3. Block cracking on the shoulder is not included in this rating, as many sections paved with experimental mixes have shoulders of conventional mix.

Figure 2.4: Typical Block Cracking and Fatigue Cracking. The Class "C" pavement is on the left, and the Class "C" with Lime and Pave Bond pavement is at the right. Location: MP 61.05 looking south.

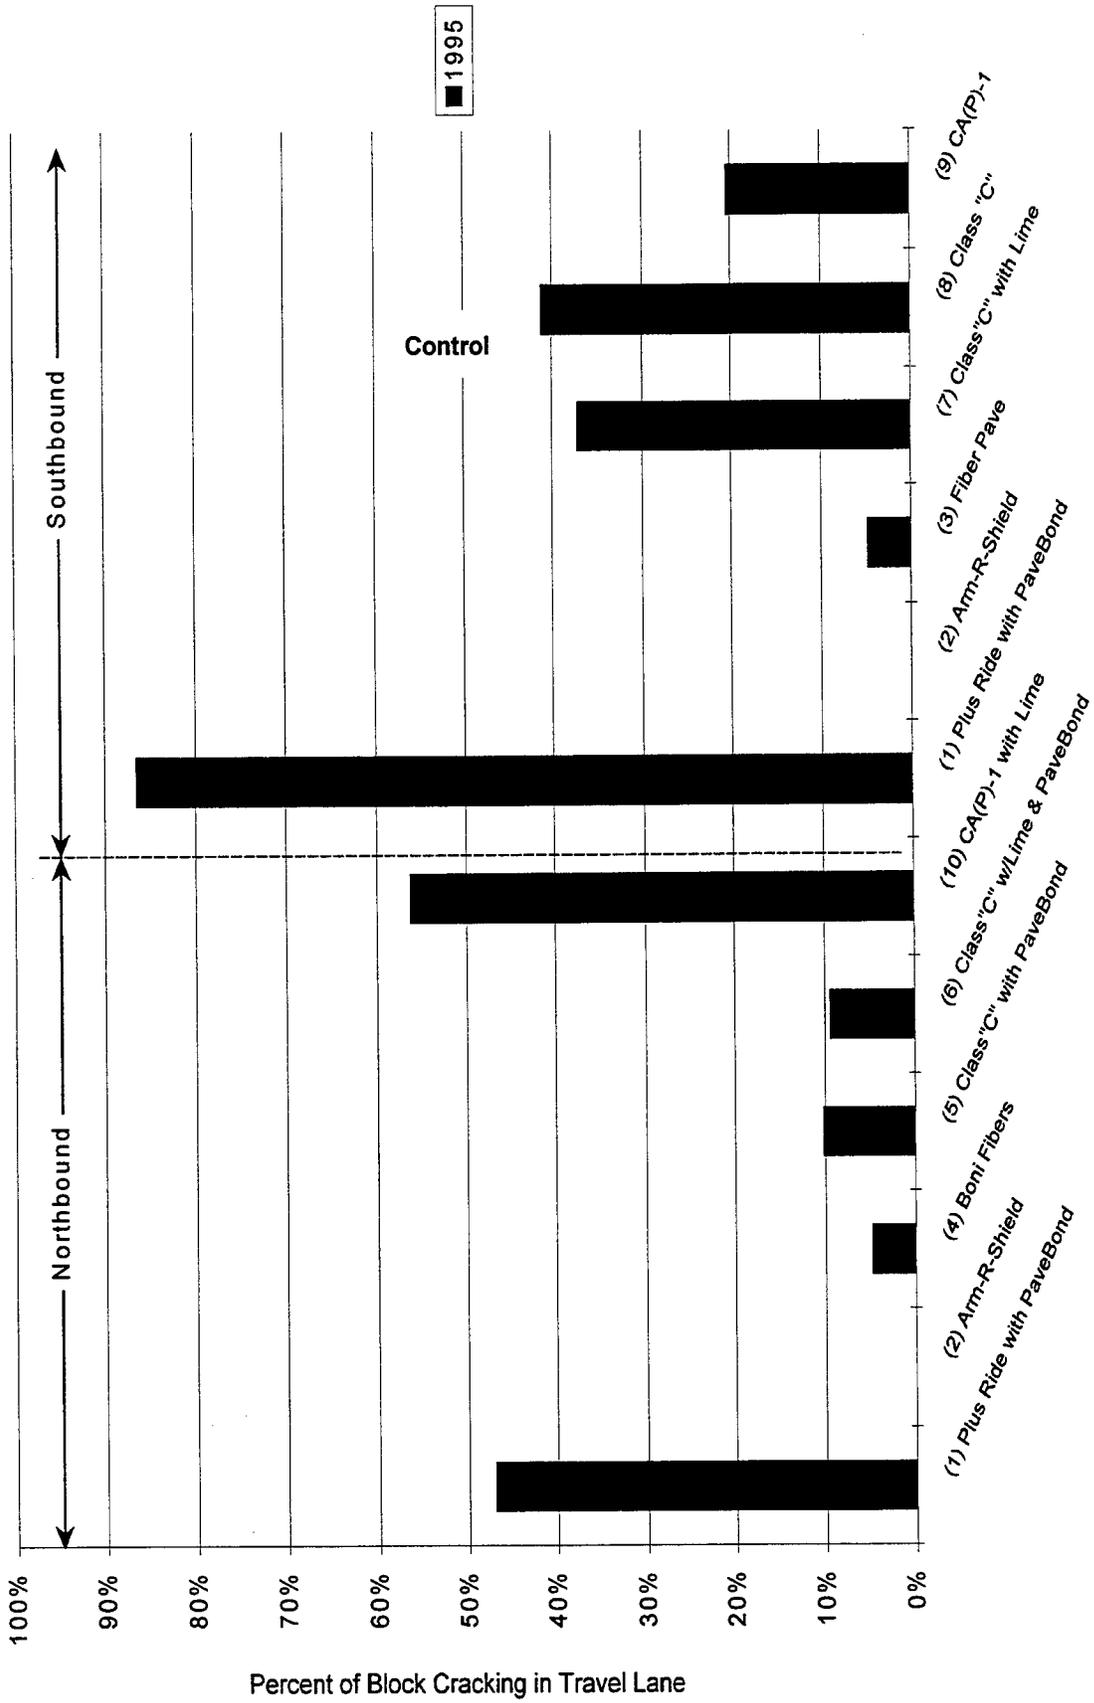
Figure 2.6: Block Cracking

Only the Arm-R-Shield section had no block cracking. All other sections had block cracking of a "low" severity level. (*SHRP 1993*).

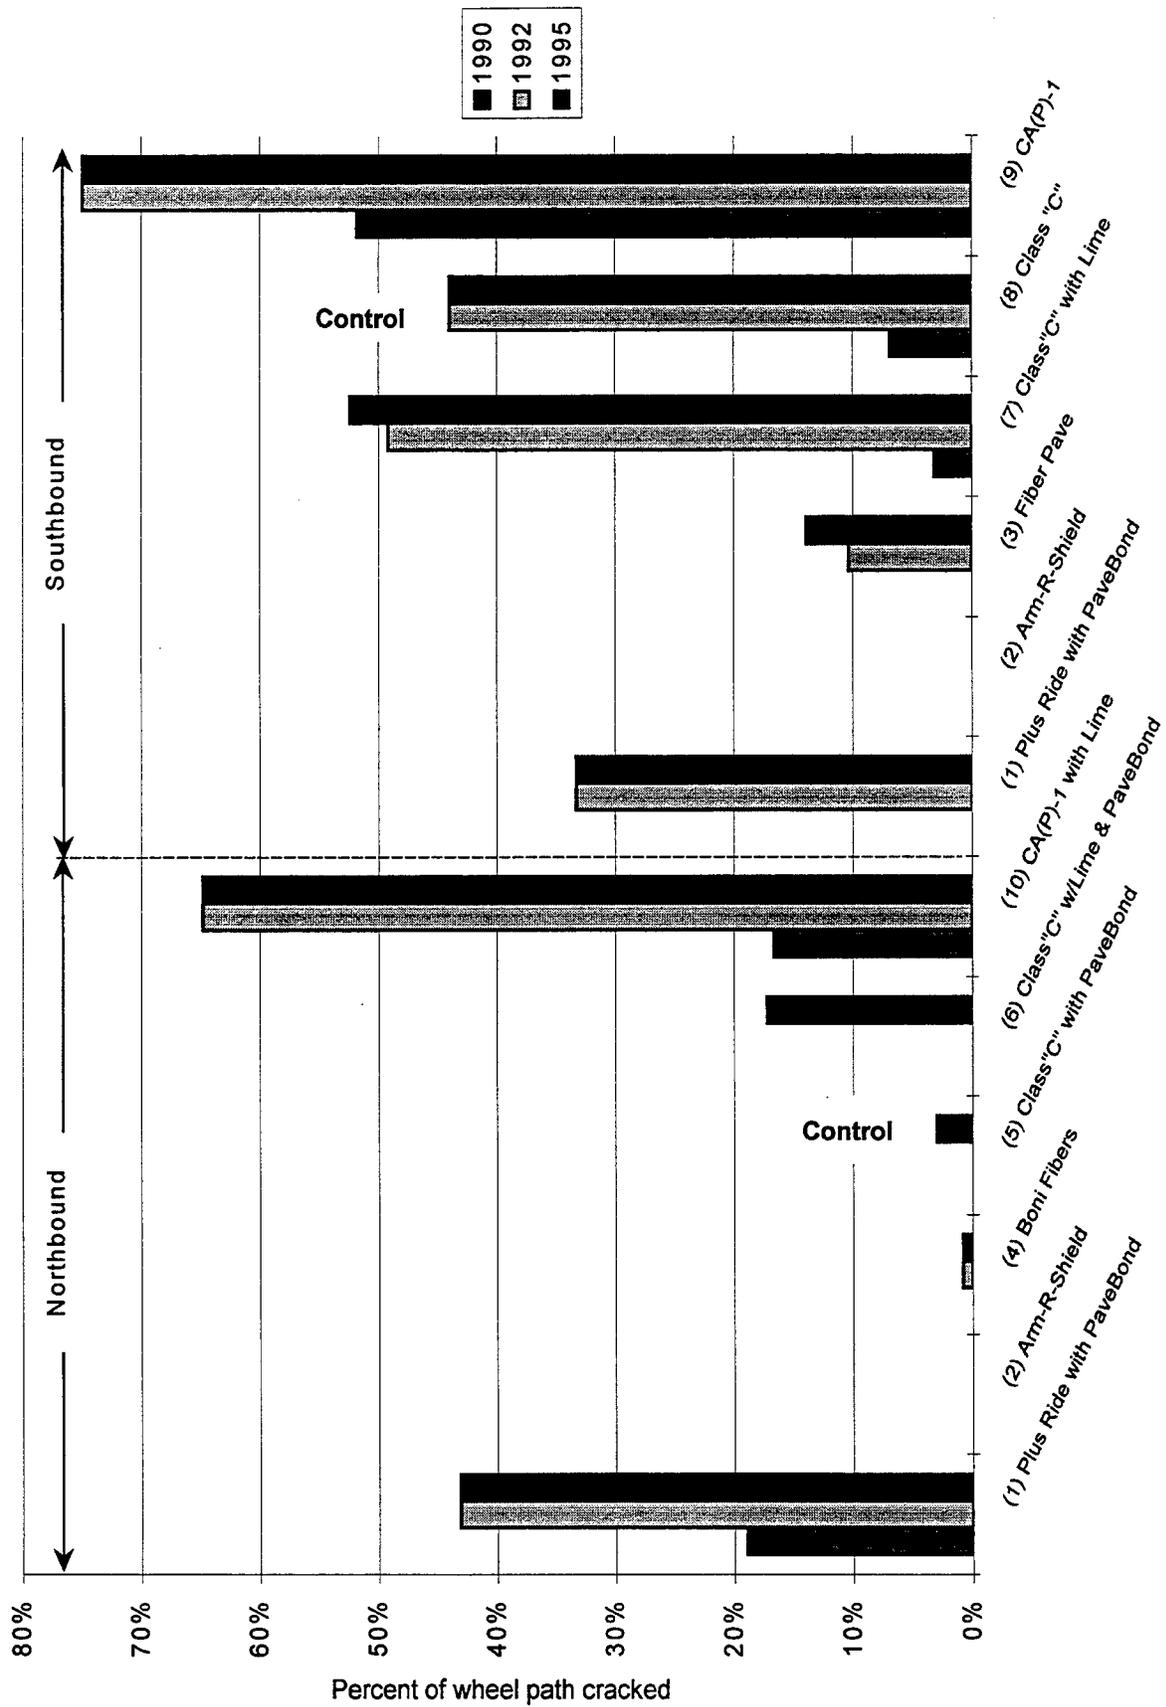
Figure 2.7: Fatigue Cracking

The Arm-R-Shield section had excellent resistance to fatigue cracking. There was no cracking in either the southbound lane with the higher truck traffic, or the northbound lanes with the lower truck traffic. All other sections had some fatigue cracking, though it was of a "low" severity level (*SHRP 1993*).
