Publication No. FHWA-RD-99-027

**FULL-SCALE CRASH EVALUATION OF THE NETC 4-BAR
SIDEWALK-MOUNTED STEEL BRIDGE RAILING**

7. Author(s) Kimball, C.E., Mayer, J.B.		6. Performing Organization Code	
9. Performing Organization Name and Address Southwest Research Institute 6220 Culebra Road San Antonio, Texas 78238-5166		8. Performing Organization Report No. 18-8518

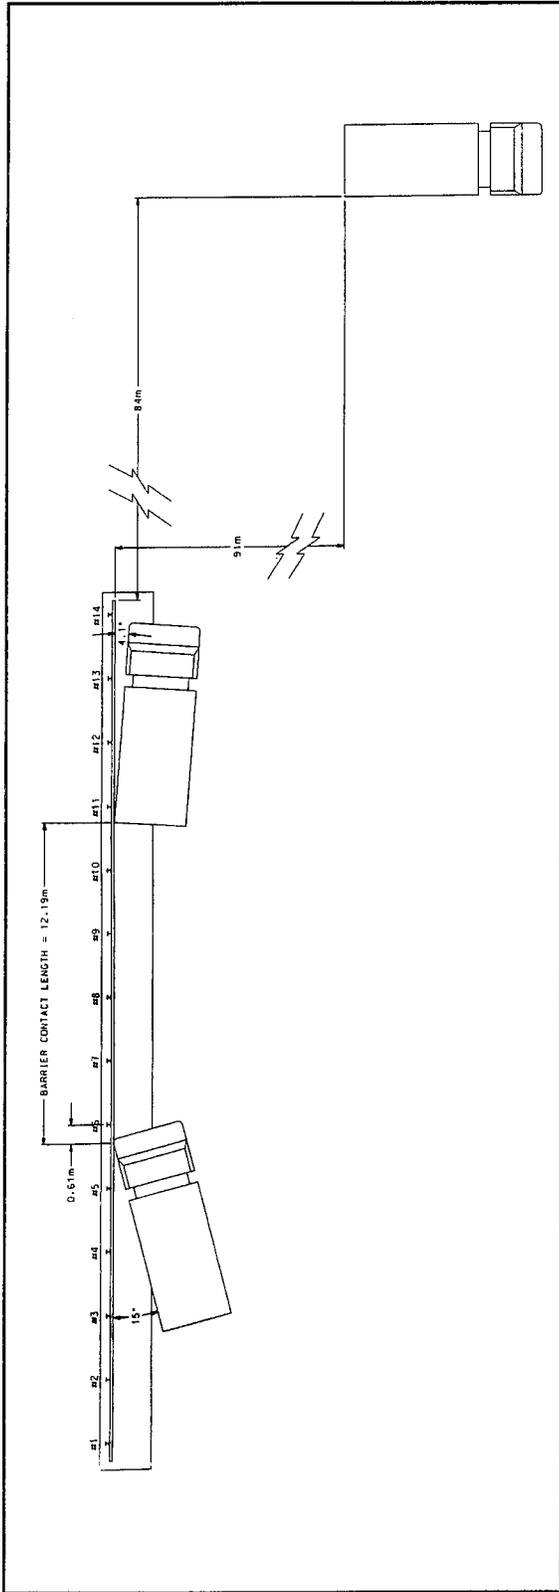
Figure 14. Impact sequence and summary of test conditions and results - Test NETC-3.

Test NETC-3. As shown in the test summary diagram of figure 14, the single-unit van truck traversed the sidewalk and impacted the barrier 610 mm upstream of post 6, deflecting the two top rails approximately 25 mm at the splice between posts 6 and 7 while maintaining contact with the longitudinal rails for 12.19 m as it was redirected. The vehicle then exited the barrier at a 4.1 degree angle (calculated from measured tire marks). Figures 15 and 16 show the redirection sequence of the vehicle from overhead as well as behind the barrier viewpoints. Since the front axle was dislodged during the impact, the vehicle veered hard to the right after exiting and stopped 84 m downstream and 91 m normal to the test installation. Although some of the vehicle accelerometers had interruptions in their data due to the impact, only one, the longitudinal accelerometer mounted on the bottom of the engine, suffered complete data loss. Maximum 50 msec average accelerations in the longitudinal and lateral directions were -2.72 g's and -5.79 g's , respectively. Occupant risk values were as follows: (1) the occupant impact velocities were 1.65 m/sec in the longitudinal direction and -2.89 m/sec in the lateral direction, and (2) the maximum occupant ridedown accelerations were -8.95 g's in the longitudinal direction and 14.30 g's in the lateral direction.

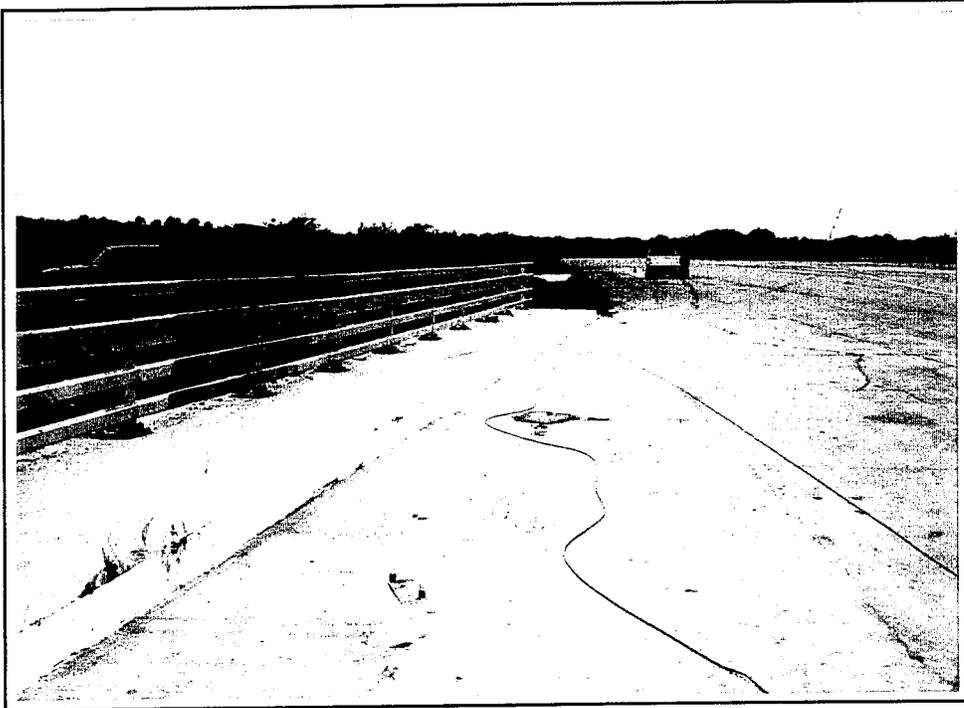
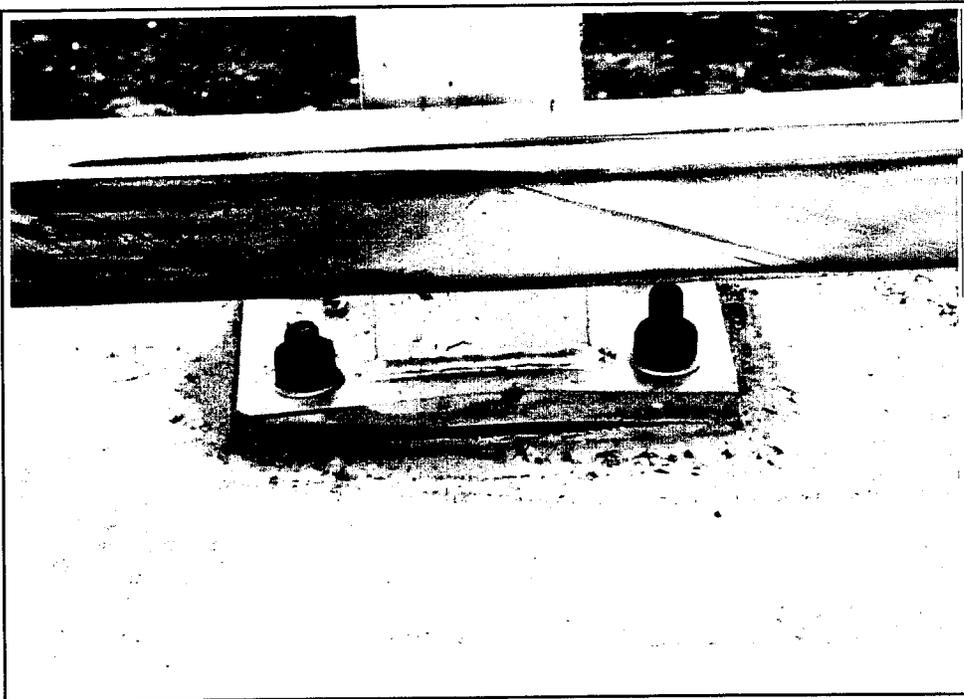
Figure 18. Barrier damage photographs - Test NETC-2.

Test NETC-2. Damage to the barrier, as shown in figure 18, occurred mostly at post 7. The top of post 7 and the top rail section attached to it had 13 mm of permanent deflection, and the baseplate of the post was raised upward at the center approximately 3.5 mm . The remainder of the damage consisted of scuffing of the longitudinal rails which only required repainting prior to further testing. The top rail was straightened, but post 7 required replacement prior to subsequent testing.

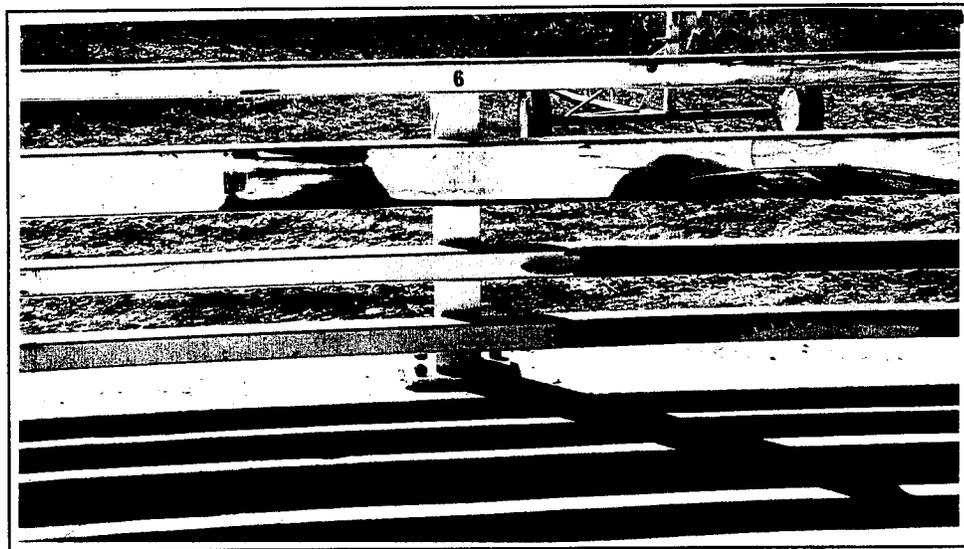
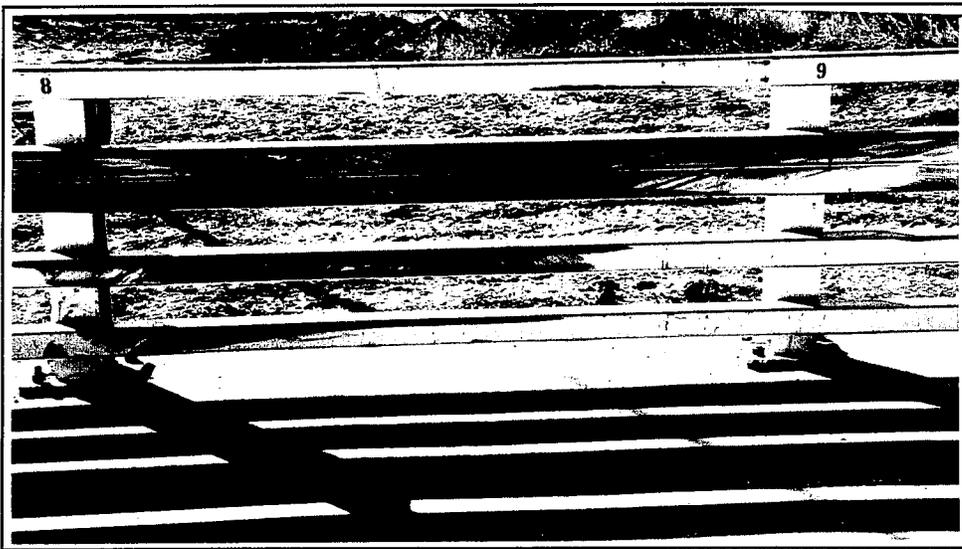
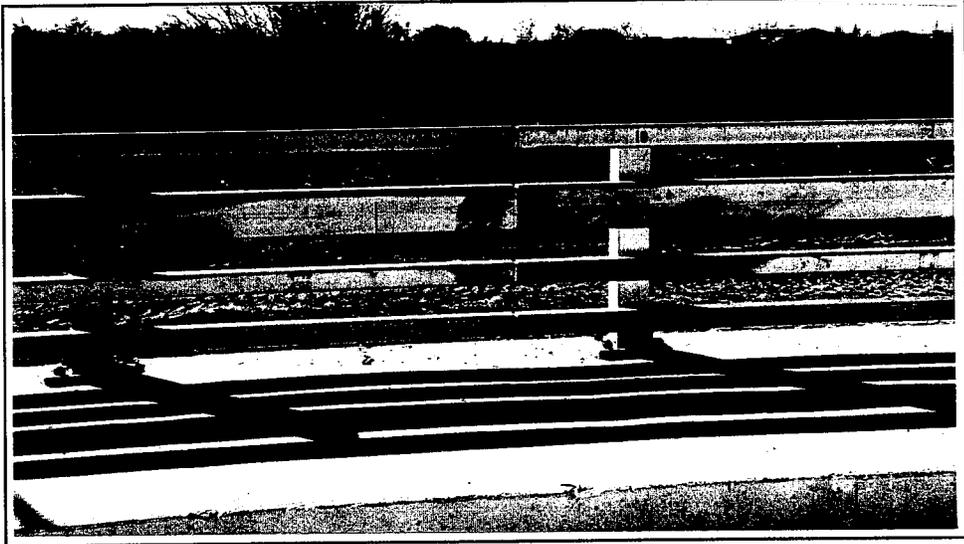
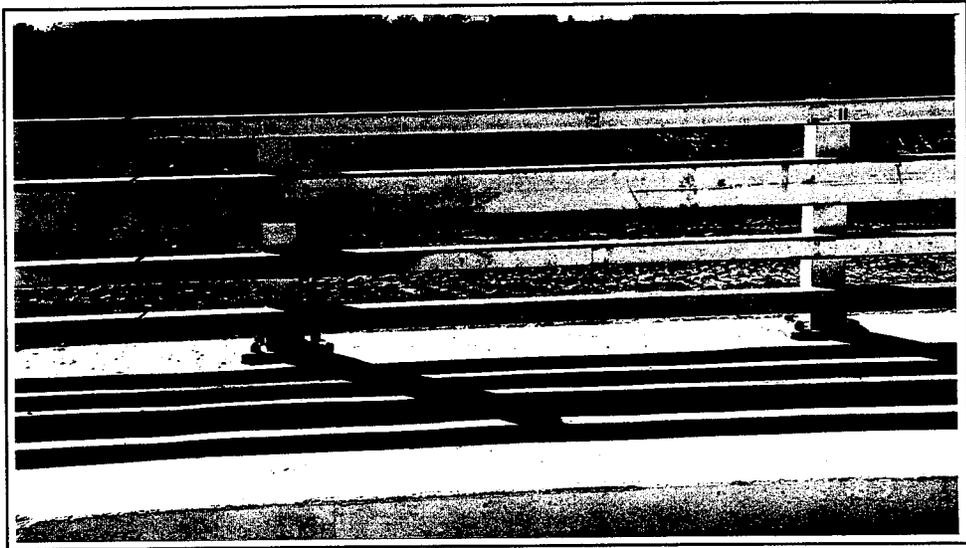
Figure 19. Barrier damage photographs - Test NETC-3.

Test NETC-3. Barrier damage is shown in figure 19. Maximum permanent rail deflection occurred at the splice upstream of post 7 and was measured as 13 mm . Two sections of the top rail had permanent deflection (deflection occurred between posts 6 and 7), and posts 6 and 7 were tilted back; the base plates of both posts were raised upward at the center approximately 3.5 mm . The remainder of the damage consisted of scuffing of all longitudinal rails between posts 6 and 11.

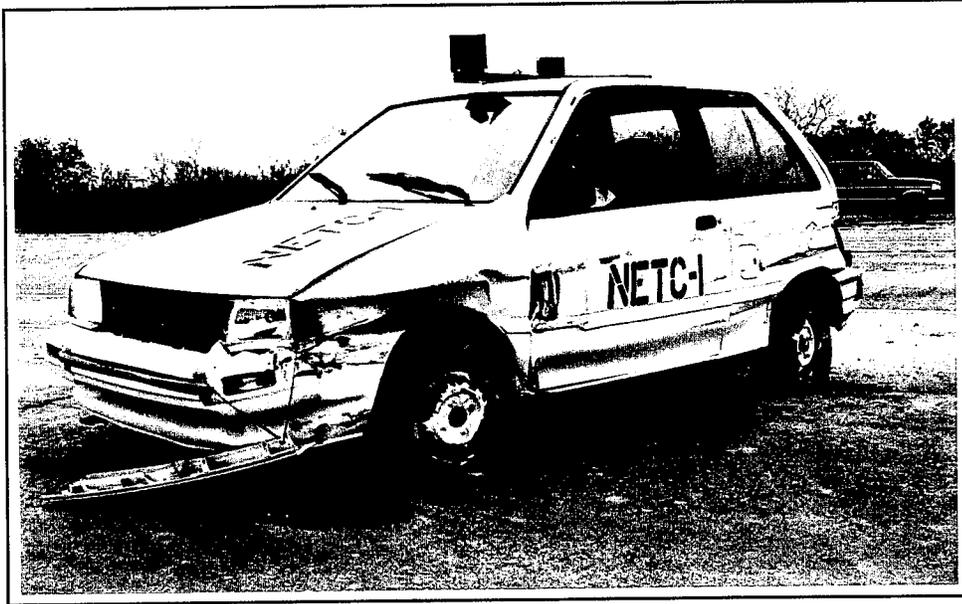
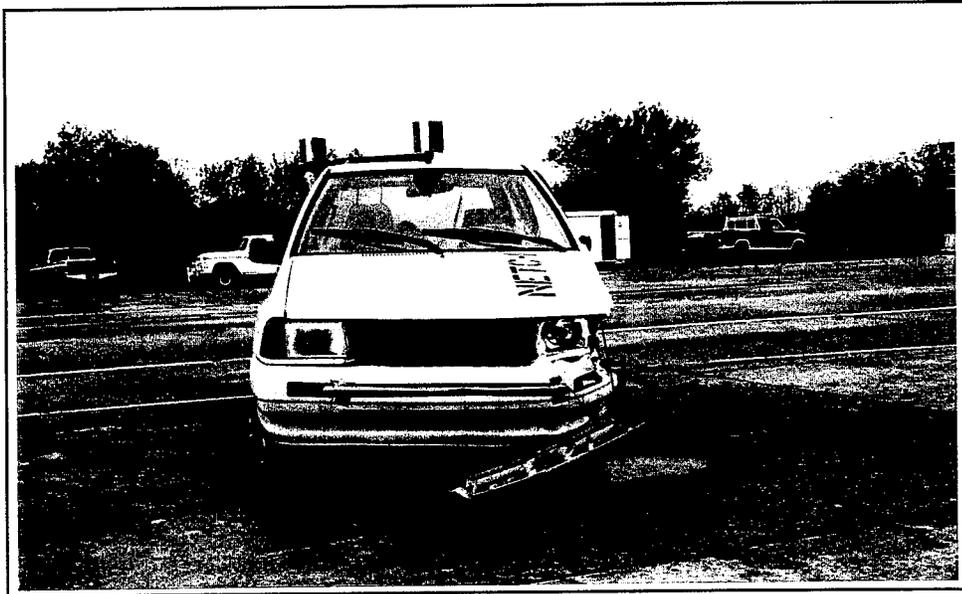
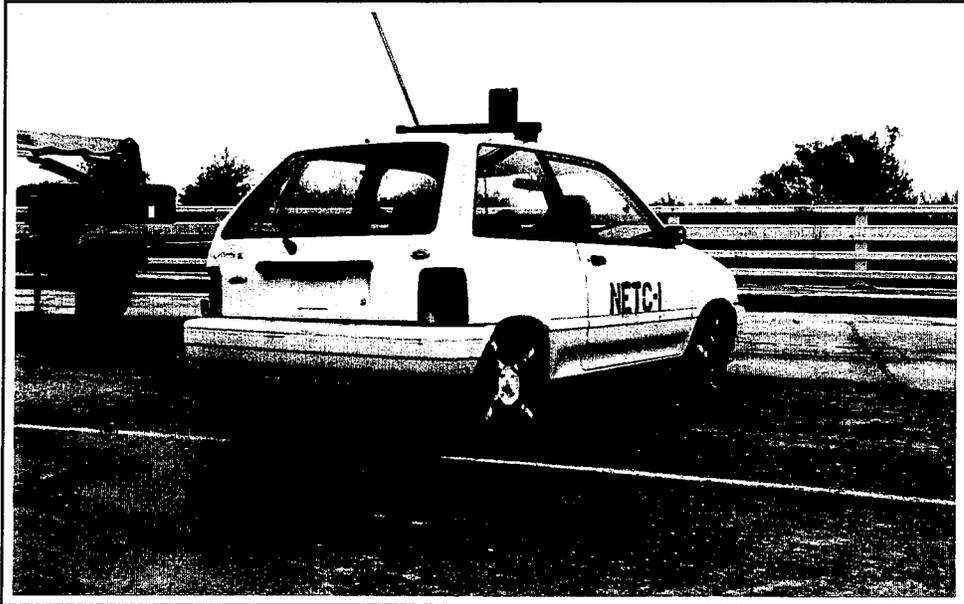
Figure 20. Vehicle damage photographs - Test NETC-1.

Test NETC-1. As shown in figure 20, the test vehicle sustained damage to the left front fender and along the left side, as well as damage to headlight/grill area. The left side of the front bumper was deformed rearward, and the left front suspension/wheel/tire displaced rearward. All tires except the right rear were either blown out or deflated as a result of the impact. The exterior vehicle damage scale was estimated to be 11-FL-2 using the VDS system and 11FLEE2 using the CDC system. The interior deformation of the occupant compartment was LF0000000 using the OCDI system. There was no deformation or intrusion into the occupant compartment.

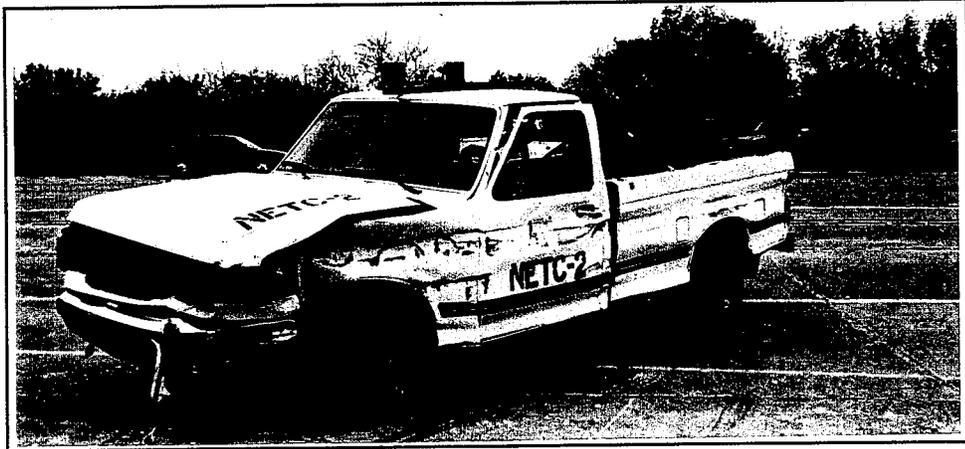
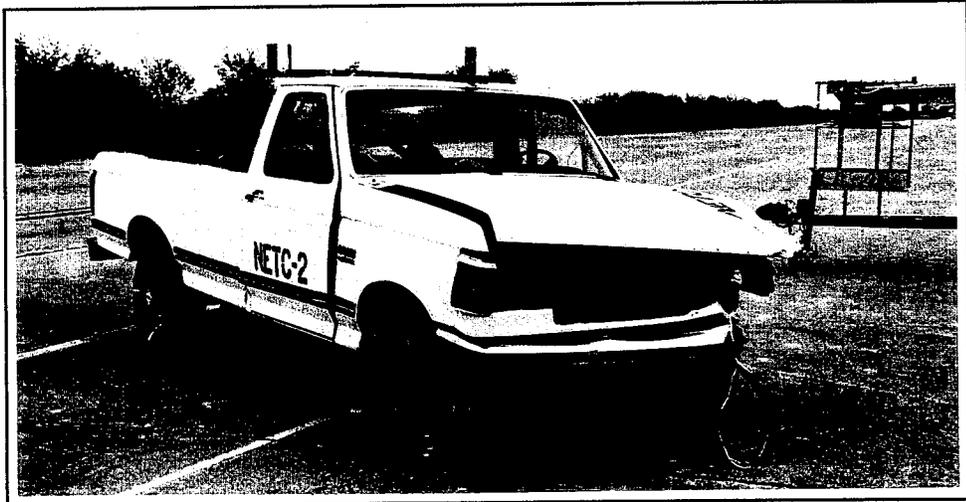
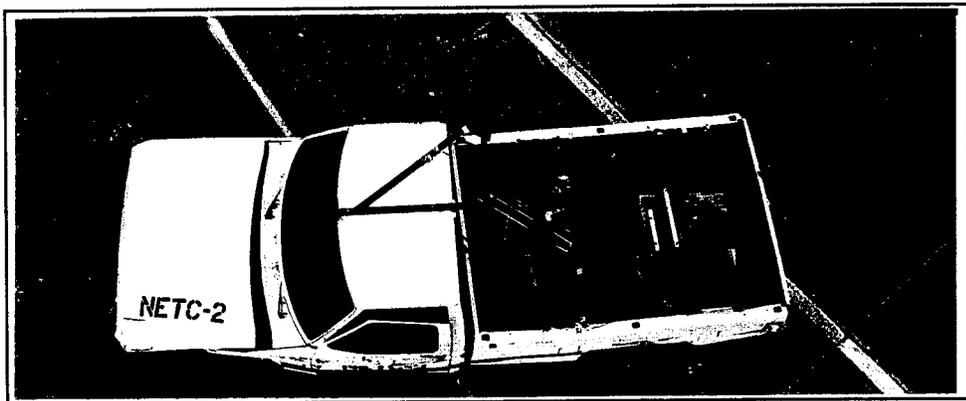
Figure 21. Vehicle damage photographs - Test NETC-2.

Test NETC-2. Figure 21 shows that the test vehicle sustained extensive damage to the left front fender and along the left side, as well as damage to the headlight/grille area. The left side of the front bumper was deformed rearward, and the left front suspension/wheel/tire displaced rearward. Contact with the edge of the sidewalk damaged the right front suspension also. All tires except the right rear were either blown out or deflated as a result of the impact. The exterior vehicle damage scale was estimated to be 11-FL-3 using the VDS system and 11FLEE3 using the CDC system. The interior deformation of the occupant compartment was LF000000 using the OCDI system. There was no deformation or intrusion into the occupant compartment.

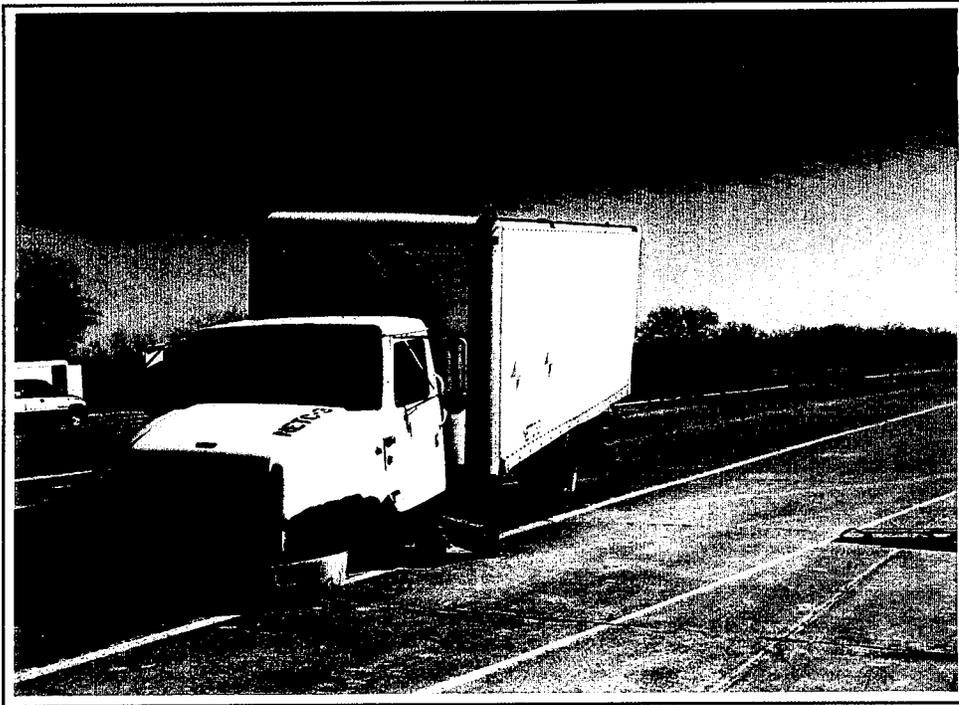
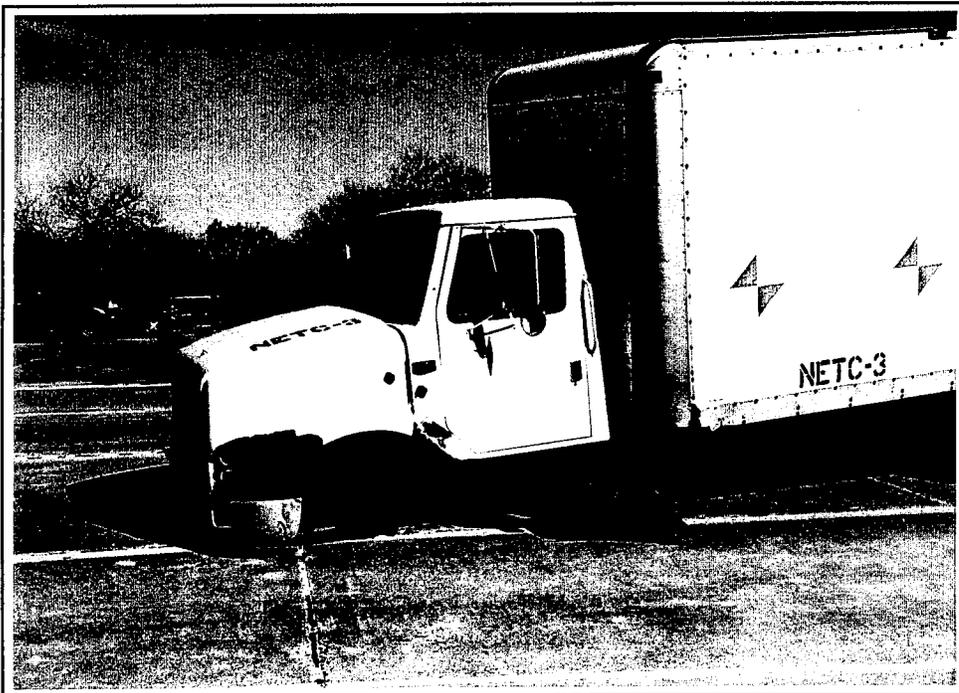
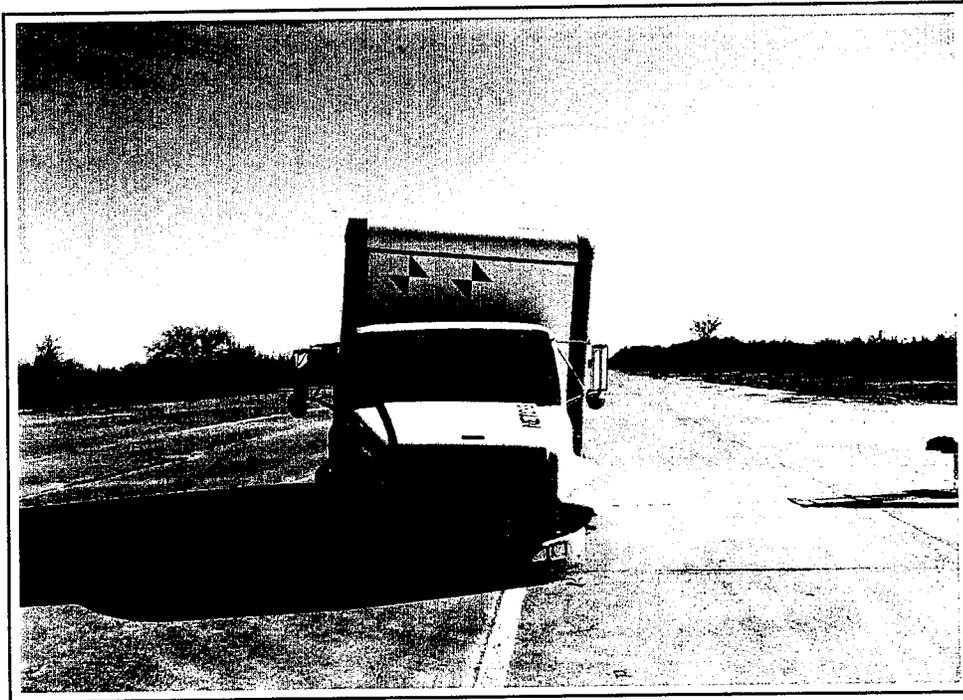
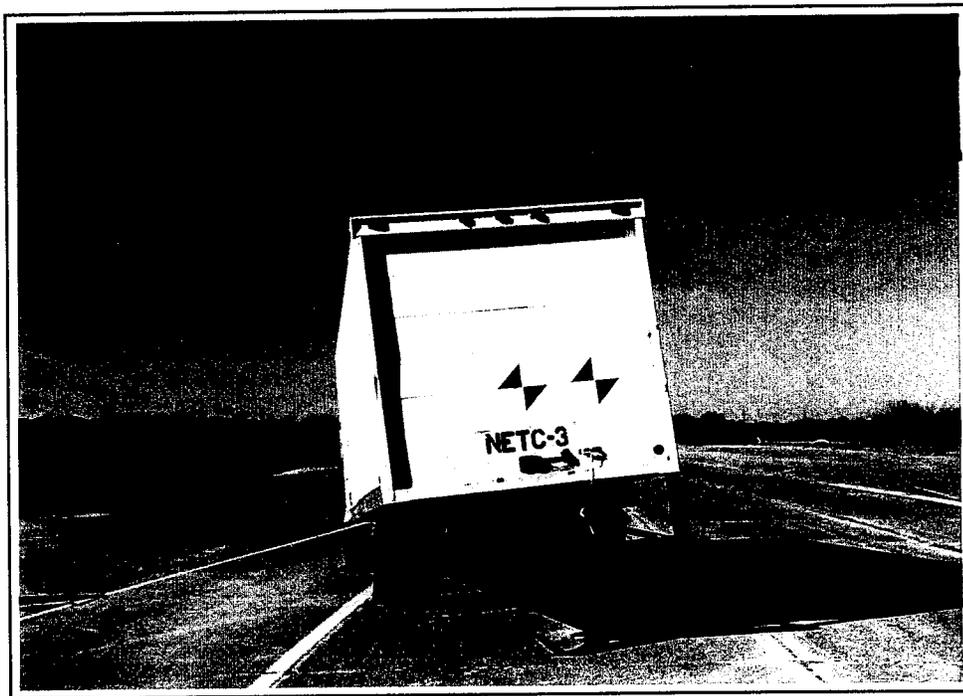
Figure 22. Vehicle damage photographs - Test NETC-3.

Test NETC-3. The test vehicle, as shown in figure 22, sustained extensive damage. As described previously, the entire front axle (axle/brakes/wheels/tires, etc.) was dislodged by the impact and later separated during vehicle run out. In addition, the left corner of the front bumper was deflected rearward, a portion of the left front fender was torn away (the vehicle had a one-piece, fiberglass front clip), the left step under the driver's door was torn away, the left rear, outside wheel was damaged, the cargo box was racked toward the left side, and the anti-underride assembly was fractured at the left rear corner. Since the exterior damage scales, i.e., the VDS system and the CDC system, are not applicable to this class of test vehicle, no assessment of that type was made. The OCDI system is also not applicable; however, there was no deformation or intrusion into the occupant compartment.
