ARIZONA DEPARTMENT OF TRANSPORTATION

REPORT NUMBER: FHWA-AZ-8604

CRACK AND SEAT CONCRETE PAVEMENT

Construction Report

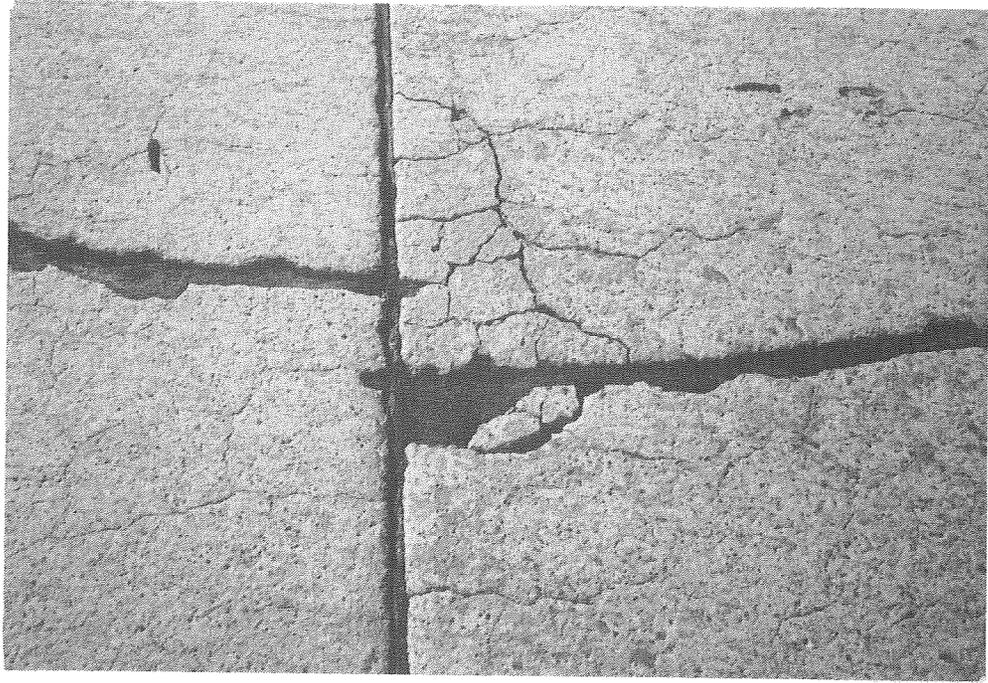
Spalls were frequently seen throughout the project and some cracks were found to be as wide as 1". Although the joints were sealed, the sealant was loose and had separated from the joints. Many of the broken slabs had not been sealed. The slabs which were sealed, however, appeared to have been oversealed. This is visible in Figures 1 and 2. Aside from the cracks and the faults, the concrete pavement had only a few areas patched with asphalt concrete.

Figure 1. Typical Severe Cracking of the PCCP Near Joints

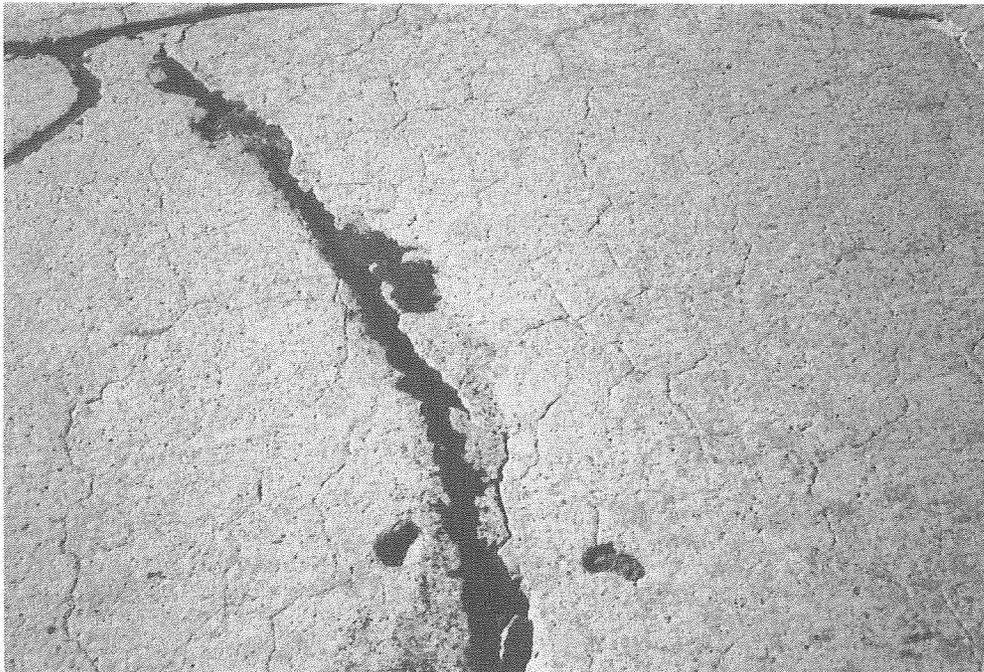
Figure 2 Typical Block Cracking of the PCCP

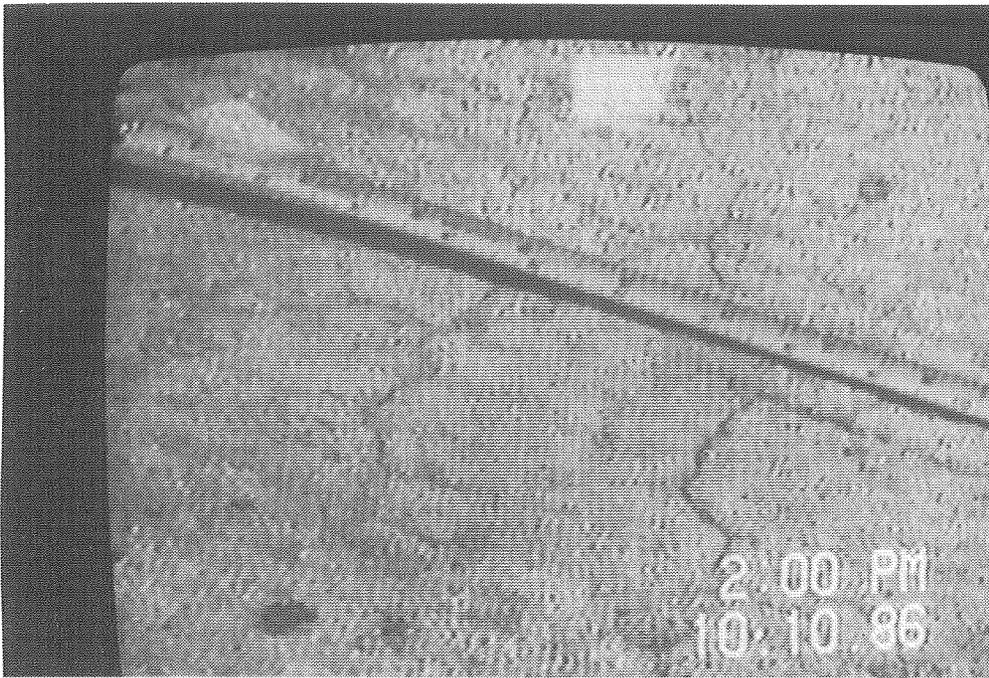
Figure 4 Typical Cracking Pattern of the Whiphammer

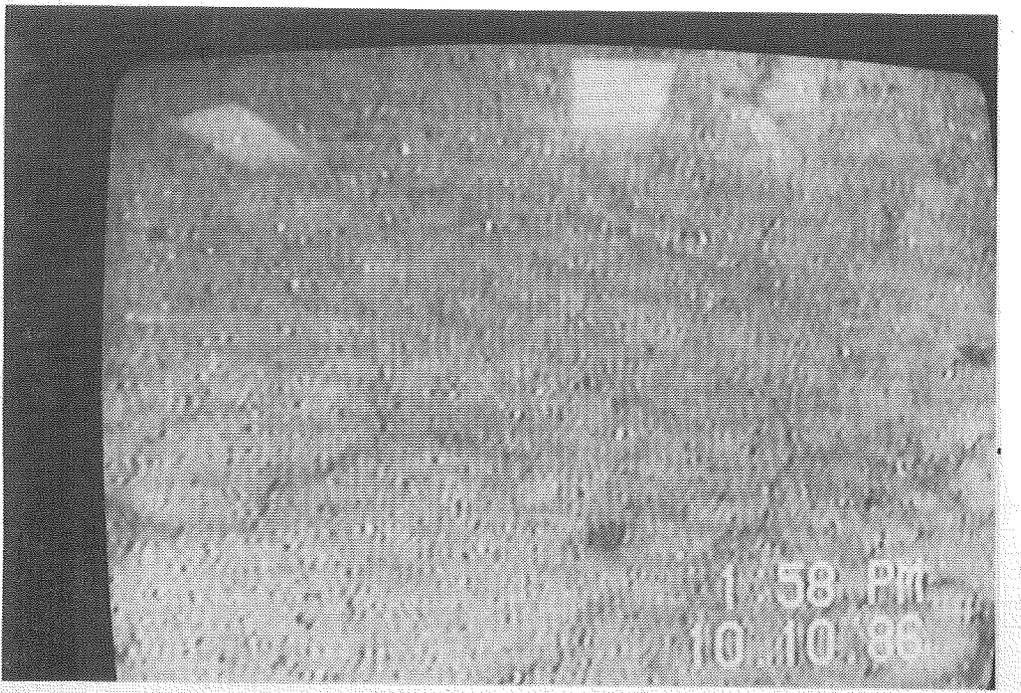
Figure 5 Typical Cracking Pattern of the Whiphammer

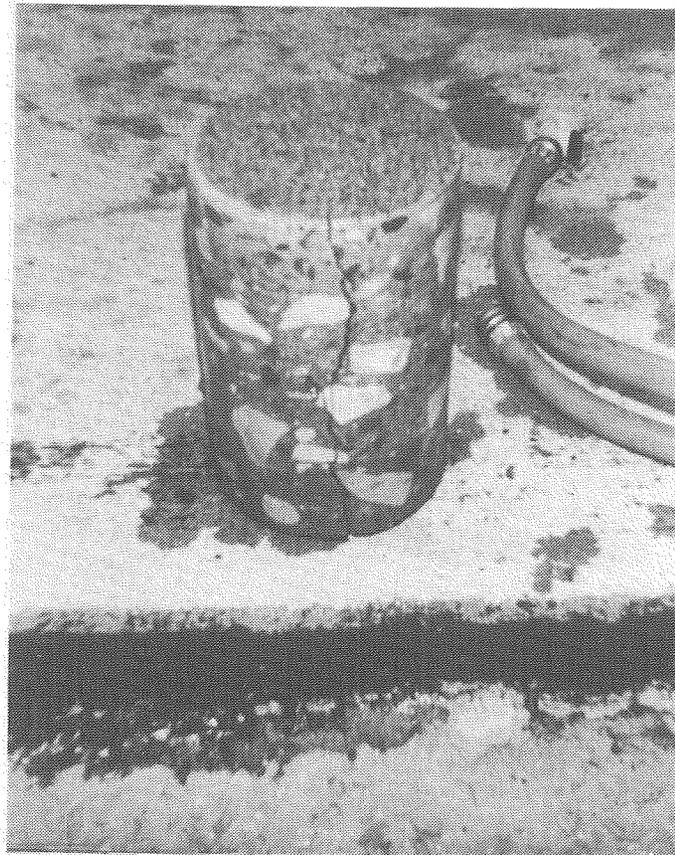
The size of the cracked pieces ranged between four and nine square feet. The cracked pieces were generally not square but were usually diamond or triangular in shape. A "Spider web" type of cracking pattern was produced by the Whiphammer. The cracks were not visually detectable on a dry pavement; therefore the pattern was checked periodically by applying water to the cracked surface so that the cracks could be more readily detected. Figures numbered 4 and 5 show a typical cracked PCCP. Figure 6 shows a rendering of the expected and the produced cracking pattern. Cores, randomly taken, verified that the hairline cracks penetrated the full depth of the slab (Figure 7).

Figure 7 Core Thru the Cracked PCCP

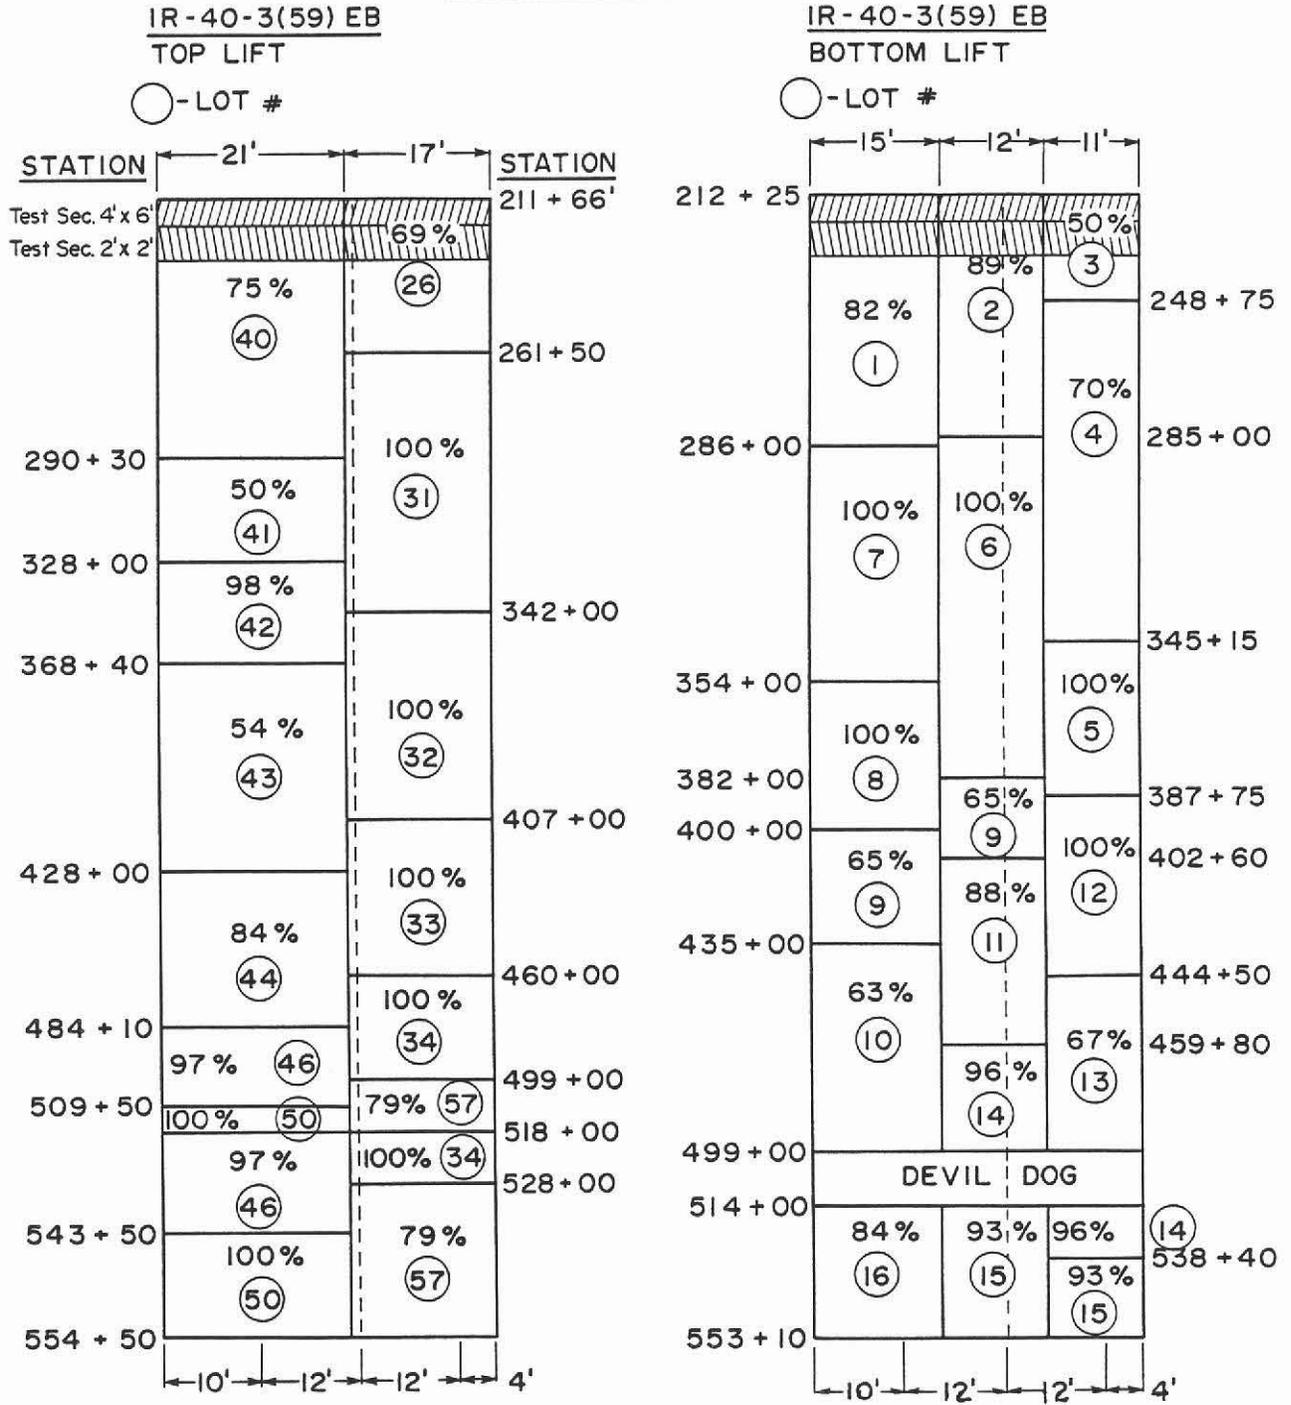
Obtaining HMAC density was very difficult at times. The bottom 2" lift of HMAC produced a total of 19 failing lots, while the top 2" lift produced 12 failing lots. Figure 10 and Figure 11 show lot locations with respective percent compliance. Compliance of at least 80% was required as per the specifications.

Figure 10 Percent Compliance and Lot Location for the East Bound Roadway

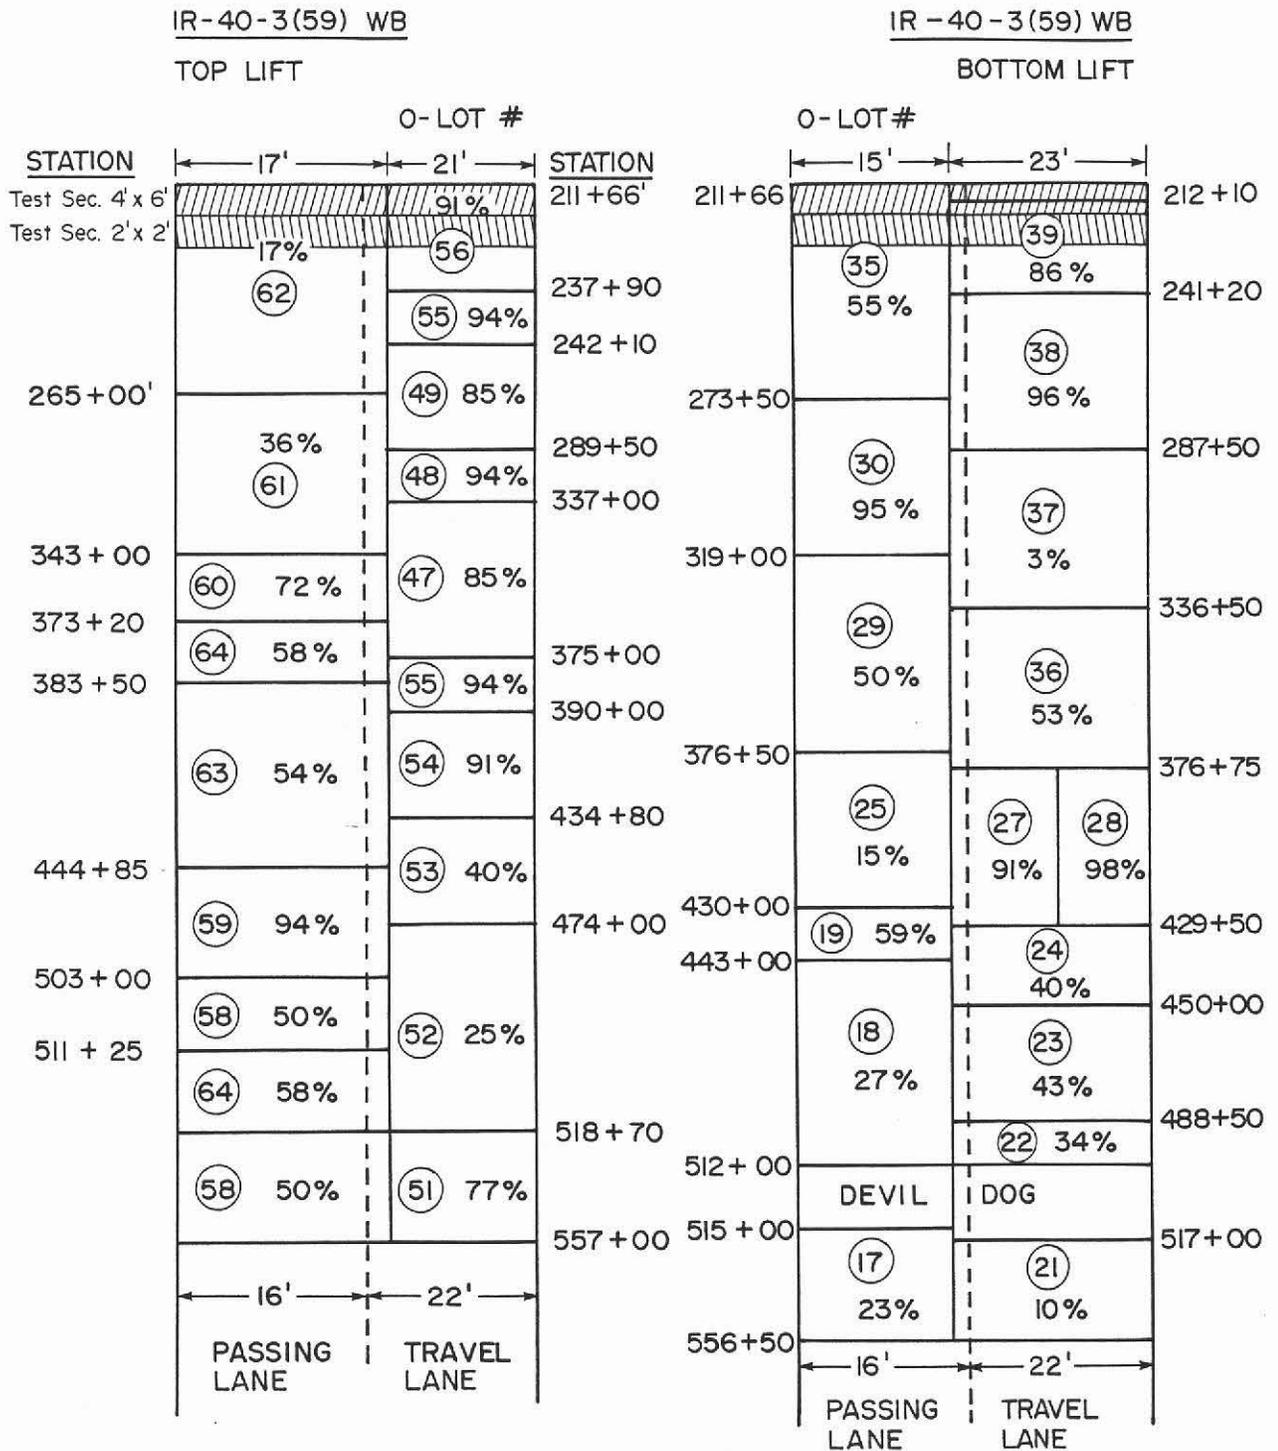
Figure 11 Percent Compliance and Lot Location for the West Bound Roadway

(3) Accept the bottom lift of asphalt concrete between westbound station 375 (approx.) and 557 (approx.) as is, with no adjustment in contract price. This will include AC density lots 17,18,19,21,22,24,25,27 and 28. These AC density lots will be excluded from the pay factor tabulation.

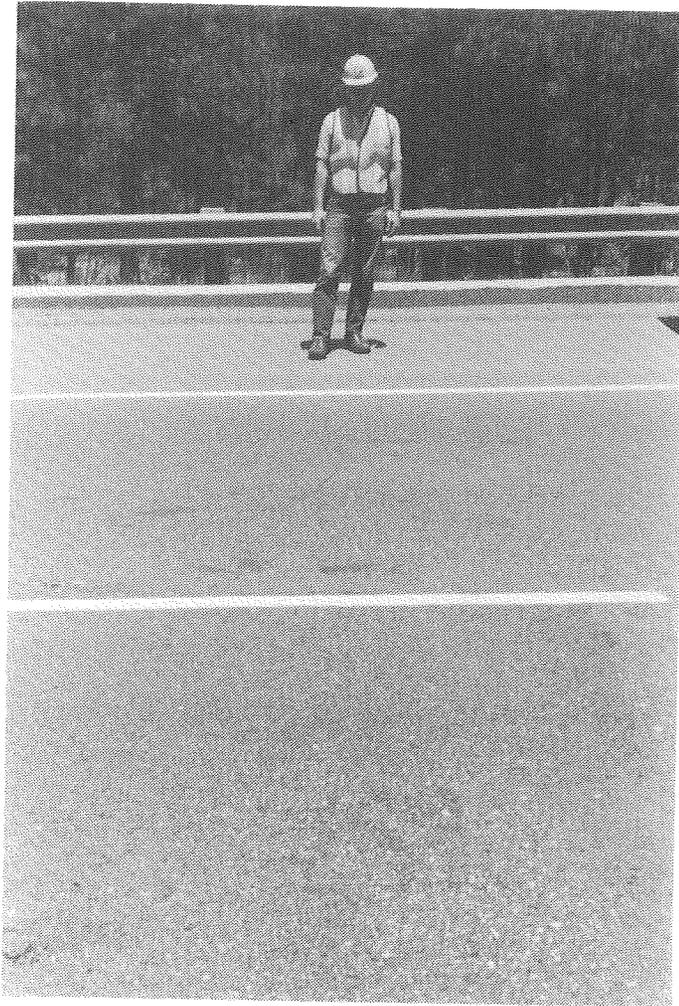
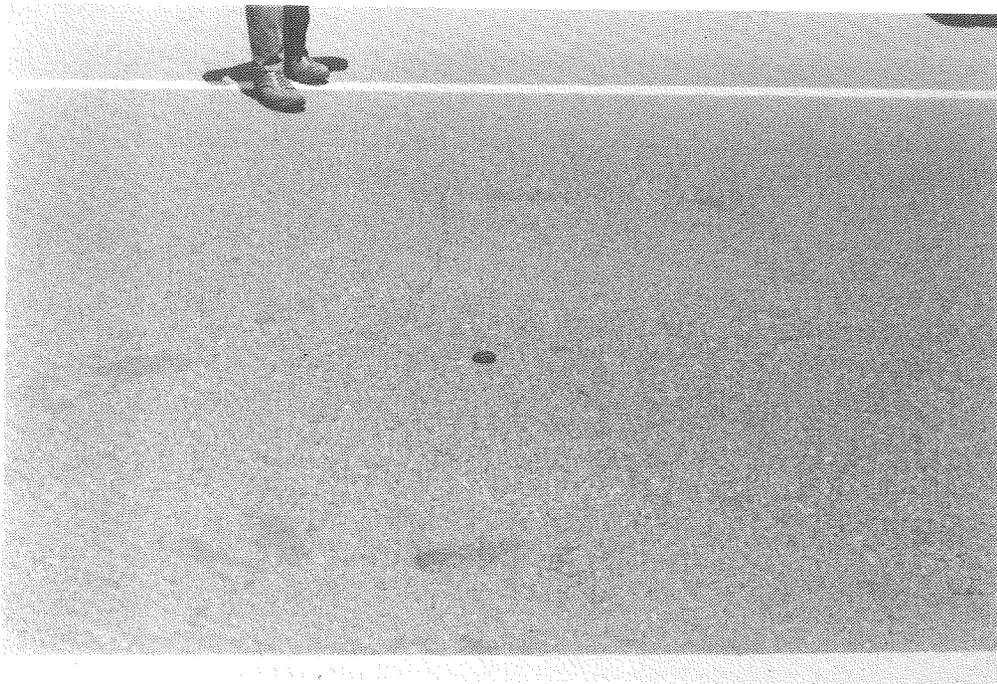
In the WB roadway between MP 158 and 157 one 3'x4' reflective crack was visible in the travel lane. A 10' long transverse crack was also visible at about 2" away from this 3'x4' crack. (Photograph #1(a) and (b)).

10 ft Longitudinal Crack and 3'x4' Reflective Crack - WB

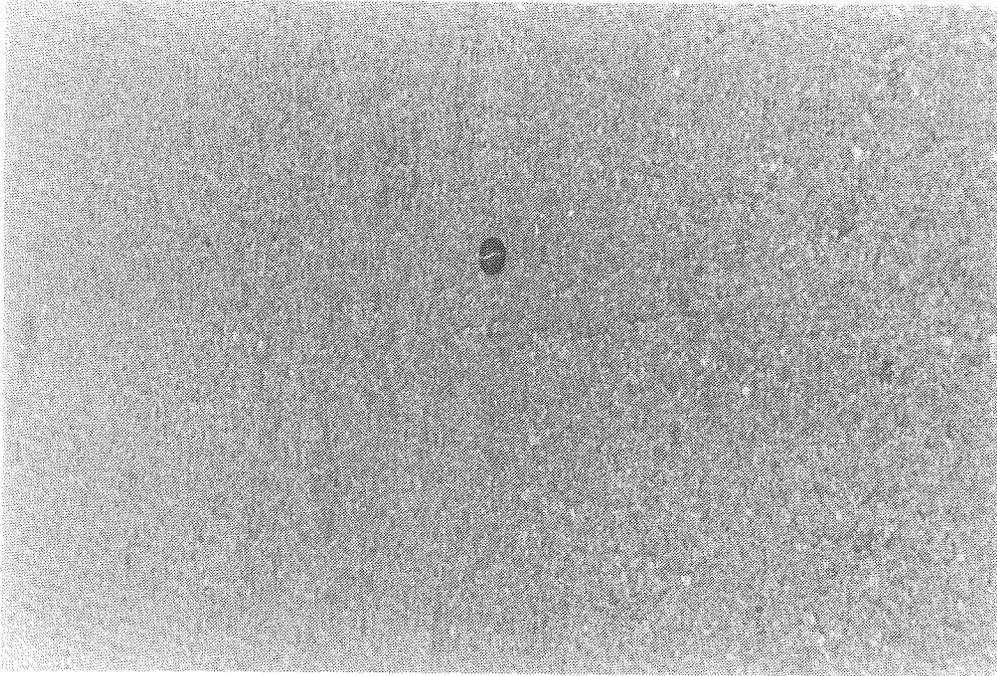
In the EB roadway several reflective cracks were visible. Between MP 153 and MP 154 there were three transverse cracks of low severity (width of the crack was less than 3/8"), 3' to 4' long. The cracks extend from the edge of the travel lane shoulder stripe inwards towards the center line (Photographs # 2,3 and 4). Photograph #4 also shows the edge crack that is believed to be along the trench drain.

Photograph #2 Low Severity Transverse Crack - EB
Between MP 153 and 154

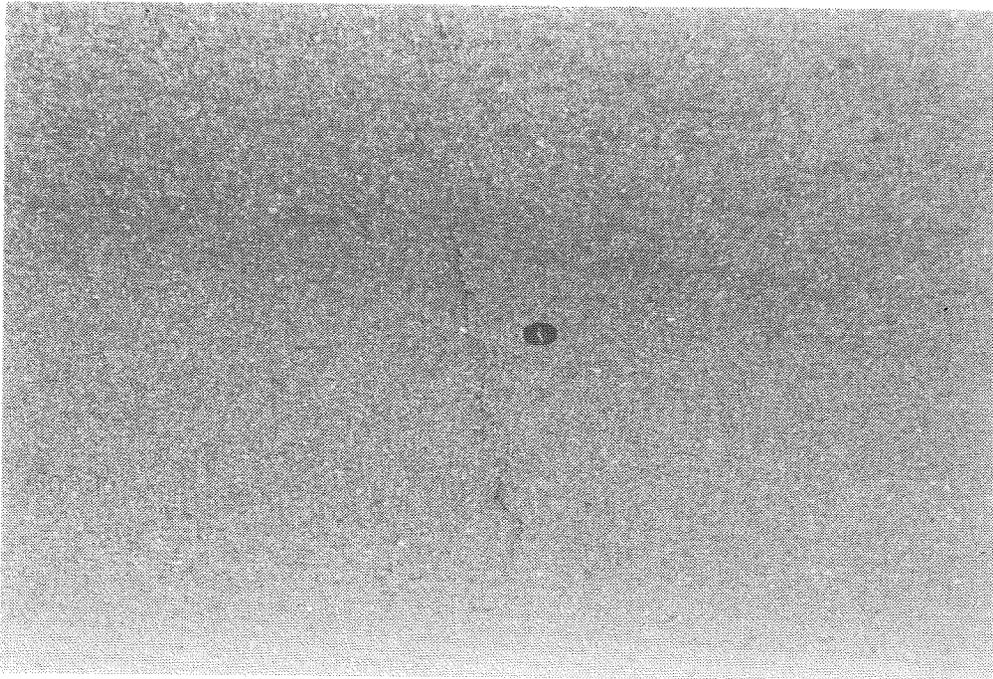
Photograph #3 Another Low Severity Transverse Crack - EB
Between MP 153 and 154

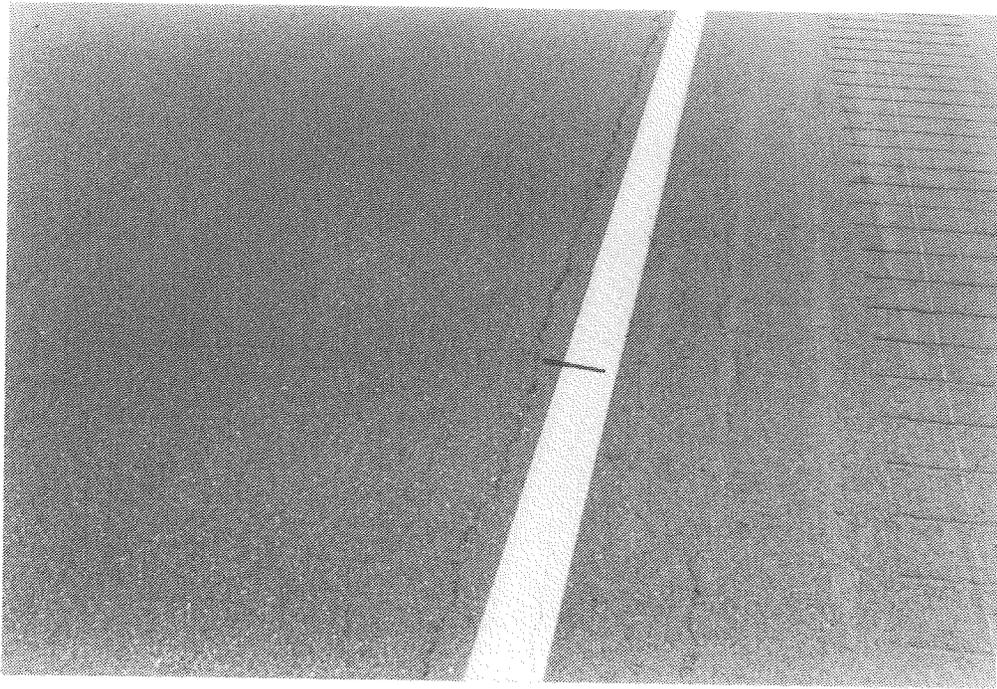
Longitudinal edge cracks were only apparent between MP 153 and 154 EB, and it is believed that these edge cracks occur above the trench drain as mentioned in section III of this report.

Photograph #4 Transverse and edge crack - EB
between MP 153 and 154

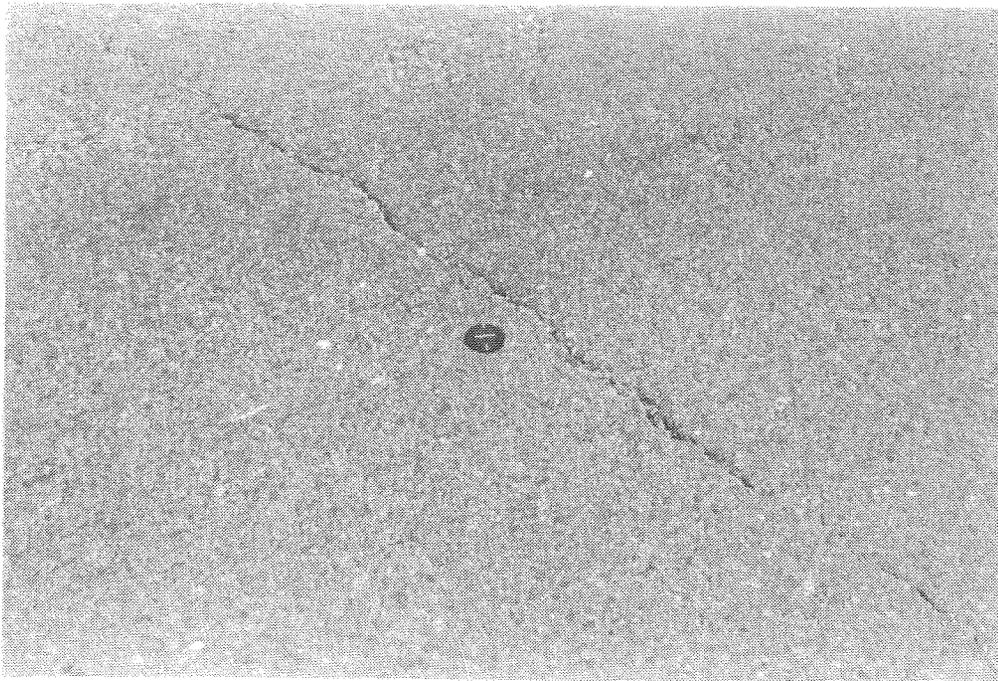
Between MP 153 and MP 154 three additional parallel transverse reflective cracks were visible with a spacing of 31.9' and 25.6'. One of these cracks was of medium severity (crack width = 0.4") and a length of about 6' (Photograph # 5).

Photograph #5 Medium severity crack - EB
between MP 153 and 154

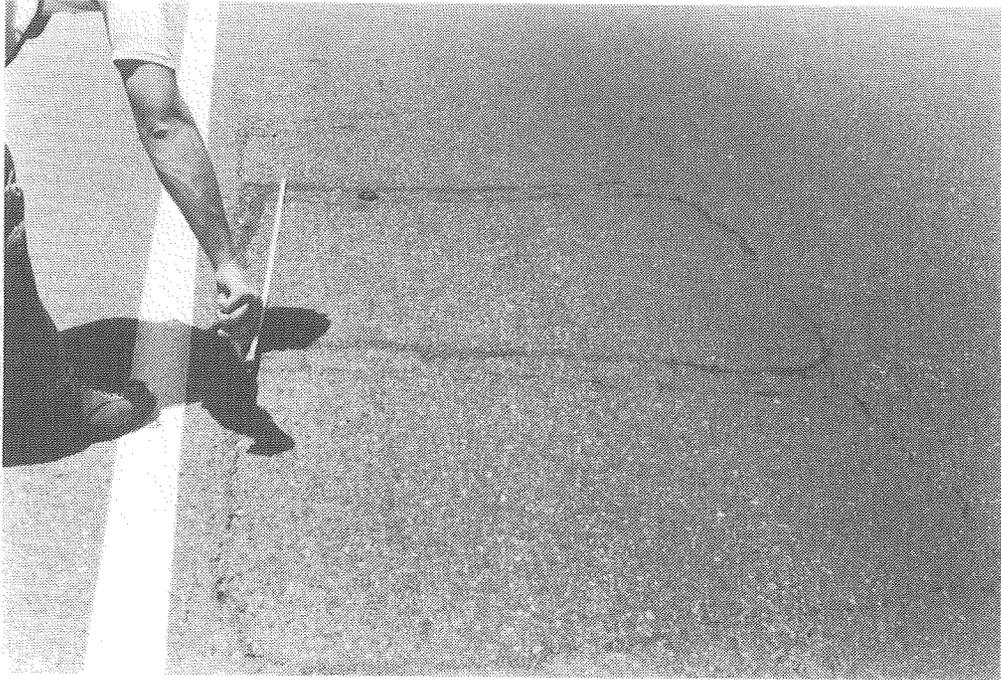
Between MP 155 and MP 156 and at the top of the hill seven severe 3'X3' reflective cracks were visible. These cracks are shown in photographs # 6 and # 7.

Photograph #6 3(3'x3') reflective "Rocking" cracks - EB
between MP 155 and 156

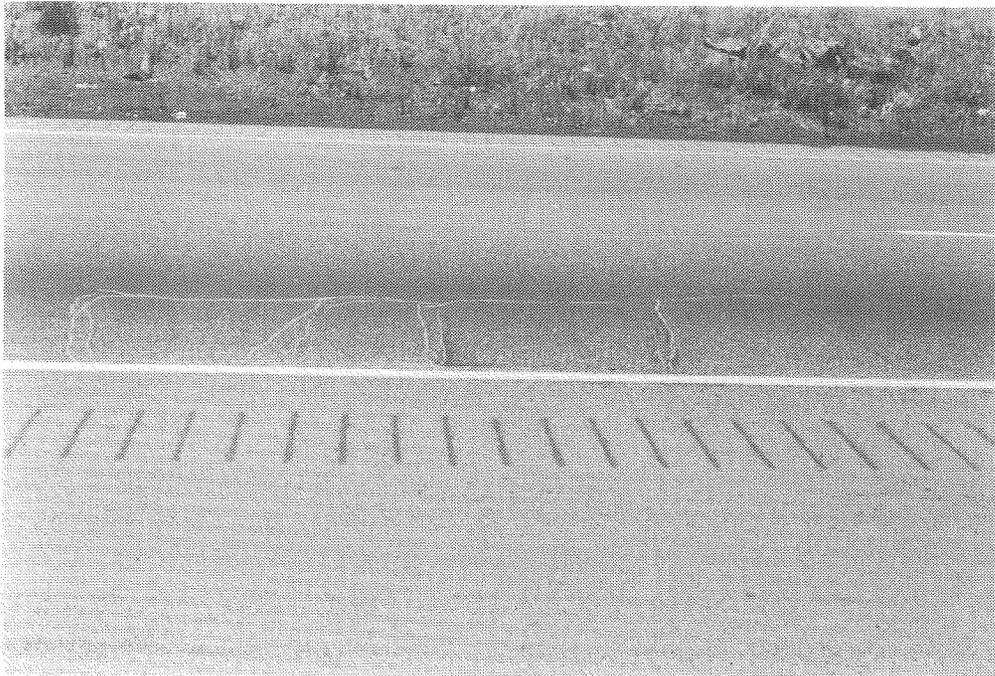
Photograph #7 4 severe 3'x3' reflective "Rocking" cracks
at the EB between MP 155 and 156
