ARIZONA DEPARTMENT OF TRANSPORTATION

REPORT NUMBER: FHWA-AZ-8604

THREE YEAR EVALUATION OF I-40 CRACK AND SEAT EXPERIMENTAL PROJECT

Interim Report

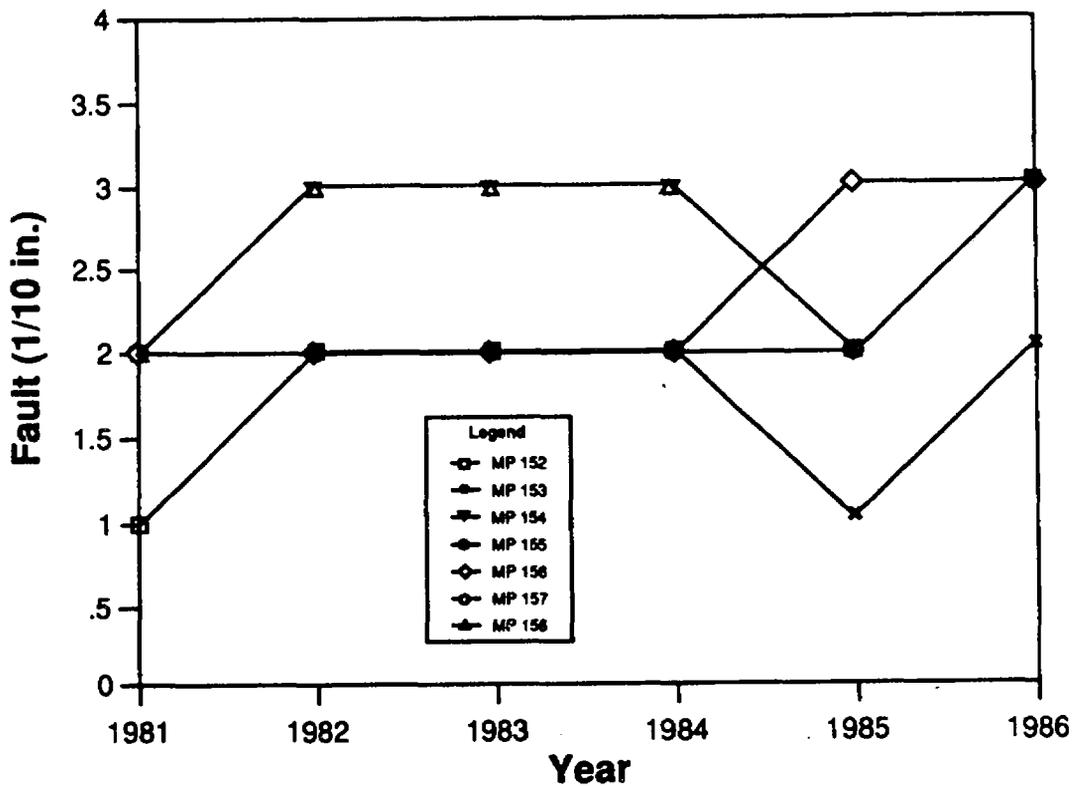
Figure 10- Fault vs. Time for the EB Direction

The correlation for the EB direction is poor and the WB direction suggests no correlation. The slopes suggest that on the average, faulting in the WB direction was increasing less than the EB direction which is also reflected by the lower roughness in the WB direction.

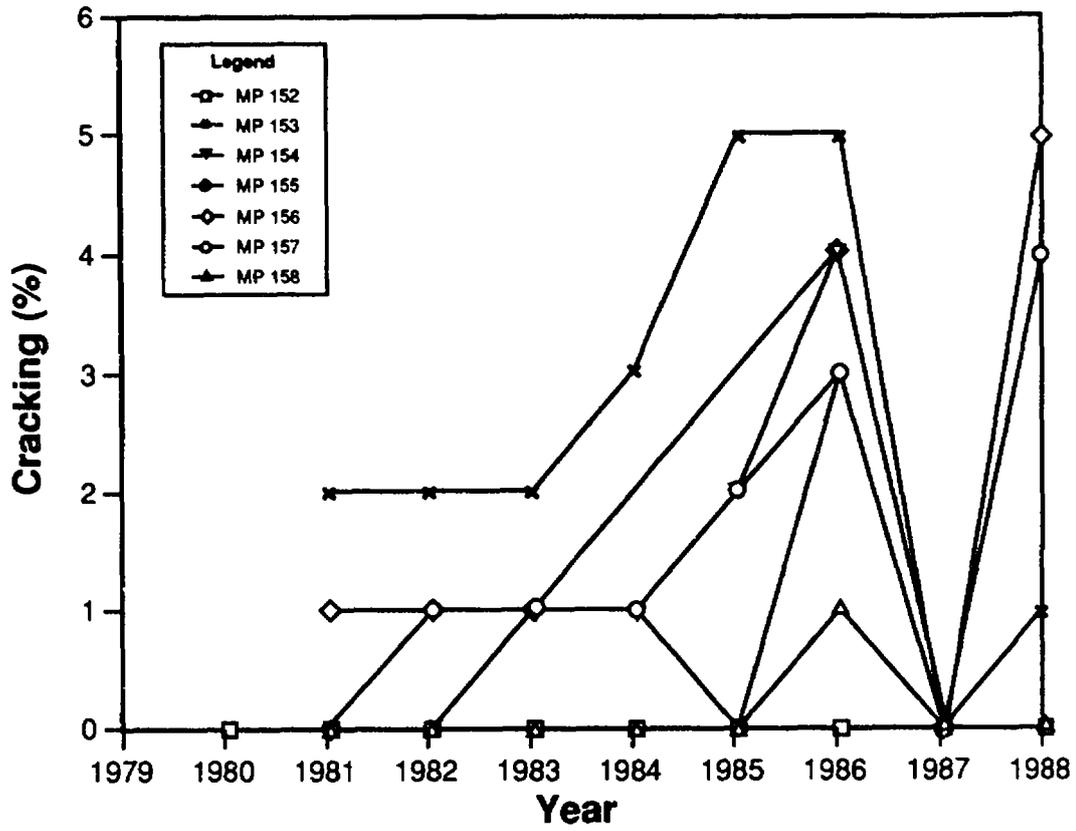
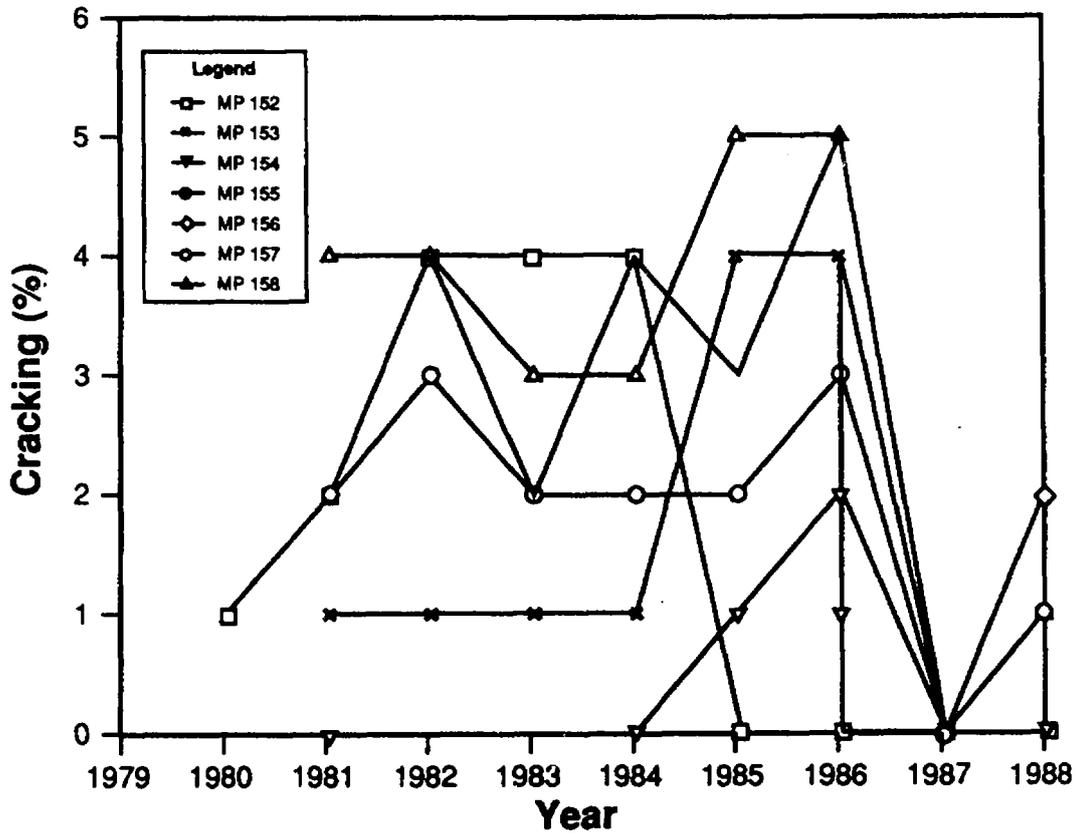
Figure 12- Cracking (%) vs. Time

Figure 12 indicates the percent of cracking as a function of time for both directions of travel for each milepost location. No cracking is evident prior to 1981 because this data was not included in the PMS prior to this. It should be noted that at the time of construction (1986), cracking averaged 3.3% and 3.2% for the EB and WB roadways, respectively. Both roadways ranged between 0 and 5% cracking throughout the reporting period. At about 1984, most of the mile post locations showed a significant increase in crack development.

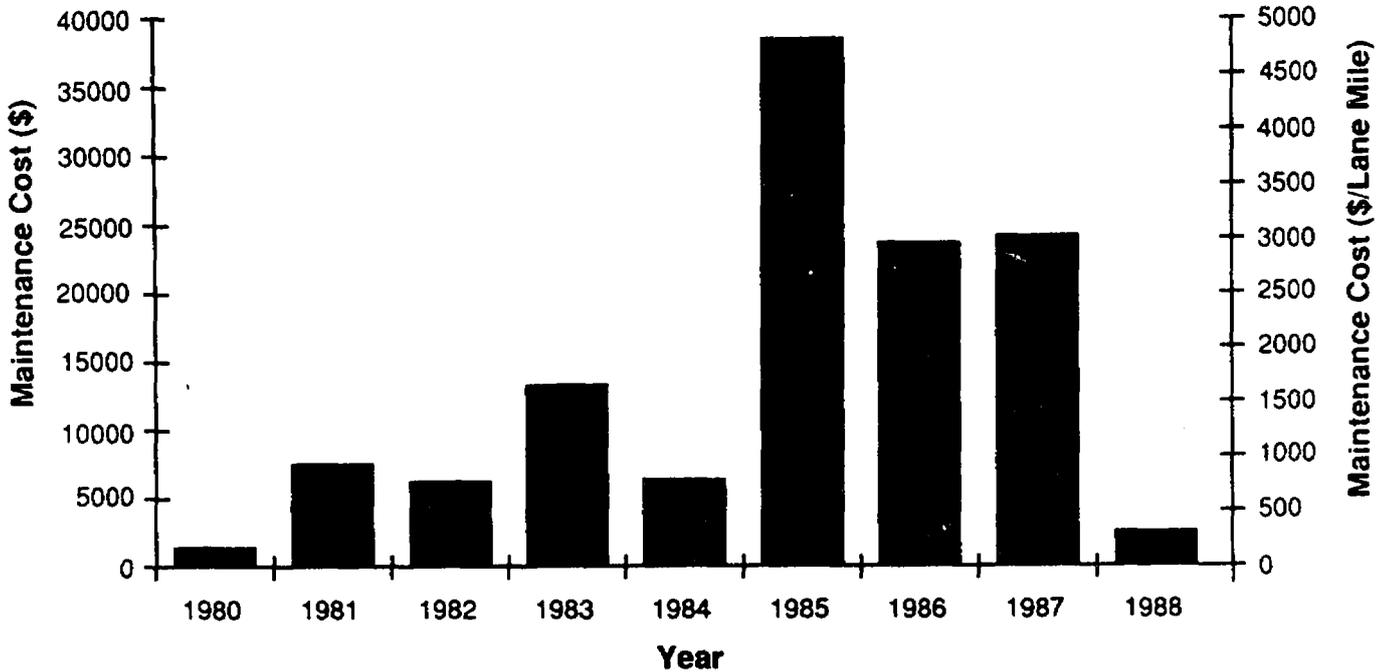
Figure 13- Roadway Maintenance Cost for the Crack and Seat Project for the Years 1980-1988.

Figure 13 represents the reported maintenance costs associated with I-40 within the construction project limits for the period 1980-1988. As noted, very high maintenance costs are evident during 1985 and 1986 just before the crack and seat construction. High maintenance costs were also incurred during the year immediately following construction (1987). This was due to the application of a flush coat to the newly constructed overlay to prevent stripping and ravelling approximately six months after the construction.

The historical maintenance costs previously shown in Figure 13 indicate a significant maintenance cost in 1987 and a sharp reduction in 1988 expenditures. Although the 1987 expenditures resulted from the need to flush the surface course to prevent further raveling, the expenditures in 1989 are also anticipated to be high. Extensive crack sealing has occurred during the current year. The authors do not believe the recent construction project has been effective in reducing maintenance expenditures.

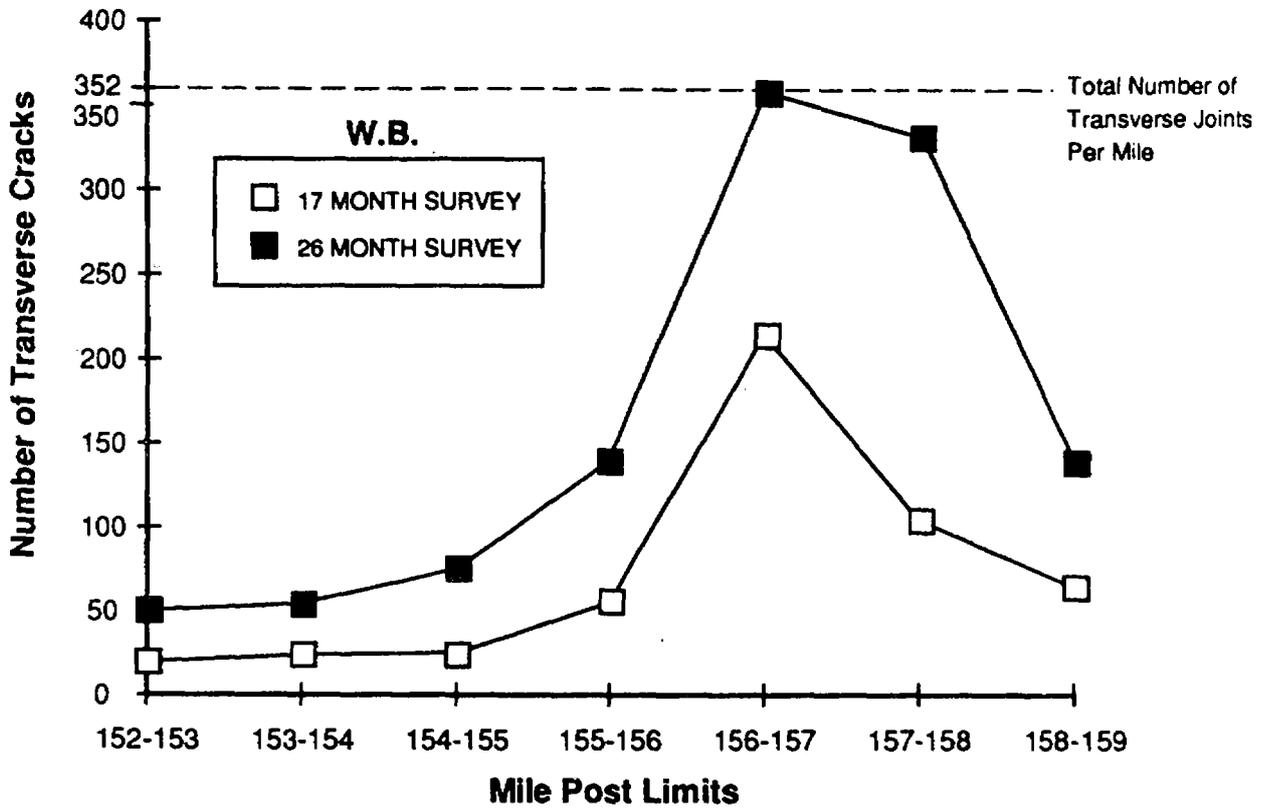
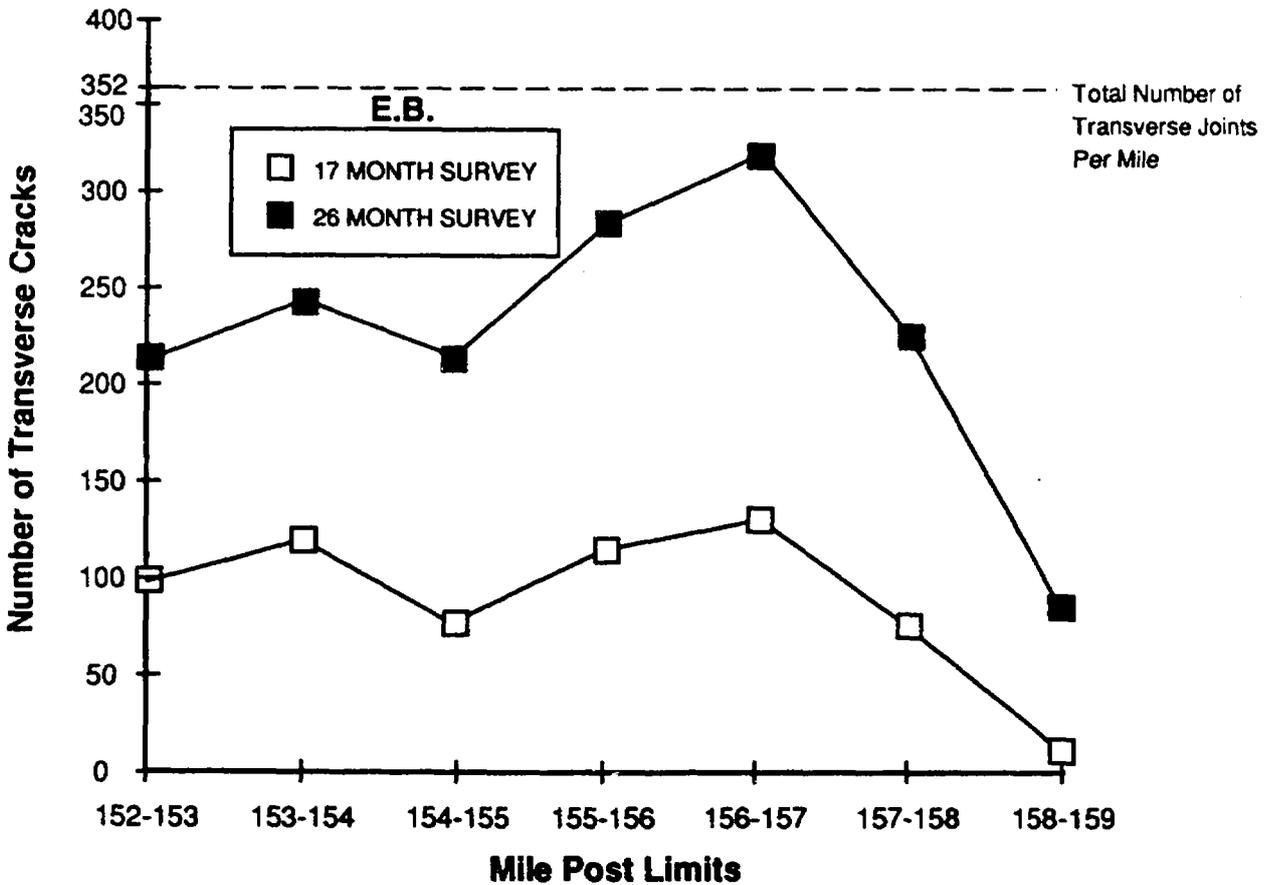
Figure 14- Transverse Cracking on the Project since Crack and Seat Construction

By the 17 and 26 month surveys, considerable reflection cracking had occurred on this project. Figure 14 indicates the number of transverse cracks observed in the travel lane during these surveys. The eastbound roadway exhibited considerably more cracking at the 17 and 26 month surveys. The eastbound roadway also experienced the largest increase in the amount of cracking between the 17 and 26 month surveys. Both roadways exhibited increased cracking when proceeding from the west end of the project in an easterly direction until milepost 156-157 where the cracking occurrence diminished.

The roadway between MP 156 and MP 158 has exhibited significantly more transverse cracking than the other sections for both roadway directions.

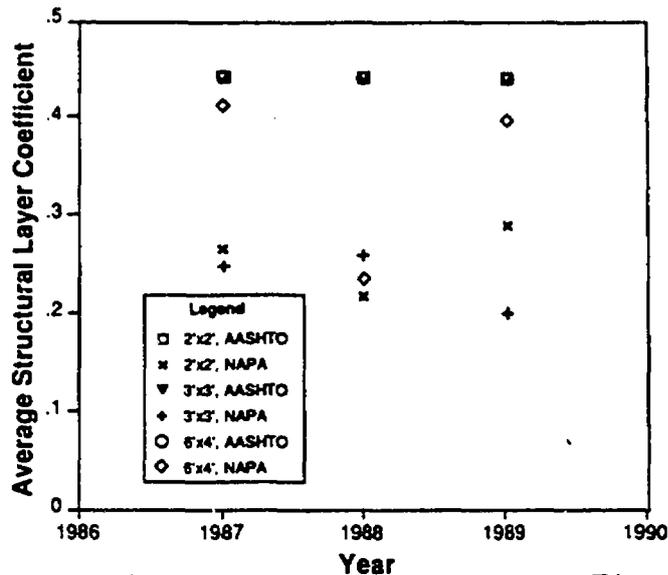
Figure 16- Structural Layer Coefficients vs. Time
25

The calculated structural layer coefficients for both the AASHTO procedures and the modified NAPA procedures are shown in Table 9. These results indicate the variation in layer coefficients with both time and spacing. These variations are shown graphically in Figures 16 and 17. The modified NAPA procedures tended to give the highest coefficient for the 2 ft spacing for 1987 and 1989 data.

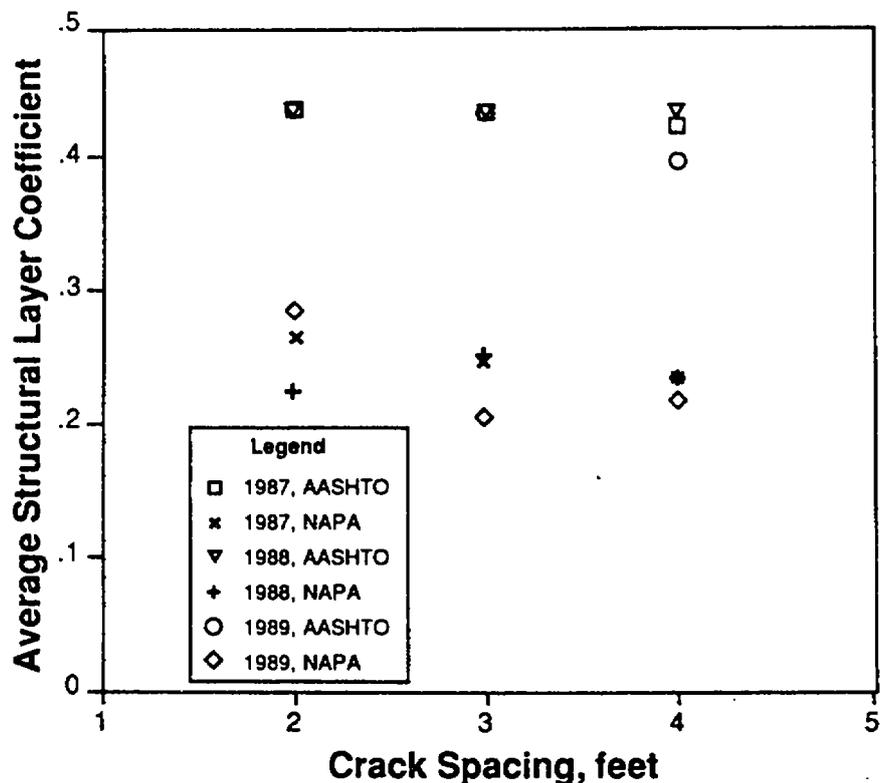
Figure 17- Structural Layer Coefficients vs. Crack Spacing

Figure 17 indicates that the modified NAPA procedures resulted in decreased coefficients with time for only the 6 ft by 4 ft crack pattern.

The NAPA coefficients were generally less than the magnitude of the AASHTO coefficients. In most of the cases, AASHTO coefficients have been taken as the highest coefficient tabulated in the Guide. It should be noted that calculation of structural coefficient of crack and seated concrete in the NAPA procedure is very sensitive to the structural coefficient of the base layer. Since the base layer coefficient and modulus have been selected arbitrarily, no comparison between AASHTO layer coefficients and NAPA layer coefficients are valid. Also, by comparing the structural layer coefficients no reasonable conclusion can be drawn about the performance of one crack spacing over another.
