Investigations of Failures of Epoxy Polymer Overlays in Missouri

FINAL REPORT

RI06-020

November 2007

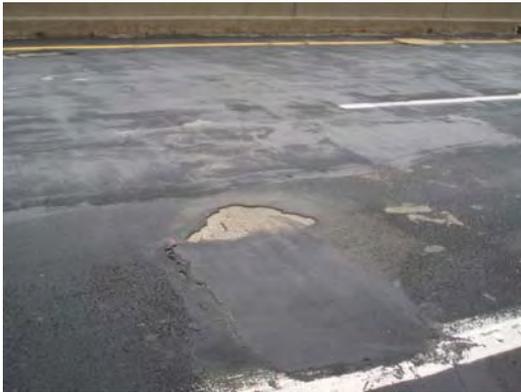
Missing areas of epoxy

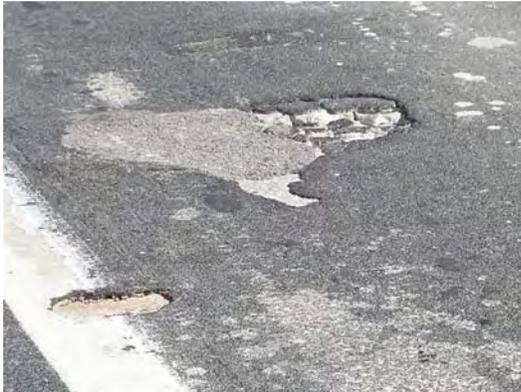
Sunken/cracked areas

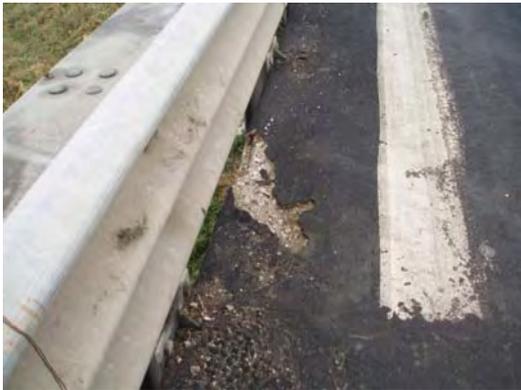
Spalling/loose areas

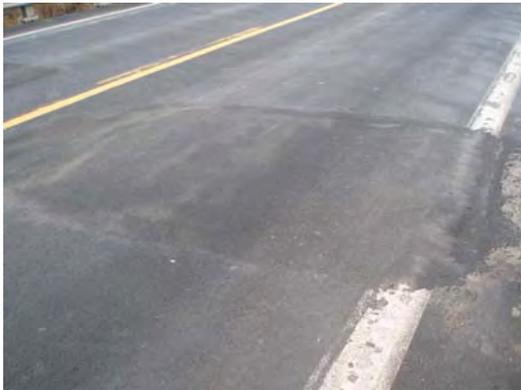
Post overlay Patches
