NCHRP Report 350 Crash Testing and Evaluation of the S-Square® Mailbox System

Research/Test Report 0-5210-7

1. Report No. FHWA/TX-10/0-5210-7	2. Government Accession No.	3. Recipient's Catalog No.	
4. Title and Subtitle NCHRP REPORT 350 CRASH TESTING AND EVALUATION OF THE S-SQUARE® MAILBOX SYSTEM		5. Report Date November 2009 Published: January 2010

Project Title: Roadside Crash Testing Program for Design Guidance
and Standard Detail Development

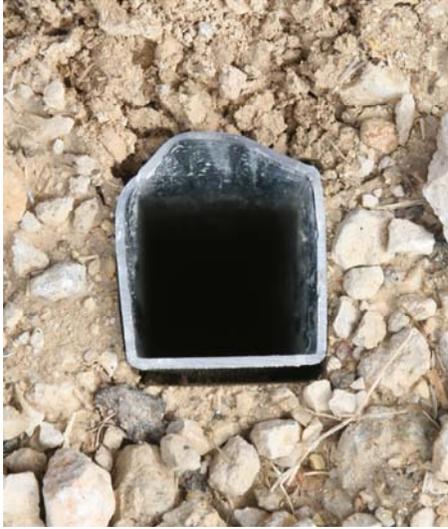
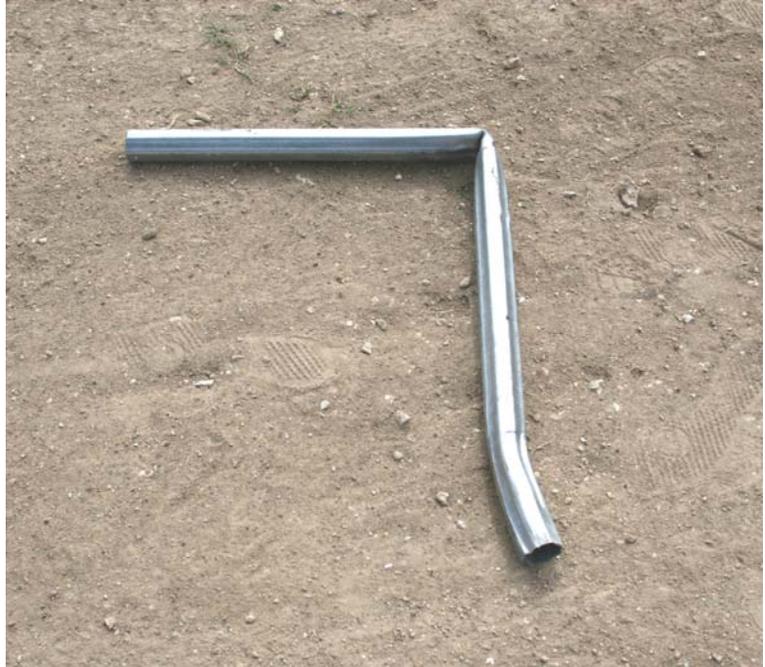
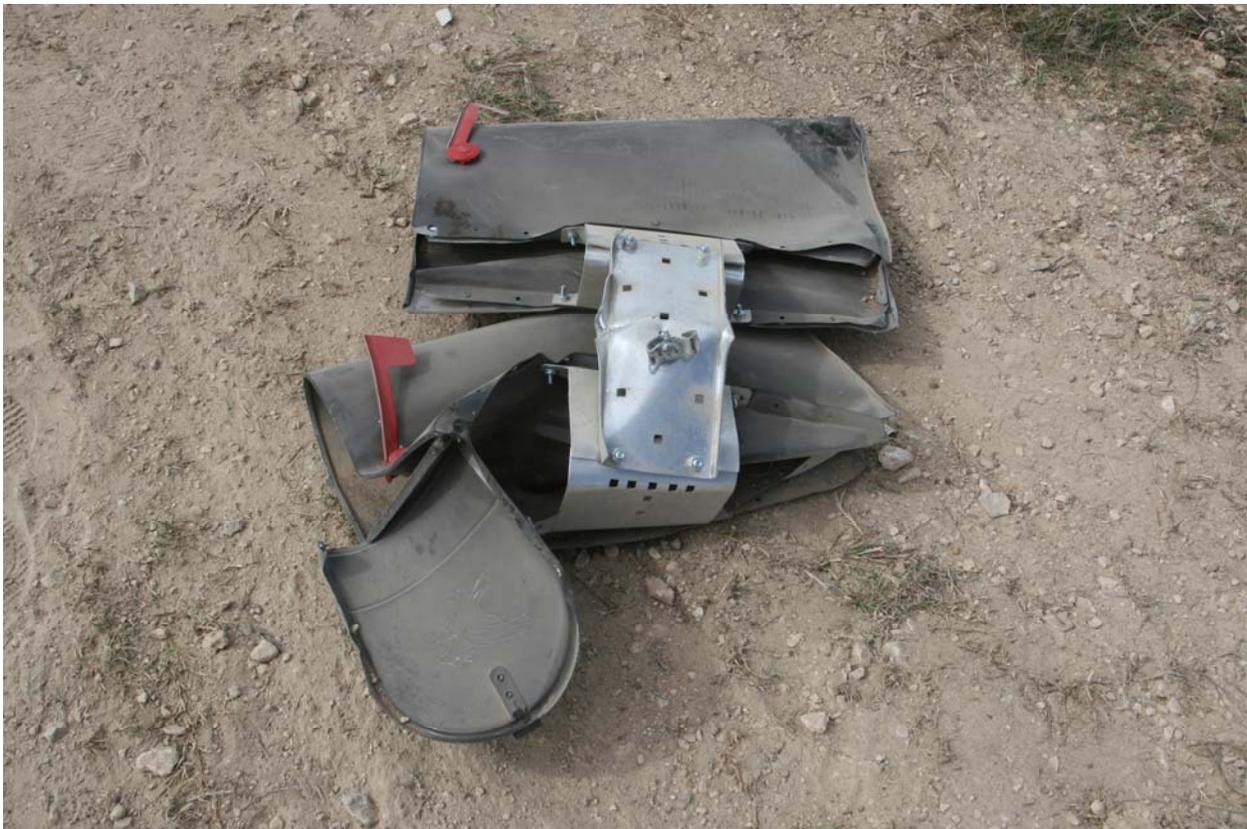
Figure 8. Installation after Test No. 452109-9.

Result: The S-Square® Dual Mailbox System readily activated by deforming and pulling out of the anchor sleeve. (PASS)

Result: The support pulled out of the anchor sleeve as designed and did not penetrate or show potential to penetrate the occupant compartment, or to present undue hazard to others in the area. No occupant compartment deformation occurred. (PASS)

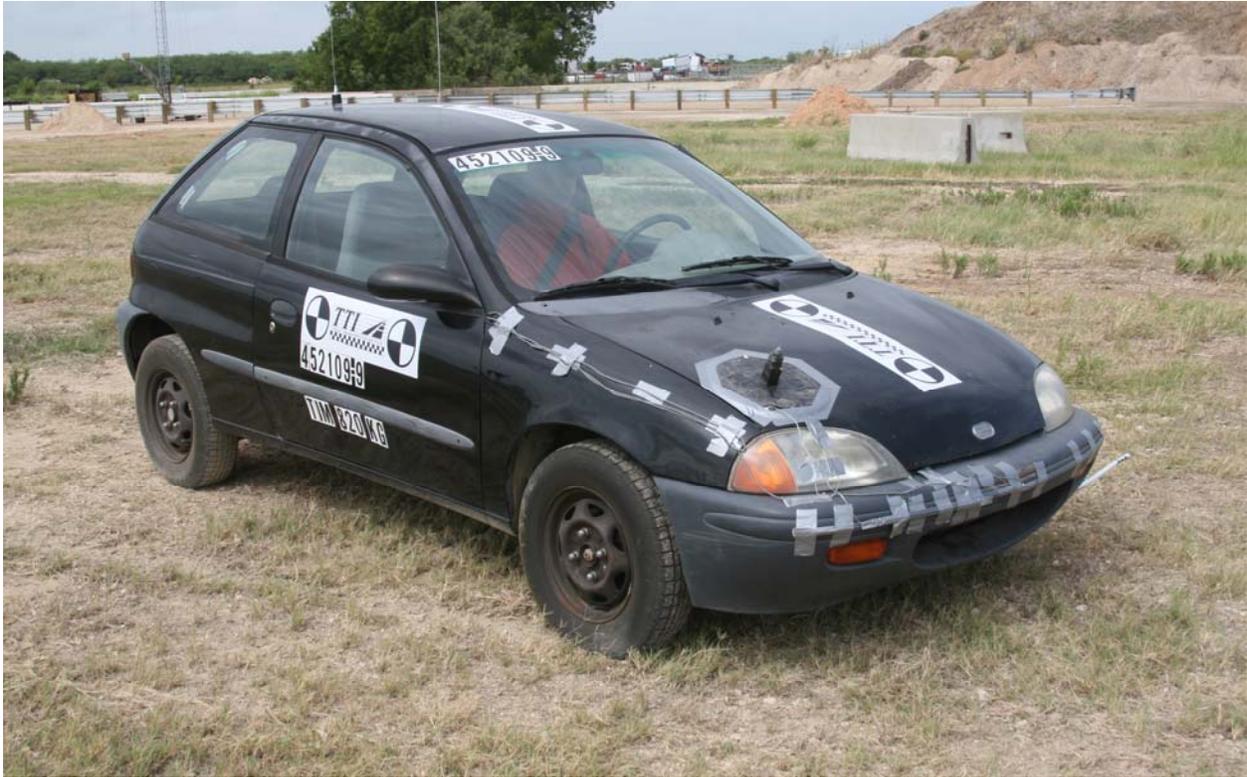
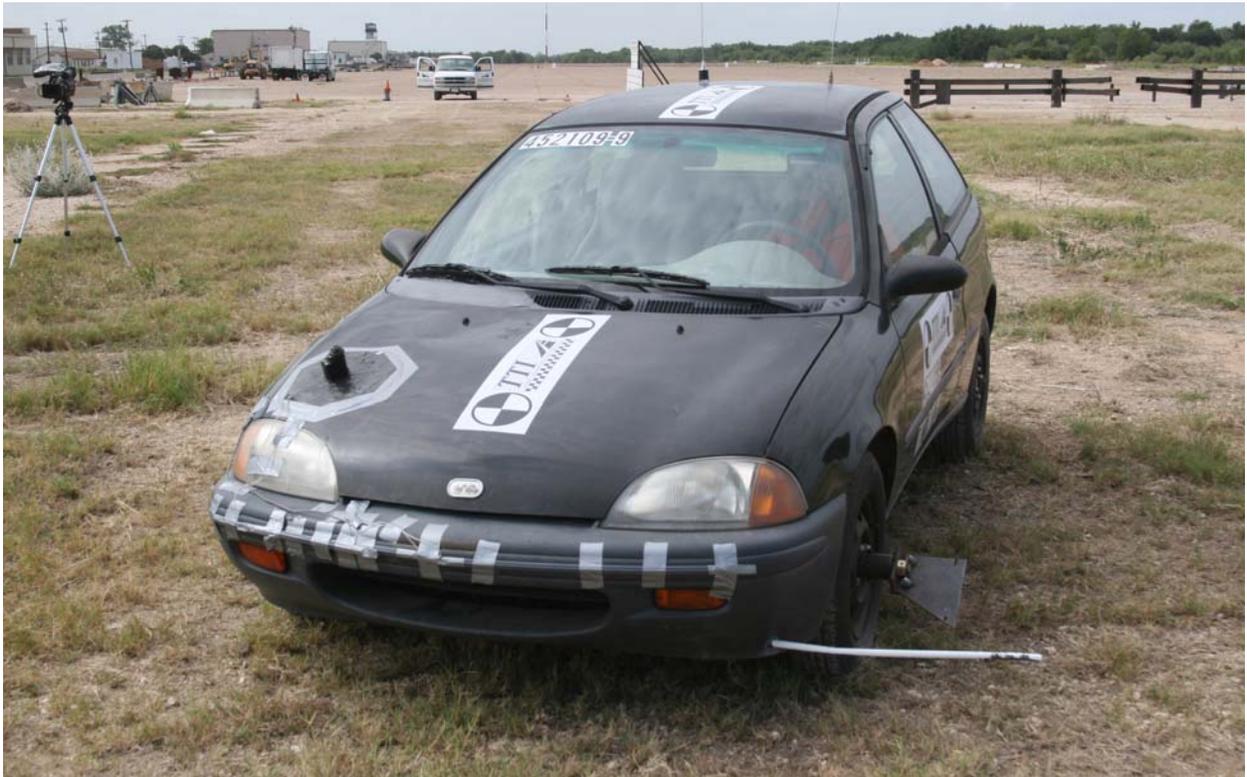
Figure 9. Vehicle after Test No. 452109-9.

Figure 9 shows the damage to the 820C vehicle. The front bumper, hood, and right front fender were slightly deformed. The hood sustained a dent just below the windshield on the passenger side measuring 10.25 inches × 20.86 inches × 0.16 inch deep. No occupant compartment deformation occurred. Photographs of the interior of the vehicle are shown in Figure 10. Exterior crush and occupant compartment measurements are presented in Appendix B, Tables 3 and 4.

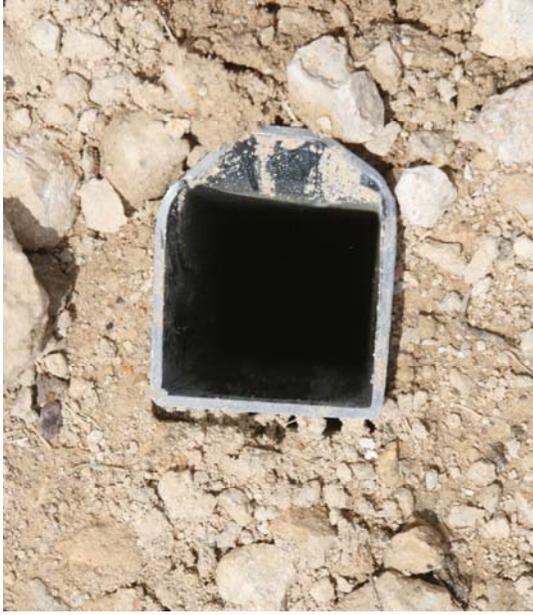
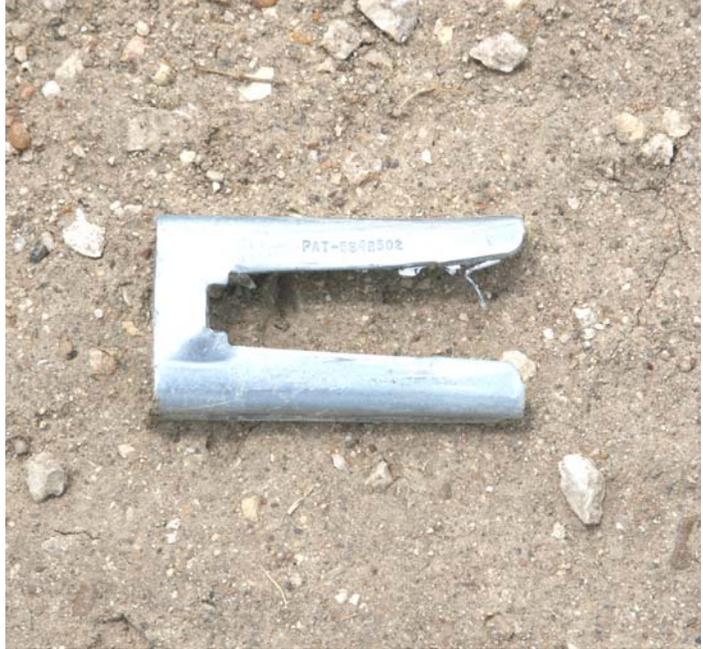
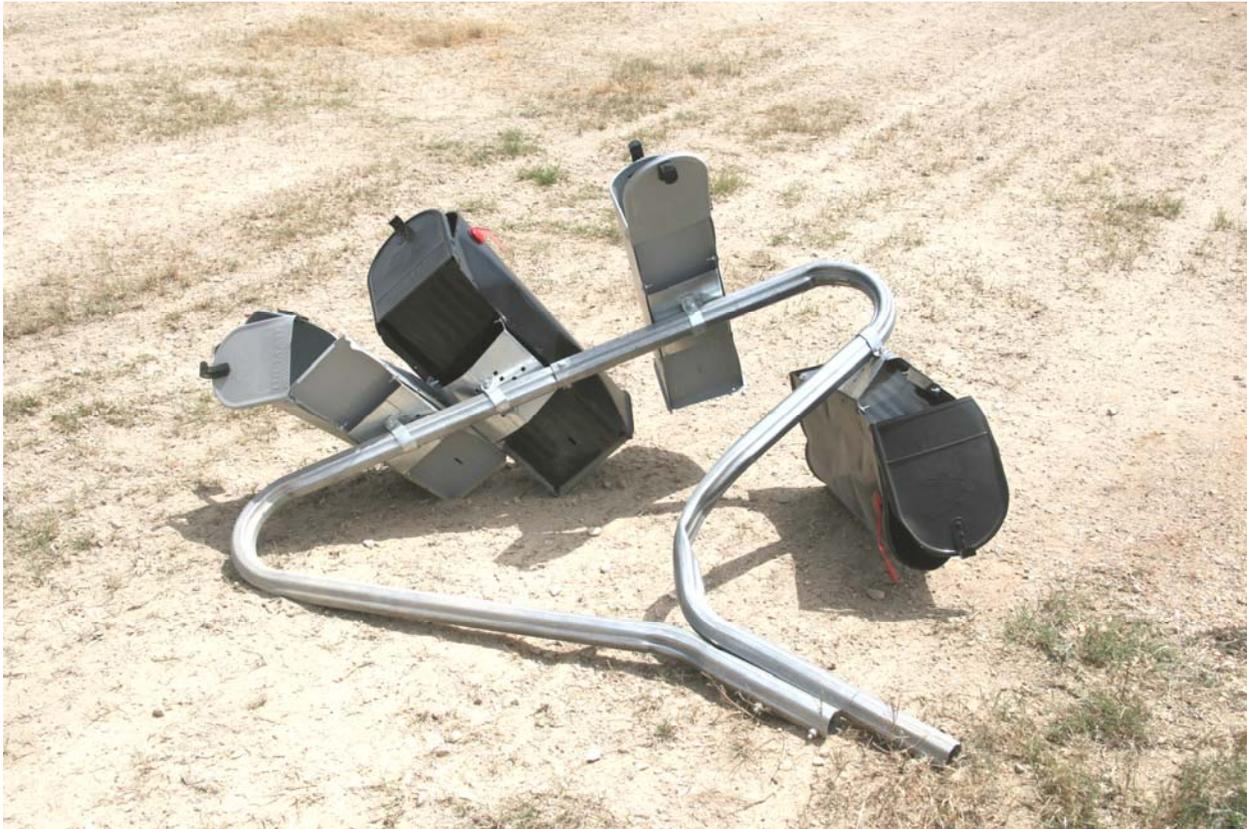
Figure 15. Installation after Test No. 452109-10.

Result: The S-Square® multiple mailbox support yielded to the 820C vehicle by pulling out of the anchor sleeve as designed. (PASS)

Result: The support and mailboxes pulled out of the anchor sleeve as designed and did not penetrate or show potential to penetrate the occupant compartment, or to present undue hazard to others in the area. Maximum occupant compartment deformation was 1.1 inches in the windshield. (PASS)

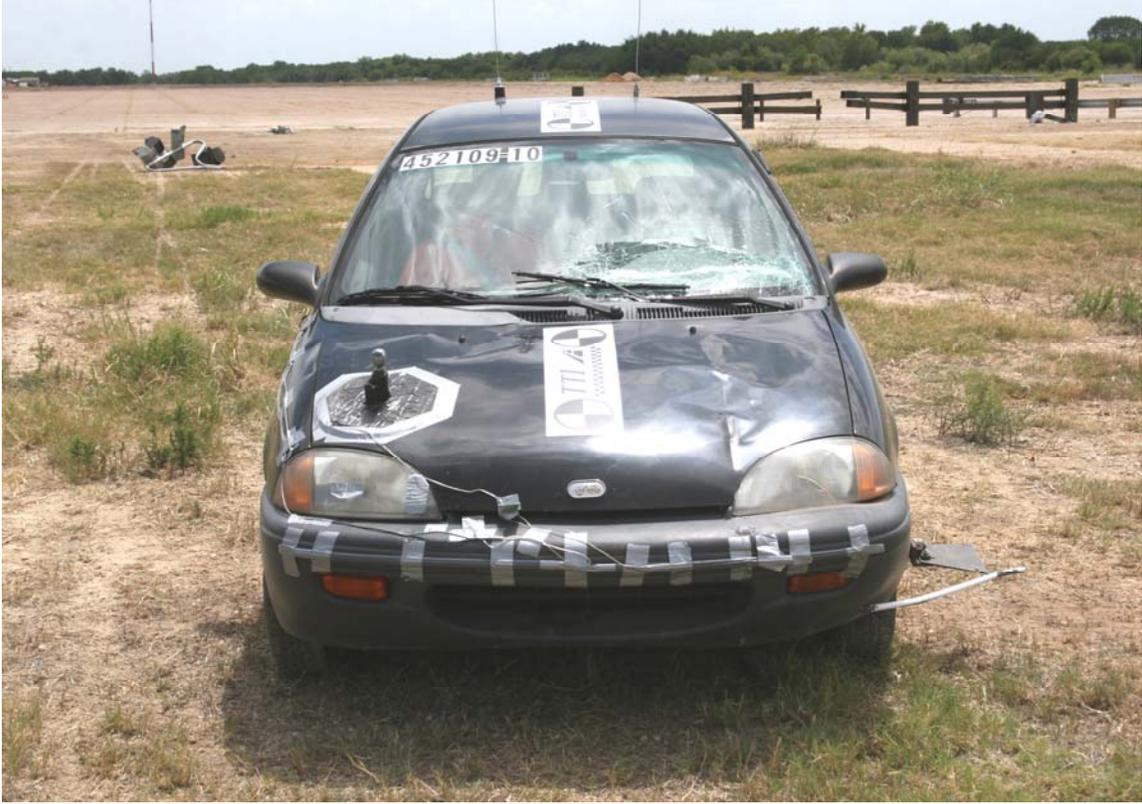
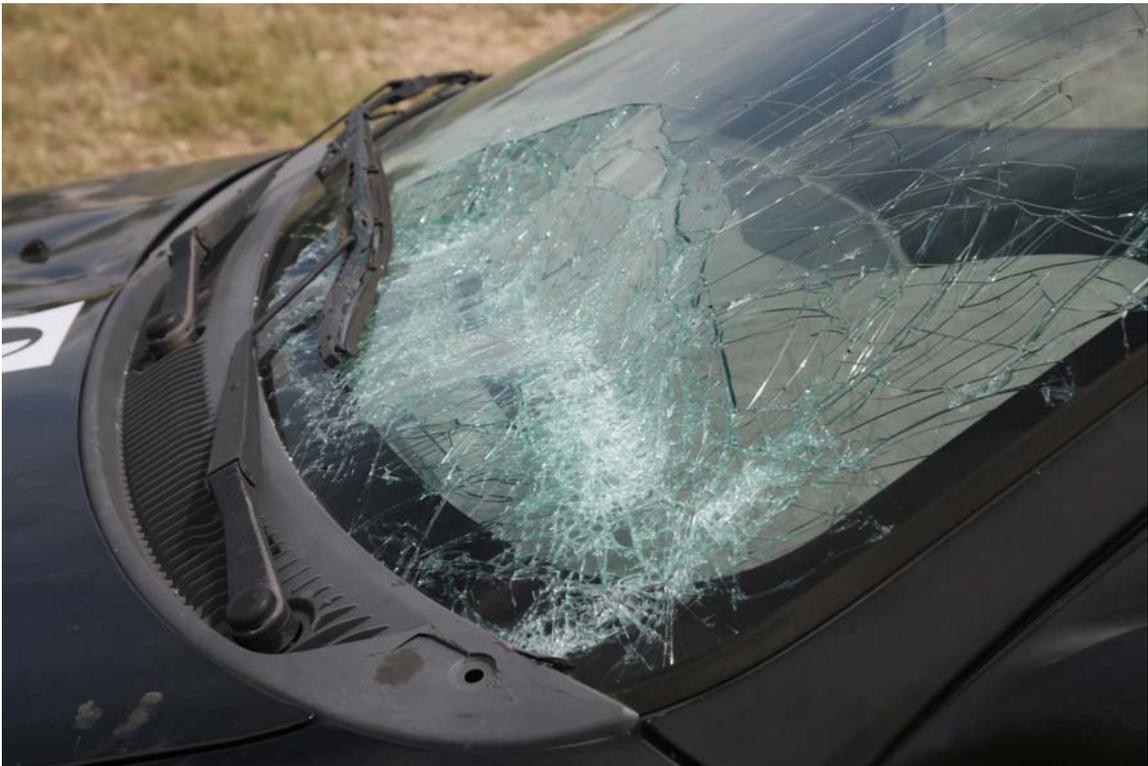
Figure 16. Vehicle after Test No. 452109-10.

Damage to the vehicle is shown in Figure 16. The front bumper was scuffed and the hood was deformed over an area measuring 23.6 inches × 1.2 inches and 0.6 inches deep. The windshield was shattered over an area measuring 26.8 inches × 9.8 inches with a maximum depth of 1.1 inches. Visibility was not obscured by the damage to the windshield. Maximum exterior crush to the vehicle was 1.1 inches in the lower left quarter of the windshield. Other than the windshield deformation, no other occupant compartment deformation occurred. Photographs of the interior of the vehicle are shown in Figure 17. Exterior crush and occupant compartment measurements are presented in Appendix B, Tables 5 and 6.
