FINAL REPORT
SIDEWALK UNDERMINING STUDIES

K. H. McGhee
Senior Research Scientist

Virginia Highway and Transportation Research Council
(A Cooperative Organization Sponsored Jointly by the Virginia
Department of Highways & Transportation and
the University of Virginia)

VHTRC 79-R40

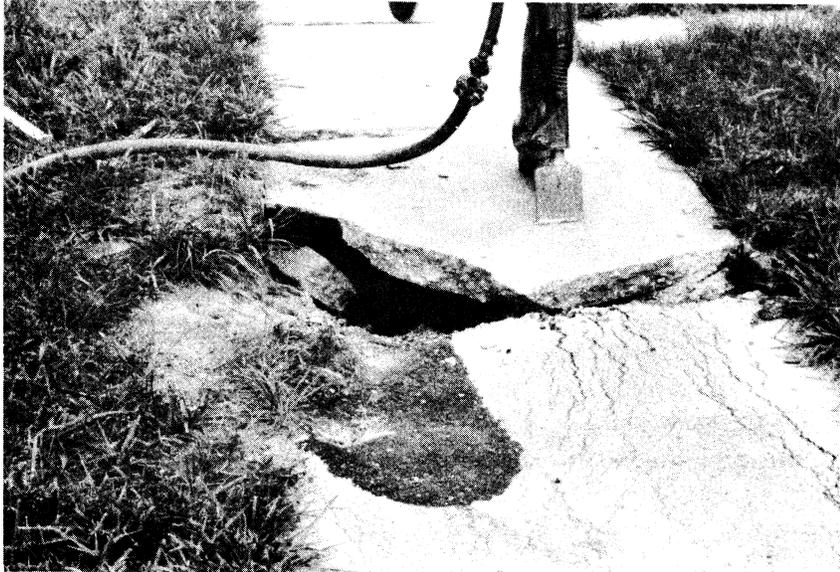
Evidence of undermining is dislocation of joints and distortion (rotation) of slabs in either the transverse or longitudinal planes. Eroded material is usually deposited at the low point of vertical curves although it may break out intermittently at sidewalk joints or along the edges. After heavy rains these deposits are very evident although much of the material is carried away into the storm drain system. Voids under the walks range from negligible up to several feet, depending upon the severity of erosion. It is apparent that large volumes of water may flow under the sidewalks on occasion. Some evidence of the severity of undermining and the types of distortion encountered is indicated in Figures 1 and 2.

Figure 1. Severe sidewalk undermining.

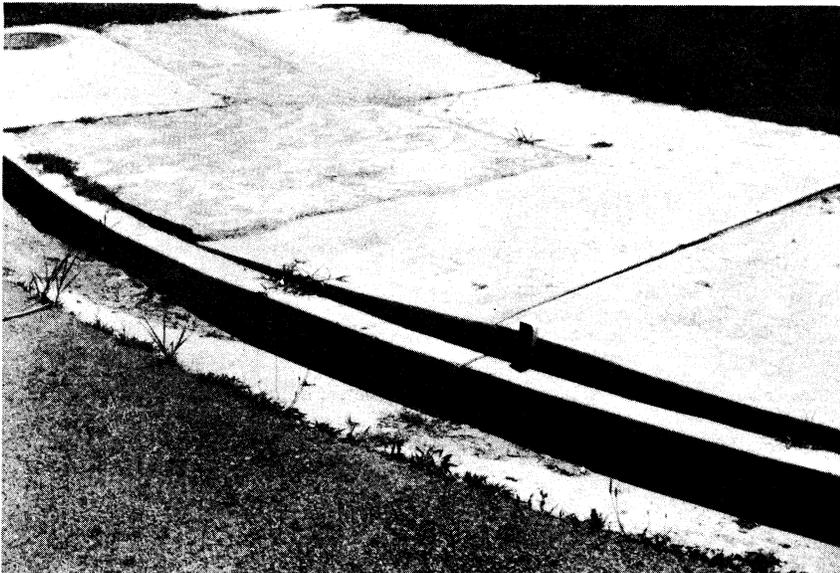
Figure 2. Sidewalk distortion due to undermining.

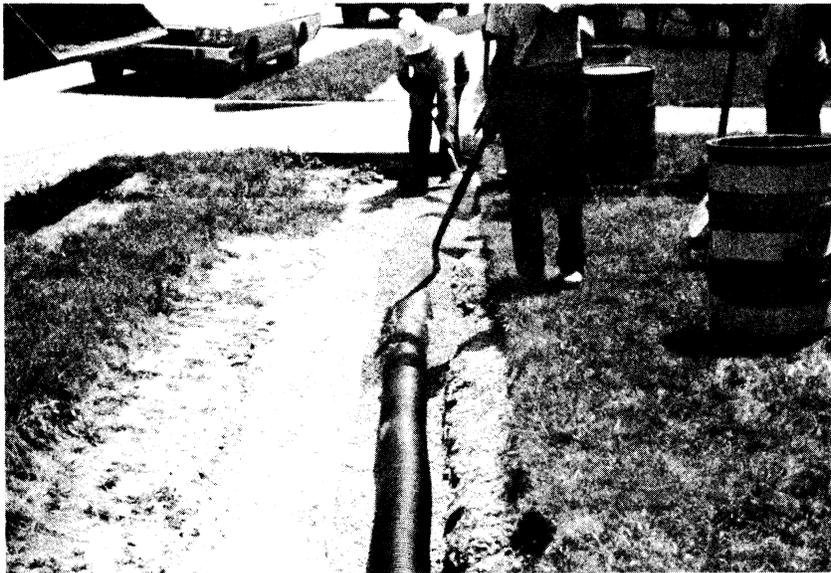
A typical installation of this type is shown under construction in Figure 3 and schematically in Figure 4. Note that the drainage system is installed on the high side of the walk to intercept lateral drainage from yards or longitudinal drainage along the sidewalk and direct it into the storm sewer system. The concrete curtain wall prevents the flow of infiltrated water laterally and directs it into the perforated plastic drain pipe. The subgrade soil to the right of the curtain wall, see Figure 4(b), is protected by a layer of densely graded crushed stone. While the curtain wall method proved relatively successful in that only one case of subsequent undermining was found, its high cost led to the consideration of other methods.

Figure 3. Sidewalk replacement utilizing curtain wall and subsurface drainage.

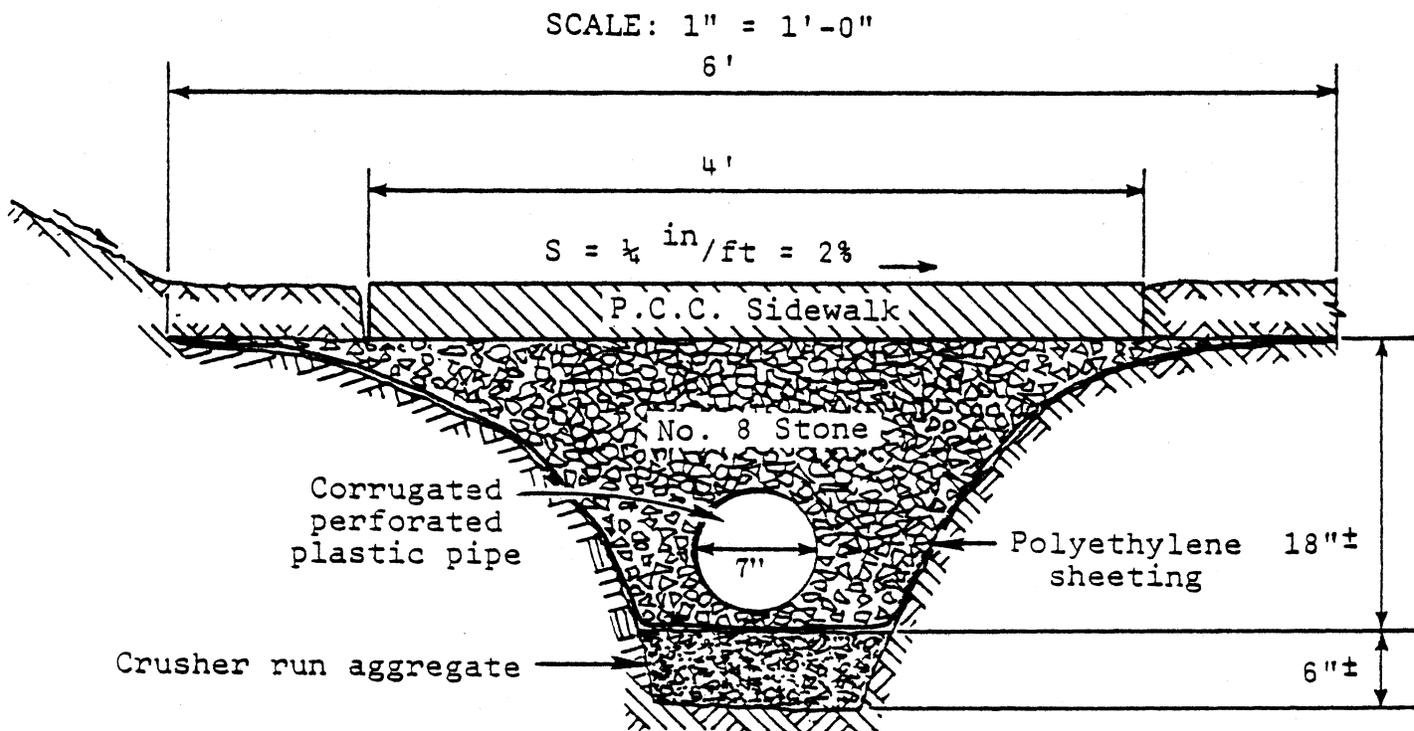
Figure 5. Cross section of experimental sidewalk installation. (Metric conversion 1 ft. = 0.3 m).

The major maintenance effort to prevent the reoccurrence of undermining involved the use of the system indicated in Figure 5. This system captures all infiltrated water and delivers it to the storm sewer system. The actual cross section is variable in shape, depending upon the nature of the erosion channel. After cleaning and shaping of the subgrade soil, approximately 6 inches (150 mm) of crusher run aggregate are placed in the lower portion of the trench. Polyethylene sheeting is then placed to cover the entire excavated area. A 7-inch (178 mm) diameter corrugated, perforated plastic pipe is laid in the trench and covered to the elevation of the bottom of the sidewalk with No. 8 stone. The No. 8 stone is open-graded to permit entry of infiltrated water to the drain pipe. After the 4-foot (1.2 m) wide sidewalk is placed and the forms removed, the 1-foot (0.3 m) width on either side of the walk is filled with top soil and seeded. Several of these operations are indicated in Figure 6.

2. All sidewalks should be constructed with an internal drainage system similar to that given in Figure 5 of this report. The pipe size and composition, the depth of No. 8 stone, and the type of waterproofing material (polyethylene or porous fabric) should be approved by the Engineer.

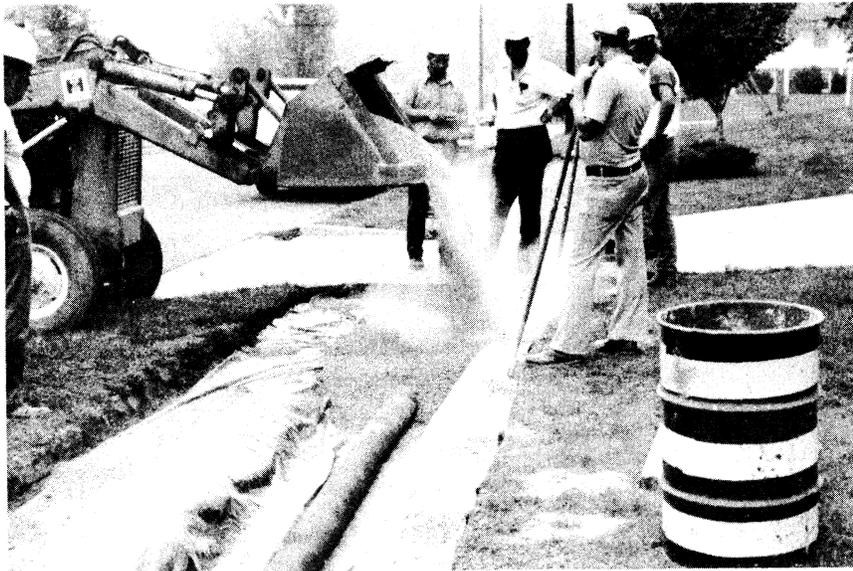
Figure 6. Test site showing installation of polyethylene, pipe, and No. 8 stone.

The first installations by this method were constructed in August 1974 and have been inspected periodically since that time. No evidence of renewed undermining has been detected with the result that for the past several years all undermining repair contracts have required that this method be used. Minor modifications from the design given in Figure 5 include (a) variations in pipe size (b) the use of concrete pipe on occasions, (c) the occasional use of porous construction fabrics in lieu of the polyethylene, and (d) an increase in the depth of the No. 8 stone to 4 inches (100 mm) for 1 foot (0.3 m) on either side of the sidewalk. While modifications (a) through (c) have had no apparent effect on the serviceability of the system, modification (d) is helpful in reestablishing sod on the sidewalk edges.

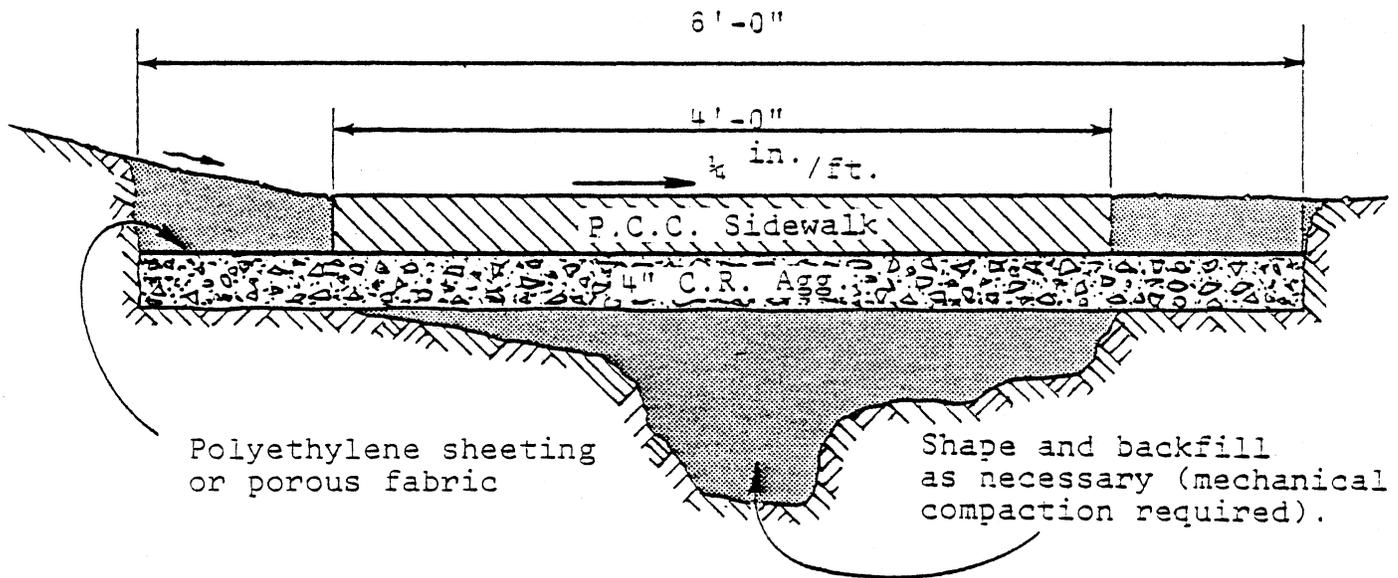
Figure 7. Sidewalk replacement without underdrains.
(Metric conversion 1 ft. = 0.3 m.)

As pointed out in the Phase I report no drain pipe is necessary where the drainage area is less than about 0.1 acre (0.04 ha). In most such cases an effective underdrain system cannot be used because a storm drainage system is not available. Where these conditions have occurred the system indicated in Figure 7 has been used successfully over the past several years.

This system apparently is successful because of the small volumes of water resulting from the small drainage area and the positive protection of the underlying erodible soil by the combination of the polyethylene or fabric and the 4-inch (100 mm) aggregate base.
