FINAL REPORT  
FATIGUE STUDY OF A GRP PEDESTRIAN BRIDGE

Fred C. McCormick  
Faculty Research Scientist

December 1986  
VHTRC 87-R7

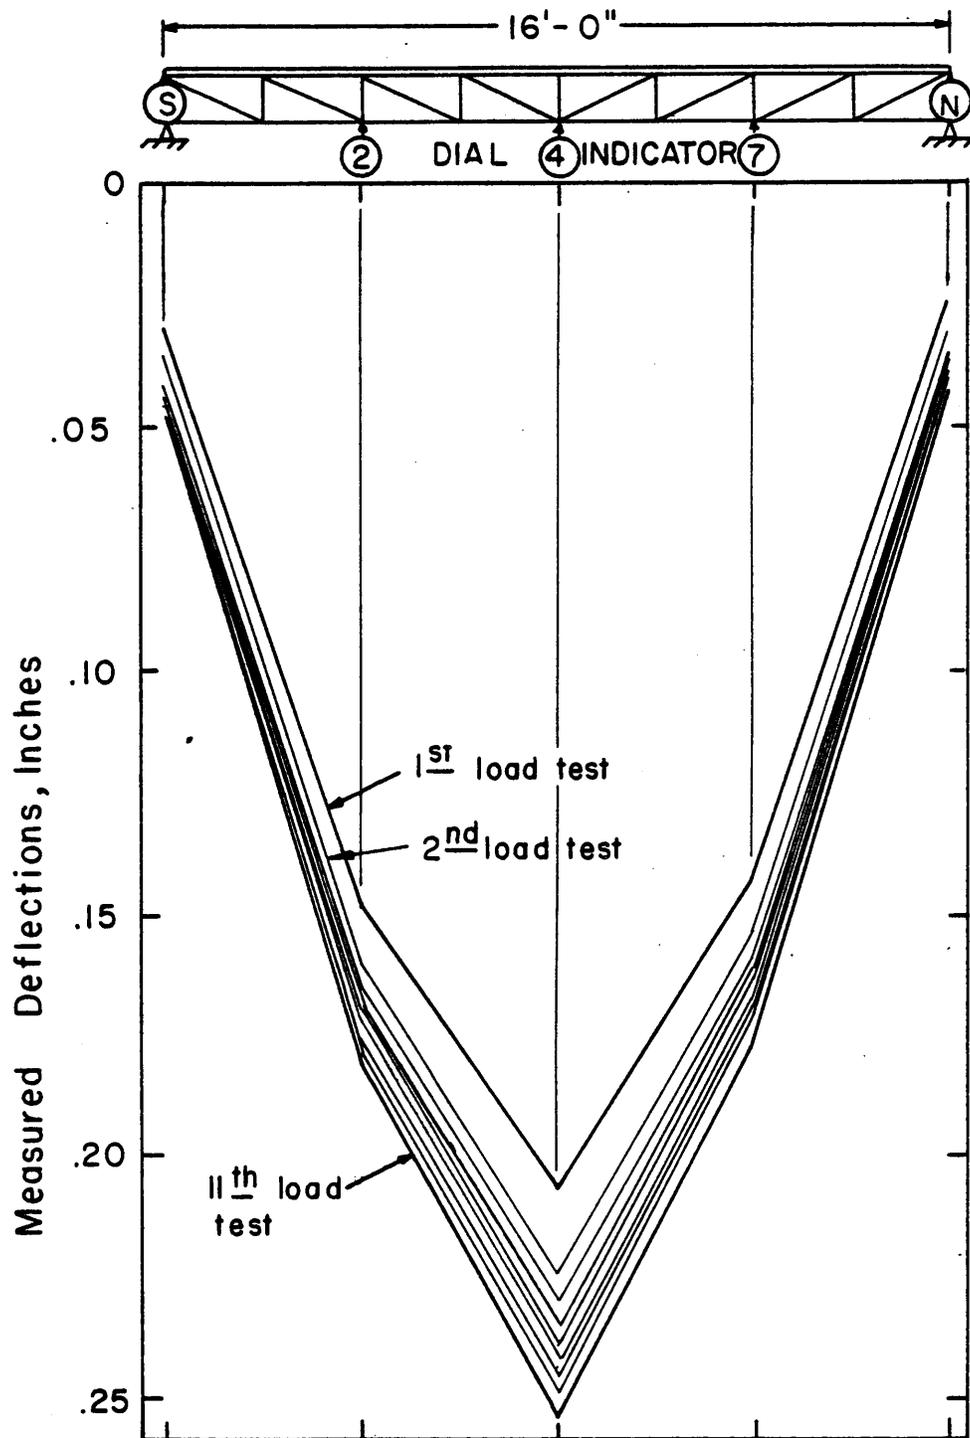
In the first load series, 500,000 repetitive loads were applied at a rate of 13 cycles per minute. The load range was held constant with a minimum of 1,200 lb and a maximum of 3,000 lb each cycle. The deflection of the lower chord of the middle girder at the midspan of the bridge (reference gage #4; see Table 1 and Figure 6) ranged correspondingly from 0.10 to 0.23 in for each cycle. With the completion of a selected number of load cycles, usually 50,000, the cyclic loading was interrupted long enough to conduct a static load to assess the damage to the structure due to the preceding increment of load applications. All deflection gage and strain gage readings were recorded and acoustic emission activity was monitored for any counts emitted during the period the static load was held. However, no emissions were noted during any of the hold periods of any of the load series, except number 7. The reference load for the static test for series 1 was 2,800 lb. The reference loads for the other load series are shown in Table 1.

Figure 7. Deflection history of middle girder at static reference loads of 2,800 lb for load series 1.

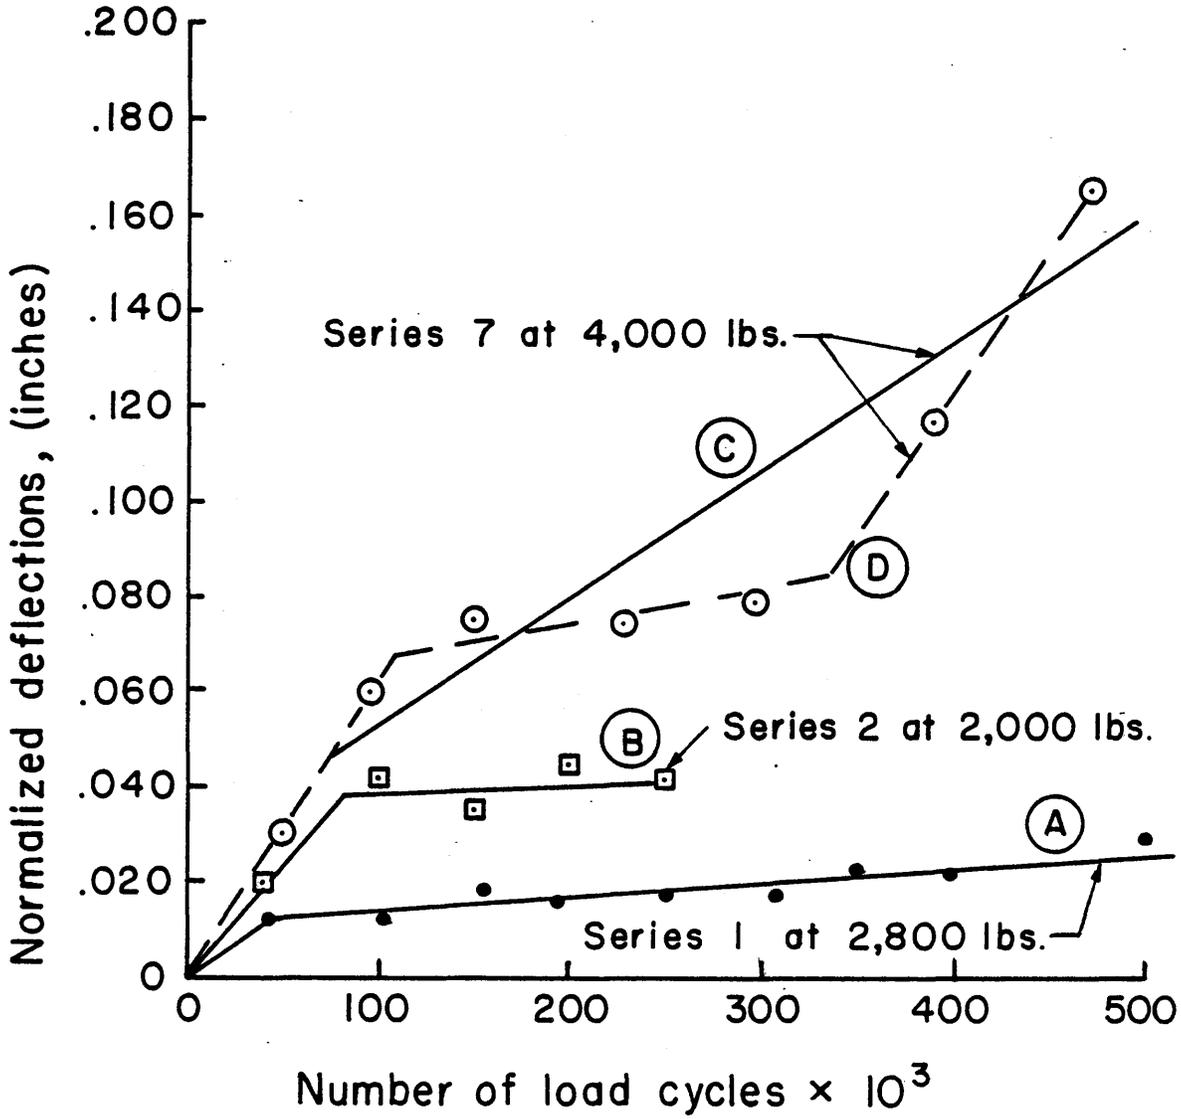
Figure 8. Deflection of middle girder at static reference loads showing effects of accumulated cyclic loads.

elements throughout the bridge or of slight movement of the elements with the propagation of cracks in the joints, the range of the dynamic deflections increased gradually throughout the load series. For example, the deflection range was 0.80 to 0.95 in after 270,000 cycles of load compared with the initial 0.65 to 0.80 in at zero cycles. As with the other load series, a measure of progressive damage during load series 7 was evidenced by the increase in the deflections observed at the periodic static reference loads of 4,000 lb. The data for series 7 are plotted in Figure 8.

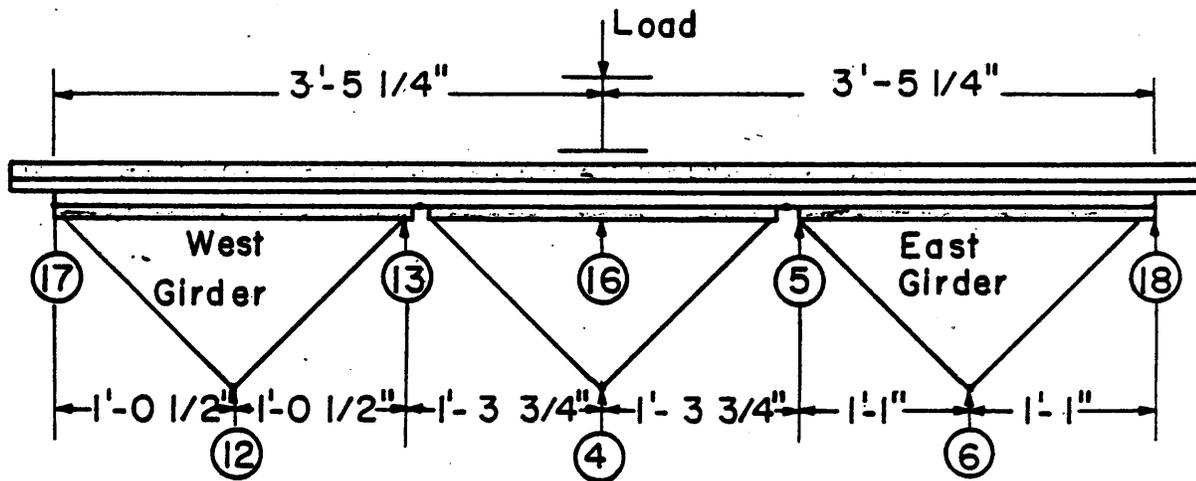
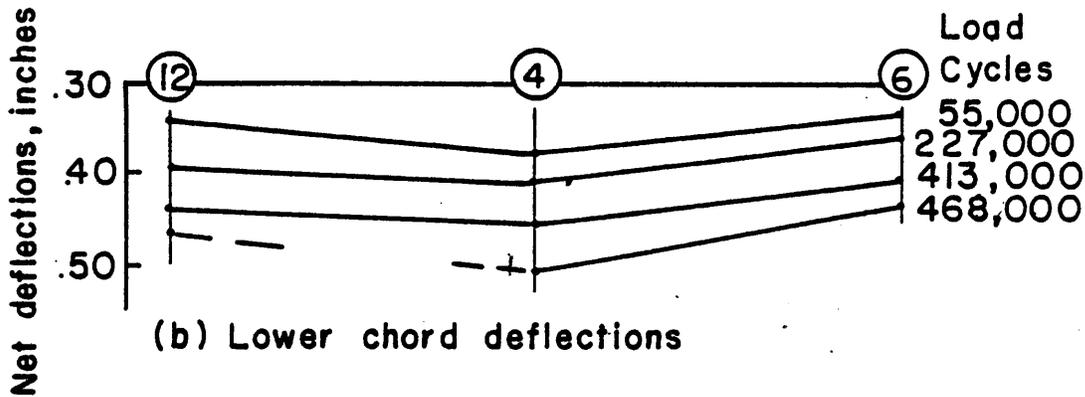
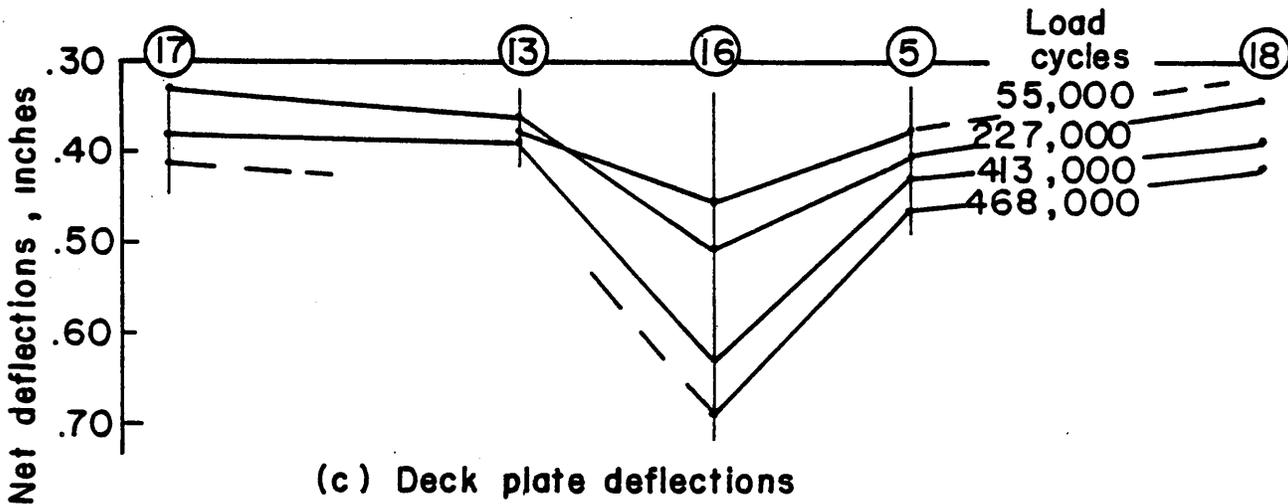
The deflection results presented in Figure 9 for several static reference loads at 4,000 lb emphasize the progressive damage effects of the cyclic loads and the differences in the deflections of the deck of the bridge and the lower chords of the girders. The deflection measurements were made immediately following the indicated number of load cycles to minimize the effect of relaxation upon the value of the deflection readings. Experience had shown that considerable variation occurred in the values of the static load deflection readings if the bridge were permitted to "rest" with the test load removed. The load arrangement of series 7 produced localized bending of the deck of the middle girder in a transverse direction, in addition to bending of the entire bridge in the longitudinal direction. The readings of dial indicator 16 reflected both of these displacements, as is evident from the relatively large deflection for that gage in Figure 9(c). The differences in the deflections of gages 16 and 4 were approximate measures of the transverse bending of the deck of the middle girder alone, if the deformations in the vertical stiffeners connecting the flange to the lower chord are neglected. As seen from Figures 9(b) and

Figure 9. Deflection of cross sections of bridge at midspan for static reference loads of 4,000 lb.

9(c) the transverse bending of the deck ranged from .084 in to .092 in after completion of 55,000 cycles and 227,000 cycles of load, respectfully. respectively. The increase in the relative displacements as indicated by gages 16 and 4 was due to either creep in the deck materials, delaminations at the interfaces in the deck assembly or a combination of both. Visual inspection of the polymer concrete wearing surface at intervals throughout the tests did not reveal any cracking, spalling, or crushing of the concrete surface. Minor cracking or interfacial bond failure made have occurred without detection.

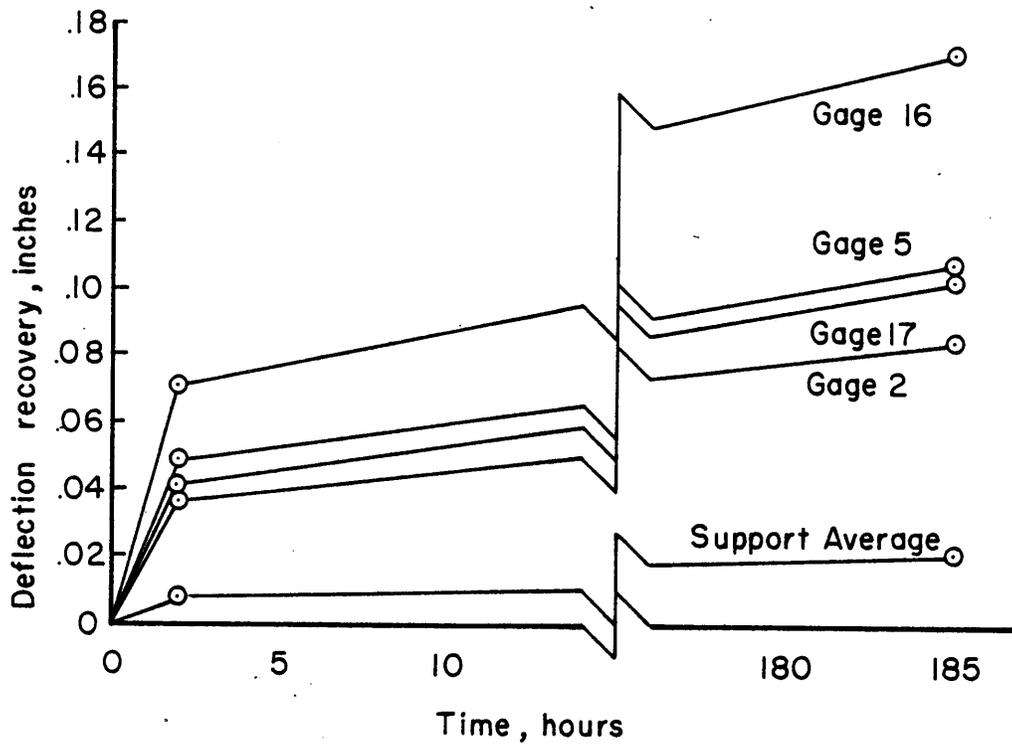
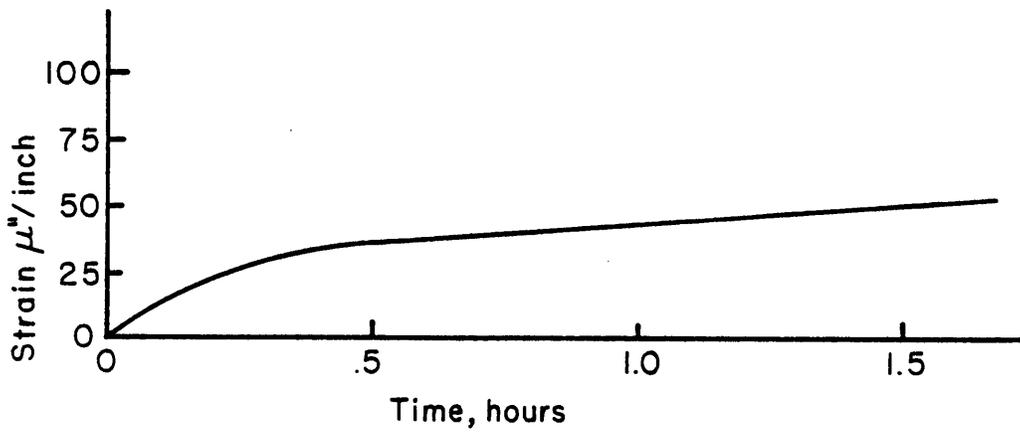
Upon completion of load series 7 and the removal of all loads, the deflection recovery of the bridge was observed. Figure 11(a) presents comparative data for several representative deflection indicators wherein readings were taken at 2 and 184 hours after removal of the test load. Gages 16 and 5 and the support gages were in contact with the deck and gage 2 was in contact with the lower chord as shown in Figure 6(a). As seen from these data, the rate of recovery of the deflections was rapid initially and then diminished with time, as was noted previously during load series 1. To better define the viscoelastic behavior of the bridge, a continuous strain recovery curve was plotted with a strip-chart recorder for number 15 of the bonded strain gages. The tracing from the recorder is shown as Figure 11(b). Due to a malfunction of the recording instrumentation, the time of the complete recovery is not known and may well have been beyond the 184-hour period of the observations.

Figure 11. Viscoelastic recovery of bridge following removal of load for series 7.

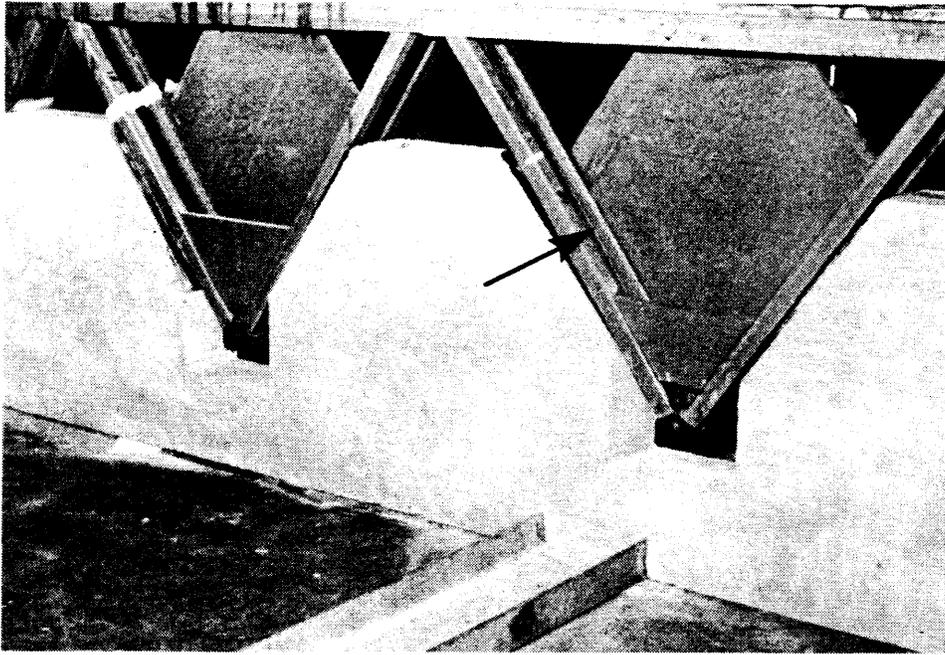
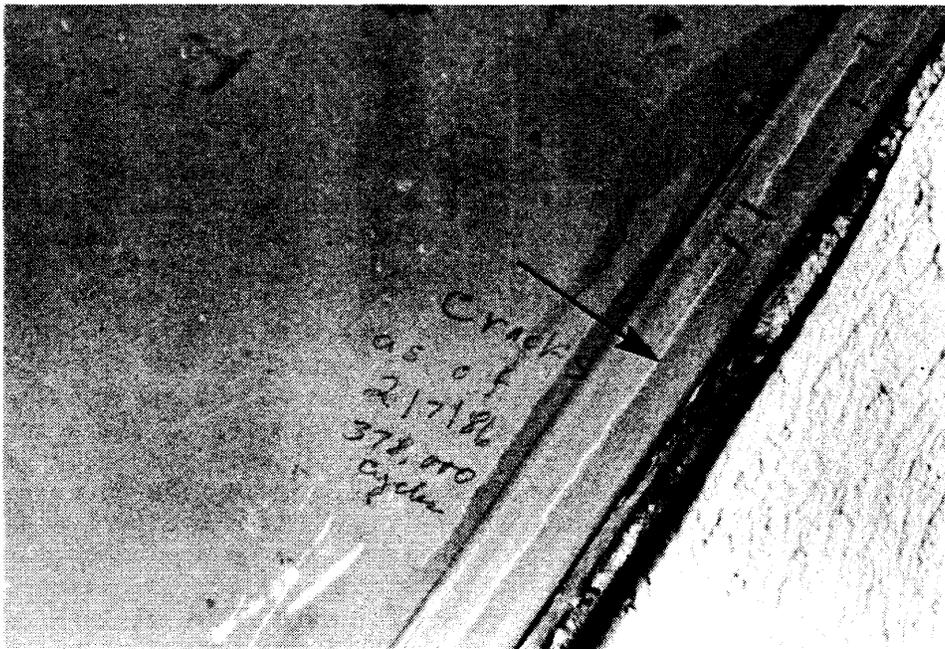
Cracks aligned parallel to the axis of one of the fiberglass tubes serving as the bearing element of the west girder were discovered on February 6, 1986, during a visual inspection of the bridge. However, it is believed that the tube first cracked on January 17, when a sudden but short-lived increase in the acoustic emission count rate was recorded. In this report, all "counts" refer to the number of acoustic emission events which occurred. The use of the term "count" is for convenience and is not to be confused with the number or "count" of the oscillations of the signal within an event. An expanded discussion of the acoustic emission data is continued on page 51. The count rate increased from less than 0.05 counts per load cycle to approximately 0.14 count per load cycle. This change was noted after 144,000 load cycles had been completed in load series 1. Additional discussion of the acoustic emission analysis is included in a later section. For the next several weeks, a clicking sound was clearly heard for each cycle of load, but the source of the sound could not be pinpointed nor related directly to the action of the bridge itself. During this time, there was no unusual change in the measurements of the deflection indicators nor of the electrical strain gages. Figure 12(a) shows the damaged stiffener in the lower right corner of the photograph. A reinforcing plate bonded to the outside stiffeners to strengthen the damaged stiffener may also be seen. Figure 12(b) is an enlargement of the cracks in one face of the stiffener tube after 378,000 load cycles on February 7, 1986.

Figure 12. Flexural cracks (identified by arrow) in the face of a vertical web stiffener at a girder end support.

Estimates of the shear, bending, and bearing stresses in the stiffener at the time of crack formation revealed low values relative to the nominal strength of the composite material. Pertinent to the flexural cracks in the face of the stiffener, the calculated maximum bending stress was 1,676 psi. When compared with a nominal ultimate strength of 10,000 psi, it appears that the crack should not have formed unless the calculated estimate of the stress is incorrect or unless the stiffener had been damaged during previous handling and testing of the bridge. The prior damage hypothesis seems most plausible since none of the remaining 11 support stiffeners developed similar cracks at any time during the load test period, even though they resisted loads more than three times the value at which the cracks developed.

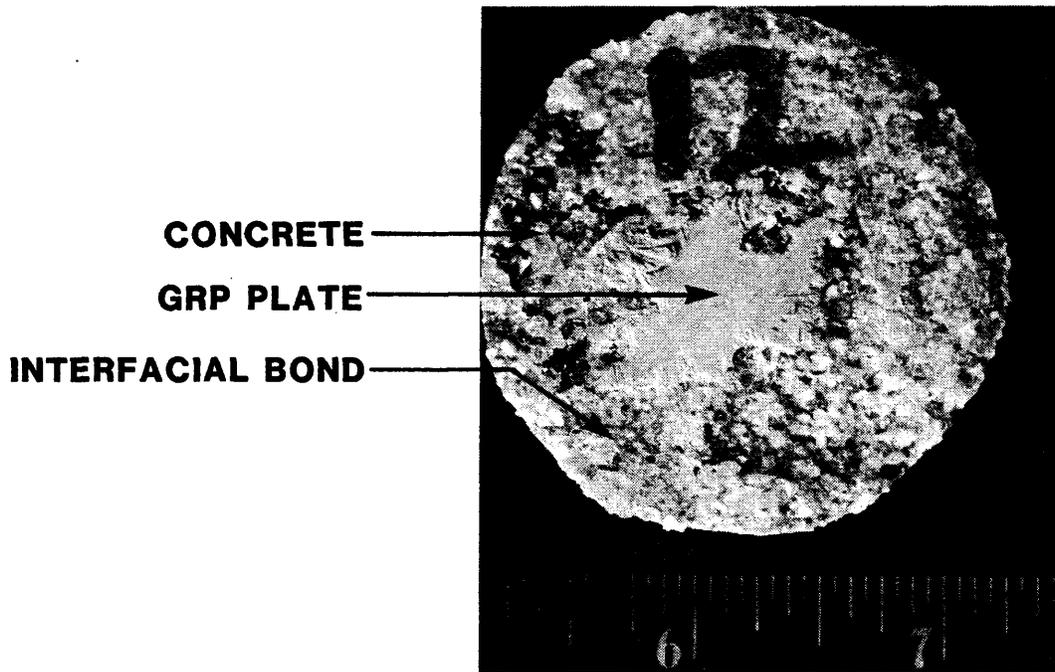
While the strength of the material over the joints apparently was lower than that of the other material, the modes of failures of the various cores do not provide conclusive evidence of preferential degradation of strength at the joint locations. For example, both cores 5 and 8 experienced failure predominantly at the interface and core 3 had a smaller interfacial failure area than core 1. While most of the failures at the interface of the polymer concrete and the GRP cover plate revealed few air voids, the surface at core 6 had a large area over which no resin was applied. Several of the fracture surfaces also included small patches of the GRP plate which had failed just beneath the fill coat of the composite. Thus, it is not known whether the variation in the core strength was due to prior damage to the structure or represents a normal distribution of strengths in the materials for this type of installation.

Figure 16. Representative fracture surfaces on core 12 showing different types of failures.
