# EVALUATION OF A CONCRETE PAVEMENT RESTORATION PROJECT IN VIRGINIA

THOMAS E. FREEMAN, P.E.  
Senior Research Scientist

1. Report No. FHWA/VA-94-R16		2. Government Accession No.		3. Recipient's Catalog No.	
4. Title and Subtitle <i>Evaluation of a Concrete Pavement Restoration Project in Virginia</i>				5. Report Date June 1994

June 1994  
VTRC 94-R16

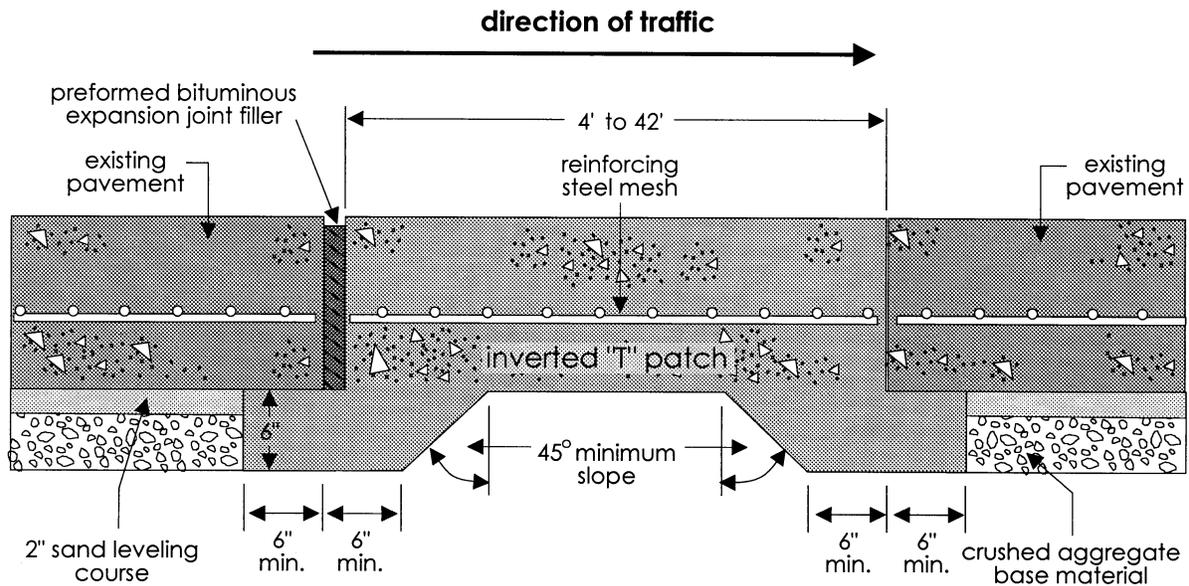
Figure 2. Profile of full-width, full-depth concrete patch.

Although most of the replaced slabs and partial-depth patches performed well throughout the 5-year evaluation period, all of the inverted "T" patches developed severe faulting and pumping within 3 years. When several of these patches were replaced, it was discovered that significant voids were present within the concrete that extended beneath the adjacent slabs, suggesting that adequate consolidation had not been achieved. The overall poor performance of the inverted "T" patches was attributed to difficulties associated with construction in addition to damage caused by water infiltration through open joints.

1. Full-depth, full-width patches using the inverted "T" design are difficult to construct and do not provide an effective mechanism for transferring wheel loads between concrete substrates. Therefore, they should not be considered in the rehabilitation design of heavy concrete pavements.
2. The slight change in edge deflection measurements observed after injecting grout beneath slabs rendered the effectiveness of the slab-stabilization activity inconclusive. Additionally, the filling of air voids within the underlying sand leveling course with grout made it impossible to estimate the volume of void pockets beneath slabs. Therefore, the establishment of a correlation between edge deflection and void pocket volumes, which may have been useful in estimating subsequent grout requirements, was not possible.

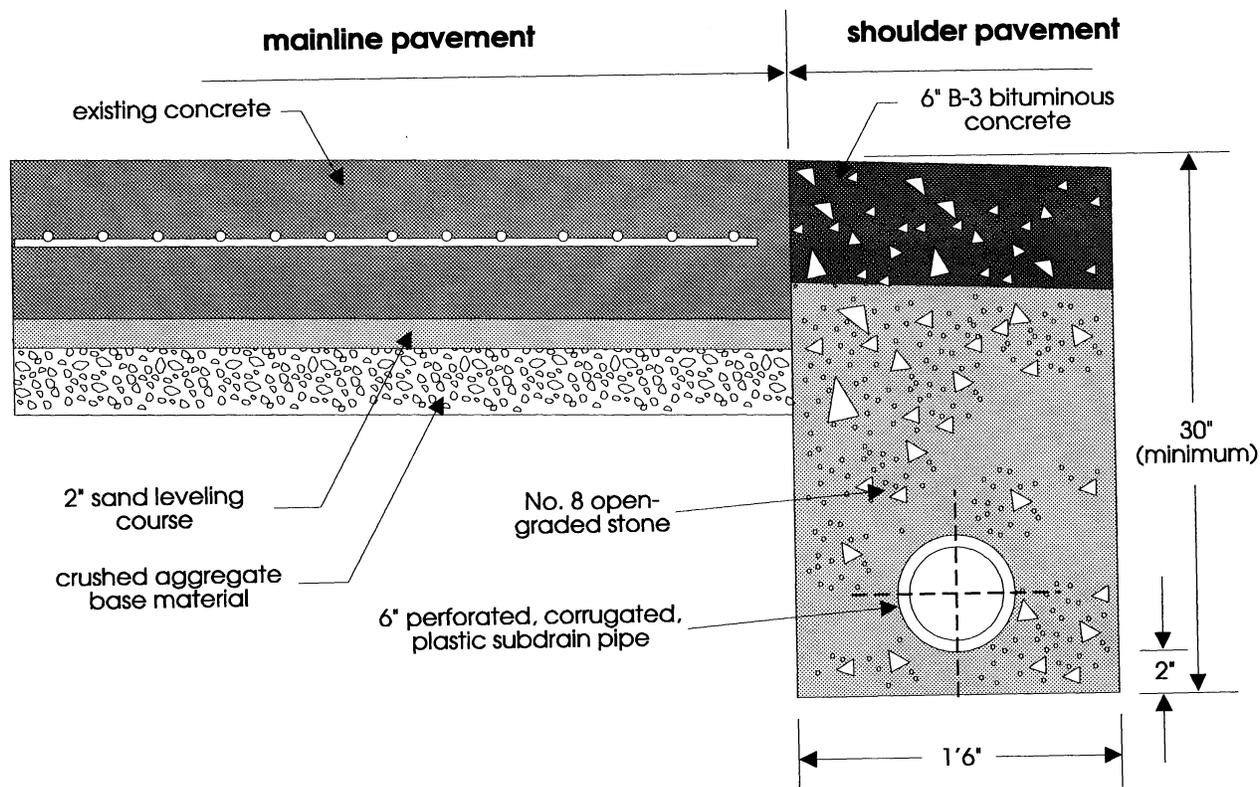
Figure 3. Typical subdrain section.

Early in the evaluation period, water was observed flowing from some of the subdrain headwalls soon after rain storms. Silt and fine-grained sand deposits were regularly noted in the bottom of several lateral outlet pipes, which may indicate that some of the finer material within the sand leveling course was transported by water (piping) through the drainage system. If so, erosion of the sand layer likely contributed to the recurrence of pumping and faulting distresses subsequently observed in the inverted "T" patches. It appeared that the subdrains were effective in removing water from within the pavement structure, but they may have caused damage at the same time by contributing to the erosion of the supporting sand layer.

5. Retrofitting some pavements with subdrains may provide a catalyst for piping, potentially eroding underlying layers to the point of creating damaging void pockets. Consideration should be given to the ability of base layer materials to resist piping when evaluating the feasibility of retrofitting with subdrains.

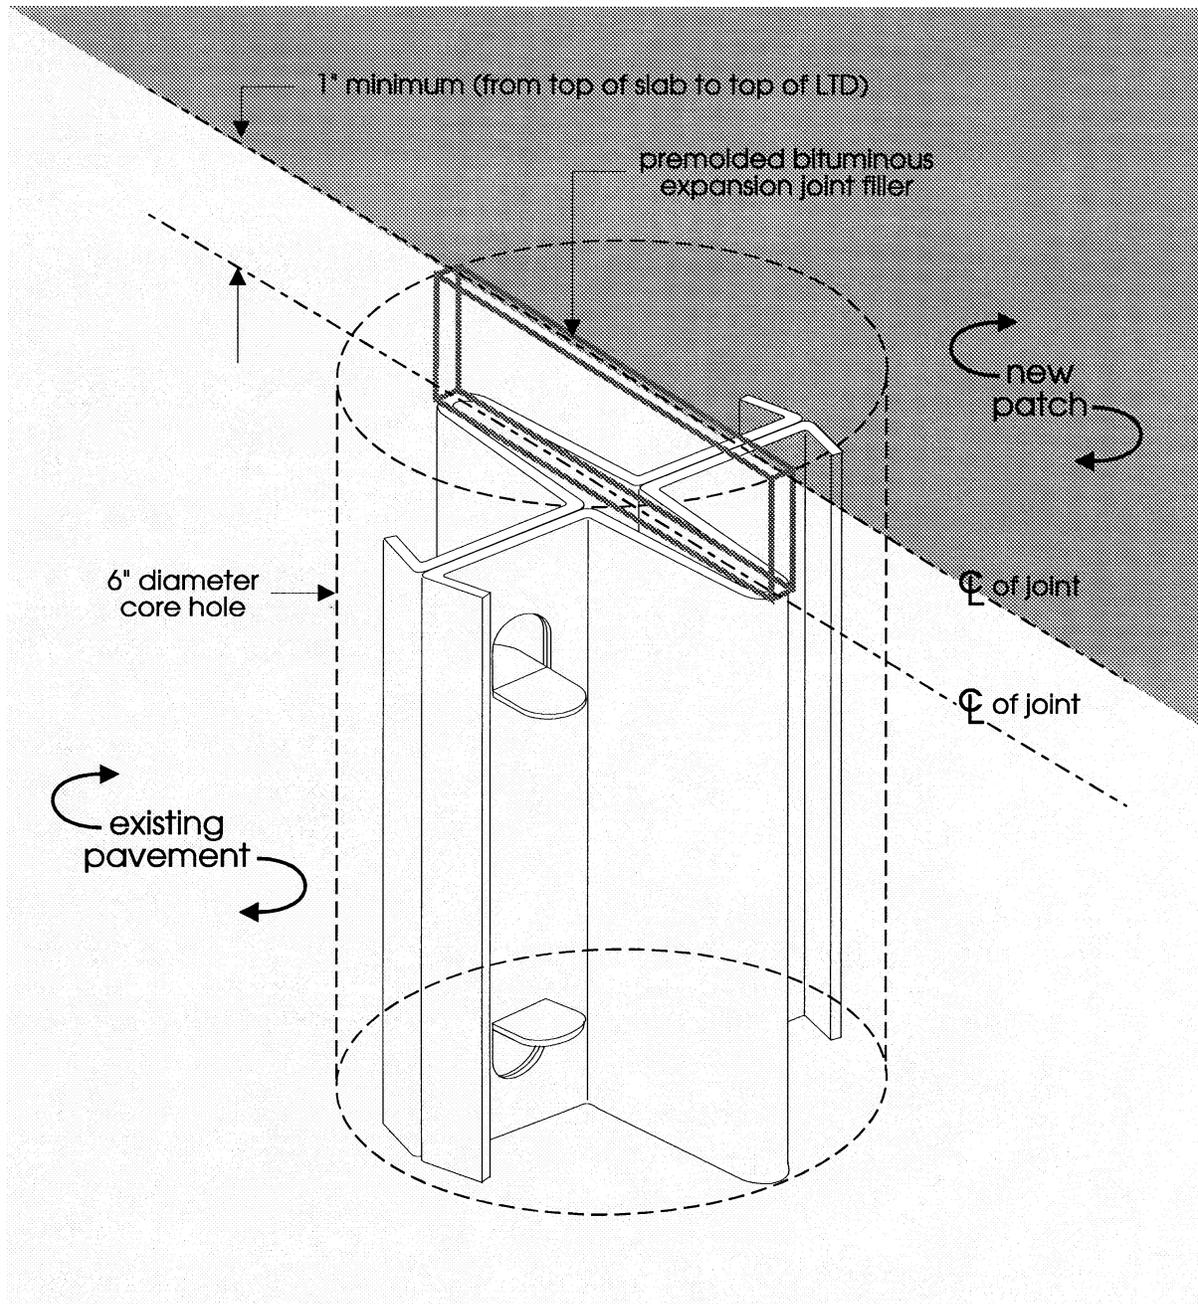
Figure 4. Isometric view of University of Illinois load transfer device.

All of the Illinois Load Transfer Devices failed within 6 months of installation and were removed from the project. In all cases, the failures were manifested by cracking in the surface of the polymer concrete used to embed the devices, some of which was visible after only a few weeks, followed by the loss of material, and exposure. It appears that the devices were not capable of remain-

ing embedded when subjected to the concentrated stresses induced by moving wheel loads.

6. The University of Illinois Load Transfer Device appears to be incapable of resisting the concentrated loads induced by heavy vehicles; therefore, it should not be considered a viable mechanism for load transfer restoration.

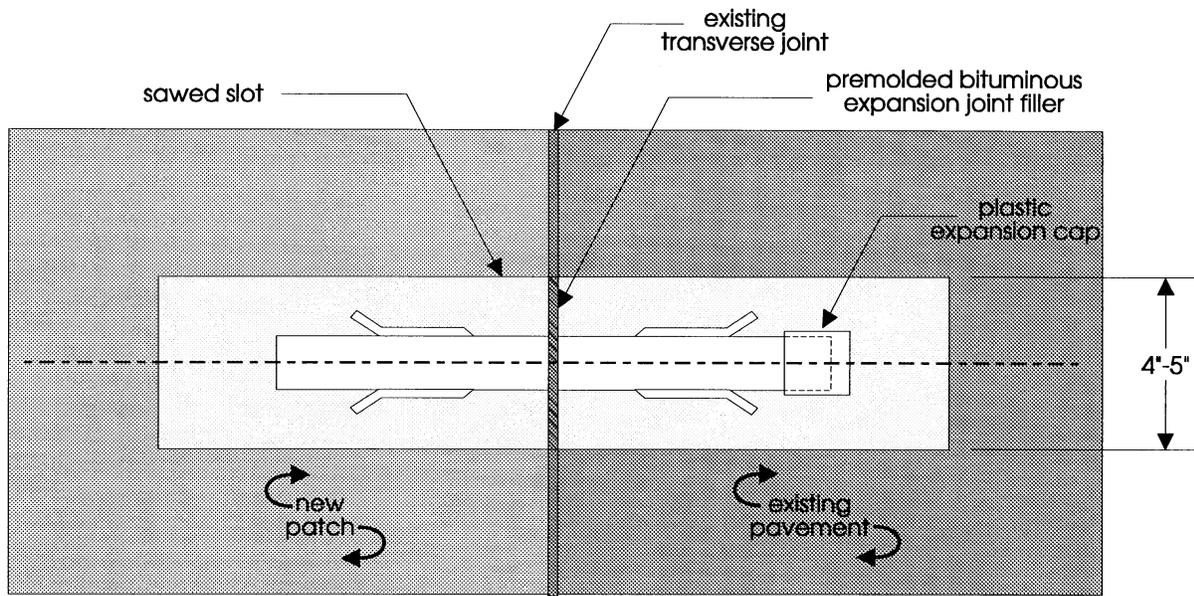
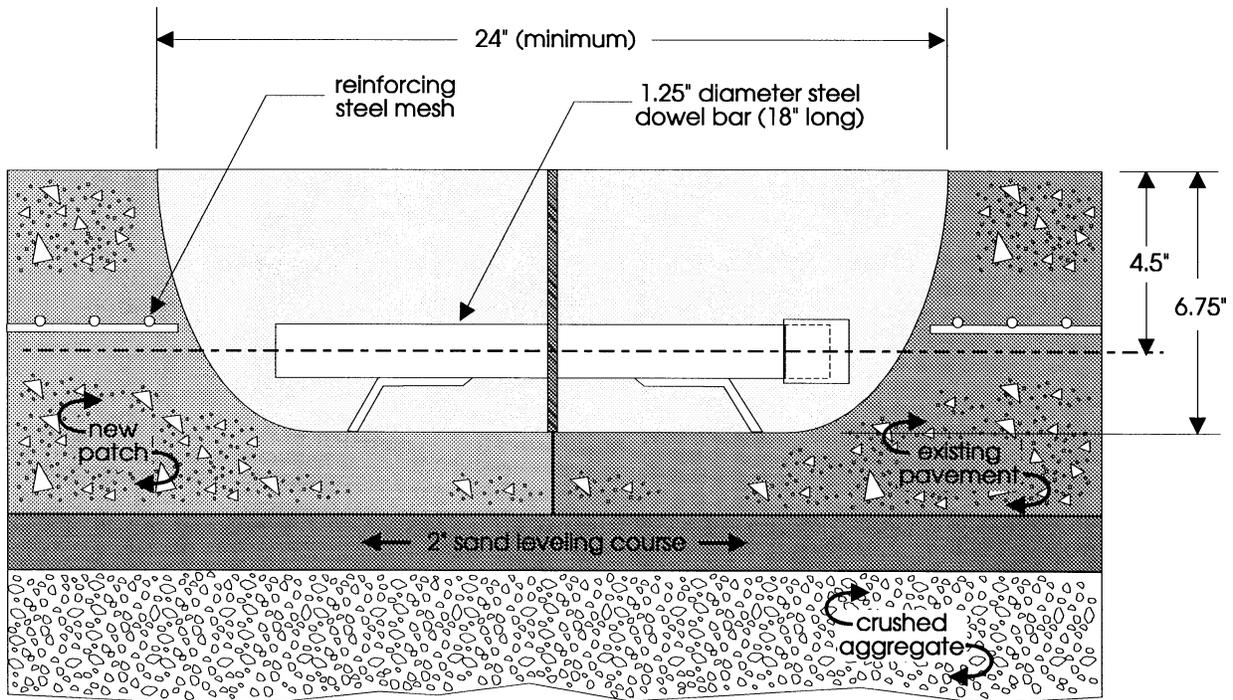
Figure 5. Plan and side views of embedded dowel (kerf) load transfer device.

Although they were rather arduous to install, the embedded dowel load transfer devices generally performed well for the entire evaluation period. Very few of the patches retrofitted with kerfs exhibited signs of faulting or settlement.

7. Embedded dowels were quite effective in restoring load transfer between patches and the old pavement. Additional research is recommended to evaluate their performance between full-length slabs and to improve their constructability.
