**INVESTIGATION
OF PAVEMENT PERMEABILITY:
OLD BRIDGE ROAD**

**Virginia Transportation Research Council
(A Cooperative Organization Sponsored Jointly by the
Virginia Department of Transportation and
the University of Virginia)**

**October 2001
VTRC 02-TAR5**

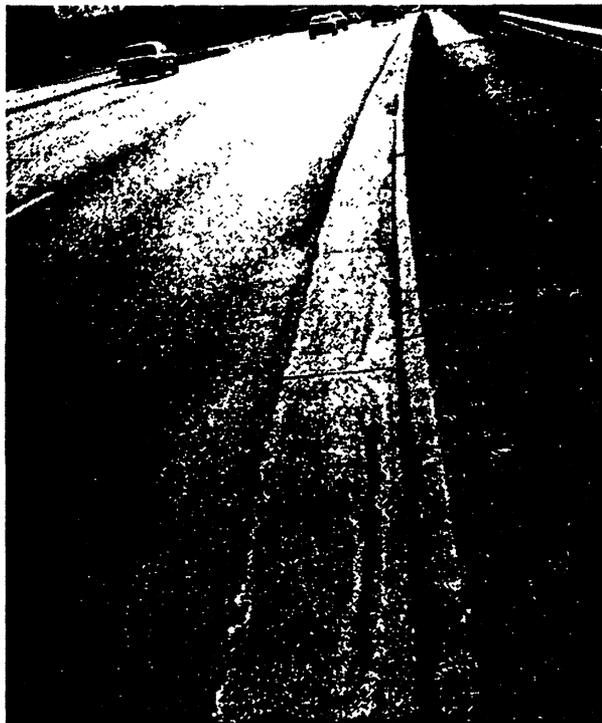
On February 21, 2001, no wet spots were observed in the curves between Elysian Drive and Occoquan Road. Two wet areas were observed at the intersection of Wood Hollow Drive, as shown in Figure 2. Another wet area, shown in Figure 3, was observed along the edge of

Figure 3. Wet Area at Edge of Pavement

the pavement just past Wood Hollow Drive (heading toward Occoquan Road). Based on data provided by the National Weather Service from their weather station at National Airport, no rain had fallen since February 17, 2001 (0.02 in, 0.5 mm): 0.58 in (14.7 mm) of rain fell on February 16, 2001.
