MINIMIZATION OF REFLECTION CRACKS
INSTALLATION REPORT — RT. 29 N. CHARLOTTESVILLE

C. S. Hughes
Highway Research Engineer

Virginia Highway Research Council
(A Cooperative Organization Sponsored Jointly by the Virginia
Department of Highways and the University of Virginia)

December 1972
VHRC 72-R17

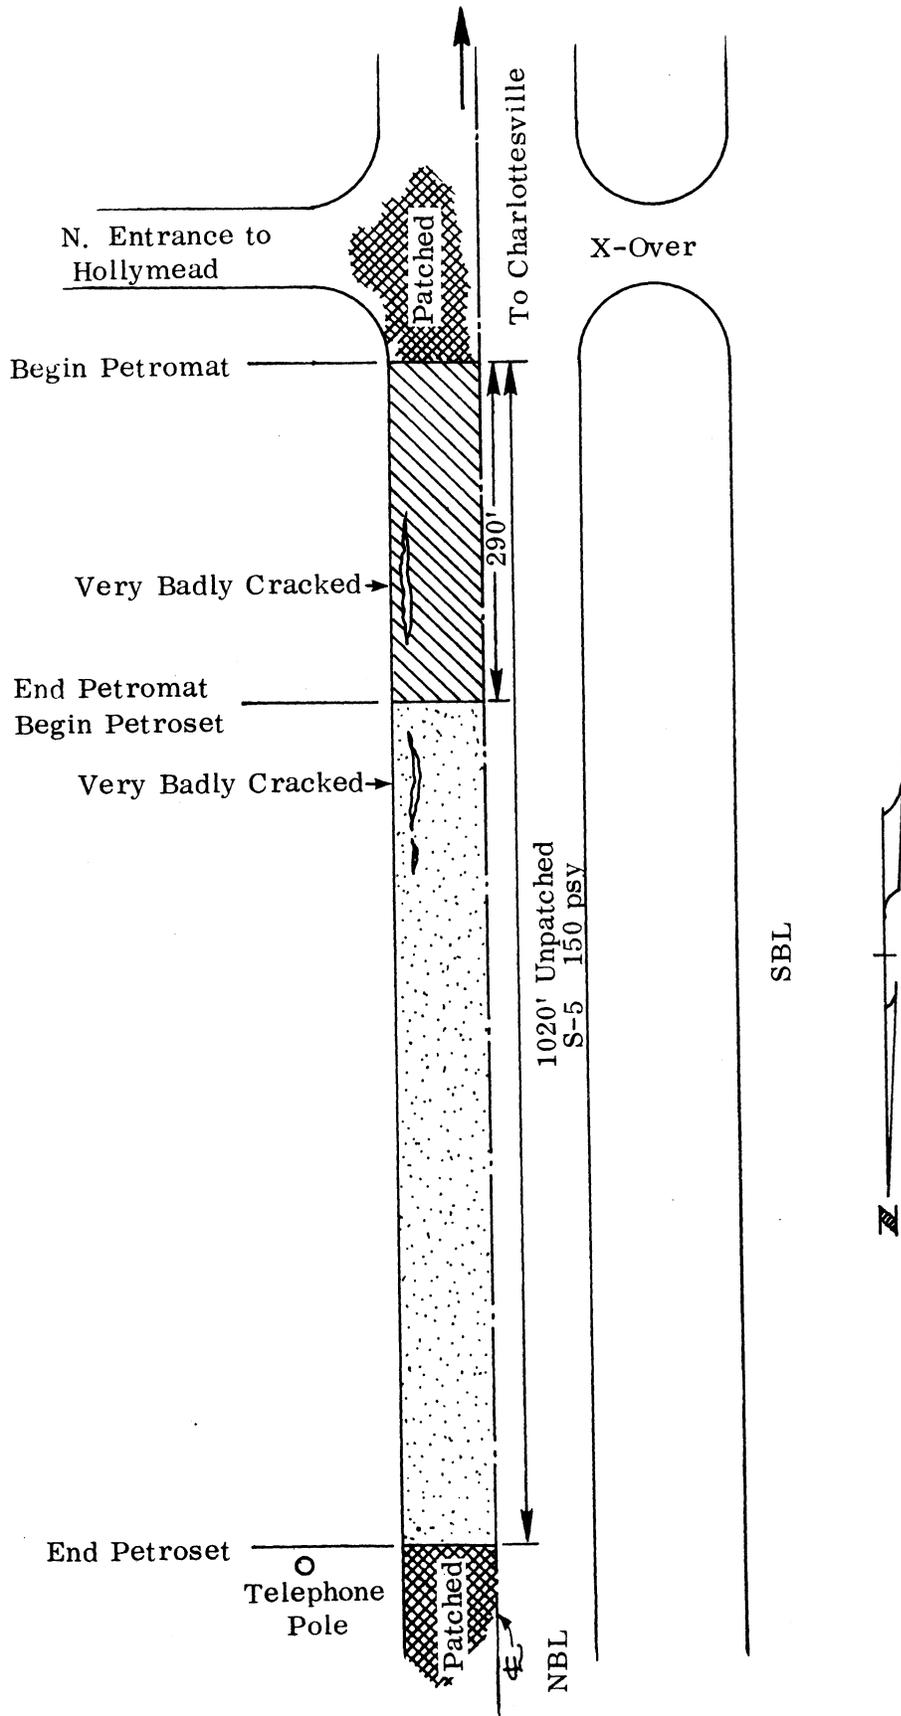
Figure 1. Schematic diagram of 29N test installation.

In mid-July 1972, three different materials were placed in a section of the NBTL of Rt. 29 north of Charlottesville at the northern entrance to the Hollymead subdivision. Figure 1 shows the location of the materials.
