Assessment of Tri-Dyne Precast Concrete Panels

LTRC Project Number 08-2TA

Louisiana Department of Transportation and Development
Louisiana Transportation Research Center
4101 Gourrier Ave
Baton Rouge, LA 70808
www.ltrc.lsu.edu

January 2008

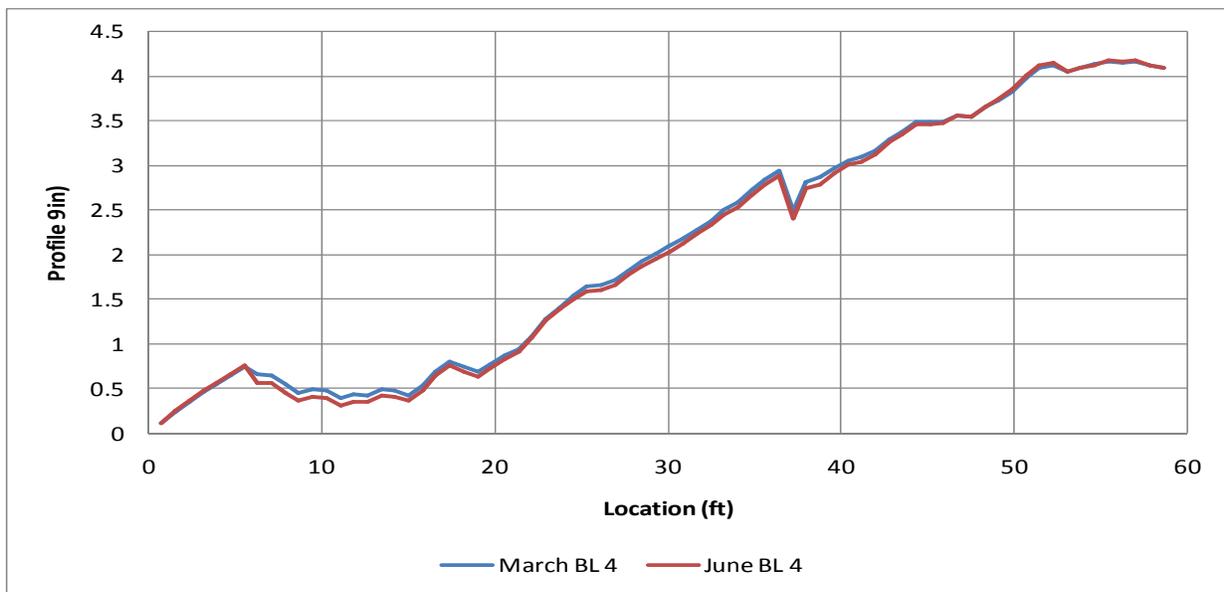
Figure 18: Profiles for BL 4

Walking profiler: Base lines 1 through 4 were each tested with the walking profiler in March and June of 2007. Profile plots for BL 4 are shown in Figure 18, and the average IRI values are shown in Table 3. Profile plots for BL 1, 2, and 3 are in Appendix 1. The profile data indicates that the slabs were rough, with IRI values ranging from 296 to 382, in the March 2007 assessment. The leveling material operation in June of 2007 did not improve the roughness, as the IRI values ranged from 294 to 413. The precast panels installed on this project did not meet DOTD ride specifications and had IRI values (150 – 165) greater than those reported by others for PCPS (9)(10).

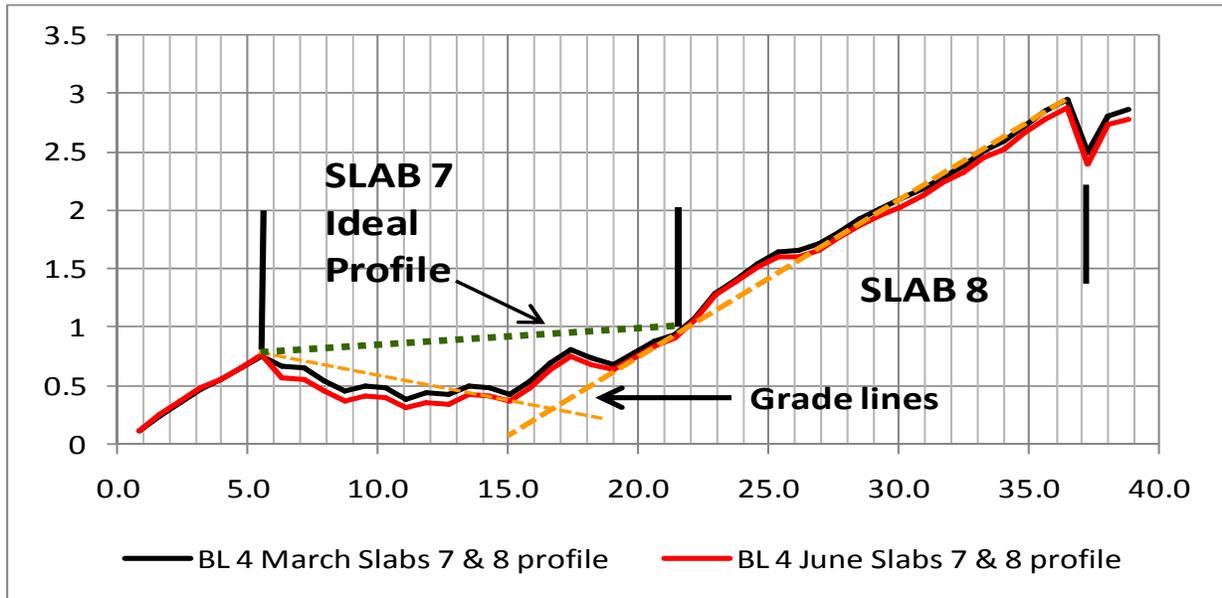
Figure 19: Slab 7 and 8 profile

Judging from the profile data, slab 7 appears to have been bending downward in relation to slab 8, as shown in Figure 19. This scenario was observed in slab 2 and 3 profiles also; see Appendix 1. Further discussion of the ramifications of such will be presented in the pressure sensor section.

at location 21; profile differential between slabs 7 and 8, as shown in Figure 19; and the mechanism of load transfer, as shown in Figure 25; the load applied at location 21 was carried predominately by the base at location 22 (slab 8).

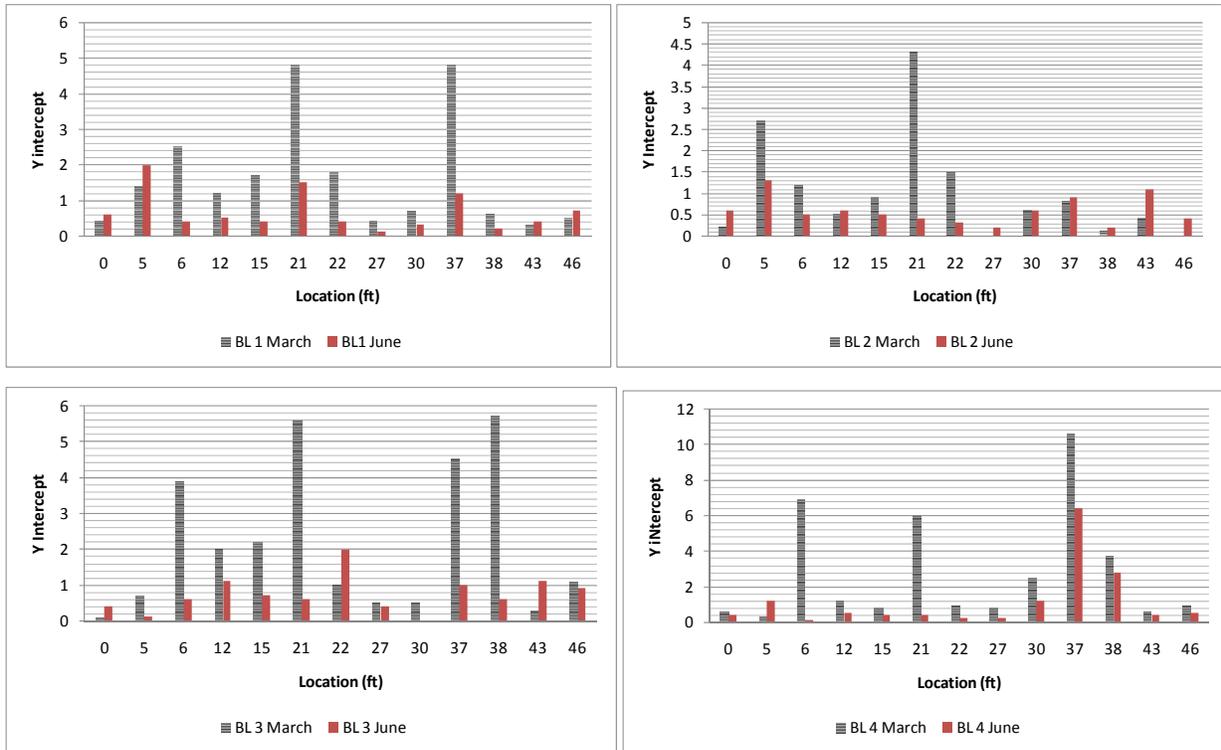
Figure 20: Y intercept values

Void detection from FWD: Figure 20 presents the Y intercept values for testing conducted on the four base lines in March and June. When the Y intercept value is greater than 2, there is potentially a void or loss of support present at that location. On base line 1, voids were present at locations 6, 21, and 27 for the March data set, and no voids were present for the June data set. Voids were present at locations 5 and 21 on base line 2 for the March data set, and no voids were present for the June data set. Base line 3 had voids present at locations 12, 15, 21, 37, and 38 for the March data set and voids present at location 22 for the June data set. Base line 4 had voids present at locations 6, 21, 30, 37, and 38 for the March data set and voids present at locations 37 and 38 for the June data set.

Judging from the void detection tests, one may infer that there is a higher incidence of voids present beneath the slabs when they are placed directly on the subgrade. Injecting leveling material beneath the slabs did reduce the number of voids but did not eliminate them.

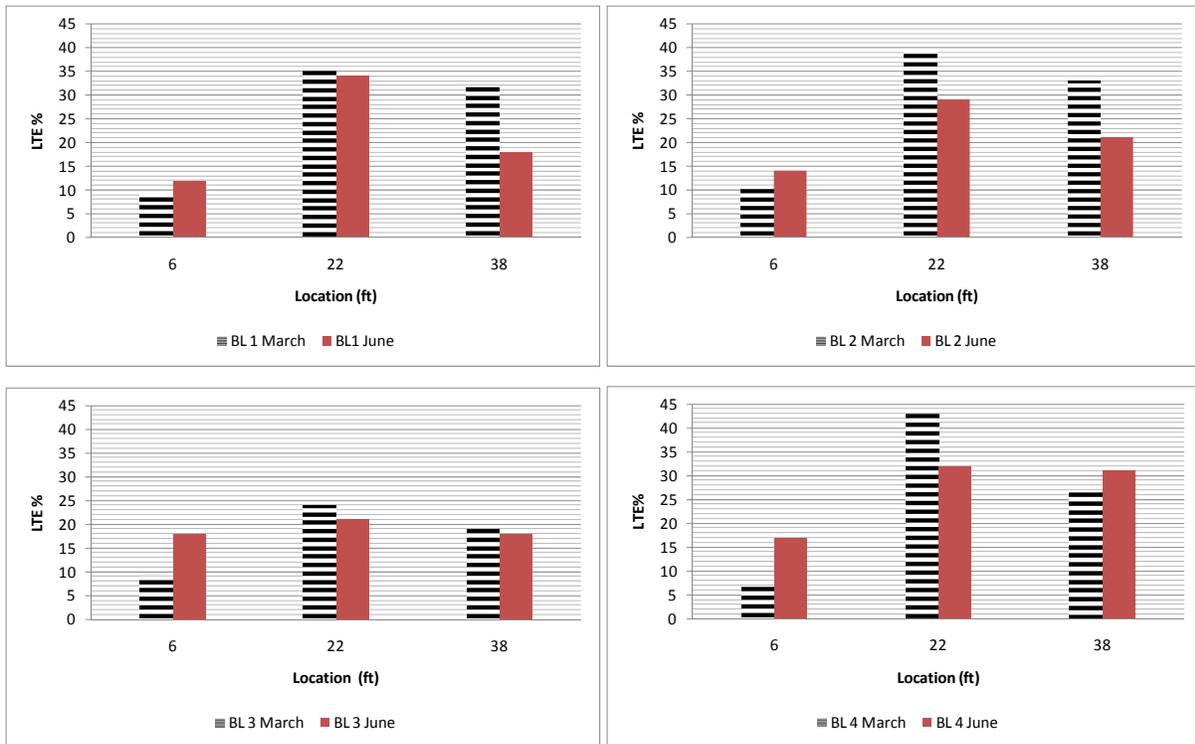
Figure 21: Load transfer efficiency

Load transfer efficiency as determined by the FWD: In both the March and June data sets, all transverse joints on all base lines had load transfer efficiencies below 43 percent, as shown in Figure 21. Therefore, the transverse joint load transfer mechanism evaluated on the PCPS produced poor load transfer.

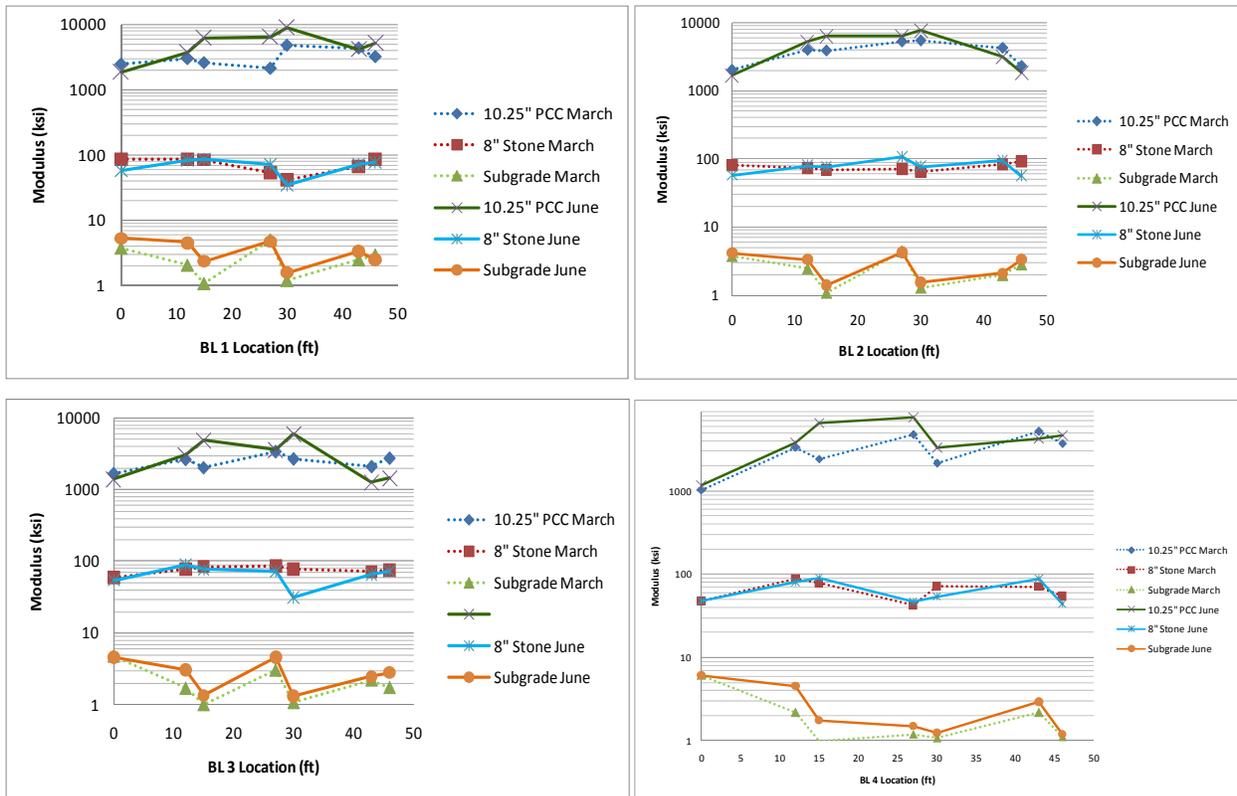
Figure 22: Layer Moduli values

Layer Moduli values from FWD tests: The layer moduli were determined for the concrete pavement, stone base course, and subgrade for the March and June assessments and are shown in Figure 22.

Modulus values in the 4,000 to 5,000 ksi range are generally found in good concrete pavements typically used on DOTD highways. The modulus values for the cast in place slab were generally less than 2,000 ksi, below the acceptable range. Modulus values for the precast panels in the March data set ranged from 2,600 to 4,198, below the acceptable range. However, these values could be inaccurate due to the instability of the slabs during testing.

The June data set had higher modulus values than the March data set and ranged from 3357 to 5822 ksi. These values were generally acceptable and were higher than the March data set, probably because the slabs were more stable due to the injection of leveling material.

Values for the stone base course modulus were generally higher than 45 ksi, indicating that the base course was acceptable. Subgrade soil modulus was on average 2.4 ksi and was very weak.

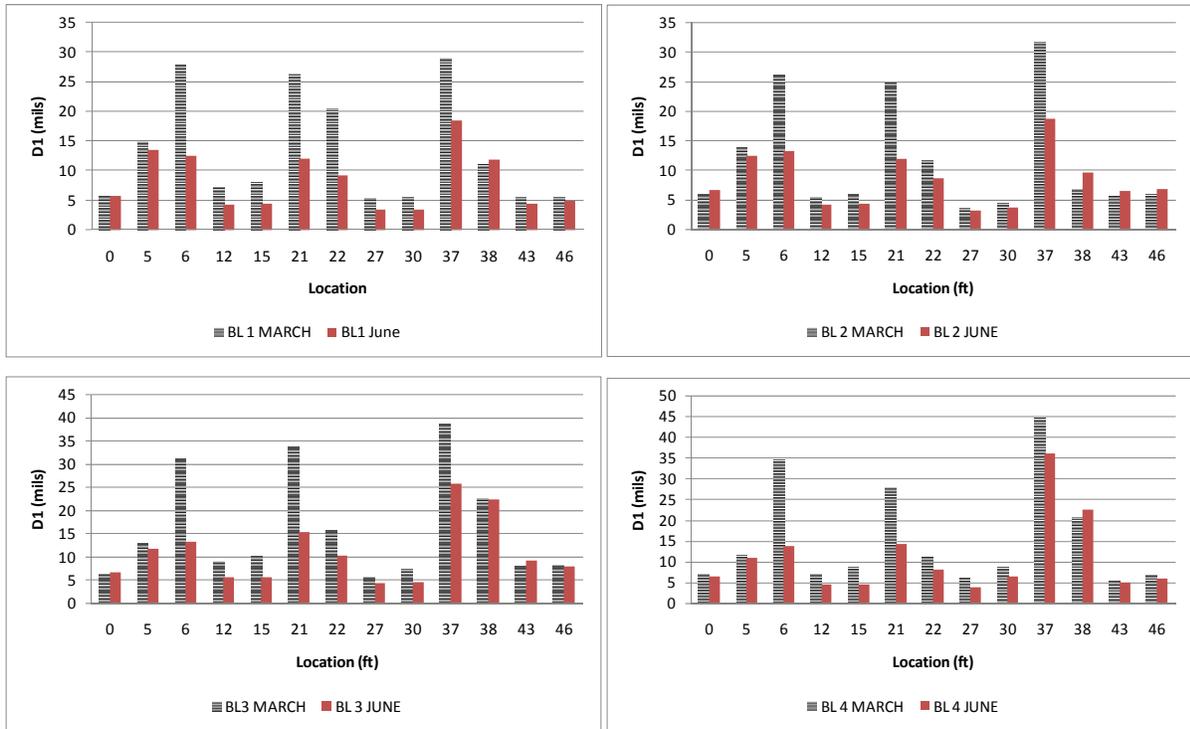
Figure 23: FWD first sensor deflections

First sensor deflection analysis from FWD: Figure 23 presents the first sensor deflections for the March and June assessments. Trends toward lower deflections were generally observed for the slabs once they were injected with leveling material (June data set). Deflections at the joint locations (2, 21, 22, 37, and 38) were higher than deflections at locations near the center of the slab (12, 15, 37, 30, 43, and 46), indicating a decrease in stiffness at the joints, which is typical. Deflections on the approach side of the joints (21, 37) were higher than deflections on the leave side of the joints (22, 38). This will be discussed further in the section on pressure sensor readings.

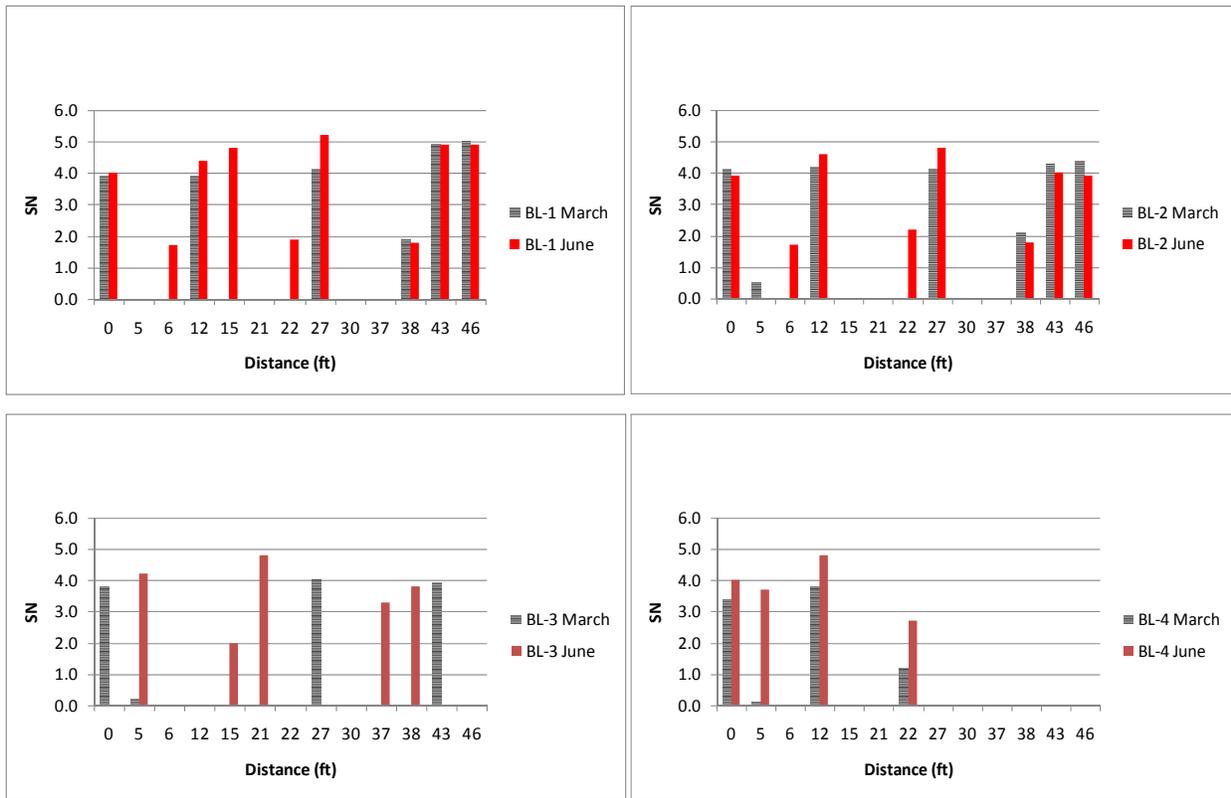
Figure 24: Dynaflect readings

Structural number readings from Dynaflect: As shown in Figure 24, many of the test locations were not plotted, due to questionable data. This phenomenon has been previously observed on concrete slabs that were either unstable or had large cracks. Pavement structures of this thickness generally produce SN values greater than 4.5. Due to the problematic data, Figure 24 is presented for informational purposes only.

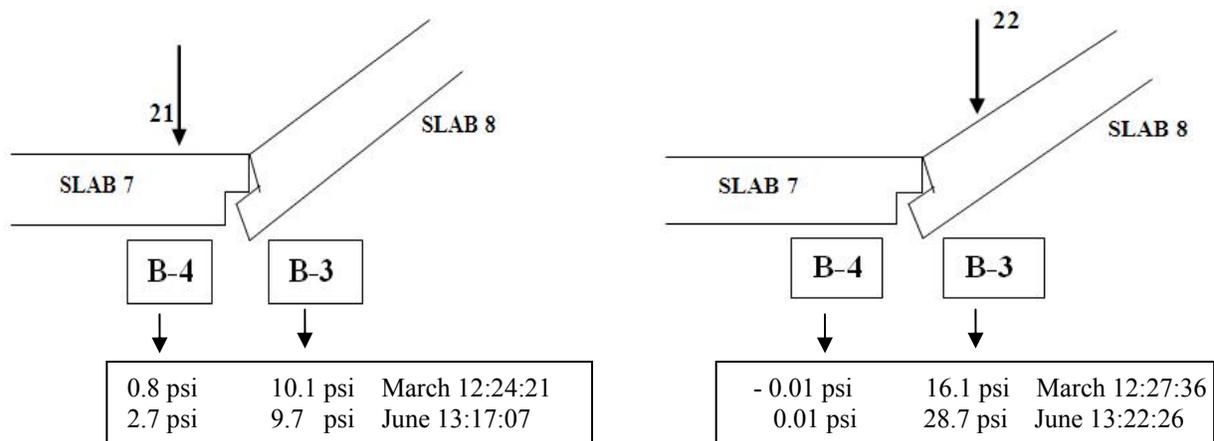
Figure 25: Data summary for slabs 7 and 8

Loading at locations 21 and 22: Figure 25 presents the pressure cell readings (B-4 and B-3), measured when dead loading from the front wheels of the large cone truck was applied at the approach side (21) and leave side (22) for the March and June evaluations, as shown in Figure 26.

When the load was applied to location 21 (March 12:24:21), the pressure cell readings for B-4 and B-3 were 0.8 psi and 10.1 psi, respectively. If the slabs were equally and fully supported by the base course and properly aligned vertically and horizontally, the pressure readings from pressure cells B-3 and B-4 should be similar when loaded at location 21 and different when loaded at location 22 due to the load transfer mechanism, as shown in Figure 25. However, there was a pressure differential of 9.3 psi across the joint when loaded at location 21. Due to the void

With one exception, a similar scenario was observed for the June data set (June 13:17:07) when the load was placed at location 21. FWD data did not indicate a void at location 21, but the deflections differed significantly from location 21 (14.13 mils) to location 22 (7.97), as with the March 12:24:21 data set. Injecting leveling material beneath the slabs did not fix the problems caused by profile differentials, voids, and the load transfer mechanism.

Applying the dead load to location 22 (slab 8) barely influenced sensor B-4 (slab 7 - location 21) due to the design of the joint.

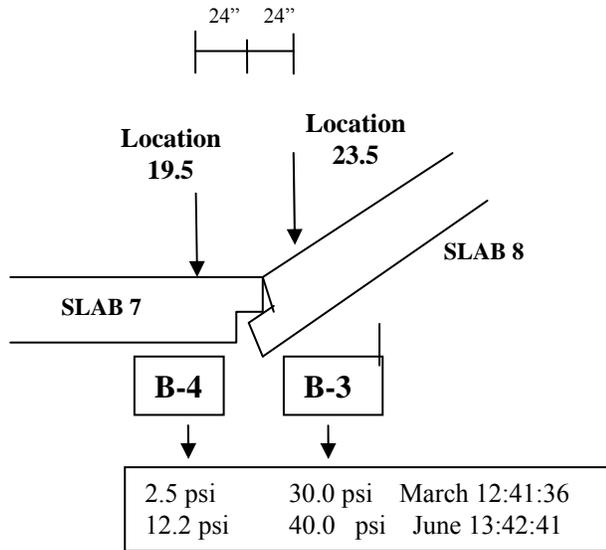
Figure 27: Data summary for slabs 7 and 8

Simultaneous loading at locations 19.5 and 23.5: The pressures for B-4 and B-3 were 2.5 psi and 30 psi, respectively, for the March 12:41:36 data set when the rear wheels of the large cone truck were located equidistant (24 in.) from the joint at slabs 7 and 8, as shown in Figures 27 and 28. Because the lap joint system was a poor load transfer mechanism, slab 8 bears the full load of the tires (location 23.5) over it and the majority of the load applied (location 19.5) to slab 7. This trend was also evident in the June 13:42:21 data, as the pressures for B-4 and B-3 were 12.2 psi and 40 psi, respectively.

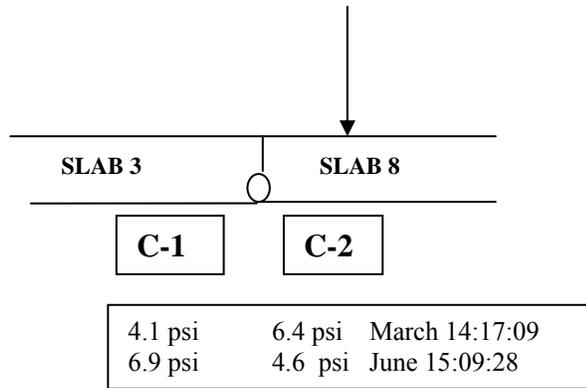
Figure 30: Pressure sensor readings for loading on slab 8

As shown in Figure 30, the pressures for C-1 and C-2 were 4.1psi and 6.4 psi, respectively, for the March 14:17:09 data set and 6.9 psi and 4.6 psi, respectively, for the June 15:09:28 data set. Similar pressures across the longitudinal joint at slabs 3 and 8 were observed for both the March and June data sets.

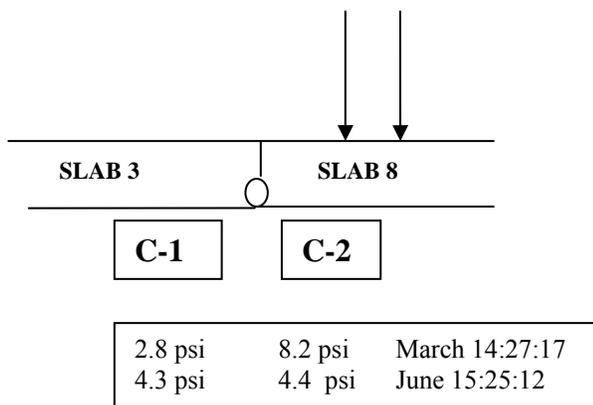
Figure 32: Front wheel load near sensor C-2

As shown in Figure 32, the pressures for C-1 and C-2 were 2.8 psi and 8.2 psi, respectively, for the March 14:27:17 data set and 4.3 psi and 4.4 psi, respectively, for the June 15:25:12 data set. The reason for the differing pressures between the March and June data set could be that the better contact between the slab and base course was created by the injection of leveling material in June.
