PROFILE ANALYSIS OF THE LTPP SPS-6 SITE IN ARIZONA

1. Report No. UMTRI-2010-17		2. Government Accession No.		3. Recipient's Catalog No.	
4. Title and Subtitle Profile Analysis of the LTPP SPS-6 Site in Arizona				5. Report Date July 2010

14. Sponsoring Agency Code	
15. Supplementary Notes					
16. Abstract <p>This report characterizes the longitudinal profiles of five pavement sections within the Arizona Specific Pavement Studies 6 project throughout their service life. This project was built and monitored as part of the Long-Term Pavement Performance Study. Road profile measurements were collected on this site about once per year since the fall after it was opened to traffic. This study analyzed the profiles in detail by calculating their roughness values, examining the spatial distribution of roughness within them, viewing them with post-processing filters, and examining their spectral properties. These analyses provided details about the roughness characteristics of the road and provided a basis for quantifying and explaining the changes in roughness with time, relating post-rehabilitation roughness with rehabilitation type, surface preparation, and profile properties, as well

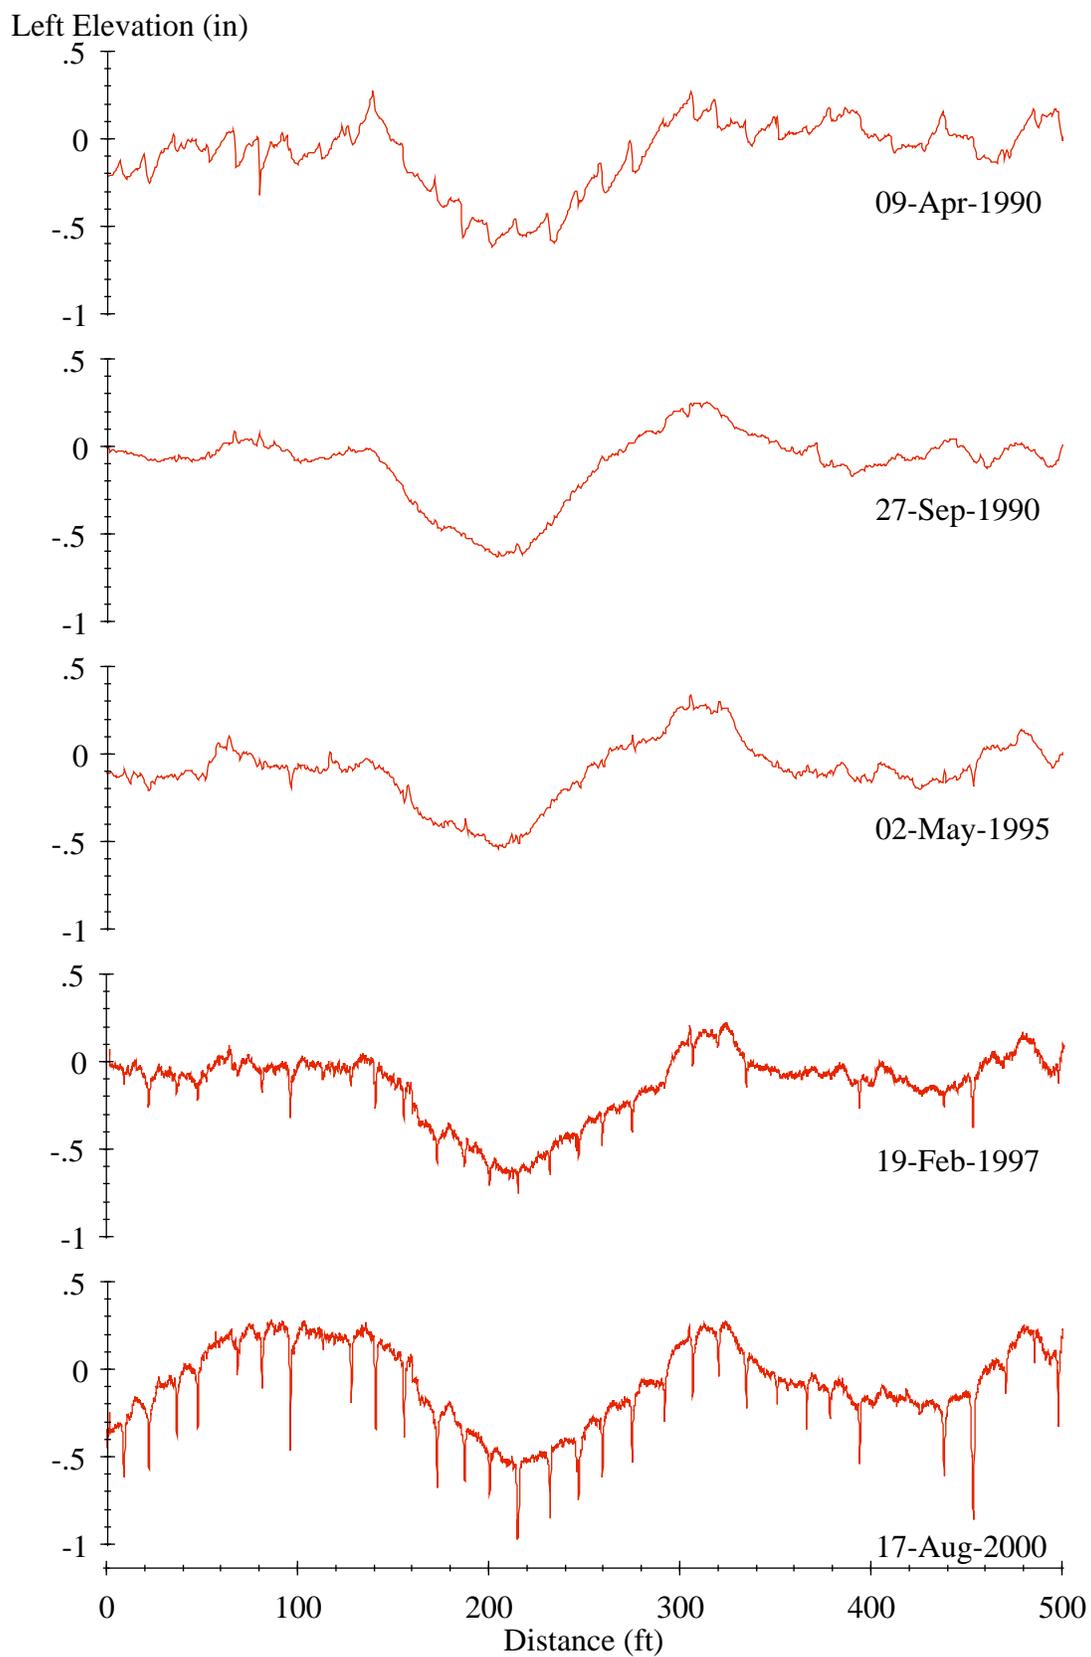
Figure 22. Raw profiles of section 0603.

Several short-duration disturbances (i.e., bumps and dips) appear in the profile measured in May 1995 that do not appear in the profiles measured in September 1990. In the two subsequent visits shown, roughness progresses with time in the form of narrow dips. Transverse cracking and the associated surface deformation at the borders of the cracks caused most of the narrow dips and small bumps.

By August 2000 the narrow dips are deep and numerous enough to stand out in the raw profile plot. However, the raw profile plot is not ideal of recognizing the first appearance of the dips, or characterizing their shape and width. Figure 23 provides a closer look at one of the dips after the application of an anti-smoothing moving average filter using a base length of 10 ft. This high-pass filter removes much of the roughness in the profile associated with changes in elevation over distances longer than 10 ft (including the long trends visible in Figure 22), and leaves most of the very short duration changes in elevation intact.

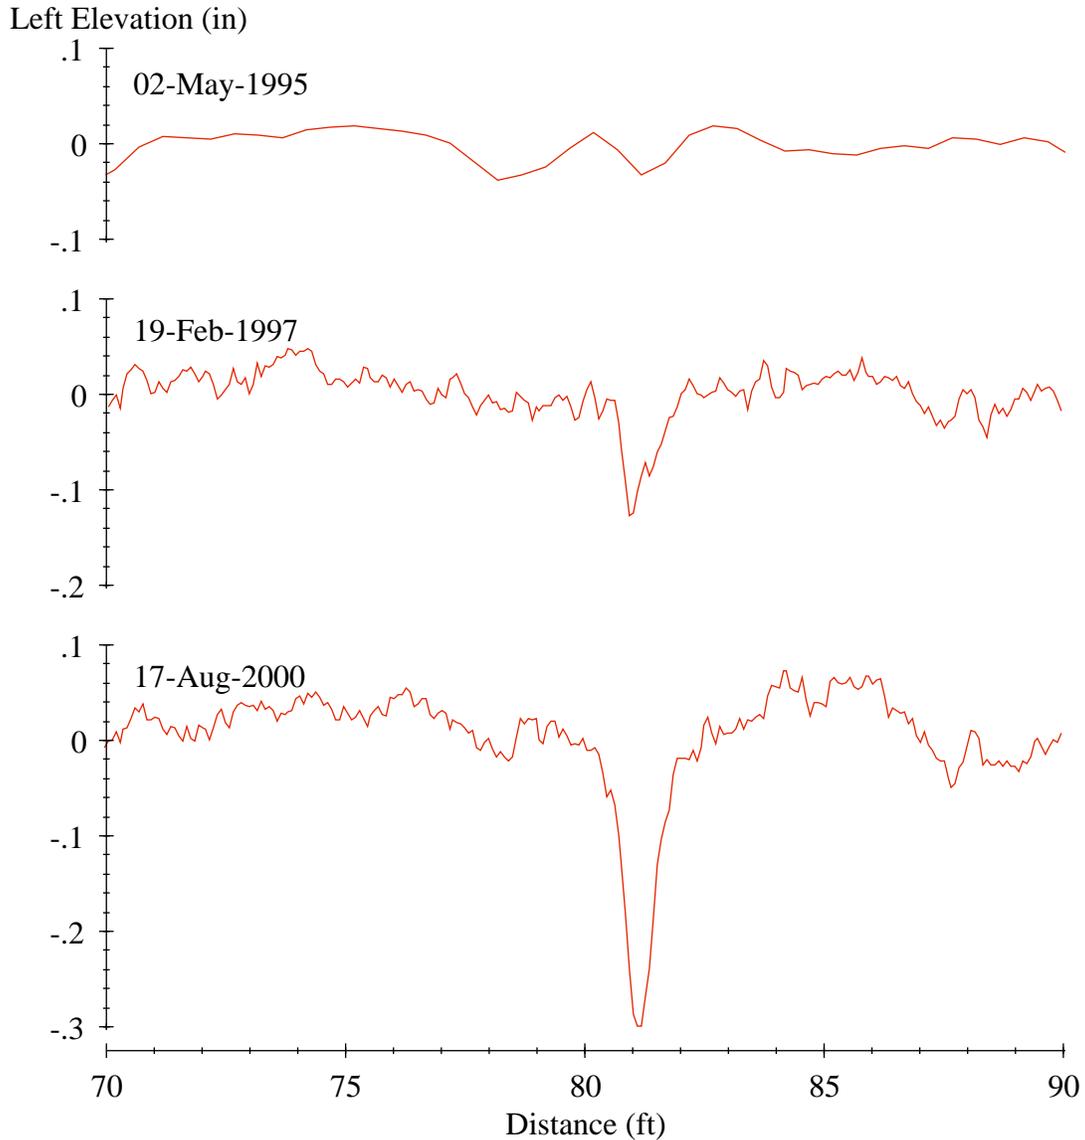
Figure 23. High-pass filtered profiles of section 0603.

Figure 23 shows a clear progression in the depth of the dip over time from a small ripple in May 1995 to a deep narrow dip in August 2000. An important feature of the dip is its width. The dip is about 1 ft wide, which is much wider than the crack that caused it. This dip is likely to degrade ride quality and penalize the IRI value much more than a narrower dip with the same depth.

Like the dips in Figure 23, any of the dips that stand out in the February 1997 profile measurements appear as much shallower dips in the same location in May 1995. (This was the case on all of the test sections with significant transverse cracking.) The change in severity between these two measurement dates has two potential causes. First, the dip itself may have grown more severe. However, the dip was rated as “medium severity” in distress surveys in August 1994, October 1997 and December 1999. (In October 2000 and later the crack was rated as “high severity”.) Second, the profile measurement was made with a K. J. Law DNC 690 in 1995 and a K. J. Law T-6600 in 1997. This is

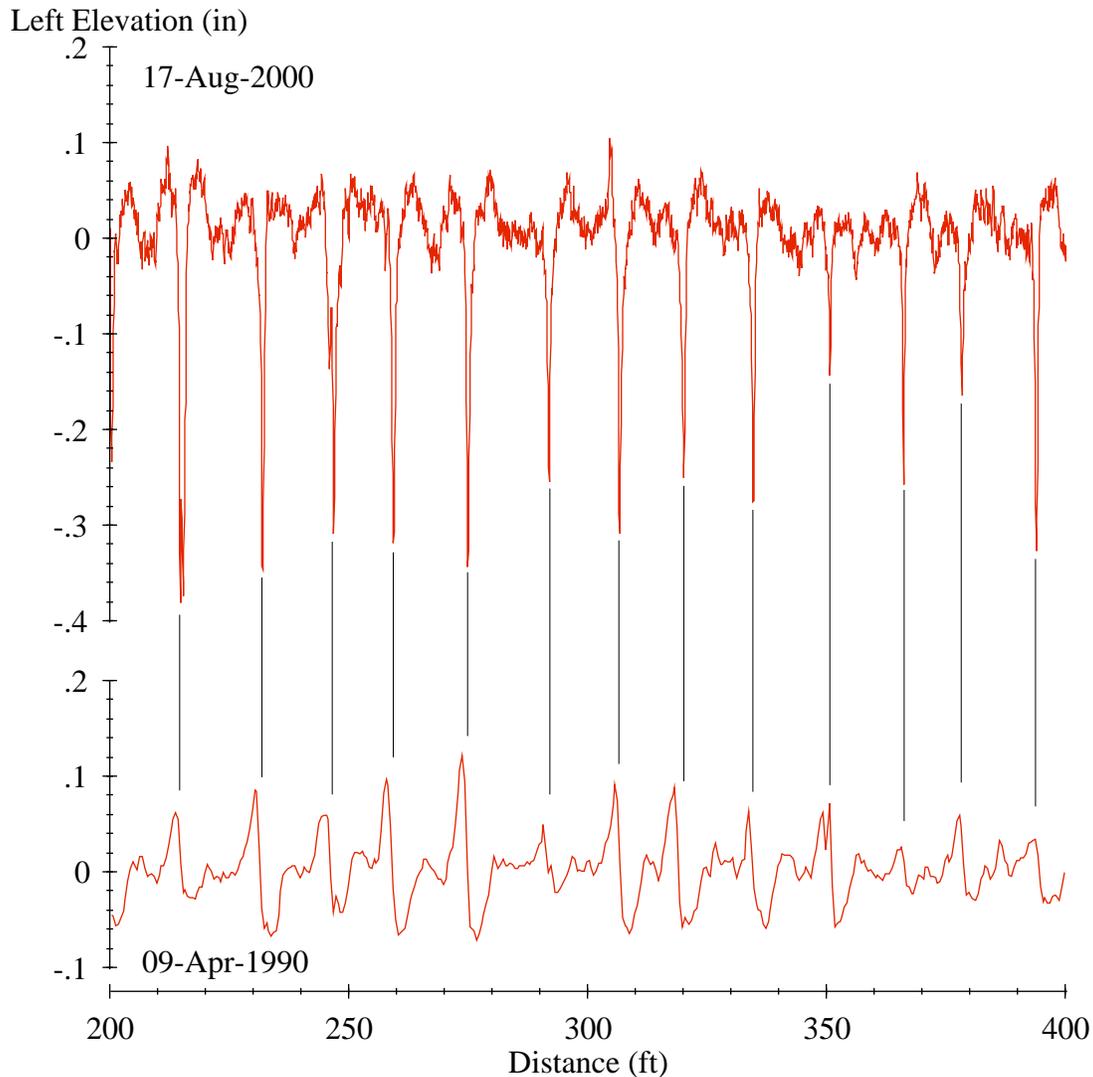
Figure 24. Joint and crack locations on section 0603.

Figure 24 shows that the narrow dips on section 0603 appear in the same pattern and in the same locations as the faults on the left side of the lane, which occurred in a pattern that approximated the original joint spacing of 15-13-15-17 ft. On the right side, not shown, the same pattern of faults before rehabilitation and narrow dips caused by transverse cracks late in the monitoring history is also present. However, the pattern is shifted about 1 ft downstream because of the skewed saw cuts. The synchronization process itself did not guarantee this alignment. Profiles collected before rehabilitation were only aligned to those afterward using data within section 0601 and extrapolation over the rest of the site.

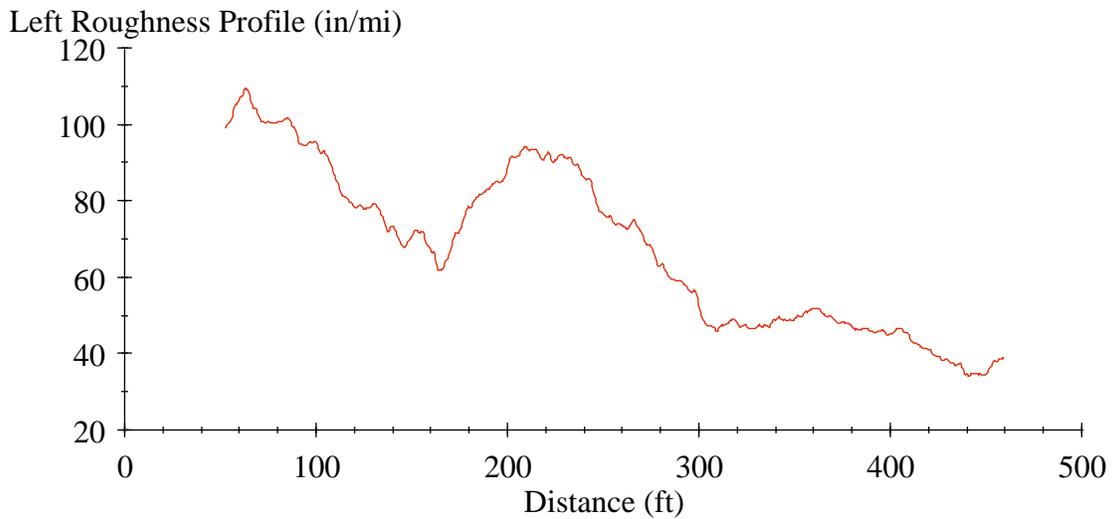
Figure 25. Roughness profile of section 0660, 100-ft base length.

The profile featured in Figure 25 was measured shortly after rehabilitation, and it represents the status of the section just after rehabilitation. The construction process itself caused the roughness in the first half of the section. Figure 26 shows the elevation profile that corresponds to Figure 25 after application of an anti-smoothing moving average filter with a base length of 100 ft. The figure shows that some very long duration features cause the roughness. The “long dip” running 30 to 90 ft from the start of the section deteriorated over time, and eventually became so rough by growing in depth that a skin patch was placed over it.

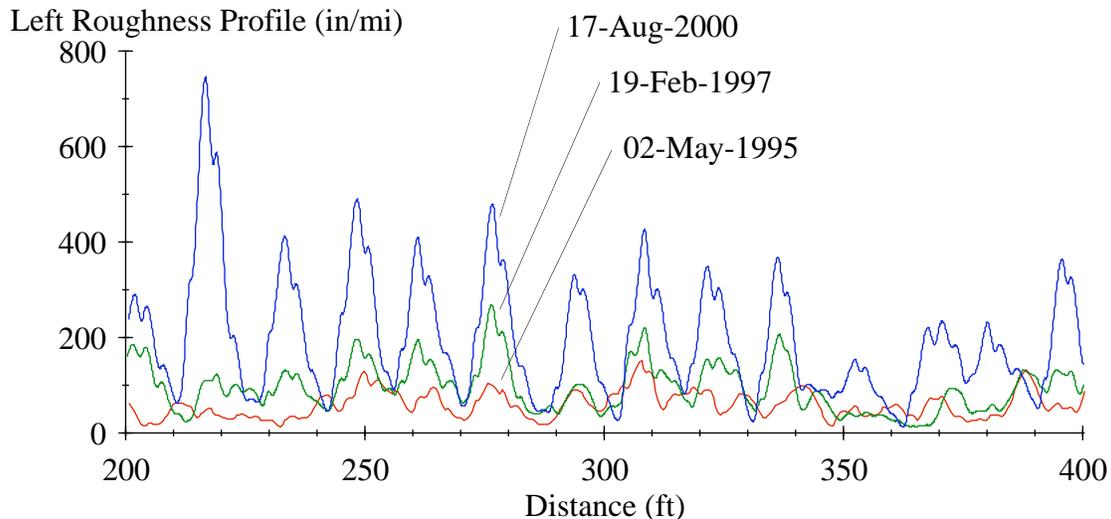
Figure 27. Roughness profiles of section 0603, 5-ft base length.

Figure 27 shows how a roughness profile can help find localized roughness and quantify its impact on the overall roughness of a section. The figure shows the roughness profile of section 0603 for the three most recent profiles shown in Figure 22. The plot was generated using a 5 ft base length, so each point shows the contribution to the IRI that has accumulated over 5 ft. With a 5 ft base length, isolated roughness is easy to identify. For example, many of the dips highlighted in Figure 24 produced peak values over 400 in/mi in Figure 27. Since these peaks correspond to roughness over 1 percent of the section length, they each account for over 4 in/mi of the overall IRI of the section.

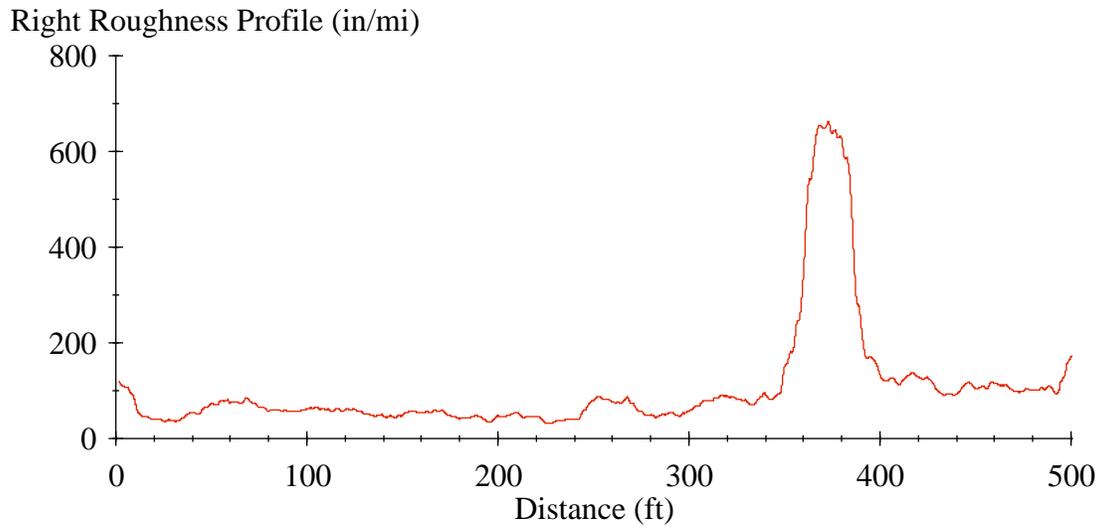
Figure 28. Right roughness profile of section 0661 in August 2000.

Figure 28 shows how a roughness profile can help find and quantify isolated roughness. The figure shows the right roughness profile of section 0661 from August 2000 using a 25 ft base length. With a 25 ft base length, the area of concern about 375 ft from the start of the section is easy to identify. The peak value there is about 678 in/mi, which is more than 575 in/mi above the prevailing roughness level surrounding it. This is a difference of 575 in/mi over 25 ft. Since that value represents the roughness over just one twentieth of the segment, it suggests that a rough feature here increased the overall IRI of the section by nearly 29 in/mi.

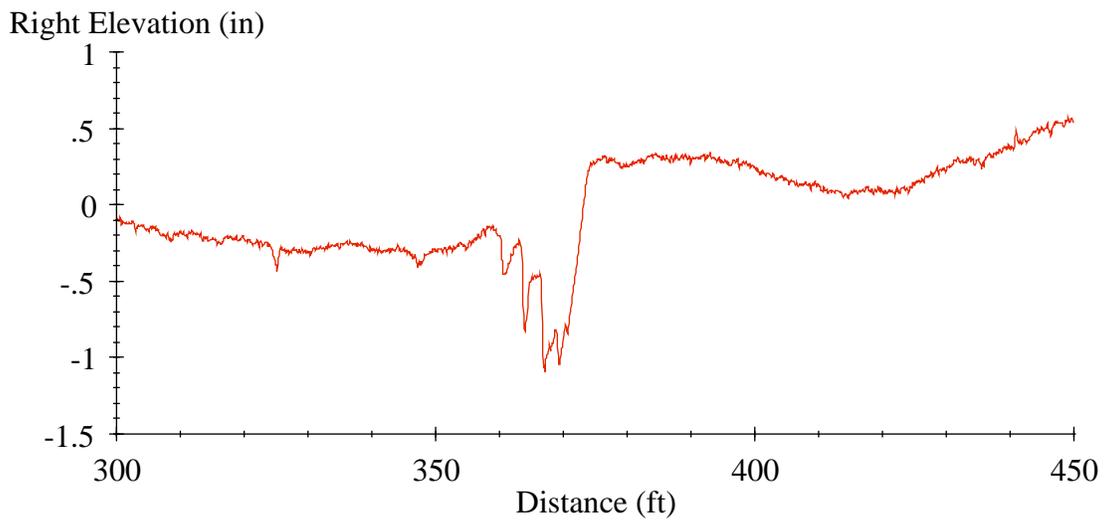
Figure 29. Right side profile of section 0661 in August 2000.

Figure 29 shows the elevation profile that produced the roughness profile of Figure 28, and Figure 30 provides a photo of the distress that caused the disturbance. As shown, the profile includes a significant dip, and significant disturbances within the dip. Figure 30 illustrates that significant localized fatigue is present between the fog line and about 5 ft into the section from the right side. This fatigue cracking developed in the winter/spring of 1999/2000, and is consistent with a “soft spot” in the pavement structure, possibly caused by excessive water buildup in the unbound layers. Many of the fines have pumped up to the pavement surface and are visible in Figure 30.

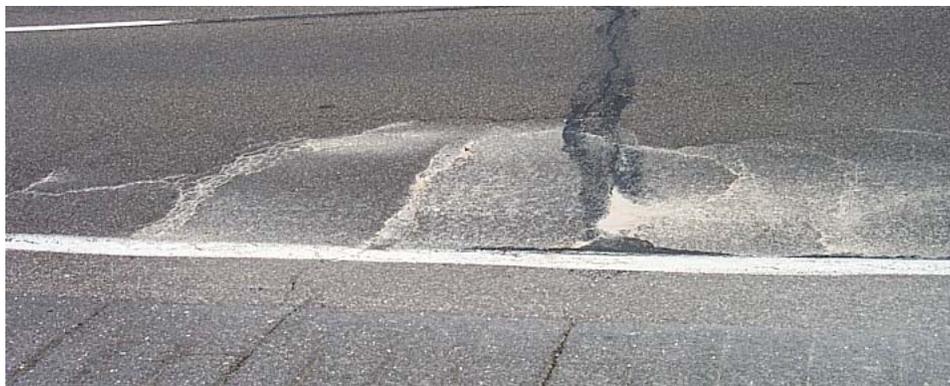
Figure 30. A fatigued area with pumping on section 0661 in august 2000.

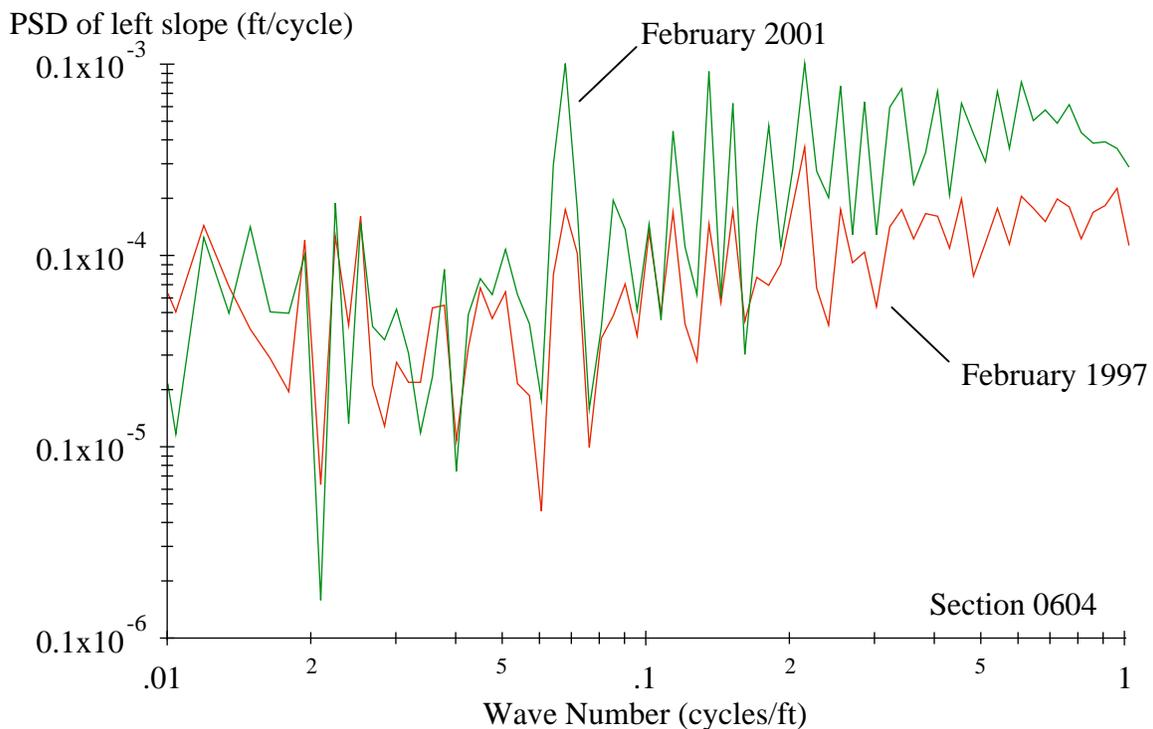
Figure 31. PSD of section 0604 profile, left side.

- The spectral content for wavelengths below 25 ft increased between visits. Roughness in this range progressed in every visit from 1997 through 2001.
- In both profile measurement visits, the trend in the PSD grew in content with decreasing wavelength (increasing wave number) for wavelengths below 10 ft. This should be interpreted cautiously, however, because a single anomalous reading in the elevation profile or a single severe narrow dip would appear on a PSD plot this way. Alternatively, it may indicate uniform growth in short wavelength roughness over the entire length of the profile. In this case, the growth was caused by narrow dips in the profile at saw cuts that were placed over the underlying PCC joints and grew rougher as the sealant deteriorated.

- The peak at about 0.067 cycles/ft indicates emerging periodic roughness concentrated at a wavelength of about 15 ft. This is present in the PSD because the enough transverse cracks (and associated dips) appeared to form a pattern with a spacing of roughly 15 ft. The narrow dips were present in both visits, but they were much more severe in February 2001.

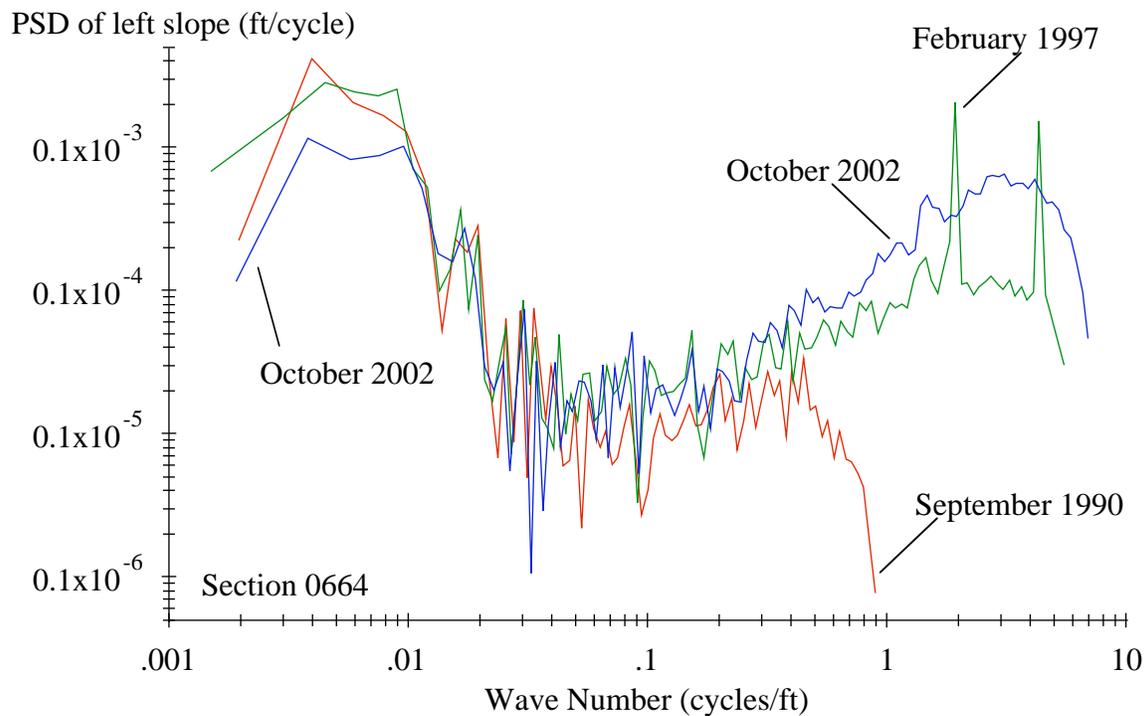
Figure 32. PSD of section 0664 profiles, left side.

- The spectral content for wave numbers between 0.01 and 0.25 cycles/ft (100 and 4 ft) is about the same in all three visits. This is the range that affects IRI most. (10)

- The spectral content differs for very long wavelengths (low wave numbers). This is not caused by a change in the true profile of the section. Rather, it is the result of the changes in profiler, and an associated change in the high-pass filtering methods. (6) In particular, the content below a wave number of 0.01 cycles/ft is much lower in October 2002, after the transition from K.J. Law profilers to an ICC profiler.

- The spectral content in each trace decreases at short wavelengths (high wave numbers) near the end of the plotted range. This is an artifact of low-pass filtering applied at the time of the measurement, which is a combination of digital filtering and height sensor footprint. (10) Since each profiler stores data at a different interval, each profile applies a low-pass filter with a different cut-off value.

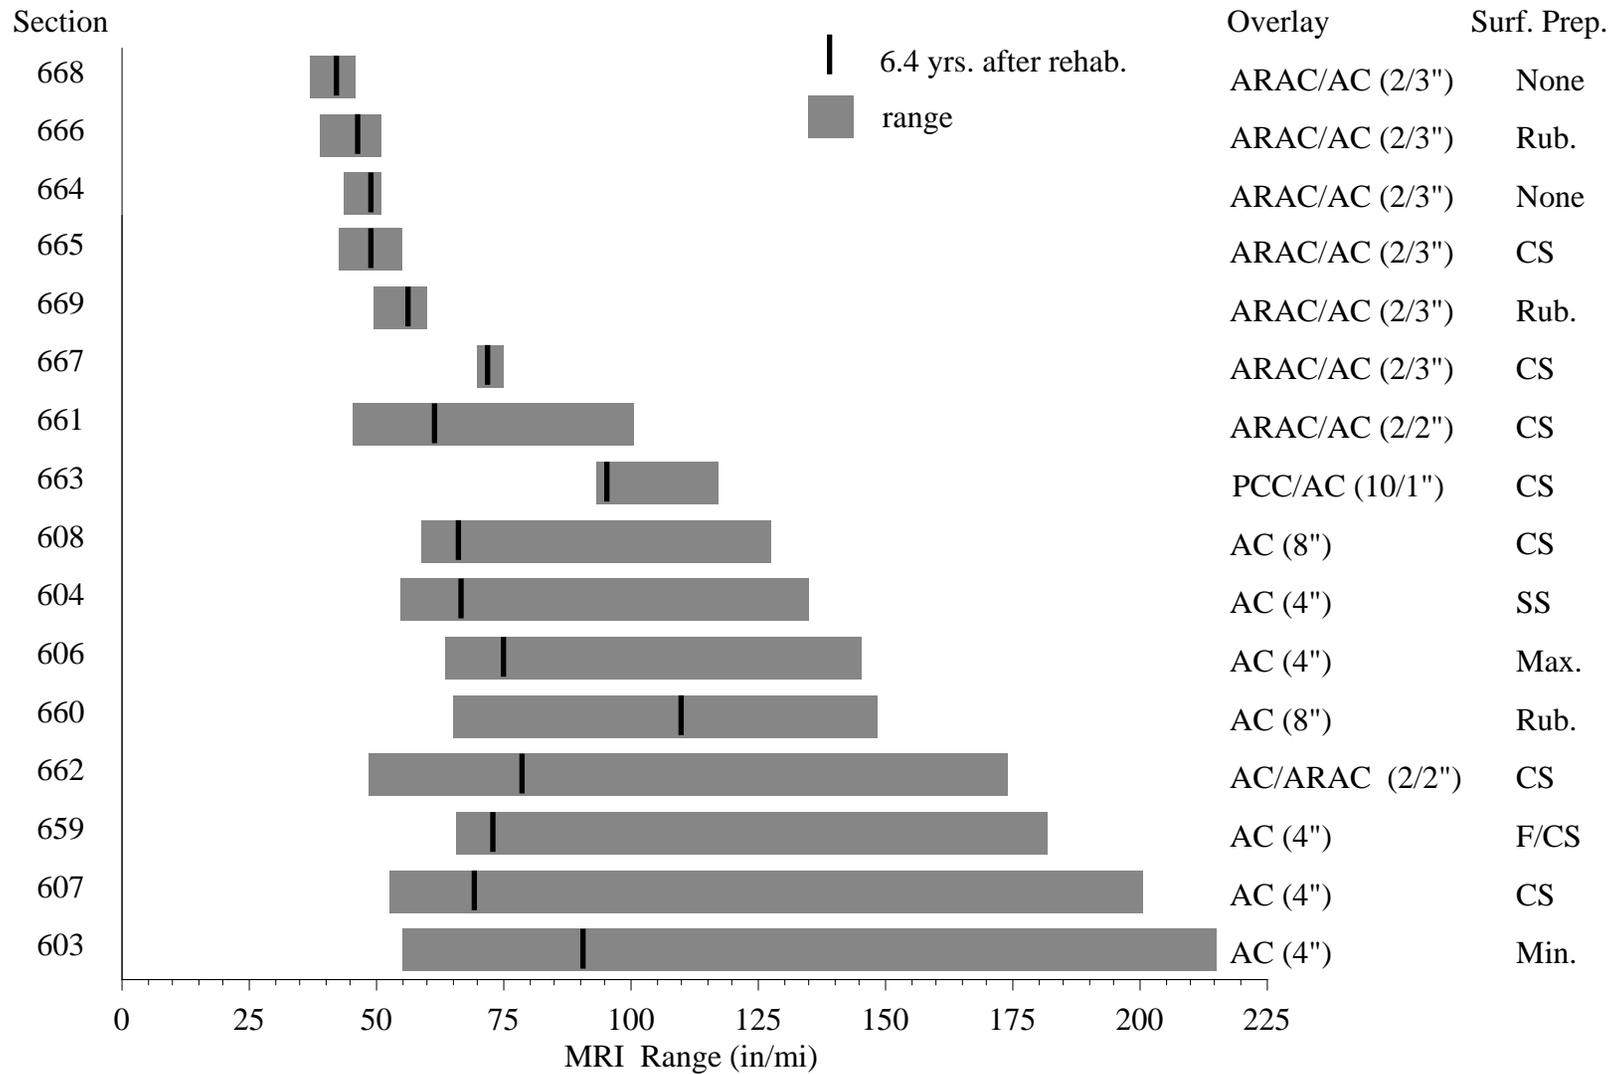
Figure 33. Roughness summary.

Figure 33 summarizes the roughness progression of all of the sections that received an overlay. The figure shows the entire range of MRI values observed in post-rehabilitation profile measurements with a gray bar. (Appendix A provides values for each visit.) The figure also provides markings at two landmark visits. First, the value 6.4 years after rehabilitation is marked to distinguish sections with high initial MRI or roughness that progressed early from those that may have held their roughness for several years before losing their functional performance. Second, the final value (12 years after rehabilitation) is also marked, and the test sections are sorted using this value in the figure.

- Disturbances at transverse cracks dominated the roughness on of the sections with a 4-in AC overlay (0603, 0604, 0606, 0607, 0659) by the end of the experiment. (These were reflective cracks in all of the sections except 0604, where the cracks were sawed and sealed.) However, they did not all perform equally.

- The saw and seal section (0604) and the section with maximum restoration (0606) finished the experiment with the lowest roughness, and the least amount of roughness at transverse cracks.
