[Docket No. 95-SW-33-AD; Amendment 39-9484; AD 96-01-08]

Airworthiness Directives; Bell Helicopter Textron, A Division of Textron Canada Ltd. Model 222, 222B, 222U, and 230 Helicopters

96-01-08 BELL HELICOPTER TEXTRON, A DIVISION OF TEXTRON CANADA LTD. :
Amendment 39-9484. Docket No. 95-SW-33-AD. Supersedes Priority Letter AD 95-23-02, issued November 3, 1995, Docket No. 95-SW-31-AD.

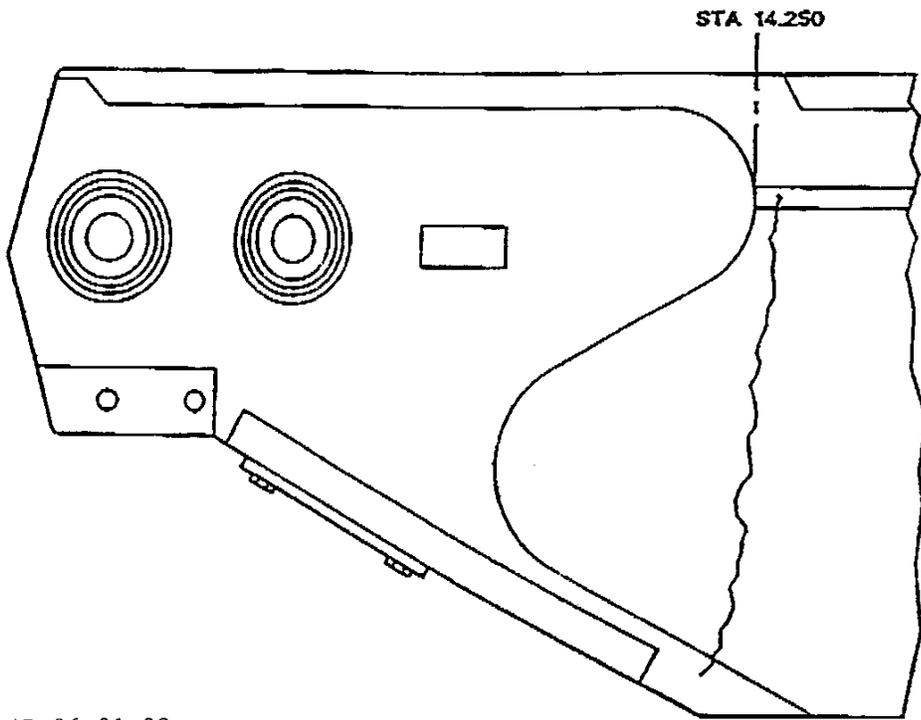
To prevent failure of a tail rotor blade (blade) due to a fatigue crack (see Figure 1), loss of the tail rotor and tail rotor gear box, and subsequent loss of control of the helicopter, accomplish the following:

FIGURE 1. SKIN CRACK IN TAIL ROTOR BLADE

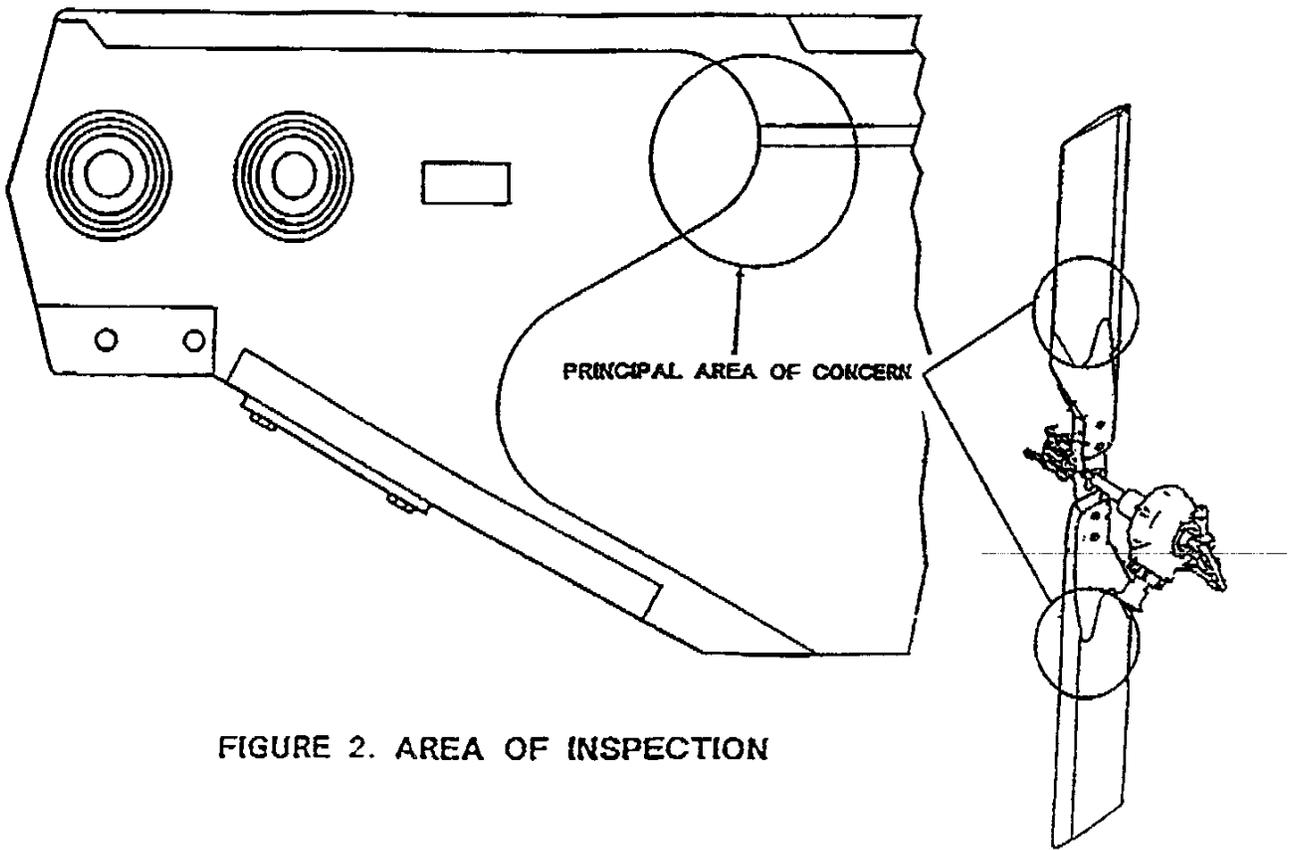
(a) Clean the painted surfaces of the blades in an area approximately 6 inches spanwise on either side of the doubler tip. Visually check both surfaces of each blade for cracks by pushing the blade tip away from the surface being checked until it contacts the flapping stop and then holding the blade firmly against the stop. Pay particular attention to the area reaching from the doubler tip to 1 inch outboard, centering on an area 2 inches aft of the blade leading edge (see Figure 2).

FIGURE 2. AREA OF INSPECTION

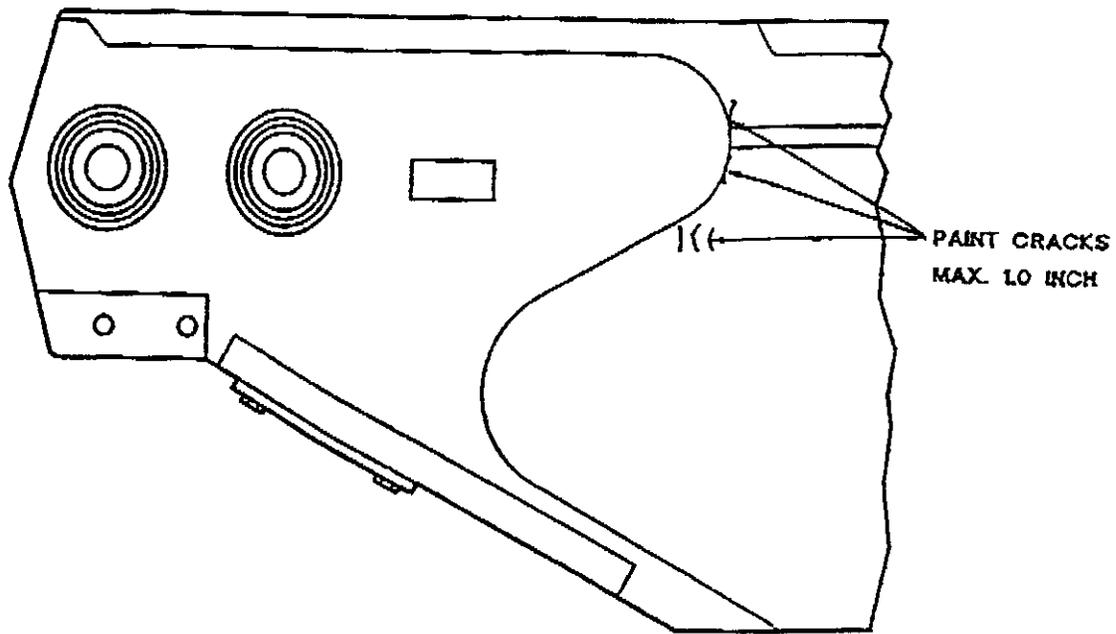
FIGURE 3.

(c) If the visual check described in paragraph (a) reveals any crack outboard of the doubler tip (Station 14.250), or any chordwise crack inboard of the doubler tip that is longer than 1 inch (see Figure 3), accomplish the following:

(2) If any crack is discovered, remove the blade and replace it with an airworthy blade.

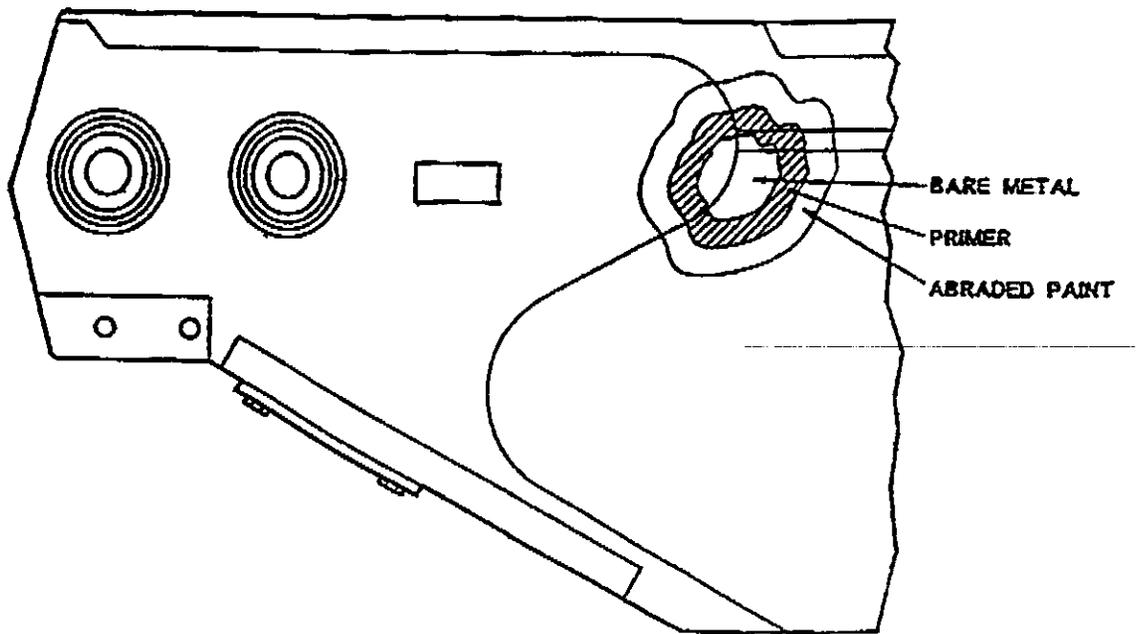
FIGURE 4.

(1) Remove the paint from the skin in the cracked area using the following procedures (see Figure 4):

(3) Using spanwise or circular sanding motions, continue hand-sanding the remaining greenish- or yellow-colored primer in the cracked area using a 320 or 400 grit paper until sufficient metal has been exposed to allow inspection (see area indicated in Figure 4).
