14 CFR Part 39 [61 FR 53046 NO. 198 10/10/96]

[Docket No. 96-SW-25-AD; Amendment 39-9779; AD 96-18-22]

Airworthiness Directives; Robinson Helicopter Company Model R44 Helicopters

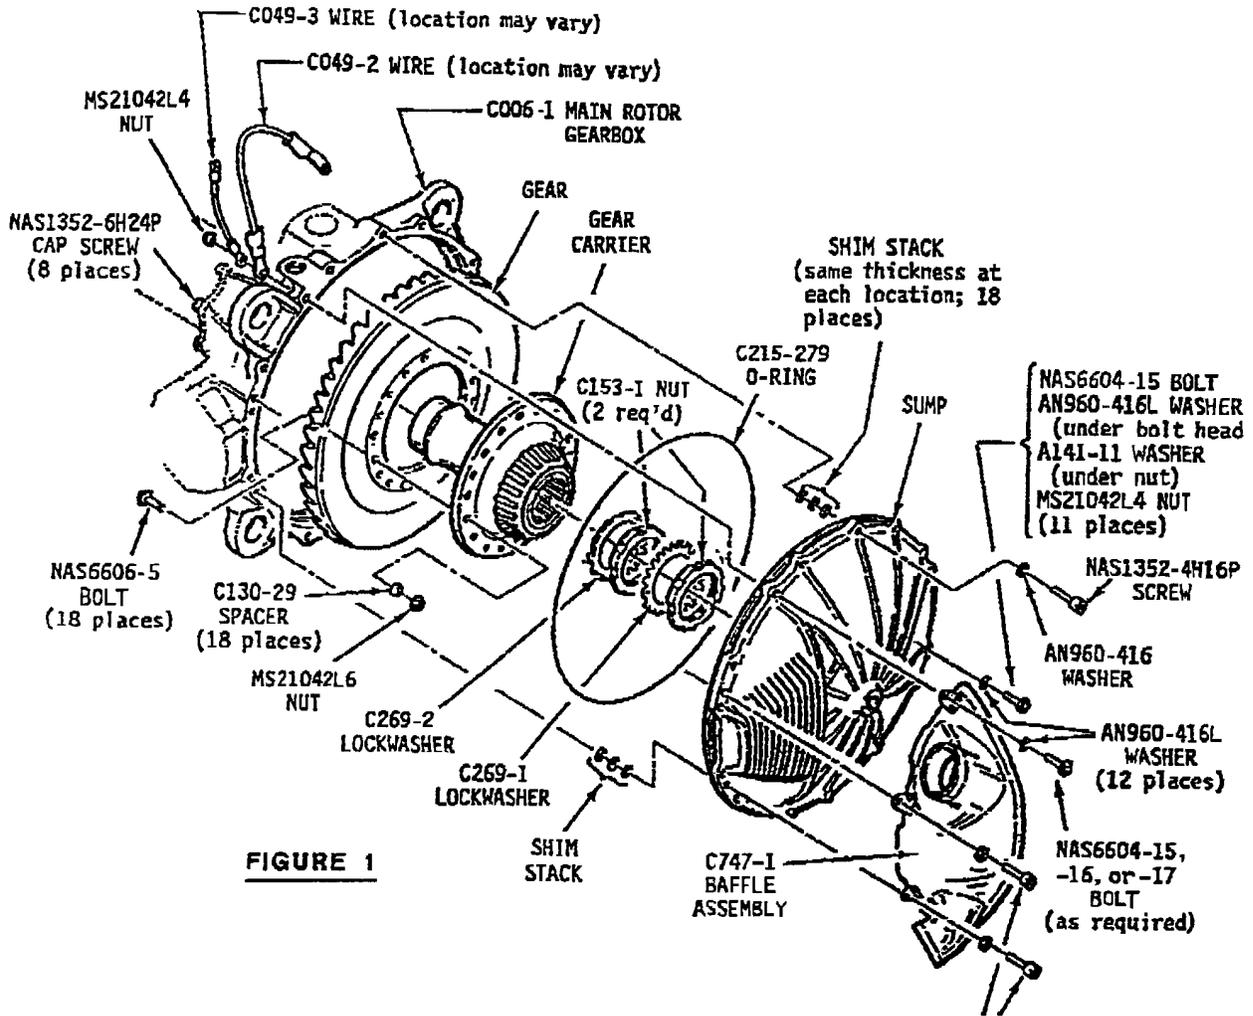
FIGURE 1

(b) Lay the gearbox on its side with input yoke up. Loosen the eight cap screws attaching the mast tube to the gearbox, but do not remove the screws. Remove the twelve bolts and six cap screws holding the sump and baffle in place (Figure 1). Note the location of ground wires.
