Testing and Recommended Practices to Improve Nurse Tank Safety, Phase I

U.S. Department of Transportation
Federal Motor Carrier Safety Administration

October 2013

1. Report No. FMCSA-RRR-13-032	2. Government Accession No.	3. Recipient's Catalog No.	
4. Title and Subtitle Testing and Recommended Practices to Improve Nurse Tank Safety, Phase I		5. Report Date October 2013

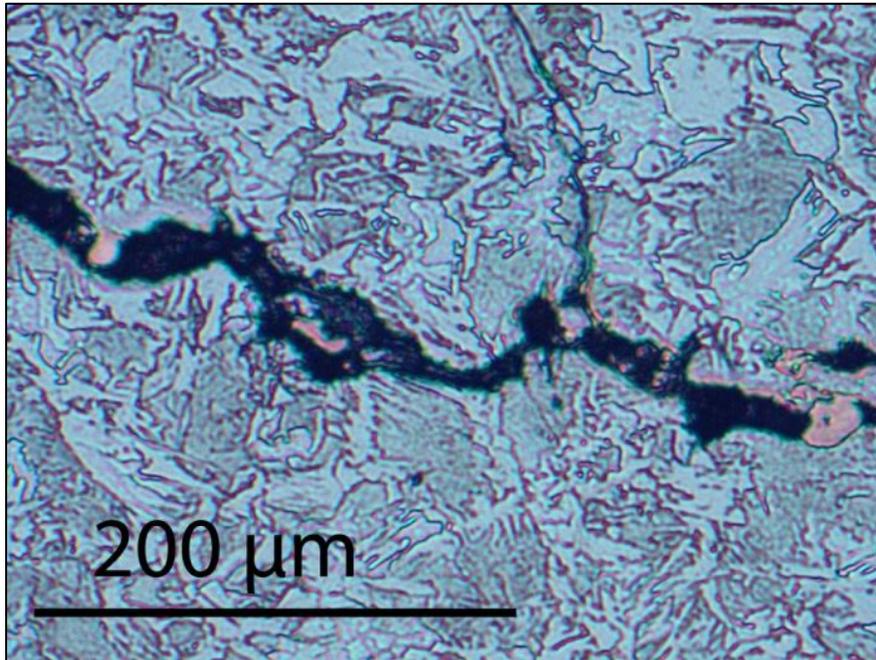
Figure 1. Photograph. Metallographic cross-section of tank wall steel containing a crack.

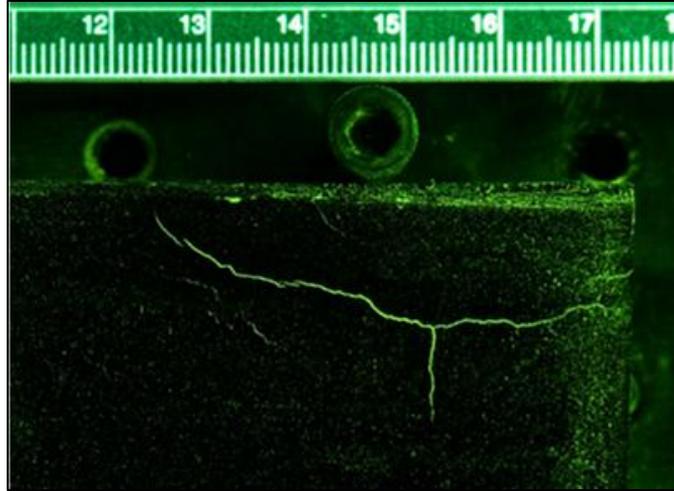
Once the tank interiors were accessible on the test specimen coupons, it was possible to use magnetic particle fluorescent dye penetrant testing to reveal cracks on the interior surface. This technique magnetizes the tank steel to attract magnetic powder particles to the edges of cracks; once there, the particles can be detected visually by shining an ultraviolet light onto the surface (Figure 4) to make the particles poised at the crack's edges fluoresce. This method provided a corroborating cross check on the accuracy of the angle-beam ultrasound inspection for cracks detected from the tank's exterior surface.

Figure 4. Photograph. One of several cracks made visible by ultraviolet-light-induced fluorescence of magnetic particles poised at the crack edges.

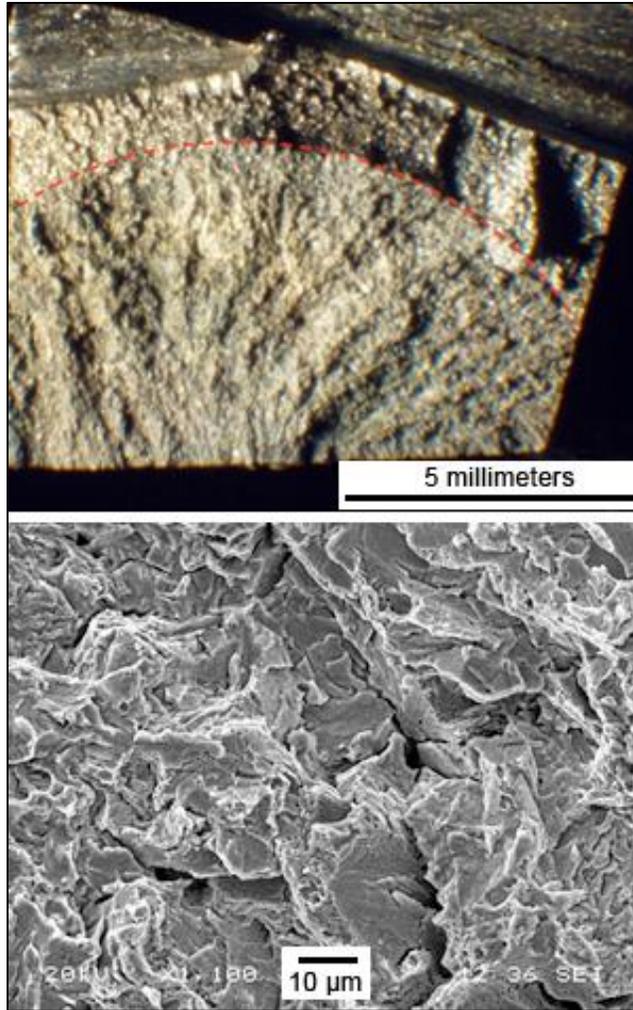
This allowed examination of the fracture surfaces in the SEM. The fracture surfaces showed the faceted surface (Figure 5) characteristic of the intergranular cracking that occurs with SCC.

Figure 5. Image. Photographs of a typical fracture surface in one of the tanks examined.

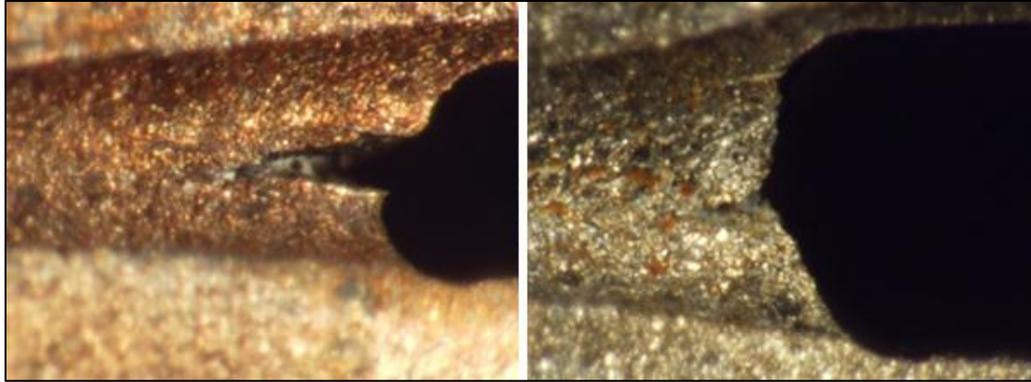
The data show only a loose correlation between stress intensity factor and crack size. This is typical of SCC data and reflects the stochastic (random) nature of SCC crack growth rates, which illustrates why significantly more data is needed. It also illustrates that it is possible for a particular crack to grow much faster than most other cracks, and thus establishes the importance of an inspection protocol to detect such cracks before they lead to rupture of the tank.

Figure 11. Image. Two cracks that initiated and grew during the stress corrosion cracking test.

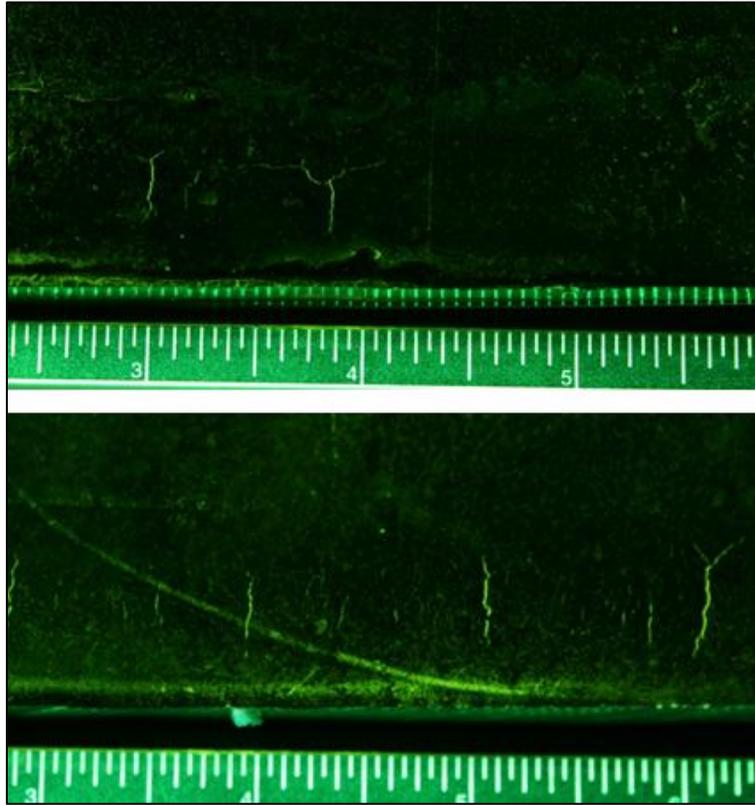
Figure 35. Image. Y-shaped cracks highlighted with florescent magnetic particles found on two tanks.

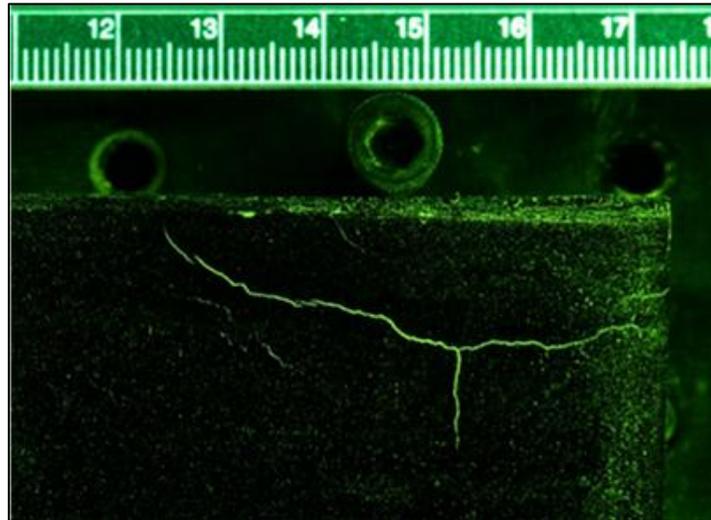
Figure 36. Photograph. Fluorescent wet magnetic particle testing of a segment of a crack in the head of the tank. The scale bar is in cm.

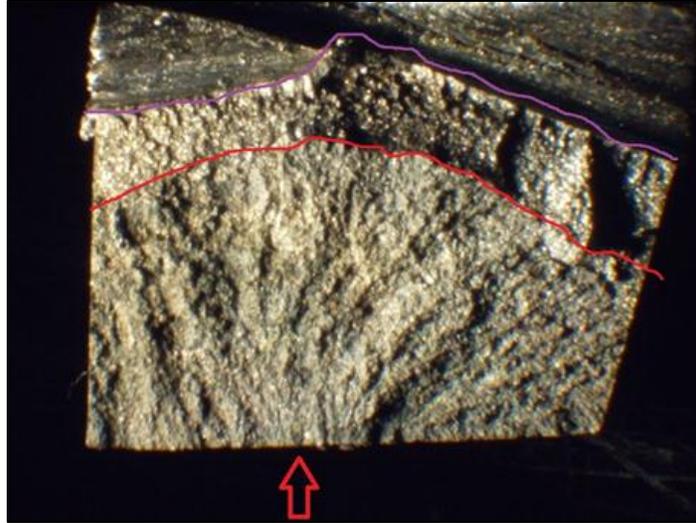
Figure 37. Image. The arrow indicates initiation of a crack on the interior of the tank head.

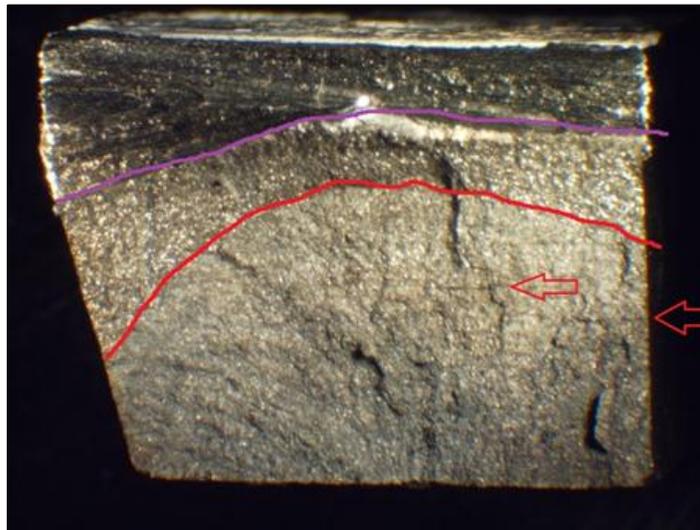
Figure 38. Image. Positioning the light source at a different angle revealed several horizontal lines visible in the cracked region of the sample, two of which are indicated by arrows.

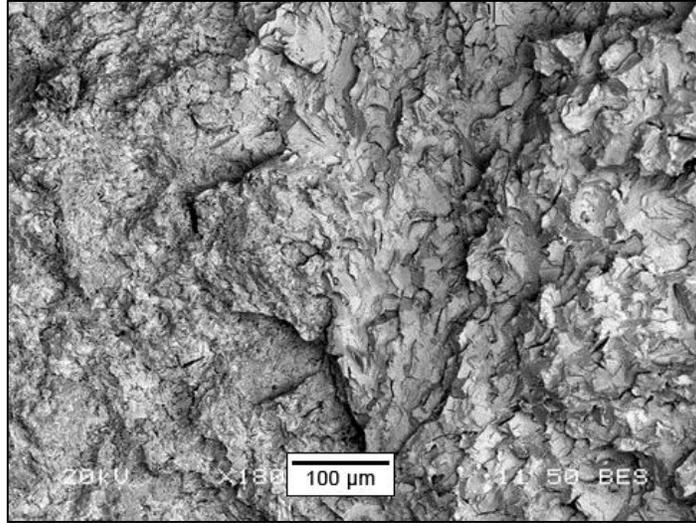
Figure 39. Image. Shadow image of surface before cleaning. The right side has no oxide and is clearly faceted due to cleavage fracture when the sample was subjected to an impact loading after cooling to liquid nitrogen temperatures.

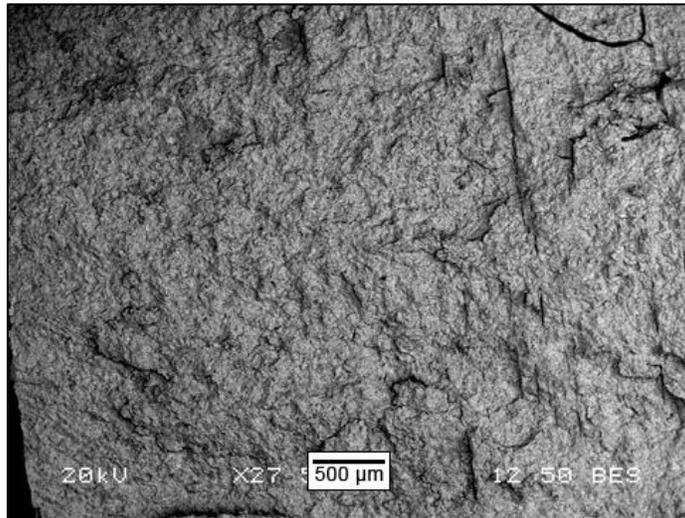
Figure 40. Image. Vertical cracks produced by backscattered electrons.

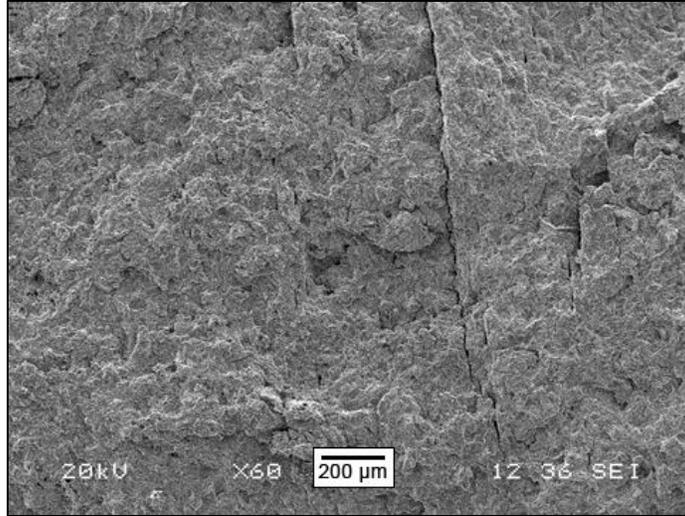
Figure 41. Image. Secondary electron image of vertical cracks.

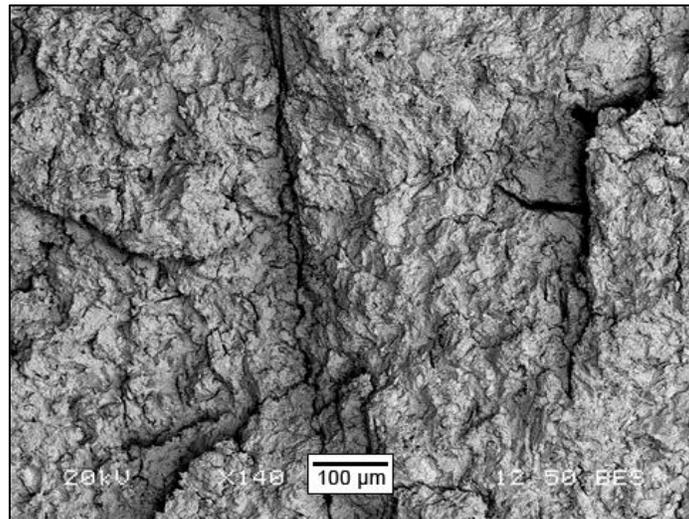
Figure 42. Image. Vertical cracks produced by backscattered electrons.

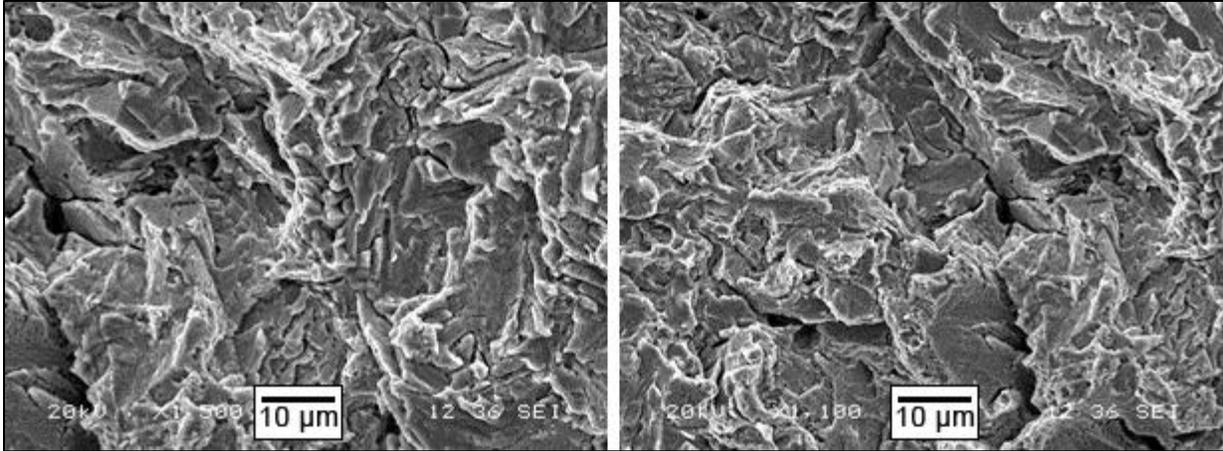
Figure 43. Image. After cleaning, the stress corrosion cracking region shows faceted regions indicating intergranular cracking.

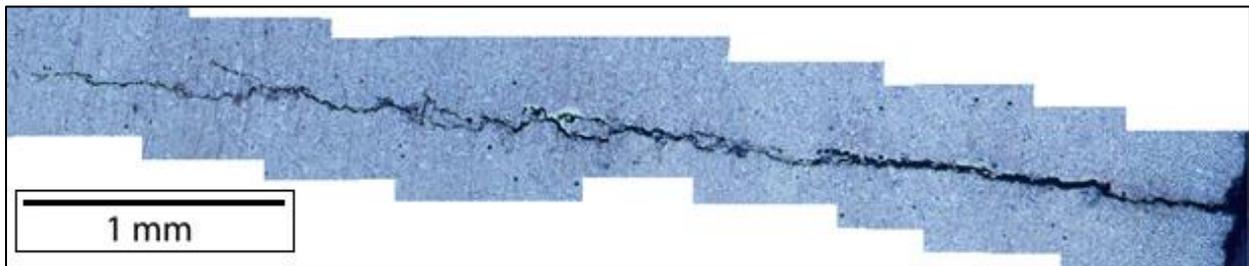
Figure 44. Photograph. Cross-section of a penny-sized crack located in a 1,450-gallon nurse tank head manufactured in 1977. The crack originated near the circumferential weld on the interior.

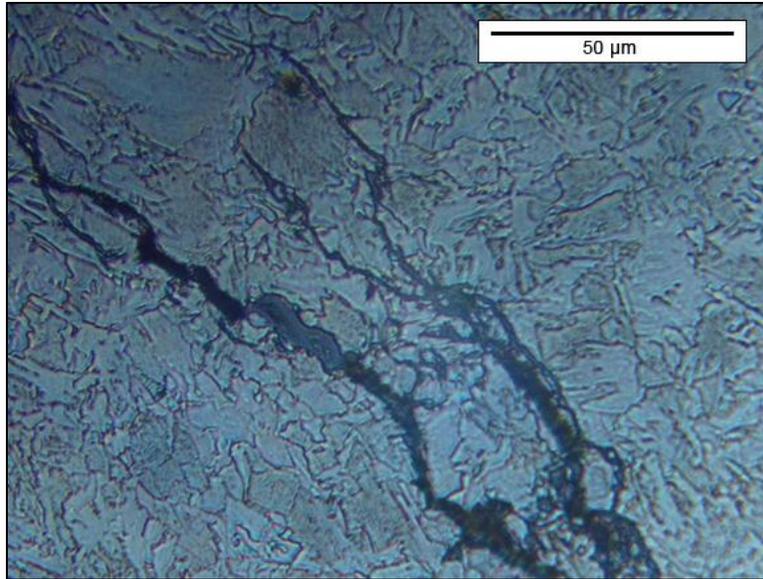
Figure 45. Image. Optical microscopy of the cracks indicates intergranular cracking as the crack path swings around grains.

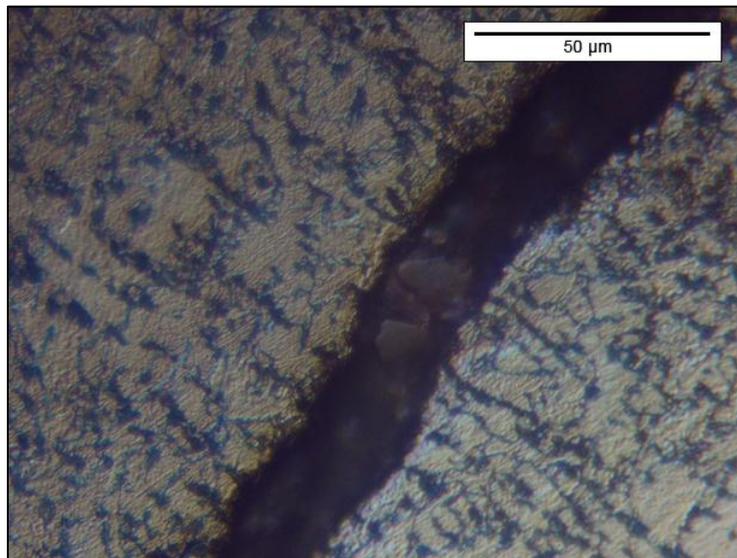
Figure 46. Image. At this point, the crack is larger than the surrounding grains, obscuring whether intergranular or transgranular cracking is occurring.

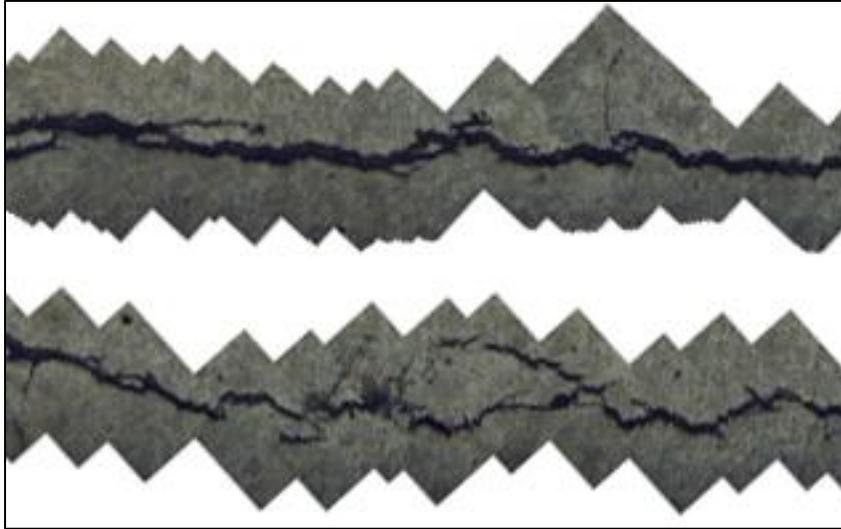
Figure 47. Image. The crack branching is clearly seen in these micrographs.

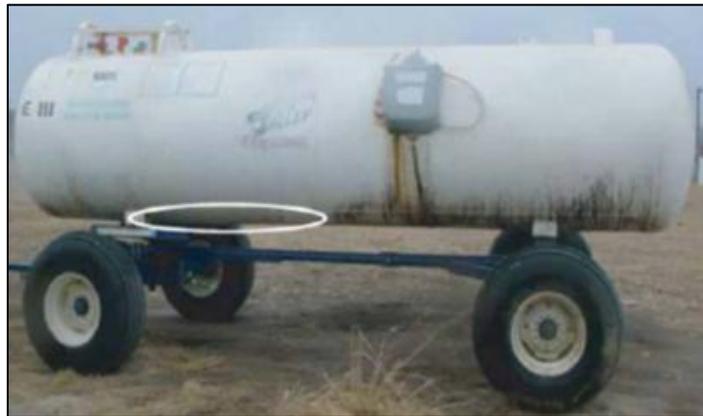
Figure 85. Photograph. Calamus nurse tank post-accident. The white oval indicates the location of the ruptured seam.

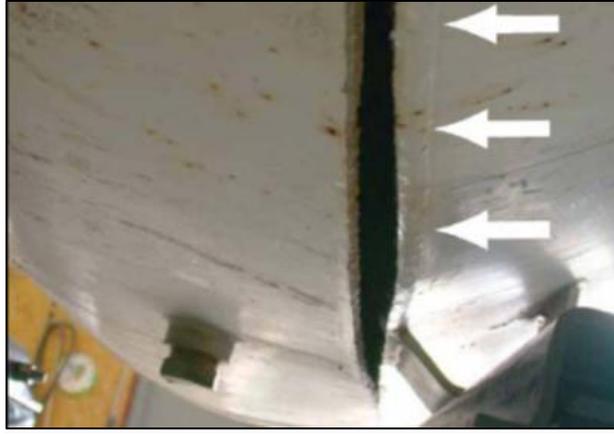
Figure 86. Photograph. Close-up picture of the ruptured seam circled in Figure 128.

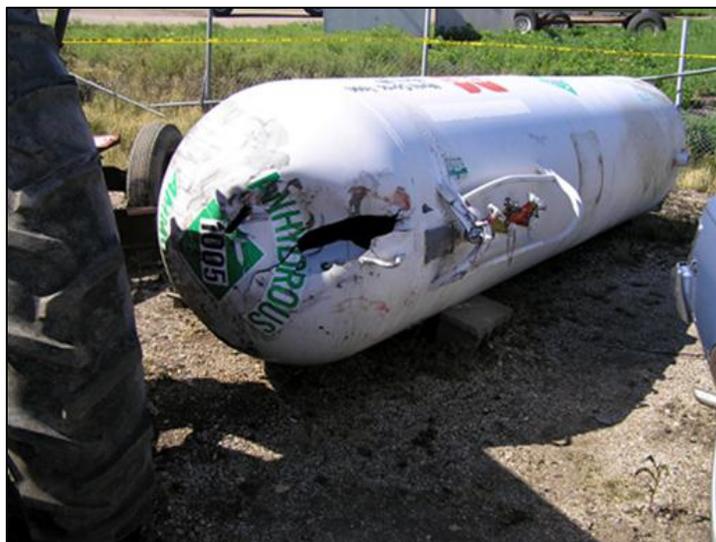
Figure 87. Photograph. Front end of Cenex vessel showing impact damage.

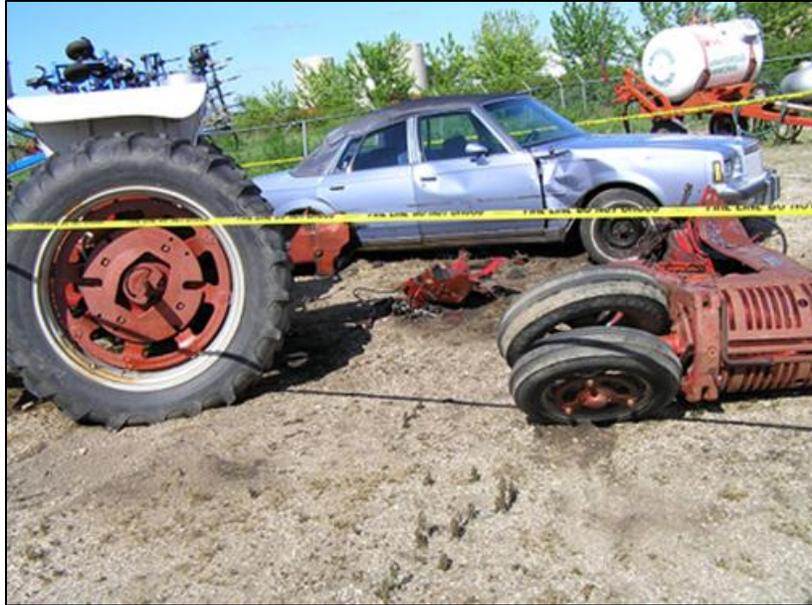
Figure 88. Photograph. Severed tractor and automobile damage caused by the propelled nurse tank.

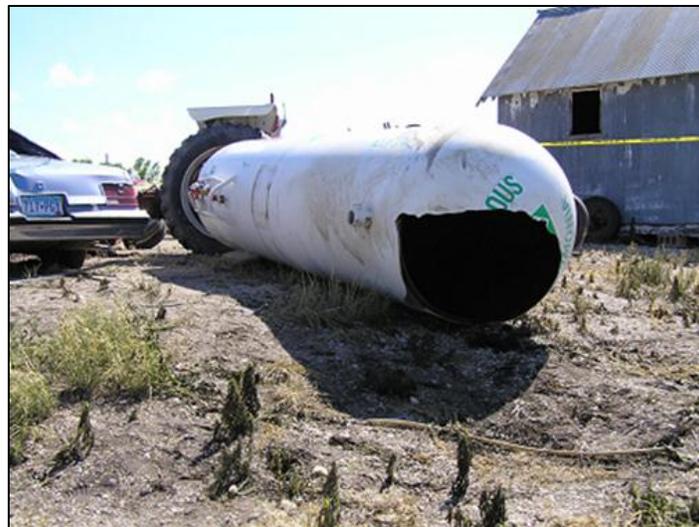
Figure 89. Photograph. Blown-out rear end of nurse tank.

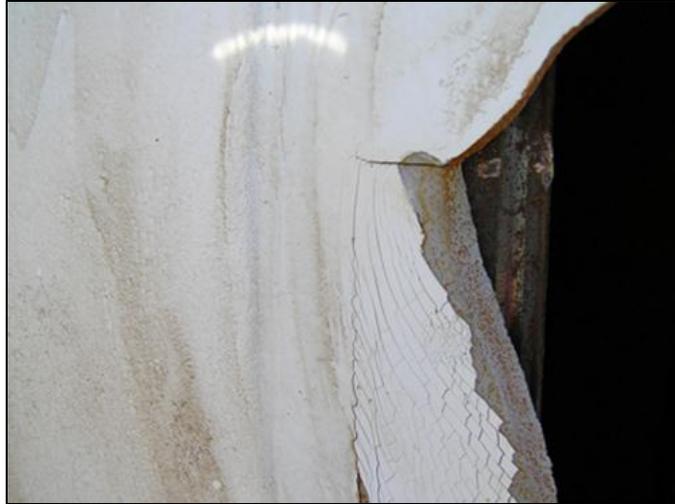
Figure 90. Photograph. Point of vessel where the fracture meets the circumferential weld.

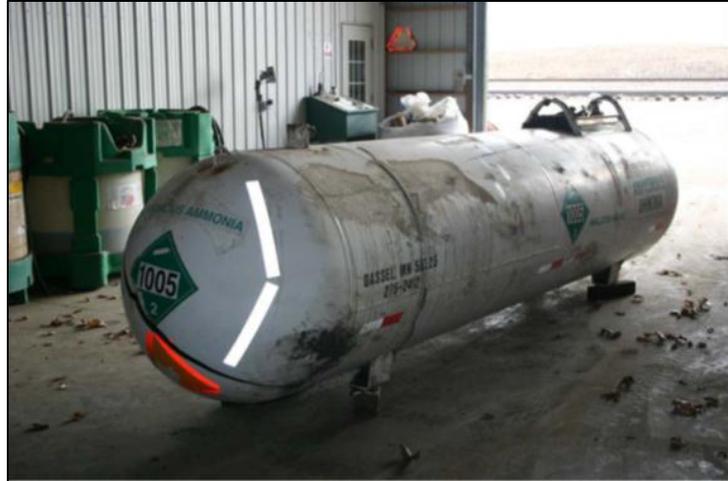
Figure 91. Photograph. Silver Lake nurse tank post-accident.

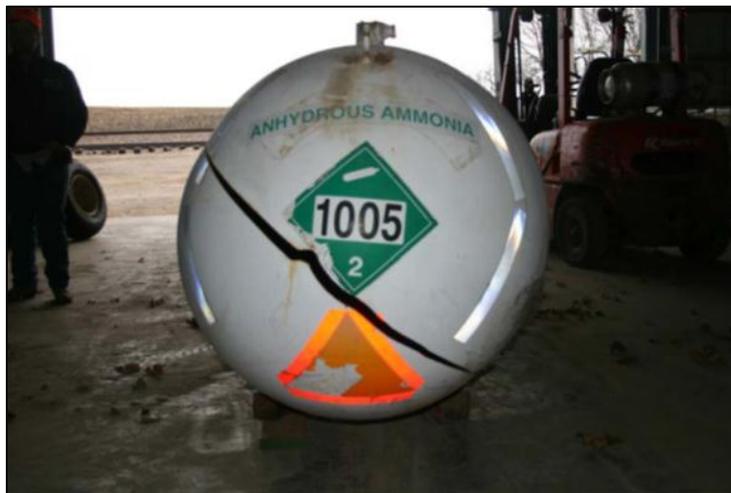
Figure 92. Photograph. Ruptured tank head.

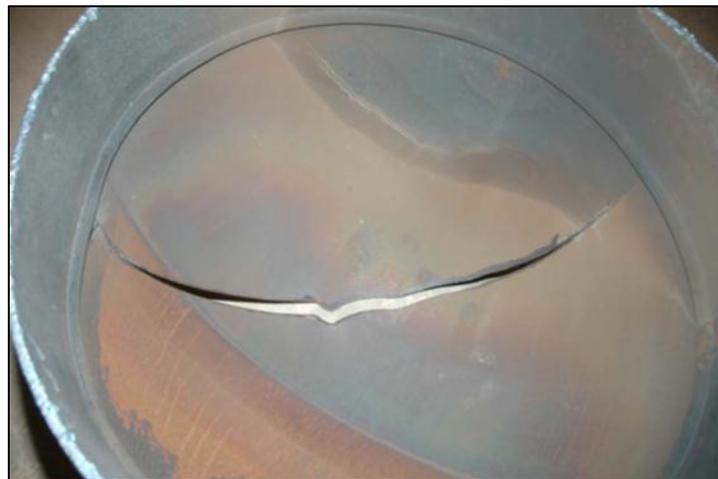
Figure 93. Photograph. Inside view of the ruptured tank head.

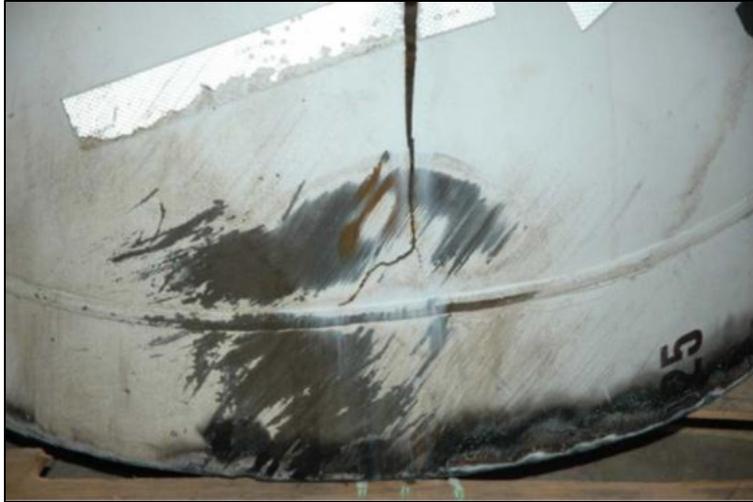
Figure 94. Photograph. Crack initiation site.

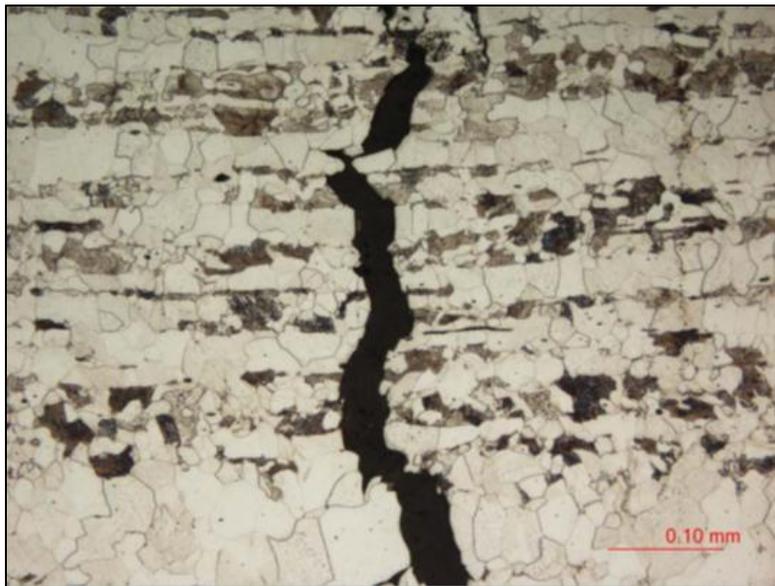
Figure 95. Image. Ferrite/pearlite microstructure at crack initiation site, 200 x magnification. Both transgranular and intergranular fractures are observed.

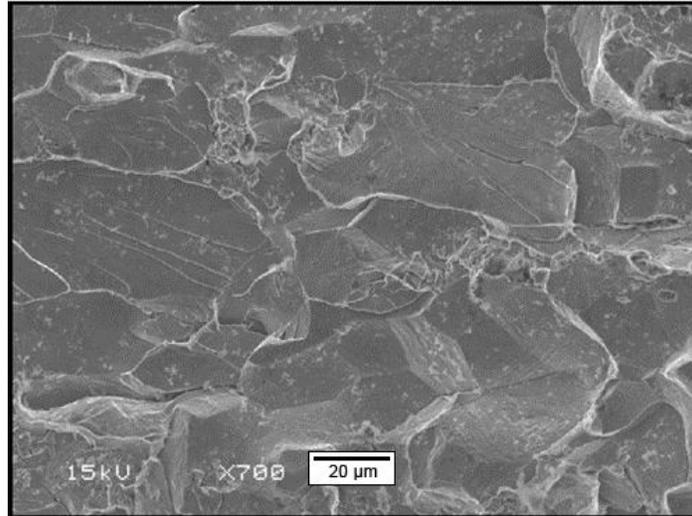
Figure 96. Image. SEM image of fracture surface showing transgranular and intergranular fractures.

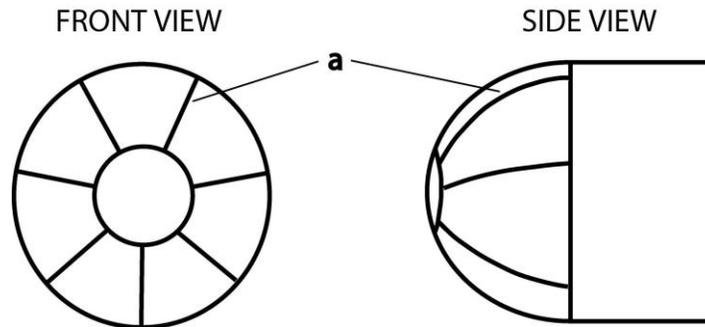
Figure 97. Diagram. Schematic of observed crack locations. The letter “a” denotes the location of a through-wall crack. Lines represent weld seams.

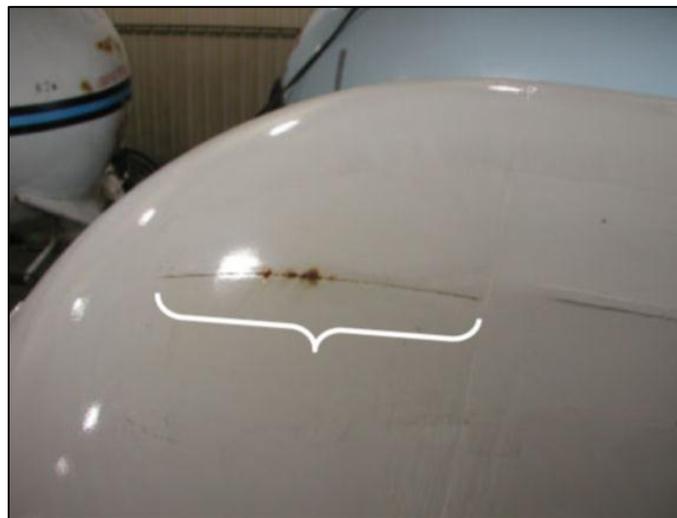
Figure 98. Photograph. Through-wall crack in head.

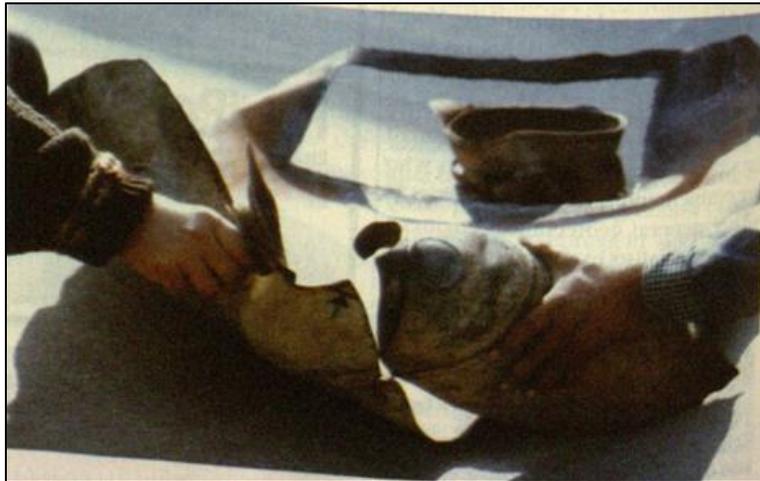
Figure 99. Photograph. Pieces of LAG cylinder post-explosion.

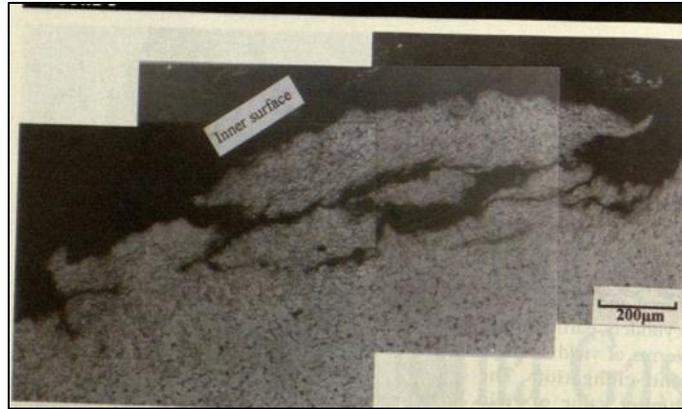
Figure 100. Photograph. Rupture initiation site showing severe cracking.

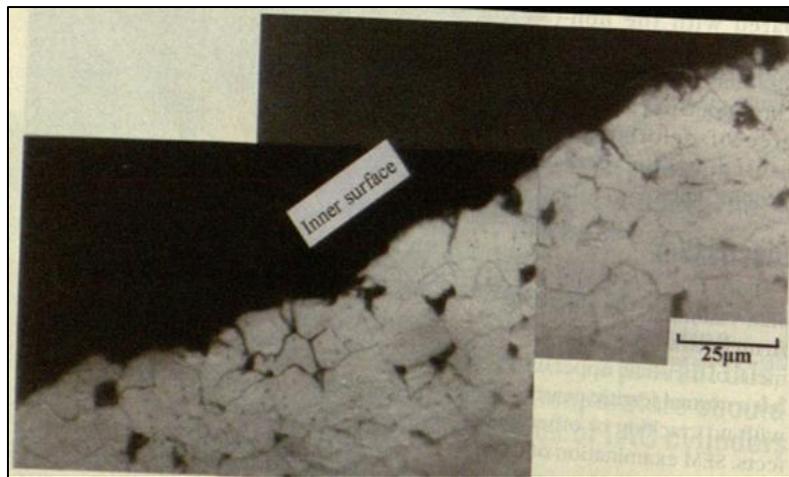
Figure 101. Photograph. Grain boundary microcracks at the crack initiation site.

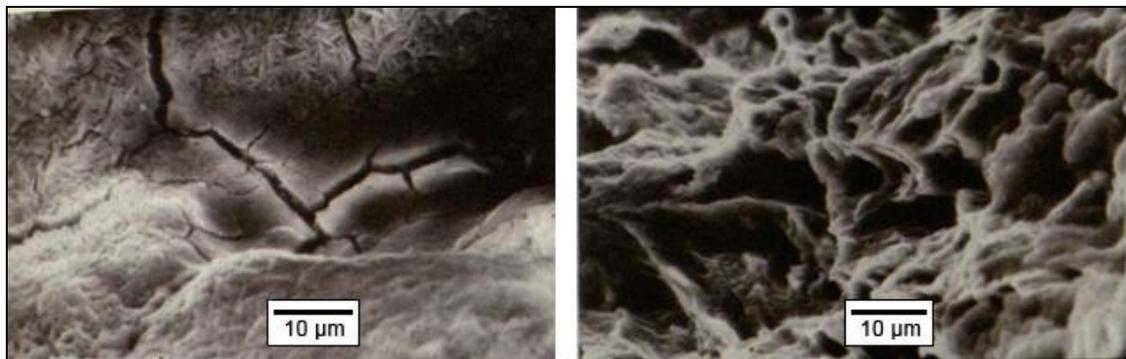
Figure 102. Grouped Image. SEM of fracture site showing grain boundary microcracks (left) and SEM showing the dimpled morphology of the fracture region (right).
