Uncontrolled Concrete Bridge Parapet Cracking

State Job Number *134602*

June 2013

FINAL REPORT

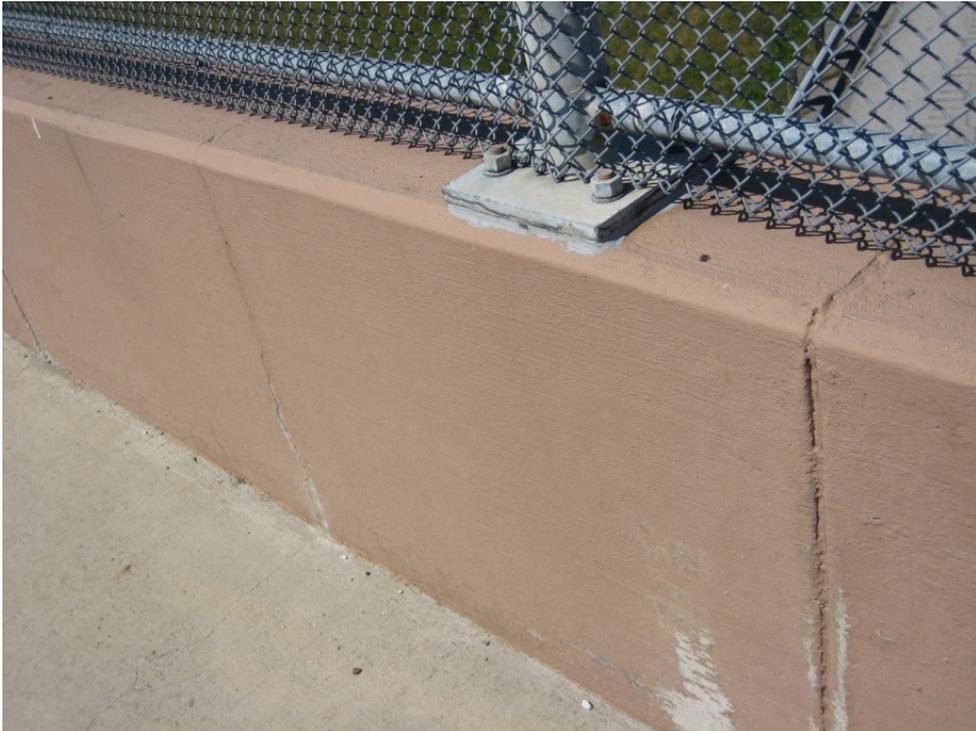
Figure 9: Vertical crack midway between control joints, Canterbury Road

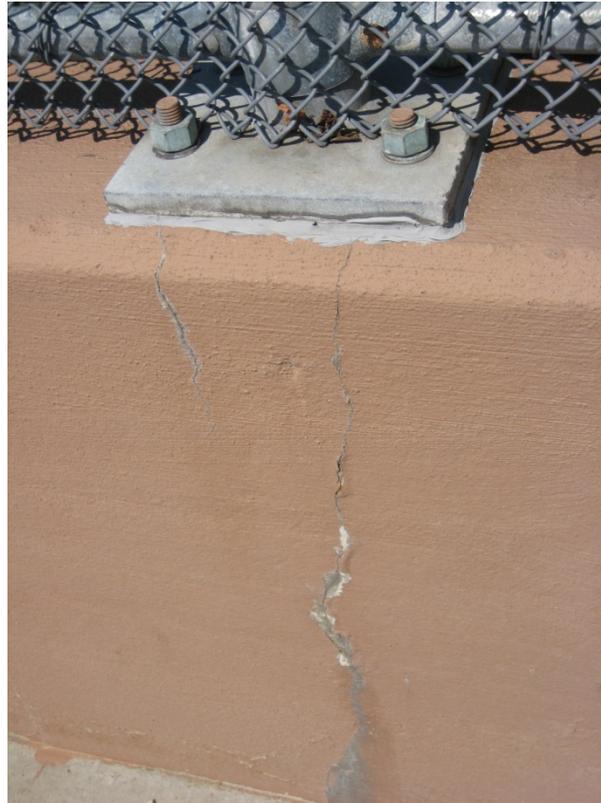
Figure 10: Crack below VPF base plate, Canterbury Road

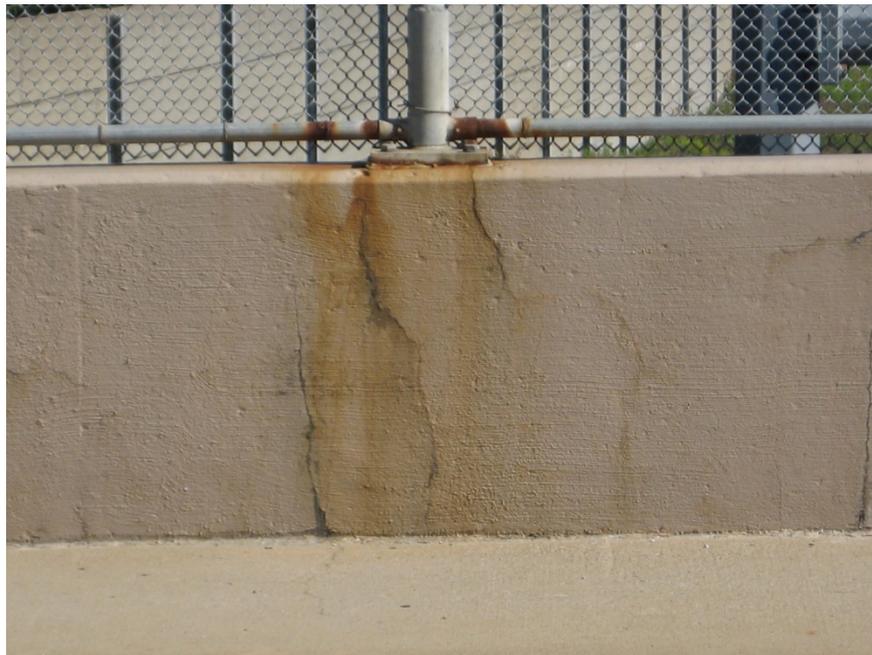
Figure 11: Crack below VPF base plate, Sheldon Road

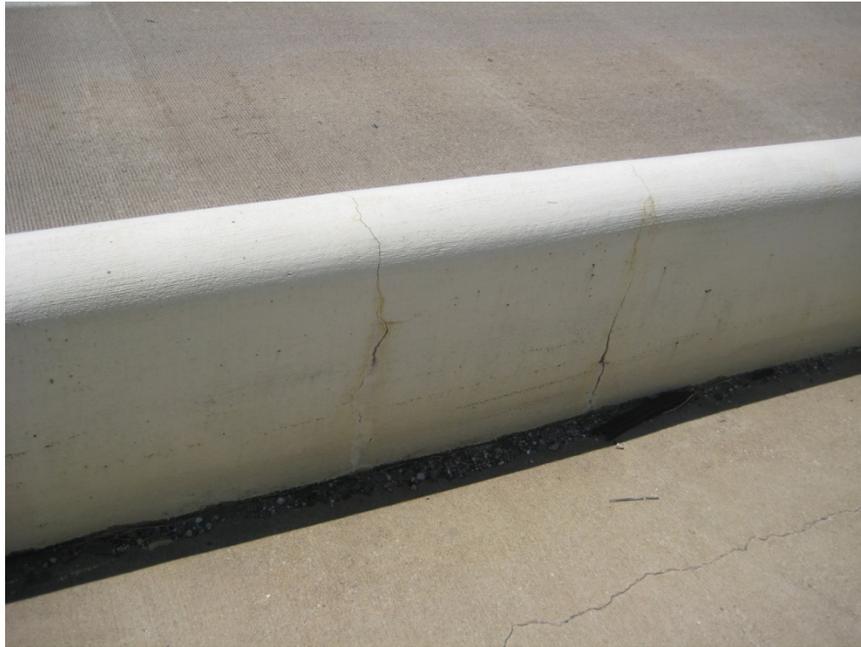
Figure 12: Vertical cracks on inner parapet midway between control joints, Spring Road

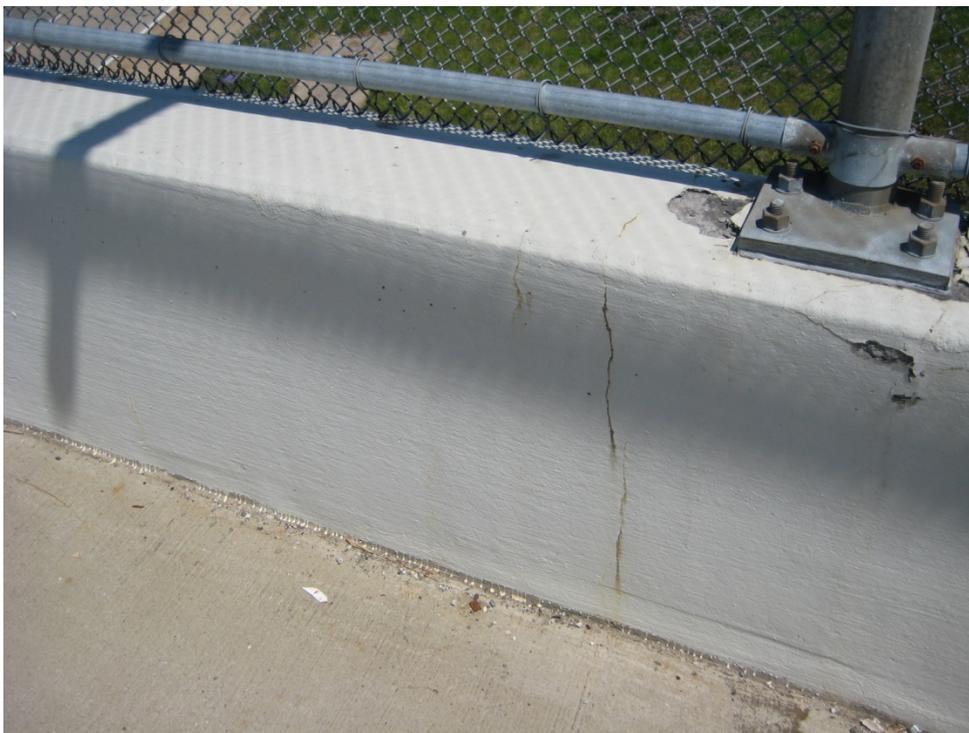
Figure 13: Cracking and flaking below VPF base plate, Spring Road

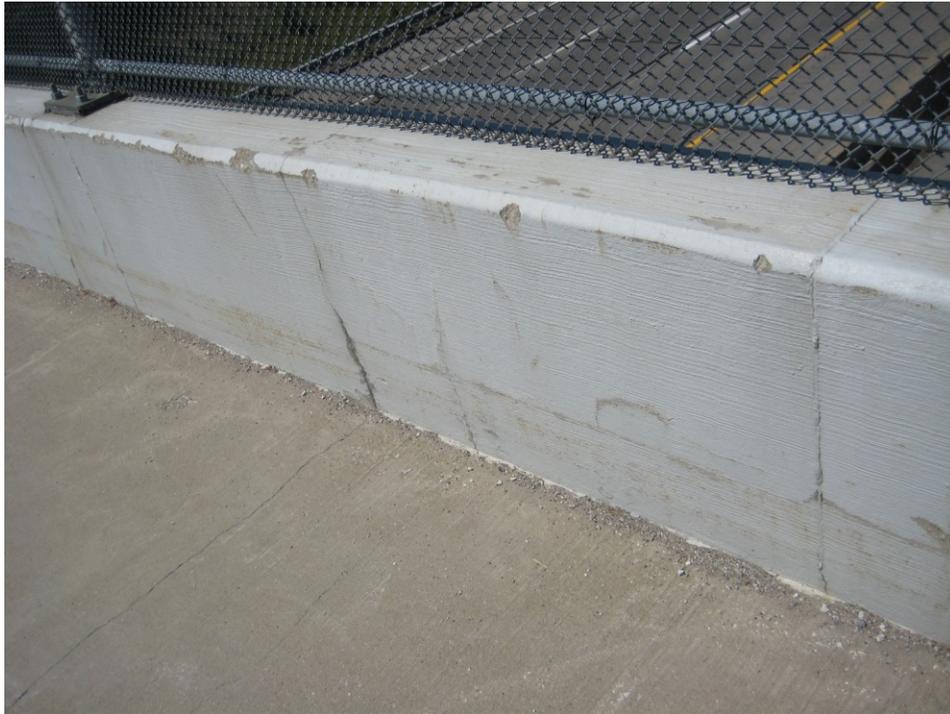
Figure 14: Vertical crack midway between control joints, Wagar Road

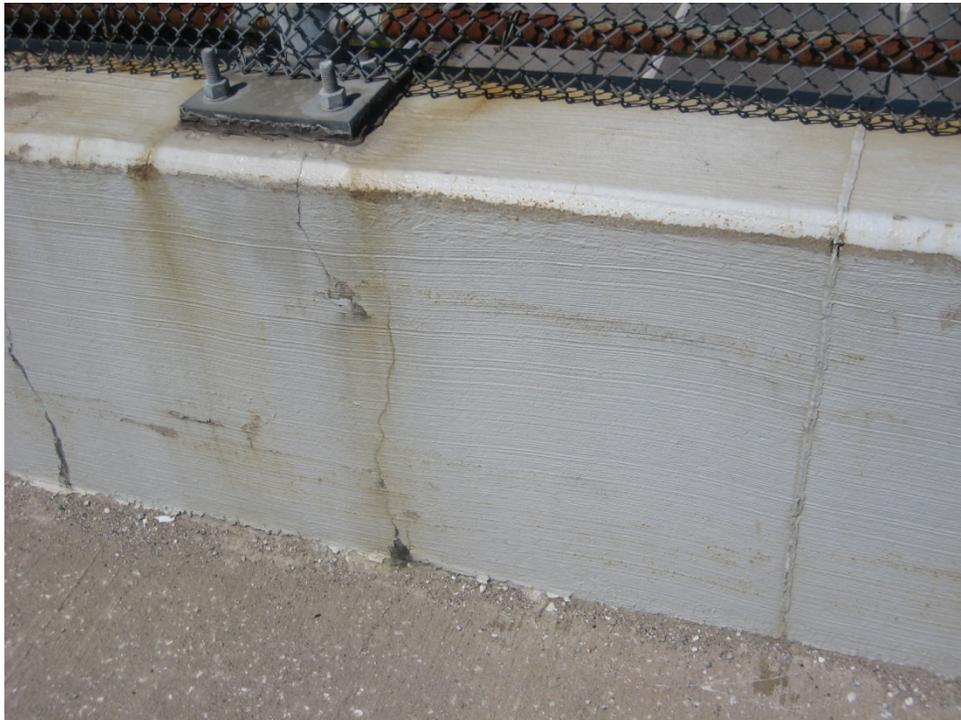
Figure 15: Crack below VPF base plate, Wagar Road

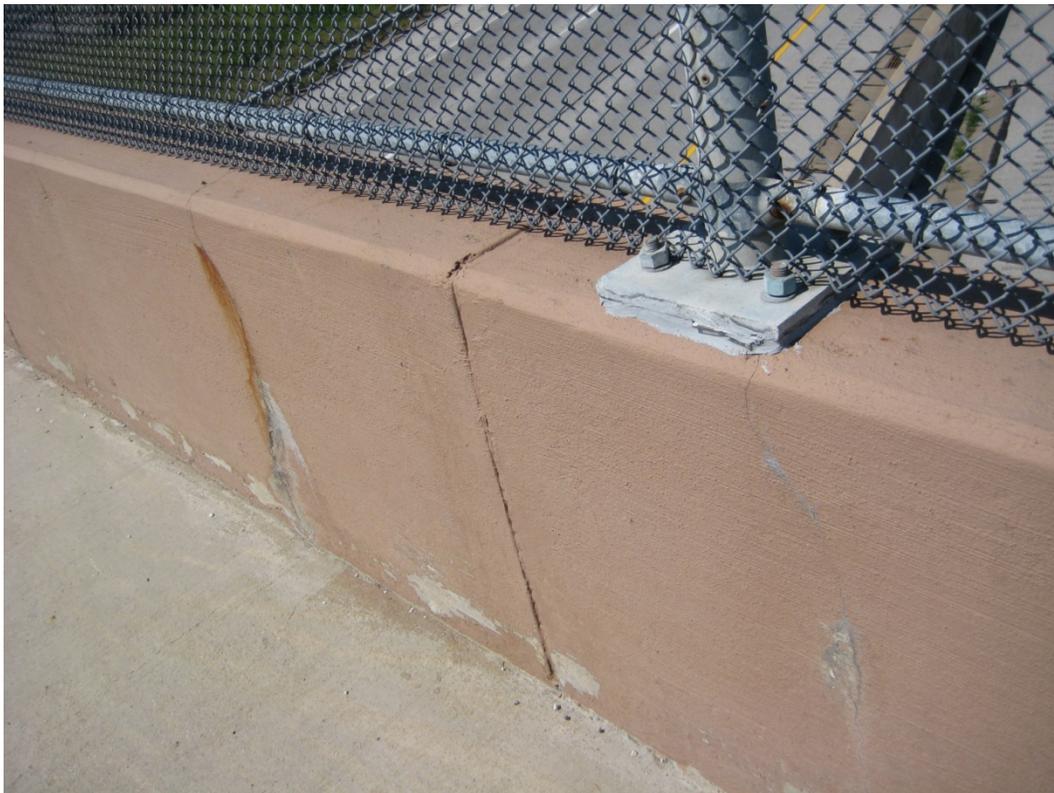
Another major observation is that many of the control joints in the parapets are improperly or poorly constructed. Specifications typically call for a ¼ inch (6 mm) wide, 1 ¼ inch (32 mm) deep sawcut joint, spaced in the range of six to ten feet (1.8 to 3.0 m). The sawcut should extend through the full height of the parapet on both sides and is to be filled with a sealant material all the way around the sawcut, except for the bottom two inches (50 mm) at the base of the parapet to allow moisture to drain out. However, the majority of control joints observed in the field contained at least one and sometimes several of the following discrepancies: sawcuts less than 1 ¼ inches (32 mm) deep (often measured to be around ½ inch (13 mm)), poor quality application or complete absence of the joint sealant, joints that are completely sealed to the bottom and do not allow for moisture drainage, sawcuts that terminate several inches above the base of the parapet, and joints located too close to a VPF base plate. These are shown in Figures 16 through 19.

Figure 16: Completely sealed control joint, Canterbury Road

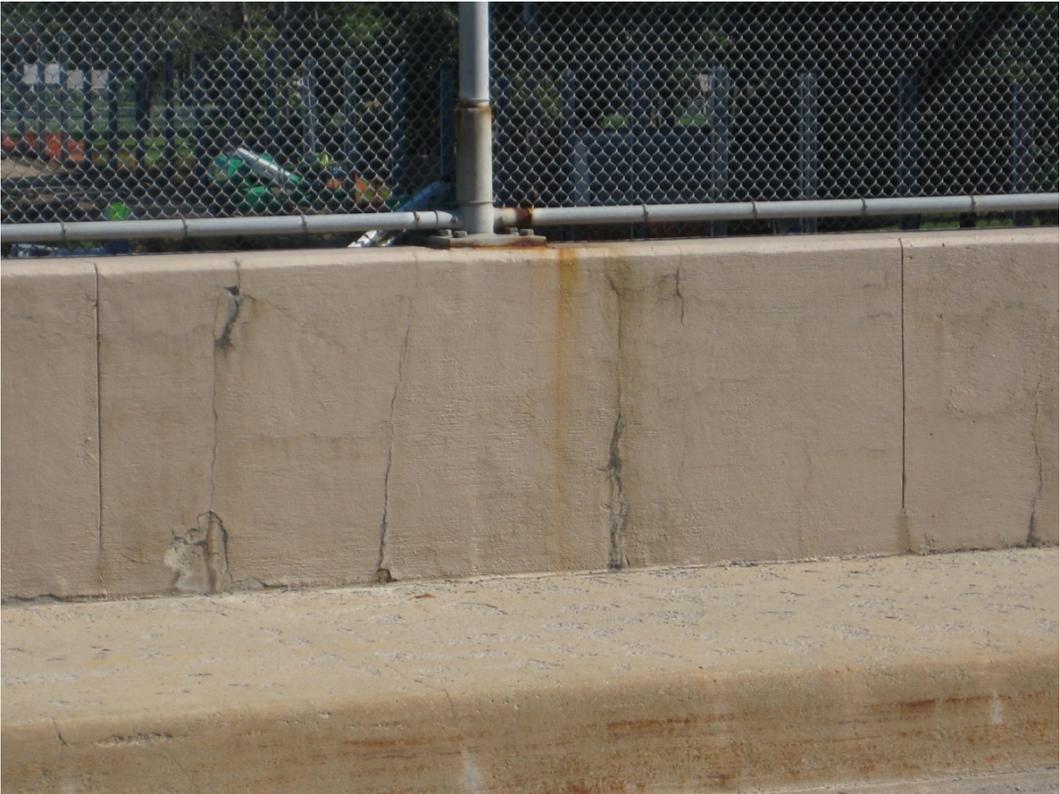
Figure 17: Unsealed control joints with incomplete sawcuts, Sheldon Road

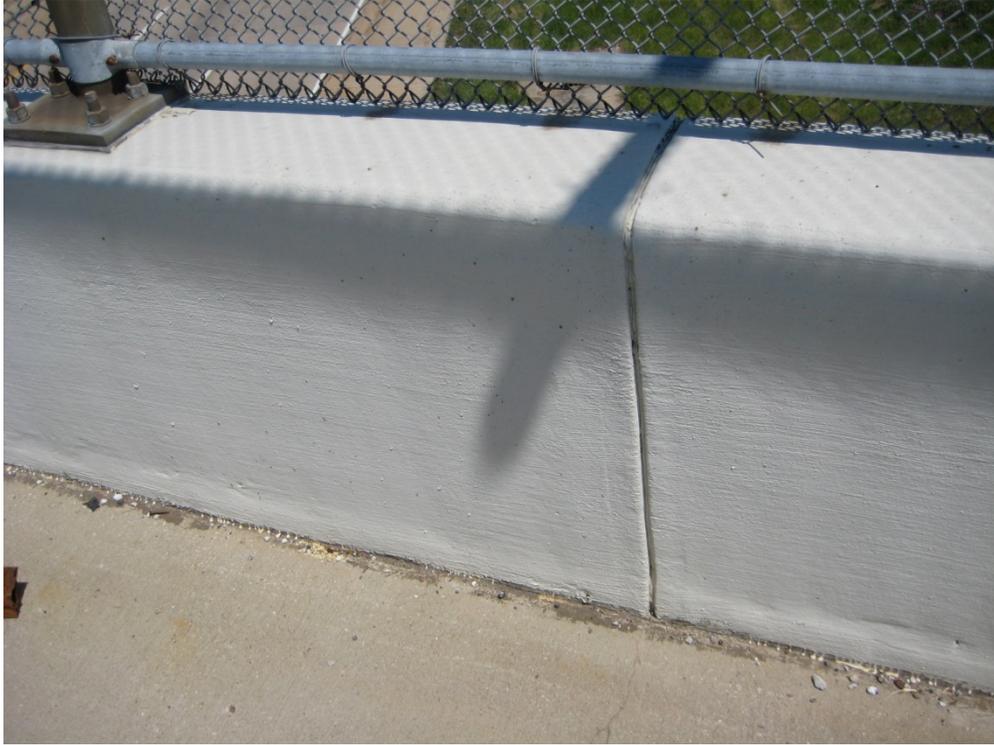
Figure 18: Completely sealed control joint, Spring Road

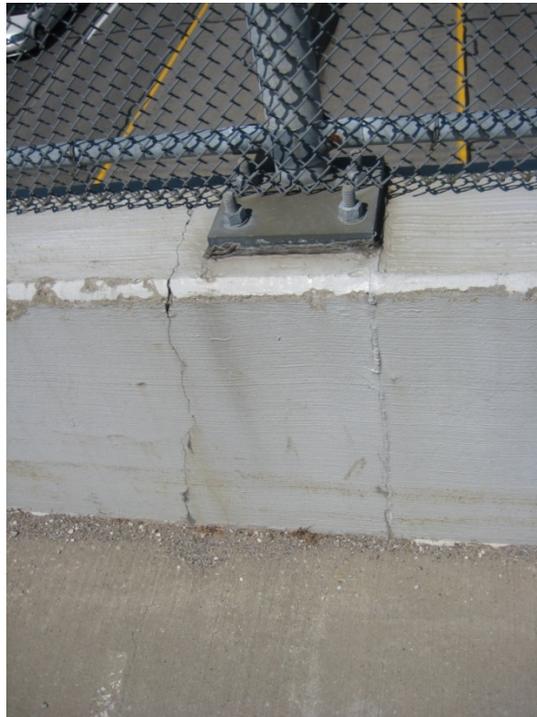
Figure 19: Completely sealed joint located directly below VPF base plate, Wagar Road

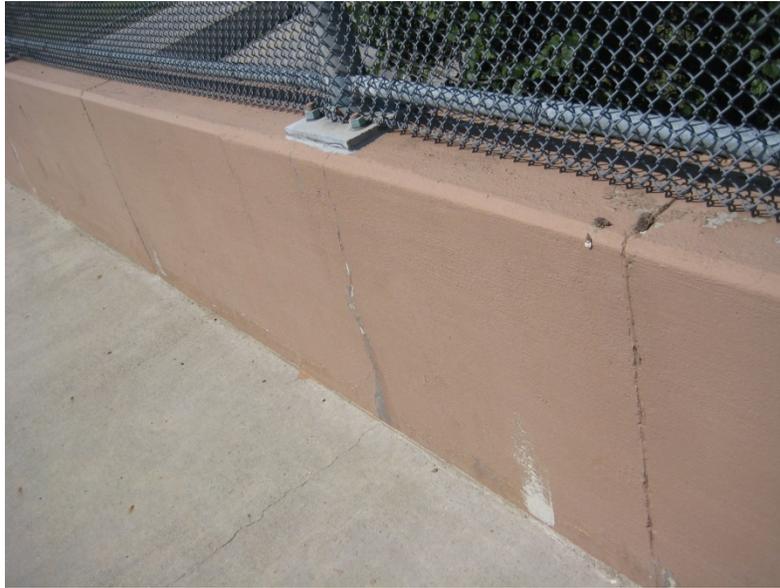
An additional major observation consisted of many vertical parapet cracks continuing through the sidewalks and bridge deck. These are visible as a completely continuous transverse crack through the concrete deck and superstructure. This phenomenon implies that a high degree of continuity is present between the bridge deck and sidewalk and between the sidewalk and parapets,. High continuity between components subsequently creates a higher degree of composite structural action, as tensile stresses are shared among the components. These are shown in Figures 20 through 22.

Figure 20: Continuous crack through sidewalk, Canterbury Road

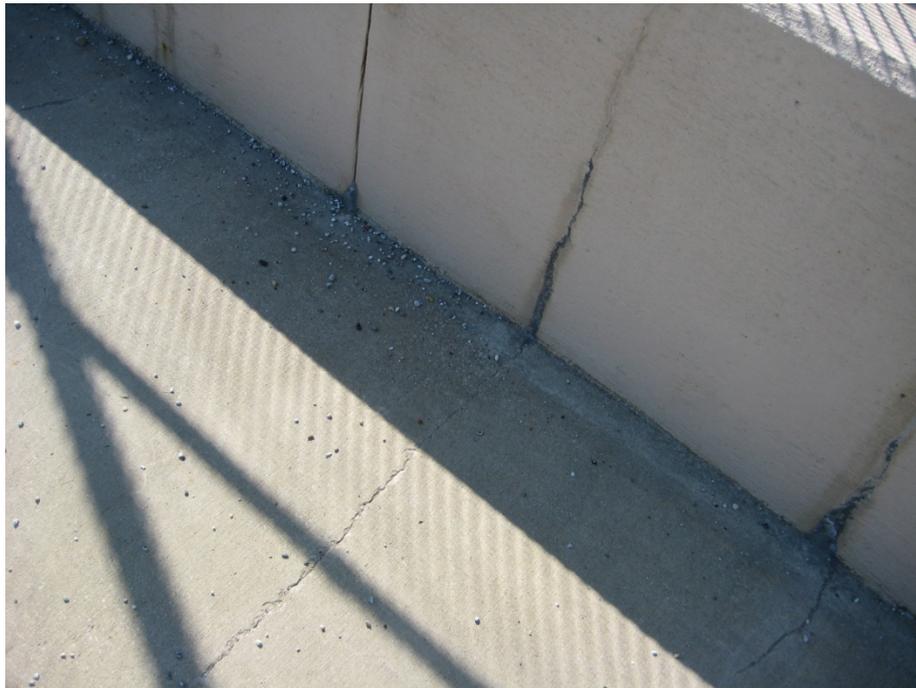
Figure 21: Continuous crack through sidewalk, Sheldon Road

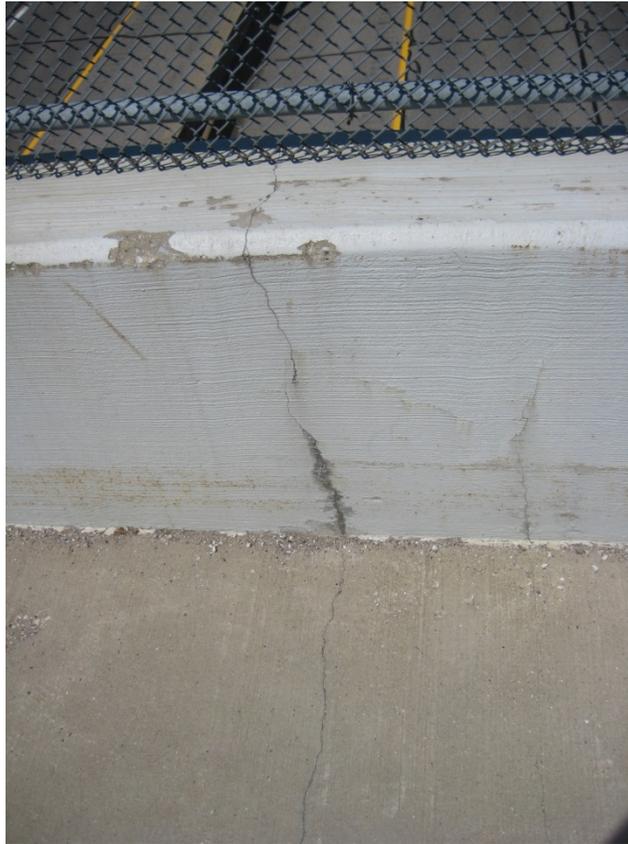
Figure 22: Continuous crack through sidewalk, Wagar Road
