Testing and Recommended Practices to Improve Nurse Tank Safety: Phase II

U.S. Department of Transportation
Federal Motor Carrier Safety Administration

December 2013

1. Report No. FMCSA-RRR-13-055	2. Government Accession No.	3. Recipient's Catalog No.	
4. Title and Subtitle Testing and Recommended Practices to Improve Nurse Tank Safety: Phase II		5. Report Date December 2013

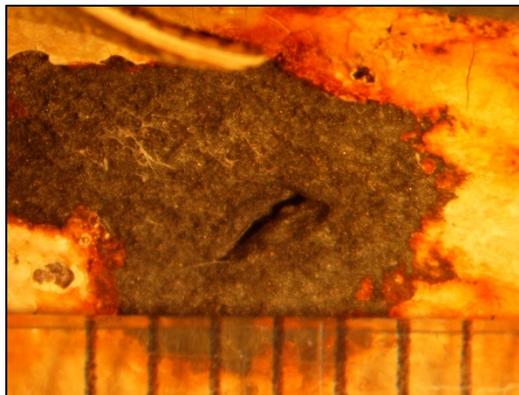
The shape of the voids-to-steel interface of the pinhole is very irregular and varies with depth below the metal's original surface. The average diameter of this pinhole was approximately 1 mm, but the diameter varied greatly from one depth to the next as the milling progressed through the full thickness of the tank wall. The varying cross-section shapes and dimensions demonstrated that it was not a simple crack, but an amalgamation of multiple bubbles/voids. This is consistent with the researchers' theory that the through-the-wall pinhole is actually a composite of many porosity bubbles that are later joined together by the process of accelerated metal fatigue failure of the remaining thin steel webbings between the bubbles.

Figure 8. Photograph. Exterior of a pinhole located at the vapor valve (same pinhole is depicted in Figure 9).

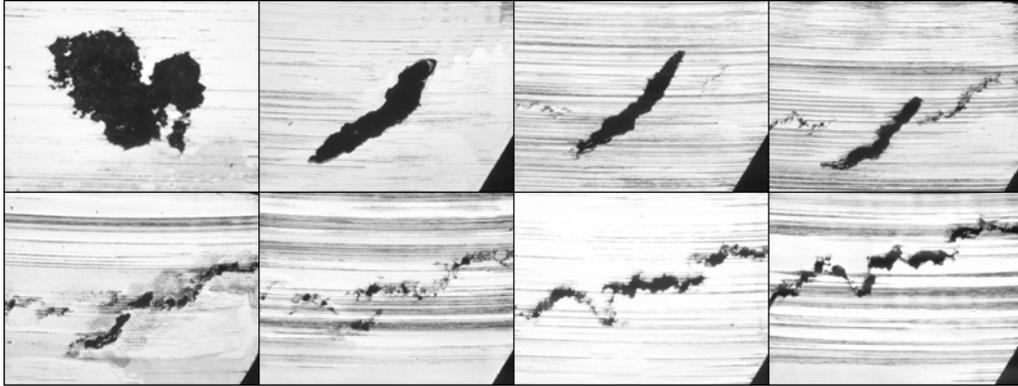
Figure 9. Grouped photograph. Metallographic sections of a serially-machined pinhole leak defect.

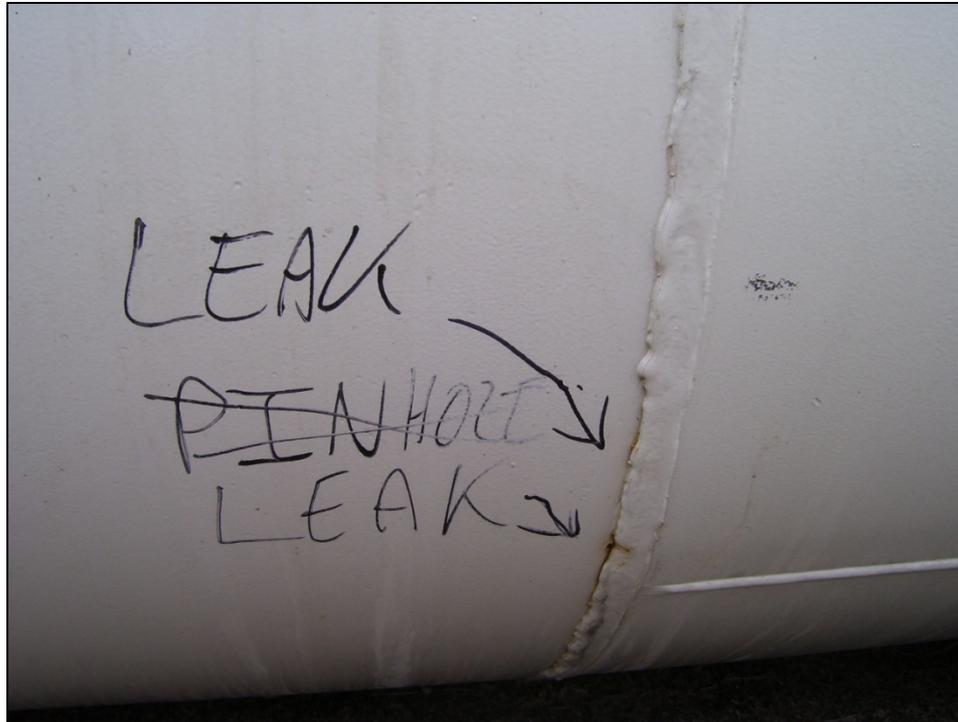
This was completed in an effort to confirm the research team's theory regarding the origin of the weld porosity. Tank 9NU001882 was selected for radiographic examination because it had two pinhole leaks in a girth (shell-to-shell circumferential) seam-weld joint (Figure 10).

Figure 10. Photograph. Two pinhole leaks in the roundseam weld of 1,450-gallon tank 9NU001882.

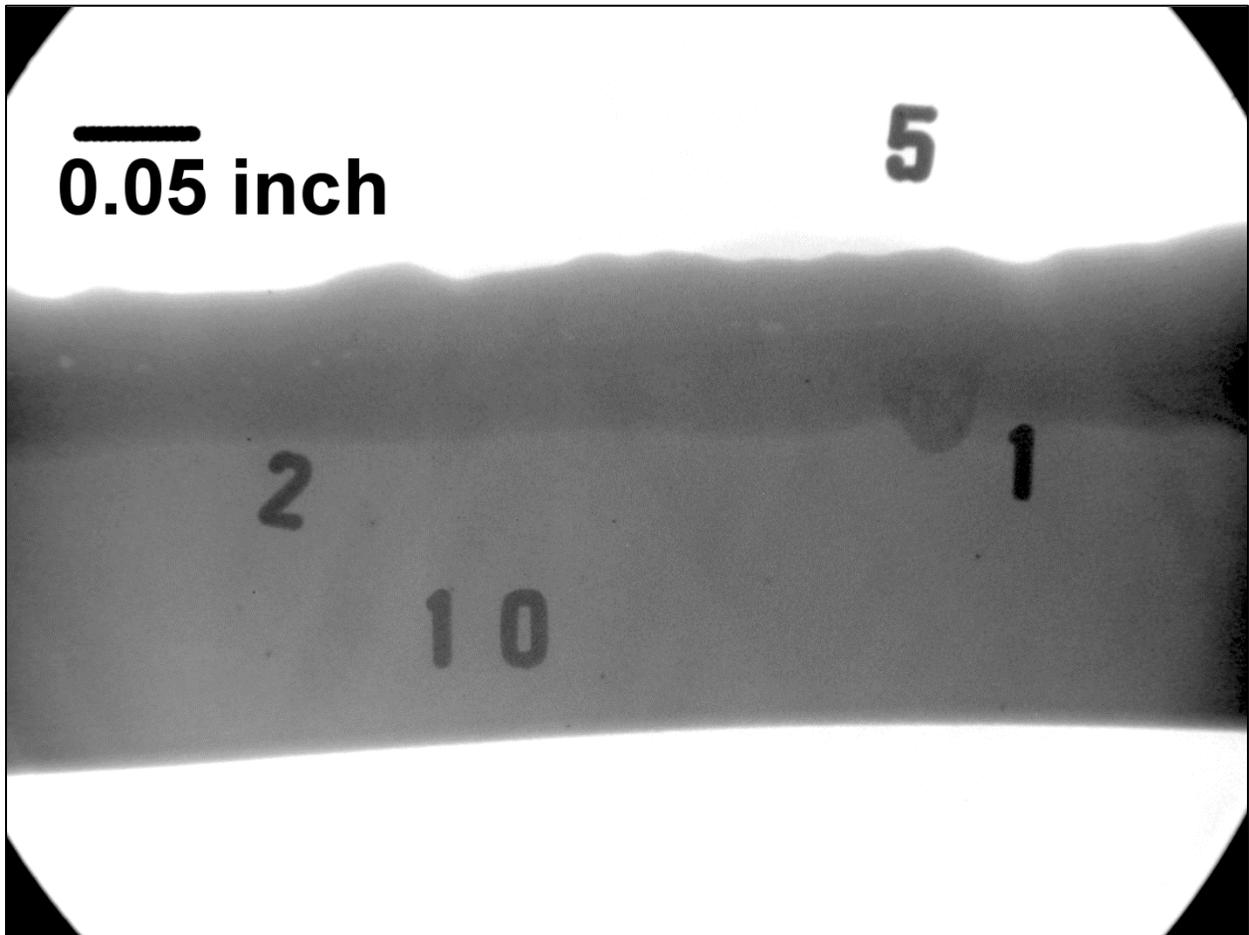
All nurse tanks are routinely checked by hydrostatic testing as a manufacturing quality assurance step. That means that even though this tank had considerable porosity in the welds, it did not have a pinhole leak at the time of the manufacturer's hydrostatic test. The researchers hypothesize that the pinhole developed rapidly (after the nurse tank was in service) from metal fatigue of the remaining steel membranes between the porosity bubbles. The nurse tank may have been aided in passing the hydrostatic pressure test because the manufacturers used the newer ASME hydrostatic pressure of 325 pounds per square inch (psi) rather than the regulatory specification of 375 psi.

Figure 11. Photograph. Radiographic image of section of center girth weld showing radio-opaque markers (1 and 2) placed at the locations of the pinholes.

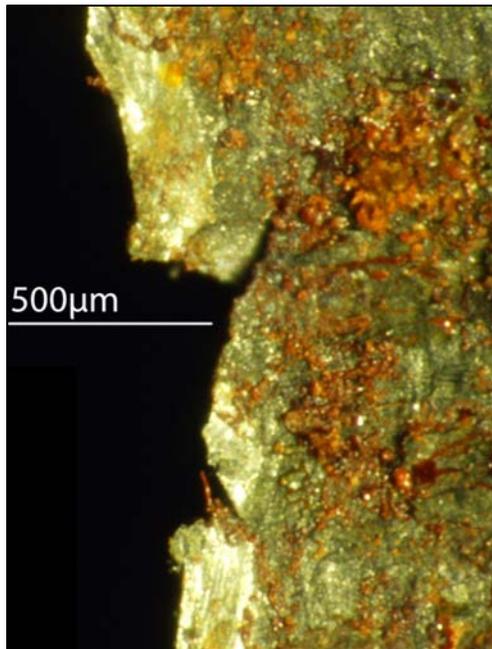
Figure 21 shows a close-up of one specimen before, during, and after 15 months of exposure. The crack lengthened during the first 3 months of exposure. No further growth was seen after that.

Figure 21. Photograph. Sample #055 after 15 months of exposure to liquid ammonia.

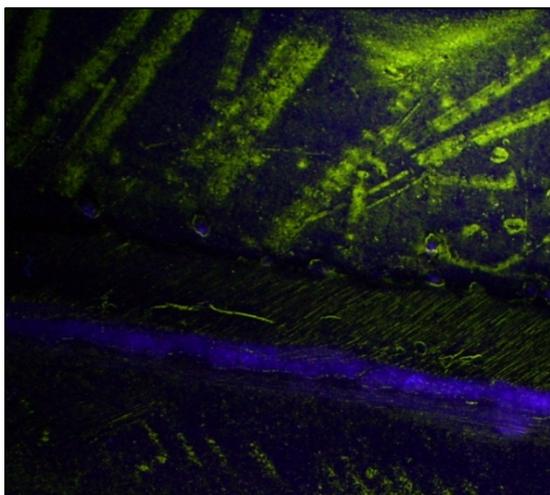
Figure 22. Photograph. Magnetic particle inspection of a weld region, before 12 months of exposure to NH_3 .

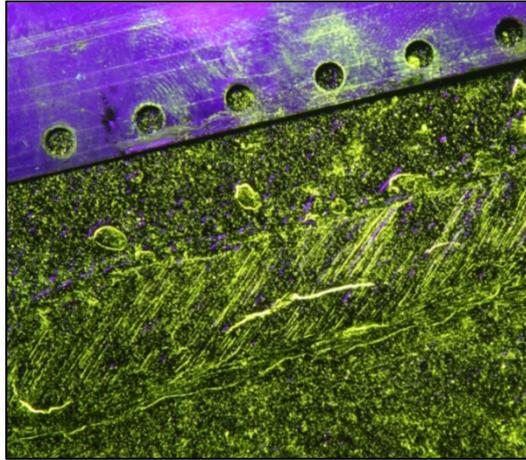
Figure 23. Photograph. Magnetic particle inspection of the same weld region shown in Figure 22, after 12 months of exposure to NH₃.

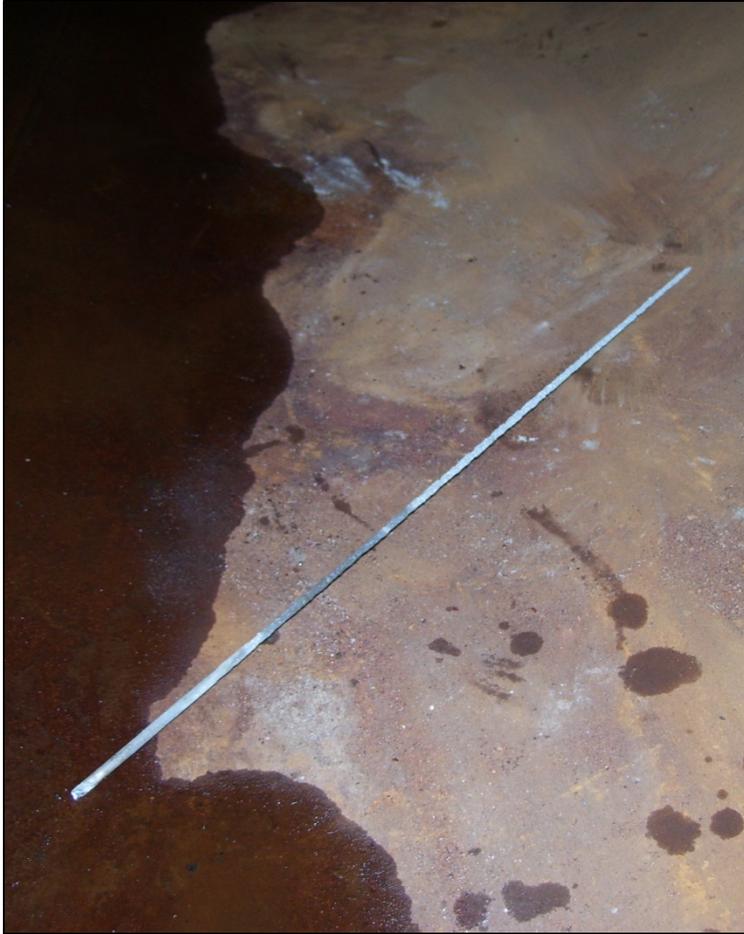
The interior surface of the tank containing N-Serve had more corrosion product than the other two tanks. Another example of adverse corrosion effects of N-Serve was that the float gage in the N-Serve tank had corroded and broken off, while the other two float gages were still whole (see Figure 24 and Figure 25). Analysis of nurse tanks during Phase I of this project showed that there was little wall thinning due to corrosion from NH₃ containing 0.2 percent water. However, Phase II observations of the test tank containing N-Serve indicate that tanks containing N-Serve should be monitored to ensure that the walls have not become dangerously thin.

Figure 24. Photograph. The rod from the fill gauge had corroded off its fitting in the tank containing N-Serve.

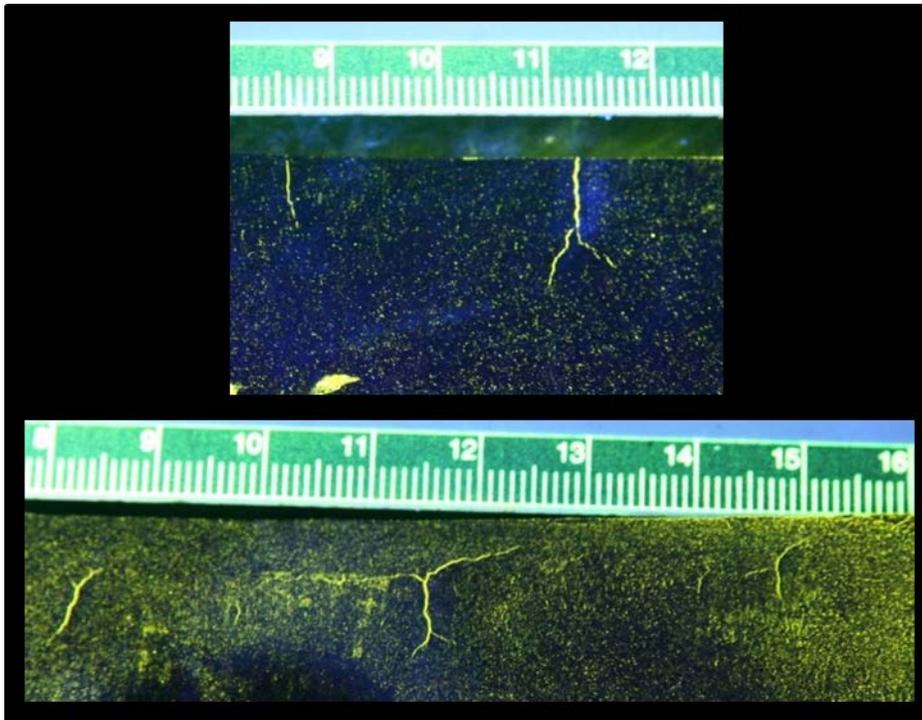
Figure 66. Grouped photograph. Magnetic particle highlighted examples of crack branching in nurse tank SCCs.

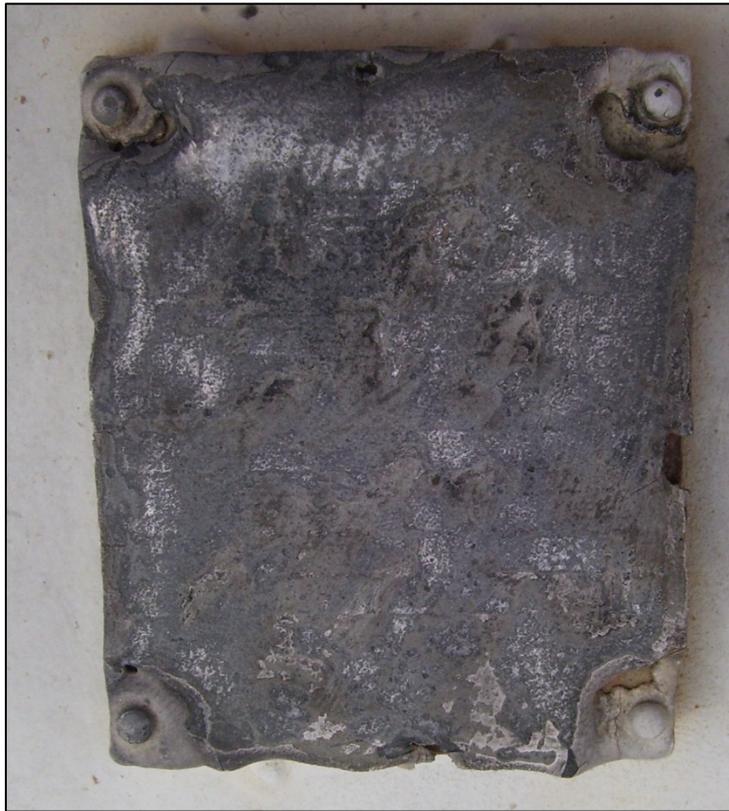
Figure 68. Photograph. Illegible data plate.

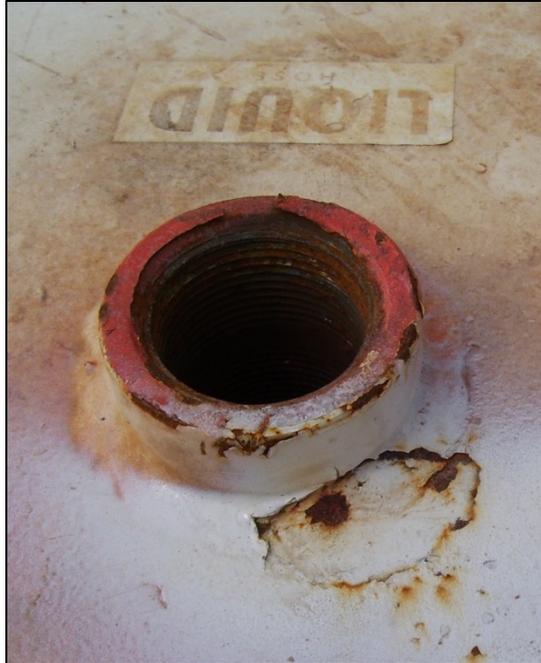
Figure 69. Photograph. Pinhole leak on liquid vapor valve on nurse tank DOT SP 13554.

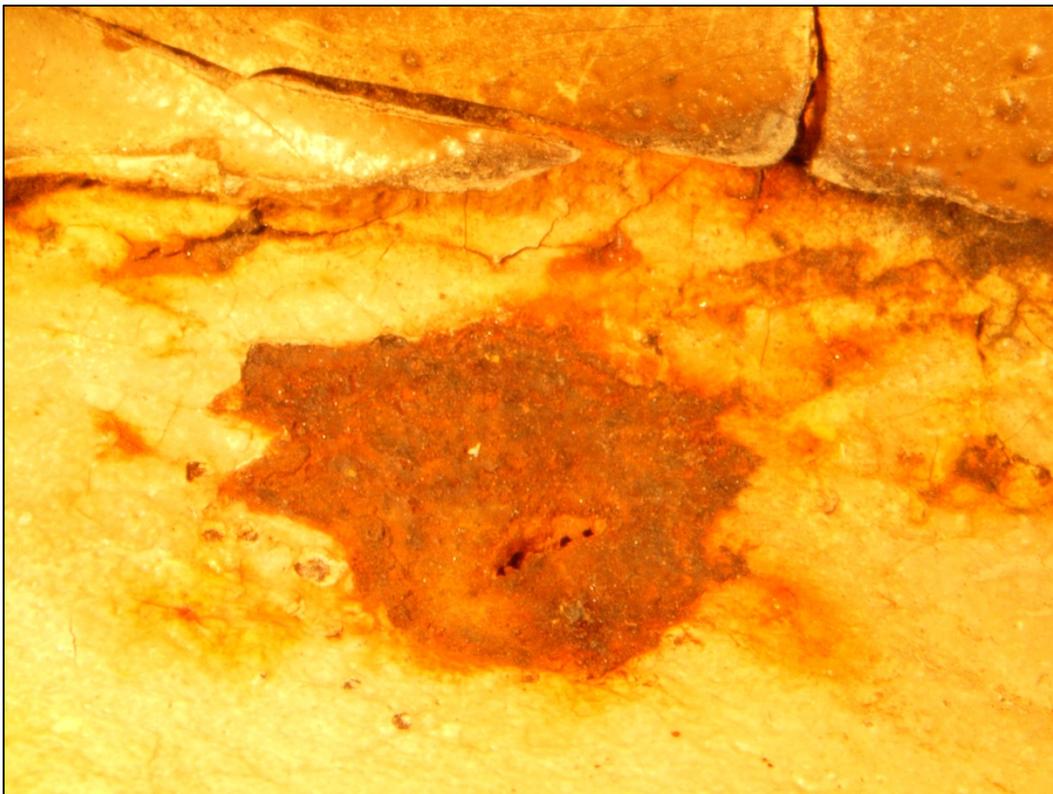
Figure 70. Photograph. Close-up of pinhole leak on the liquid vapor valve of nurse tank DOT SP 13554.

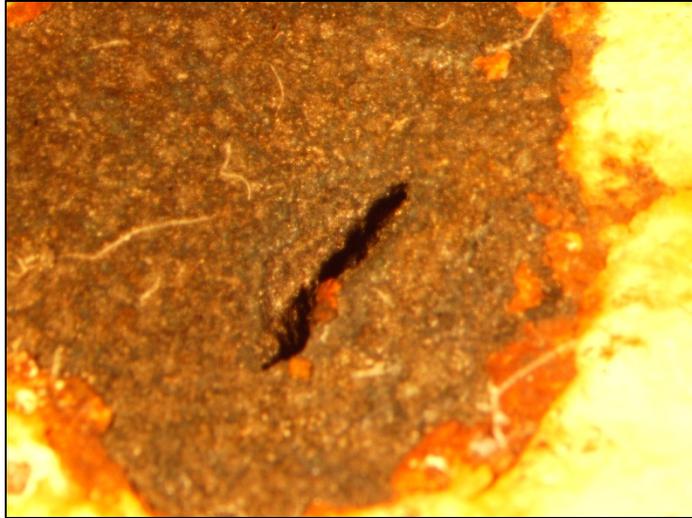
Figure 71. Photograph. Same pinhole leak after cleaning the site with Calcium Lime Rust (CLR) remover.

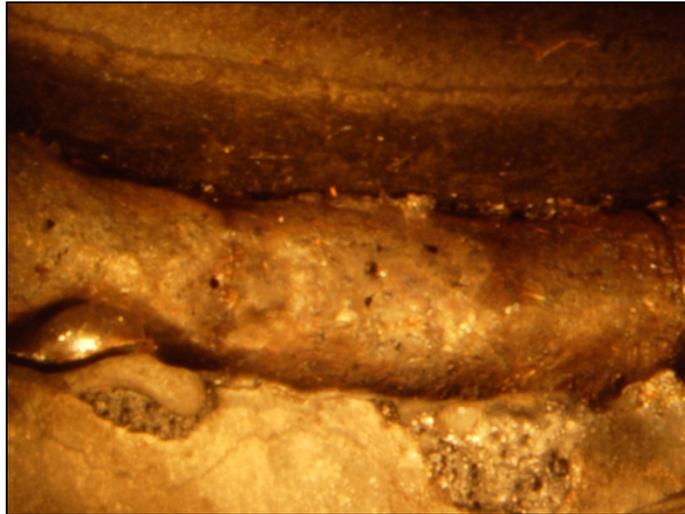
Figure 72. Photograph. Reverse side of same pinhole showing underside of weld.

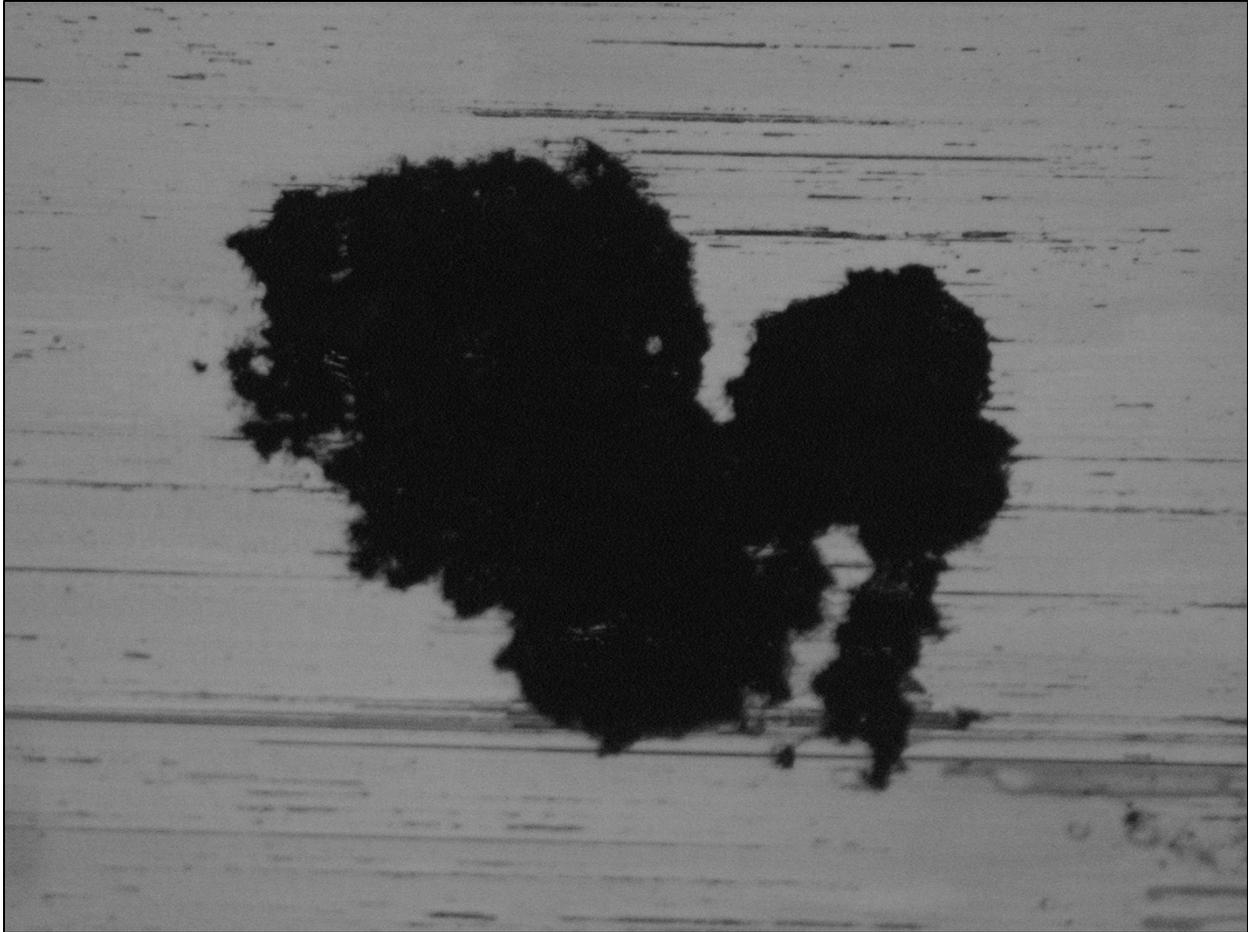
Figure 73. Photograph. Serial mill picture of pinhole path.

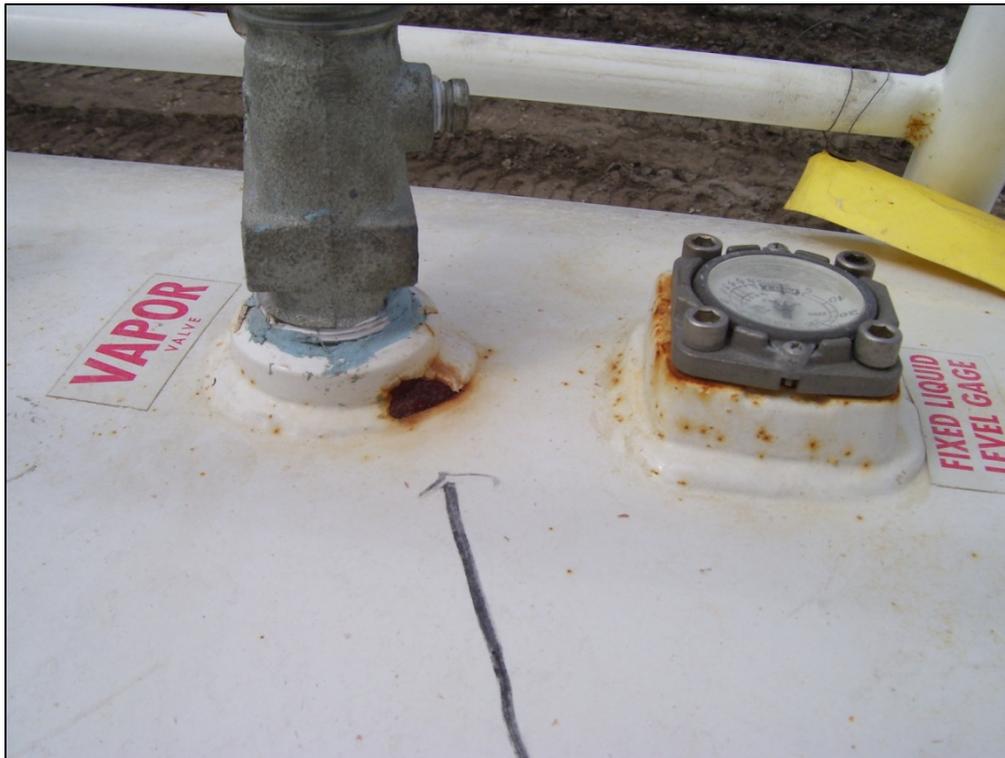
Figure 75. Photograph. Pinhole leak on vapor valve on nurse tank 6NU001139.

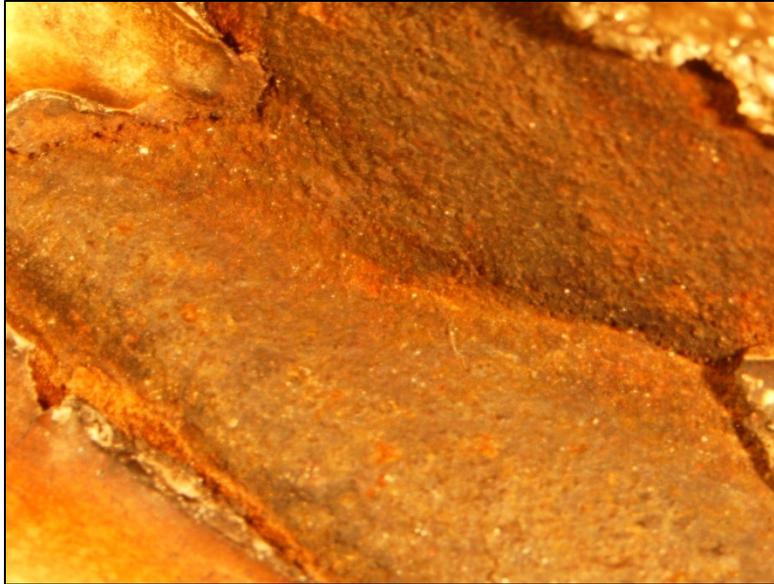
Figure 76. Photograph. Close-up of pinhole leak on vapor valve on nurse tank 6NU001139.

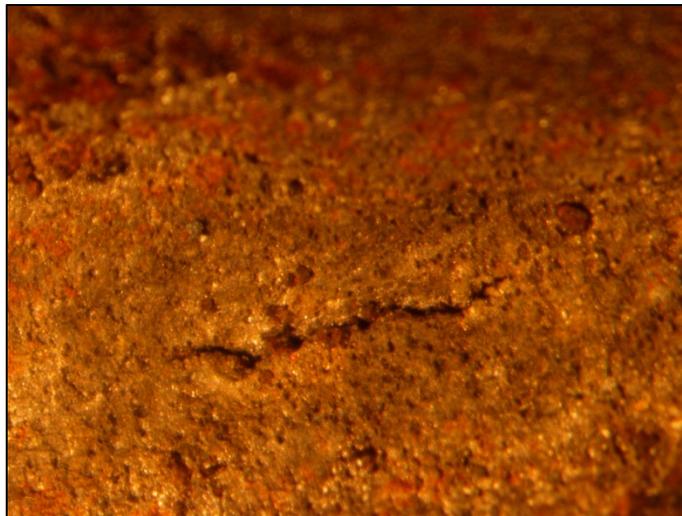
Figure 77. Photograph. Close-up of pinhole leak on vapor valve on nurse tank 6NU001139 after being cleaned with CLR.

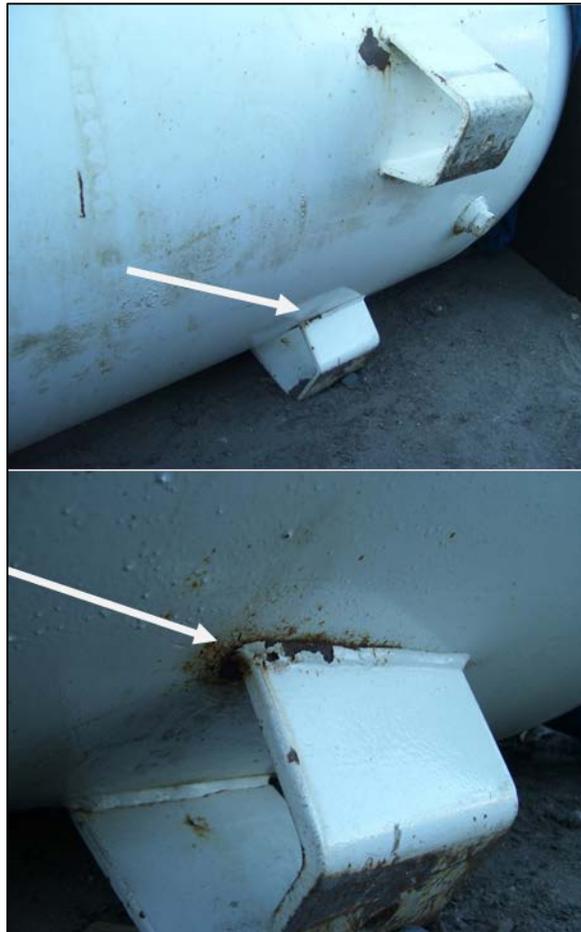
Figure 79. Grouped photograph. Location of leak on leg weld of nurse tank 9NF000057.

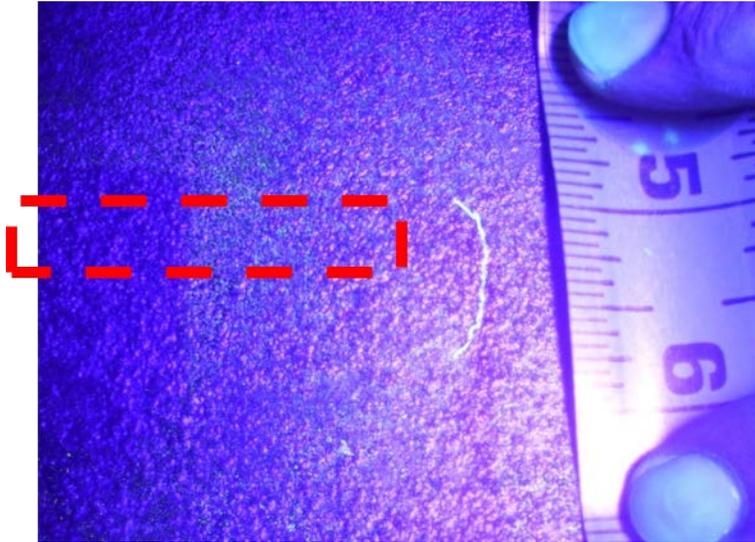
Figure 80. Photograph. The crack from inside the tank under ultraviolet illumination.

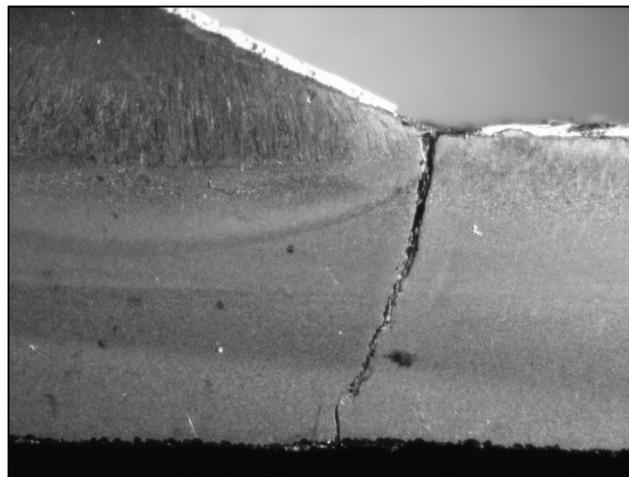
Figure 81. Photograph. A cross-section of the tank shell at the end of the leg weld.

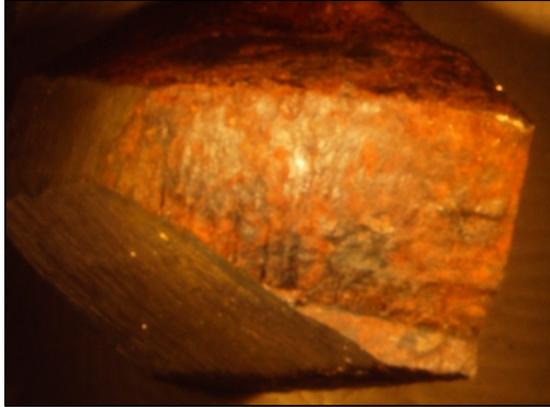
Figure 82. Photograph. Opened-up weld side of crack in tank shell.

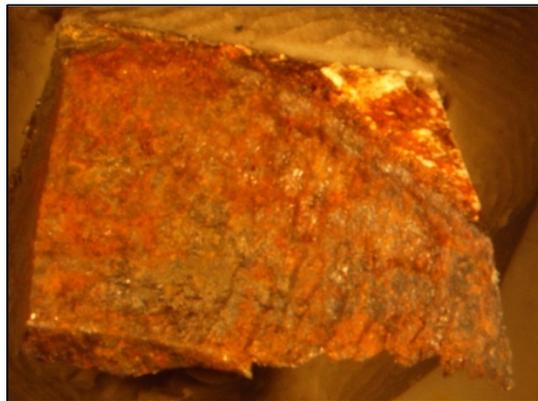
Figure 83. Photograph. Opened-up crack in tank shell, anti-crack side.

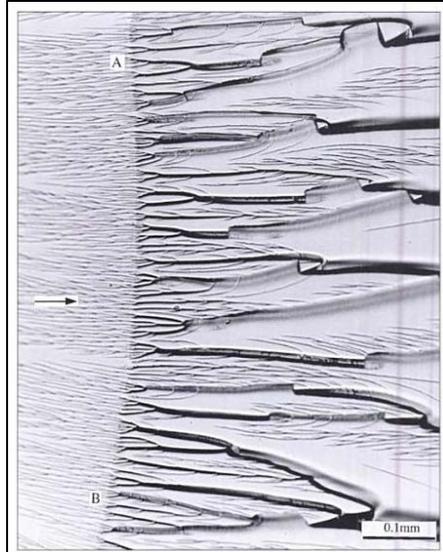
Figure 84. Photograph.Displays how river lines begin as closely-spaced steps which merge into larger and more widely-spaced steps as the fracture progresses.

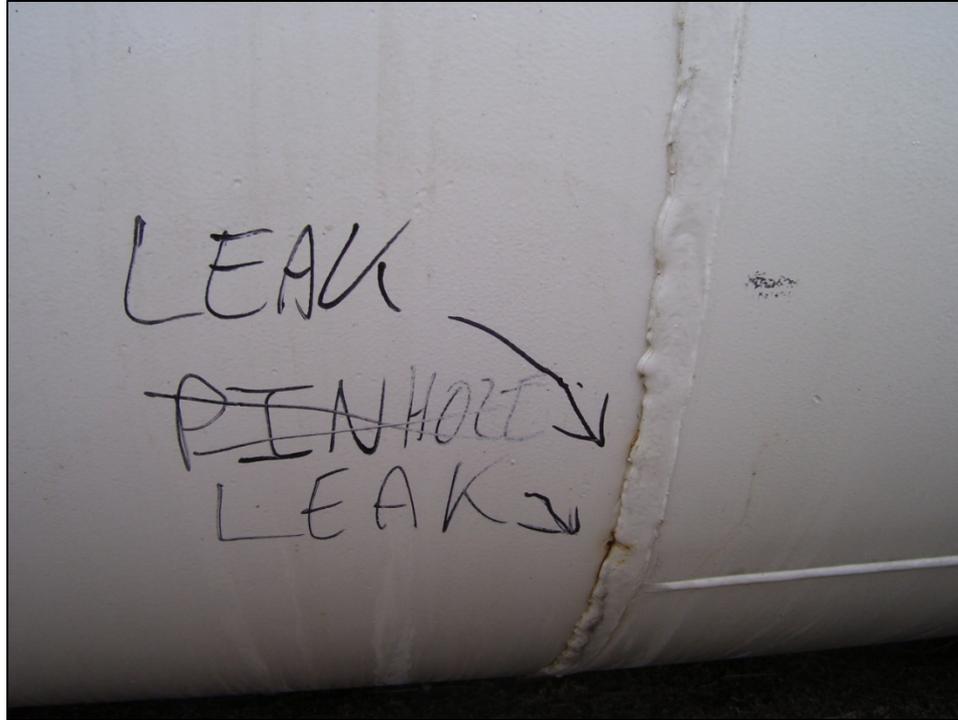
Figure 86. Photograph. Nurse tank 9NU001882 had two pinholes on the center circumferential weld.

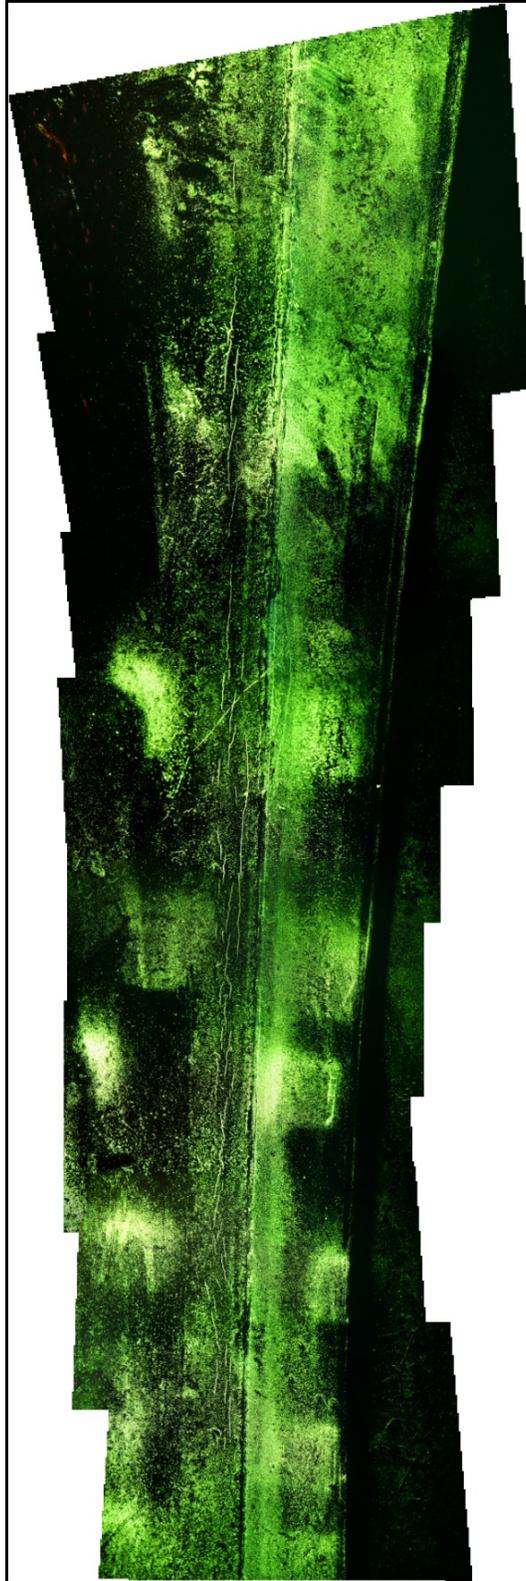
Figure 87. Image. An 18-inch flaw found on the shell side of the interior of a head-shell circumferential weld.

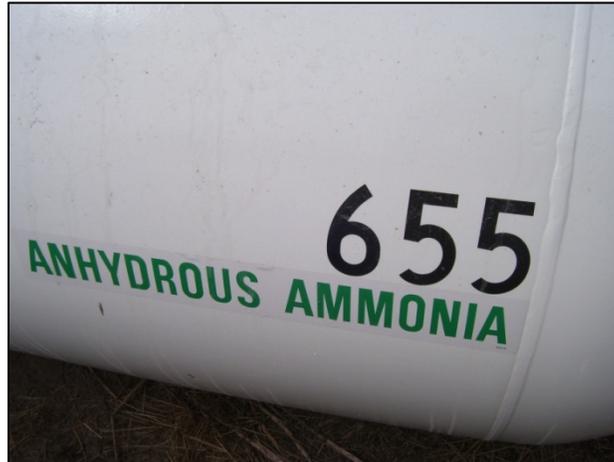
Figure 88. Photograph. Nurse tank #655 had a pinhole leak along one of the weld seams.

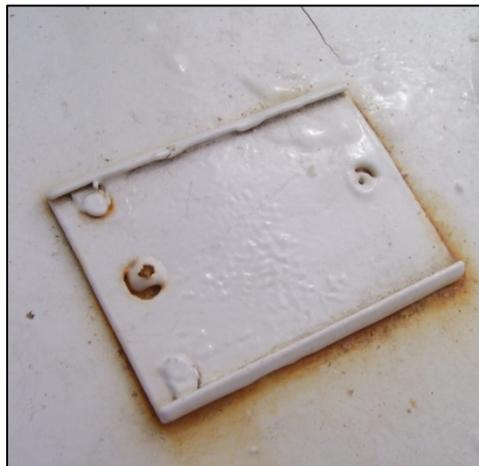
Figure 89. Photograph. Nurse tank #655 did not have a data plate.

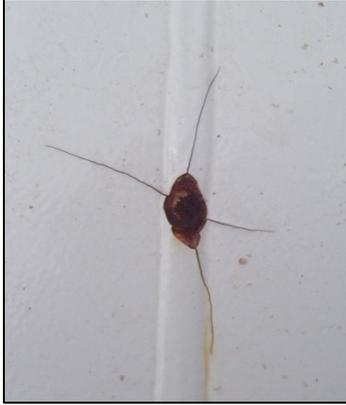
Figure 90. Photograph. This tank had a pinhole leak where the head was welded to the tank shell.
