**DEVELOPING GUIDELINES FOR REPAIRING SEVERE EDGE
FAILURES: TECHNICAL REPORT**

Report 0-6271-2-1

Project 0-6271

Published: April 2014

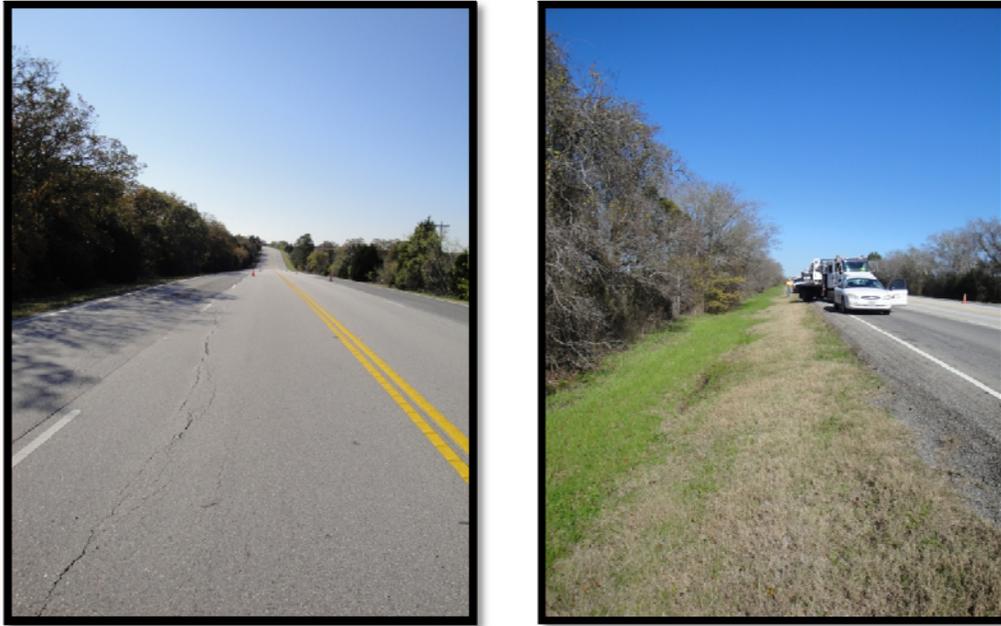
The Austin District recently completed two projects on SH 21 involving mitigation techniques for edge cracking. Figure 1 shows example cracking and steep front slopes typical of the SH 21 project. Figure 2 shows other pavements in the Austin District with severe edge failures.

Figure 1. Cracking and Steep Front Slopes on SH 21.

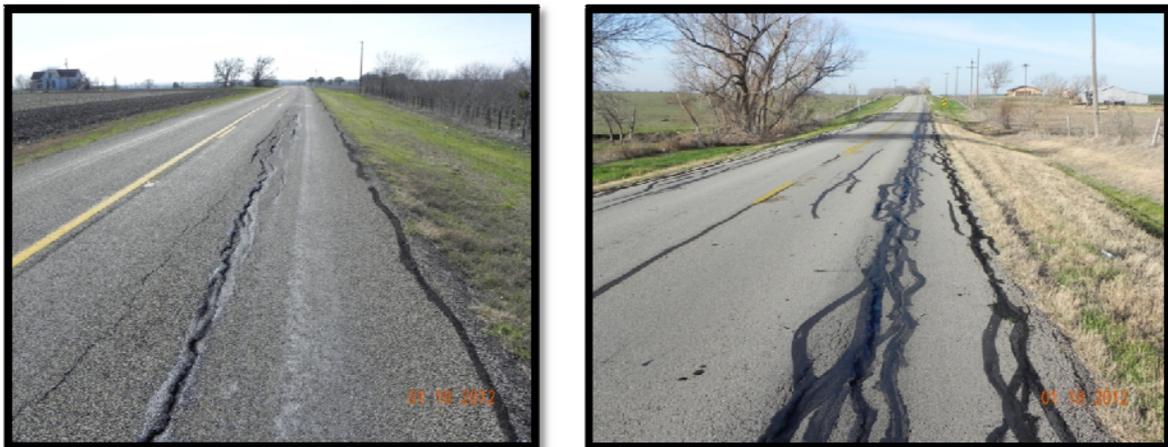
Figure 2. Edge Failures on Other Pavements in the Austin District.

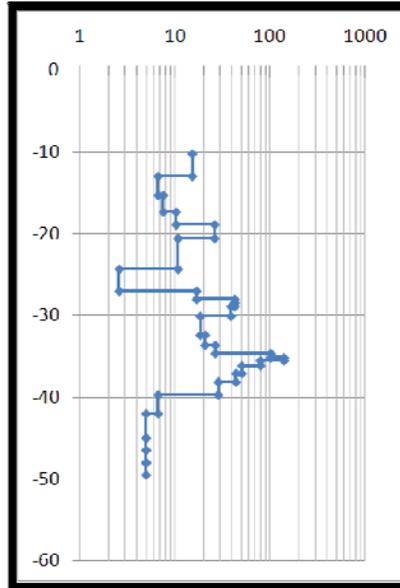
The Austin District also recently performed a project on SH 21 from US 290 to 0.8 mi east of FM 1441. The existing pavement had a lot of structure; however steep front slopes and soils with a plasticity index as high as 59 resulted in consistent maintenance requirements for cracking and roughness. Additionally, DCP profiles, illustrated in Figure 5, suggested a slip plane existed from about 24 to 28 inches from the pavement surface.

Figure 5. Slip Plane Evident in DCP Profile.

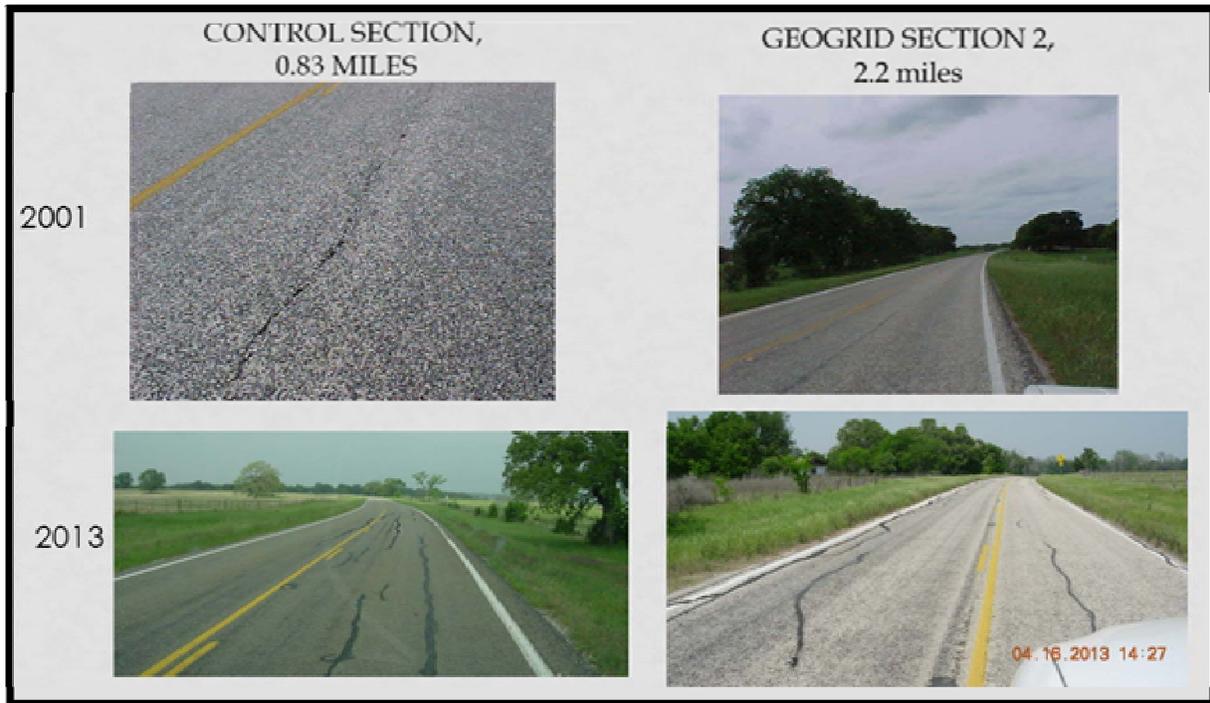
The first major test of using the FDR technique with geogrid reinforcement in the Bryan District occurred on FM 1915. Constructed in 1997, Figure 8 illustrates that in general the sections reinforced with the geogrid do not have as much cracking distress as the control sections.

Figure 8. FM 1915 Sections 5 and 16 Years after Repair.
Images Courtesy of Darlene Goehl.

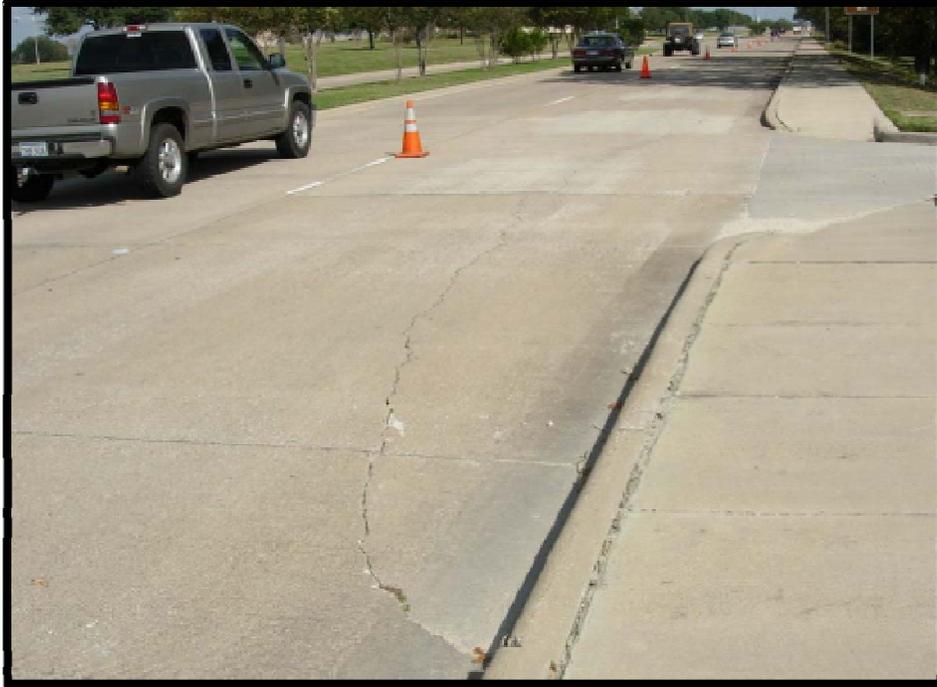
The Bryan District also has one of the few well documented cases of edge repair of concrete pavement. The distress shown in Figure 9 occurred shortly after construction. The subgrade plasticity index ranged from 14 to 49. Figure 10 presents the typical existing section. Figure 11 presents the repair details, which used a continuously reinforced concrete pavement (CRCP) repair tied to the existing concrete pavement contraction design (CPCD). As Figure 12 illustrates, although the crack did recur, the crack severity is much less than before.

Figure 9. Edge Failure of Concrete Pavement.
Image Courtesy of Darlene Goehl.

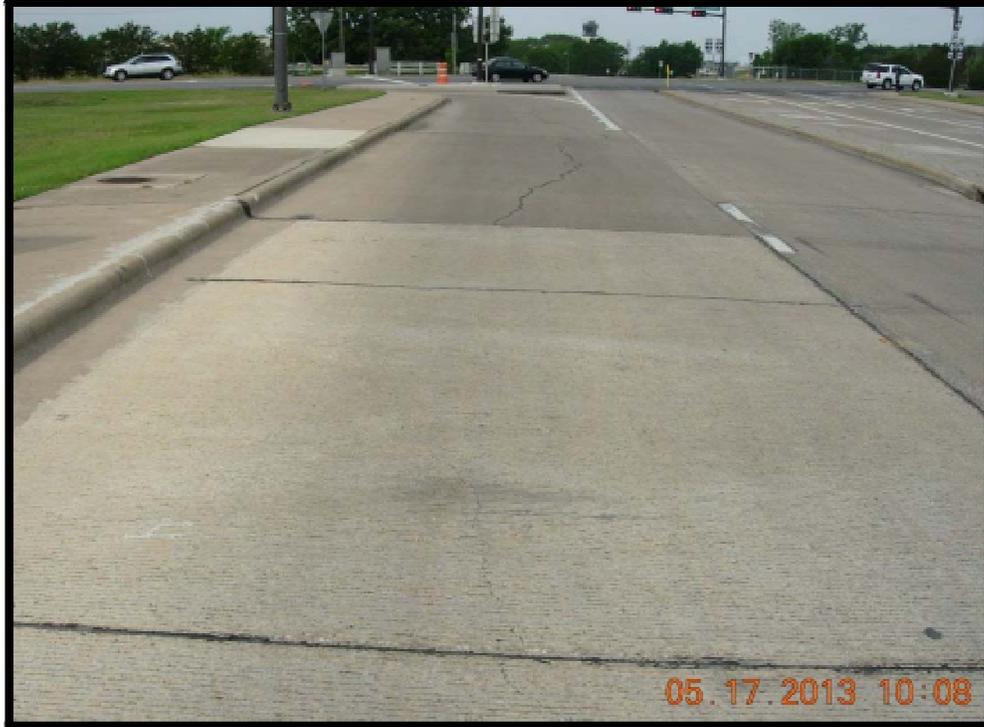
Figure 12. Concrete Pavement Edge Distress 7 Years after Repair.
Image Courtesy of Darlene Goehl.

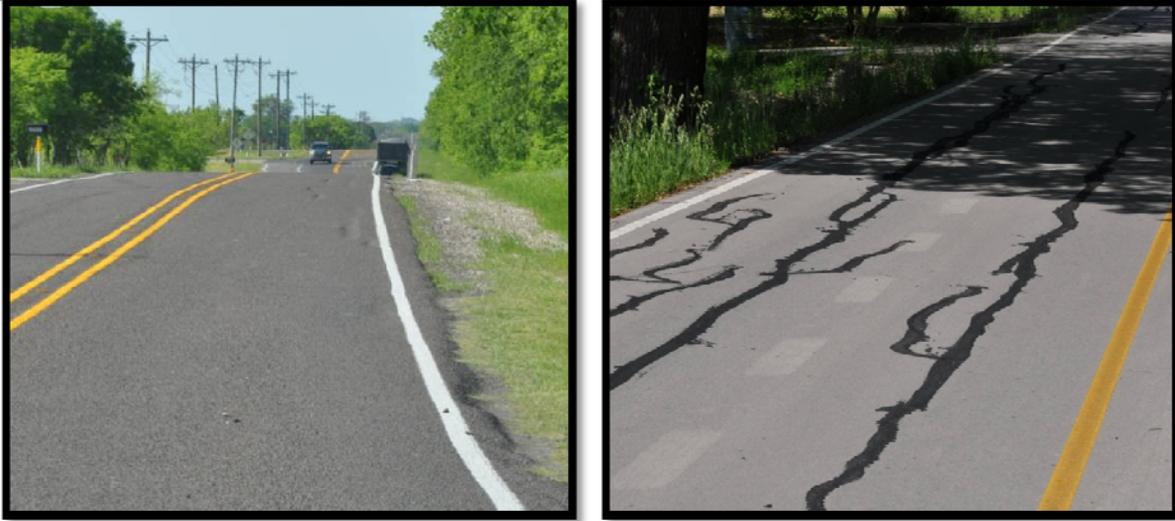
Figure 14 contrasts FM 549 and FM 1827, both after 3 years of service. While FM 549 has edge failures with roughness continuing to occur on the project, on FM 1827 the ride is still good although cracking has recurred.

Figure 14. FM 549 (Left) and FM 1827 (Right) after 3 Years of Service.

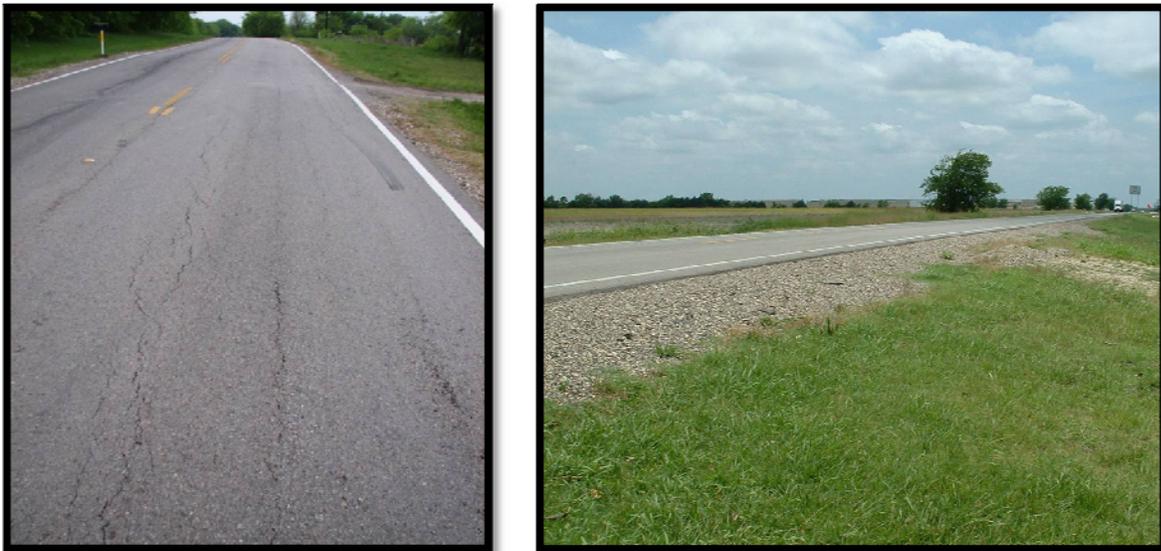
The Dallas District also constructed several projects where FDR employed dual treatment with cement and asphalt emulsion. The results were mixed, where on two projects, pavement distress recurred rapidly; on the third project, results were substantially improved. Figure 17 shows FM 429 and FM 548 after about 3 years of service, where distress has recurred on the former while the latter exhibited excellent overall condition.

Figure 17. Contrast of Performance on Projects with Cement/Asphalt Emulsion Treatment (L: FM 429; R: FM 548).

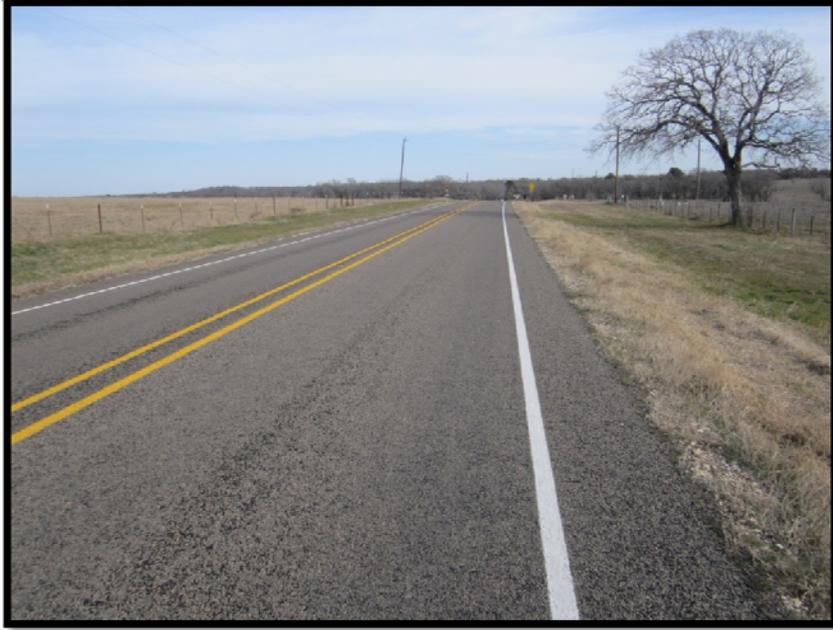
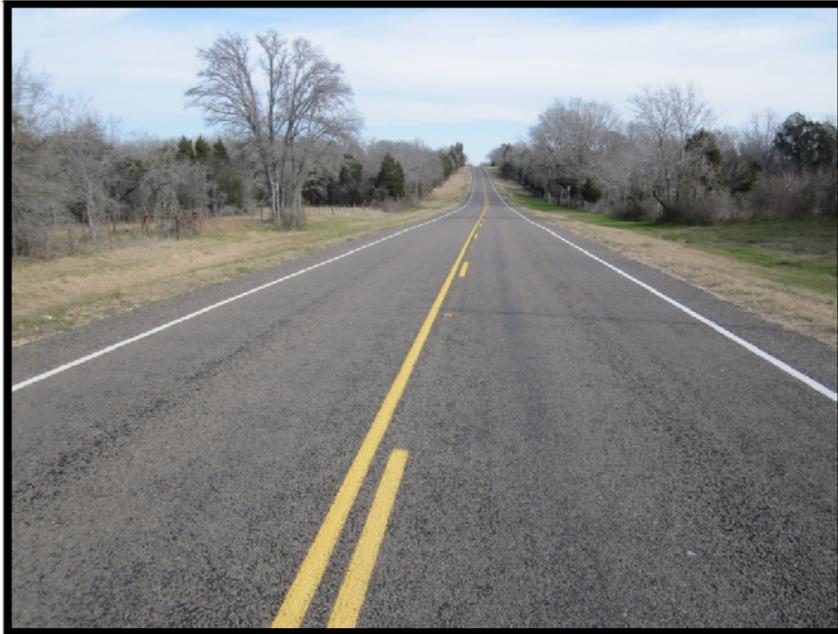
Figure 18 presents the existing and proposed typical sections for FM 1712 from reference marker 406+1.604 to FM 487. The edge problems on this pavement were addressed by subgrade widening, scarifying, and reshaping the existing material followed by cement treatment to a depth of 8 inches, and then a 4 inch flexible base layer surfaced with a two course surface treatment. The Bryan District used Type D, Grade 2 flexible base for the new flexible base layer. Figure 19 shows representative images of the pavement's present condition. No distresses were observed.

Figure 19. Representative Condition of FM 1712.

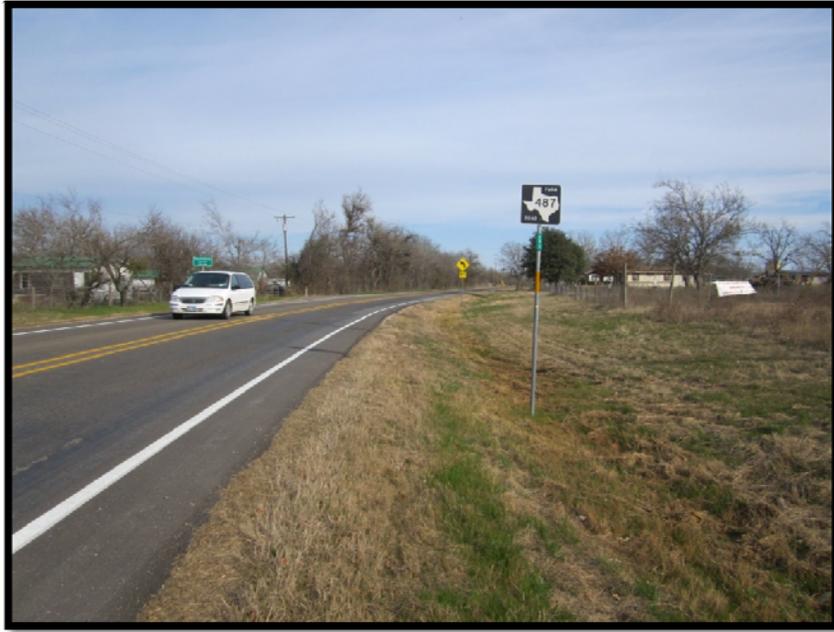
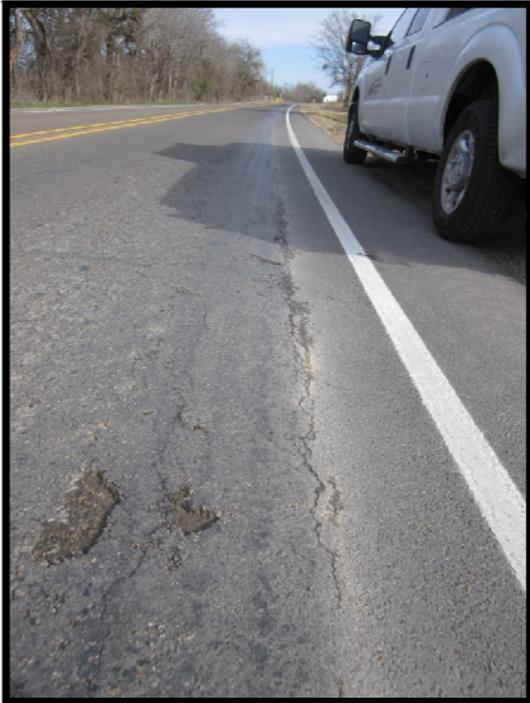
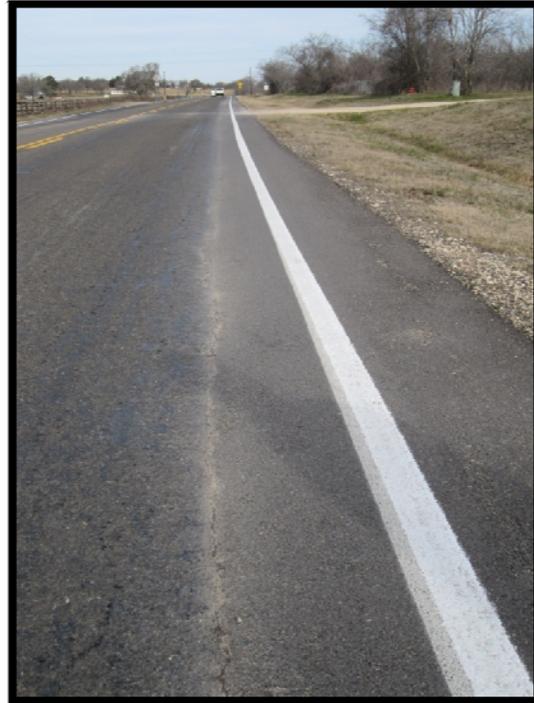
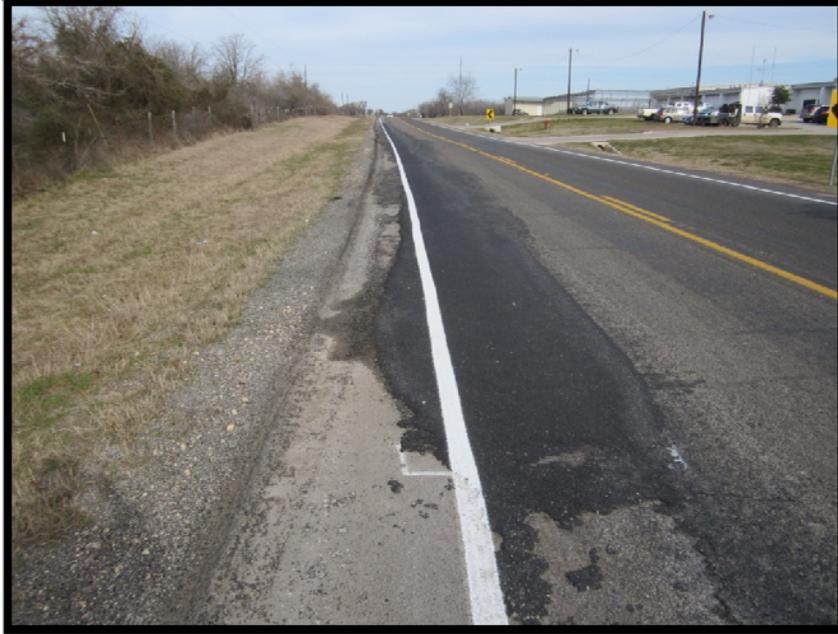
Figure 21 shows current conditions on FM 487. Problems exist at the longitudinal construction joint between the added shoulder and the existing pavement. In many locations a crack exists at the joint, resulting in pumping of fines and initiation of additional cracking in the vicinity. Several locations already exist where surface patches have been applied at the joint and shoulder.

Figure 21. Representative Condition of FM 487.

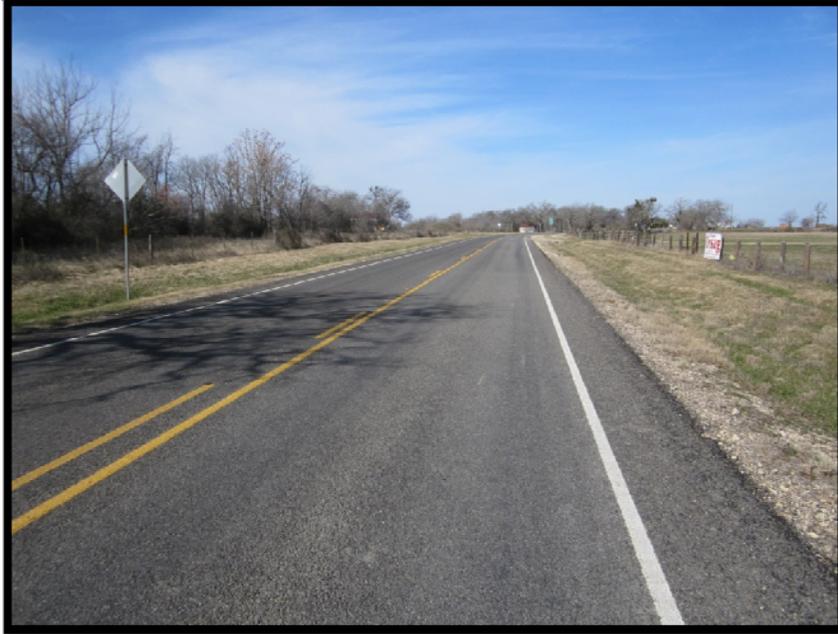
Figure 23 shows the representative current condition of the majority of the project, which shows no distress. However, localized edge distress exists near reference marker 404. Figure 24 illustrates the edge failure, where steep front slopes exist and longitudinal cracking and settlement have occurred at the pavement edge.

Figure 23. Representative Condition on FM 1600.

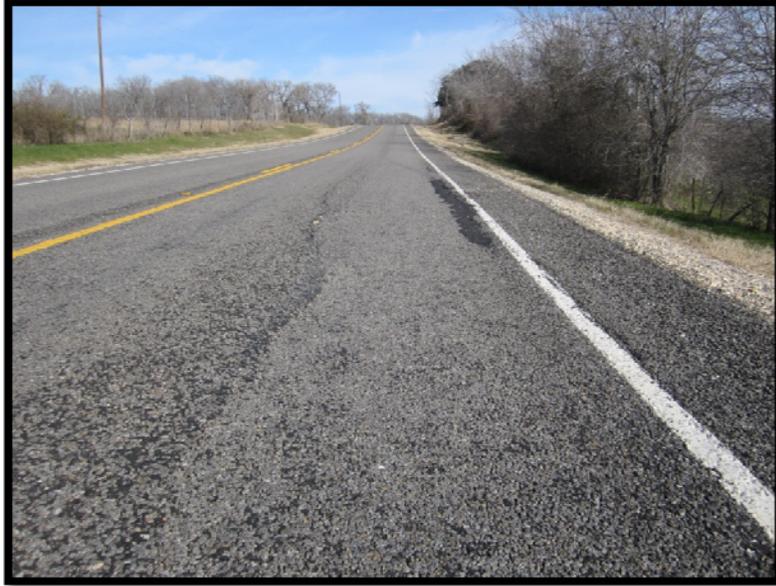
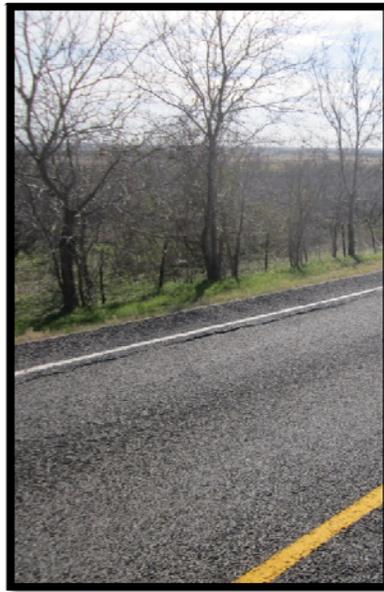
Figure 24. Localized Edge Distress on FM 1600.

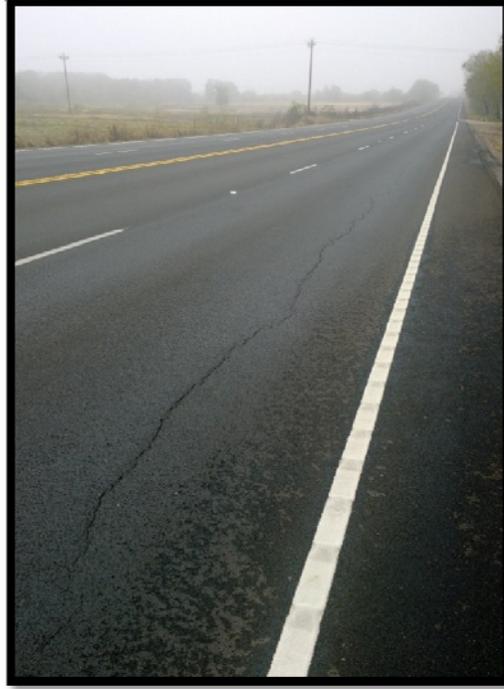
Figure 26. Longitudinal Crack on SH 21.

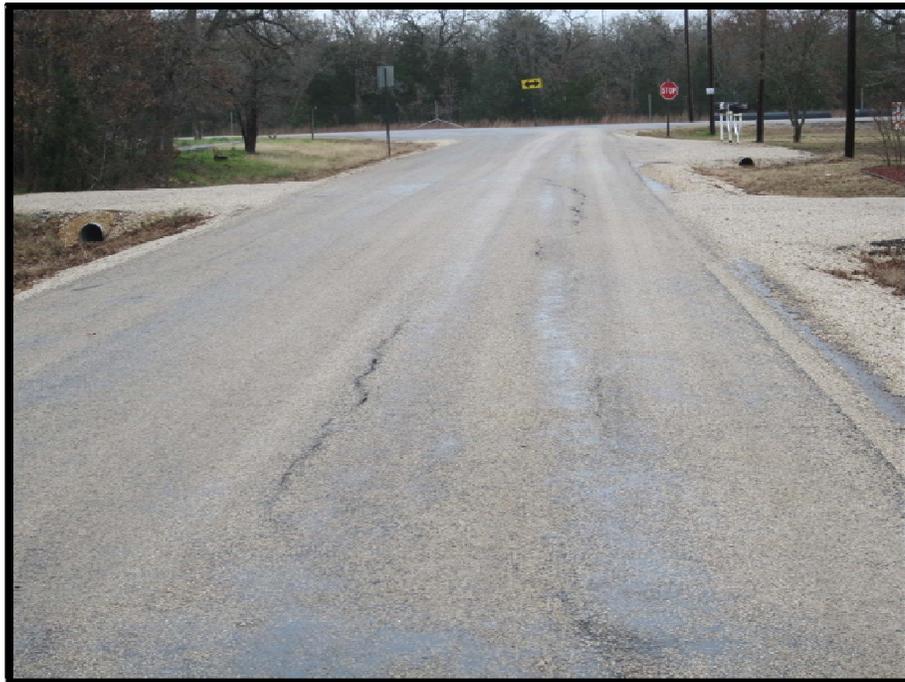
Figure 28. Section on Benchley Dr. without Geogrid.

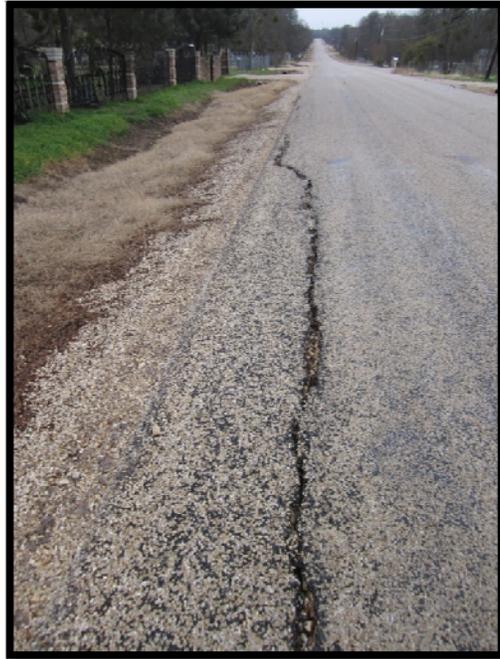
Figure 30. Longitudinal Crack Observed in Section on Benchley Dr. with Geogrid.

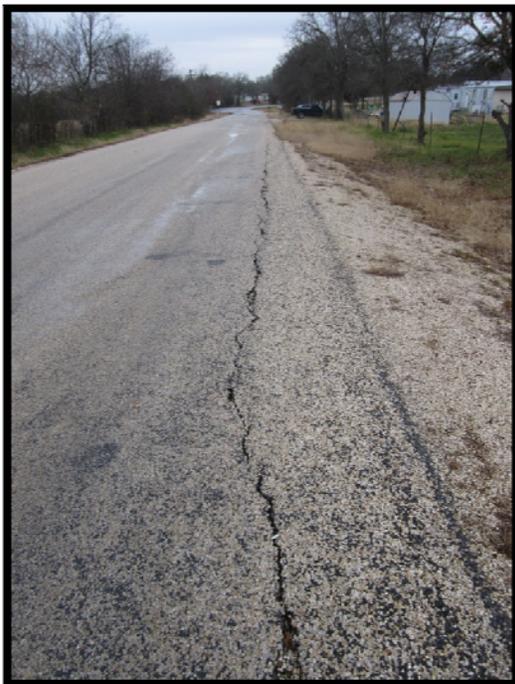
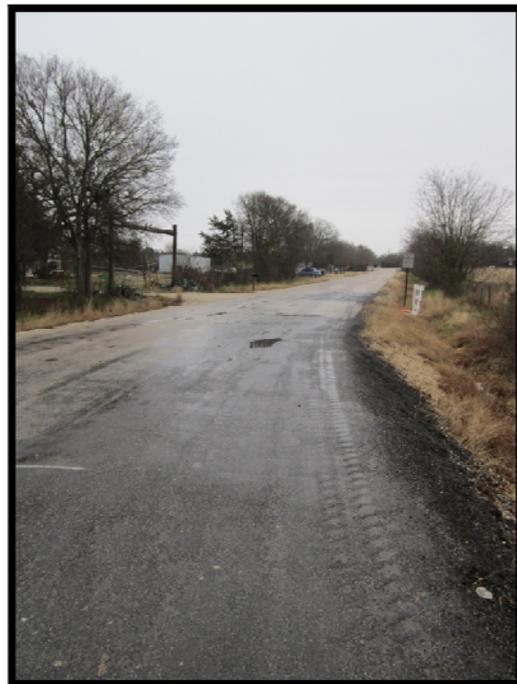
Figure 31 shows the current condition of Mumford Rd. reconstructed without geogrid in 2011. Substantial cracking exists, along with significant surface patching.

Figure 31. Current Condition of Mumford Rd.
