## **Technical Report 12-05**

*Fiber Reinforced Polymer (FRP) Composite Piles Used  
on Pier Rehabilitation, Little Diamond Island, Casco Bay,  
Portland, Maine*

*October 2012*

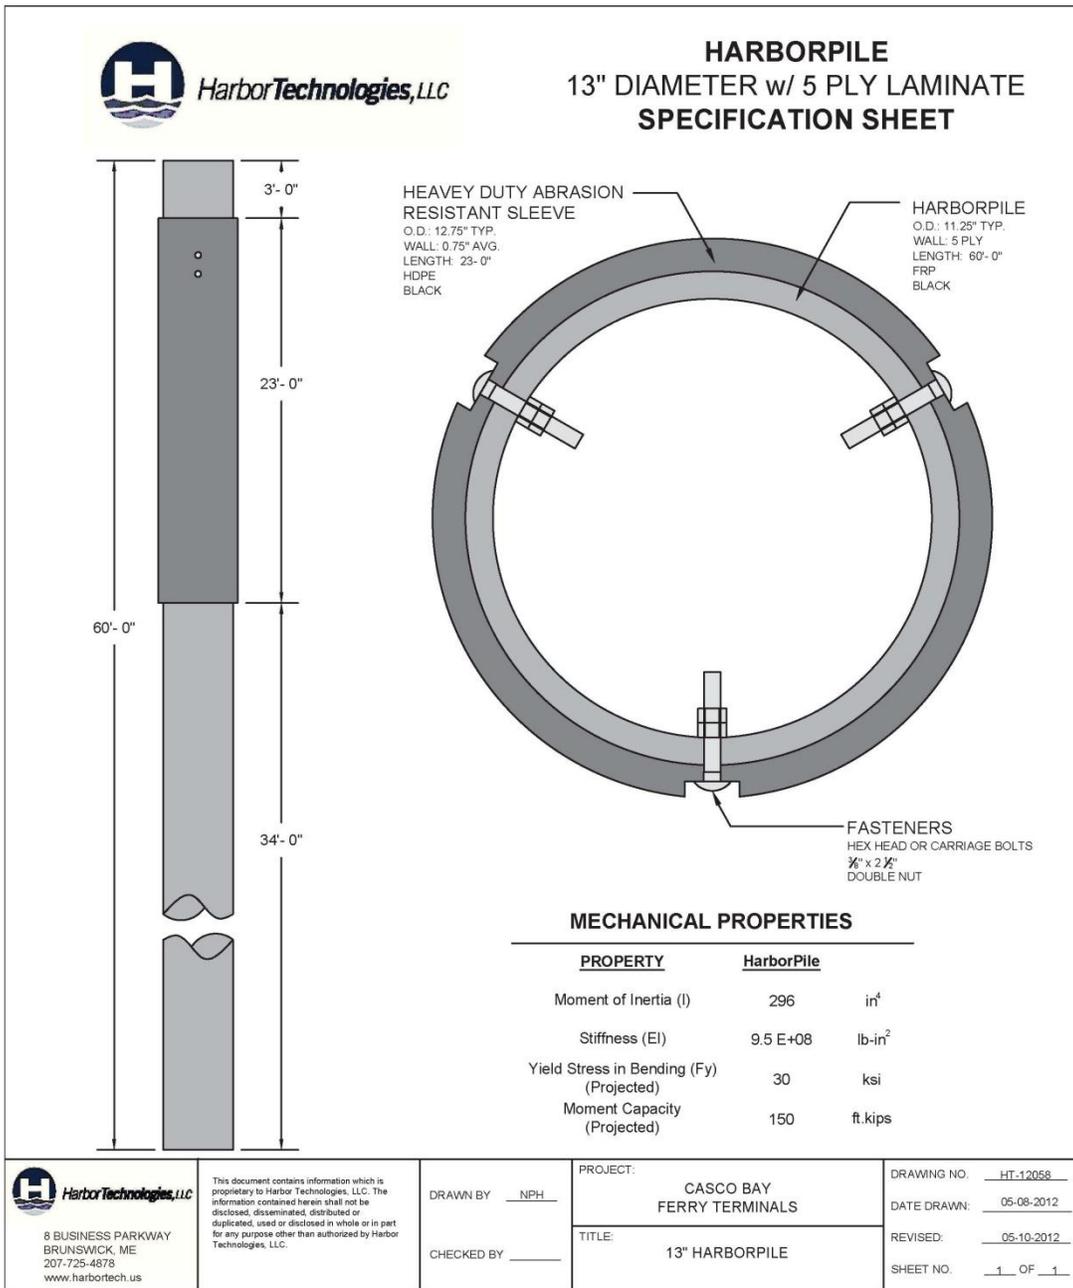
Figure 13. FRP Pile Cross-Section

There were no significant problems during construction of this project. Using the FRP composite piles required a re-design of the bolting configuration, due in part to the fact that counter-sinking for bolt heads is limited on the hollow FRP composite piles. The FRP Pile cross-section plan and bolting design is in Appendix A of this report.
