Technical Report 07-3

*Utilizing Snap-Tite Slip Line Pipe
as a Direct Burial Cross Pipe*

Second Interim Report, January, 2009

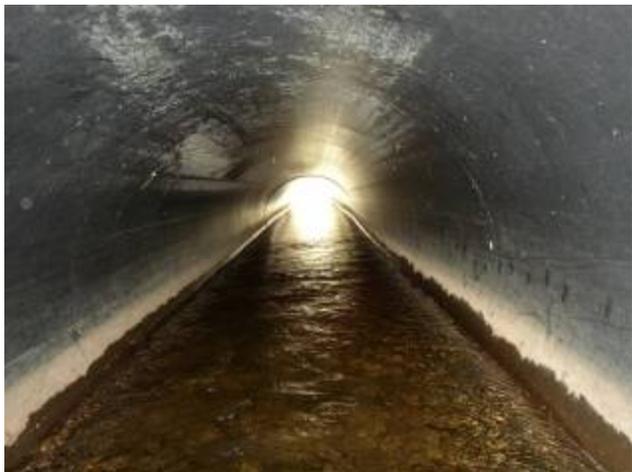
Photo 1: Left Pipe - From Inlet End

Approximately three years after installation, these pipes remain in very good condition. The 4 to 5 inch elevation drop at the center of the pipe identified in the 2006 visual evaluation has not changed. No appreciable deformation is visible in either pipe (Photo 1). Neither pipe appears to have moved and

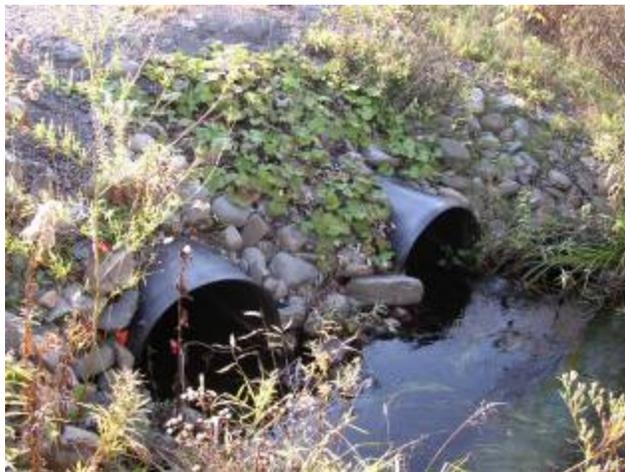
Photo 2: Inlet End of Pipes

banking material at both the inlet and outlet ends remains in place (Photo 2). Roadway settlement, where the pipes cross under the road continues to be approximately 1 to 1.5 inches.

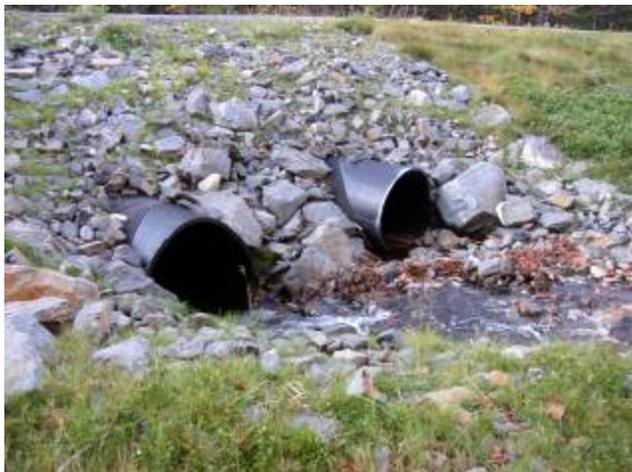
Photo 3: Main (left) and Overflow Pipe

Two Snap-Tite pipes were installed at this location to replace the two existing metal corrugated pipes. Both the main pipe and the overflow pipe are approximately 35 to 40 feet in length. The overflow pipe is approximately 1 foot higher than the main pipe (Photo 3).

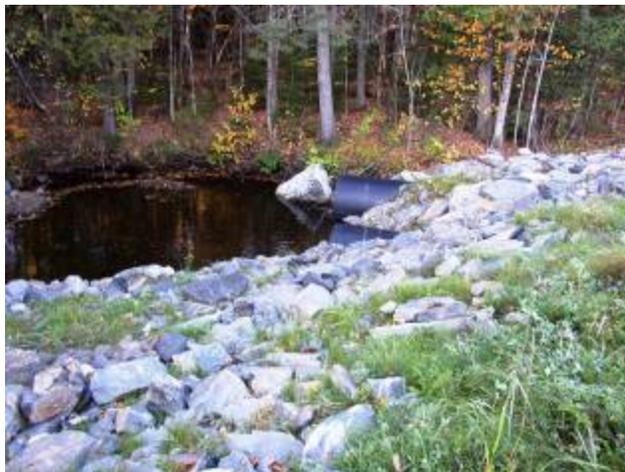
Photo 4: Banking at Outlet End of Pipes

After one year of service, the two pipes at this location are performing very well. Minimal deformation was observed in each pipe, believed to be caused by the weight of the backfill. Pipe joints were found to be intact, with no separation. Banking at both the inlet and outlet ends of the pipes remains in place, with no washouts visible (Photo 4).
