# STATE OF MAINE DEPARTMENT OF TRANSPORTATION

### EXPERIMENTAL CONSTRUCTION 95-05

#### EXPERIMENTAL USE OF HIGH DENSITY POLYETHYLENE DRAINAGE PIPE AS A CROSS ROADWAY DRAINAGE STRUCTURE

#### Final Report

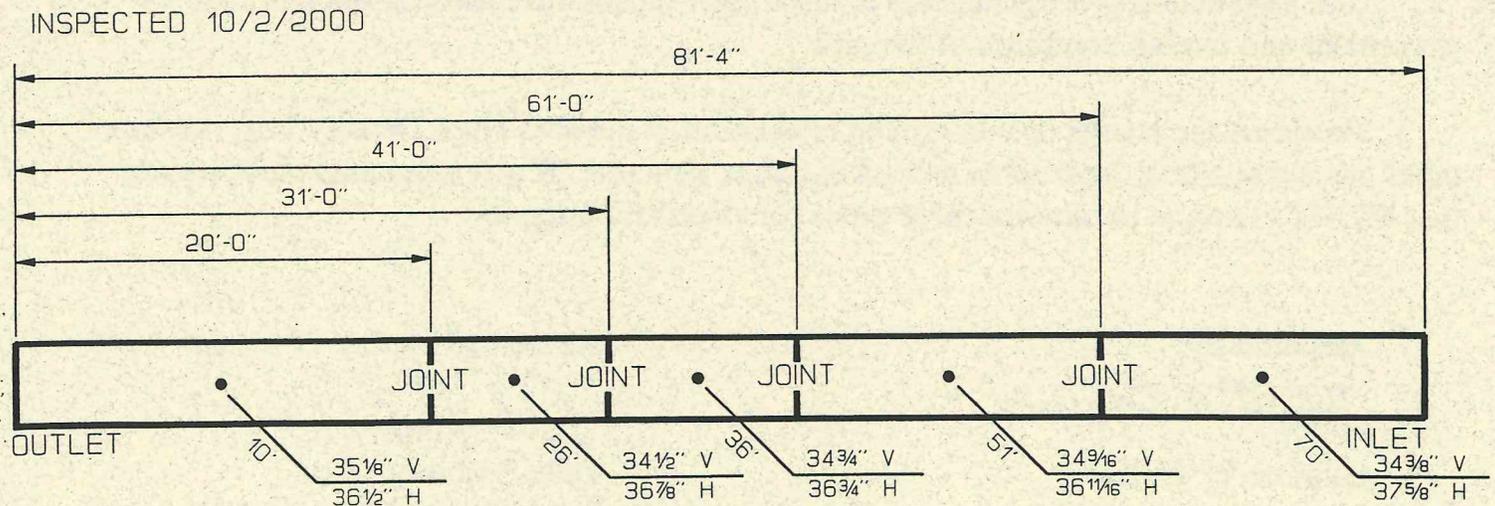
Figure I

Measurements were taken vertically and horizontally in the easterly pipe at the same locations measured in each of the previous inspections (See Figure 1). This inspection marked the fourth year that separations at each of the joints in the easterly pipe were measured and documented. In addition to these separations, some settling of each pipe was again noted. The north (outlet) end of pipe section 5 was also noted to be approximately 25.4 mm (1 in.) above the south (inlet) end of pipe section 4. These conditions are consistent with the initial findings, and are believed to have been present since the completion of the pipe installation.

EASTERLY PIPE OF TWIN 36" POLYETHYLENE PIPES
