# Risk Assessment and Update of Inspection Procedures for Culverts

**Final Report**  
**February 2005**

**RISK ASSESSMENT AND UPDATE OF INSPECTION  
PROCEDURES FOR CULVERTS**

**Leading Research Agency:** Ohio Research Institute for Transportation and the  
Environment (ORITE), Russ College of Engineering and Technology,  
Ohio University:

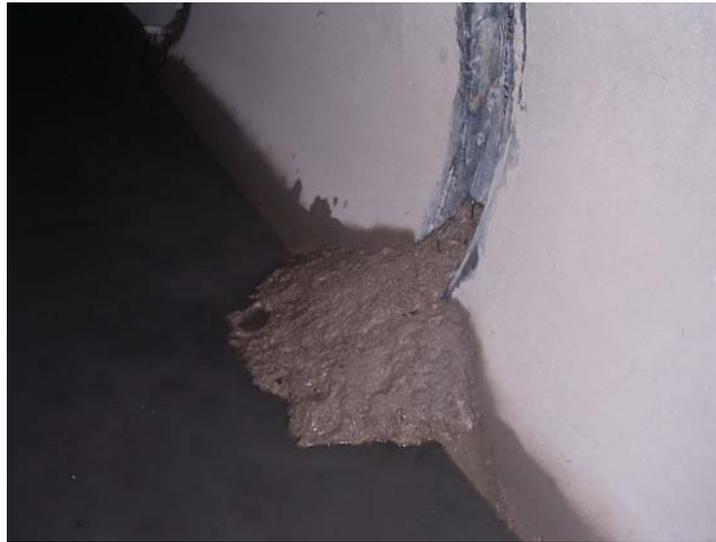
problem were Sections #1, #9, #14, and #17. No longitudinal cracks were detected in the crown region. Backfill was infiltrating into the culvert through a 4-inch (102-mm) opening at the joint between Section #22 and Section #23 (shown in Figure 6.1). The headwall at each end was showing signs of advanced stage of material deterioration (numerous cracks; softening) due to a combination of impacts from moving debris and chloride attack, as seen in Figure 6.2.

**Figure 6.1: Backfill Infiltrating Through Joint Opening (HAN-224-6.84)**

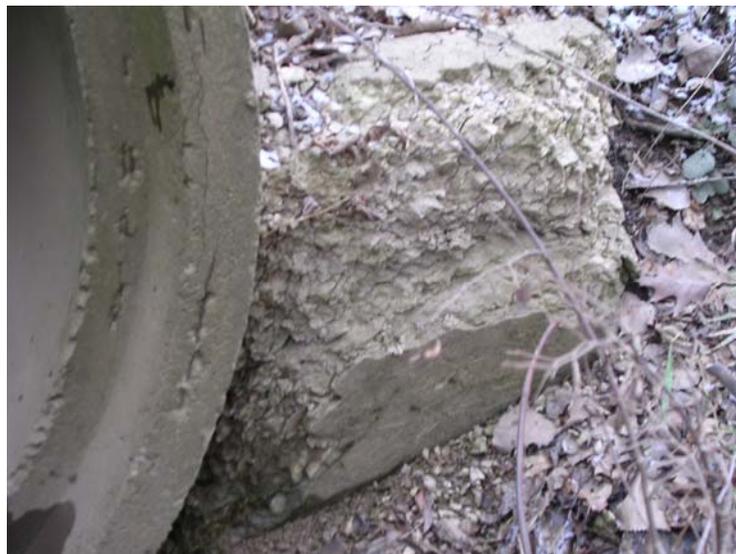
**Figure 6.2: Deteriorated Headwall at Inlet of HAN-224-6.84**

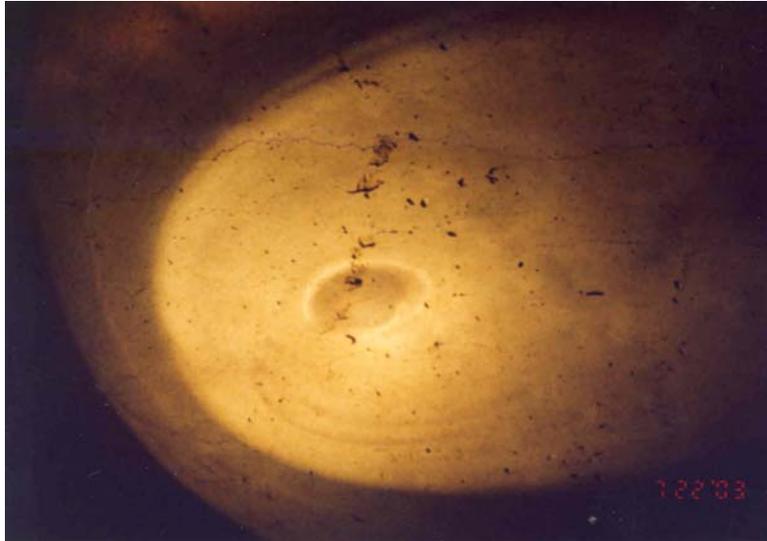
The culvert LIC-70-13.52 (6' or 1.83 m diameter RCP) consisted of fifty-eight sections joined together. At this site, longitudinal hairline cracks were detected within the top section between Section #5 to Section #54 (see Figure 6.3). None of the cracks had iron staining. At some locations, the cracks developed a map pattern, causing small scaling in the area. Section #33 had a 1/8-inch (3-mm) width crack running along its length at the shoulder. The joint offset was as much as 1.5 inches (38 mm) at the joints between Section #11 and Section #12 and joint between Section #32 and Section #33. No signs of backfill infiltration were found anywhere between the ends. The culvert appeared to have a minor sagging in the middle. At each end, one side of the headwall had more cracks and material deteriorations. Only a minor (5 inches or 127 mm deep) scour was detected at the inlet end.

**Figure 6.3: Longitudinal Crack Detected at Crown of LIC-70-13.52**

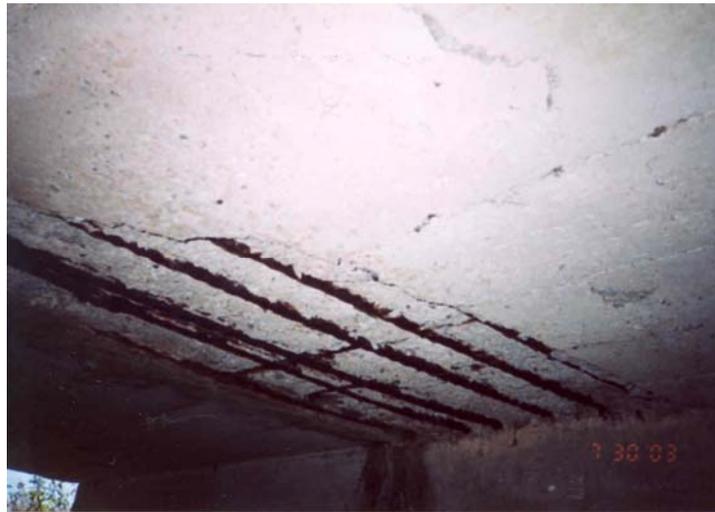
Headwalls at the site of MAD-142-4.30 (4' x 3' or 1.22 m x 0.91 m cast-in-place concrete box) were also showing signs of severe material deteriorations through cracking and softening (due to winter deicing operations). Deterioration/softening of concrete was also observed on the bottom slab. The top slab had a large area near the middle length where material deterioration (softening) had taken place and scaling had made a 1-inch (25-mm) deep cavity into the concrete, as seen in Figure 6.4. The bottom layer of rebar were exposed and heavily rusted in the area. A moderate degree of soil erosion was noted on the embankment slope behind the headwall at the southeast end of the structure.

**Figure 6.4: Top Slab of MAD-142-4.30**

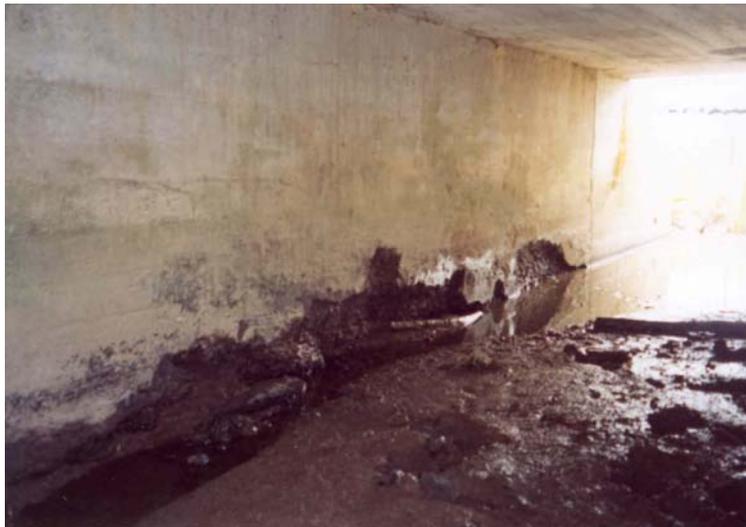
**Figure 6.5: Deteriorated Lower Section of Abutment Wall (CLI-28-7.84)**

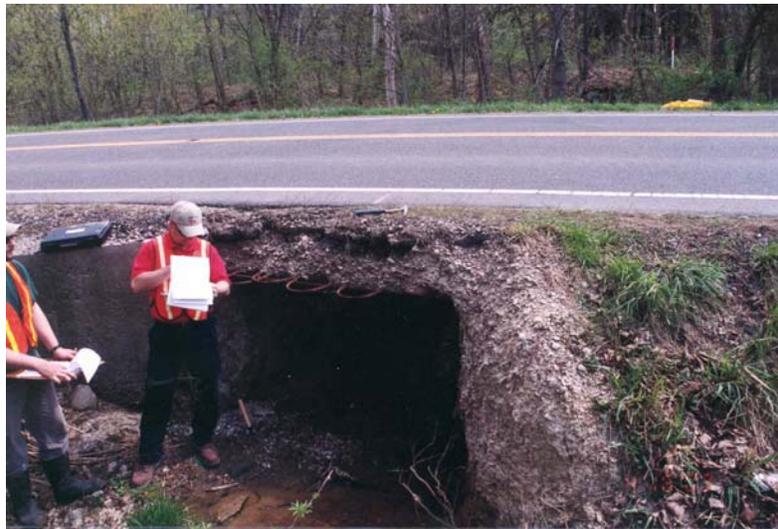
**Figure 6.6: Deteriorated Headwall at Inlet of HOC-78-1.05**

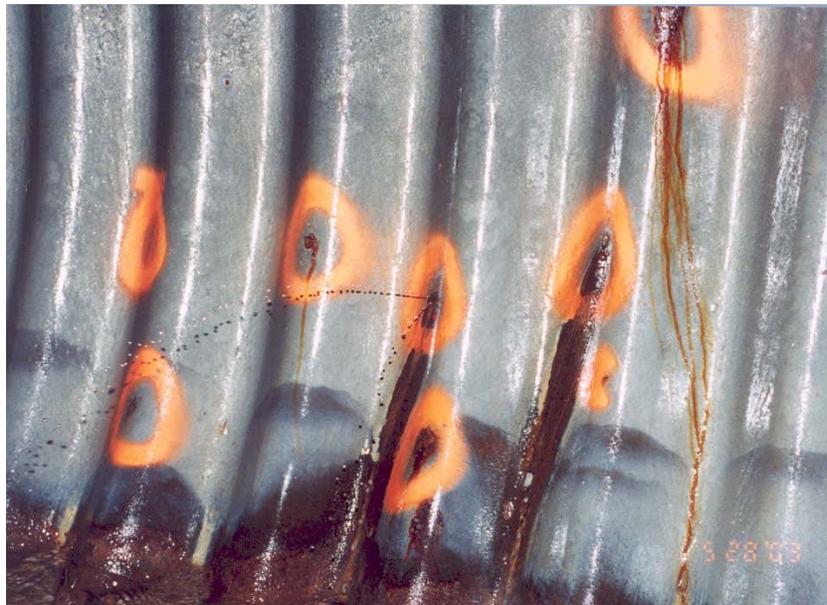
The culvert LIC-16-13.66 (6.3' or 1.92 m diameter metal pipe) had 3 to 4-inch (76 to 102-mm) diameter perforation holes in the right haunch area, close to the air/water interface, at isolated locations. It was not possible to inspect the invert section because of sediment accumulation. At 33 ft (10.1 m) away from the outlet, seepage water was squirting out through a couple of pinholes located at the right haunch (as shown in Figure 6.7). The top arc was relatively flat over the length of the culvert positioned under the maximum fill height. No stress cracks were detected at bolt lines. Moderate rusting of plates and bolts was observed along seams near the outlet end. The stream bed was significantly lower than the culvert invert at the outlet. The headwall at the inlet was showing damage received from moving debris on the front side and erosion taking place behind. The headwall at the outlet looked rotated. Also, the concrete face below the invert exhibited spalling/flaking.

**Figure 6.7: Seepage Water Flowing In Through Pinhole (LIC-16-13.66)**

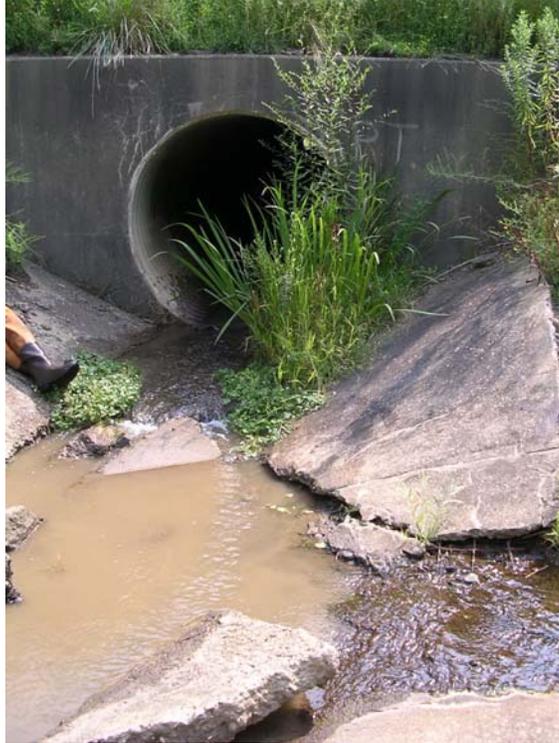
The culvert GUE-77-7.85R (6' or 1.83 m diameter metal pipe) was under a 40-ft (12.2-m) soil cover. Several small (2"-3" or 51-76 mm diameter) perforation holes were detected in the springline region in the inlet section. A small amount of backfill soil was infiltrating through one of the holes. Small perforation holes continued to exist at the springline at isolated places throughout the structure. In addition, larger perforation holes were found at the 5:00 o'clock position at a few locations (34.5' and 6', or 10.5 and 1.8 m, away from the outlet end). The invert plates were buried under sediment. The plates above the springline were rusted only superficially along the edges and on the bolts. Moderate degree of rusting and flaking was observed on the plates at the 9:00 o'clock position (left springline), 10.5' (3.2 m) away from the inlet end. The vertical deflection taken at the mid-length was about 5%. However, the vertical deflection taken further downstream (126' or 38.4 m from the outlet end) was 11.8%. Slight flattening of the top and bottom arcs was noticed in this area. The headwall at the inlet had only minor material deteriorations. However, its lower right corner was cracked. The headwall at the outlet had several hairline cracks above the crown. The stream bed was lined with concrete at the outlet. The concrete liner was broken into many pieces (see Figure 6.8).

**Figure 6.8: Deteriorated Concrete Liner at Outlet of GUE-77-7.85R**

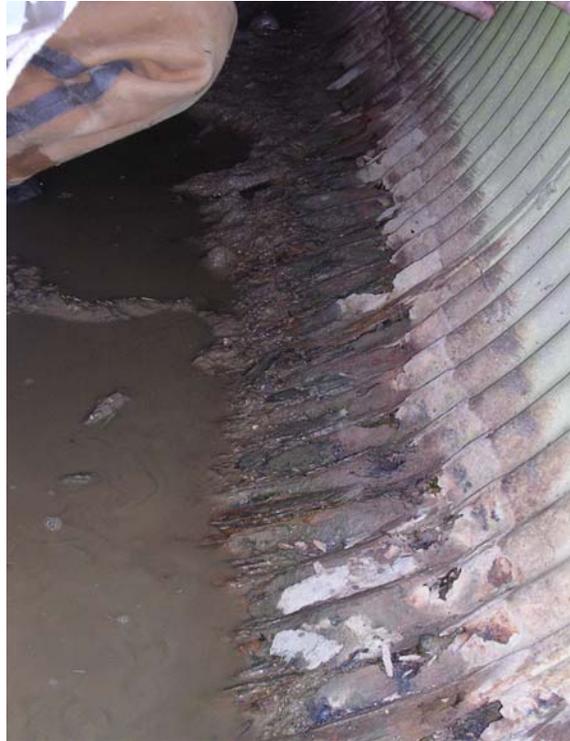
The culvert KNO-95-0.08 (4' or 1.22 m diameter metal pipe) normally carried no drainage flow and served as a flood control device. The culvert consisted of three seamless 20-ft (6.1-m) length pipe sections. The corrugated plates had a size of 3" (76 mm) pitch by 0.5" (13 mm) depth and a thickness of 0.111" (3 mm). The metal plate was heavily rusted and perforated at 4:00 and 8:00 o'clock positions, as shown in Figure 6.9. The invert section was not visible for direct inspection, being covered under 6-inch (152-mm) deep sediment. Inside measurements taken at several locations found a maximum vertical deflection of 18% at Joint 2 (20 ft or 6.1 m away from the inlet end). The culvert shape appeared to be somewhat nonsymmetrical. At the crown of Joint 1 (20 ft or 6.1 m away from the outlet end), a 2-inch (51-mm) gap existed between the two pipe ends, exposing granular soil. The culvert had no concrete headwalls at the ends.

**Figure 6.9: Perforations at Flow Line Inside KNO-95-0.08**

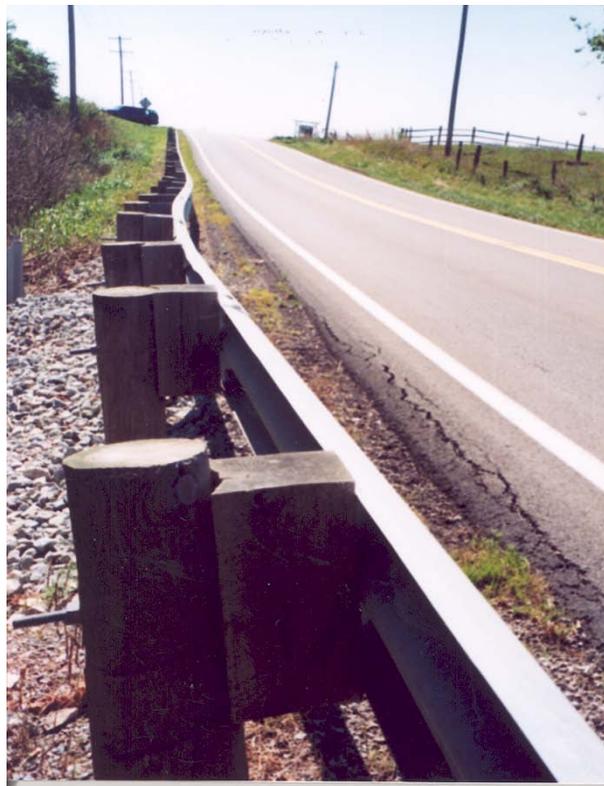
**Figure 6.10: Tension Cracks along Edge of Pavement (MAD-29-8.80)**

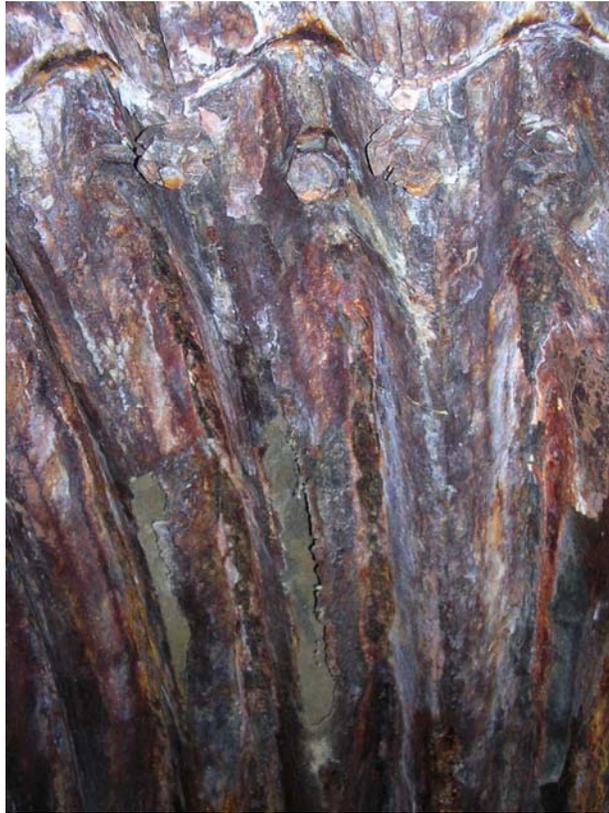
On the left shoulder, an elongated hole of size 1” (25 mm) width by 18” (457 mm) length was detected 30 ft (9.14 m) away from the outlet end (shown in Figure 6.11). Gray, cohesive backfill soil was visible through the hole. No sizable void space had developed outside the perforated hole. The invert plates were moderately rusted and somewhat soft in the inlet area. The culvert had a symmetric shape and only slight deflections (vertical deflection 4%). The bolted seams looked tight. There was a 12-inch (0.31-m) deep scour at the inlet. The stream bed at the outlet was concreted. Headwalls looked like they had only slight material deteriorations.

**Figure 6.11: Elongated Perforation Holes Detected at Left Shoulder (CLI-124-0.03)**

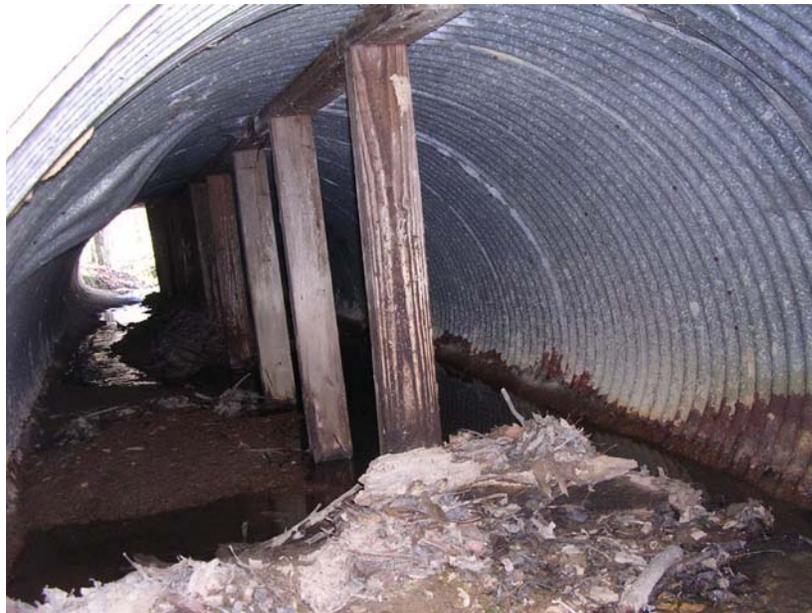
**Figure 6.12: Timber Bracing Applied Inside JAC-124-17.12**

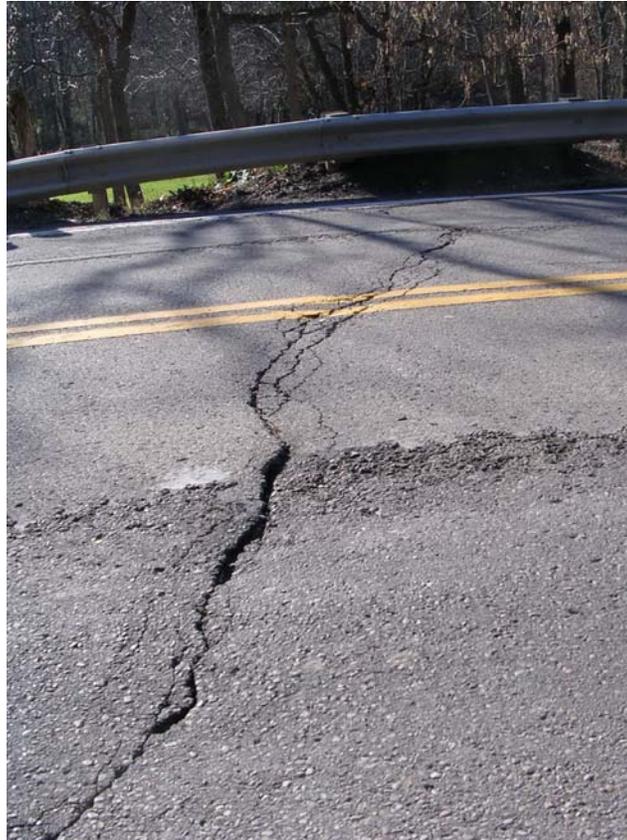
**Figure 6.13: Transverse Crack Detected Above JAC-124-17.12**

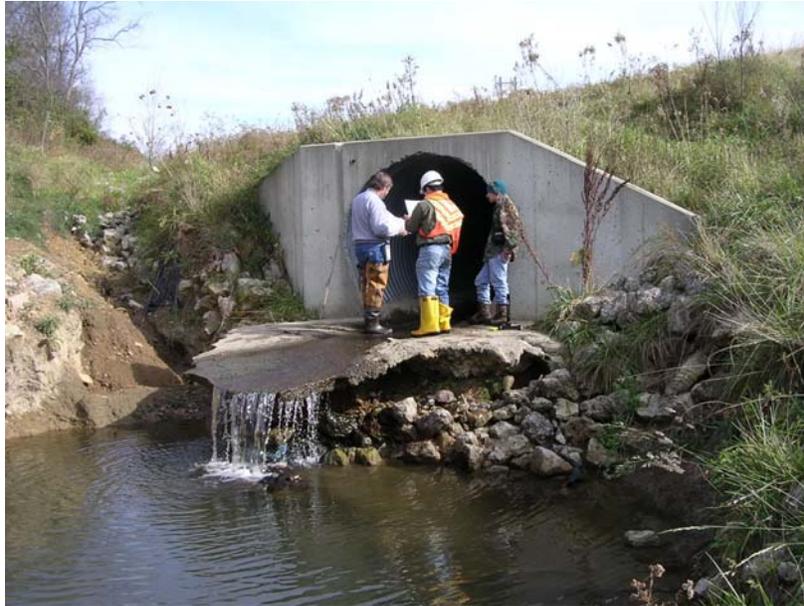
The culvert PIK-32-15.96 (7' or 2.13 m diameter metal pipe) was 391 ft (119.2 m) long and was serving under a 16 ft (4.88 m) of soil fill. Its corrugation plates had a rare size of 5" (127 mm) pitch by 1" (25 mm) depth with a thickness of 0.108" (3 mm). No protective coating layer was applied to the culvert interior. However, a concrete invert pavement existed along the culvert length. Conditions of the invert pavement layer were good. The corrugated plates had minor dents and bulges at numerous locations. These were most likely induced during construction. The culvert was experiencing only small deflections (max. vertical deflection 4%). The headwall at each end looked good with only a minor hairline crack running vertically above the crown. There was a 6-ft (1.83-m) deep scour hole at the outlet end (see Figure 6.14).

**Figure 6.14: A Large Scour Hole at Outlet of PIK-32-15.96**

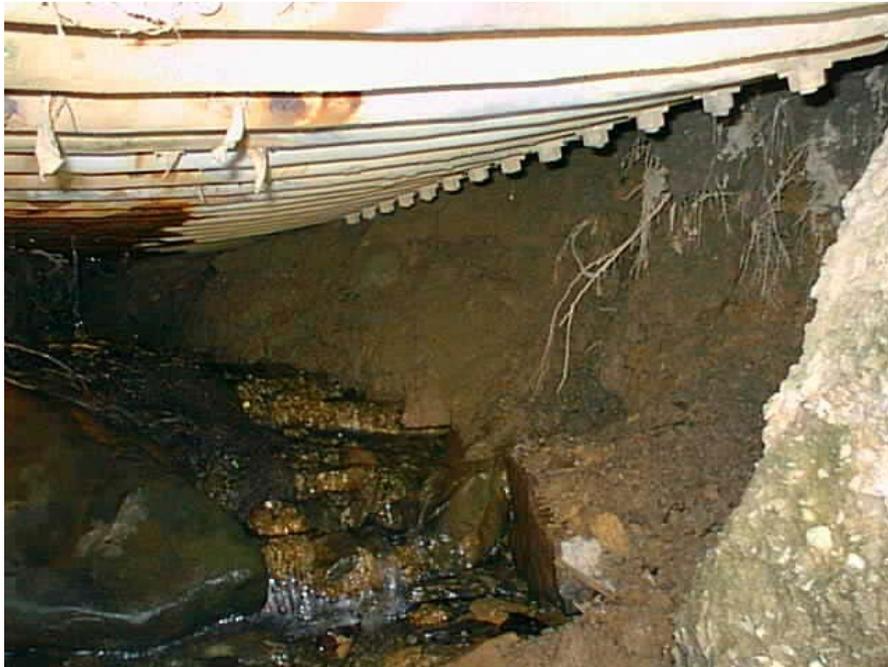
**Figure 6.15: A Large Void Space Under HOC-595-2.85**

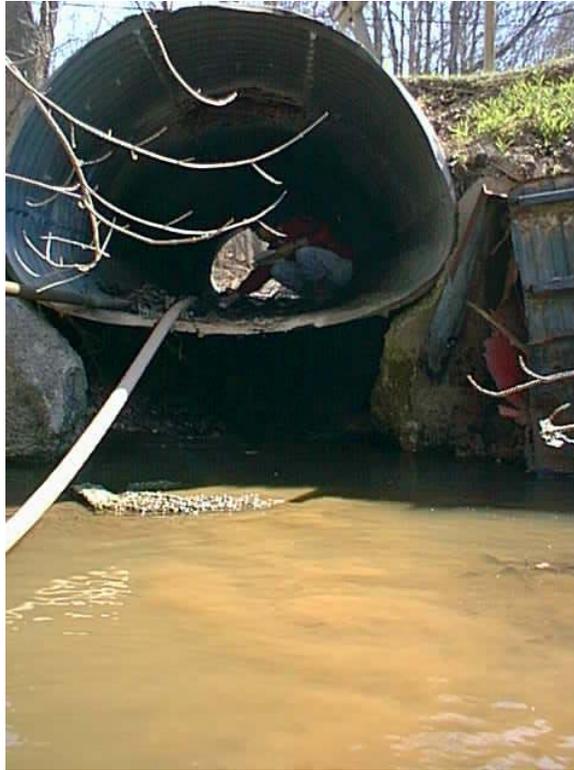
**Figure 6.16: Shear Failure of Outlet Headwall at HOC-595-2.85**

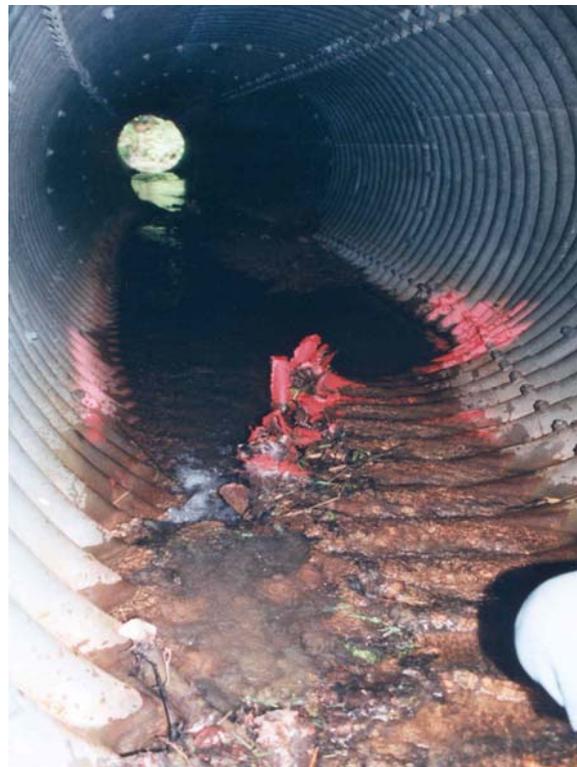
**Figure 6.17: Damaged Inlet Section of HOC-664-22.4**

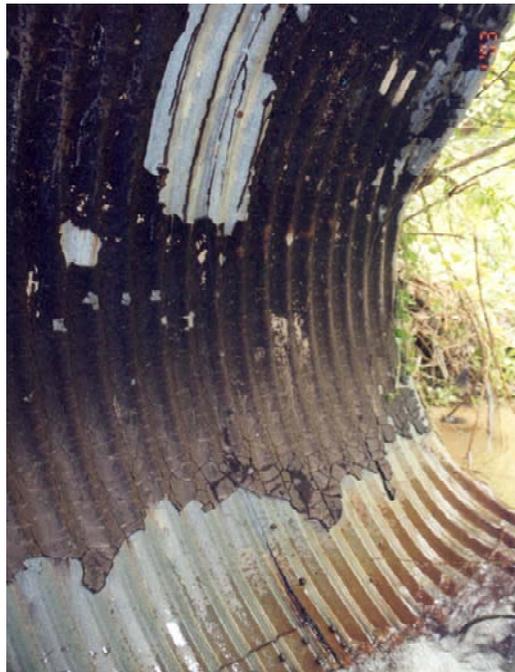
**Figure 6.18: Delaminated Protective Coating Inside MEG-681-7.94**

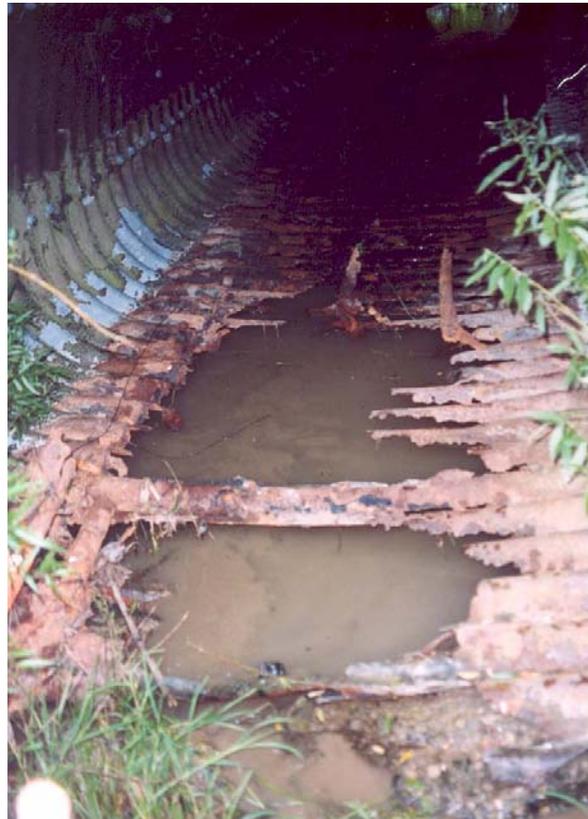
extent of perforation in this area, the drainage flow was moving below the invert and causing up to 12-inch (0.31-m) deep scouring under the culvert. Invert plates were heavily rusted at the outlet as well. One 2' x 2' (0.61 m x 0.61 m) perforation hole was discovered on the invert near the outlet end. Invert of the main barrel had small perforations scattered throughout. The drainage water was flowing over the invert in the main barrel section. The bituminous coat was nonexistent over the invert and spotty over the sides and top arc. General shape of the culvert appeared to be good, with vertical deflection only about 3%. The headwall at each end had at least one major crack and showed signs of minor material deterioration.

**Figure 6.19: Large Perforation Holes Through Invert of HOC-595-4.57**

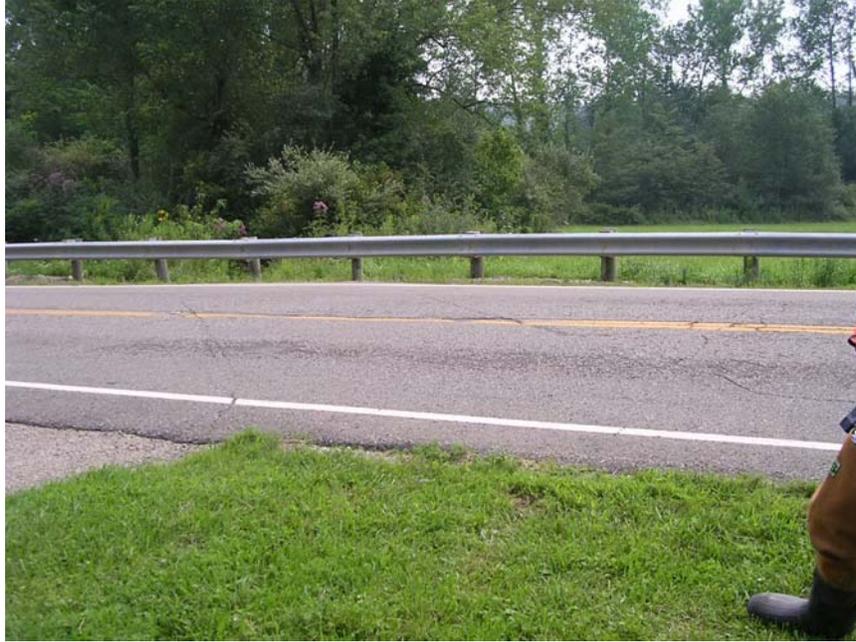
The 42-inch (1.07-m) diameter HDPE pipe (PER-13-11.14) consisted of three standard length sections, giving it a total length of 60 ft (18.3 m). According to the manufacturer, this pipe product was manufactured by an obsolete process. Minor dimpling of the internal hydraulic lining existed at the springline positions from about 6 ft (1.83 m) inside the inlet end to about 5 ft (1.52 m) away from the outlet end. In the middle section, the bottom arc appeared flat. Cross-sectional shape was like an oval and symmetric. There were no headwalls at the ends. Roadway embankment slopes surrounding the pipe inlet/outlet were treated with ODOT Type “C” rock protection. The roadway surface had two transverse cracks running parallel to the skewed pipeline structure (see Figure 6.20). The cover height over the pipe was only 1.5 ft (0.46 m). A deep scour hole was found below the outlet end.

**Figure 6.20: Skewed Transverse Cracks Over PER-13-11.14**

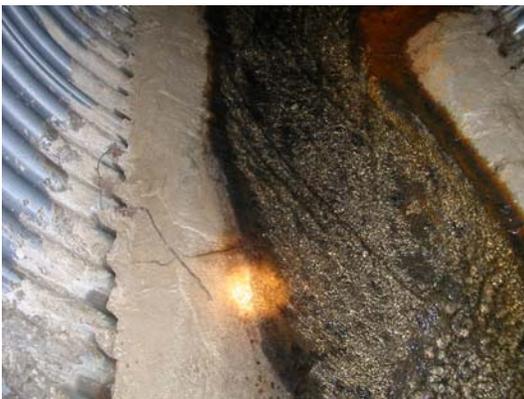
The most frequently used type of invert replacement is concrete paving. The outcome of this type of work is highly dependent on the skill of the installer. In the first photo below the invert-paving job was poorly constructed. It allows for ponding in the pipe, flow behind the paved invert, and does not cover the bottom 1/3 of the pipe. In contrast, the second photo is a good invert paving job.

**Figure 8.3: Example of Poor Invert Paving**

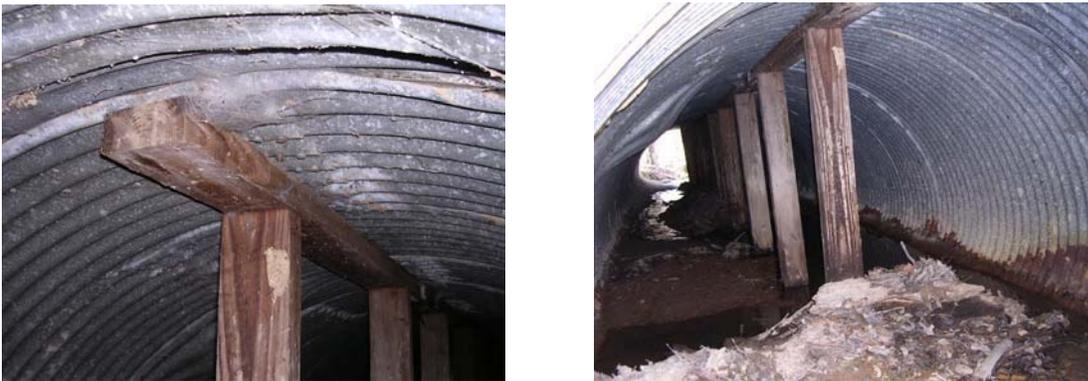
**Figure 8.5: Timber Bracing that Allowed Debris Collection**

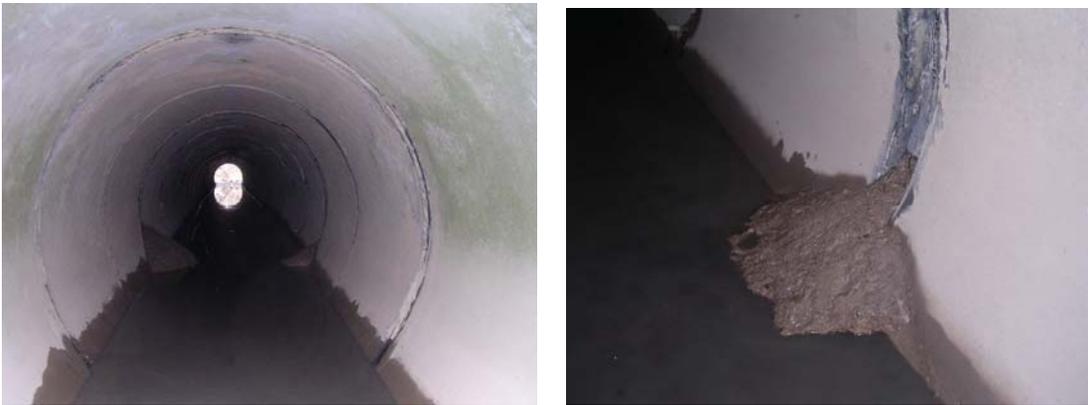
**Figure 8.6: Poor Joint Sealing that Allowed Infiltration**

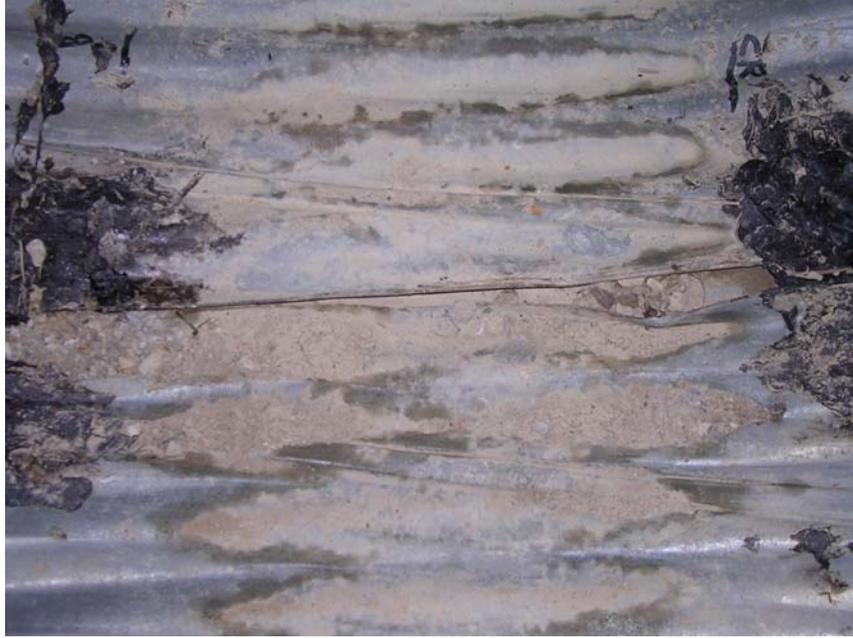
**Figure H.3: Joint Condition at Invert of Joint 1**

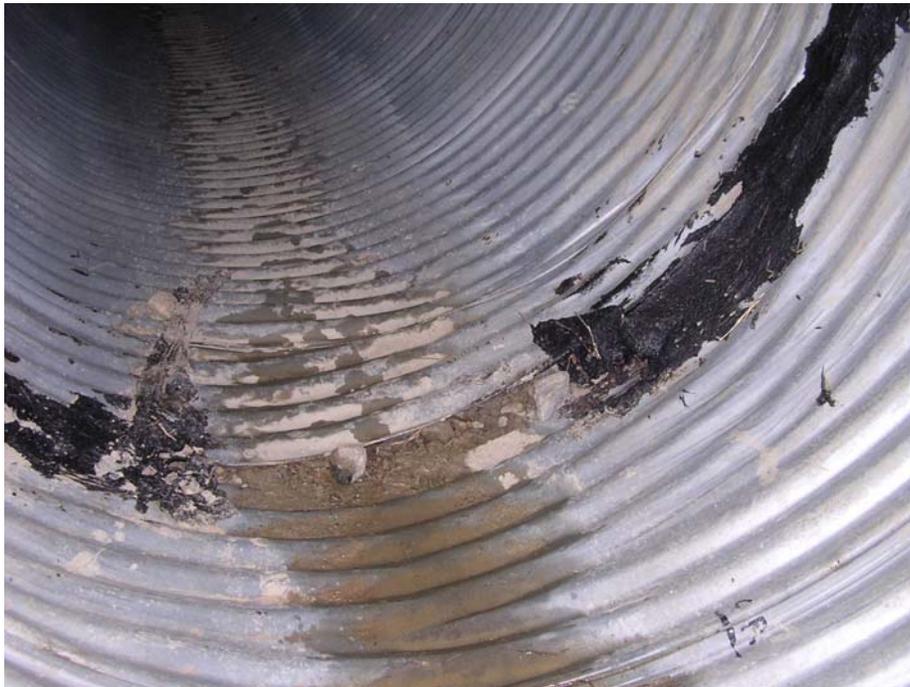
**Figure H.6: Gap and Offset Detected at Joint 3 (Near Inlet End)**
