Paper presented at the 1991 Meeting of the Transportation  
Research Board

# EVALUATION OF PAVEMENT BLEEDING PROBLEM ON I-55 IN ILLINOIS

E. R. Brown  
Stephen A. Cross  
J. G. Gehler

NCAT Report No. **91-7**

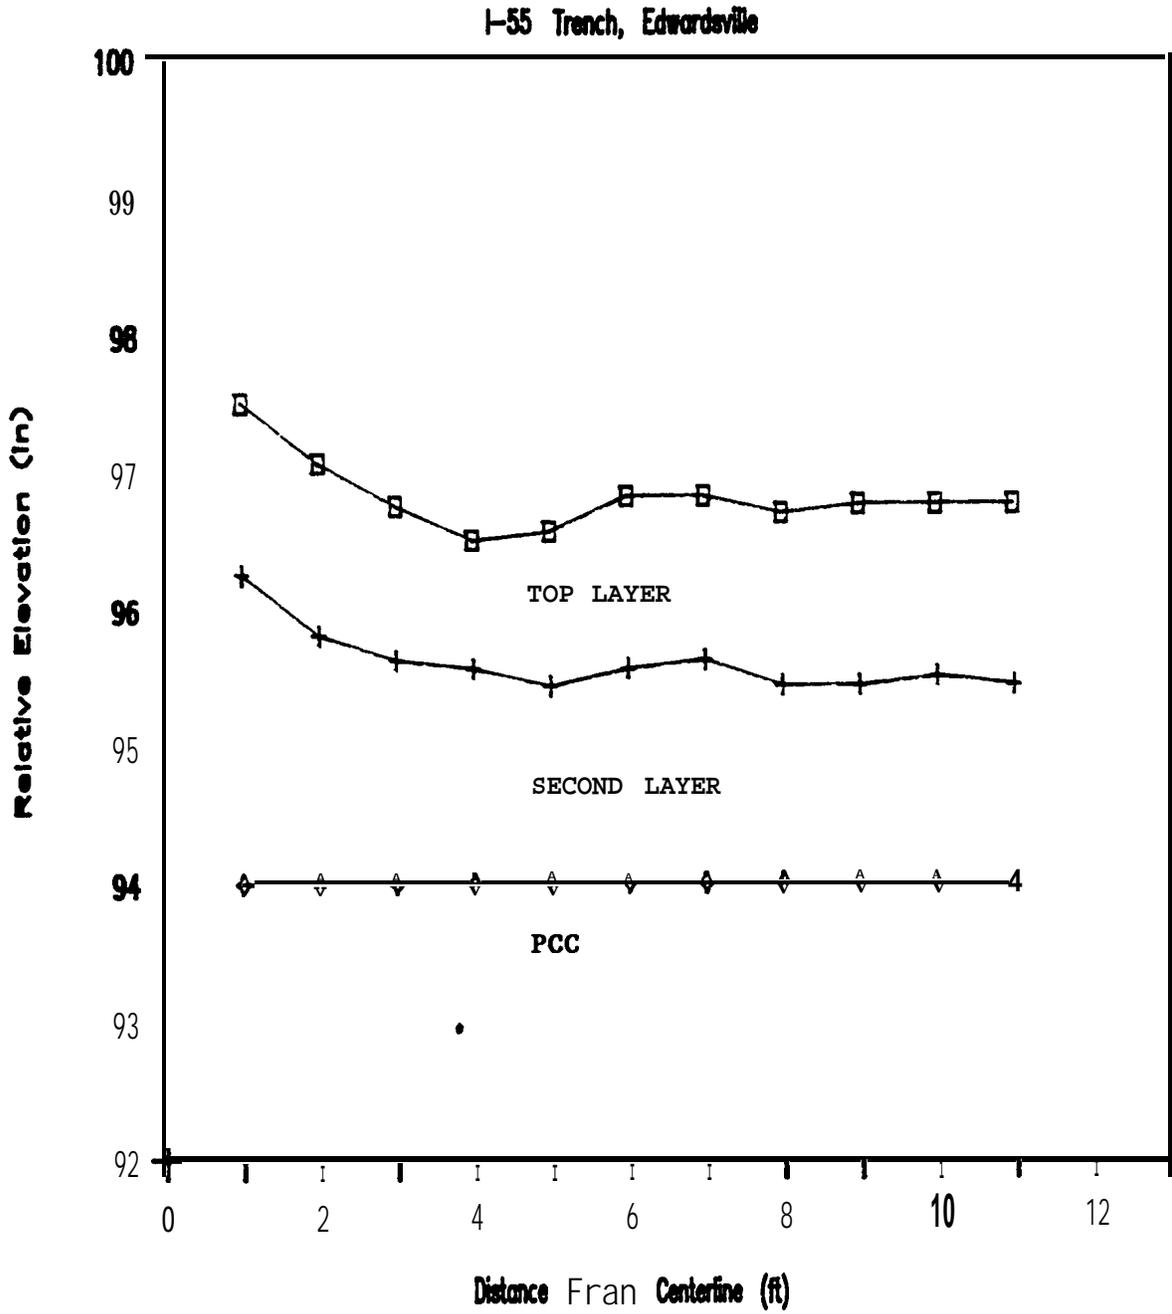
Figure 2. Trench Cut at Sta. 934+70, North Bound Lane, 1-55, Near Collinsville, IL.

Rut measurements were taken at the trench and the results plotted in Figure 2. The rut depth at this location was approximately 0.6 inches. Atypical localized bleeding area is shown in Figure 3.

The pavement section (Figure 2) shows that there were 2 layers of asphalt mixture placed over an existing layer of concrete. The total thickness of asphalt mixture was approximately 3 inches. Figure 2 shows that rutting had occurred in the surface and binder course. The rutting was more severe at the locations that had localized bleeding than in the other areas. The major concerns at the time of inspection was the rutting problem in general and the ravening and potholes being developed at the localized fat spots.

An inspection of the pavement adjacent to the trench cut through a bleeding spot did not indicate causes of the problem. This inspection did show that the problem was confined to the top layer of asphalt mixture and that the lower half of the layer had less asphalt cement than the top half.
