# **NO-TACK INLAY ON MILLED SURFACE: PROJECT REPORT**

**L. Allen Cooley, Jr.  
Research Engineer  
National Center for Asphalt Technology  
Auburn University, Alabama**

**NCAT Report No. 99-2**

**February 1999**

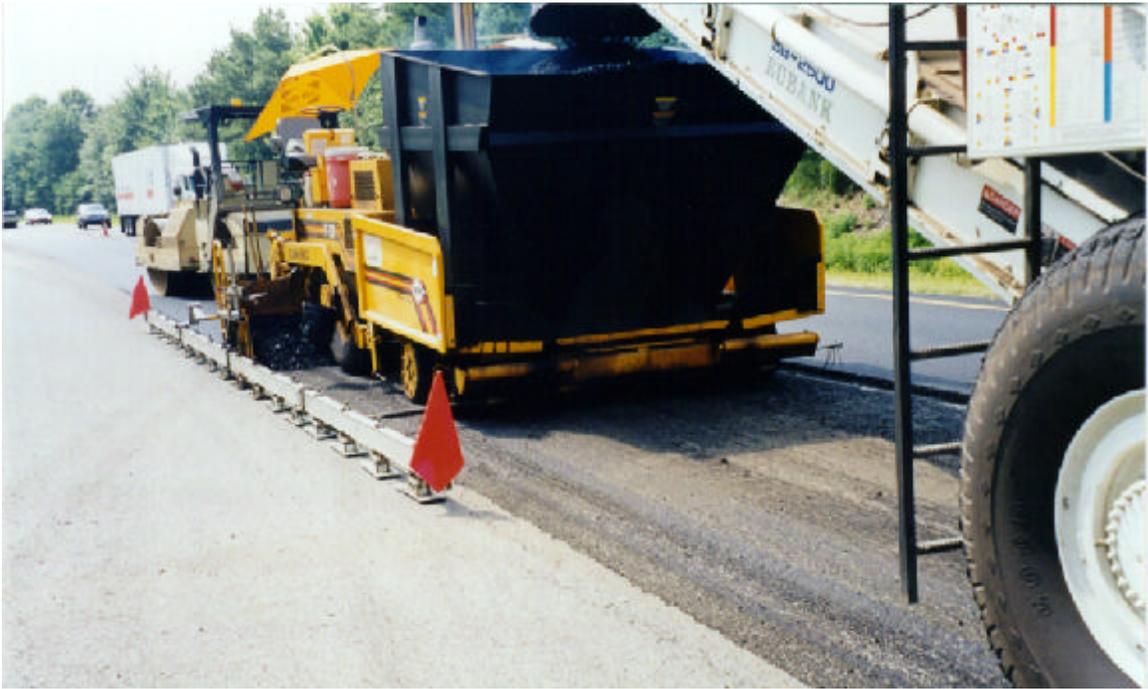
This report documents my observation of a construction project west of Nashville, Tennessee that did not use a tack coat during the placement of the hot mix asphalt (HMA). This observation took place on June 23, 1998. For this project, the existing pavement was milled approximately 50 mm (2 in) with the majority of the millings being used as recycled asphalt pavement (RAP) within the mixture being produced. Instead of sweeping the milled portion clean, the contractor lightly swept the milled surface, leaving a small amount of millings primarily in the bottom of the grooves. The new HMA mixture was then placed directly onto the milled surface with no tack coat. The premise of this methodology was that the grooved pavement in conjunction with the melting of the asphalt within the loose millings by the heat of the placed mixture would result in a bond between the placed mixture and underlying pavement. Therefore, a tack coat was not needed.

Figure 3: Pavement With No Tack Coat Prior to Placement of Mixture

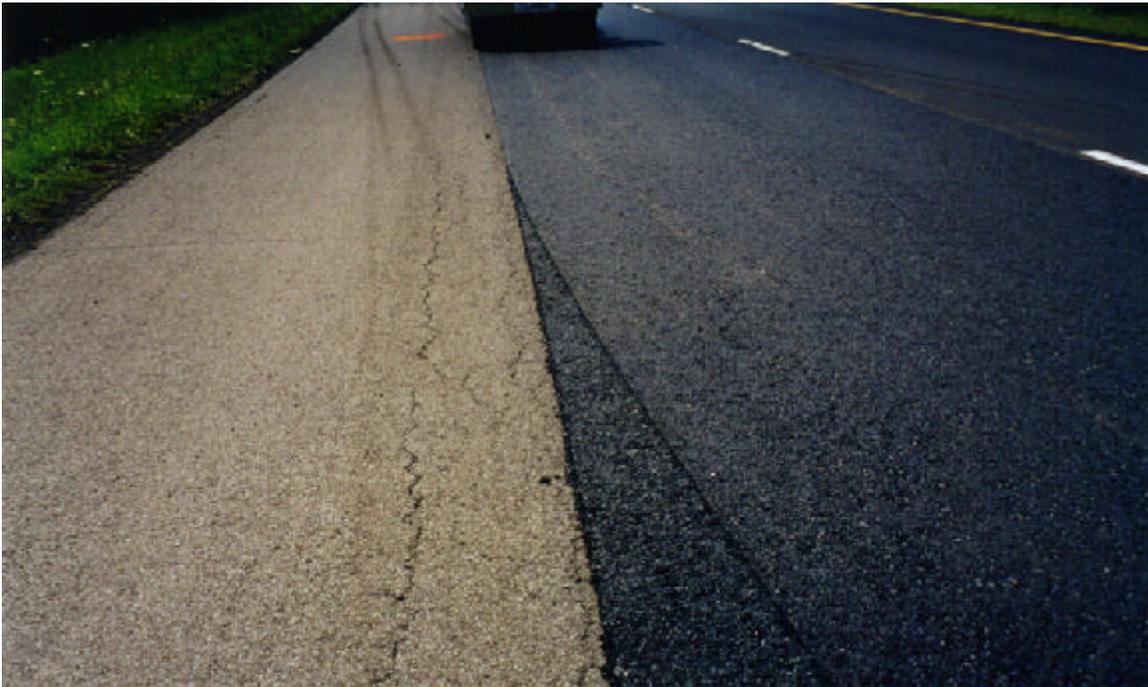
While observing the paving operation, the mixture seemed stable under the rollers. No lateral movement was noticed. Once the breakdown roller had made two to three passes, no appreciable roller marks were observed in the pavement. Figure 5 shows the pavement after one pass of the breakdown roller. The contractor and a TDOT inspector said that the pavement was being compacted to 94-95 percent of theoretical maximum density.

Figure 5: Pavement Surface After One Pass of Breakdown Roller (Roller Mark)

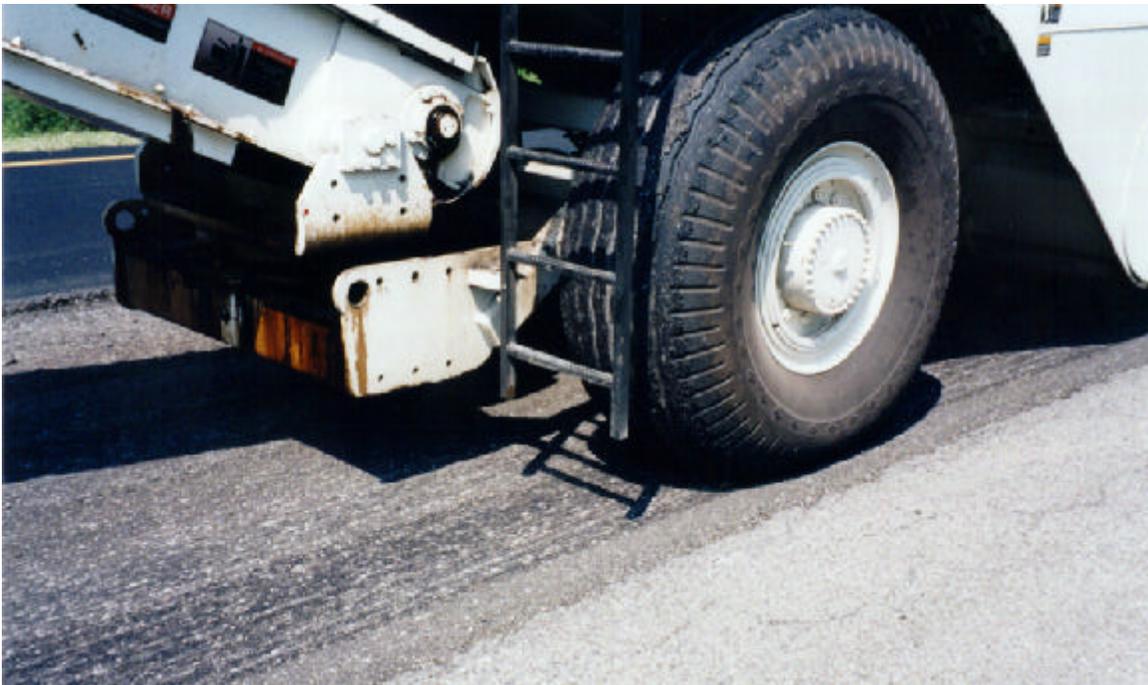
The contractor was pleased with the operation since pick-up prior to placing the HMA was not a problem. The tires on the MTV were clean since no tack coat was used (Figure 6).

Figure 6: Tire From Material Transfer Vehicle

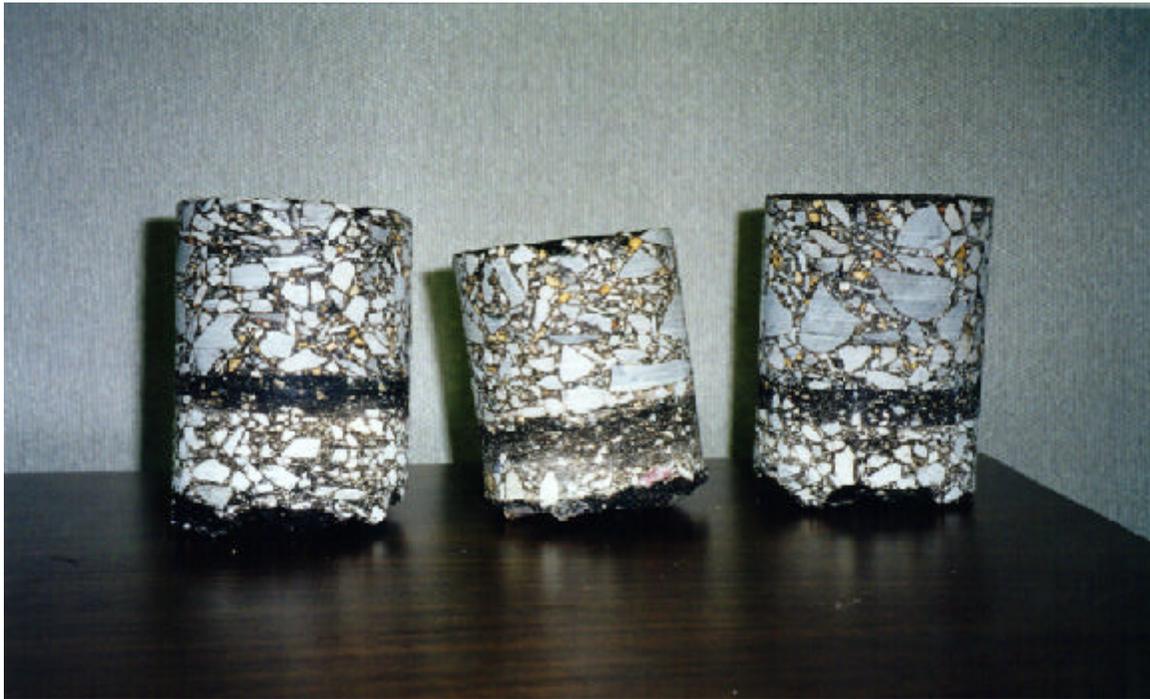
The bond between the placed mixture and underlying pavement seemed strong. The contractor had cut cores to show the strength of the bond (Figure 7). When cutting and removing the cores from

the roadway, they actually broke in the underlying pavement and not at the interface below the overlay.

Figure 7: Cores Obtained From Project

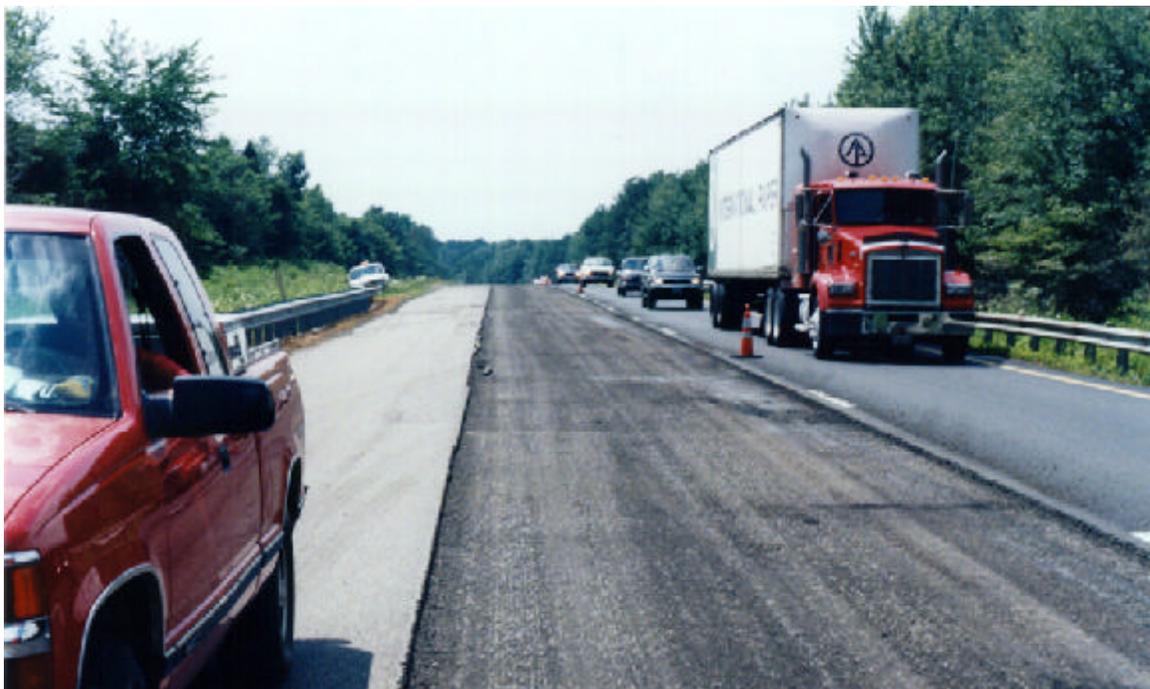
Because of the milling operation, the joints on either side of the roadway were vertical (Figure 8). After the placement and compaction of the mixture, the joints seemed to be tight (Figure 9).

Figure 8: Milled Roadway Showing Vertical Sides

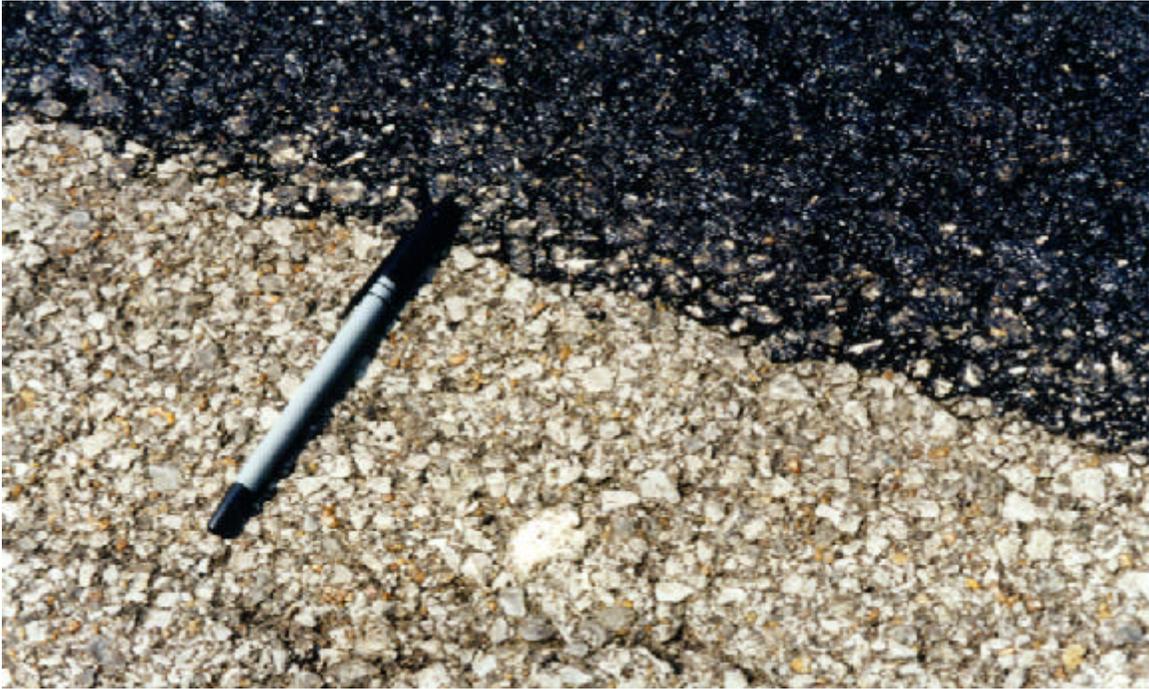
Figure 9: Finished Joint
