CAUSAL FACTOR: Vehicle Speed - Speed and Alcohol
ROADSIDE DEPARTURE: Right

PSU No. 43

Case Number - Stratum 127A

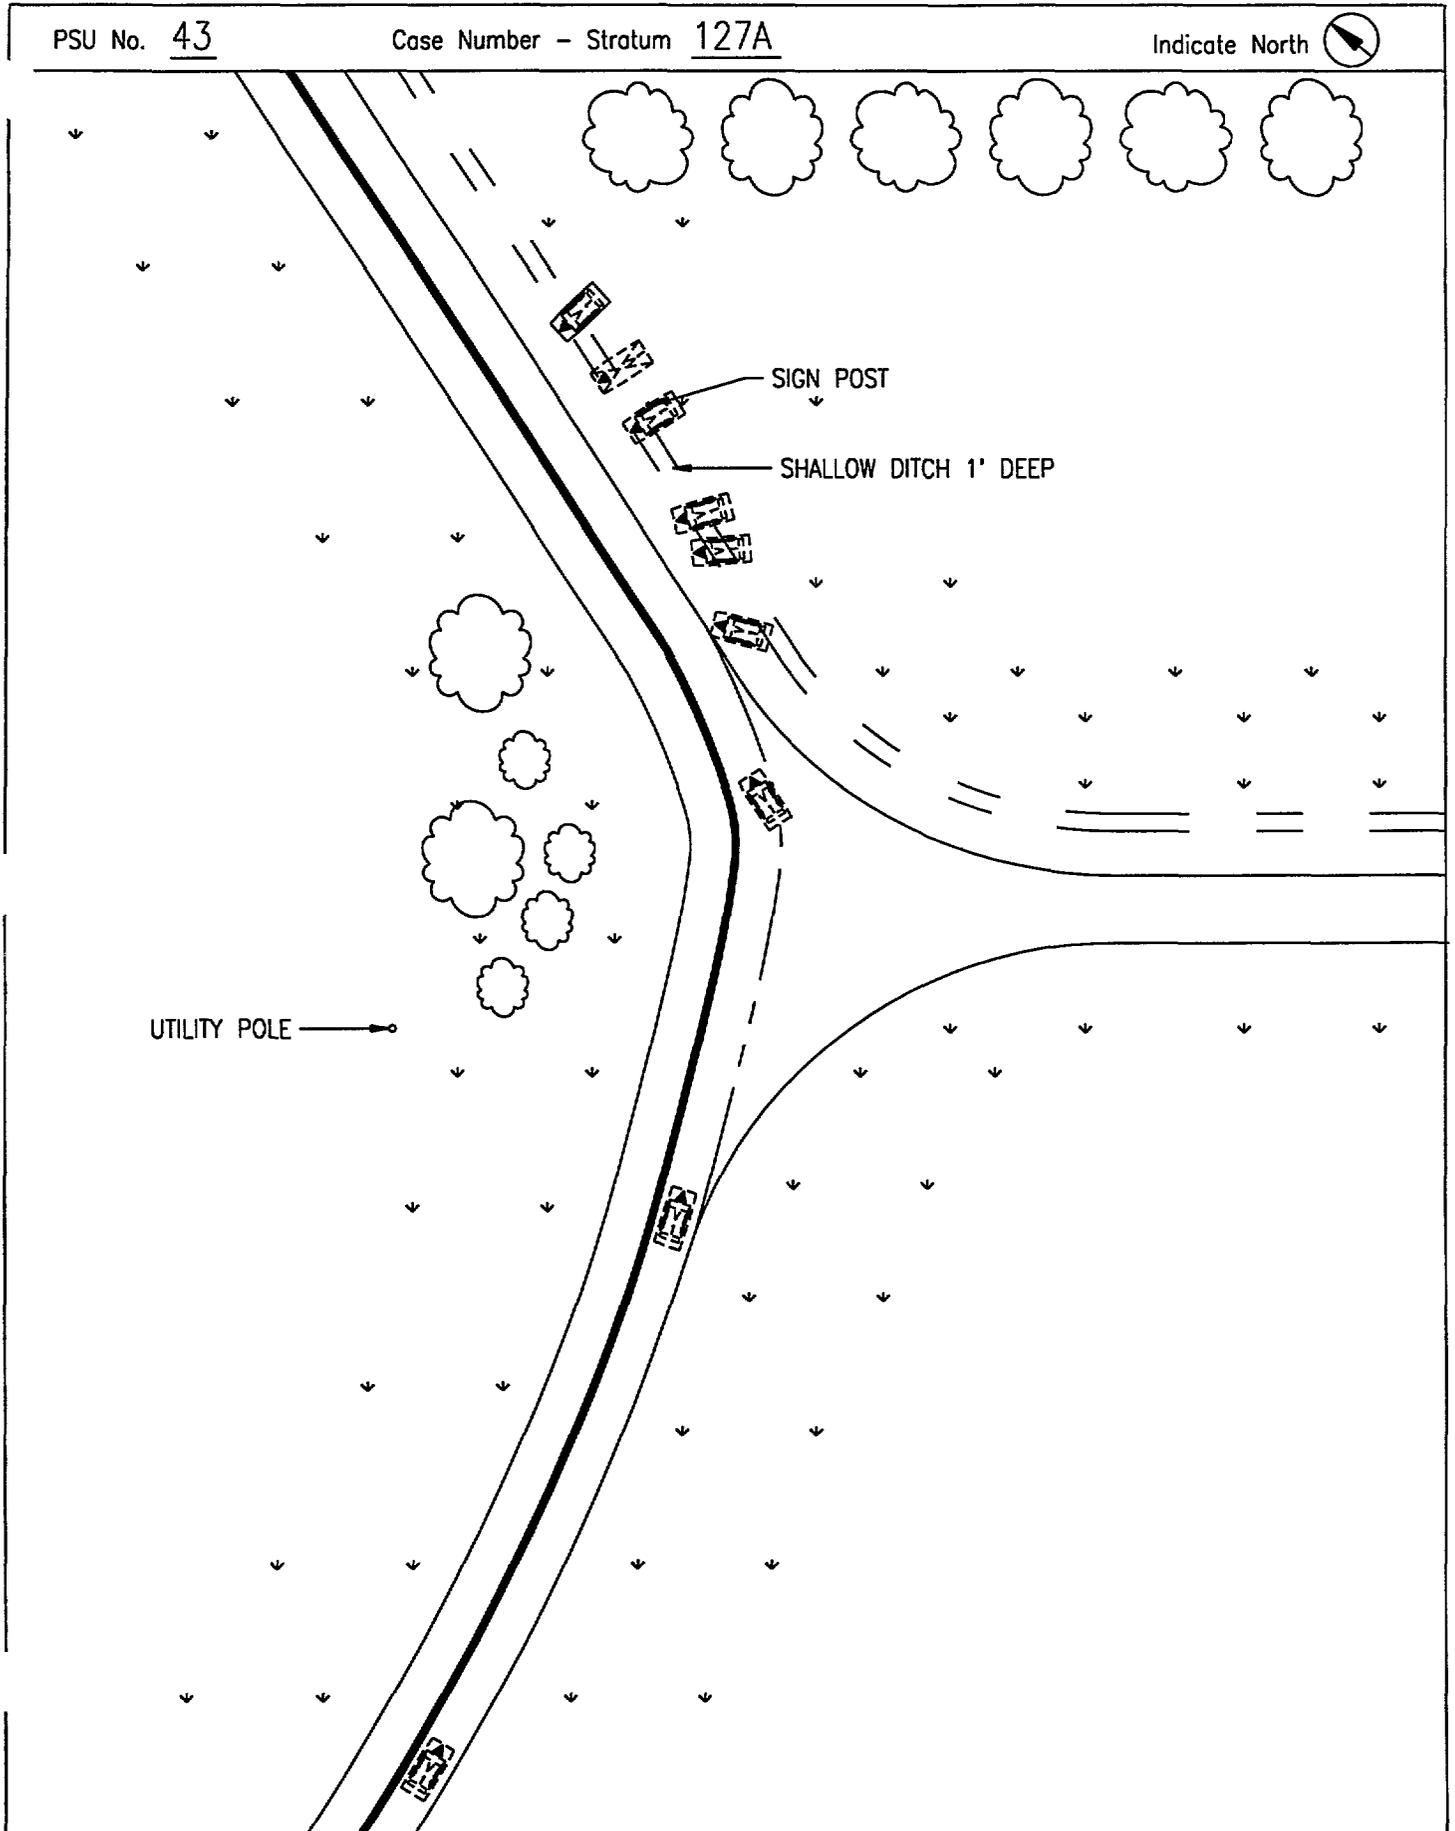
ACCIDENT COLLISION DIAGRAM

The subject vehicle was traveling on a dark, unlit, rural, two-lane, asphalt road that curved to the left with a hillcrest at the apex of the curve. While attempting to negotiate the left curve at an unsafe speed, the vehicle broke traction and yawing in a counterclockwise direction. The vehicle departed the right roadedge near the apex of the curve at a 3-leg intersection. The vehicle traversed the mouth of the intersection and departed the southeast corner in a yawed trajectory and traveled onto a grassy area. The right front tire entered a shallow drainage ditch as the right side area impacted a sign post. As a result, the vehicle overturned and came to rest on its wheels. The belted driver remained in the vehicle, however, the driver expired at the scene. The medical report stated the driver was intoxicated (BAC=0.11) and was apparently eating a taco while driving. The PAR listed 40 m of pre-impact tire marks. The road surface was repaved prior to the NASS investigation, therefore all physical evidence on the road surface was covered. There were no markings on the pavement at the time of the inspection. The PAR schematic did illustrate double yellow centerlines. There were no reflective markers or delineators along either roadedge. The PAR listed alcohol and vehicle speed as the primary causal factors.
