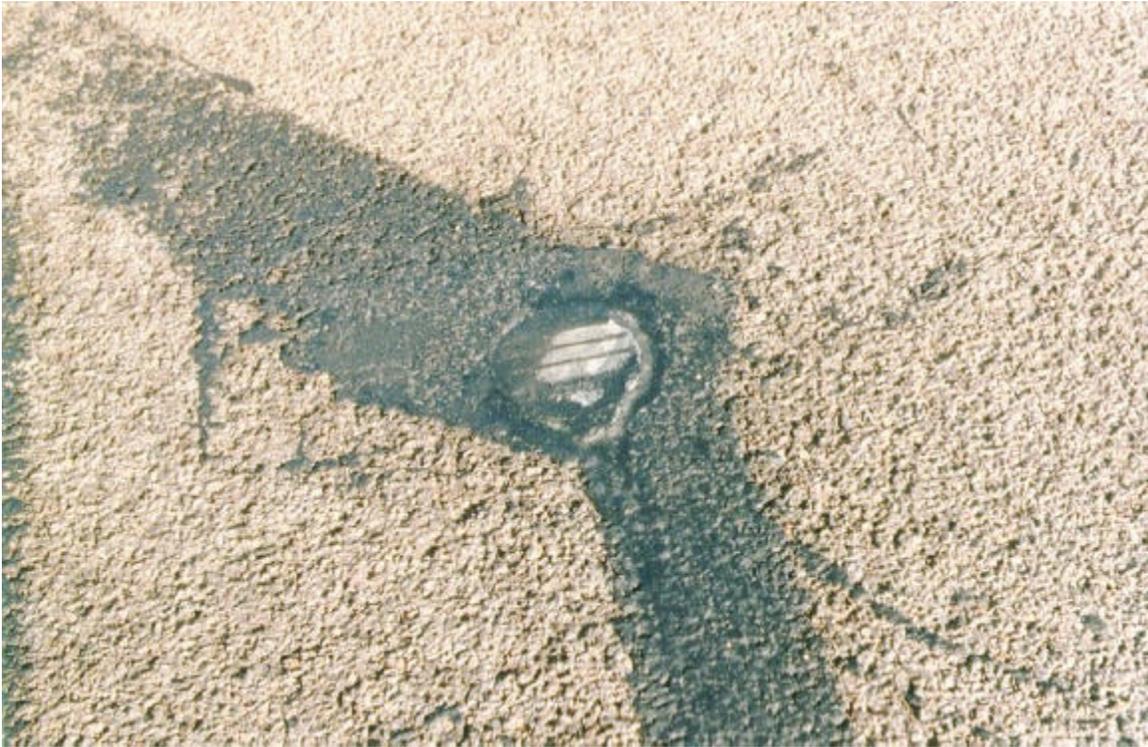
Figure 3.3. Pavement sensor at Whitaker RPU contaminated with crack sealant (February 24, 1998). This sensor has since been replaced.

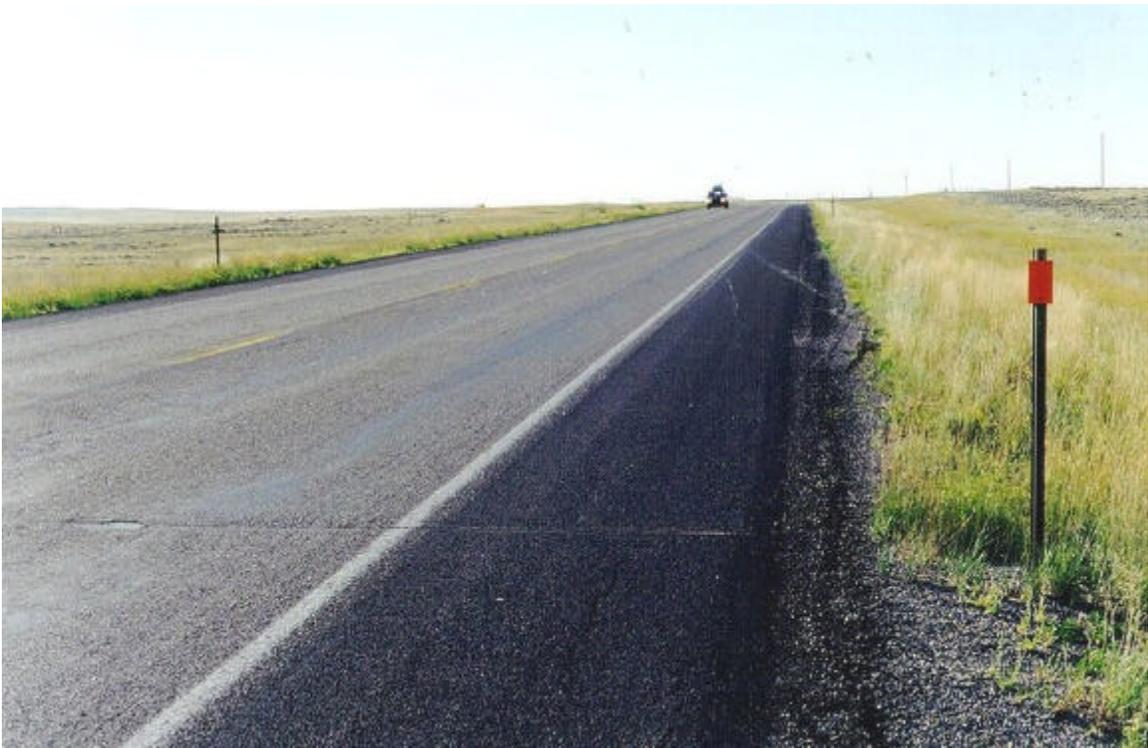
Figure 3.4. Example of proper marking of pavement sensor (Hiland, 8/15/98). The RPU is barely visible on the right side of the road 584 m in the distance—placement could have been much closer to the RPU. Note also the unavoidable depression around the sensor that results from chip sealing.
