**POLYPROPYLENE
FIBER-REINFORCED
MICROSILICA CONCRETE
BRIDGE DECK OVERLAY
AT LINK RIVER BRIDGE**

Final Report

Experimental Features Project 98-01

Oregon Department of Transportation

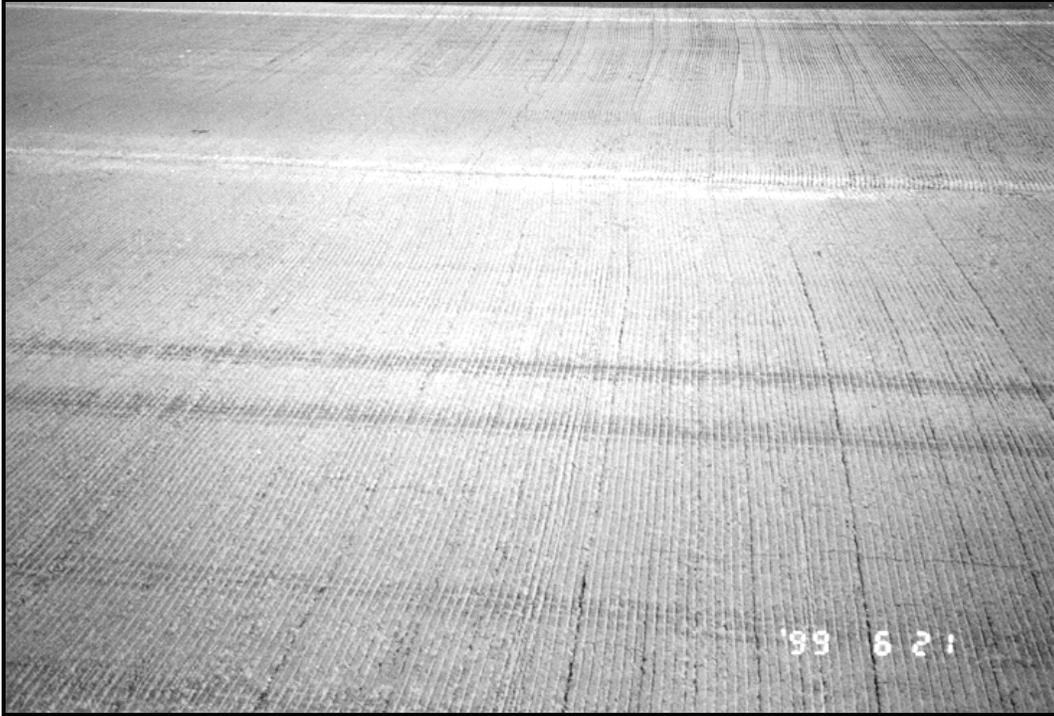
The deck was inspected about two years after the deck pour. Cracking was found in both lanes, with the majority in the northbound lanes constructed with the FMC. Figure 4.1 shows the typical cracking found in the northbound lane, while figure 4.2 shows the typical crack-free southbound lane.

Figure 4.1: Typical cracking in northbound lane two years after construction.

Cracking resistance was found to be no better in the northbound lane with fibers, compared to the southbound lane without fibers. Cracking was also observed in both lanes two years after construction. Thus the vendor's claim of reducing cracking on both the short term and long term was not supported.

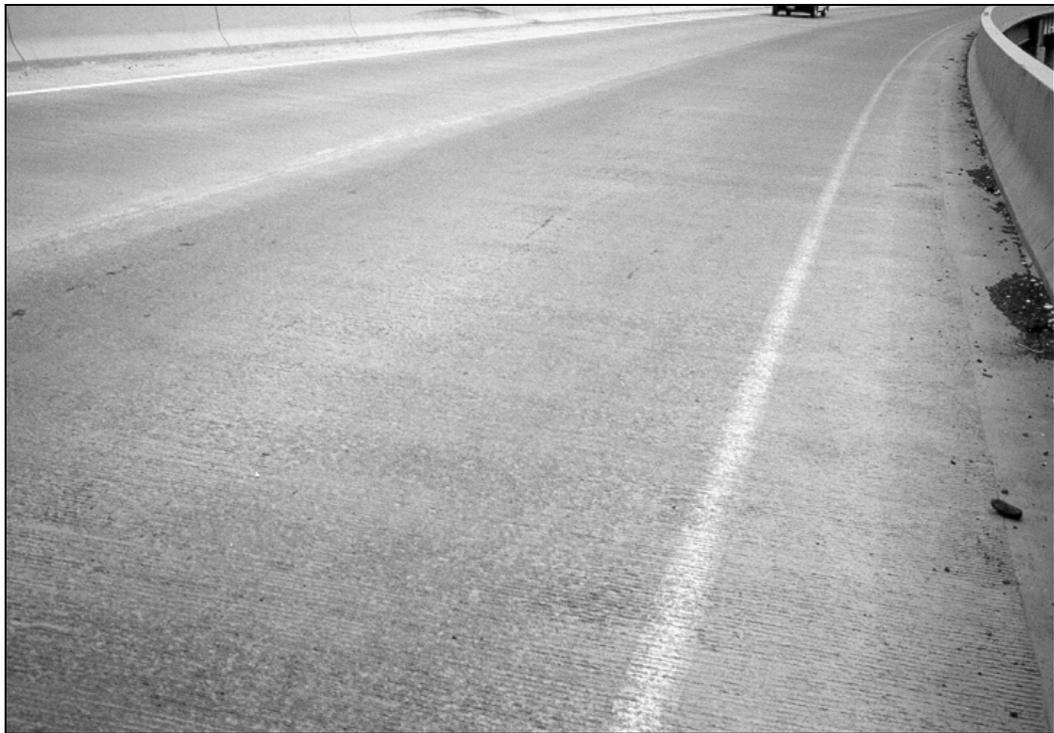
Figure 4.2: No large cracks were found in the southbound lane.
