PREMATURE FAILURE OF ASPHALT OVERLAYS FROM STRIPPING: CASE HISTORIES

**Prithvi S. Kandhal
Ian J. Rickards**

NCAT Report 01-01

April 2001

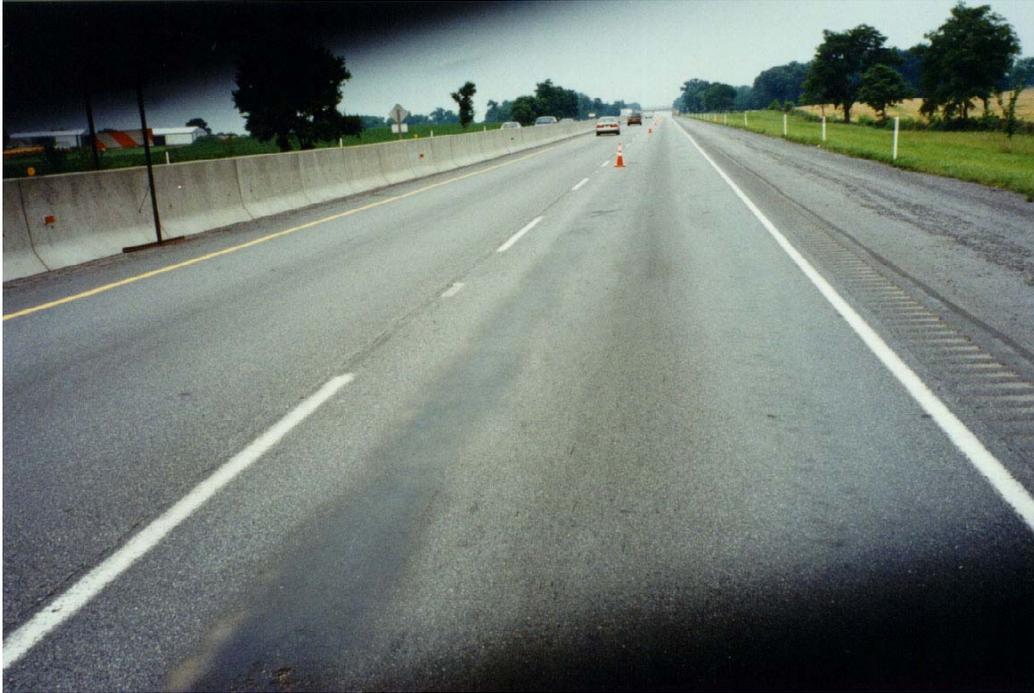
Typical telltale signs of moisture-induced stripping: fines brought up to the surface by water (mud stains), flushing of the surface, and potholing, were clearly visible on the W.B. slow lane from MP 215.5 to 218.0 (Figure 1). Potholes had developed in both wheel tracks of the W.B. slow lane between MP 215.5 and 218.0. There were more potholes in the inside wheel track compared to the outside wheel track (Figure 2). Rutting of the pavement had also started to develop in many areas (Figure 3). A similar investigation of an adjacent section of the Pennsylvania Turnpike between MP 218 and 226 was conducted by the first author in 1978 (1). On that project, the potholing was primarily occurring in the inside wheel track of the slow lane and rutting associated with stripping was not a significant problem. Therefore, this project was exhibiting more severe distressed condition than the 1978 project.

Figure 1. General view of the distressed westbound lane near MP 217.65 showing mud stains, flushing, and potholes.

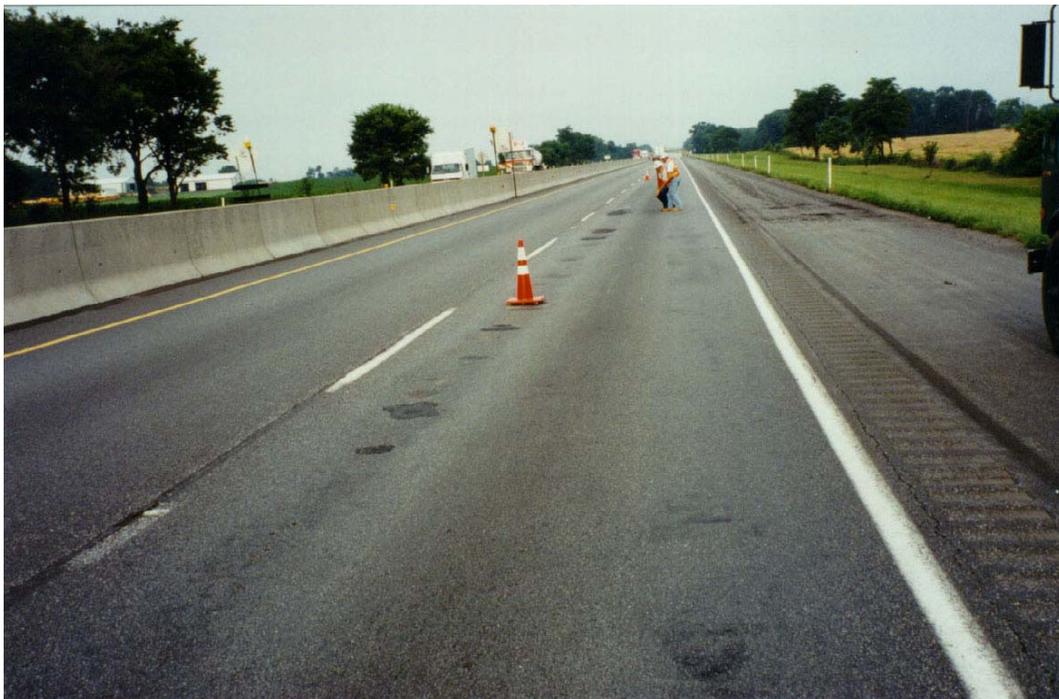
Figure 2. Potholes in both wheel tracks of the distressed westbound slow lane near MP 217.65 (most potholes in the inside wheel track).

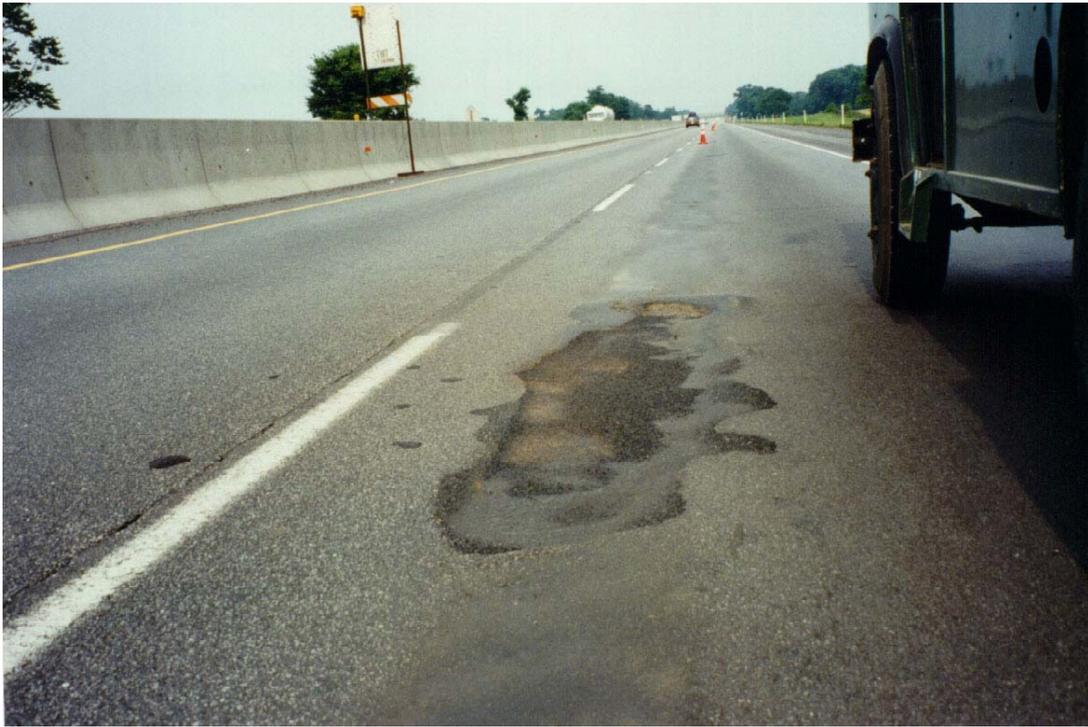
Figure 3. Potholes and rutting in the westbound slow lane near MP 217.65.

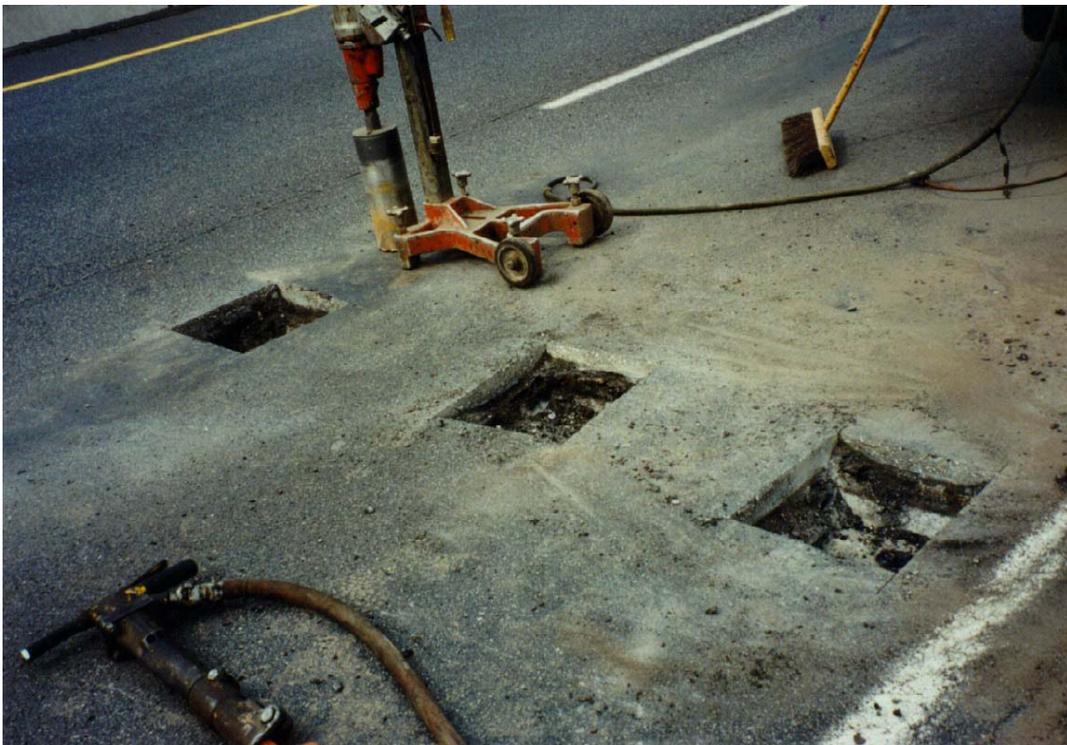
Figure 4. Three square holes cut in the westbound slow lane at MP 217.65.

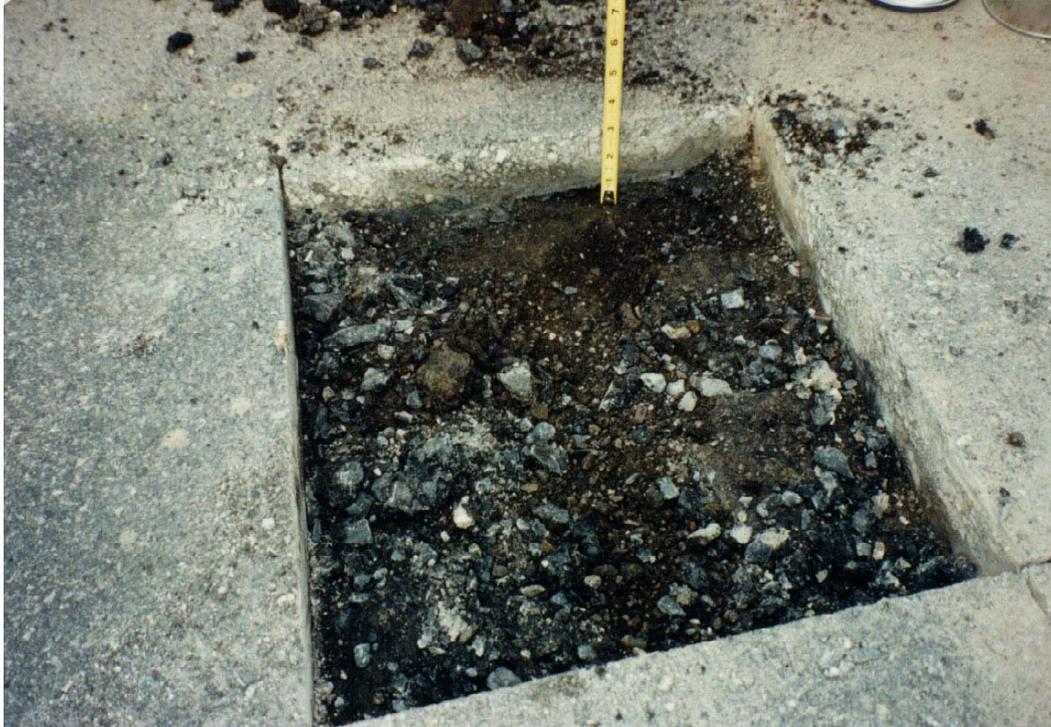
Figure 5 shows the two top layers of the pavement: the new gravel wearing course and the old limestone binder course. The old limestone binder course was about 80% stripped with bare rock particles and hardly any cohesion. This course had a lot of cavities and free moisture (Figure 5). The new gravel wearing course had started to strip from the bottom upwards (about 50% stripping) and one could see the migrated asphalt binder at the top of this layer. It was evident that the excessive moisture or water in the old limestone binder course was causing the stripping in the new gravel wearing course because of the excessive pore pressure buildup under traffic in the slow lane.

Figure 5. Hole exposing new gravel wearing course and underlying old limestone binder course at MP 217.65.

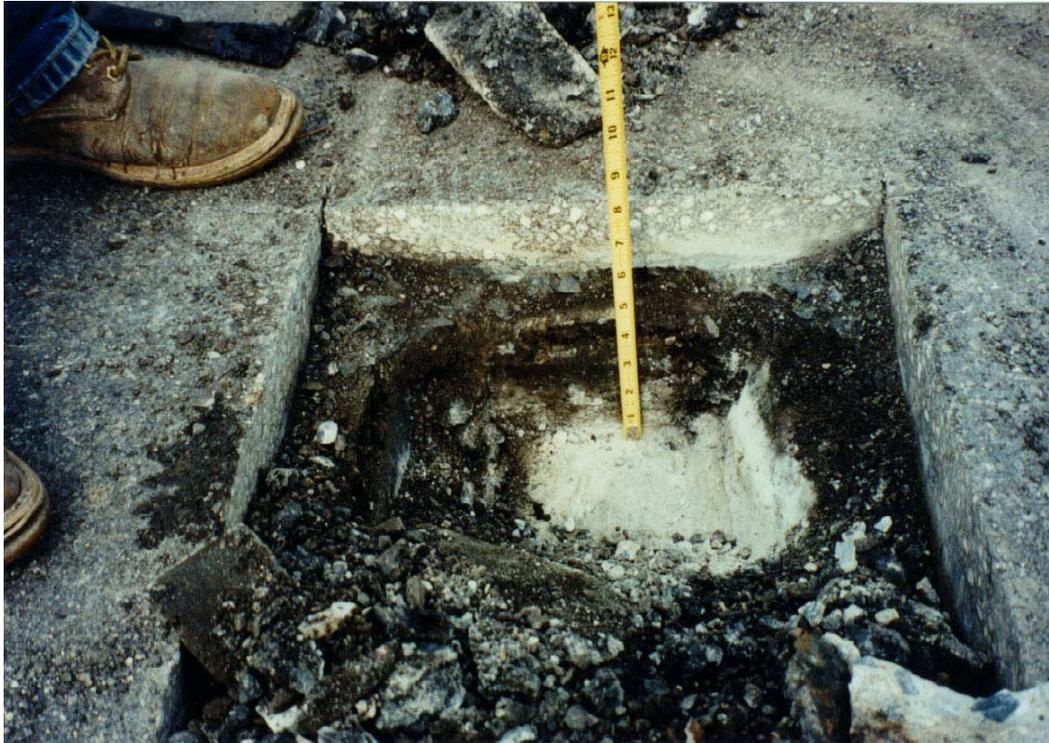
Figure 6 shows the hole cut out full depth about 200 mm to the existing PCC pavement. It was observed that the old gravel wearing course underlying the old limestone binder course was also saturated with water, about 50% stripped, and very friable. It was hard to imagine that such a friable mix (with almost no cohesion) was existing at a depth of about 75 mm only from the road surface. Figure 6 clearly shows wetness in the old limestone binder course as well as in the old gravel wearing course.

Figure 6. Hole exposing all asphalt concrete layers and PCC surface at MP 217.65.

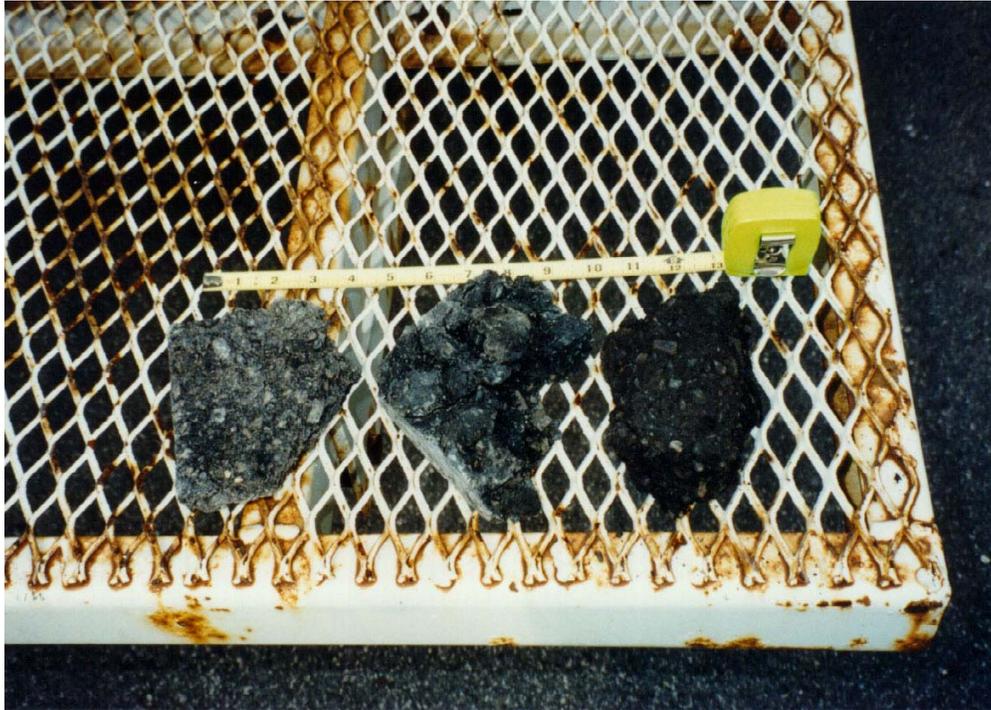
Figure 7. From left to right: new gravel wearing course, old limestone binder course, and old gravel wearing course, from a hole at MP 217.65.

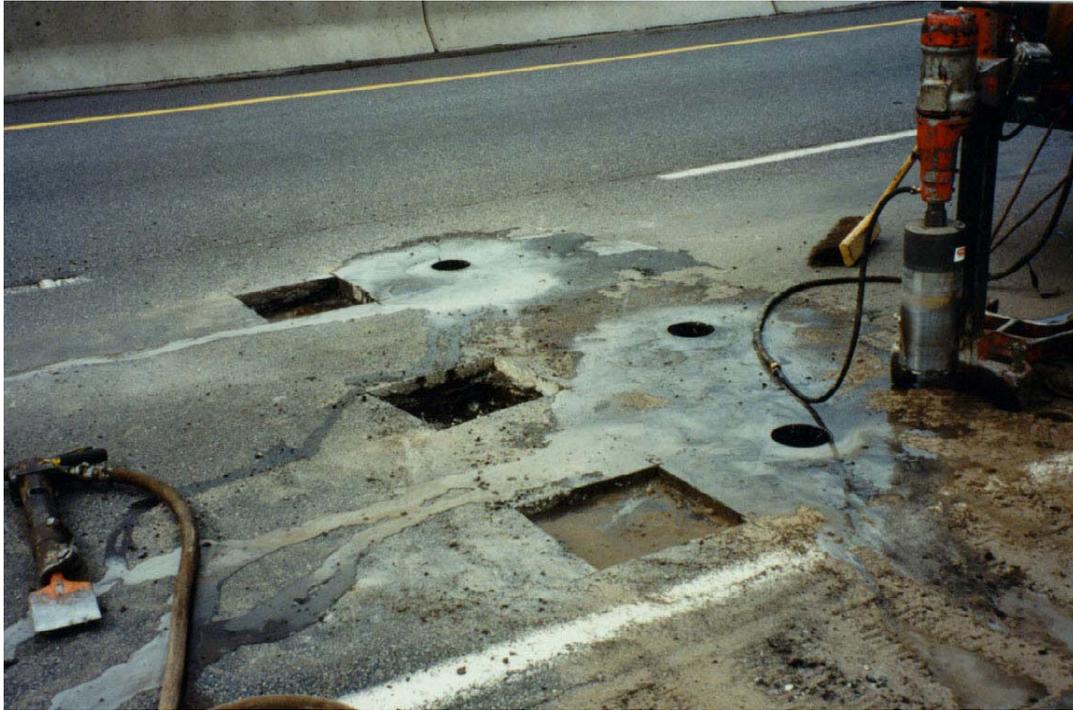
Full depth pavement cores (150-mm diameter) were also obtained adjacent to the square holes to observe the pavement layers and to determine the thickness, bulk specific gravity, and air void content of each layer (Figure 8).

Figure 8. Cores taken adjacent to square holes at MP 217.65.

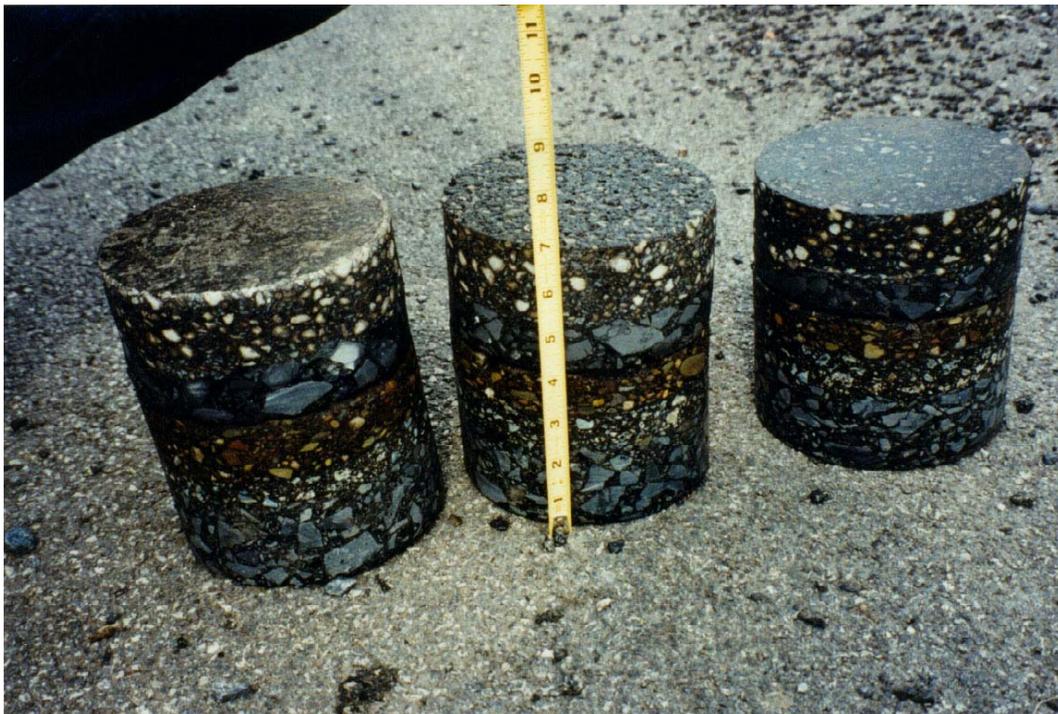
Figure 9 shows the full-depth cores taken (from left to right): inside wheel track, between the wheel tracks, and outside wheel track. All cores showed the following five asphalt pavement layers from top down: new gravel wearing course, old limestone binder course, old gravel wearing course, old slag wearing course, and old limestone binder course. The old limestone binder course underlying the new gravel wearing course had more cavities in the core taken from the inside wheel track compared to the other two cores (Figure 9). Evidently, the inside wheel track was showing more distress compared to the outside wheel track at the time of inspection. More severe stripping was taking place in the inside (left) wheel track of the slow lane probably due to (a) close proximity to the longitudinal center line joint of the PCC pavement where ingress of water from the subgrade is usually high, and (b) increased distance from the pavement base drain at the edge compared to the outside (right) wheel track.

Figure 9. Cores taken at MP 217.65 (from left to right): inside wheel track, between the wheel tracks, and outside wheel track.

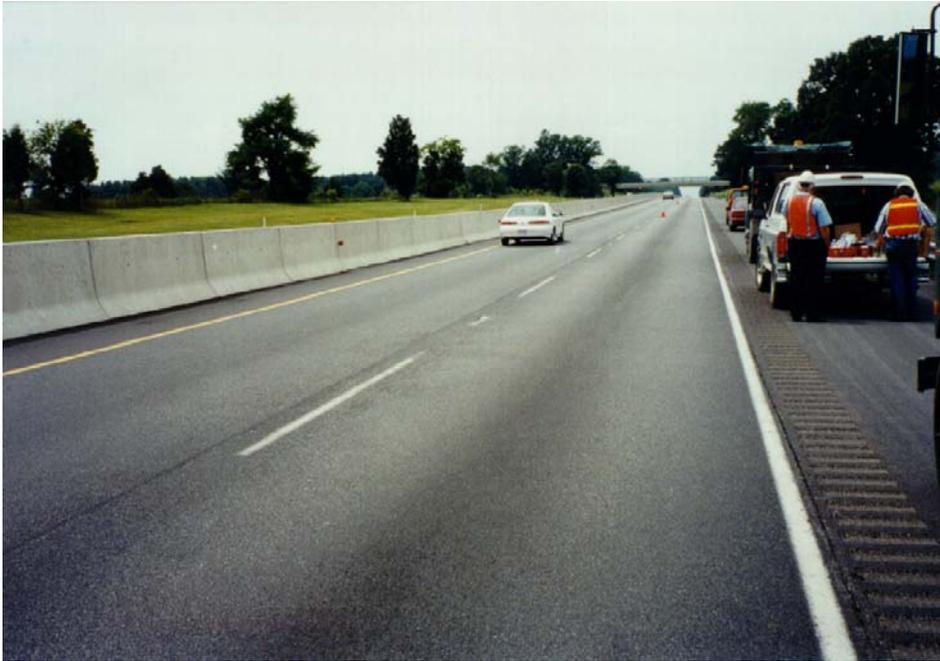
As mentioned earlier, pavement investigation was also conducted in a relatively good area of this project at MP 212.9. Figure 10 shows the westbound lanes which do not exhibit any distress at this time (July 1996). Three holes were cut at MP. 212.9 similar to MP 217.65. Stripping had already initiated in the new gravel wearing course at the bottom. Although the old limestone

Figure 10. General view of the relatively good area of the westbound lanes near MP 212.9.

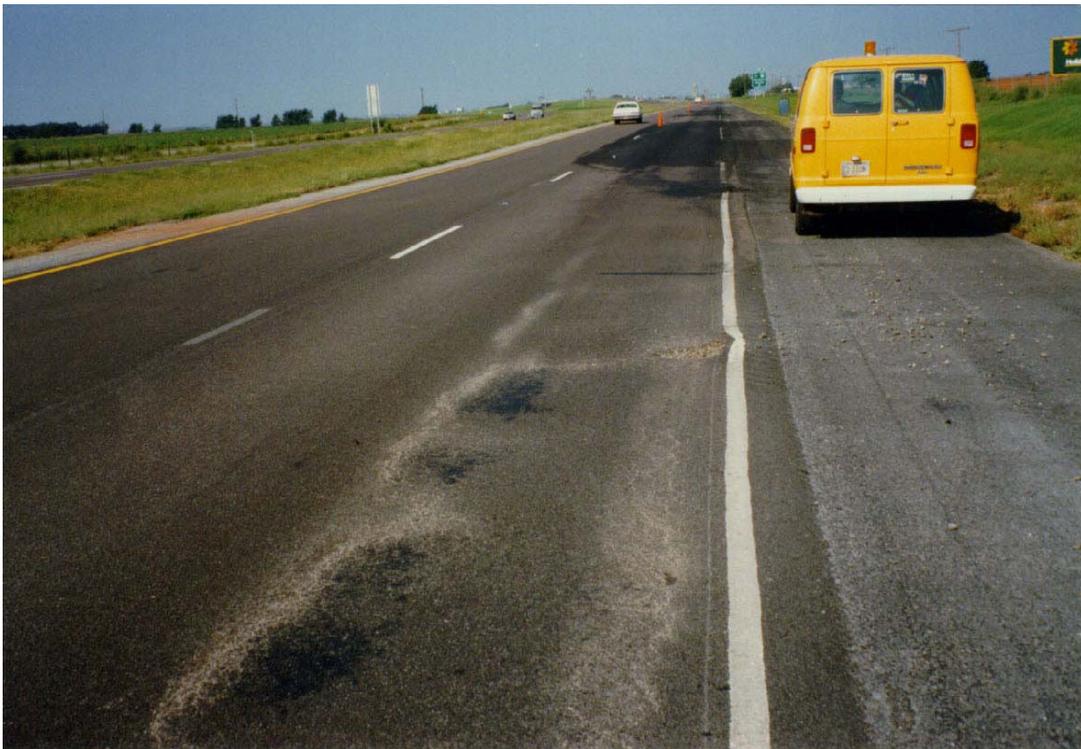
Figure 11. Development of potholes primarily in the outside wheel track of I-40 in Oklahoma.

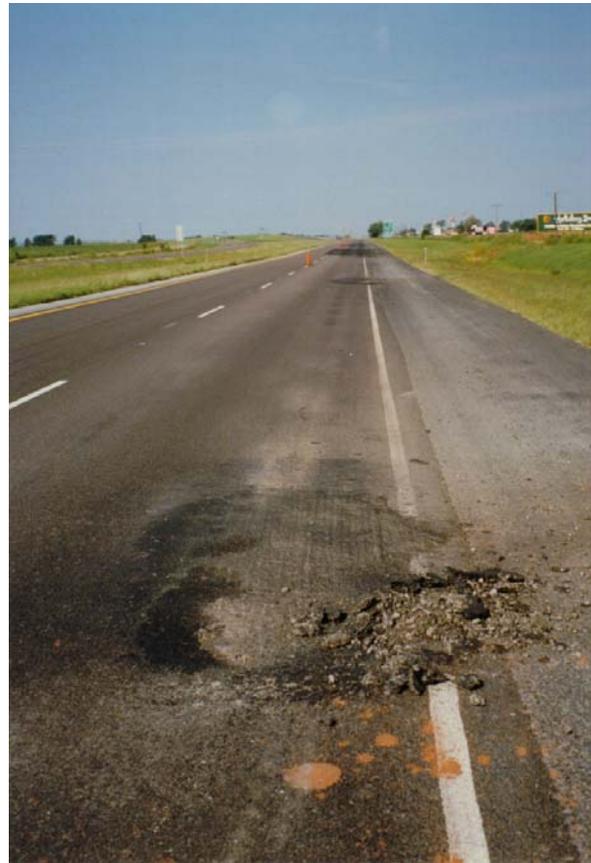
Figure 12. Potholing on I-40, Oklahoma.

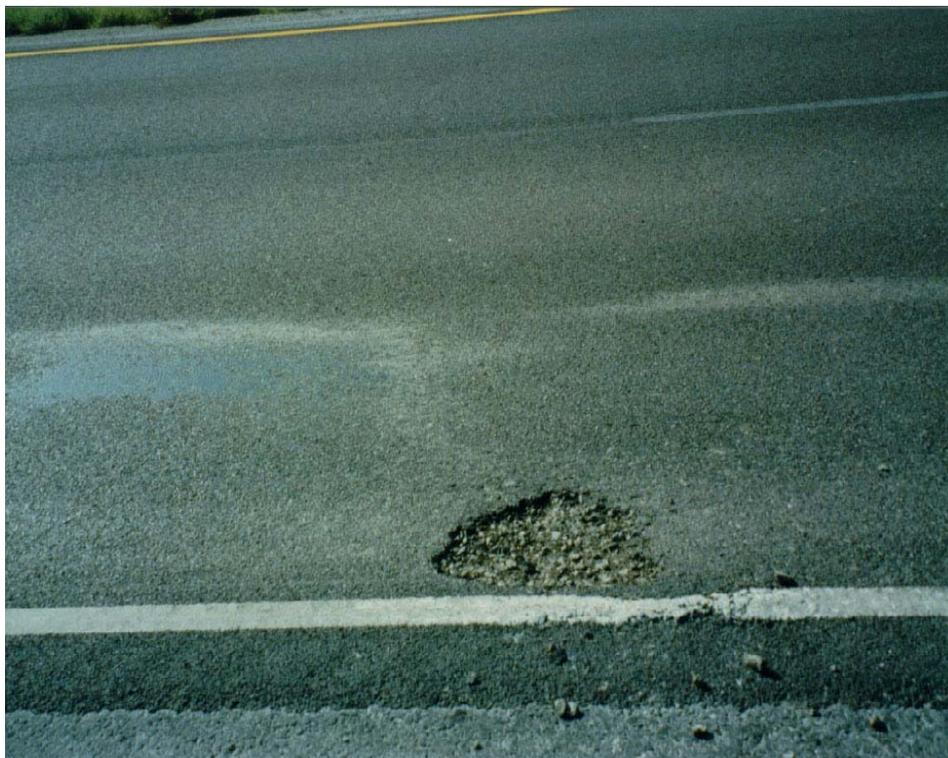
Figure 13. Three stages of stripping: white stains, flushing, and pothole (I-40).

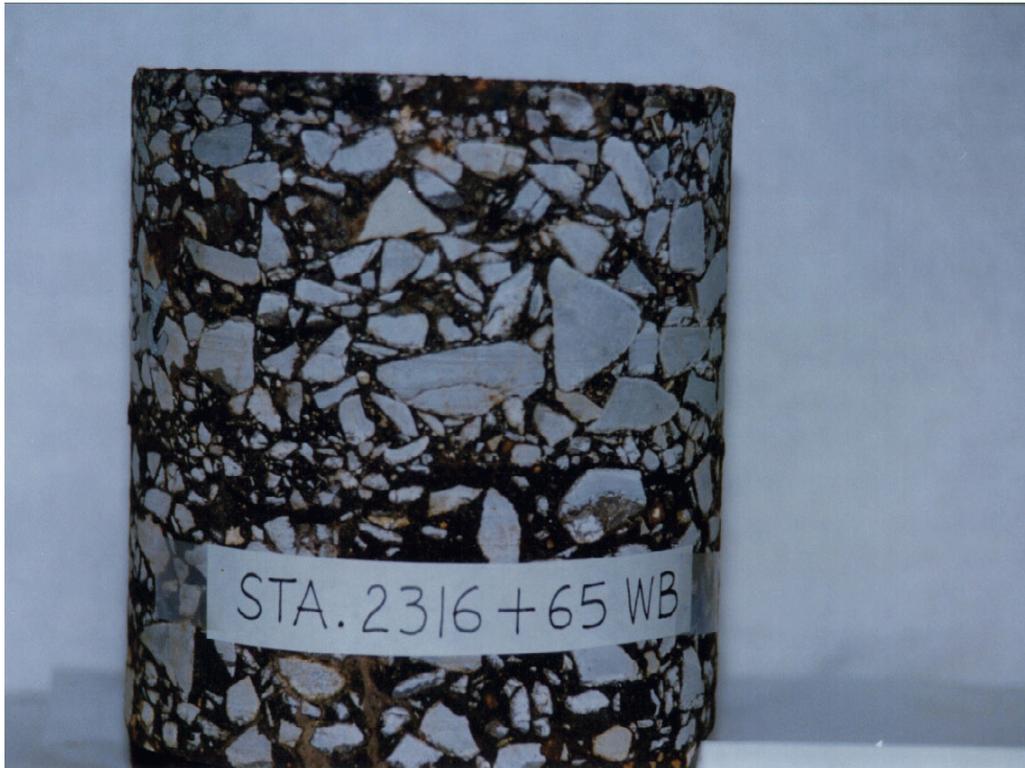
The roadway was sampled with a jack hammer as well as a coring device. No moisture content determinations were made on this project. Figure 14 shows a very open F binder mix underneath the OGFC. In many cases, F mix crumbled and OGFC stayed intact (Figure 15). Therefore, the primary cause of the stripping problem being experienced

Figure 14. Pavement core showing an open, coarse-graded F binder mix underlying the OGFC (I-40).

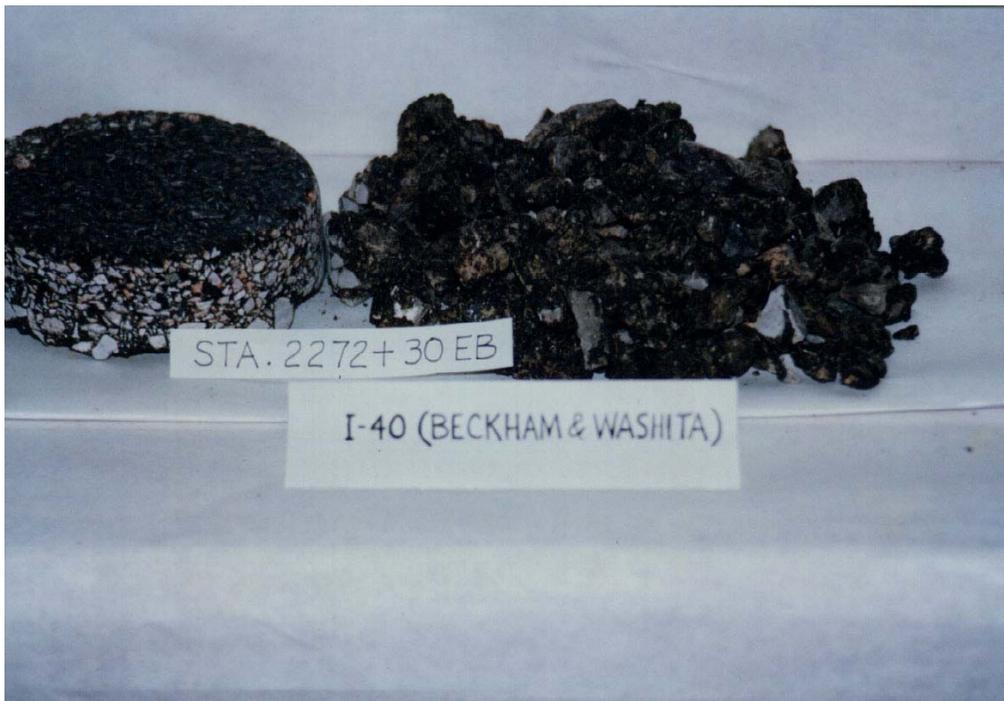
Figure 15. Stripped F binder mix (right) which crumbled on coring with an intact OGFC layer (I-40).

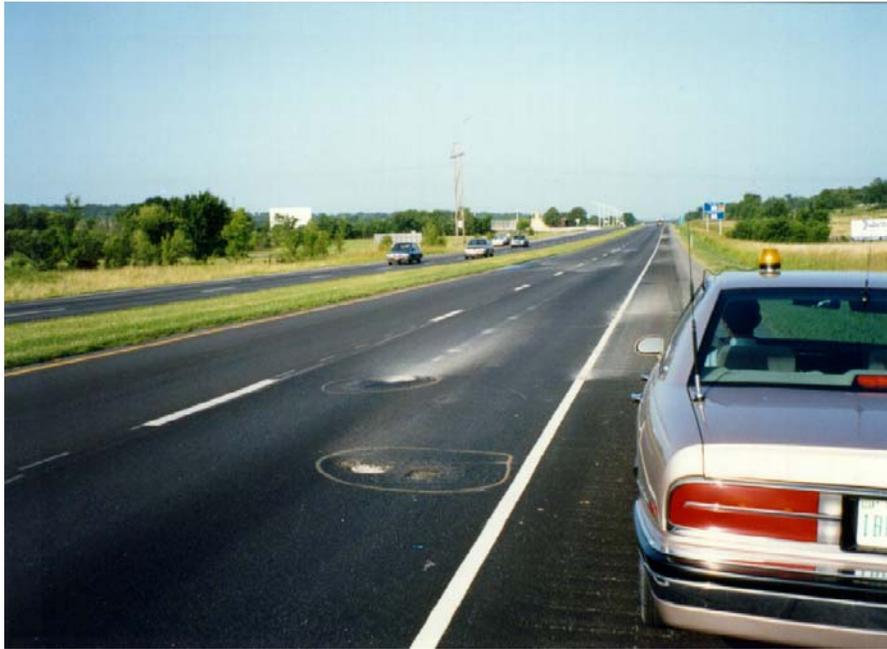
Figure 16. Potholing in the inside wheel track of slow lane.

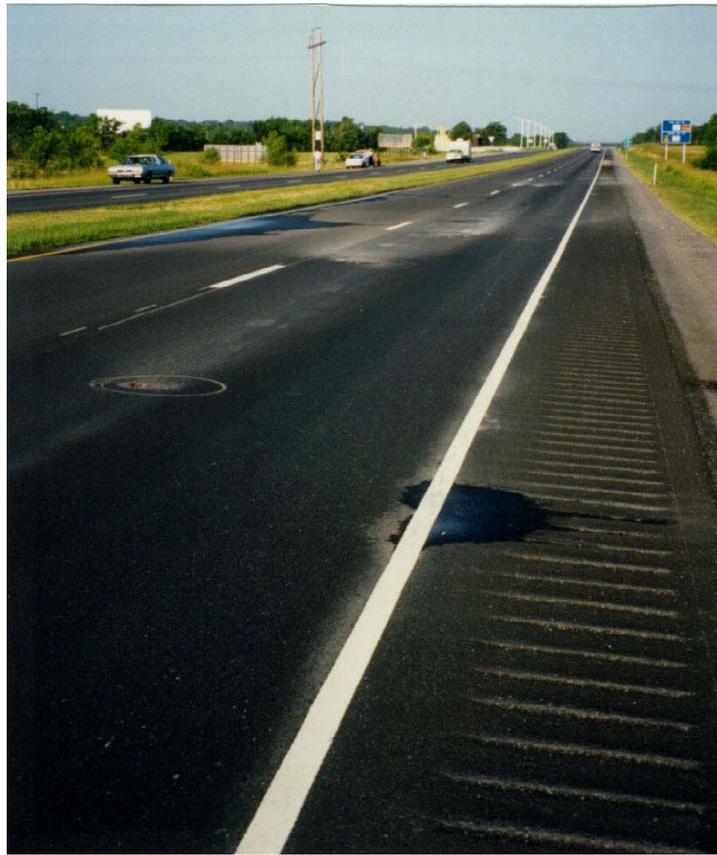
Figure 17. Potholes in the inside wheel track of slow lane (another location).

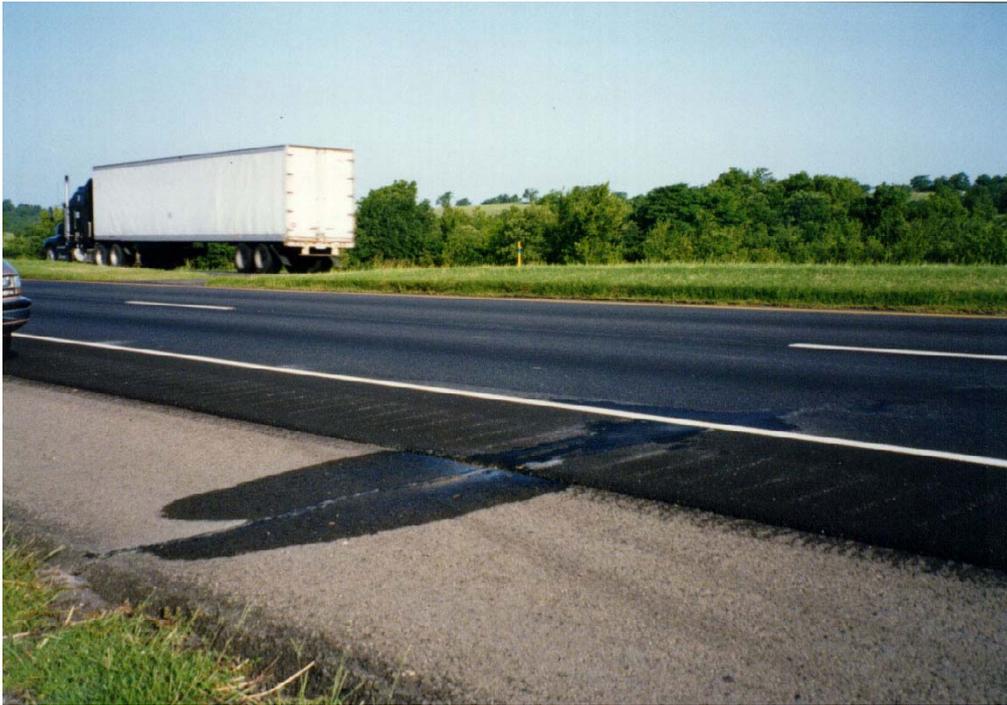
3. Although it had not rained for more than two days prior to this inspection, free water was observed to be coming out of thermal cracks in the shoulder area (Figure 18), from the edge of the raised grassy median (Figure 19), and from the pavement/shoulder joint (Figure 17). This pavement did not have any edge drain to intercept subsurface water.

Figure 18. Water coming out of thermal cracks.

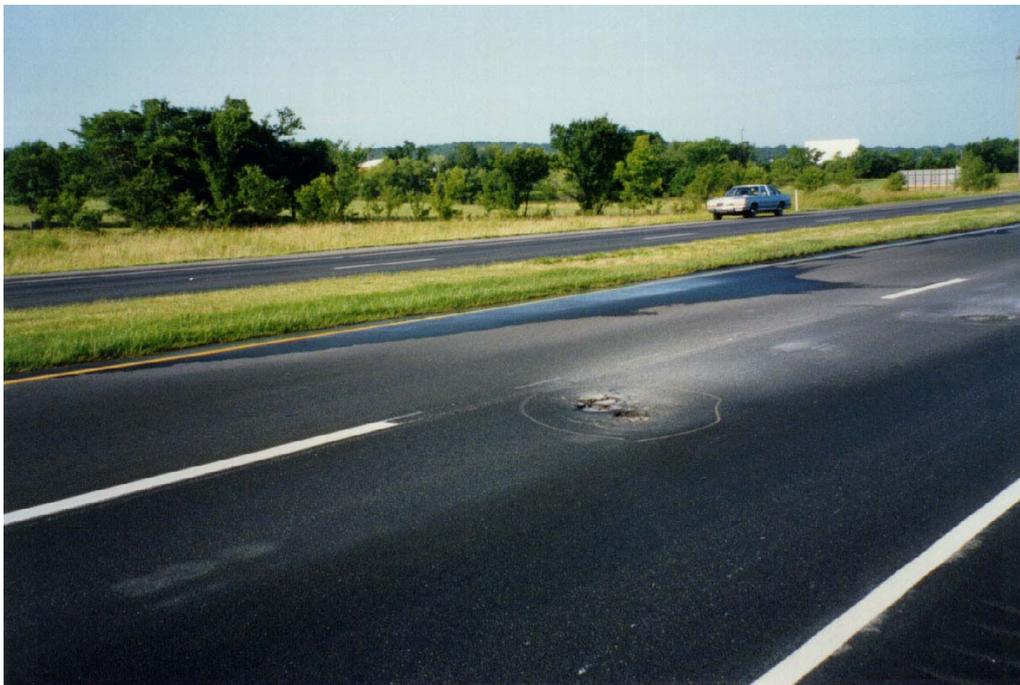
Figure 19. Water from the raised grassy median.

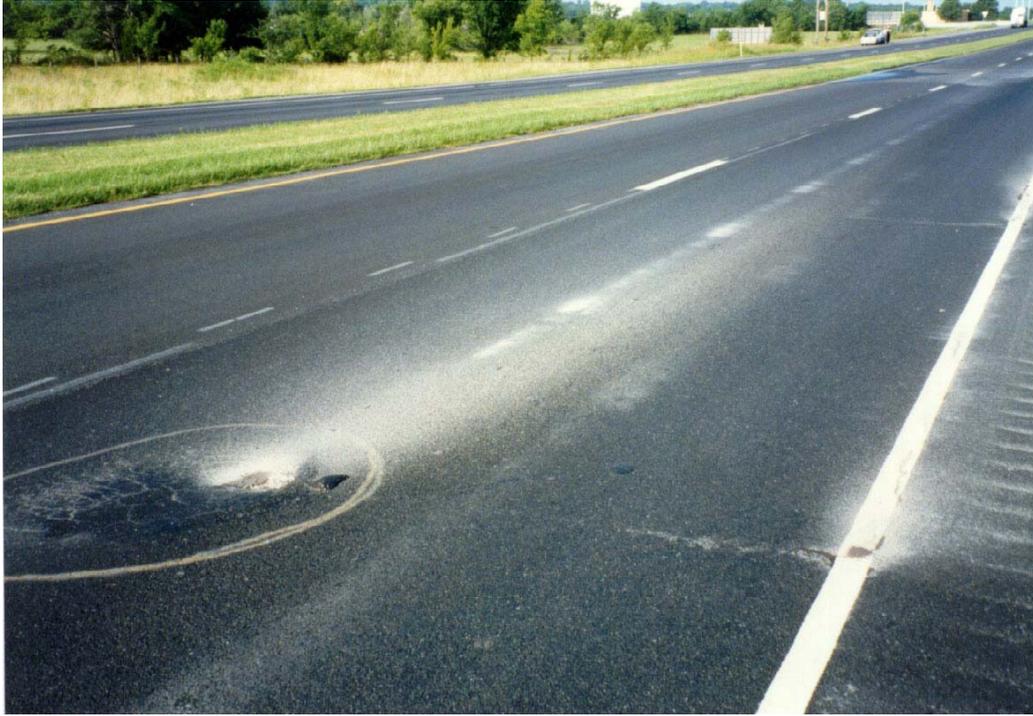
5. Big white-stained patches (Figure 20) could be seen near the potholed areas. No flushing of the pavement was observed. Typically, when the stripping is initiated in the underlying layer(s), white stains appear first (due to migration of fines from the stripped aggregate upwards with water), flushing or bleeding appear next (due to migration of stripped asphalt binder upwards), and the potholing occurs last in the flushed area (this sequence was observed in the first two case histories. Since no flushing was observed in this case, it indicated that the underlying B mix had already stripped substantially and had lost most of the binder prior to the placement of E mix.

Figure 20. Big white-stained patches near potholed areas.

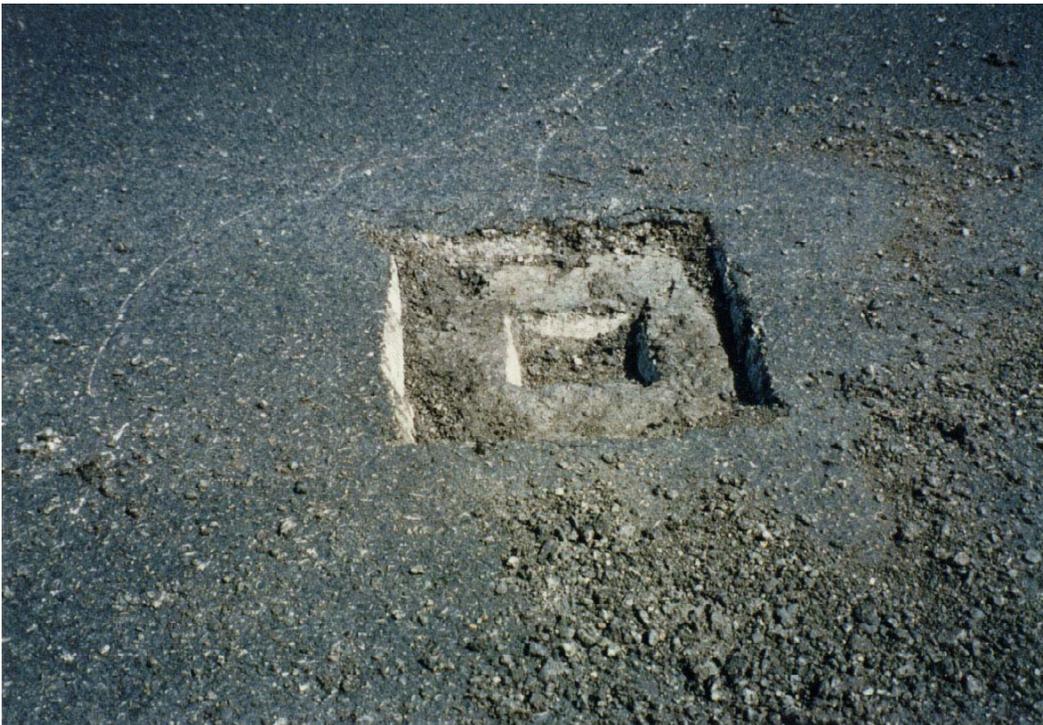
7. A jack hammer was used during the inspection to remove the HMA pavement layers for observation without adding any water (Figure 21). First the E mix was removed. It appeared satisfactory. Then the B mix layer was removed. The top half of the B mix layer was stripped severely (Figure 22). The mix was very friable (no cohesion due to lack of asphalt binder) and it contained excessive visible moisture. The concrete pavement underneath was also wet. Average moisture (water) content in the B mix was determined to be 2.76% when the samples taken by jack hammer were sealed and tested in the

Figure 21. E mix and B mix layers removed by jack hammer.

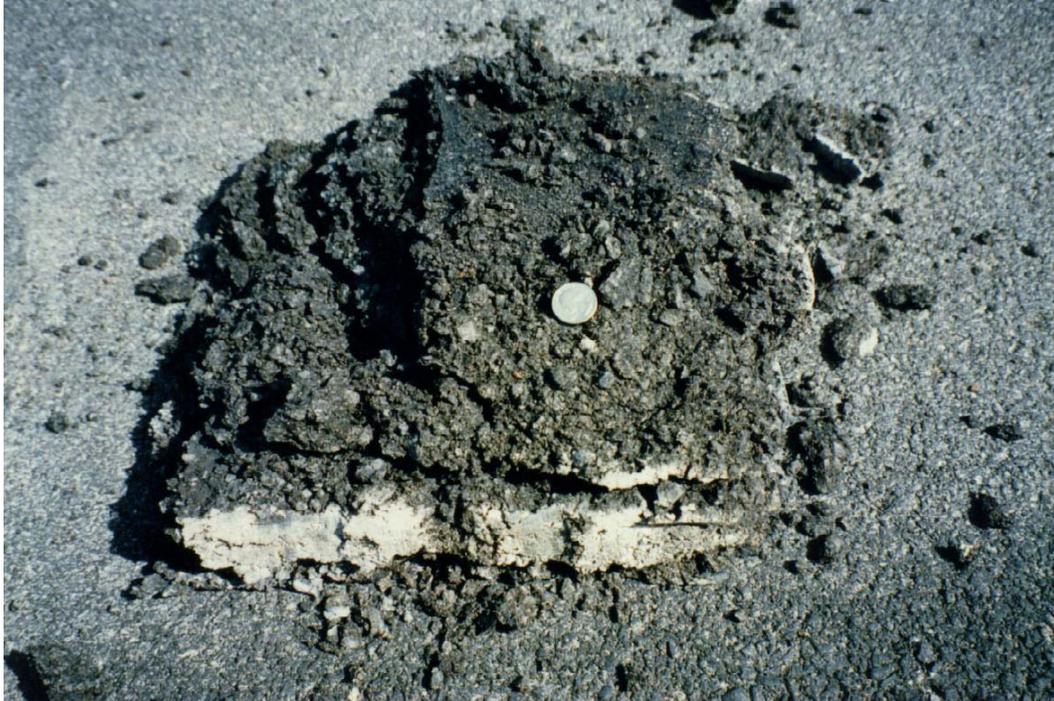
Figure 22. Bottom of stripped B mix layer.

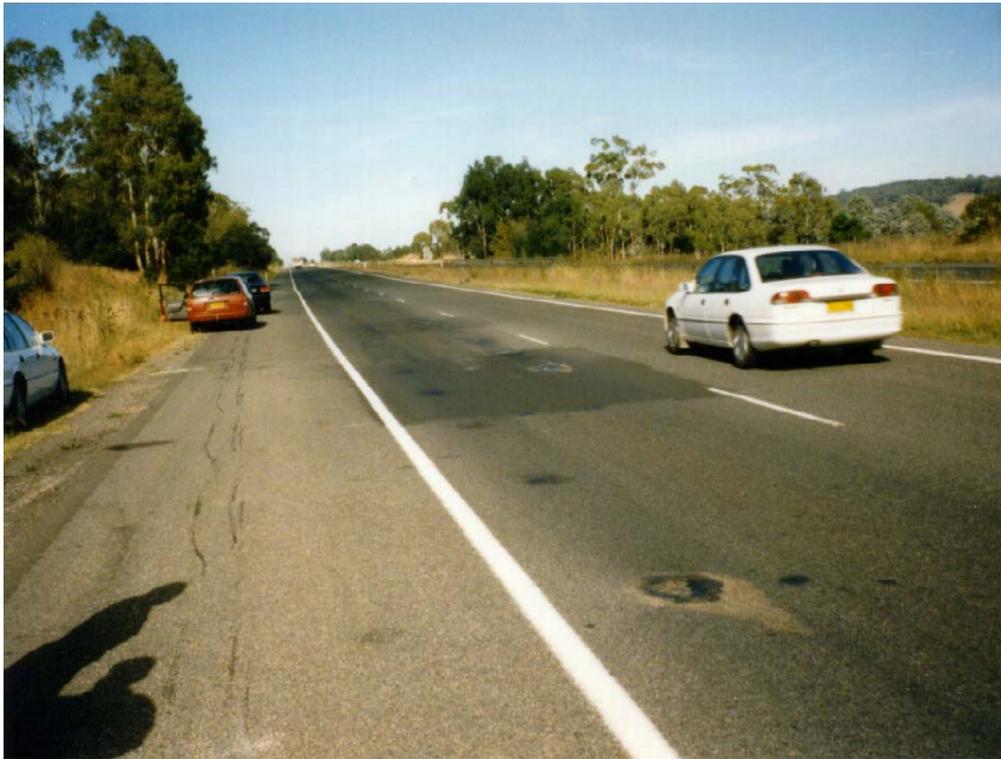
required frequent patching) can be seen in Figures 24 and 25. First a white stain would appear on the surface of the OGFC, followed by a circular pattern of alligator type fatigue cracking (as shown in Figure 26), and then a pothole.

Figure 24. Pattern of potholes and patch repairs in the southbound slow lane of Hume Highway.

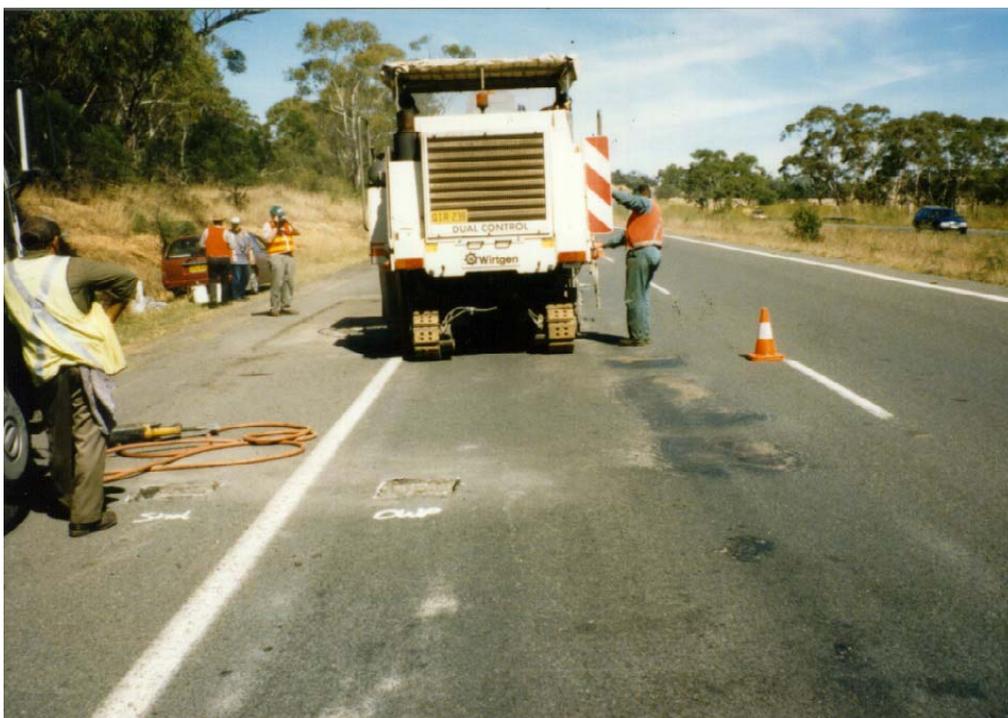
Figure 25. Potholes in the southbound slow lane of Hume Highway (another location).

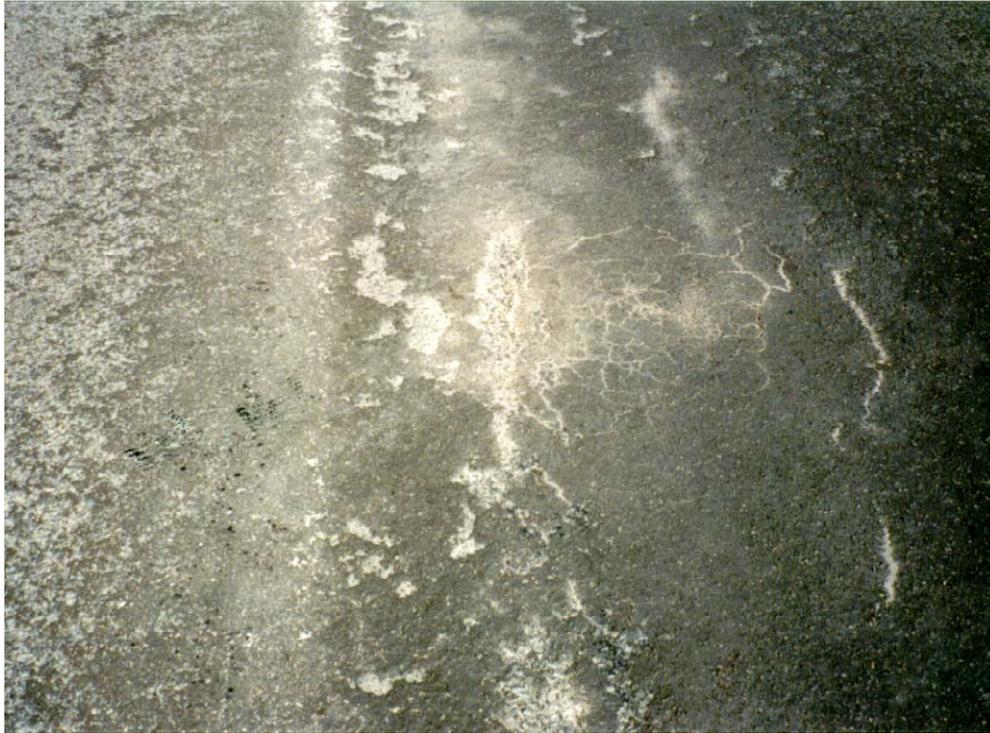
Figure 26. Stages of pavement distress: white stains, alligator cracks, and pothole.

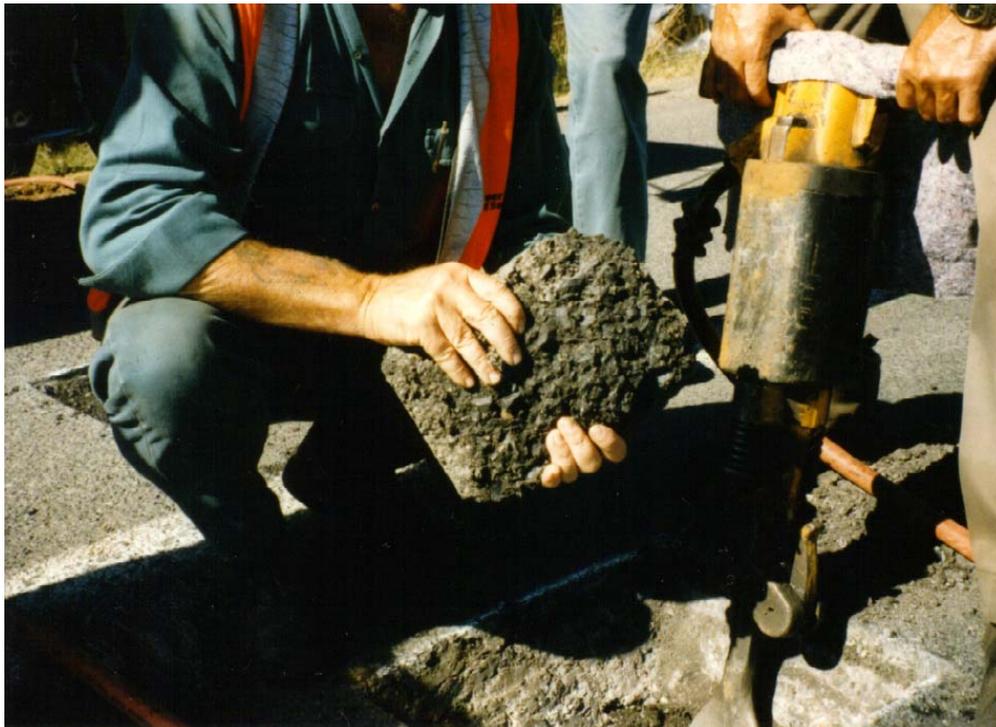
Figure 27. Excavation of each asphalt layer with a jack hammer.

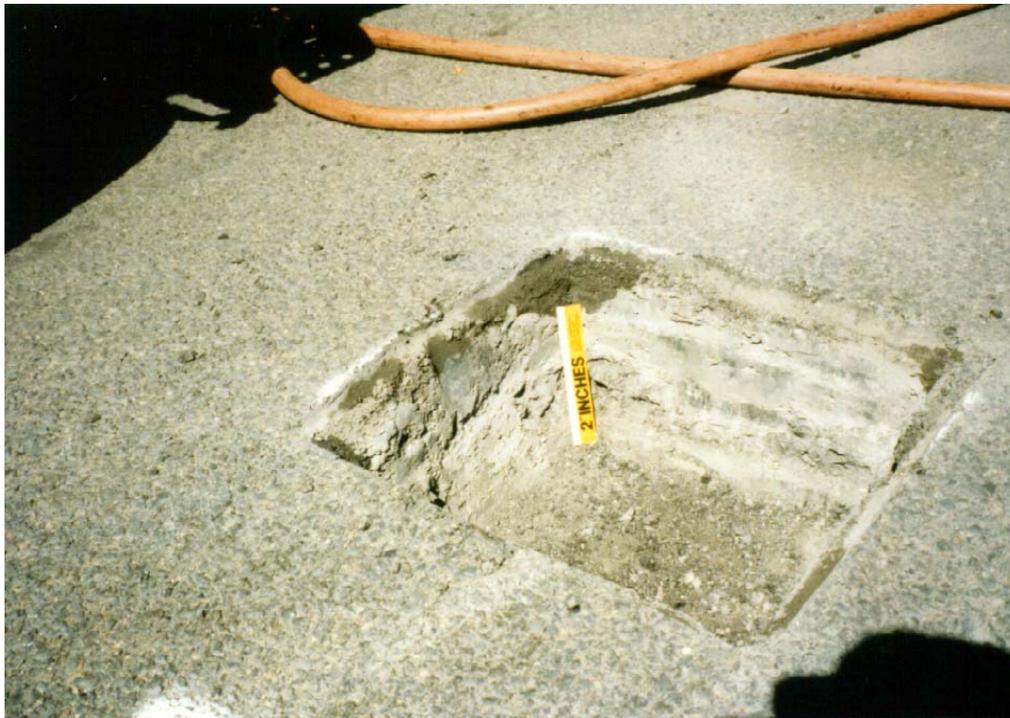
1. Generally, AC 14 which underlays the OGFC has higher moisture content than AC 28. Figure 30 clearly shows a very wet AC 14 course just below the OGFC in the test hole.
2. Moisture contents are slightly higher at locations between the wheel path compared to the locations on the wheel path. This probably resulted from relatively lower air voids in the wheel path resulting from densification by traffic.

Figure 30. Test hole showing a very wet AC 14 course just below the OGFC.

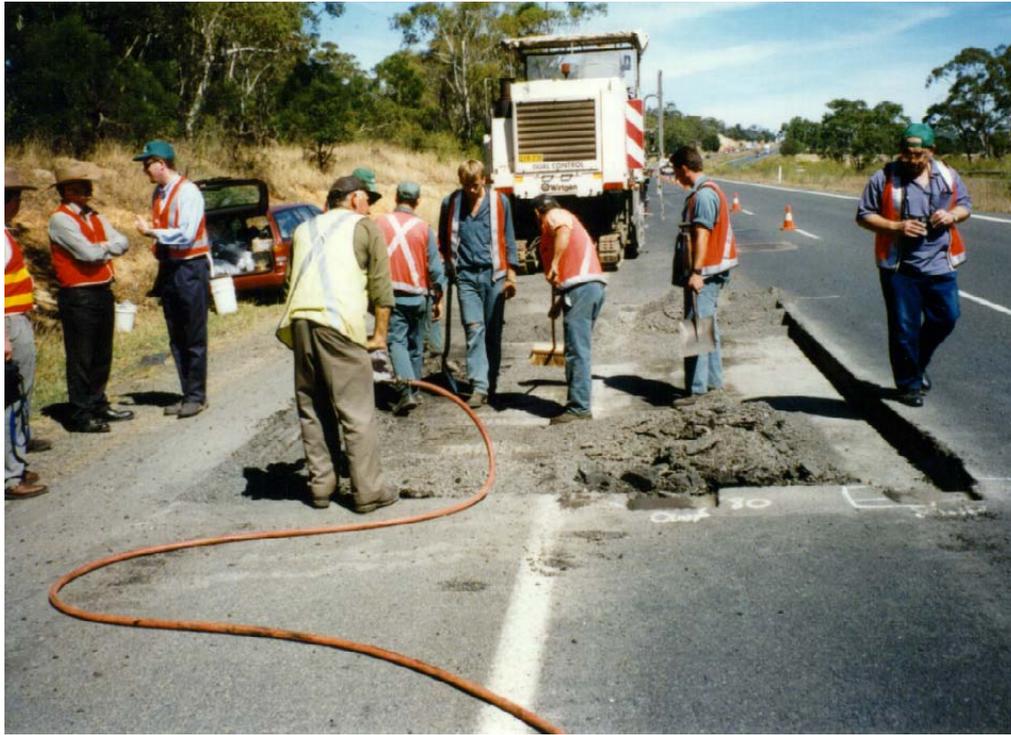
Figure 31. Cold milling in the slow lane and shoulder area to evaluate the condition of asphalt layers.
