PREMATURE FAILURE OF ASPHALT OVERLAYS FROM STRIPPING: CASE HISTORIES

**Prithvi S. Kandhal
Ian J. Rickards**

NCAT Report 01-01

April 2001

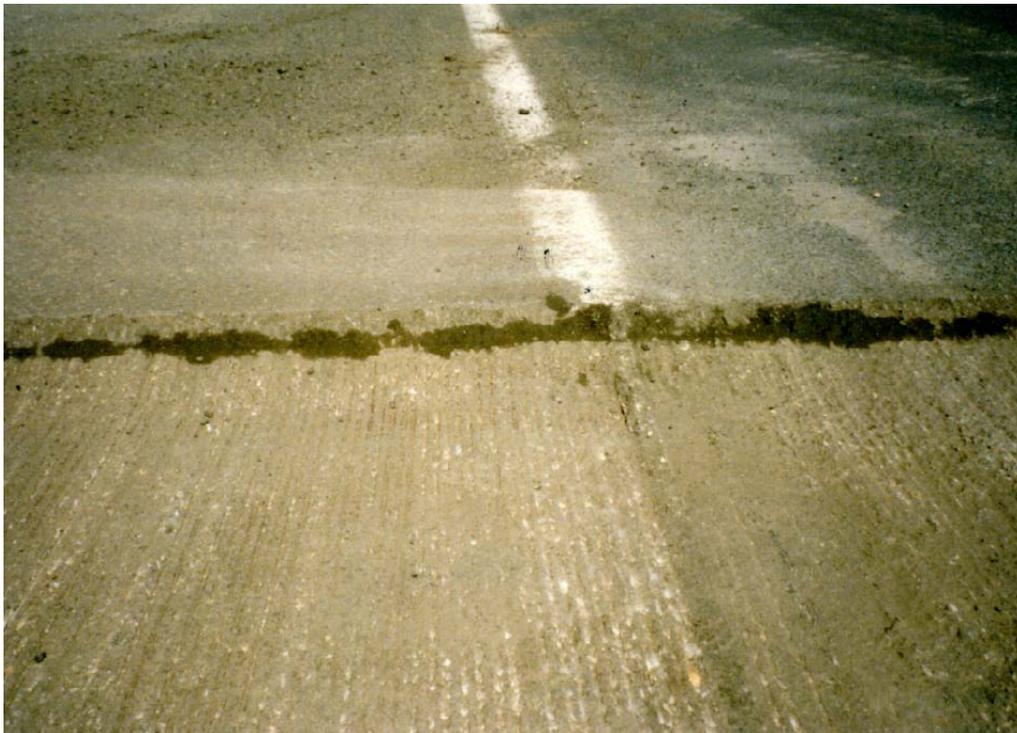
Figure 32. Wet AC 14 course just below OGFC at the edge of the milled trench.

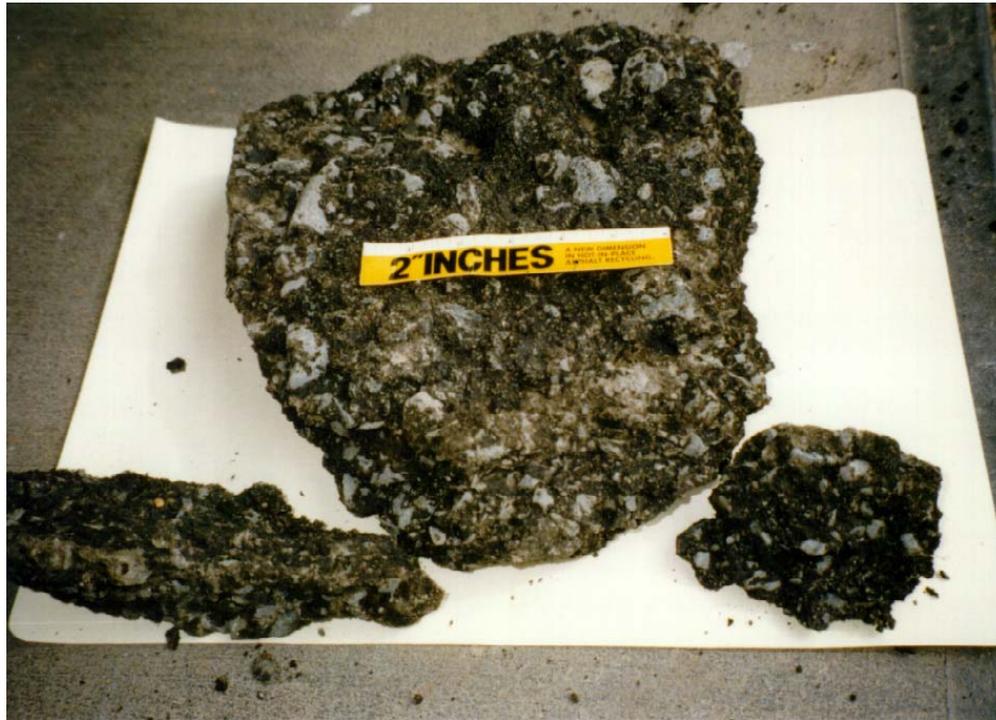
Figure 33. Badly stripped AC 28 and AC 14 courses.
